City of Hamilton
HERITAGE PERMIT REVIEW SUB-COMMITTEE
AGENDA

10.1. HP2021-033 - 398 Wilson Street East, Ancaster

Proposed relocation of existing stone heritage building (Marr House – 398 Wilson Street East) to rear portion of amalgamated site (392-412 Wilson Street East)

Date of issue: Friday, June 4, 2021

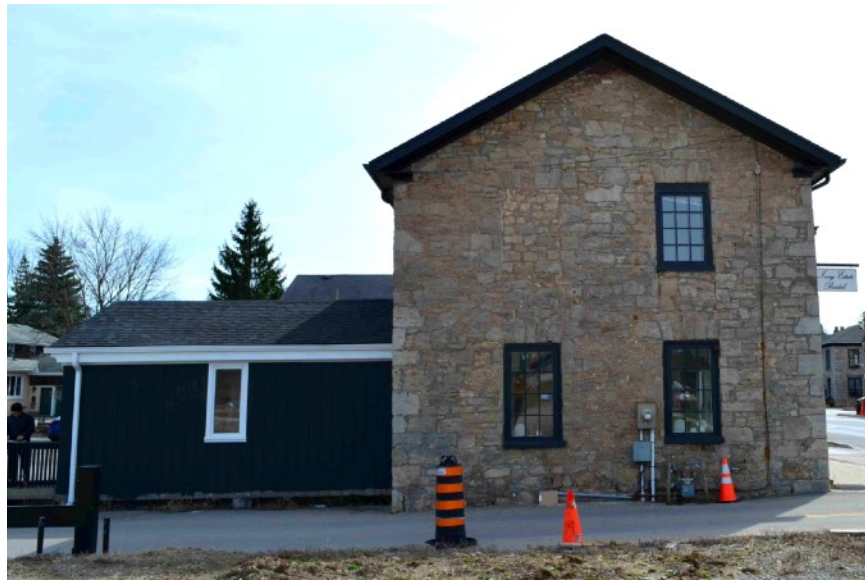
Marr House, 2021 (GBCA). North Elevation. Top left window opening closed in.

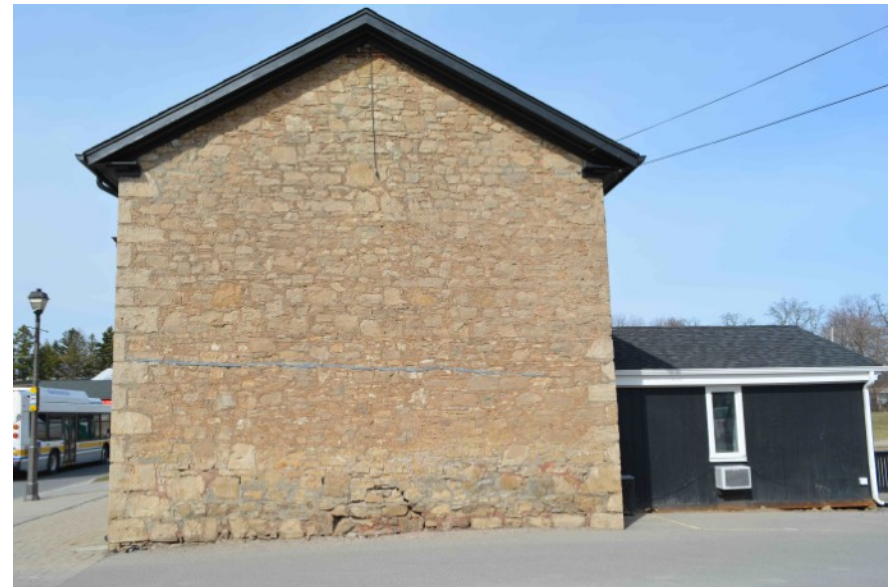
Marr House, 2021 (GBCA). South Elevation. Blank wall with tail extending to the east. Foundation issues notable from a distance.

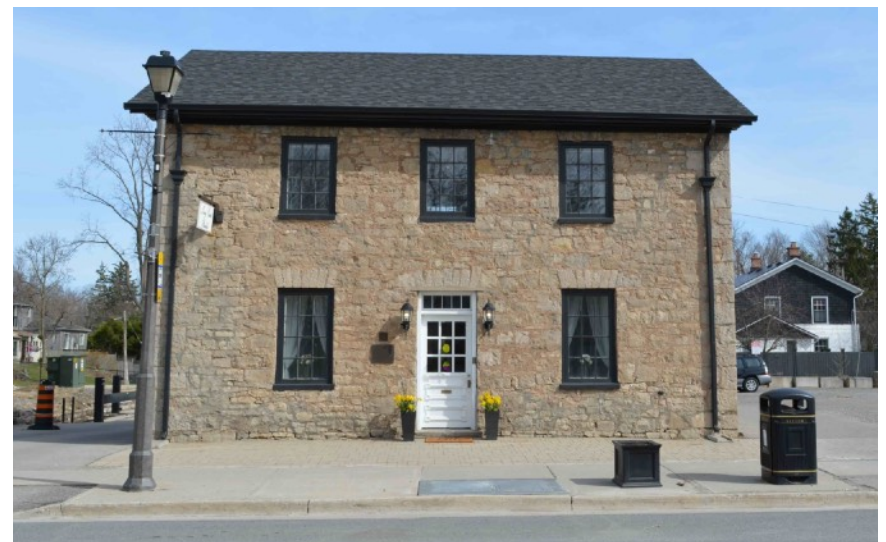
Marr House, 2021 (GBCA). West Elevation 2.4 meters from Wilson Street East. Although the designation by-law notes that chimneys are a contributing heritage attribute, in its current state these are no longer present.

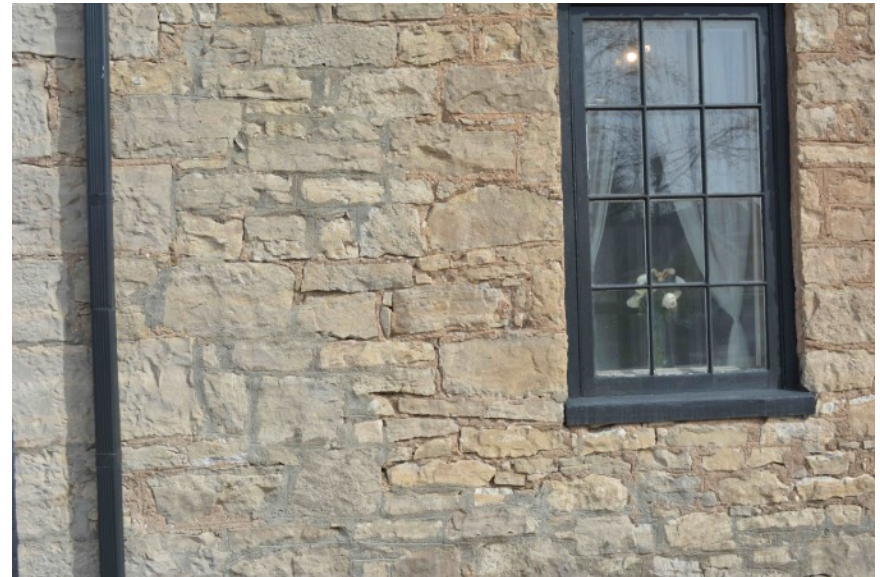
On all elevations there are signs of water infiltration, evidence of improper mortar repairs and patches, staining of stone – including efflorescence, unsympathetic parging, atmospheric staining, rust from metal fasteners, etc.

West elevation: ground level showing cementitious parging applied at the northern edge of the building.

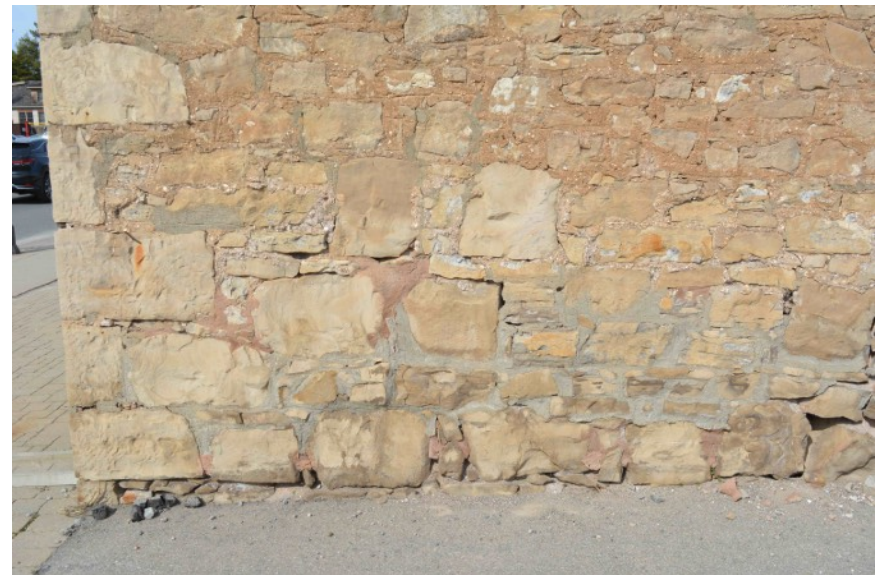
South elevation: ground level showing open joints, and repair work.

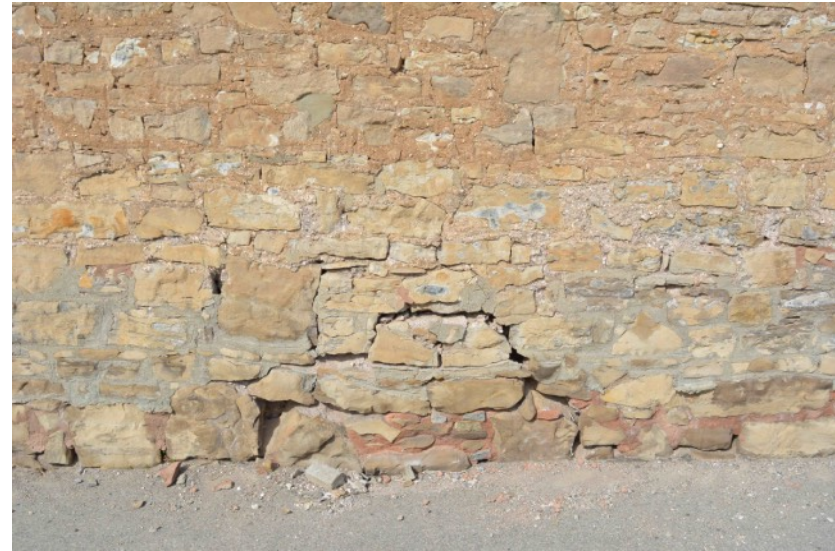
The lower areas of walls at grade level are mostly in fair condition given their proximity to ground water, snow, ice and de-icing salts; all of these contribute to extensive masonry and mortar deterioration. Localised damage was noted with large openings on the southern elevation.

South elevation: ground level failed and open joints with previous repair work also visible.

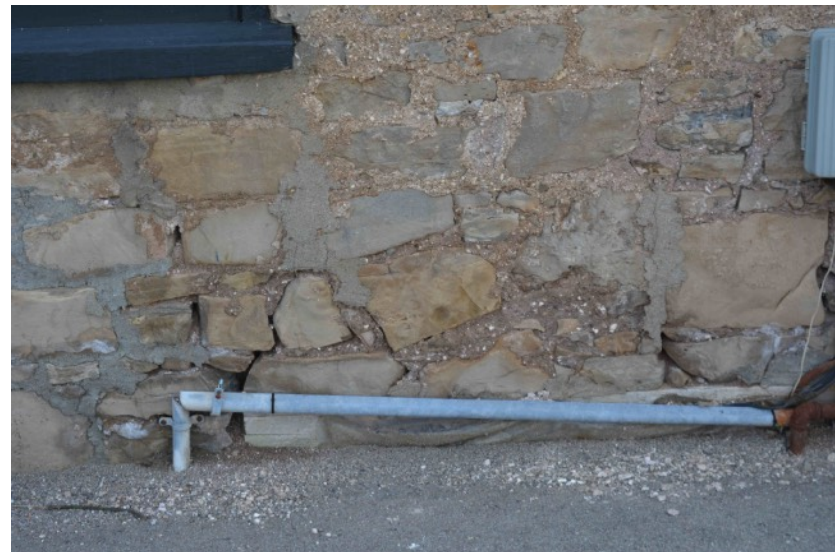
North elevation: failed and open joints, oxidization and metal anchors near foundation.

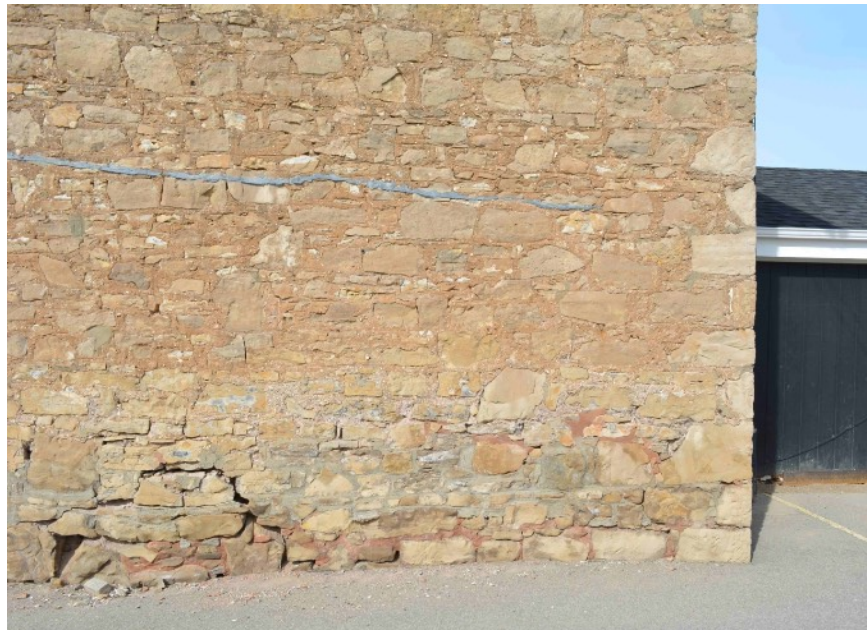
Settlement cracking and movement lines are present at the midpoints of the north and south facades consistent with the rotation of the rear part of the building. Other cracking and displacement is found on the east end of the north and south walls and the base of the east wall which is consistent with the slow-motion rotation of half of the house.

South elevation: failed and open joints at foundation. Movement lines are present at the midsection of this elevation.

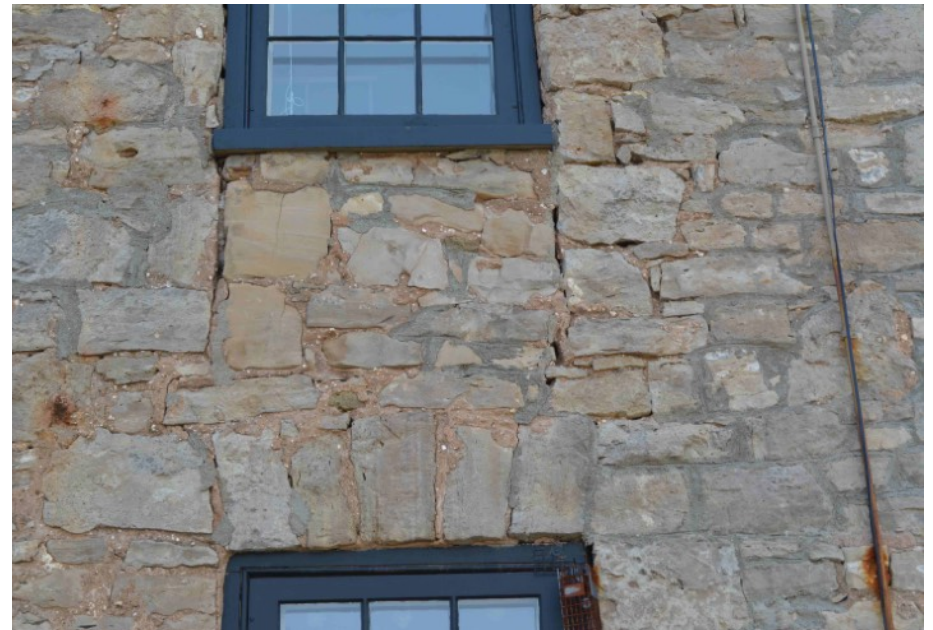
West elevation: Recent repair and pointing work, parging and entire sections of stone removed below the 2nd storey window.

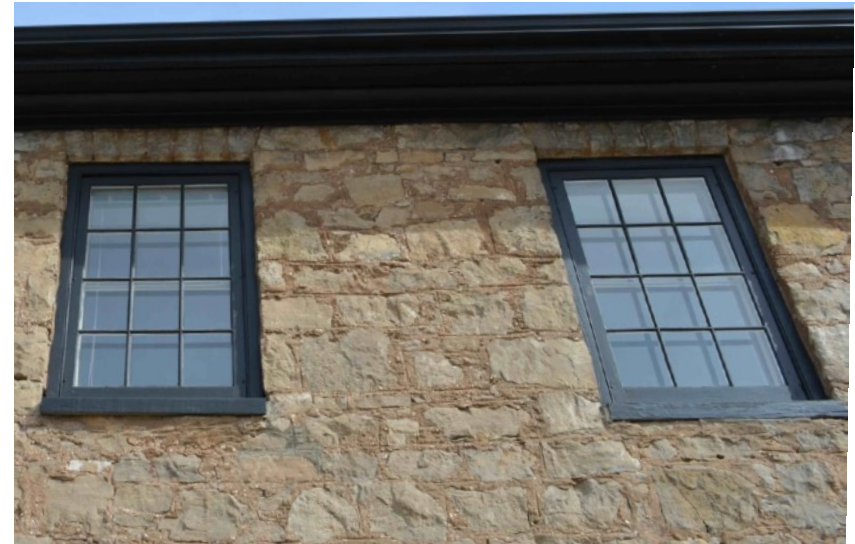
West elevation: window frames on 2nd storey appear to be in good repair upon visual review..

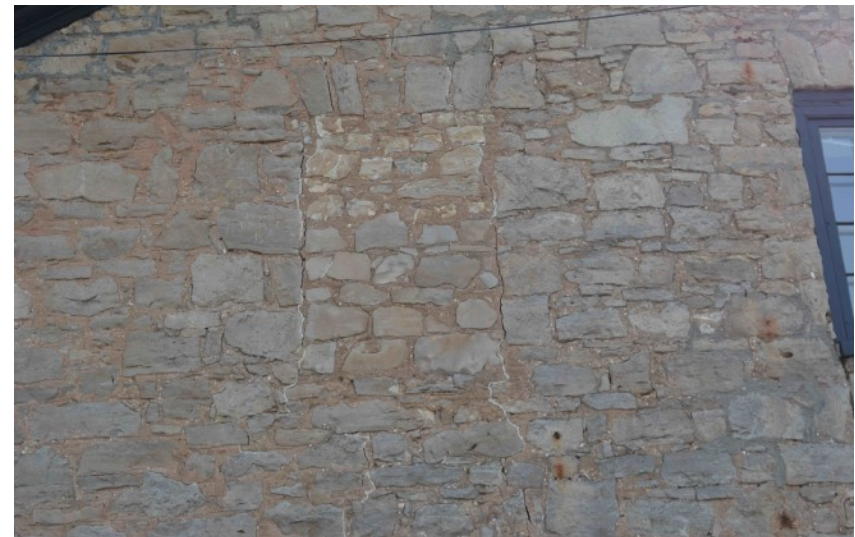
North elevation: eastern-most window opening on 2nd storey has been closed in.

- Repair, replacement and painting of windows, and sills where required;
- Repair and replacement of awnings;
- Reinststate blocked in window openings;
- Repairs to exterior stone masonry;
- Repairs to exterior woodwork – fascia, soffits, etc.;
- Removal of unsympathetic cladding;
- Repairs or replacement to - metal railing, eaves and troughs;
- Replacement of visible roof area with new high quality shingles.

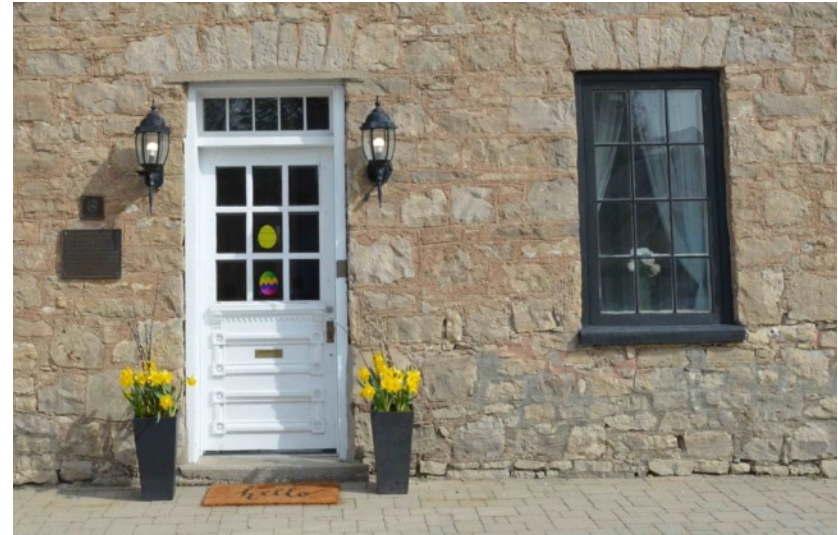
West elevation: Central door with with 12-over-12 sash and five-pane toplight is in good repair.

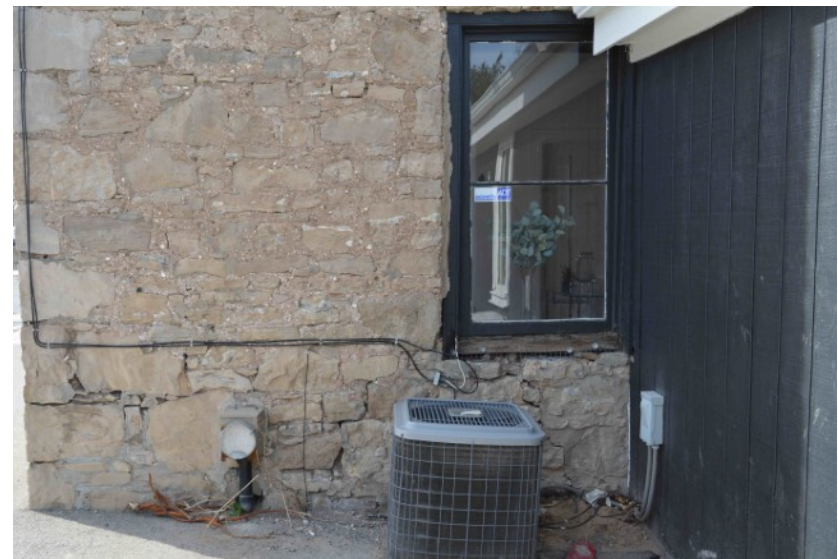
East elevation: Openings at rear elevation have been obscured by the later addition of a one-storey tail.

- The removal of the tail from the main residence will require repair, infill of new stone, reinstatement of original openings, refinishing and repainting upon removal of the extension. Restoration and conservation of the former Marr House will involve rehabilitating the rear facade based on archival material, in keeping with the original design intent which would be further explored in a forthcoming Conservation Plan.

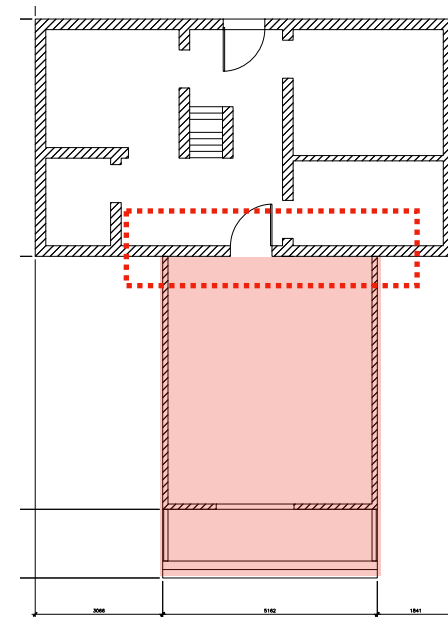
The above plan and elevation illustrate the proposed tail to be removed from the Marr House. Areas with a dashed line will require infilling of new stone and reinstatement of original openings upon removal of the extension.
