**CITY OF HAMILTON**

<b>TO:</b> Chair and Members Planning Committee	<b>WARD(S) AFFECTED:</b> WARD 11
<b>COMMITTEE DATE:</b> April 2, 2013	
<b>SUBJECT/REPORT NO:</b> Binbrook Sanitary and Stormwater Systems Performance (PED12182(a)/PW13016) (Ward 11) (Outstanding Business List Item)	
<b>SUBMITTED BY:</b> Tim McCabe General Manager Planning and Economic Development Department Gerry Davis, CMA General Manager Public Works Department	<b>PREPARED BY:</b> Chris Gainham (905) 546-2424 Ext. 3421 Sally Yong-Lee (905) 546-2424 Ext. 1428
<b>SIGNATURE:</b>

**REPORT ON BINBROOK AND  
STONEY CREEK MOUNTAIN  
SURVEY AND IN-HOUSE INSPECTIONS  
JULY 22, 2012 STORM**

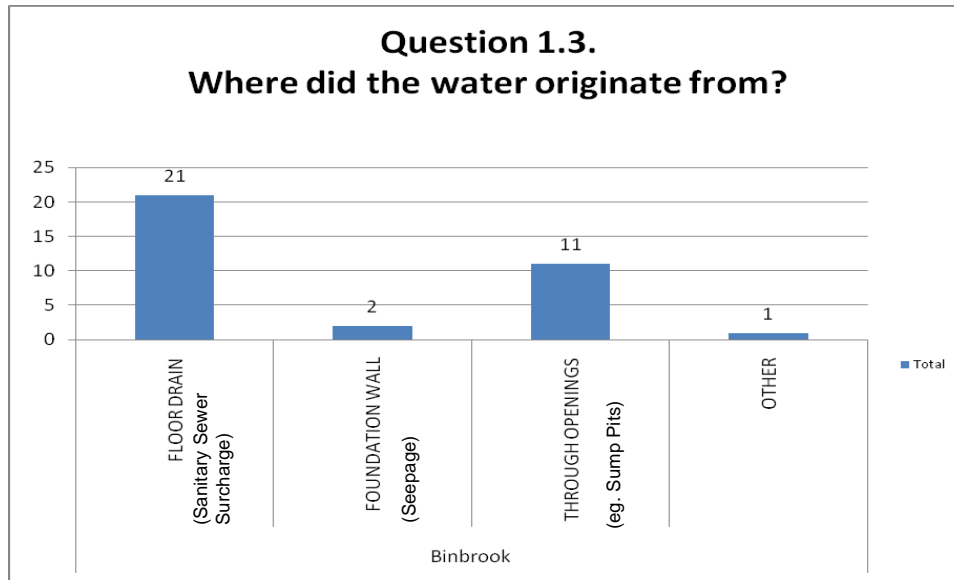
**Figure 1 – Flooding Origin for Homes in Binbrook**

The majority of the respondents across Binbrook (89%) reported that this was the first flooding in the home. Figure 1 identifies the location where the flooding originated from within the homes.

Many residents experienced what can be characterized as surcharge of the sanitary sewer. The homes inspected from Regional Road 56 and 290 m along Southbrook Drive noted that there was a significant amount of muddy debris which originated from the floor drain suggesting a sanitary sewer system surcharge. Additionally, for those homes within 100 m of the 290 m boundary, or in proximity to the intersection of Southbrook Drive and Etherington Crescent (at the upstream limit), basement flooding originated from the floor drain which was characterized as liquid only, and in some instances was described as being a 5"-15" geyser with basement flooding reaching depths of 4"-6".

In addition to the flooding related to floor drains, respondents reported clear/clean water flooding related to the "foundation wall" and "through openings" (i.e. sump pit opening). During the follow up inspections, residents noted that they have had to replace their sump pumps several times (i.e. 2 and 3 times) noting that they have a tendency to "burn-out". In particular one resident had their sump pump burn-out during the storm event of July 22, 2012, which resulted in basement flooding as the sump pit became overwhelmed with water collected by the dwelling's perimeter weeping tile system. Additionally, residents interviewed along Voyager Pass, west of the intersection with Bradley Avenue, reported that during the July 22, 2012 storm event, area residents were disconnecting their sump pump discharge line from the gravity storm lead so that it would discharge to surface to flow away from the home, through the use of hoses and piping.

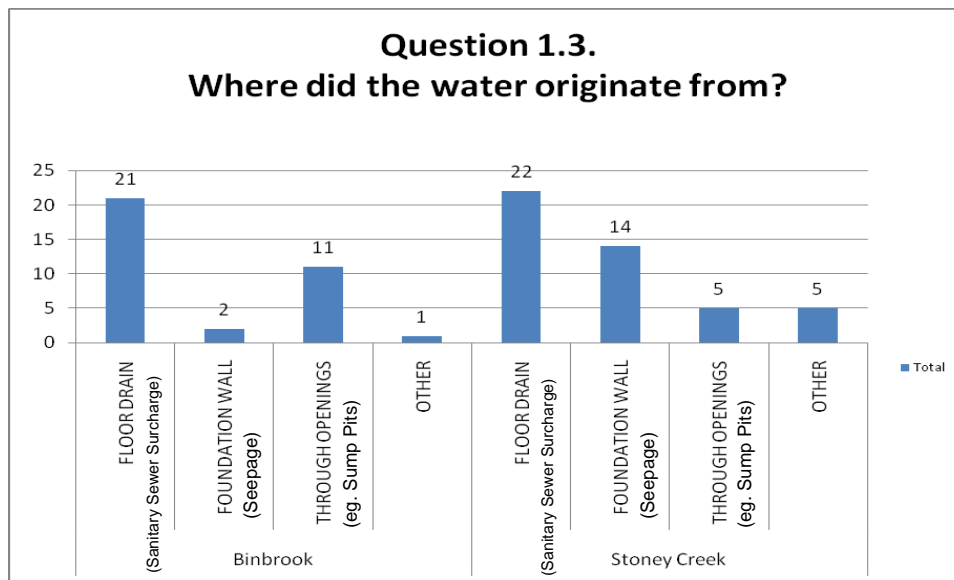
**Figure 2 – Flood Origin Comparison, Binbrook v. Stoney Creek**

Based on the results from the survey and inspections, two different flood mechanisms were characterized by respondents. However, unlike the data collected in Binbrook, there were more reported cases (14 of 46 responses) of flooding related to water originating from the foundation wall, though there was a similar amount of responses related to water originating from floor drains. A comparison of these results is provided in the following graph.

It should be noted that there were less occurrences of flooding related to “Through Openings” in the Stoney Creek area, which is to be expected as the majority of the homes and all of those which were inspected, do not have sump pumps.

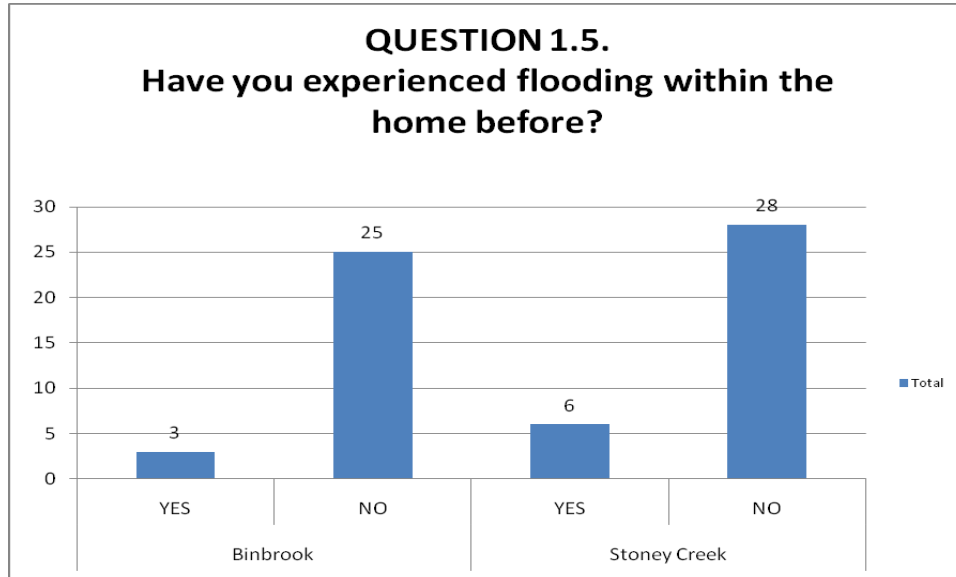
**Figure 3 – Residents with flooding prior to July 22, 2012 comparison, Binbrook v. Stoney Creek**

It was determined through the responses that a number of residents had experienced flooding within the home prior to the July 22, 2012 event. Of those who experienced flooding previously, a small percentage identified the flooding as being similar in nature, which is presented in Figures 3 and 4.

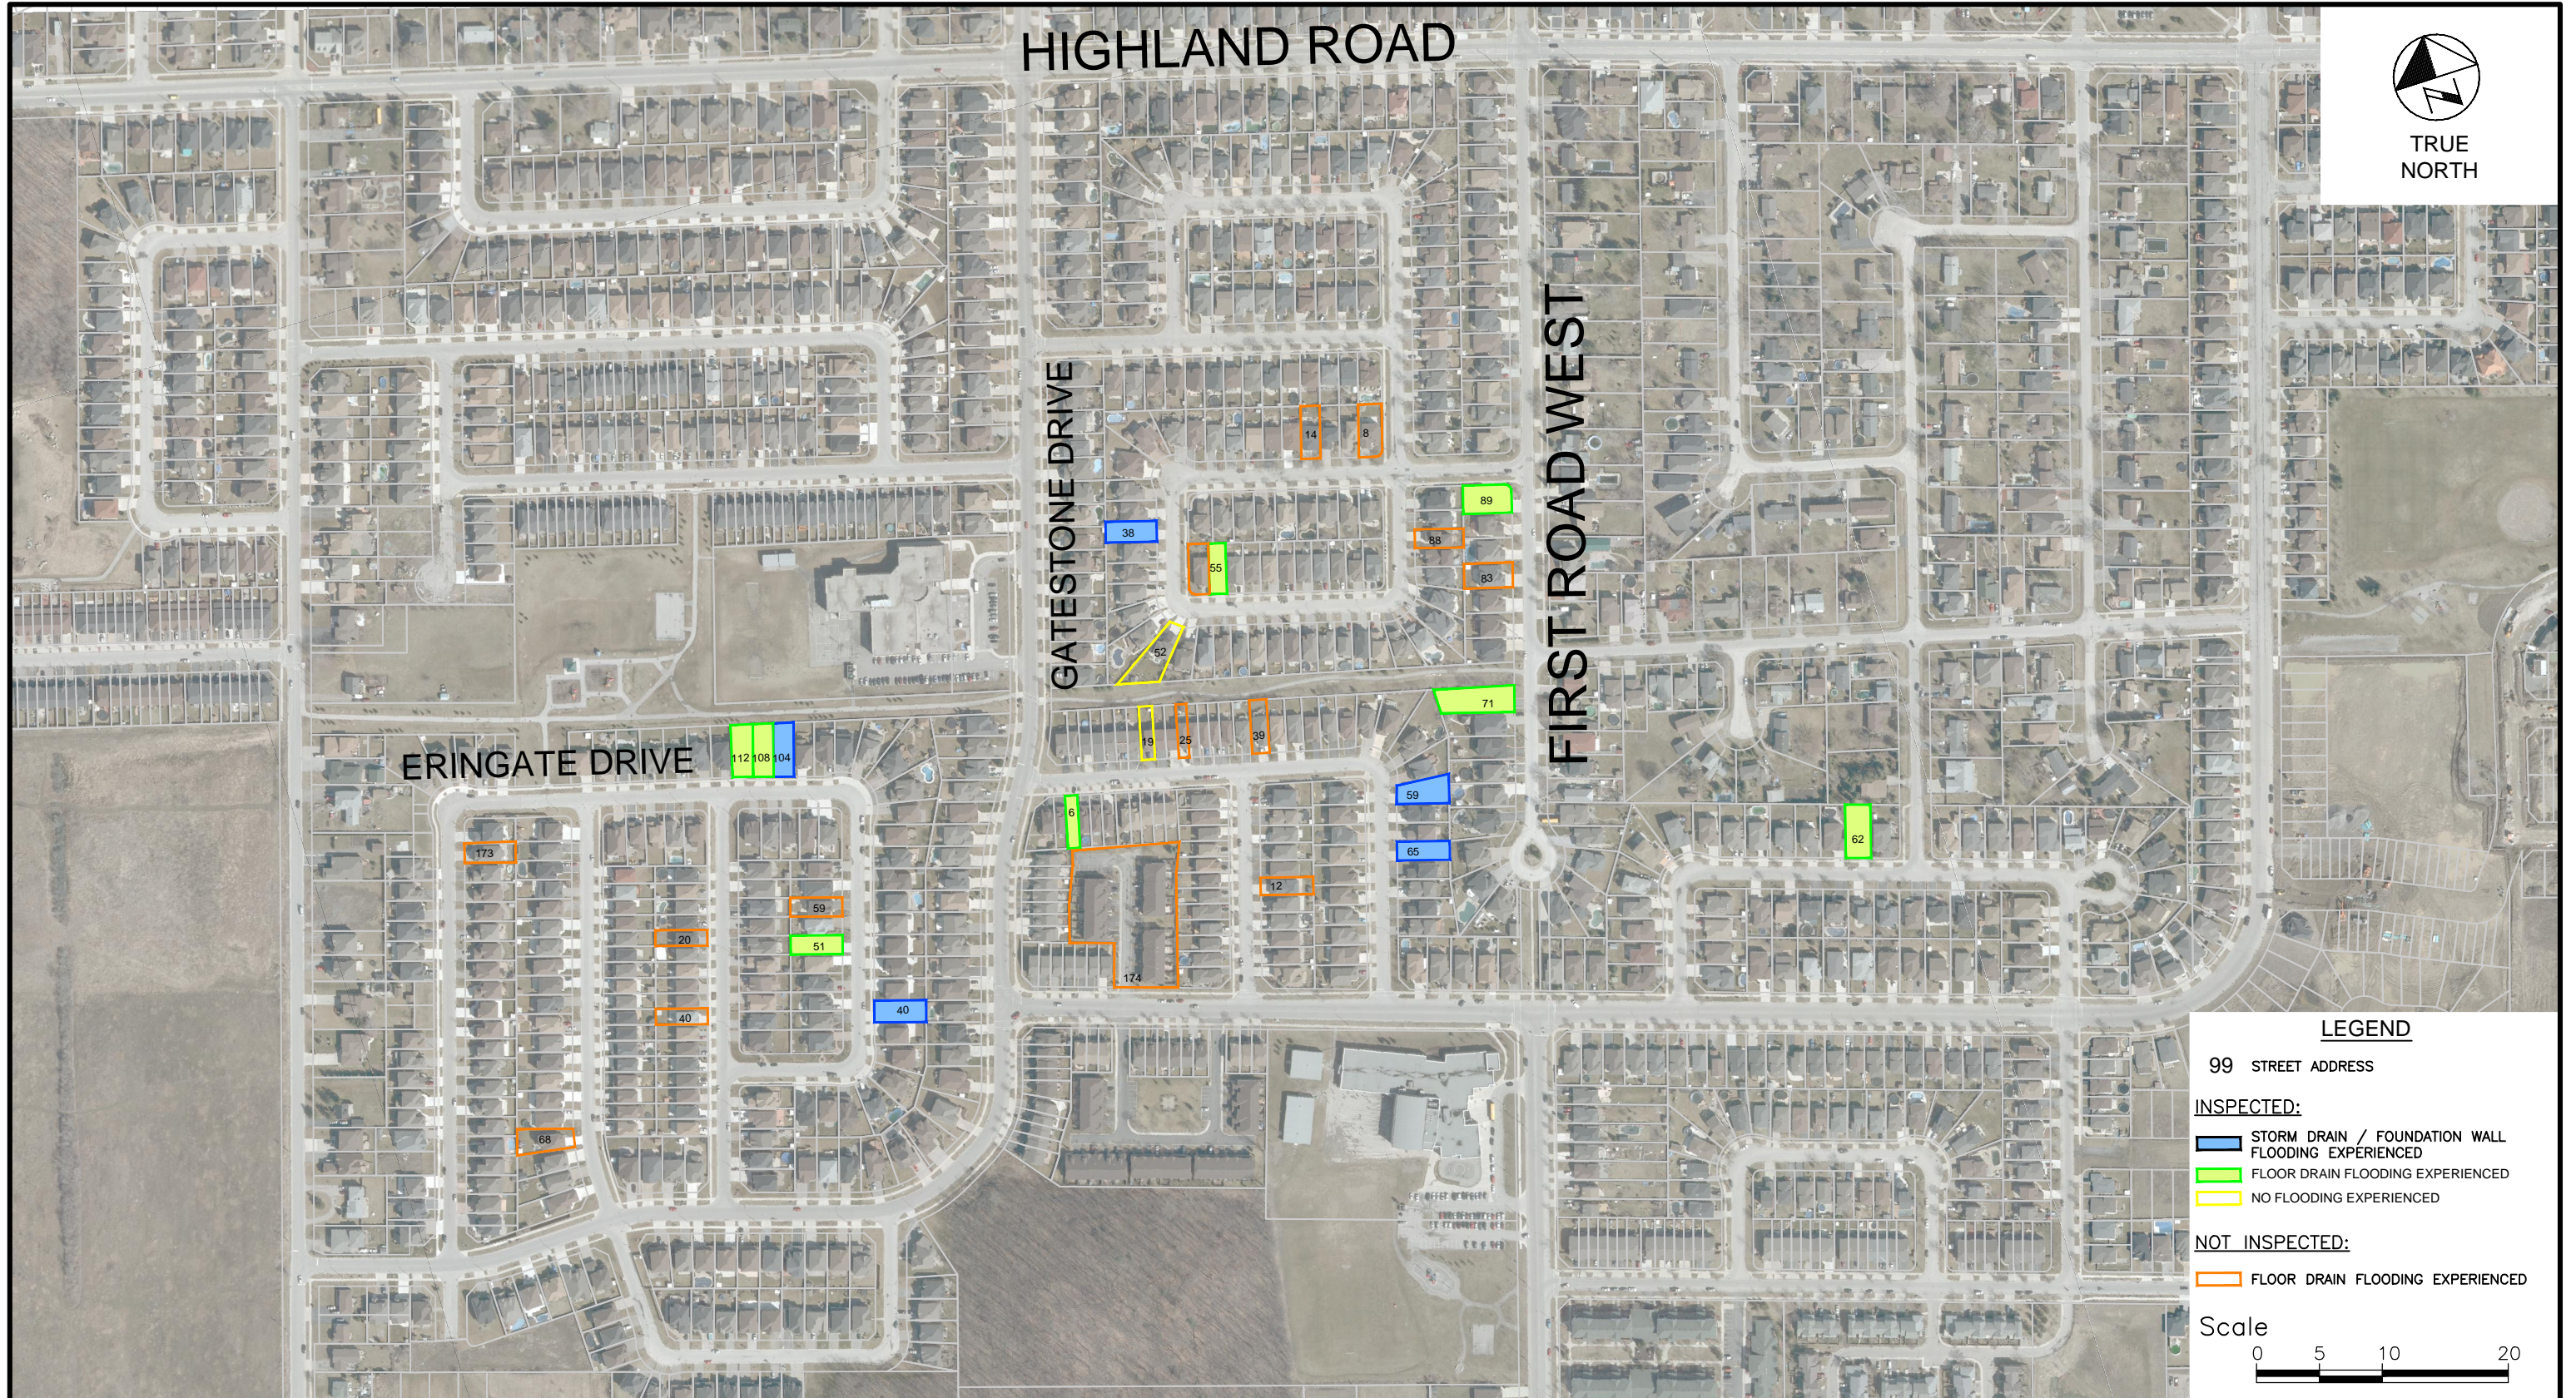
Based on mapping of those residents that reported flooding (ref. Drawing 4), either clear or dirty, the majority of the flood reports appear to be centralized, or are adjacent, to the Gatestone Open Space corridor, specifically in the area of Eringate Drive and the Gatestone Open Space corridor (i.e. the Shady Glen development) and First Road West and the Gatestone Open Space corridor.
