**RE: Feasibility Assessment  
Confederation Park Boat Ramp, Hamilton  
Our File: 14-2162**

This letter presents our assessment of feasibility of reopening the former launch ramp in Confederation Park.

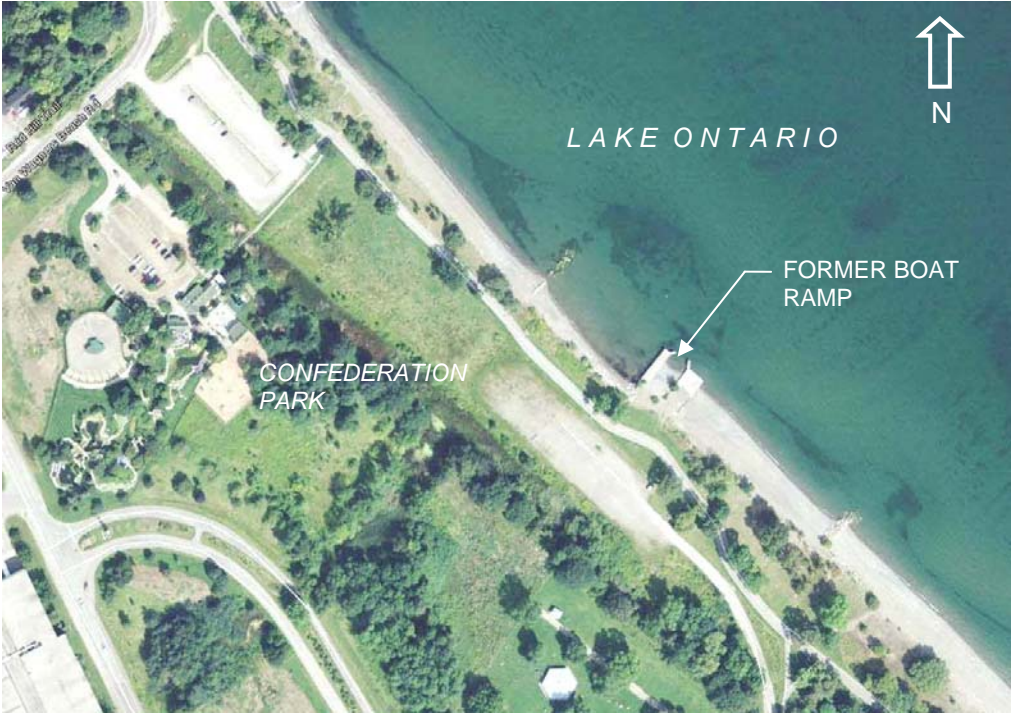
Figure 1: Site Plan (not to scale)

The former launch ramp is enclosed between two groynes. The groynes appear to be a steel sheet pile wall caisson structure with a concrete cap (Photos 1-3). The east groyne is approximately twice as wide as the west groyne. A short nodule is located on the inner, seaward corner of each groyne (see Figure 1). On the day of the site visit, the ramp surface, if it remains, was buried beneath accumulated beach material and not visible

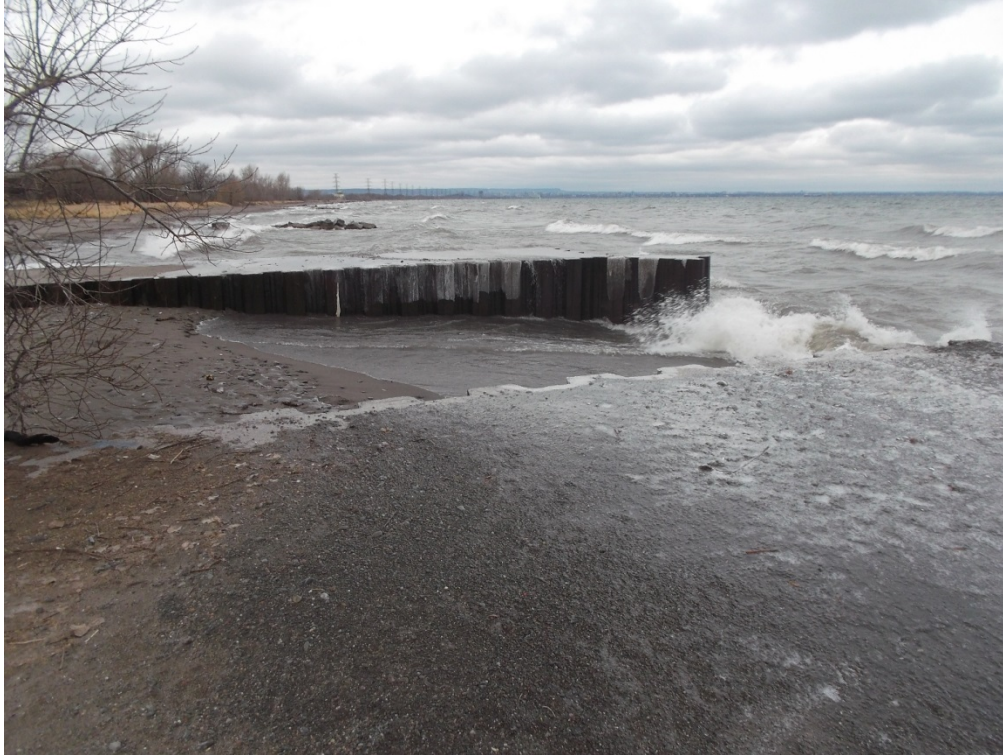
**Photo 1:** Boat ramp, looking north-west along shoreline

The shoreline at this location is a natural sand and gravel beach (Photos 1 and 2). Several stone mound groynes were observed along the shoreline in both directions. From a provincial planning perspective, as outlined in the Provincial Policy Statement and under the criteria given in the MNR Technical Guidelines, this site is classified as a dynamic beach. As such, the dynamic beach hazard would be applicable at this site. The default dynamic beach hazard is defined as the landward limit of the flood hazard plus a 30 metre dynamic beach allowance. We expect that the dynamic beach hazard at this site lies landward of the back of the beach. Generally, development is not permitted within the dynamic beach hazard.

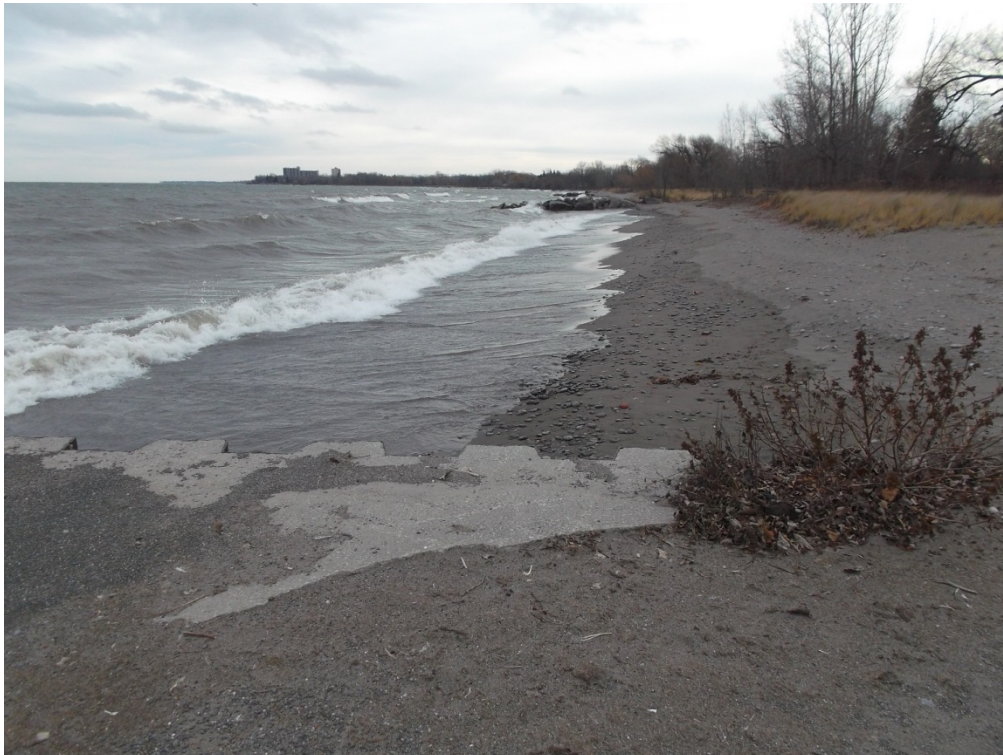
**Photo 2:** Former launch ramp, looking south-east along shoreline

(Photo 3). Beach material also covered the groynes at the back of the beach (Photo 2). We were not able to carry out a detailed inspection of the steel sheet piles on the exposed side of the groynes due to wave and ice conditions at the time of our site visit. We understand that the ramp was built in 1967 and we would expect the steel piles to be substantially reduced in thickness due to sand abrasion. They are likely near the end of their design life.
