Subject: FW: Diesel fuel spill to Red Hill Creek

From: Joe Minor
Sent: July-31-15 3:52 PM
To: clerk@hamilton.ca
Subject: Diesel fuel spill to Red Hill Creek

I am requesting your assistance in obtaining the public release of information regarding the environmental effects of the diesel fuel spill into Red Hill Creek on July 14th, 2015. I am also interested in information about the short term and long term cleanup measures, as well as lessons learned that could be applied to reducing the chances of a future spills.

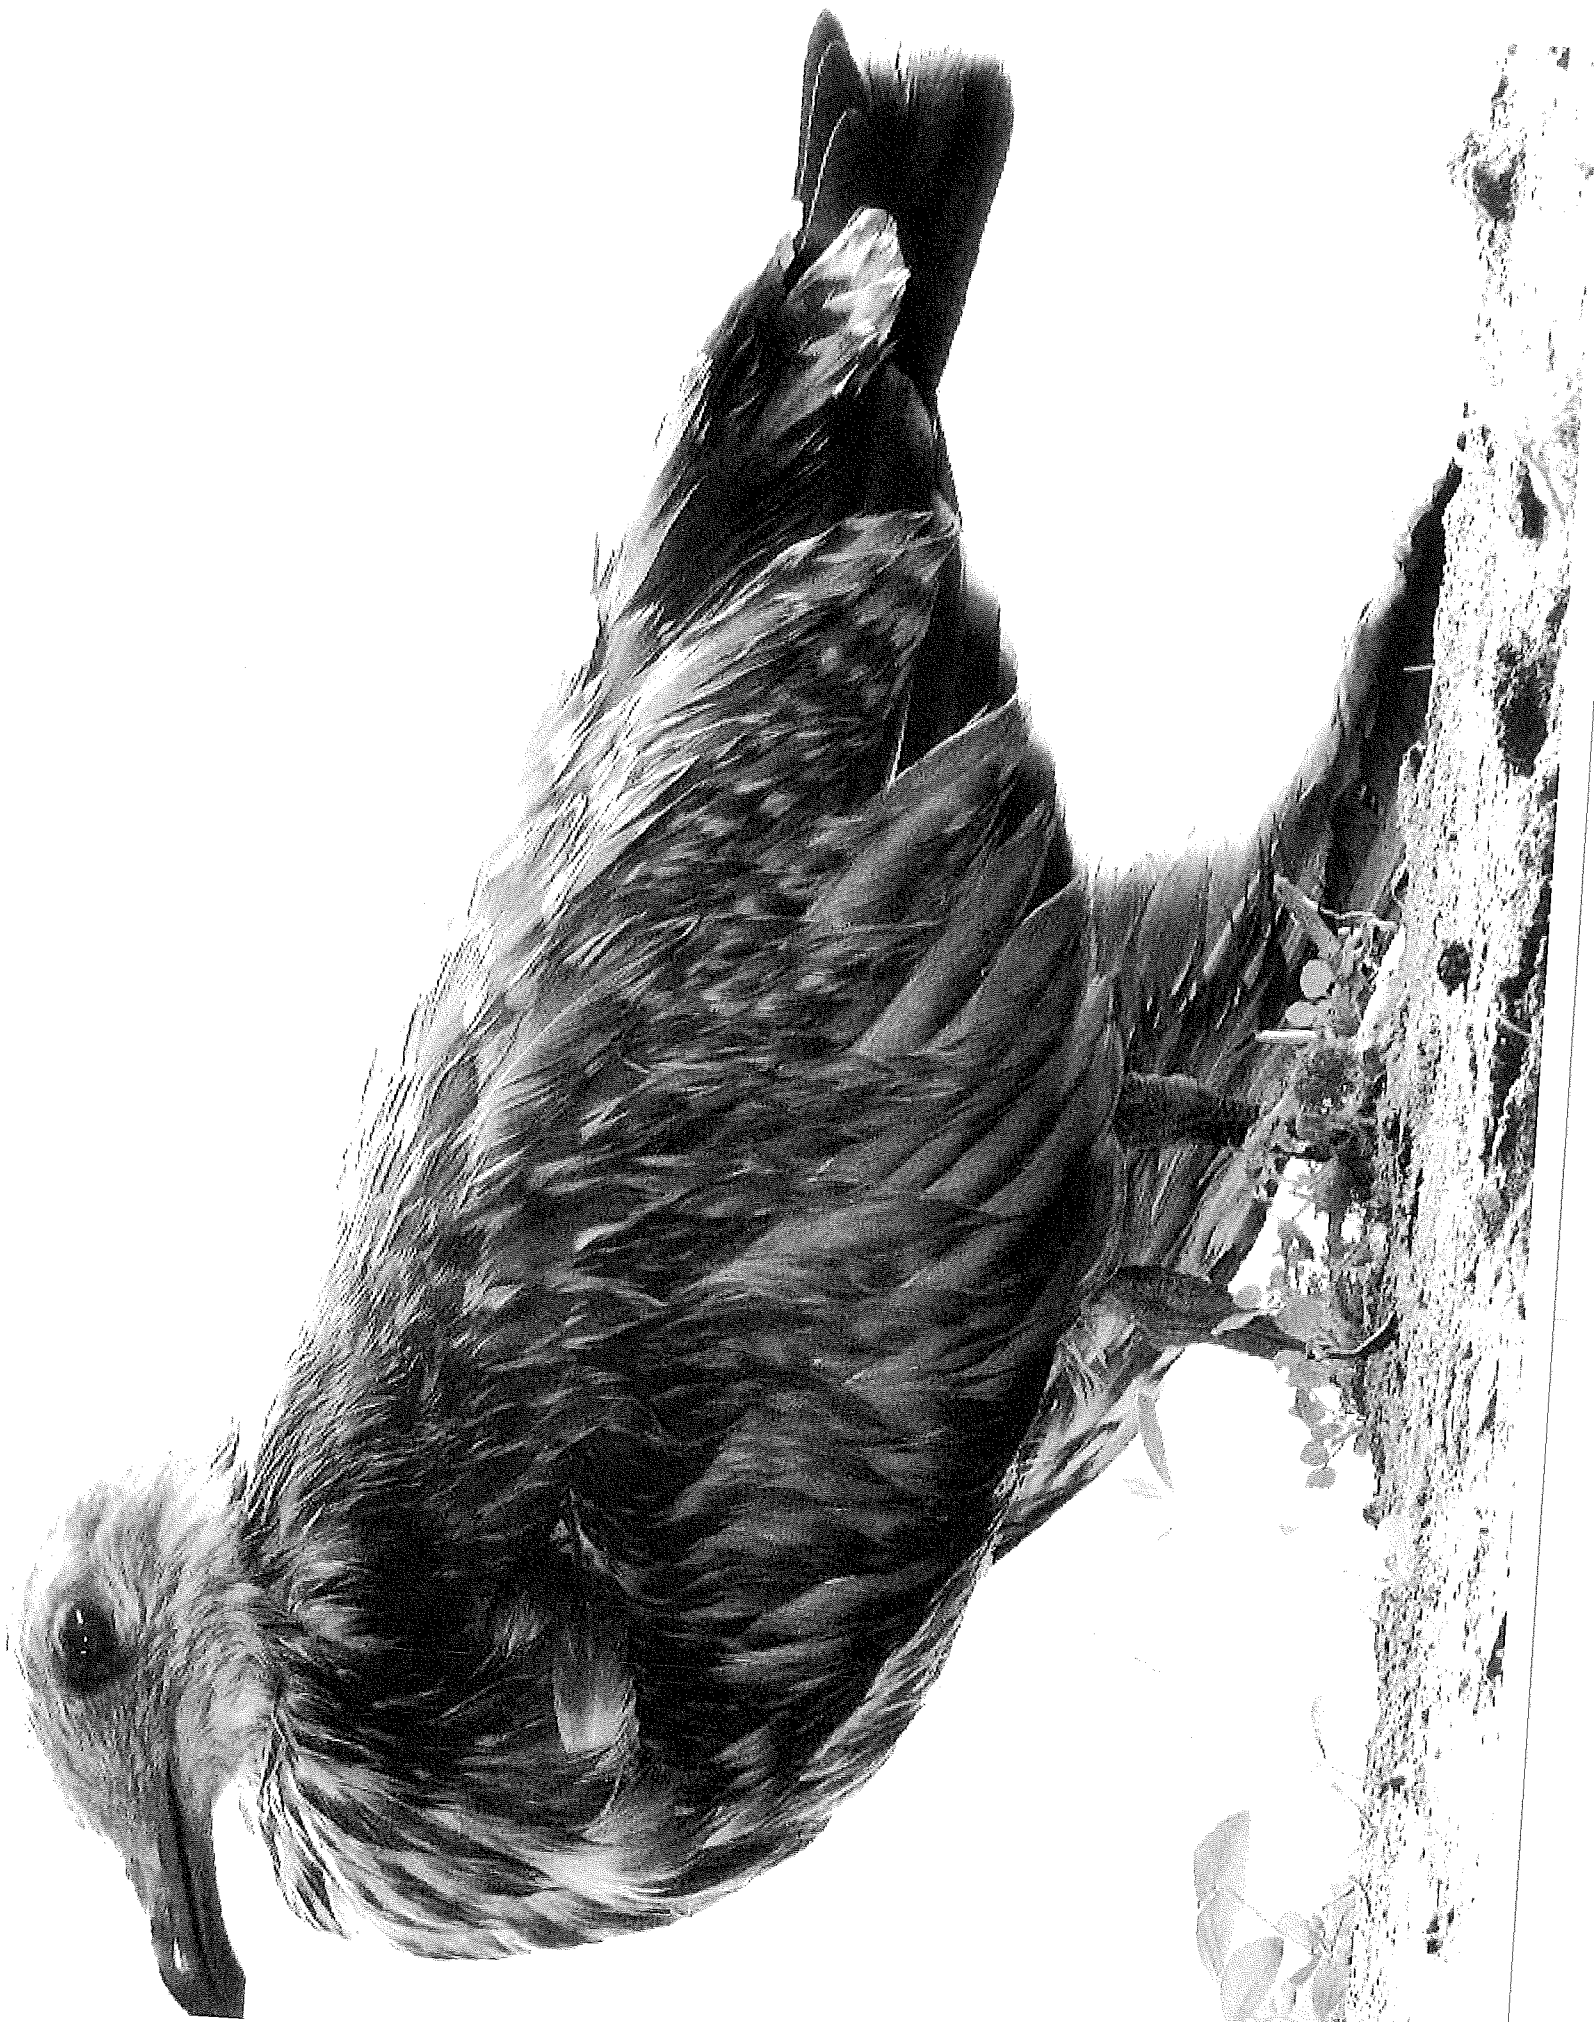
See photo "gullA.jpg", attached.

In this area, the shade from the overhanging expressway prevents vegetation from growing, allowing access to the creek (a pretty dismal place.....). While I was watching the diesel slick flow by, I noticed a bird floating down the creek. It pulled itself out of the creek and I took its picture:

I sent the photo out for identification, and I was told that the photo shows a "heavily oiled juvenile Ring-billed Gull". The juvenile bird was quite ill and was unable to fly. It even lacked the energy to move away, and when approached dropped back into the water, paddled slowly back across the diesel slick, and pulled itself out on the other side of the creek. Photo:

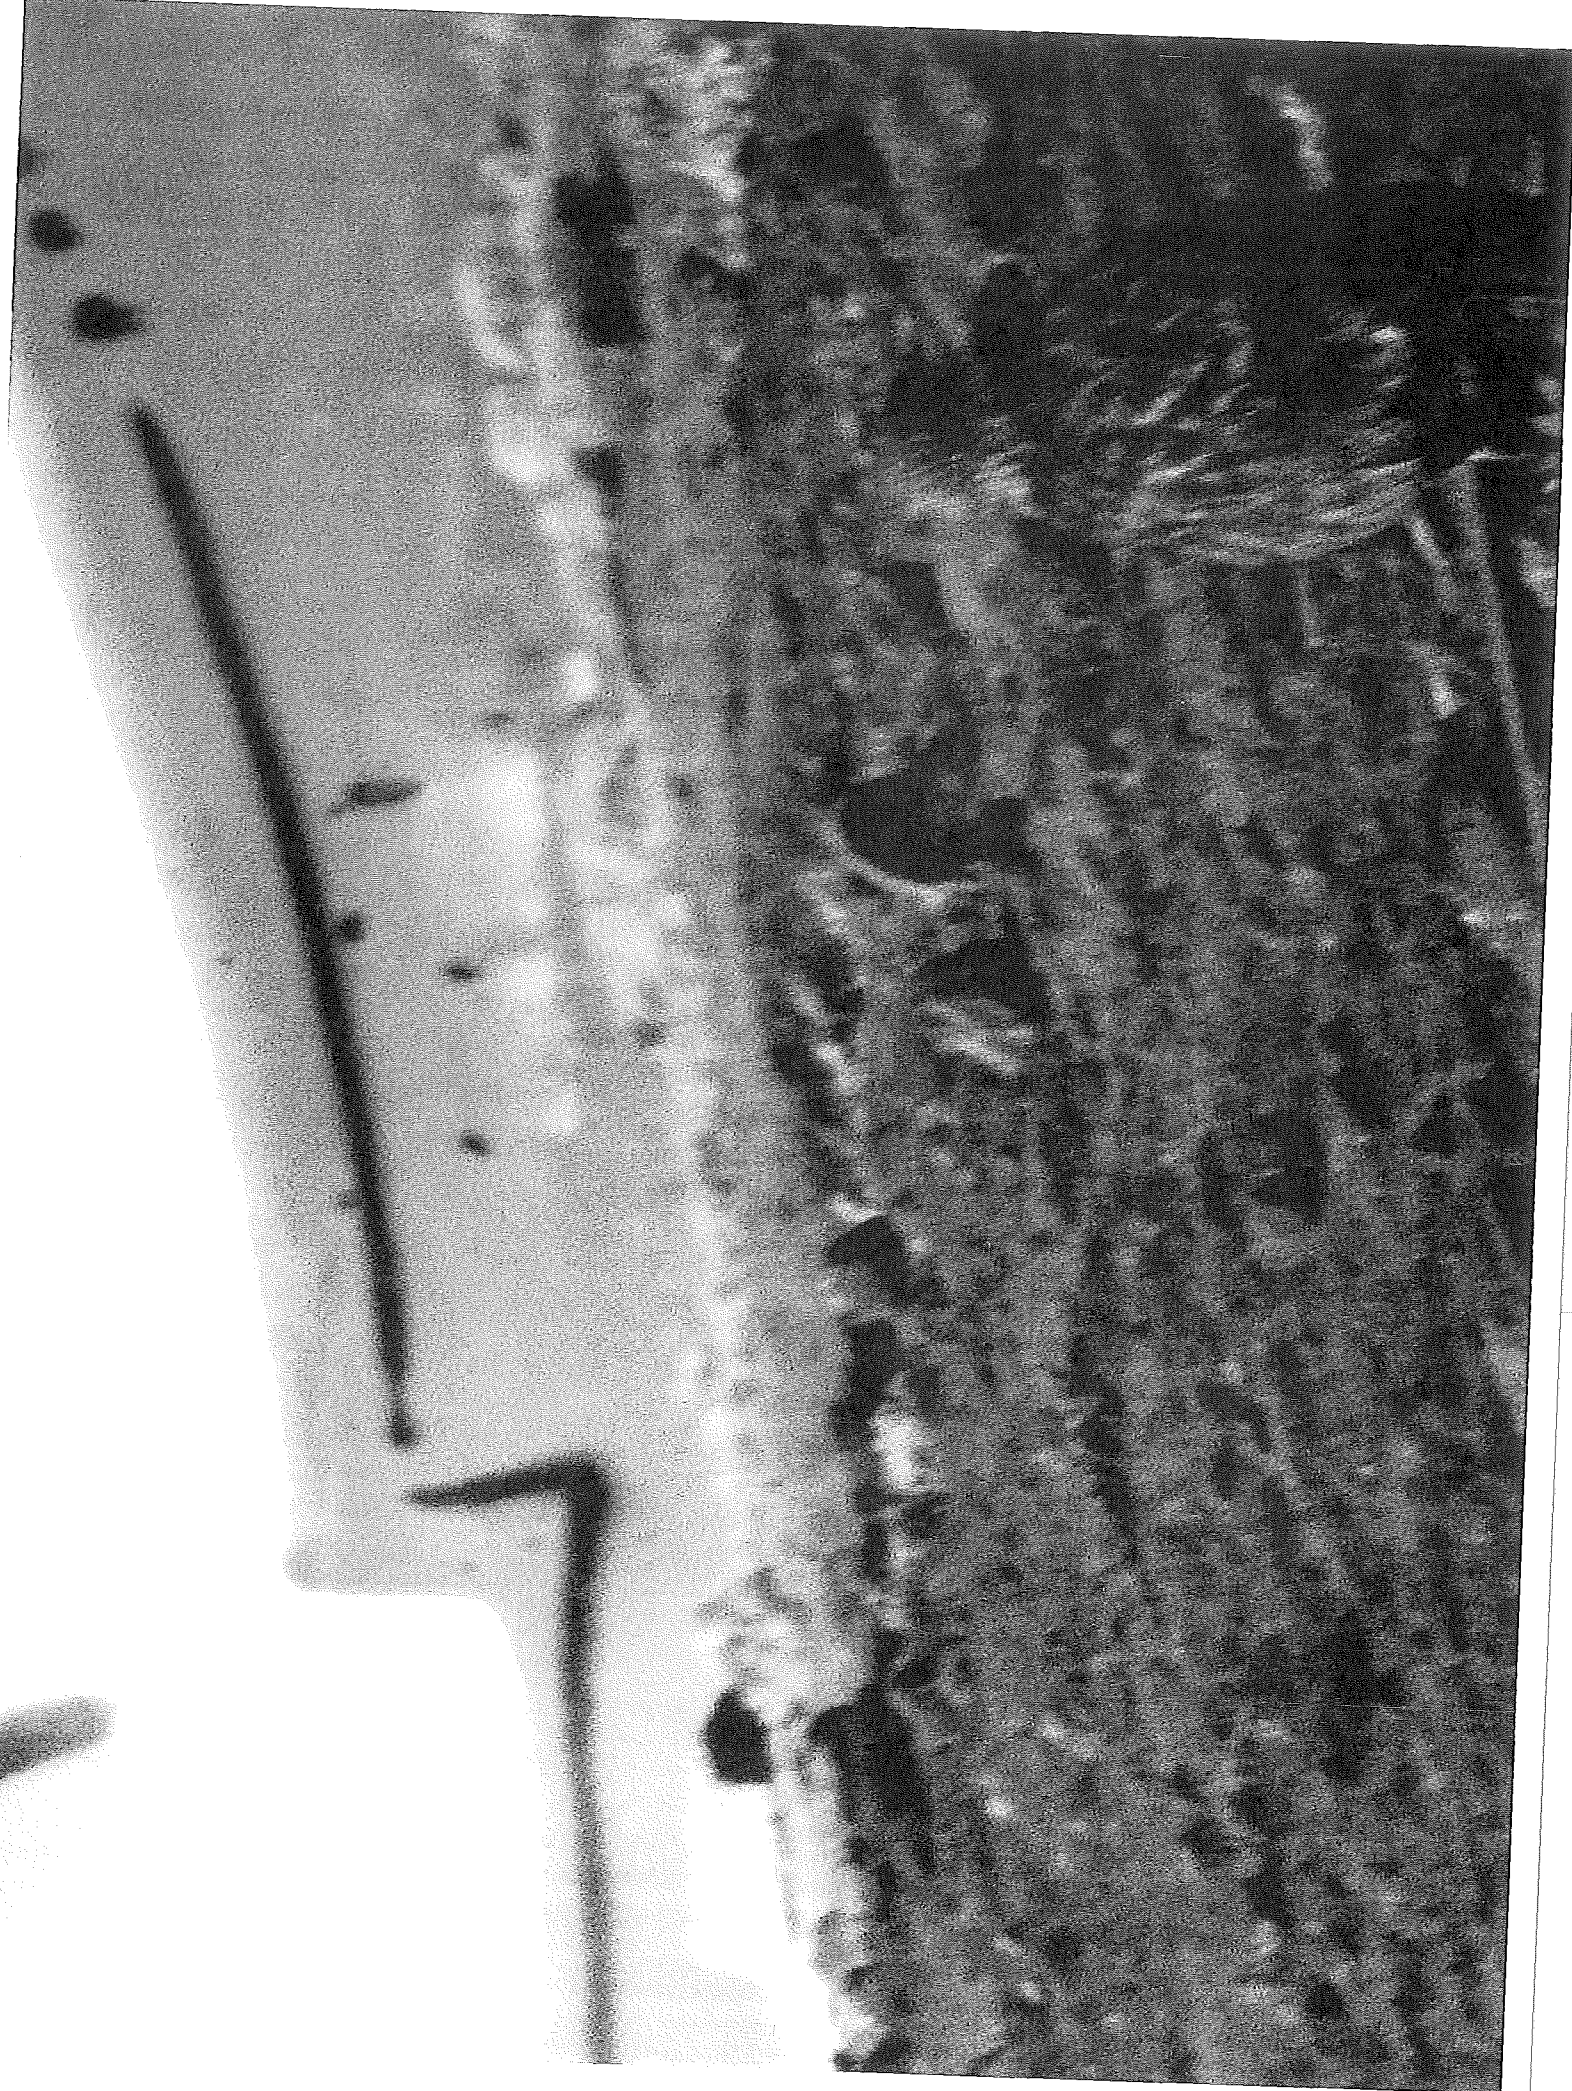
See photo "gullB.jpg".

I include this photo because the graffiti on the expressway support wall makes the location easy to identify to those familiar to the area.

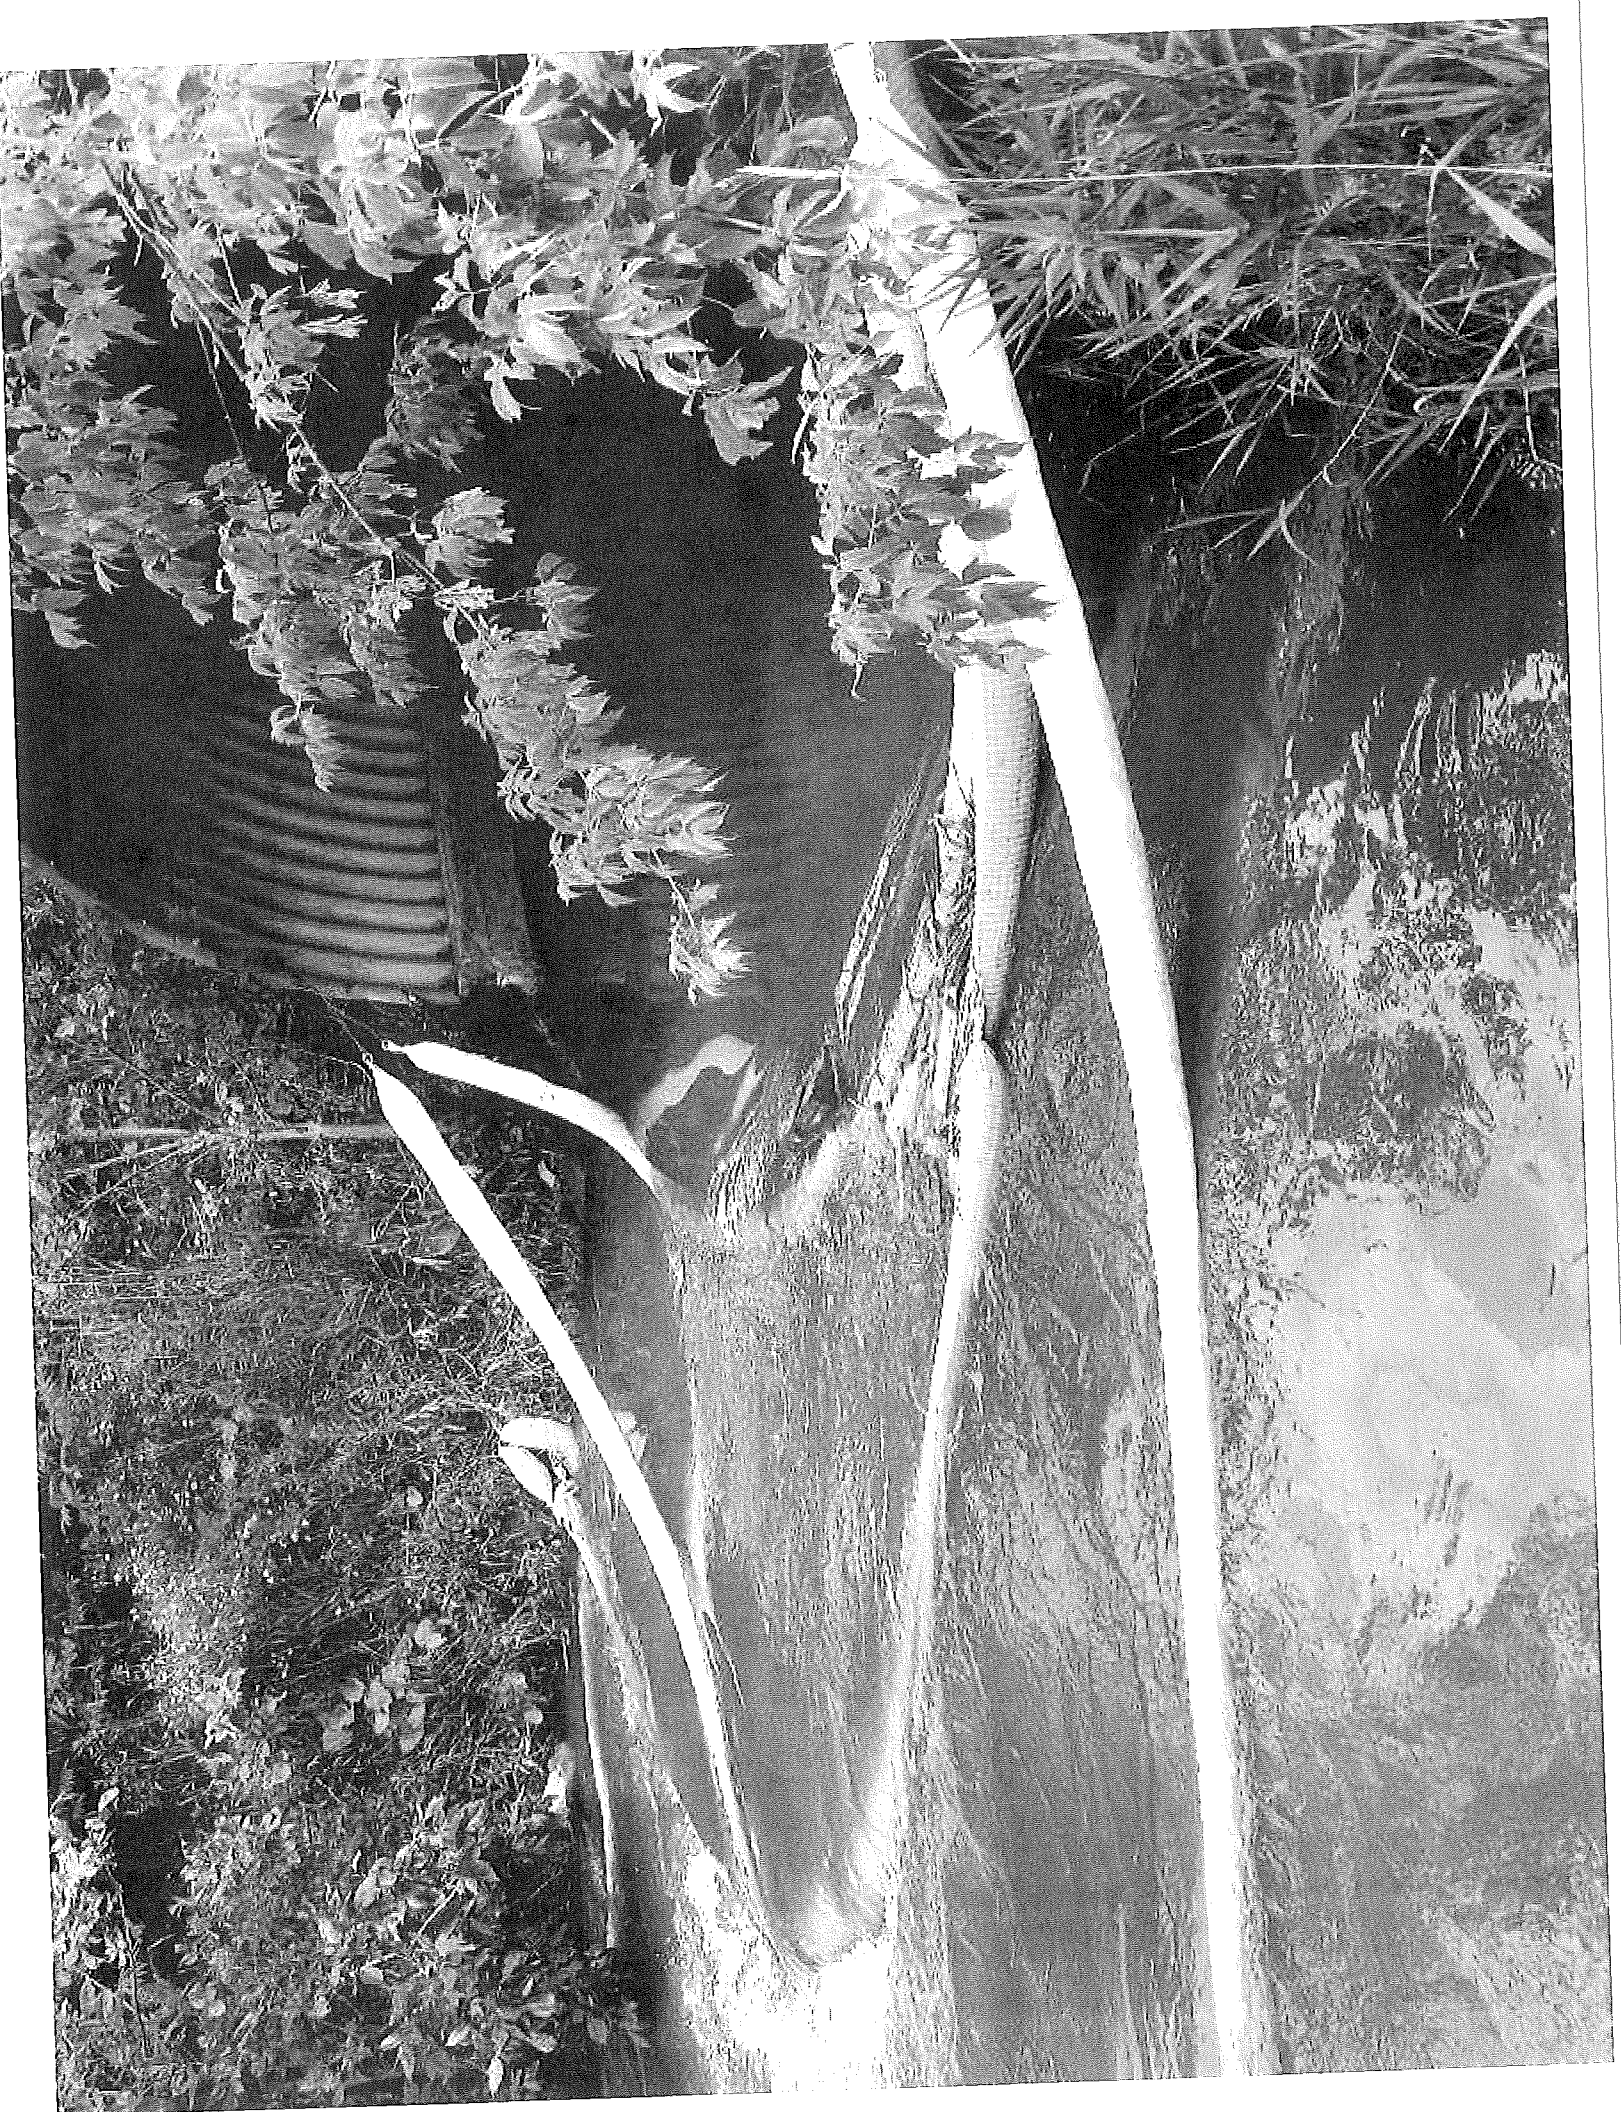
See photo: "downboom.jpg".

At this location, it was clear that the booms were not collecting all of the surface film of diesel, because chunks of the film were floating around the booms near the shoreline.

So even 9 hours after the accident, the diesel spill was still spreading downstream. Signs of ongoing air pollution and water pollution were obvious.

When a spill occurs, the highest priority needs to be given to containment, because it is extremely difficult to extract significant amounts of pollutants from moving water. The first responders (after properly seeing to the needs of the people at the crash site) should focus on cleaning at the source. (I.e., efforts should focus on removing the diesel from the tanks, as opposed to setting up booms.)

Because good cleanup efforts were made, and the diesel spill still spread anyway, some thought needs to be given to spill prevention measures.
