City of Hamilton

McMaster University Town Ctr (old courthouse)

Eric Neu, Vanderwesten Rutherford Mantecon, 2013

The following report is an asset level condition assessment based on visual observations at the time of assessment. No comments can be made on assets which are not visible or accessible during the assessment.

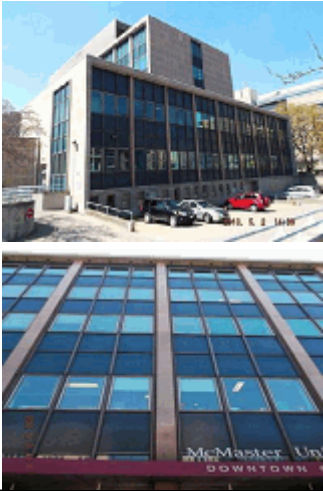
Fresco provided on the front elevation. Restoration of the fresco completed in the summer of 2006.

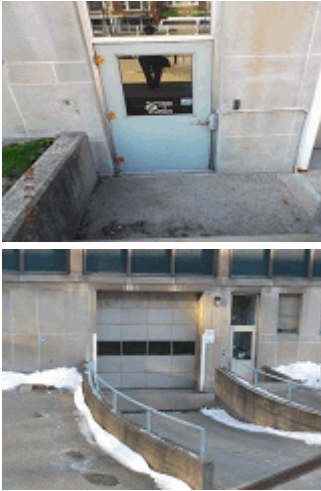
Two (2) exterior hollow metal doors were observed in fair to poor condition during the assessment. Surface rust was noted on the doors, frames and hardware. Replacement of the doors is recommended at the end of their useful life.

Replace exterior hollow metal door

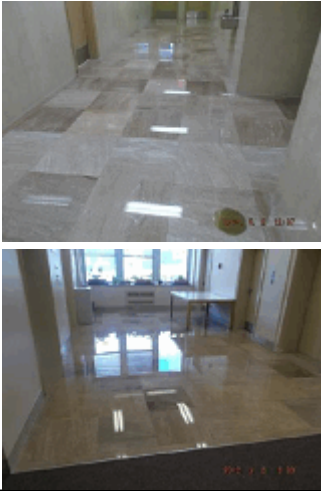
Portion of the marble floor covering seen in main entrance foyer.

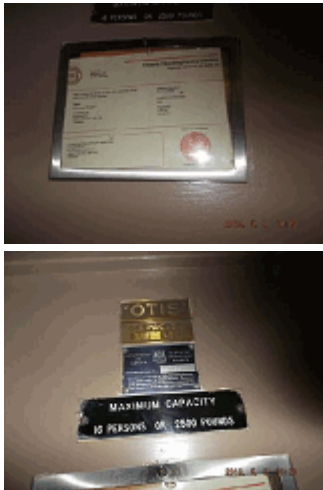
The interior of the cab is out dated and in poor condition. Refinishing the interior of the cab should be considered.

Pending regular maintenance and continued TSSA certification, the elevators may need to be replaced as they have already exceeded their expected life use.

**Event Details** Replace interior traction elevators, 5 storey, 2500 lbs

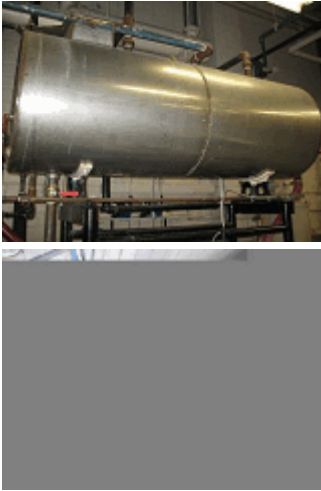
The heat exchanger and pump, which provide heating hot glycol water to the snow melt beneath concrete ramps and driveway, are disconnected. The concrete ramps and driveway snow melt has experienced leaks and is not in use.

Snow melt heat exchanger currently de-commissioned.
