Photographs

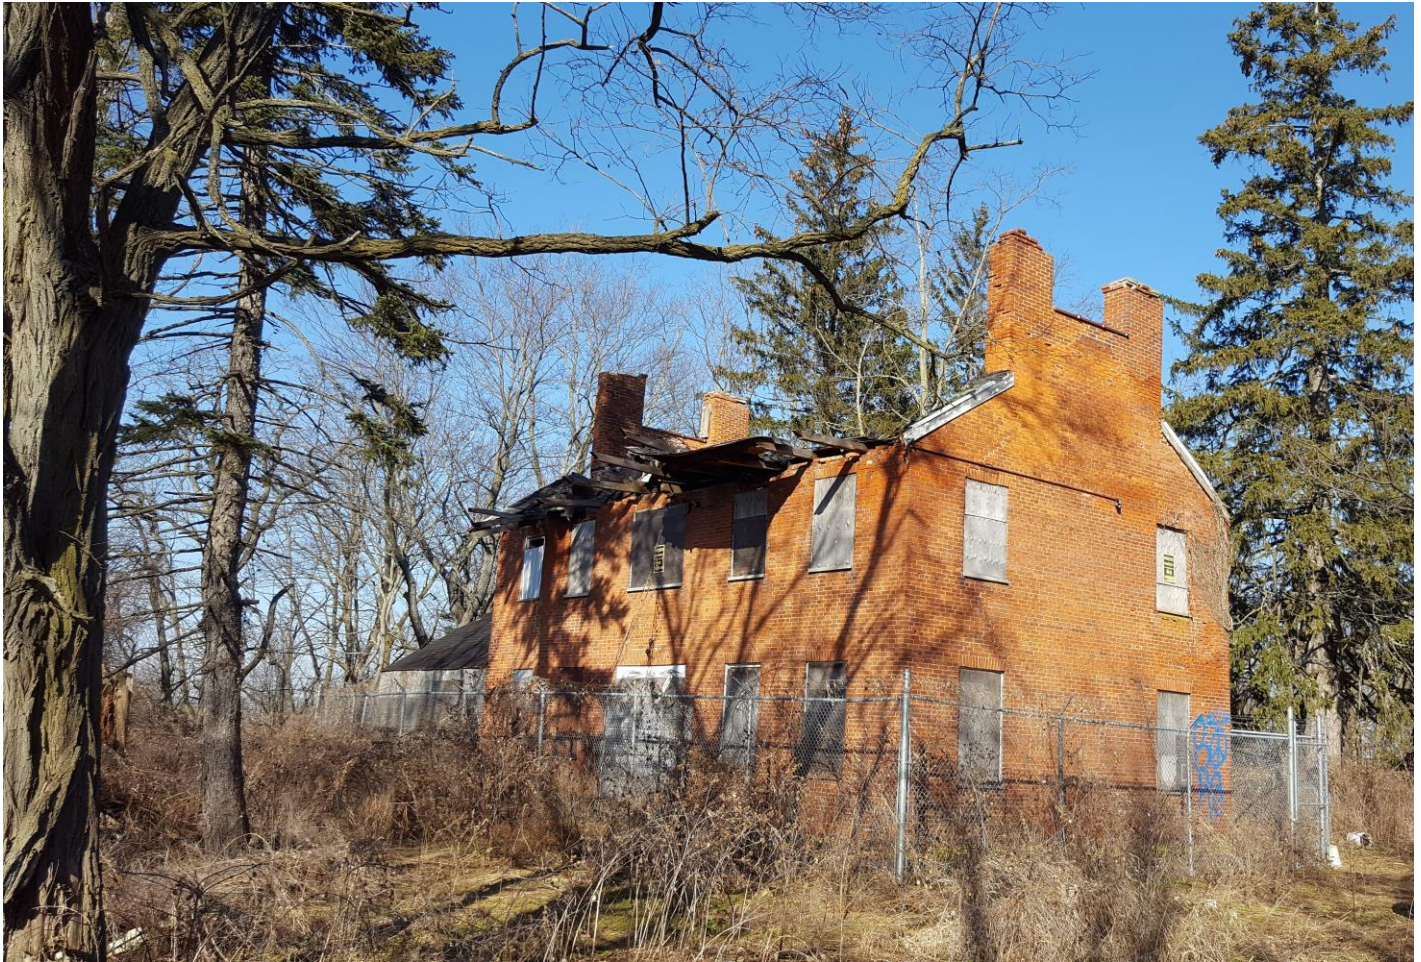
Image 1: Northwest-facing image of the Book House showing the structure’s disrepair and roof collapse (Roman Catholic Diocese of Hamilton, 2018).

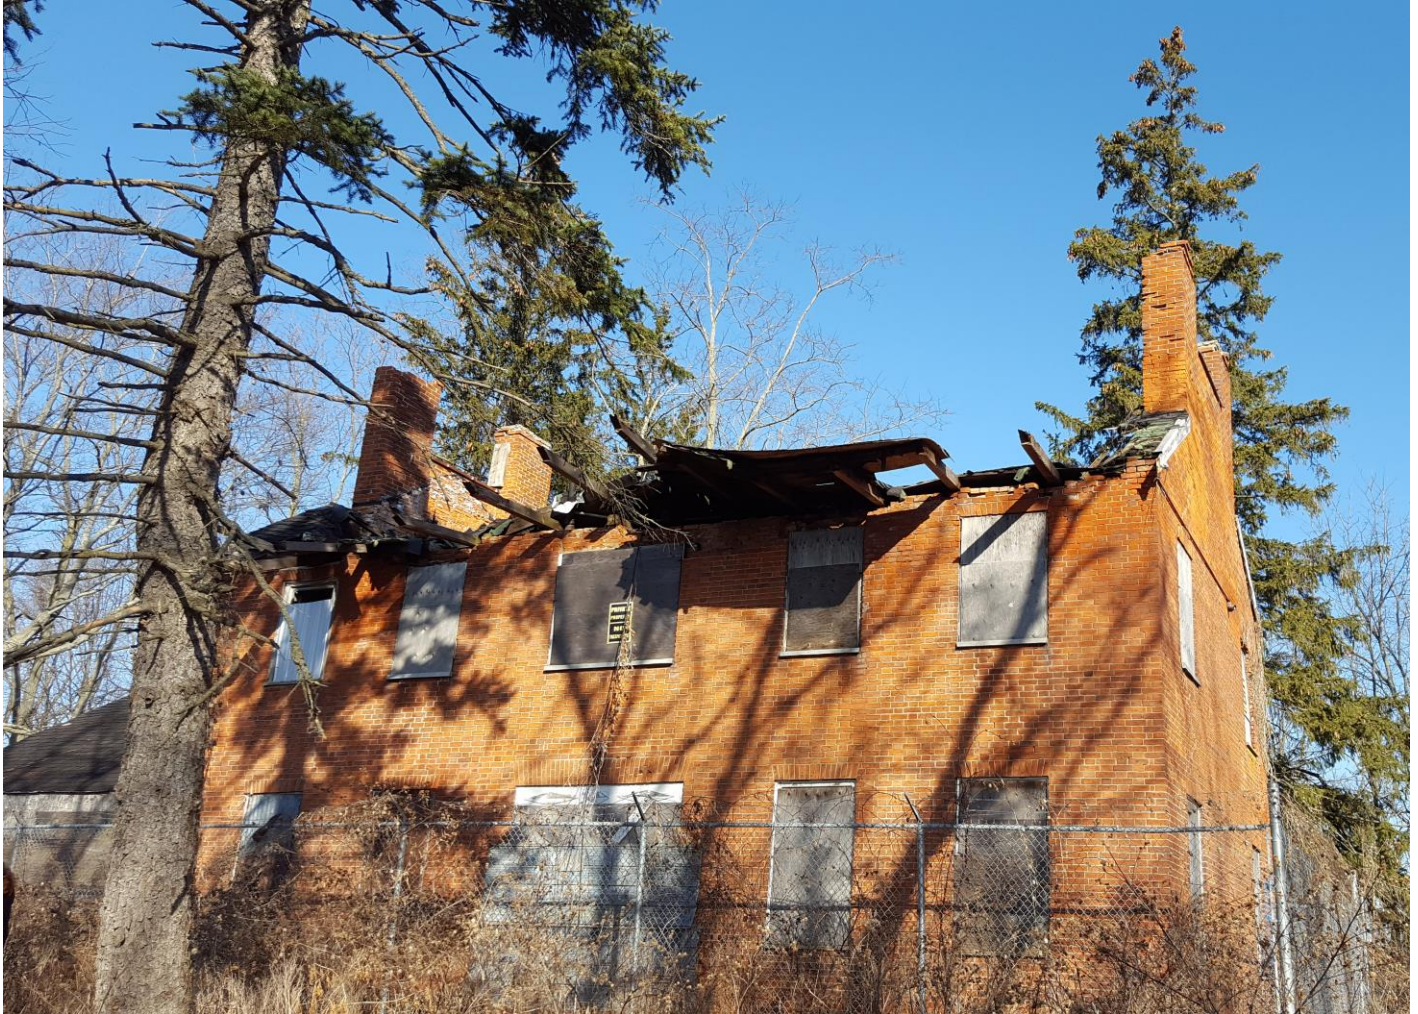
Image 2: A closer view of the front façade showing the remains of the roof and plywood covered windows and door. The owners erected a barbed wire fence perimeter around the building sometime after 2010 (RCDH, 2018).

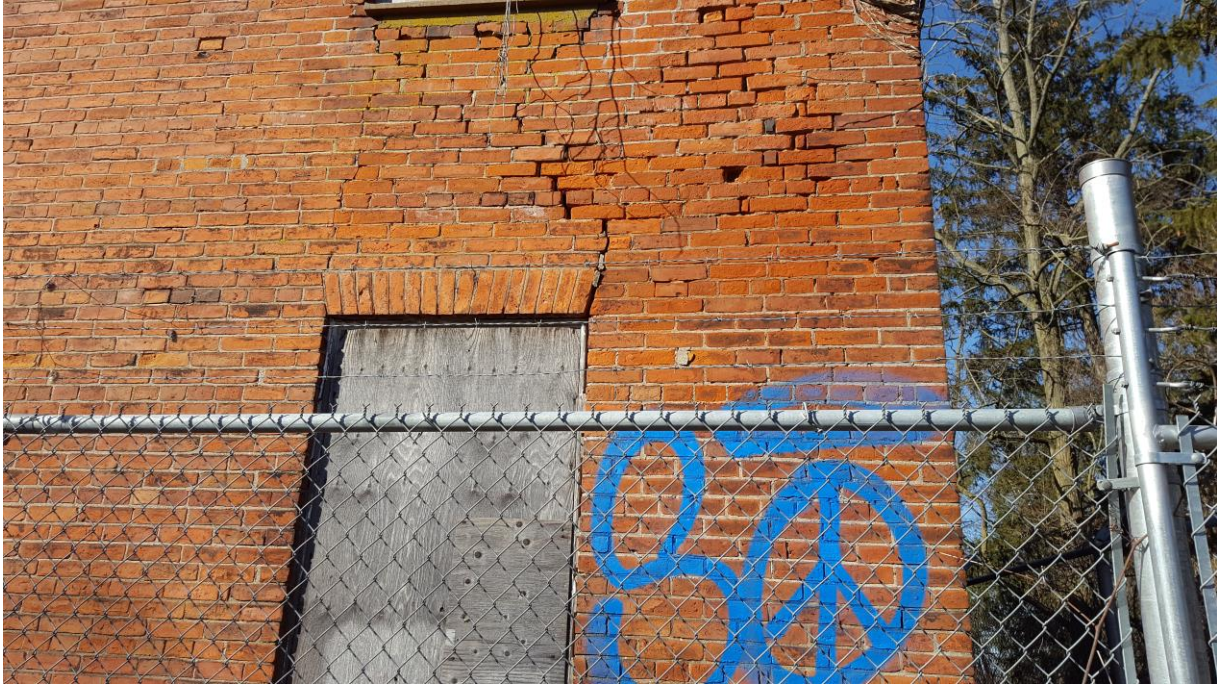
Image 3: The building has seen multiple instances of vandalism, such as graffiti as can be seen here on the northeast corner. Failing masonry and crumbling mortar is also visible throughout the walls (RCDH, 2018).

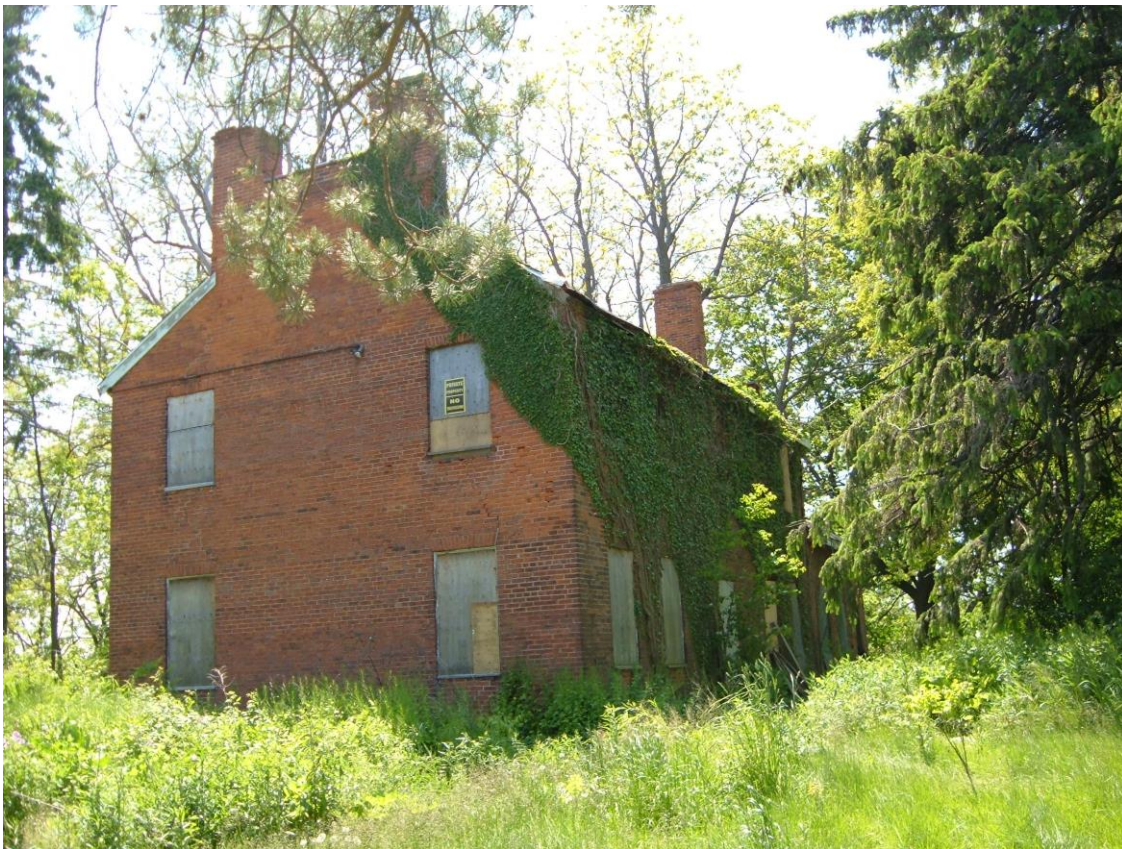
Image 4: In 2010, HMHC member Sylvia Wray conducted a site visit of the property. This image of the northeast corner shows the structure from the east (Wray, 2010).

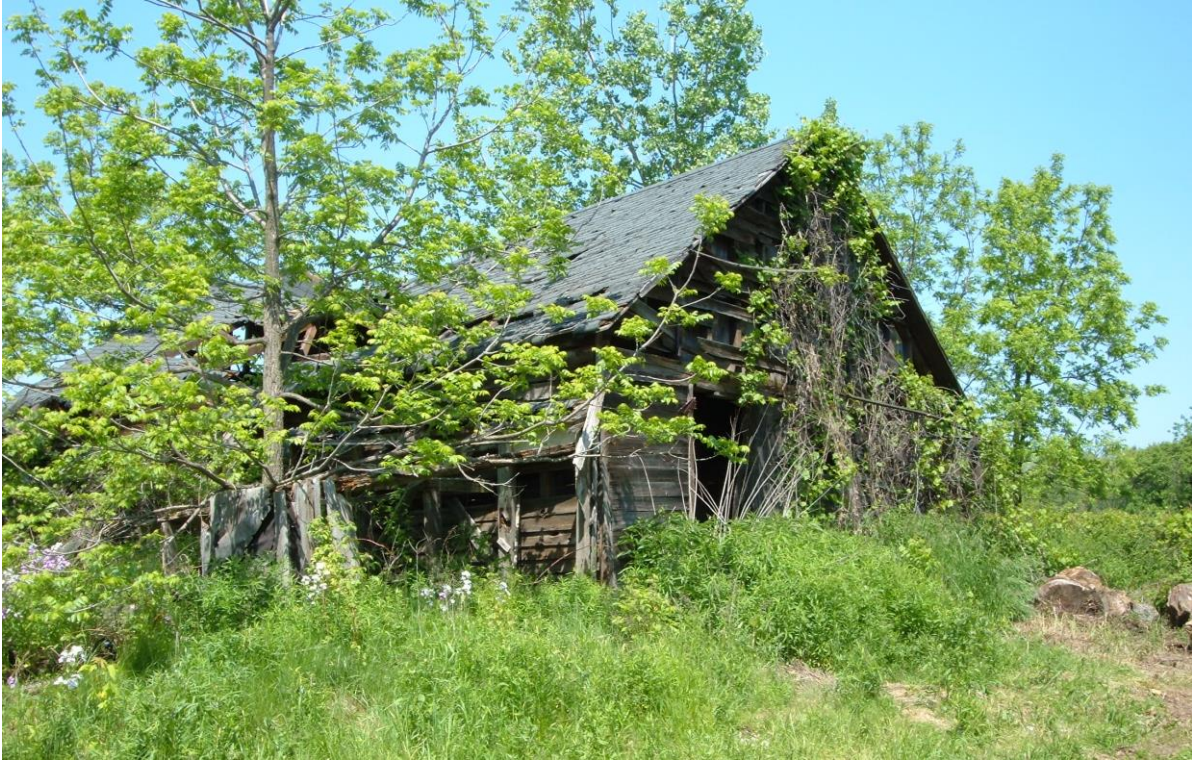
Image 5: View of one of the property’s crumbling outbuildings in 2010 (Wray, 2010).

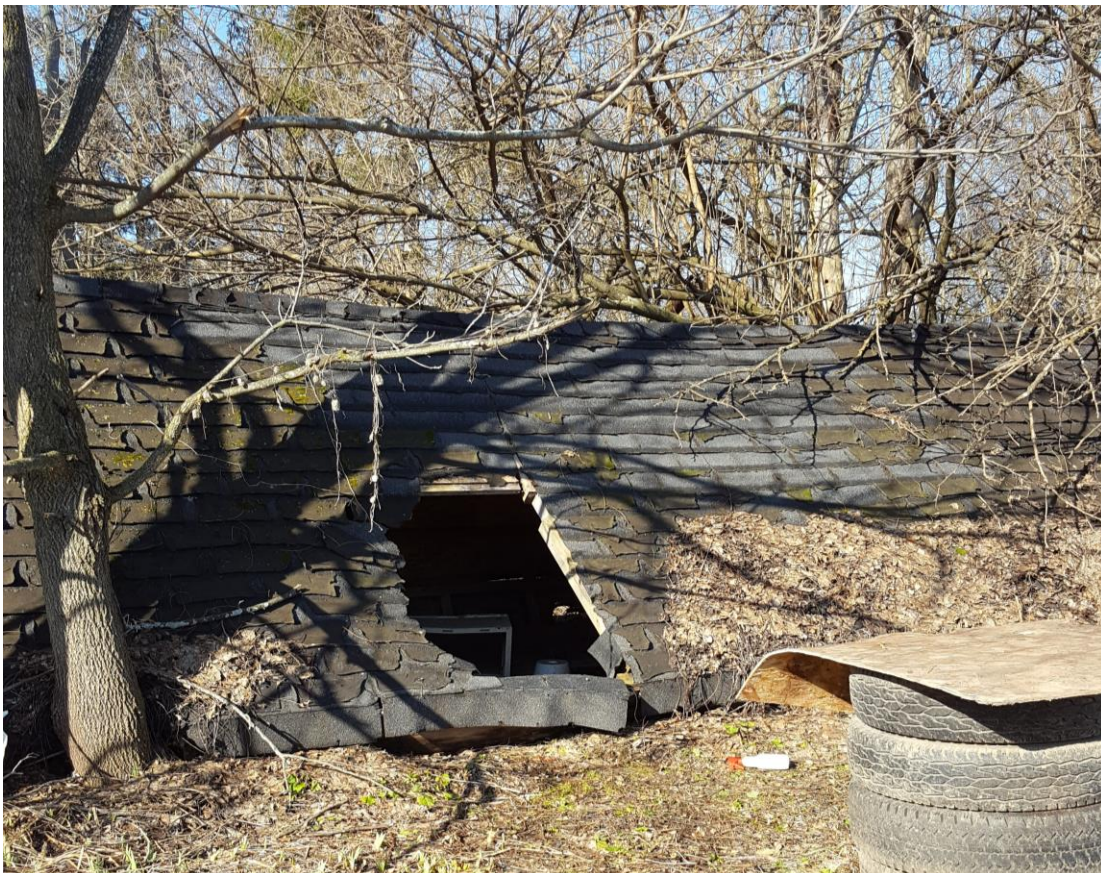
Image 6: View of what appears to be the remains of the same structure in 2018 (RCDH, 2018).

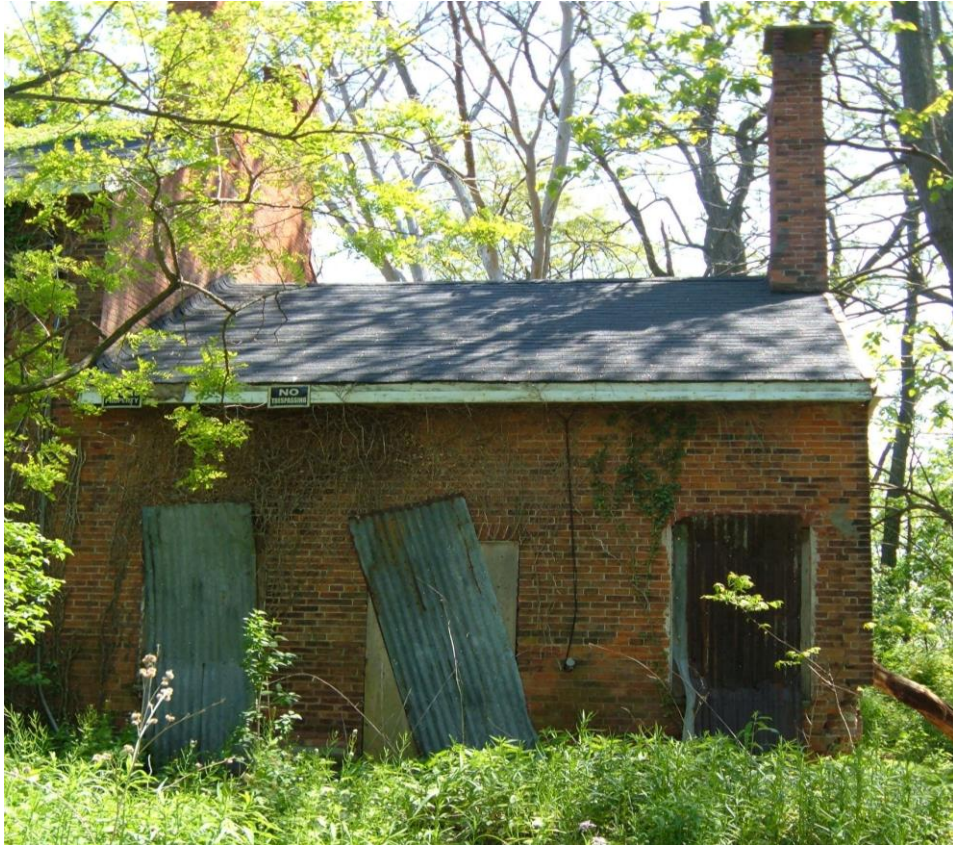
Image 7: The property contains an early or original one-storey brick wing, likely built as a kitchen, with a large chimney (Wray, 2010).

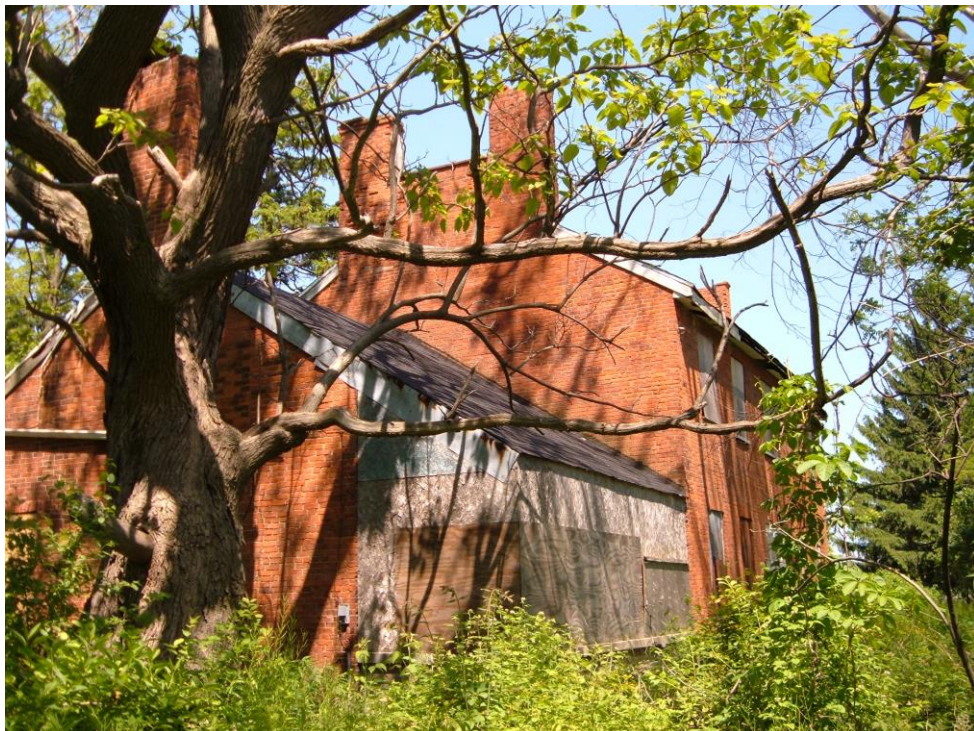
Image 8: View of the front of the kitchen wing section, showing plywood secured to the front to prevent illegal entries (Wray, 2010).

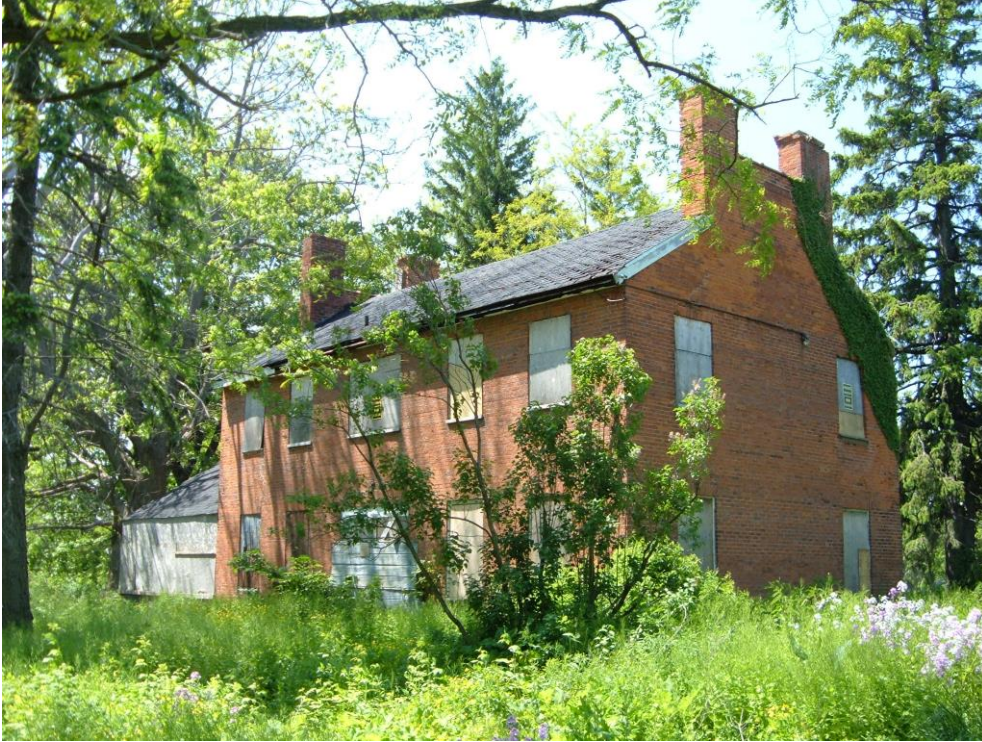
Image 9: The Book House as photographed in 2010 (Wray, 2010).

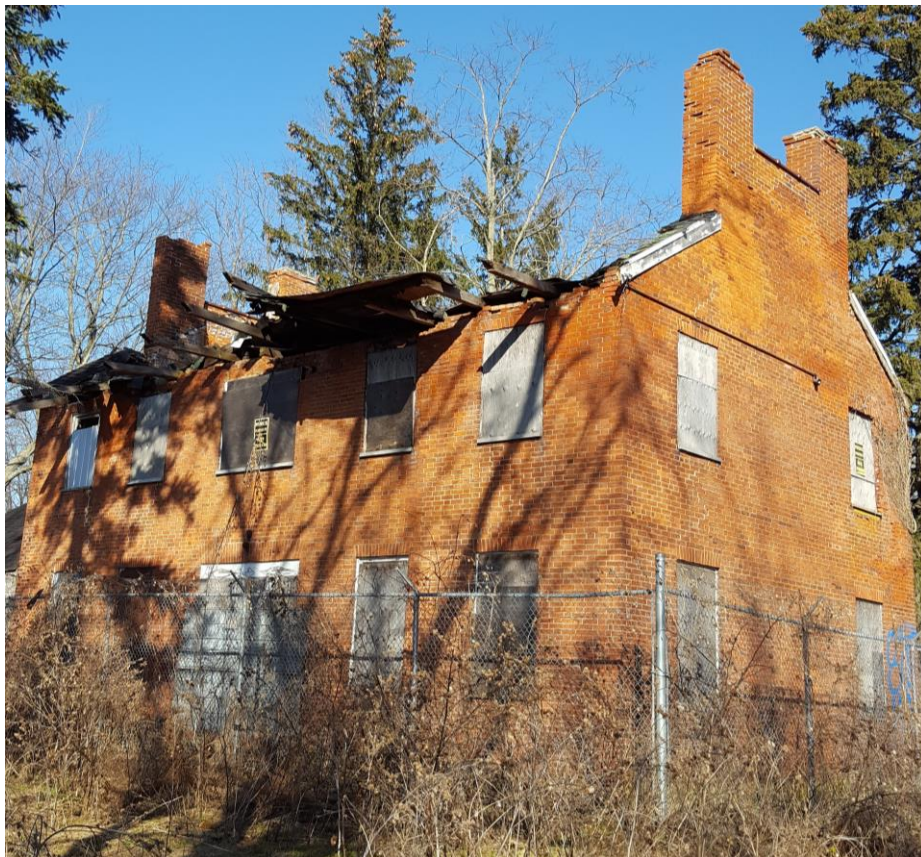
Image 10: The Book House as photographed in 2018 (RCDH, 2018).
