**HERITAGE ASSESSMENT**  
**BROWLANDS, CHEDOKE HOSPITAL, HAMILTON, ONTARIO**  
**for**  
**DEANLEE MANAGEMENT INC.'s OFFICIAL PLAN SUBMISSION**

SBA Project #: A0679

June 2007

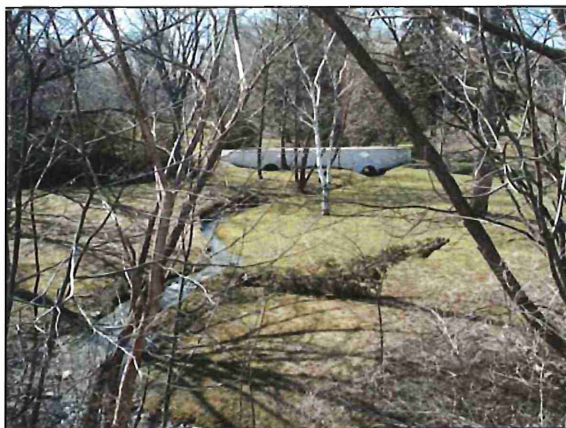
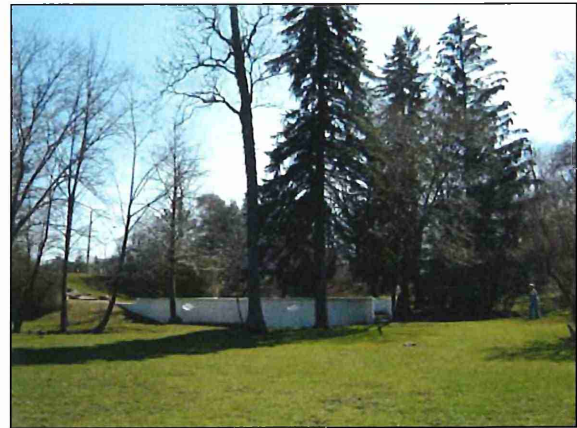
## .2 The Pedestrian Bridge

The early concrete pedestrian bridge is part of the designed landscape adding a scenic picturesque quality to the site. The composition of the bridge and meandering stream is part of viewing yard overlooked by the East Pavilion and Brow Building. The tree collection contains a variety of trees such as white birch, Norway spruce and others which add interest to the setting. The access to the bridge is by means of a walkway which leads from the East Pavilion to Sanatorium Road.

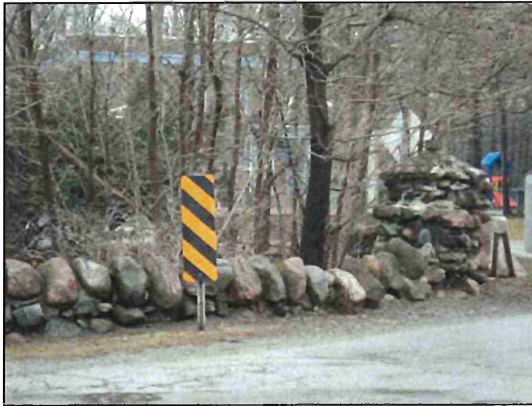
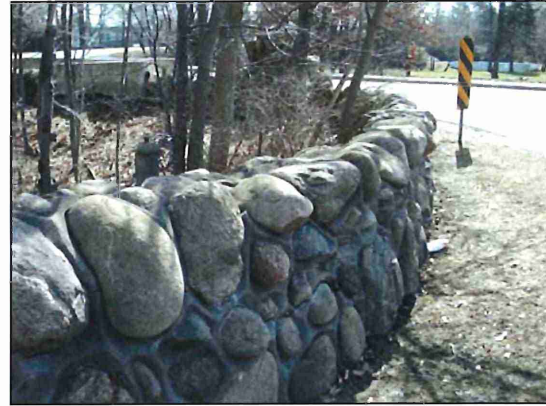
### .3 The Stone Wall and Pillars at the Vehicular Bridge

The stone wall and two pillars at the vehicular bridge along the edge of escarpment are a rare example of ornamental rustic stone work with raised ribbon jointing. The deliberately selected granite boulders contrast the indigenous limestone of the escarpment found below it. There is evidence of extensive repairs being completed and oral history confirms that a staff person repaired or built a section of the wall in the 1950s. Pillars mark the end of the bridge section with a lower wall extended north around the top of the brow for several metres.

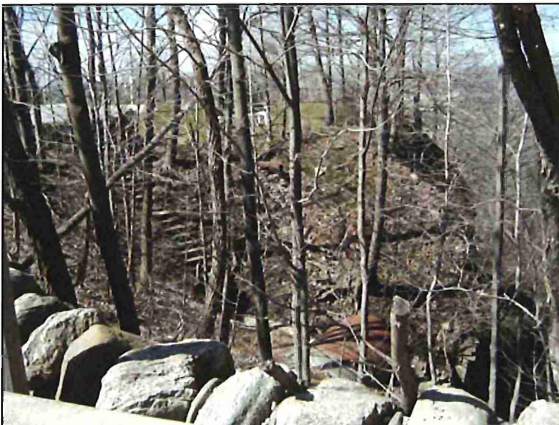
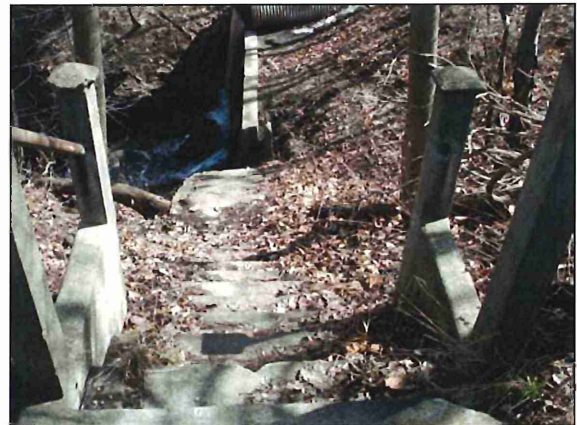
### .4 The Stairs

There is documentary evidence that a set of stairs extended down the escarpment, providing access to the railway below for employees and visitors of the Sanatorium. The existing concrete stairs lead directly to the stream headwall outfall and are possibly a remnant of this earlier access route. The top of the stairs is currently blocked by a section of the restored stone wall which may indicate that this section of the wall was extended across the stairs from the northern most bridge pillar. Further investigation will be required to more precisely date the period of the concrete stairs in comparison to the wall.

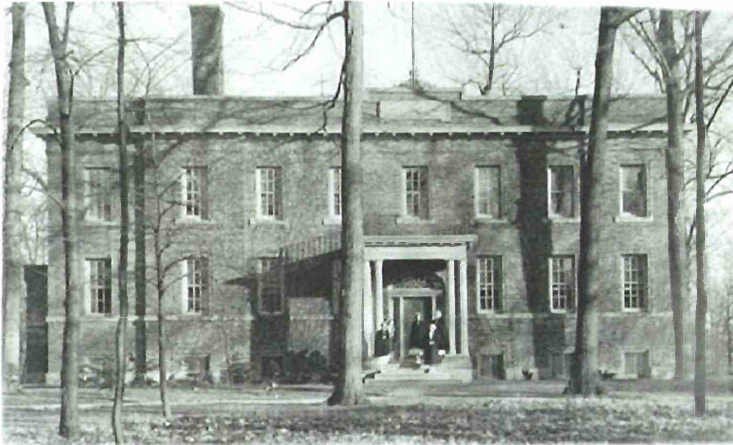
EARLIER PHOTO

- Protruding wooden cornice with dentils has been replaced with flush wood band & metal flashings.
- Flag standard and masonry chimney have been removed.
- Returned stone entry steps have been replaced by straight run.
- Original double hung 6 panes over 6 panes have been replaced by single hung single pane, single glazed sash.

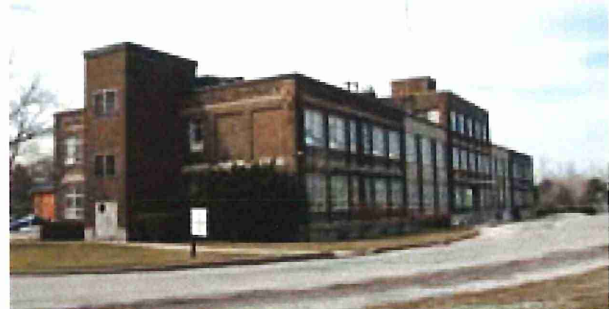
**2007 Photo**

- 1959: converted to convalescent and chronic care facility
- .2 Present Use**
  - Vacant, undergoing decommissioning
- .3a Integrity of Original**
  - The following elements are missing: the curvilinear parapets over the entries, the glazed roofing tiles on the sloped roofs at the entries and parapets, the decorative eave brackets, the balconies, floor to ceiling wood windows, and the balustrade of the roof decks of the bays adjacent to the central three storey portion.

- In the crawl spaces, there is water infiltration between the footings and the underlying limestone.
- There is water infiltration through cracks in the parging over the soft fired clay bricks of the foundation walls.
- The replacement windows are substandard.
- The ballasted membrane roofing system complete with metal flashing has had the chronic leaking problems commonly associated with this type of system. Substantial interventions would be required to run services and insulate the envelope.

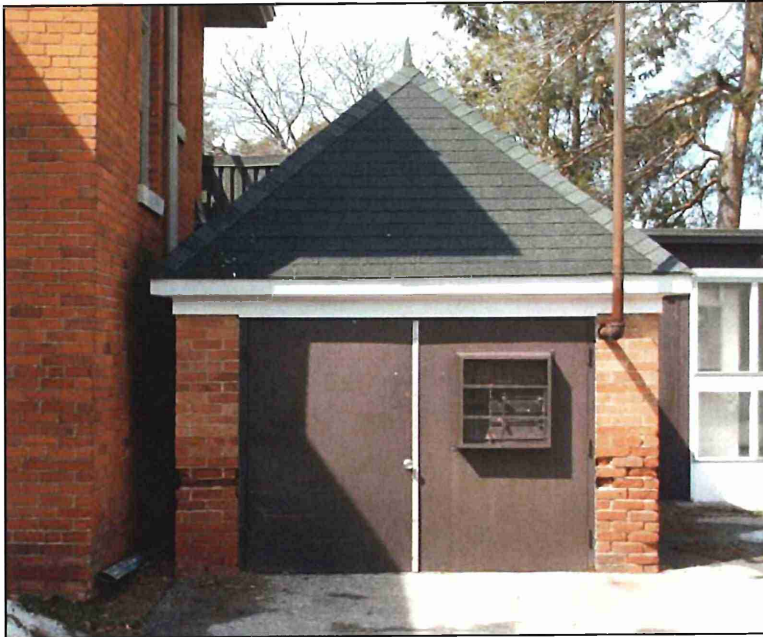
**.8 Photo Elevation**

#	ELEMENT	CONDITION
A10	FOUNDATIONS	Good. No settlement cracking
B20	EXTERIOR WALLS Red brick, matching Annex	Fair Lower portion requires repointing, replacement
B25	ENTRIES / DOORS Replacement	Serviceable
B30	ROOF TYPE & MATERIALS Cottage Roof Quaint central pole framing	Good New asphalt shingle roofing

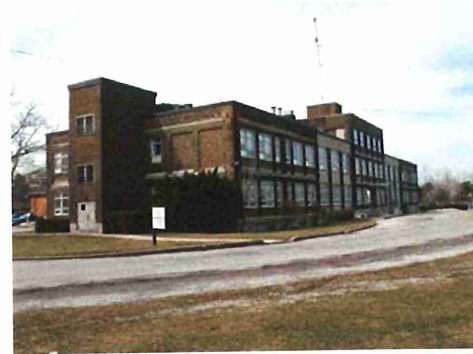
**2007 north (front) elevation**

The Brow Infirmary Building as it appears today has little architectural merit and does not reflect the original design intent. It would be possible to reconstruct the missing architectural features but this would be pure reconstruction, not preservation of existing significant features.
