HERITAGE ASSESSMENT
BROWLANDS, CHEDOKE HOSPITAL, HAMILTON, ONTARIO
for
DEANLEE MANAGEMENT INC.'s OFFICIAL PLAN SUBMISSION

SBA Project #: A0679

June 2007

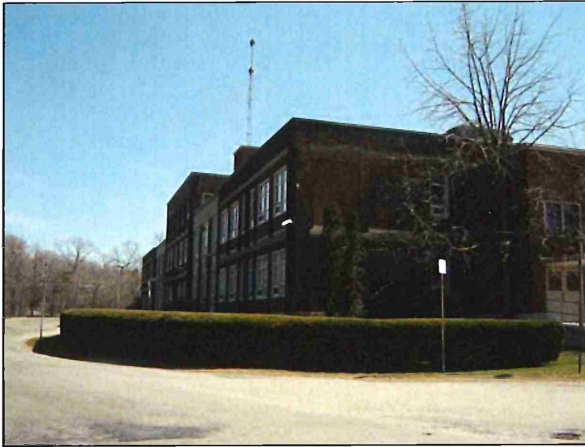
Oblique View to the Western End of the Brow Building from Sanatorium Road.

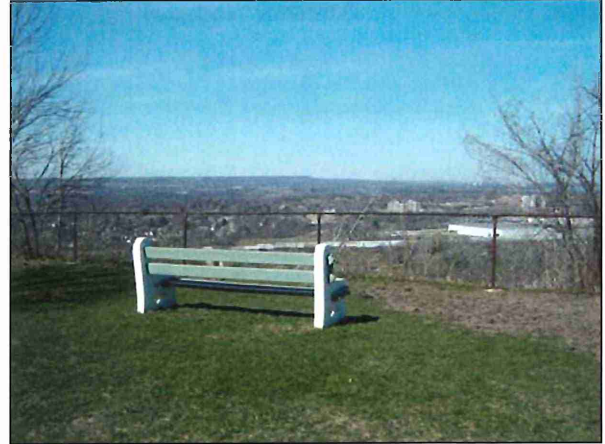
Open View from the top of the Escarpment to the North East.

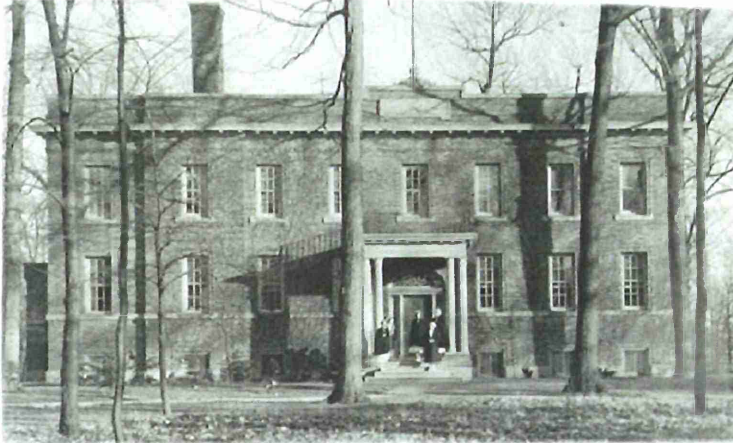
EARLIER PHOTO

- Protruding wooden cornice with dentils has been replaced with flush wood band & metal flashings.
- Flag standard and masonry chimney have been removed.
- Returned stone entry steps have been replaced by straight run.
- Original double hung 6 panes over 6 panes have been replaced by single hung single pane, single glazed sash.

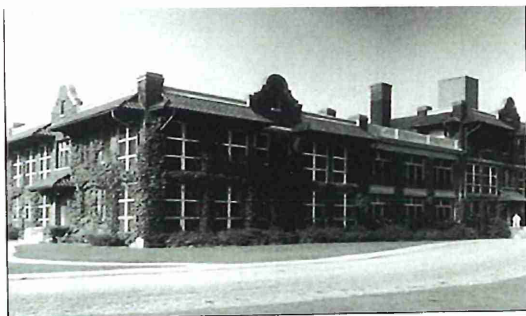
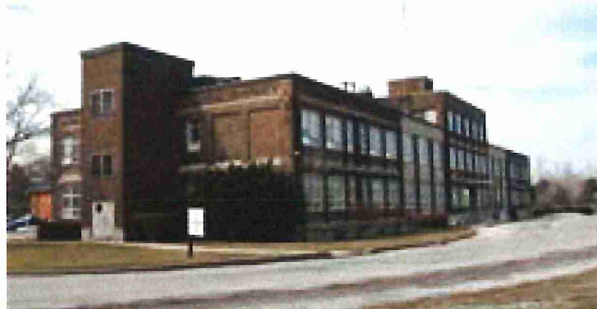
- In the crawl spaces, there is water infiltration between the footings and the underlying limestone.
- There is water infiltration through cracks in the parging over the soft fired clay bricks of the foundation walls.
- The replacement windows are substandard.
- The ballasted membrane roofing system complete with metal flashing has had the chronic leaking problems commonly associated with this type of system. Substantial interventions would be required to run services and insulate the envelope.

This building is presently being decommissioned. The decommissioning will leave the aboveground area extremely susceptible to mould. The hollow clay tile foundations are extremely susceptible to damage once the heat has been shut off.
