# Added Presentation to Item 8.1

City of Hamilton

April 1, 2019

Subject: Unsafe Roadway South Service Rd, East of Belgraden Ave. Stoney Creek

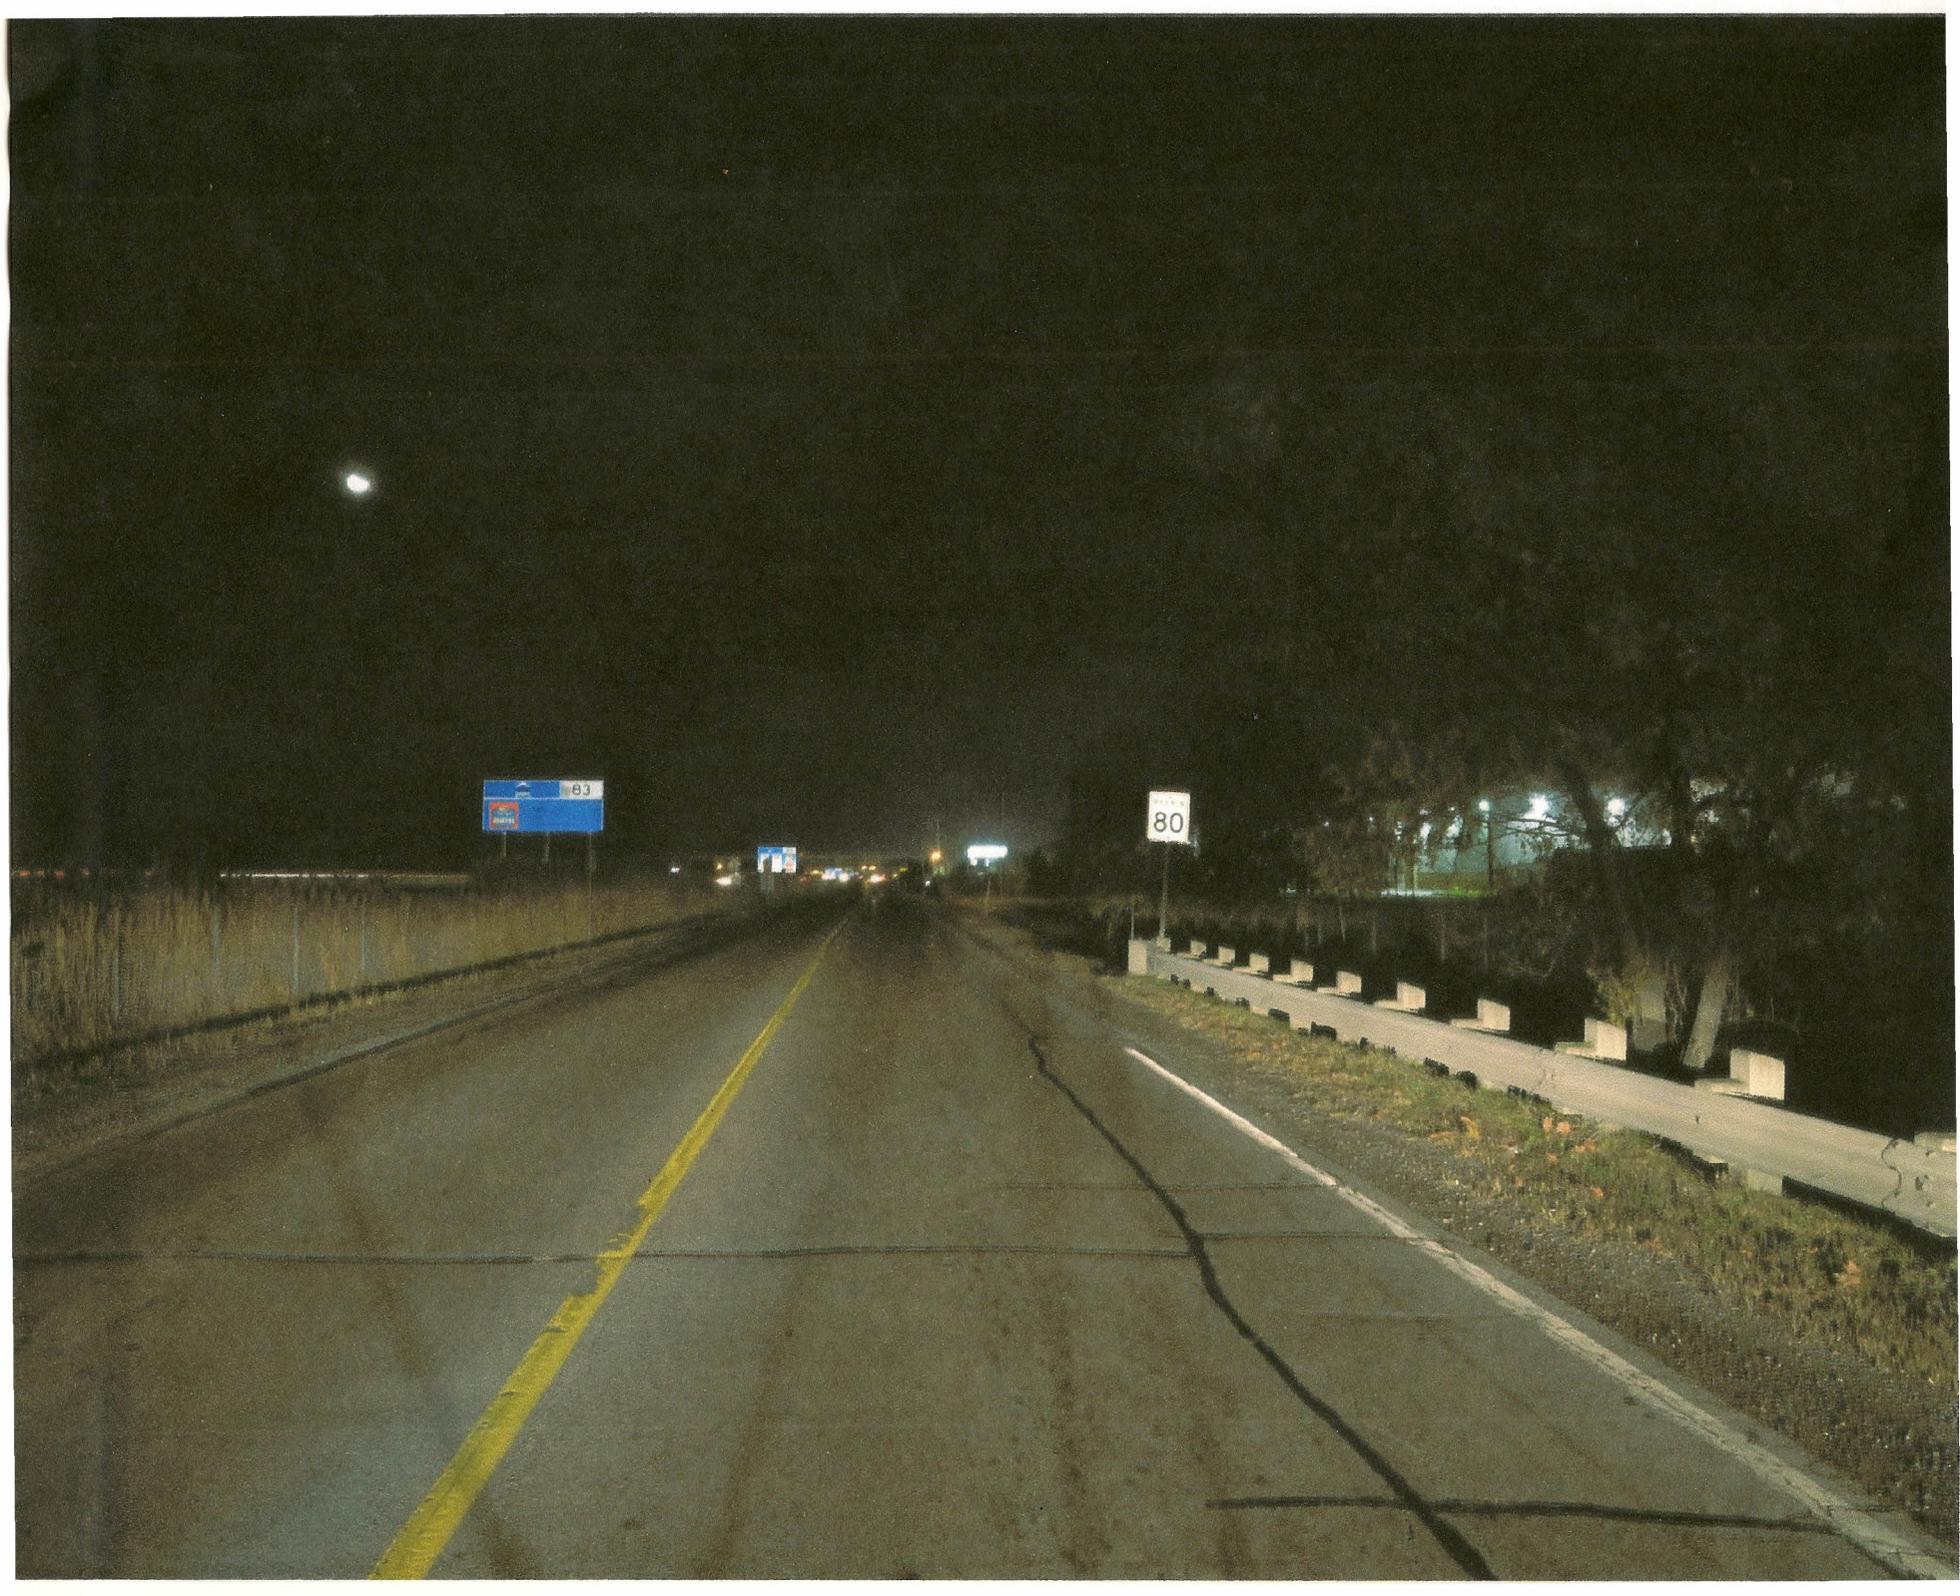
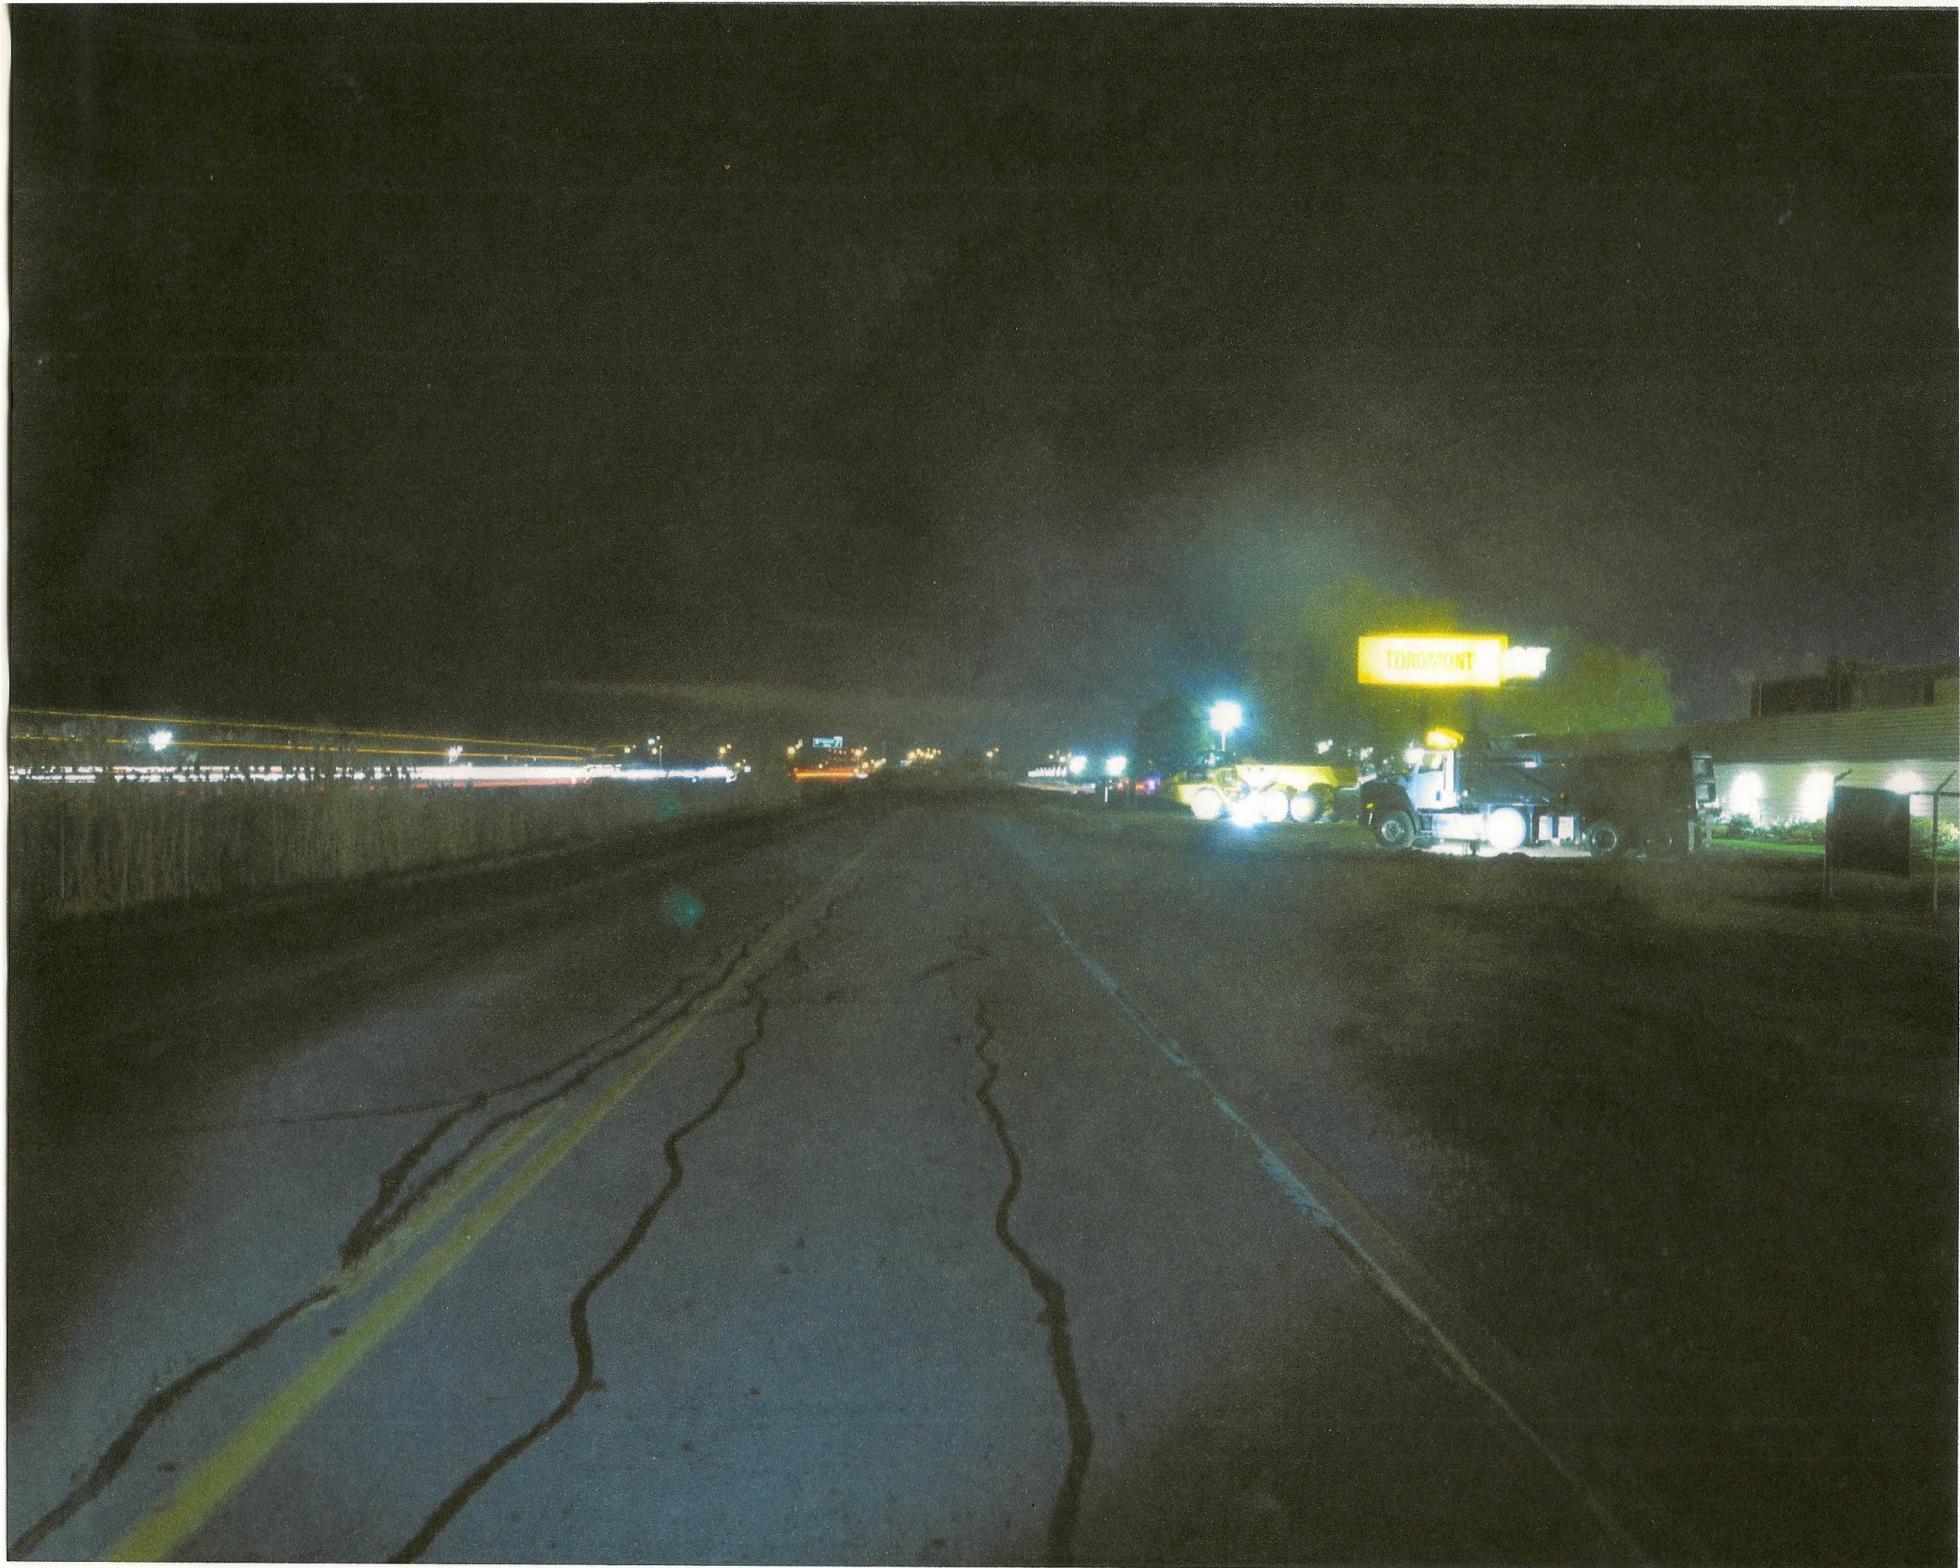
Picture 1 and 2 show the speed limit at the time of the accident and what a driver sees as they are travelling east on the South Service Road.

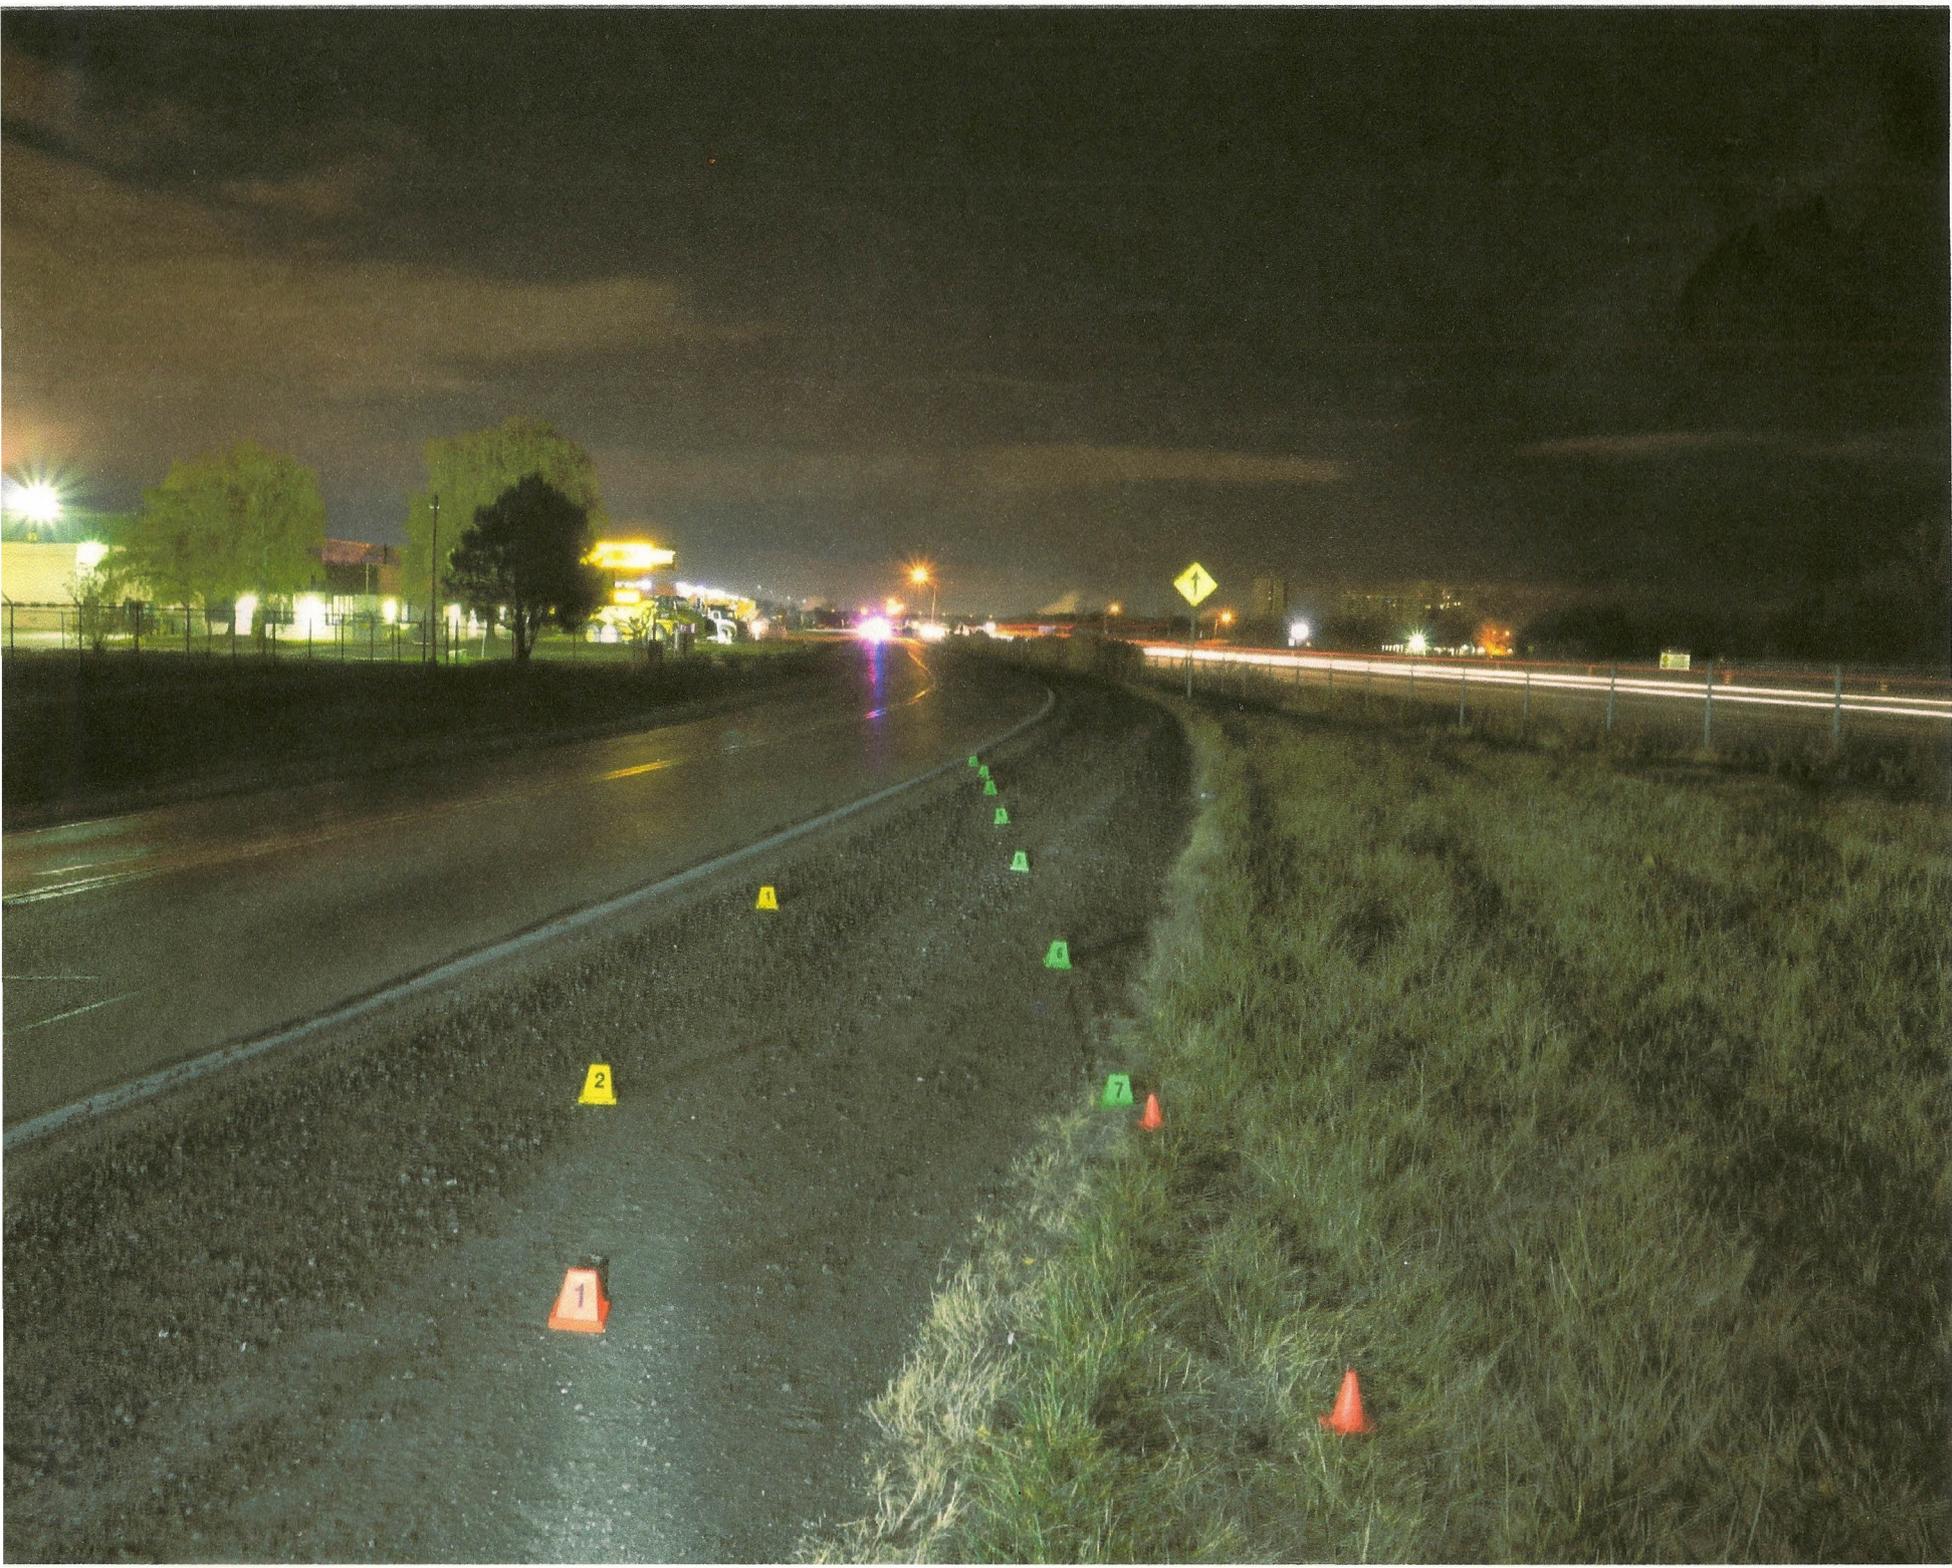
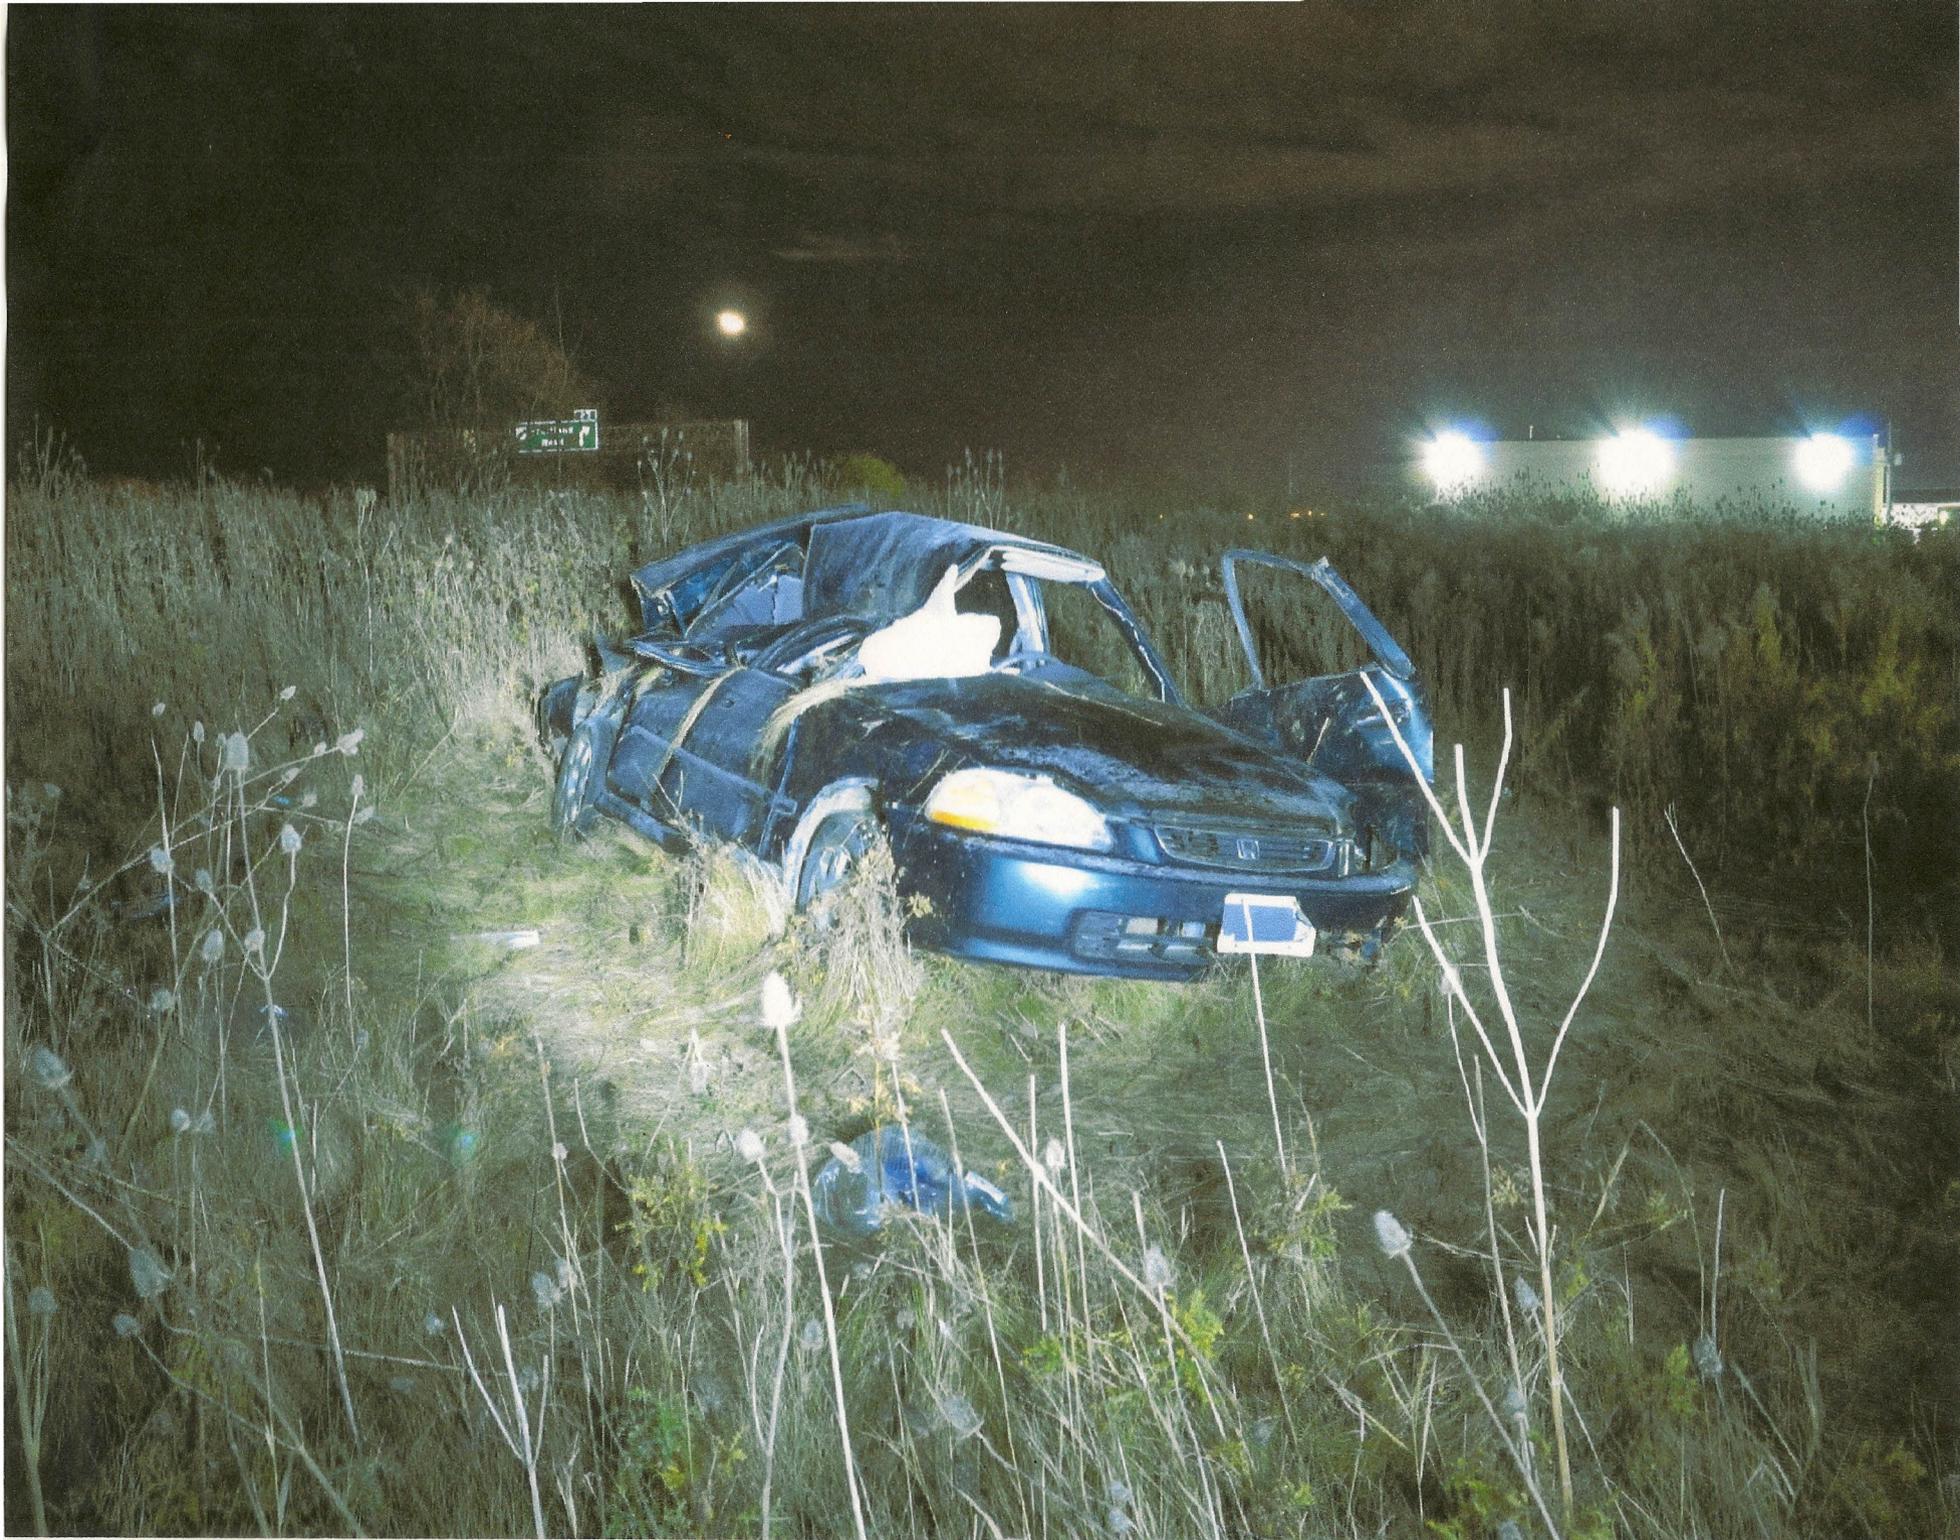
Pictures number 3 and 4 show the approach to the accident and the eventual resting place when the accident was finished.

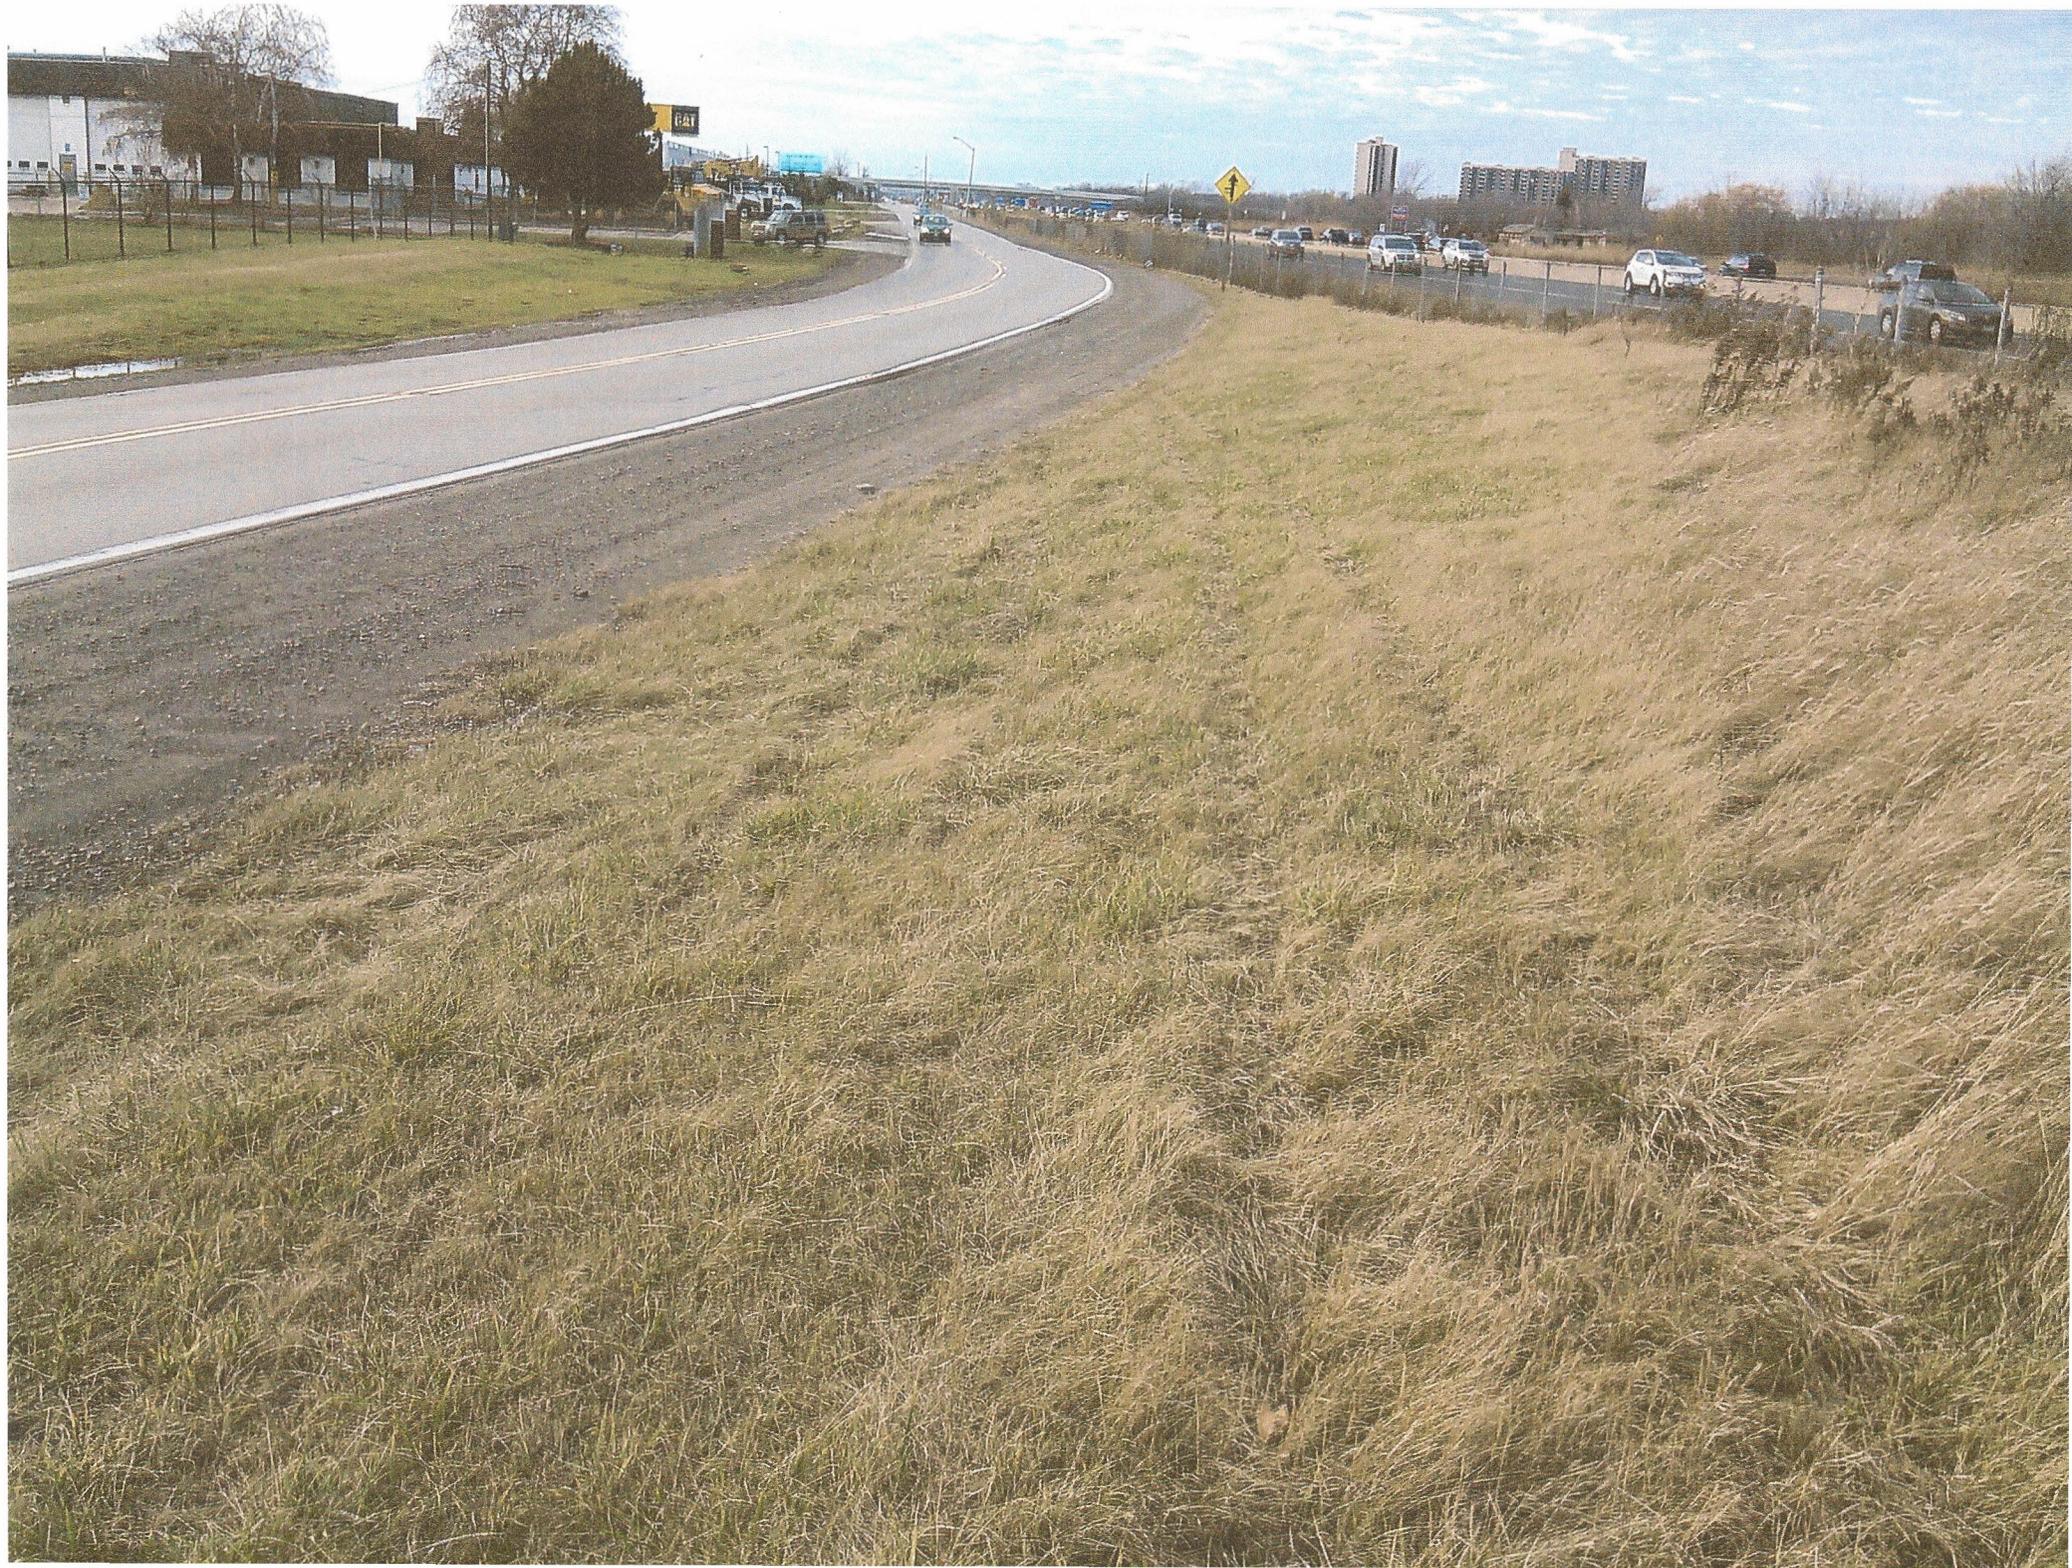
Picture number 5 show the roadway from the approach during the day. As you can see there is no protection for motorists on this roadway, there is no ditch or anything to stop someone from leaving the roadway especially in the dark.

We feel that if there was sufficient warning such as a checkerboard or Chevron markers or even a rumble strip centre line that this accident may not have happened.

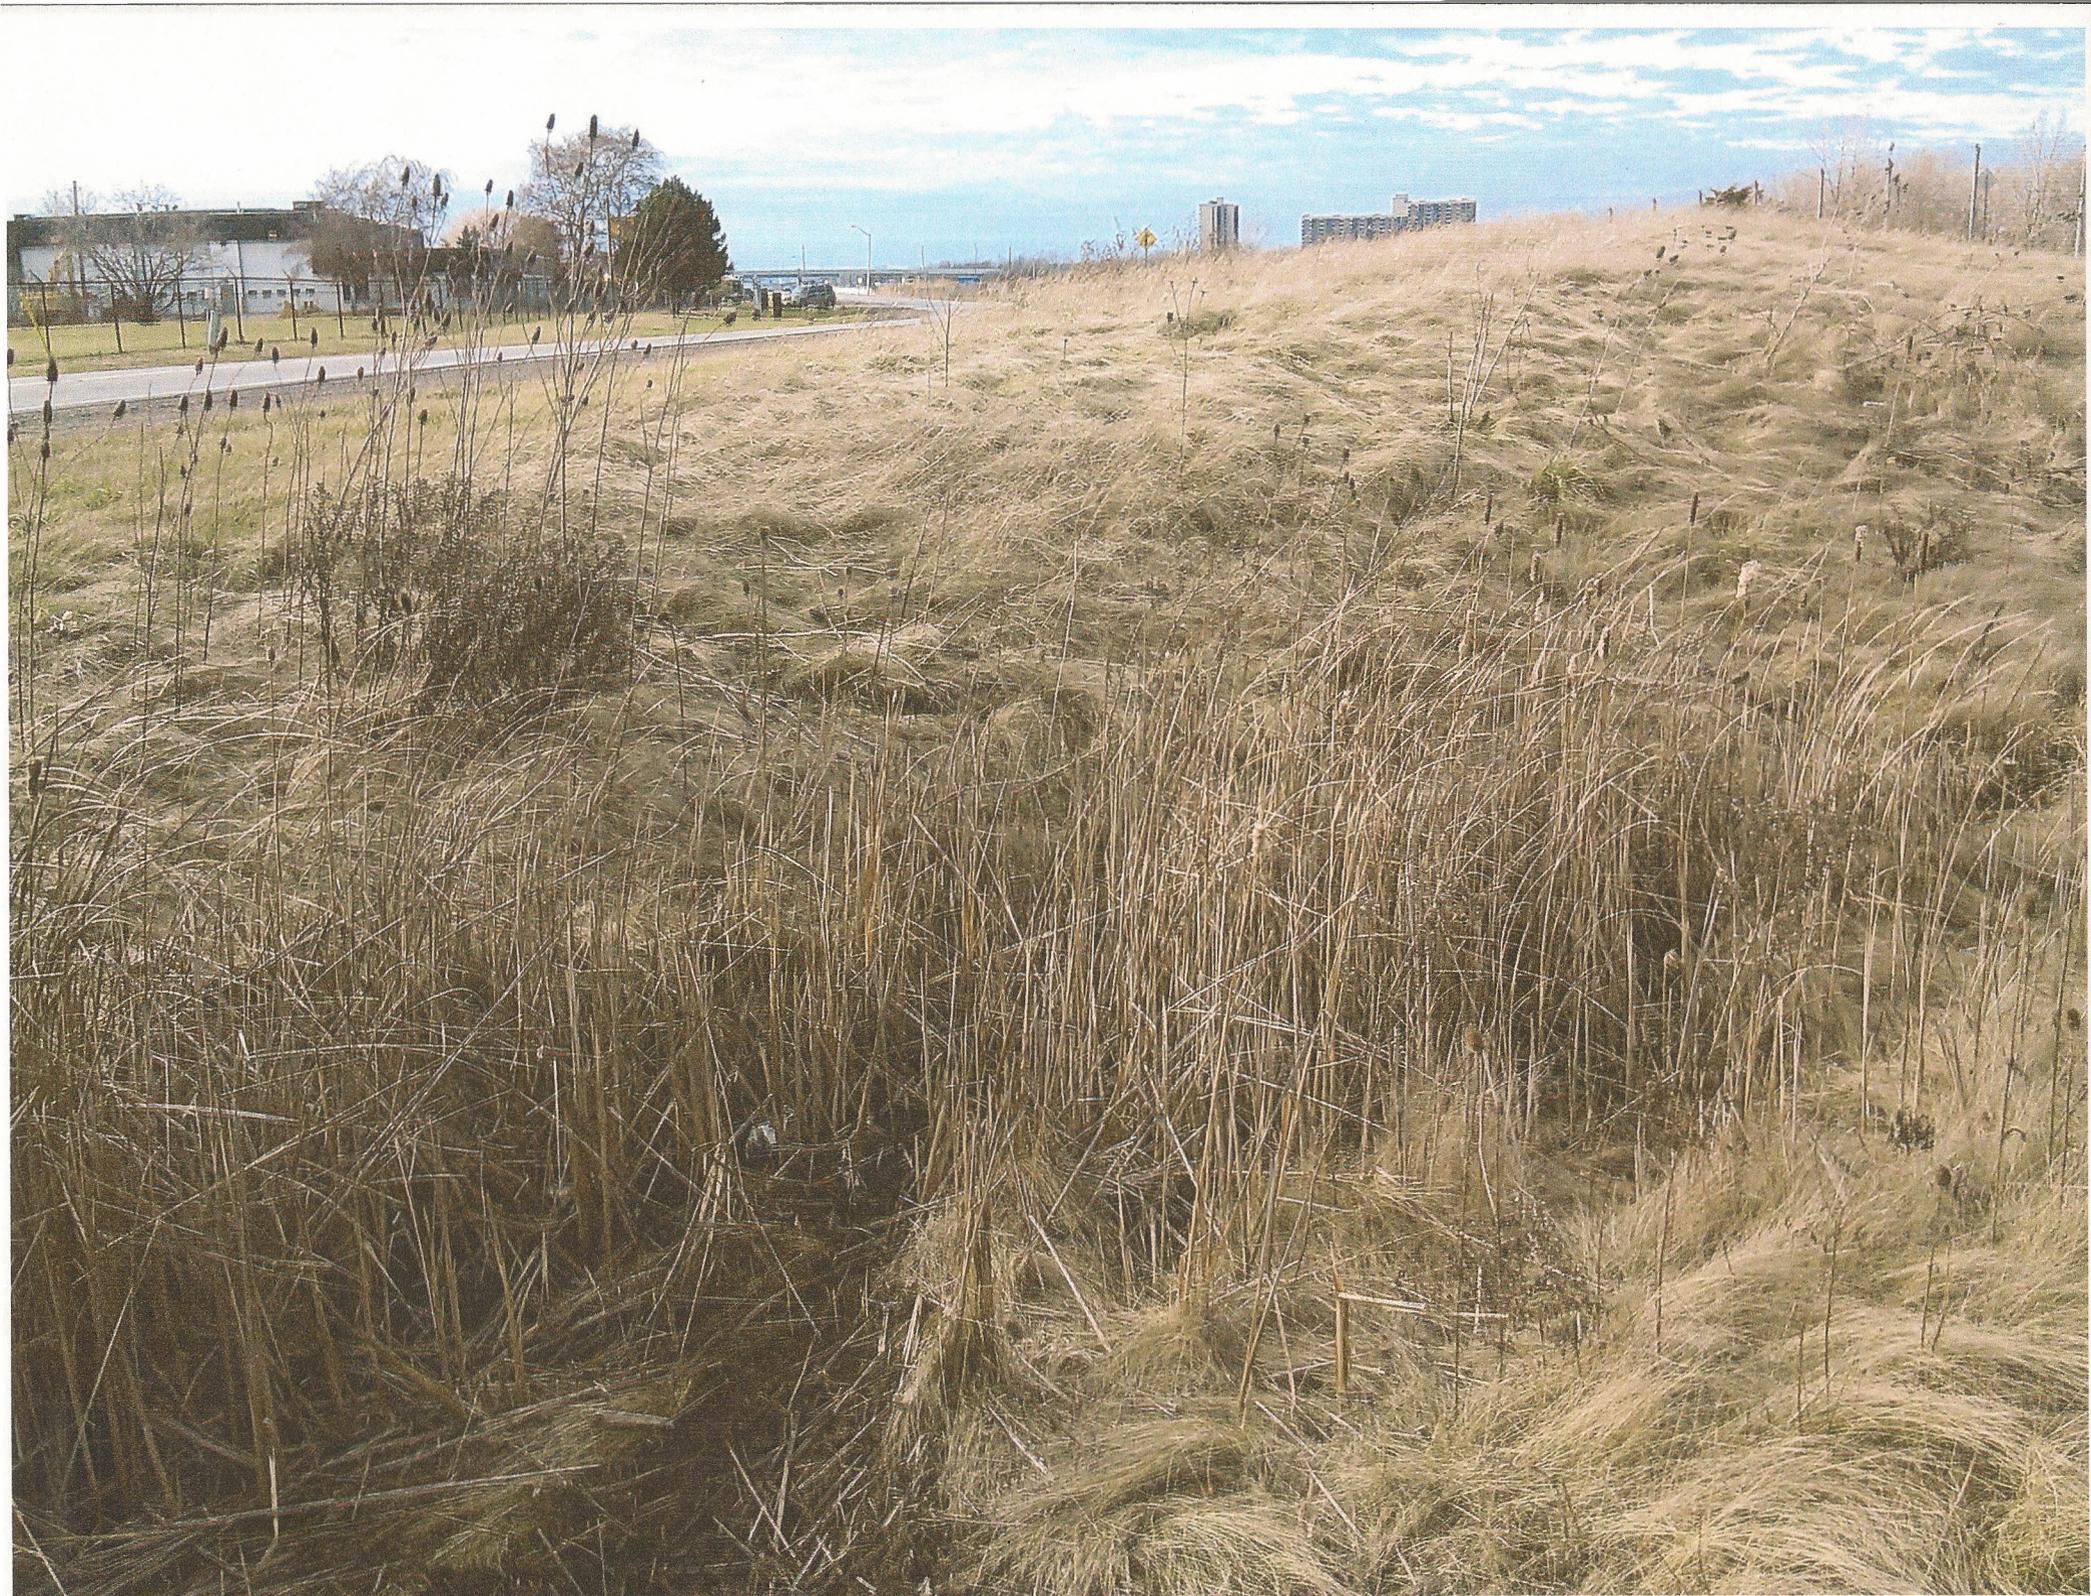
There is no ditch on the north side of the curve and in the field there is a 6 foot drop into a small water run off area.

Picture number 6 shows the hill that drops off after you leave the road which made the car go air born and and flip and role several times.
