City of Hamilton

2017 Sign Support Inspections Summary Report

Project No: 60554463

Regarding: 2017 Sign Support Inspections Summary Report

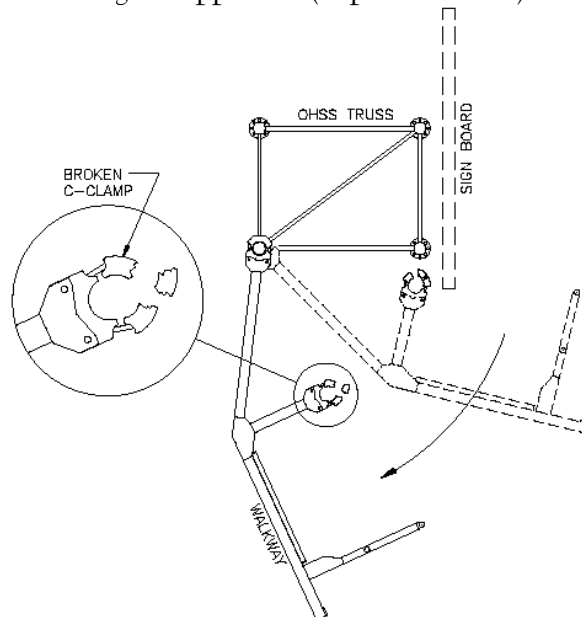
Cracked C-clamps

C-Clamps are used to support both the sign boards and the maintenance walkway. These clamps are constructed of a brittle casting and various factors result in cracking. These factors are: quality of casting, over tightening, imperfections of mating chord, and excessive structure movements/vibrations. The most critical C-clamps are the maintenance walkway support arms. Two clamps support each arm; one on the front and one on the back. The critical of these two is the front. When this support is lost (broken C-clamp) the walk arm can rotate around the back chord and is no longer supported (depicted below).

This is the reason that the maintenance walkway should not be utilized until all crack/broken C-clamps are replaced. Of particular concern are all front clamps. After replacement, a general inspection is still recommended prior to each use of the maintenance catwalk. During the design of the first overhead sign support (1960's) the main reason for the catwalks was to provide support for lighting and access to allow sign re-facing (overlay). Due to today's long life span of sign reflective sheeting signs no longer require lighting and/or re-facing. Based on this we recommend all catwalks be removed. This will dramatically reduce ongoing maintenance, reduce the dead load on the support and inhibit further vandalism.
