19 July 2018

City of Hamilton
77 James Street North, Suite 400
Hamilton, Ontario
L8R 2K3

Reference: Glen Road Inspection and Monitoring Program

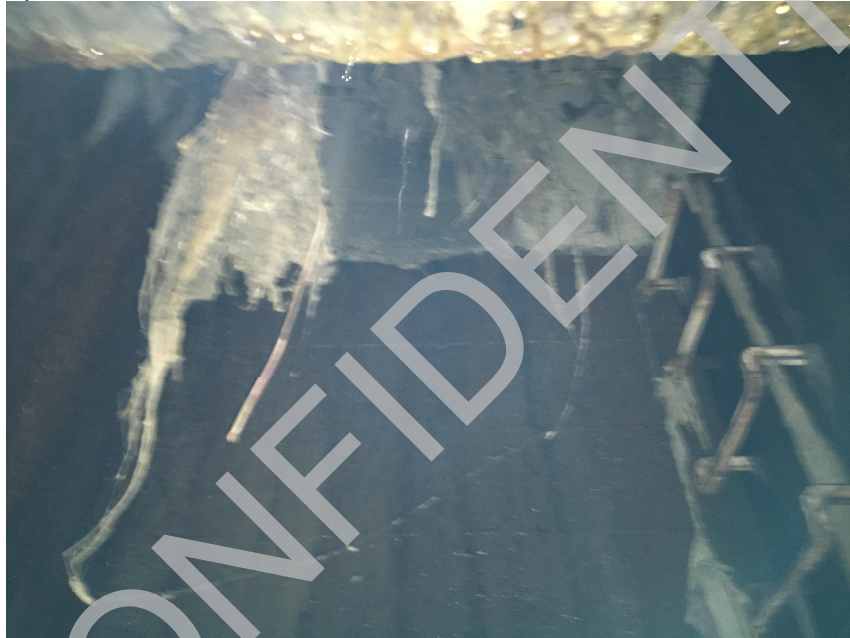
3. Manhole (HE09B118) - Glen Road Overflow: 31.4m from the North End

Flow: No flow

The overflow occurs at a manhole located on the west side of the pipe. The inlet pipe is approximately 4 meters above the invert of the Creek. There is significant sewer debris on the manhole steps and safety grate. Some of the manhole steps are missing and the safety grates look to be severely corroded and may not open. Maintenance work is recommended.

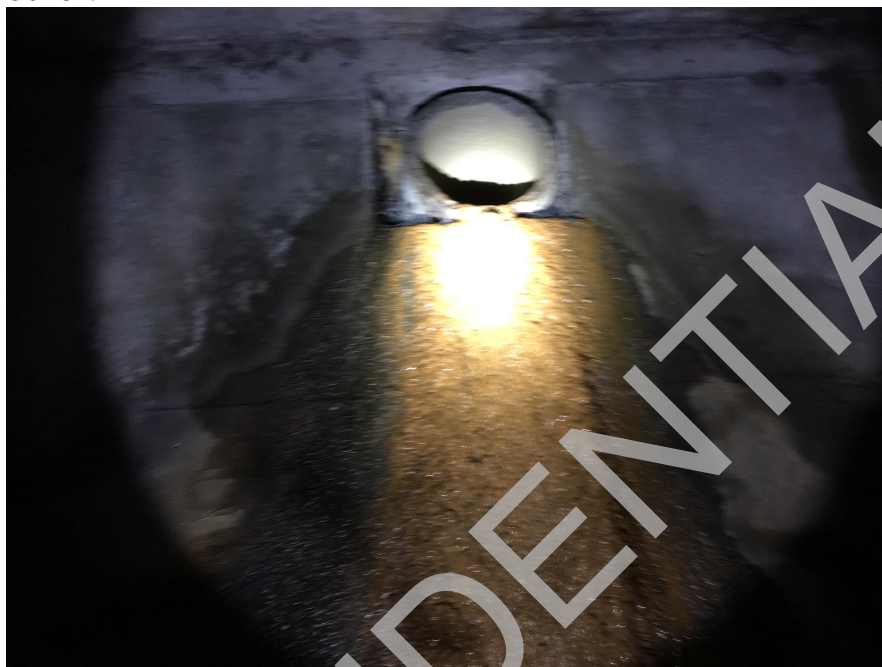
4. Storm Sewer: 97.3m from the North End
Flow: 0.2 lps . Clear Water
Sample: Yes . Bottle Set 3
The pipe is a 300mm diameter storm sewer entering the sewer at the pipe obvert.

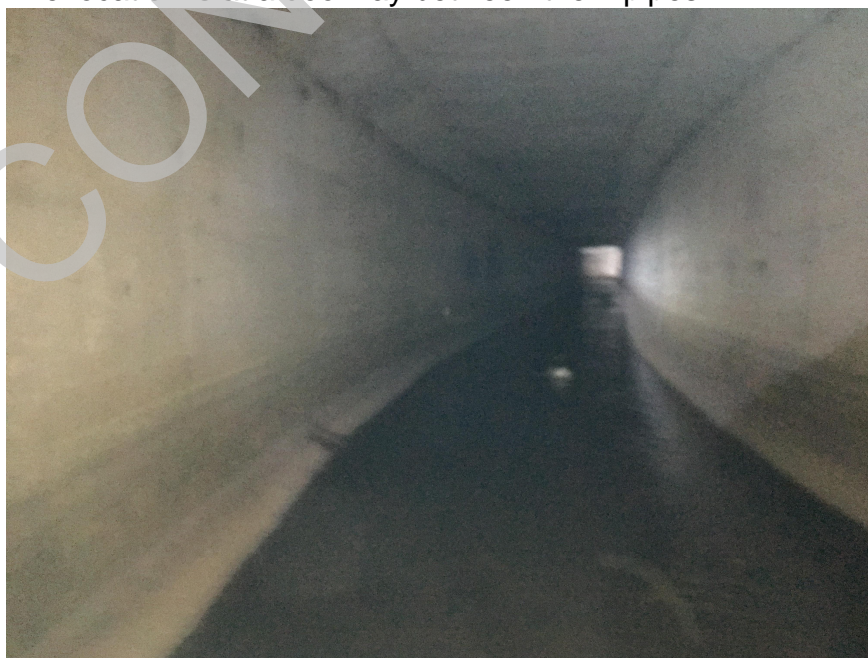
5. Chedoke Creek: 194m from the North End
Flow: 100 lps . Clear Water
Sample: Yes . Bottle Set 4
The location is at a doorway between the 2 pipes.

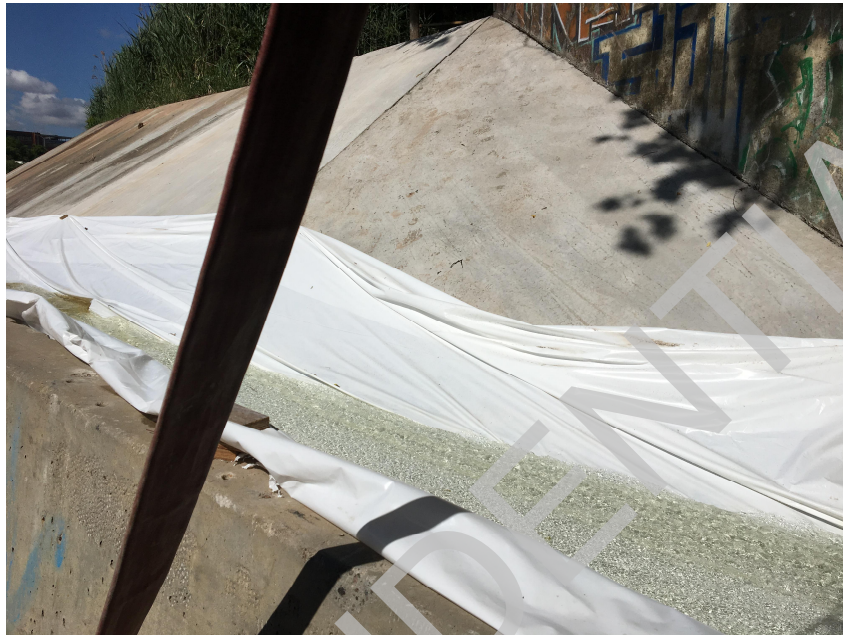
6. Chedoke Creek: Inlet (South End) 364m from the North End
Flow: 100 lps . Clear Water
Sample: Yes . Bottle Set 5
Sample collected from the invert of a plastic lined diversion channel constructed by the contractor which is undertaking work on the channel.

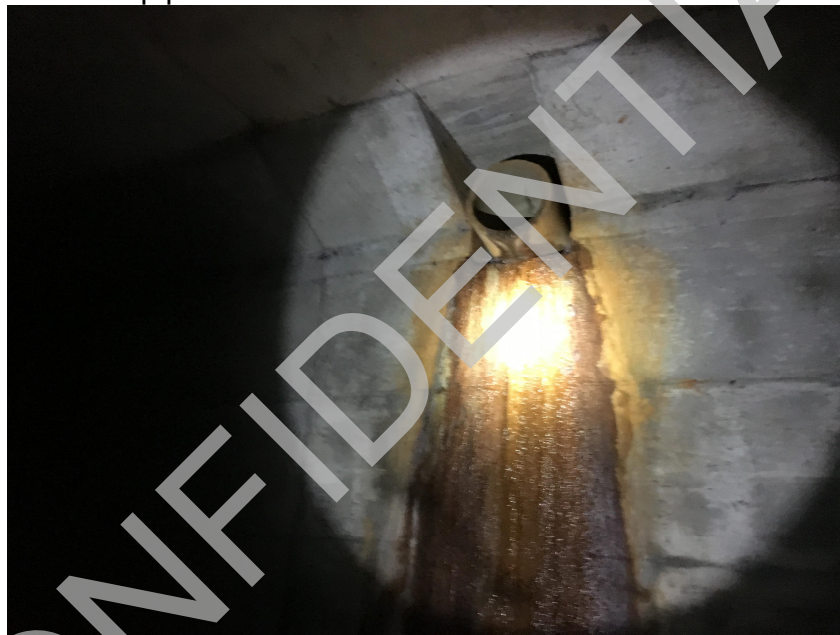
7. Storm Sewer: 134m from the South End
Flow: No Flow
Sample: No Sample Taken
The pipe is a 300mm diameter storm sewer entering at the pipe overt on the East side of the pipe.

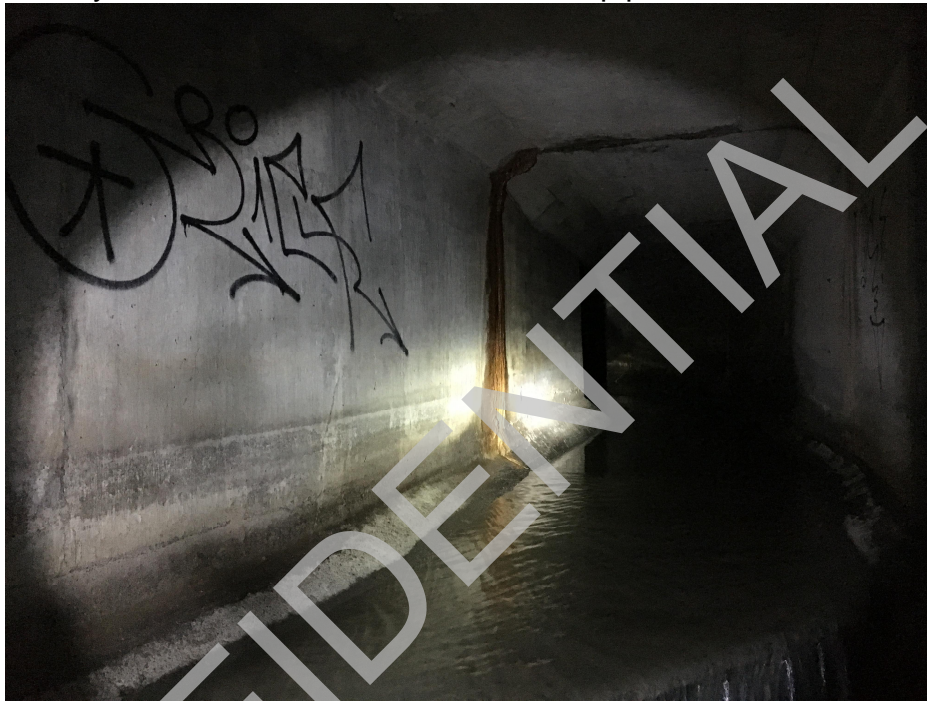
9. Main King Diversion: 245m from the South End
Flow: 30 lps
Sample: Yes . Bottle Sets 6 and 9 (duplicate taken)
The pipe is a 1.8m X 1.8m box. The water is cloudy with a sewage smell. There is no visible paper product in the flow or on the pipe walls. The pipe is approximately 0.6 m above the invert of the east pipe.

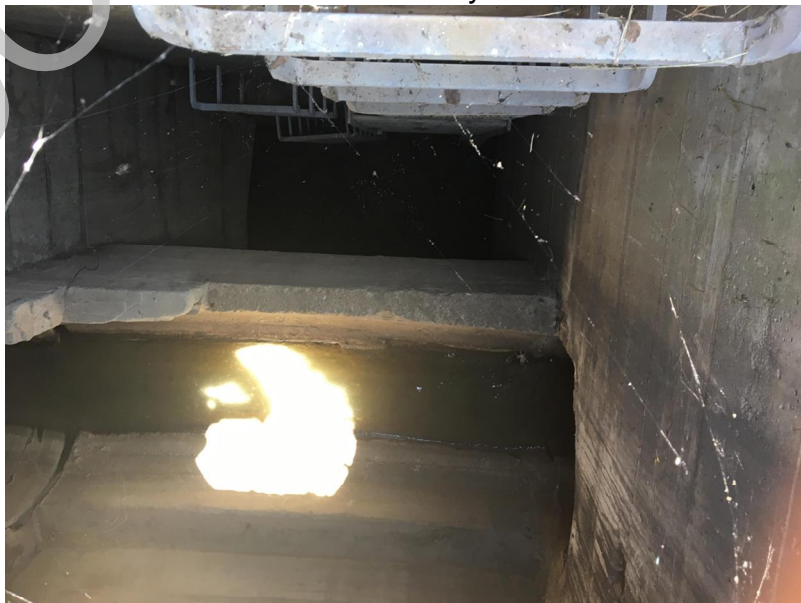
10. Manhole (HE09T003 and HE09E048) . 248m From the South End
Flow: N/A
Sample: N/A
There is an overflow in this manhole from the sanitary sewer on Tope Crescent. There is some sanitary debris on the manhole steps.

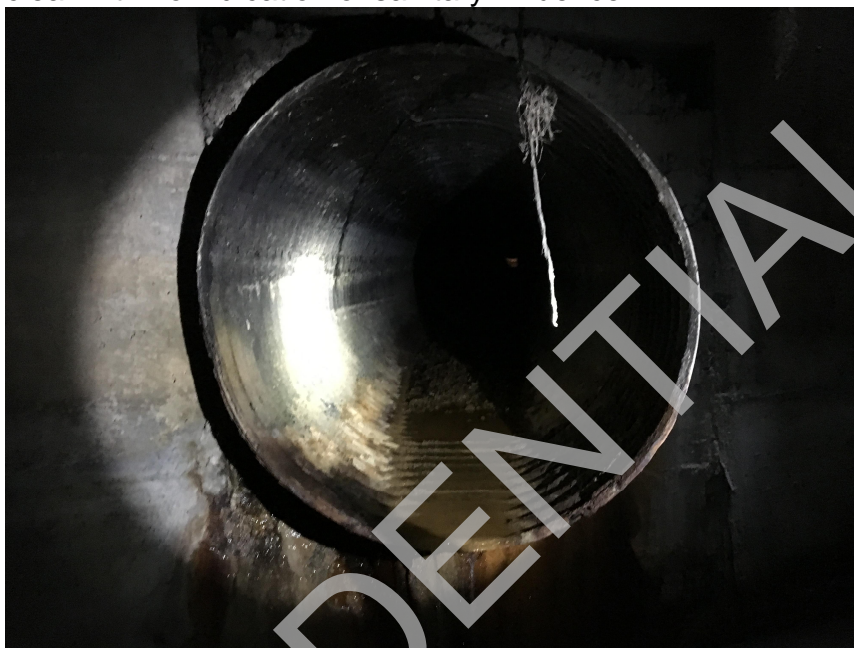
11. Storm Sewer . 251m From the South End
Flow: <0.1lps
Sample: Yes . Bottle Set 11
The pipe is a 900mm CSP with some corrosion on the invert. The water is clear with no indication of sanitary influence.

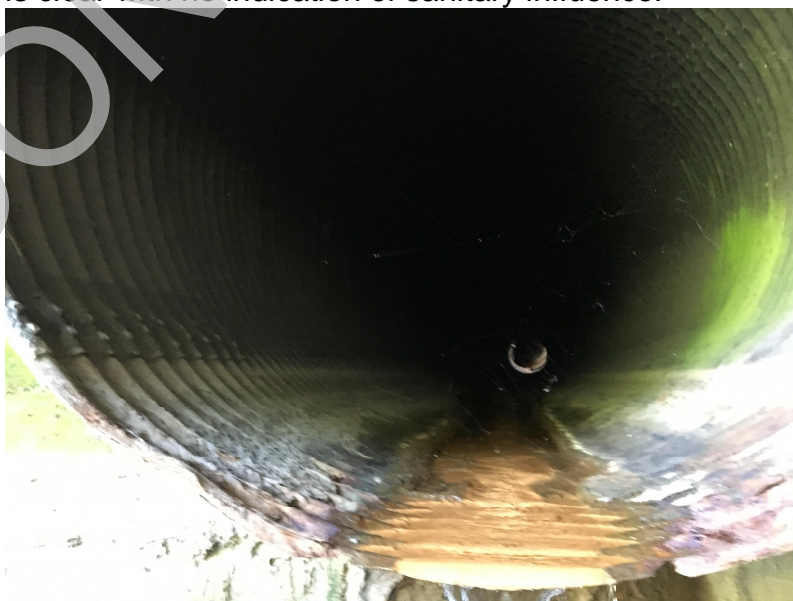
13. Storm Sewer . 367m From the South End
Flow: <0.1lps
Sample: Yes . Bottle Set 10
The pipe is a 1500mm CSP with some corrosion on the invert. The water is clear with no indication of sanitary influence.
