From: [REDACTED]
 To: [Ferguson, Lloyd; Golden, Alissa](#)
 Cc: [Bishop, Kathy](#); [REDACTED]
 Subject: Cultural Heritage comments for FC-15-081/ for the 105 Filman property
 Date: January 25, 2021 11:54:57 AM
 Attachments: [Filman Rd City Contract.pdf](#)
[Heritage Comments - FC-15-081 \(11\).doc](#)
[105 Filman Ancaster Heritage Assessment Report.pdf](#)
 Importance: High

105 FILMAN ROAD, ANCASTER

January 16, 2021

Prepared by: T. Murison Heritage Consultant

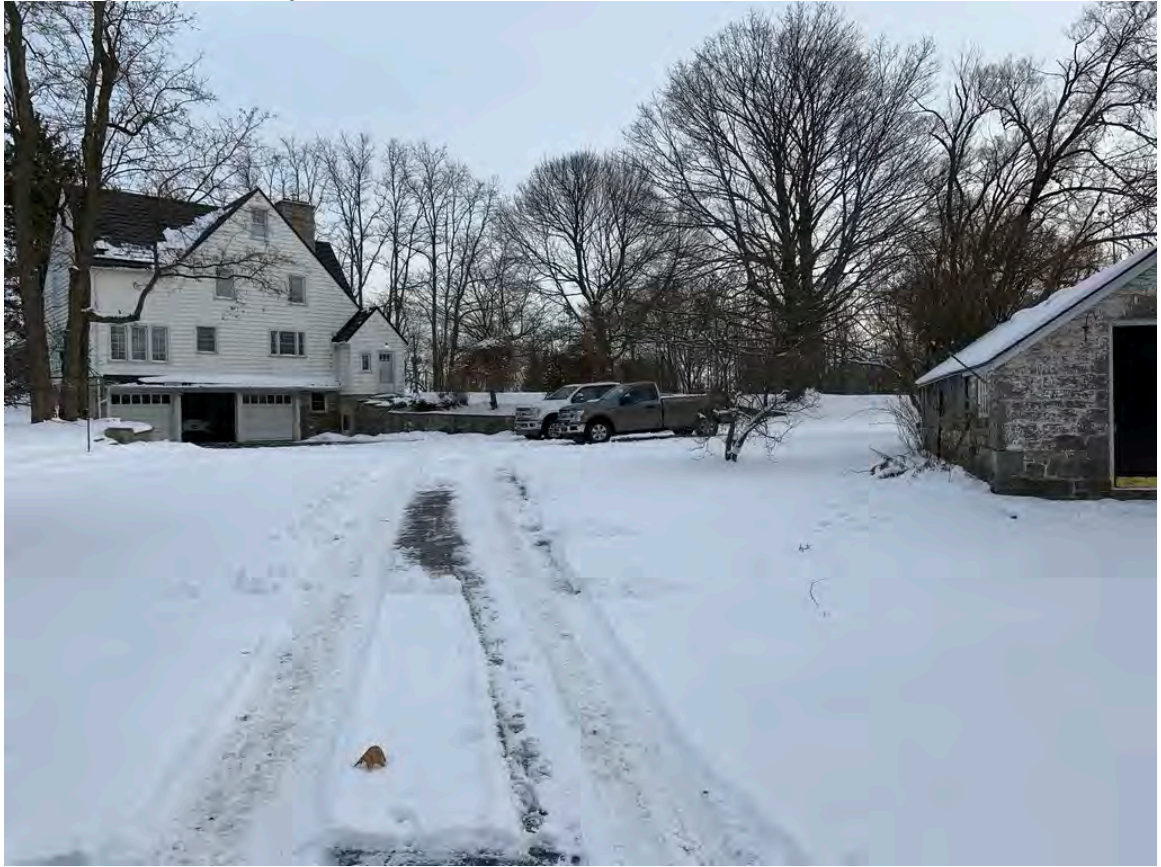
01.02 A three-car garage (basement level) fronts the driveway. The 3 segmental overhead doors (original) are now operated remotely by electric motors.

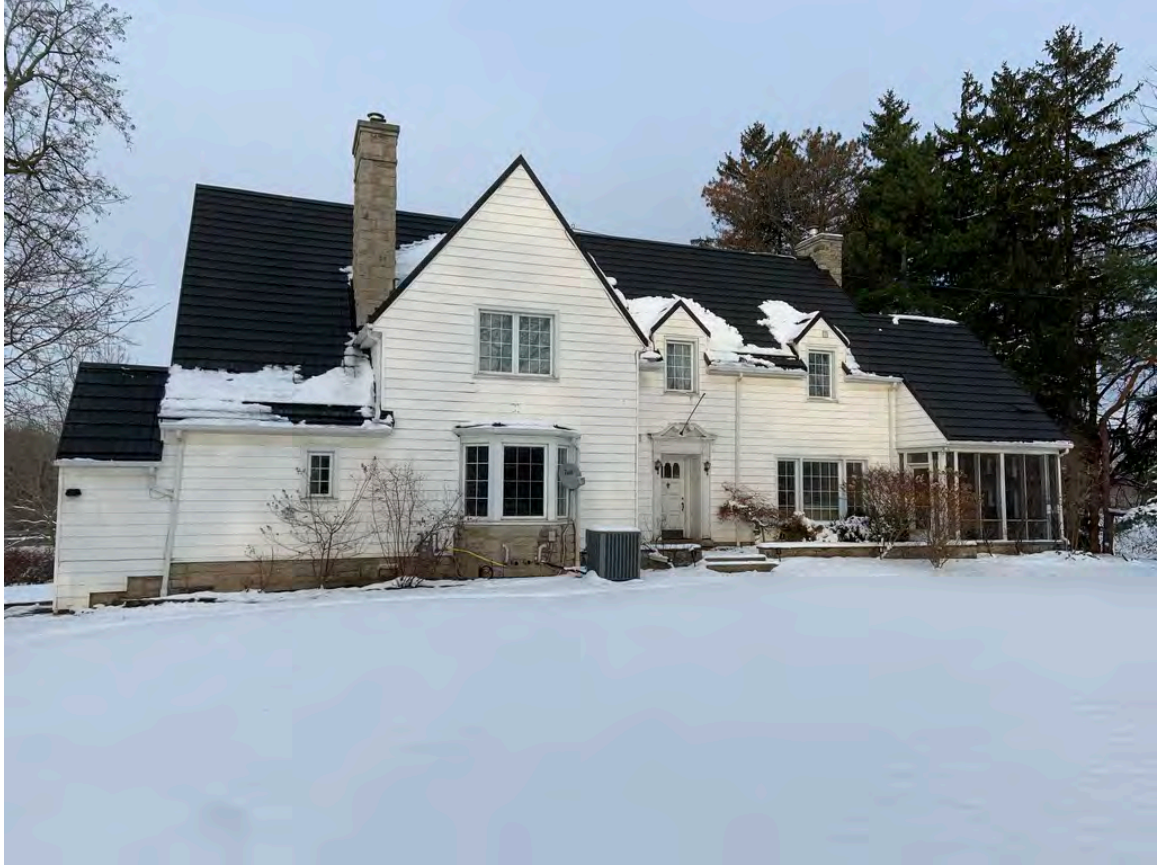
01.12 South elevation (Rousseau Street) features asymmetrical elements including:

- a). a large gable with projecting triple unit bay window at first floor and double unit window at the second floor
- b). an entry door with a Colonial Revival broken pediment.
- c). a pair of faux coach lamps (electric) on the jambs of the door surround
- d). an entry door with six raised panels below a trio of Italianate arched window panes
- e). side panels to the deeply recessed doorway have three raised panels that do not match those of the door.
- f). a hardware store brass knocker and good quality lever and deadbolt set, and brass kick plate on the door.
- g). a short flagpole over the center of the door head. This feature is much more common on American homes than those in Canada.

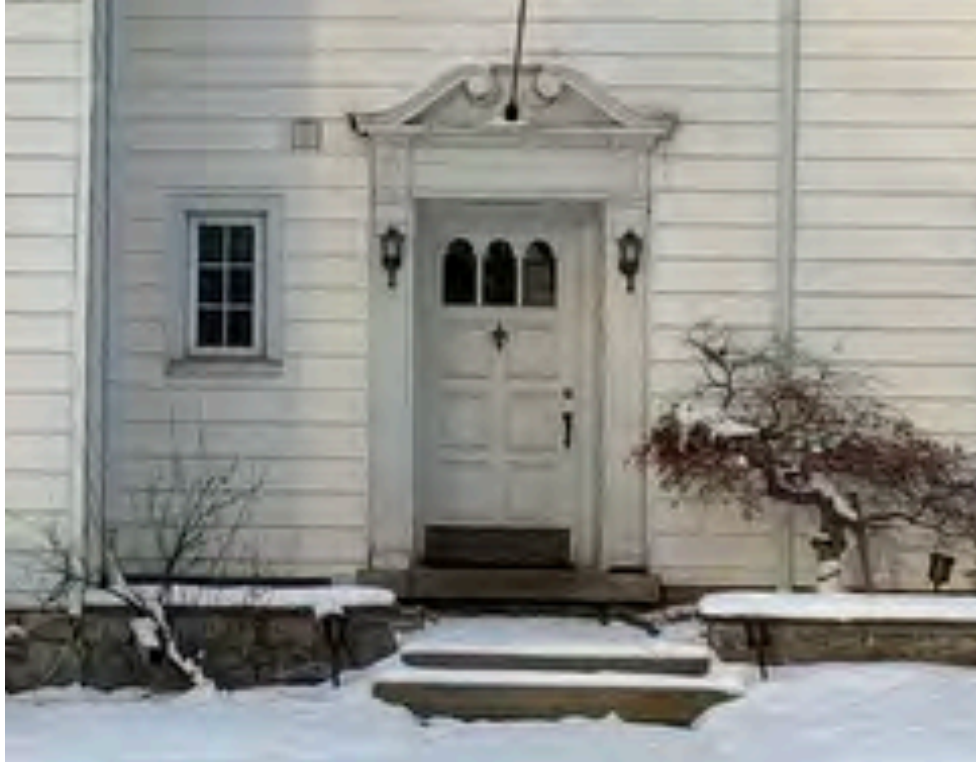
- 01.13** Detail of entry with “broken cornice” typified by American “Federal” designs, which are considerably more baroque in detail and ornament than Classical Revival, British designs.

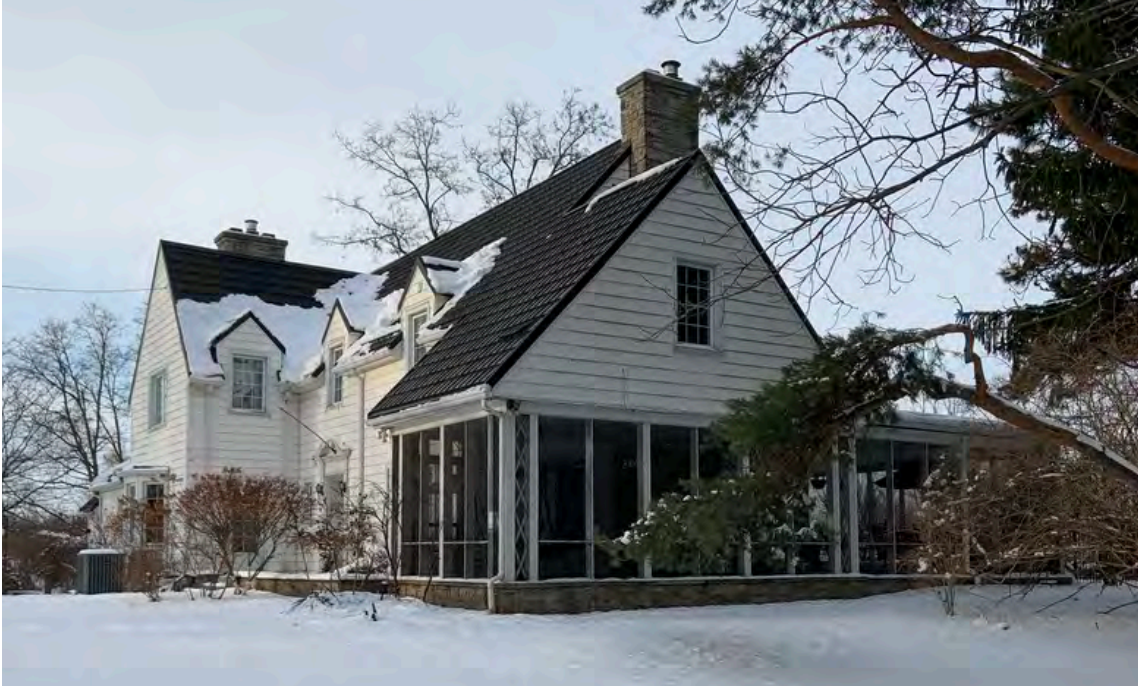
01.22 The limestone cladding of the foundation continues around the base of the sunroom, providing the impression of a low plinth.

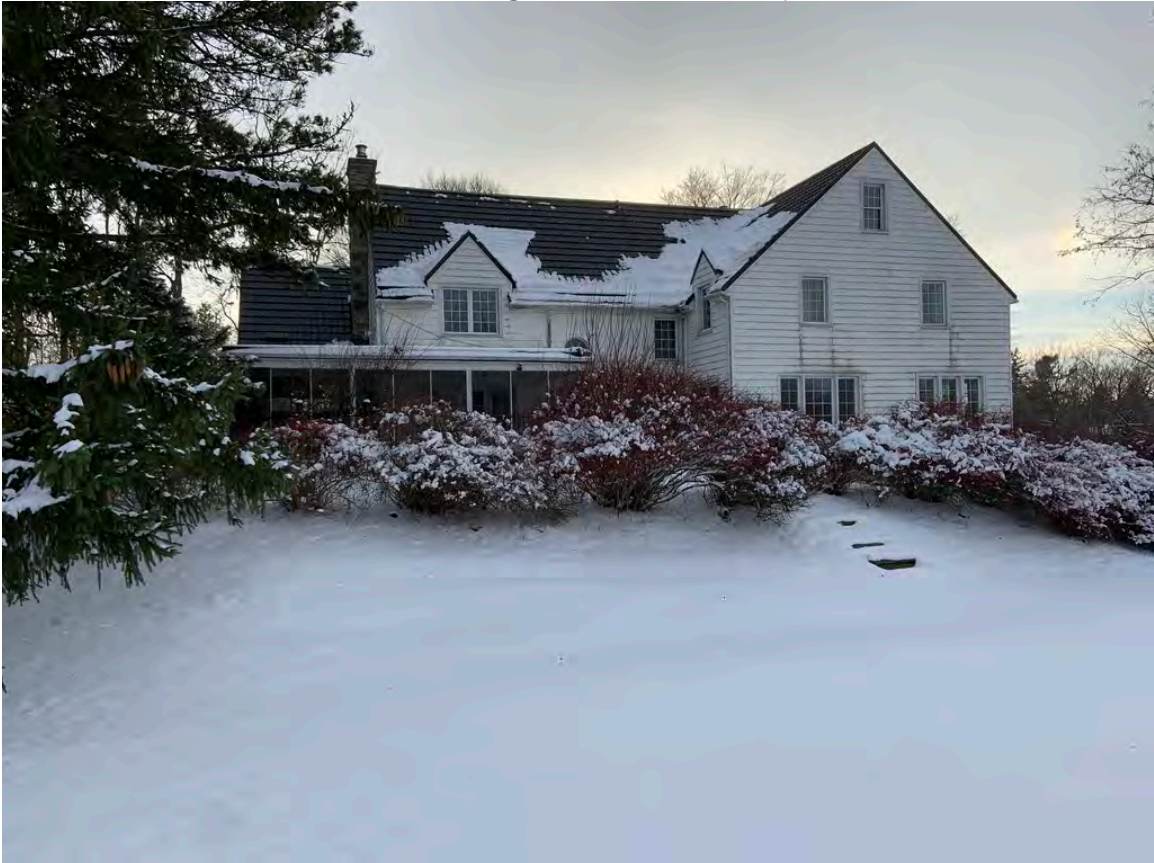
01.31 a secondary entrance with arched door on the east side is situated opposite the main entrance on the west elevation. This doorway and door seem to be heavily weathered from being located close to an inside corner on the north side of the east elevation.

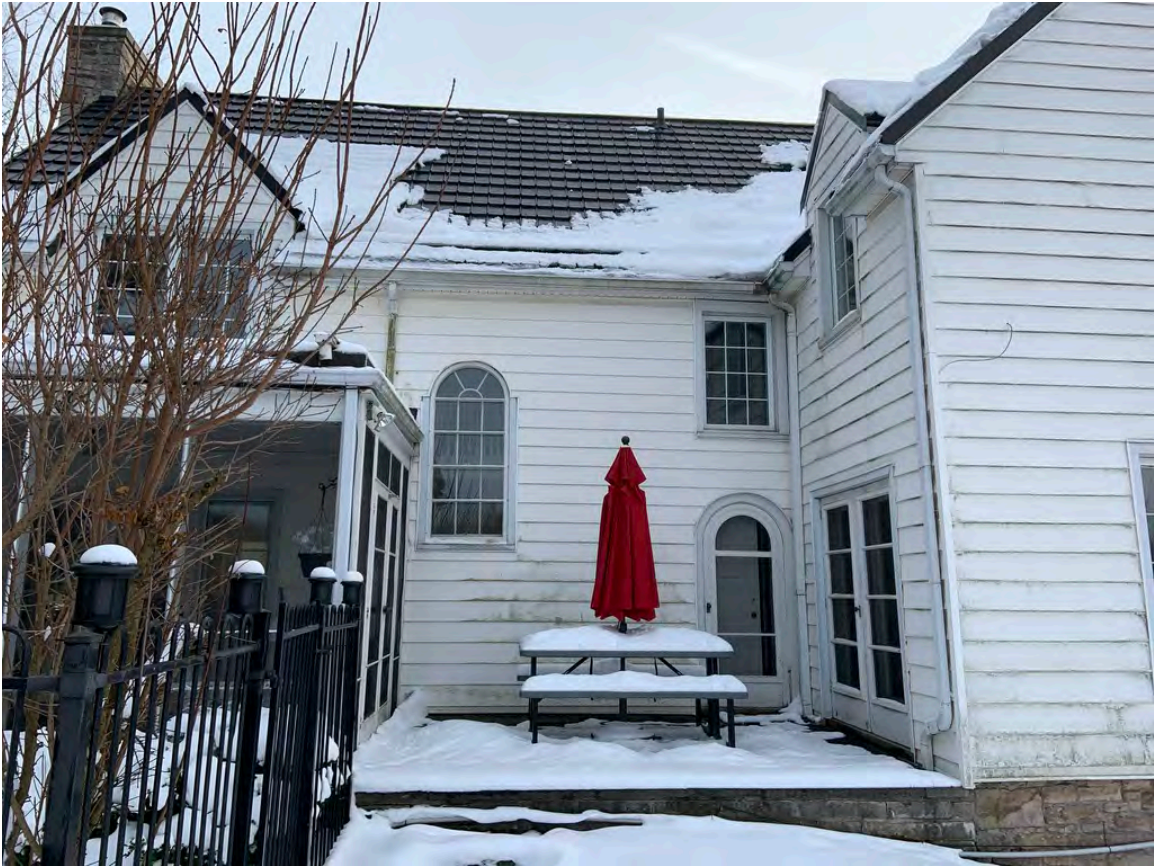
- 01.32** An arch topped window for the stair landing halfway between floors has been awkwardly flashed to accommodate the new aluminum siding. The segmented flashing demonstrates noticeably how it was made and secured by cutting and bending.

- 01.33** The yellowish white colour of the metal siding is in contrast to the bluish white painted trim surrounding the older windows.
- 01.34** Three windows at the second and third floor window on the large north east gable have noticeable staining running down the siding from the lower corners of the window sills. Why this should happen may be explained possibly by gradual drainage (or weeping) of moisture from behind the siding being directed out to the surface by the side flashings of the window jambs. The drainage is either chronic or sufficiently slow that dirt and grime is able to adhere better to the siding in these streaks.

- 01.35** The locking seams at the underside of each piece of siding also show unusual patches of dirtiness. This may be a result of sealants or mould growing on the substrate. This is difficult to account for unless the metal was painted with a product that oxidizes to produce a viable habitat for mould. This has been observed on examples of mid-1960's aluminum siding that develop a powdery surface after decades of exposure. Patches of noticeably brighter

paint were observed high up on the gable and just under the roof verge where the slightly projecting trim has sheltered the siding below. These irregular areas of white paint contrast sharply with the yellowish and stained pieces that are not protected. Paint on traditional wood siding does not tend to weather like pre-finished metal siding.

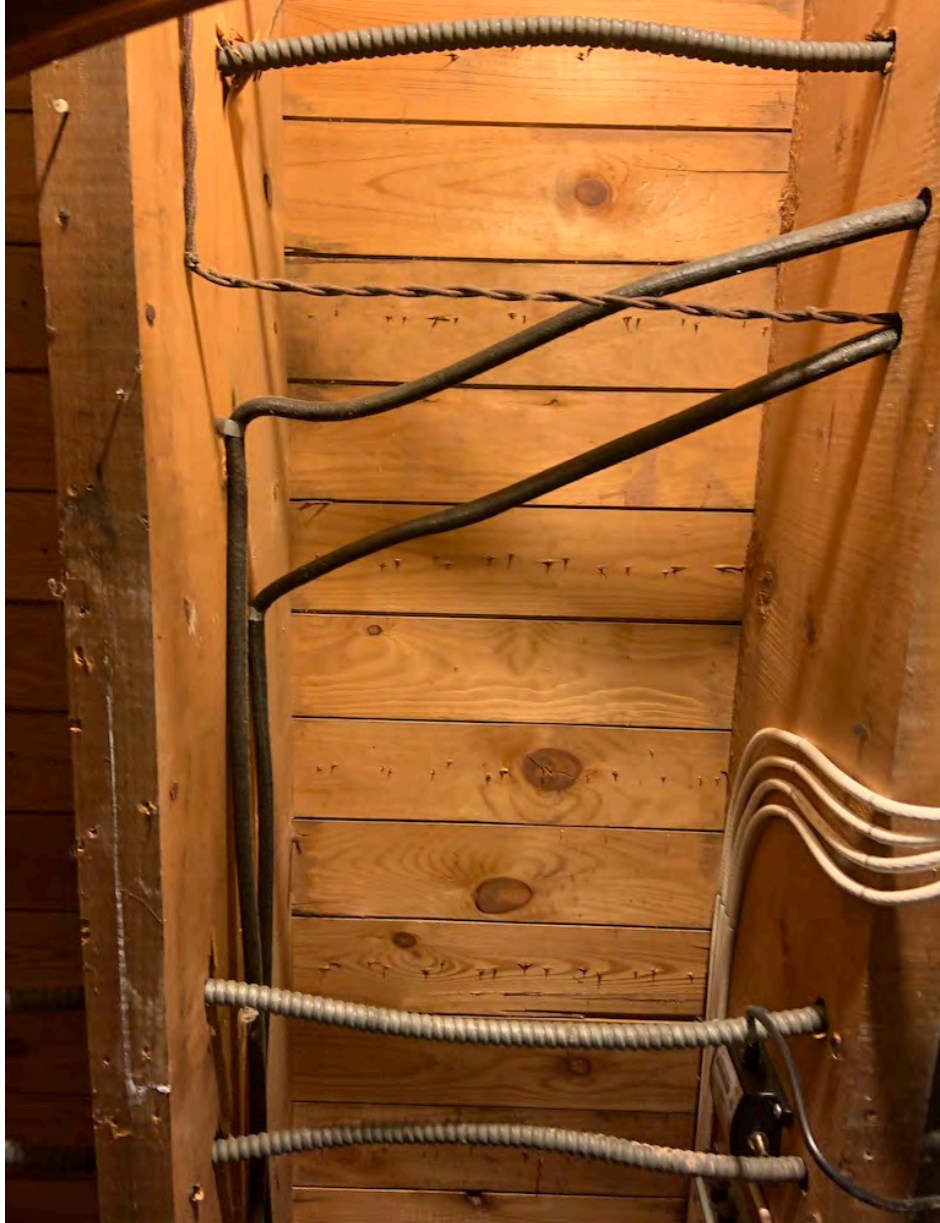
01.92 Portions of the exposed (but painted) foundation wall indicate that it was poured concrete. The limestone facing visible on the exterior was applied as a facing on the outside of the floor assembly.

01.93 Knob and tube wiring was not observed. Some heavy old wiring with black insulated sheathing was observed. This is typical of pre-WW2 construction. A disused breaker box, painted black has a brass name plate, "Bulldog Safety Switch Cat. No. 52323, Volts 115 – 230-, Amps 100. C.F.S.A. Standard Enclosed Switch. Form 60-100. Approved by Hydro Electric Power Com. Ser. 292" Division of Amalgamated Electric Corporation Limited Toronto. This type of early electrical safety equipment became common after electrification expanded along the new supply grid from Niagara Falls. The low Serial number 202 suggests that this house was built soon after electrical services became available in Hamilton. Electric street lighting was inaugurated in Hamilton in 1914. Westinghouse became a major employer between WW1 & WW2.

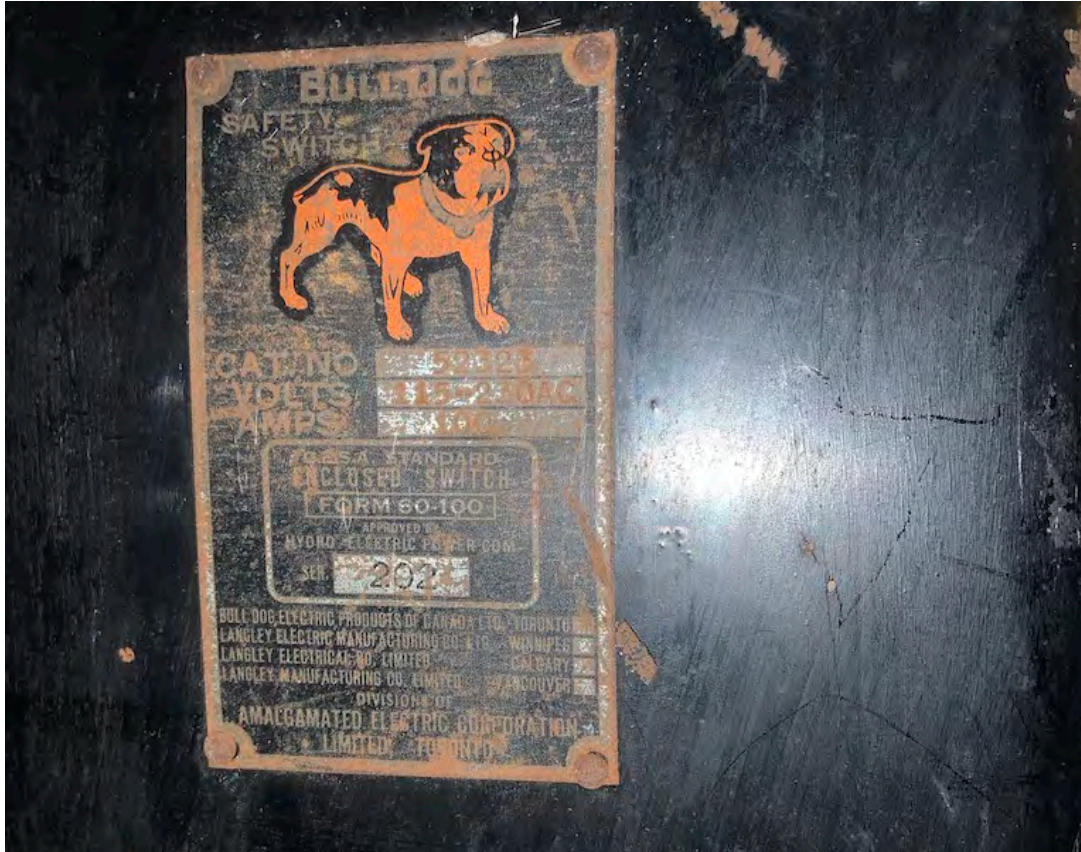
01.94 Another breaker box is labeled Taylor Electric Mfg. Co. Ltd. London – Canada. The logo and graphics on this name plate are very typical of inter-War equipment, so was probably installed at the same time as the Bull Dog Safety Switch. A note on this breaker indicates that it is still used for a dual power bar outlet on the work bench. All other electrical equipment is modern, except the heavy cast steel block (brass bolts) for original telephone wiring.

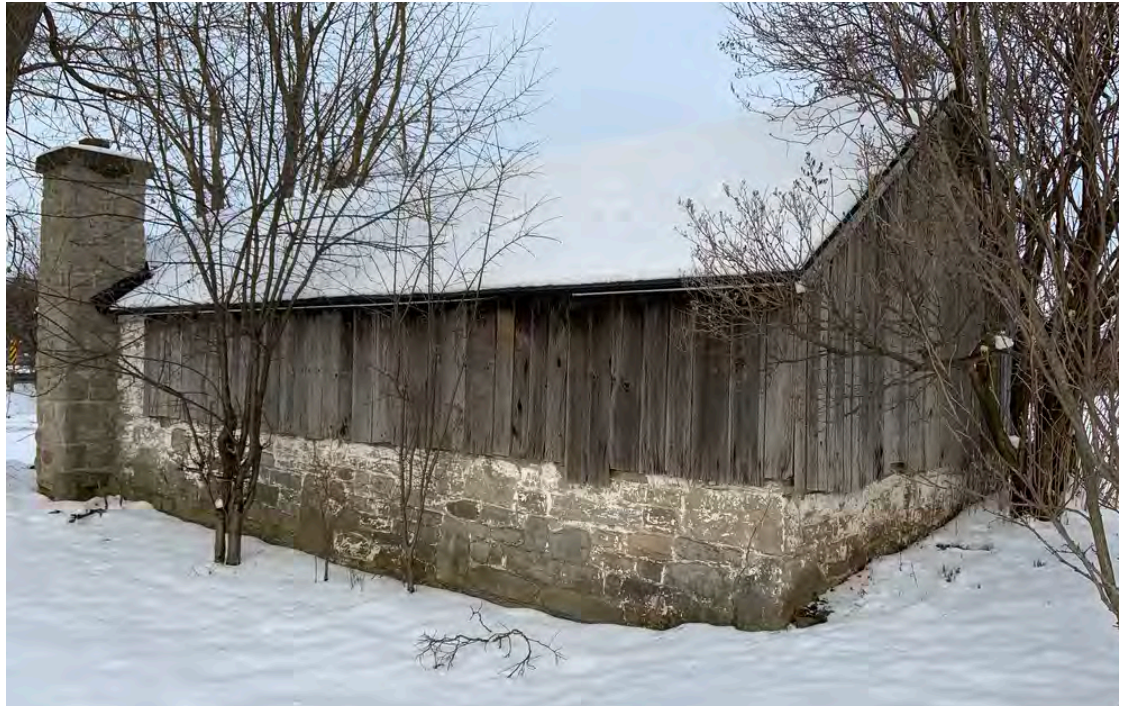
- 02.04** The random rubble masonry is of utilitarian quality except for a dressed lintel over the doorway. This lintel has drafted margins and a pecked face. This is the only stone with substantial workmanship, so may be reclaimed from another older building. Larger squared blocks were used as quoins at the lower corners of the structure to tie the walls together. This was good practice, particularly where the backs of the stone blocks are very irregular and undressed. In common work like this, the outer face received the best blocks, the inner face smaller and less perfect pieces and the core of the wall was filled with rubble, chips and mortar. The thickness of blocks may vary from six or eight inches as they appear at corners to less than three inches, as most of the load bearing capacity is on the face of the stones when properly squared and pointed.

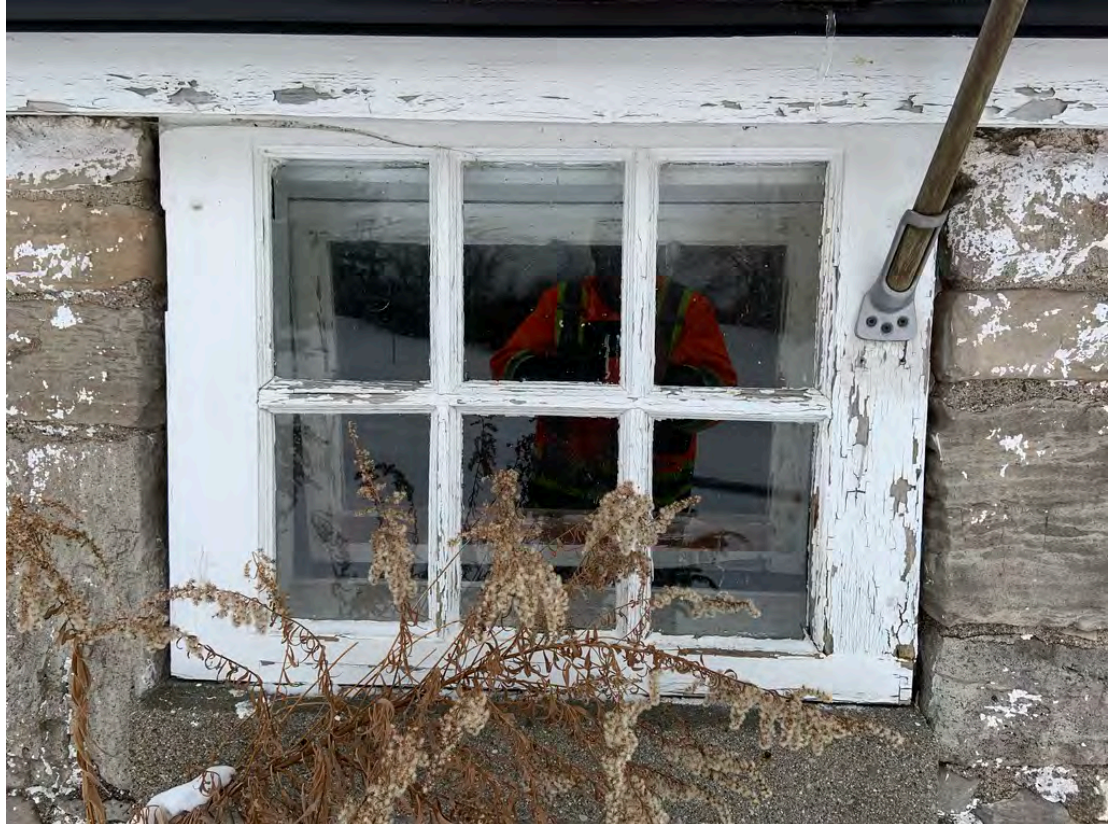
02.06 The sash window on the north elevation appears at first to be historic, but has none of the characteristics of a window built between 1790 & 1875. The masonry was not built around a framed box. The sash was cut to fit the masonry opening. The sill is poured concrete not dressed stone, pine nor white oak, as would be expected before WW1. The aggregate in the concrete is fine sharp sand with small pebbles. This is typical of hand mixed concrete before WW2. The binder in 19th. century mortars was lime. Here it is Portland Cement. Most workmen did not understand how concrete required a balance between just enough water and thorough mixing. When they opted for an easier to shovel "sloppy" mix, it would result in low strength concrete. The over hydrated Portland reduced the growth of crystals in the matrix which produce the ultimate strength of the concrete. The surface has weathered away here.

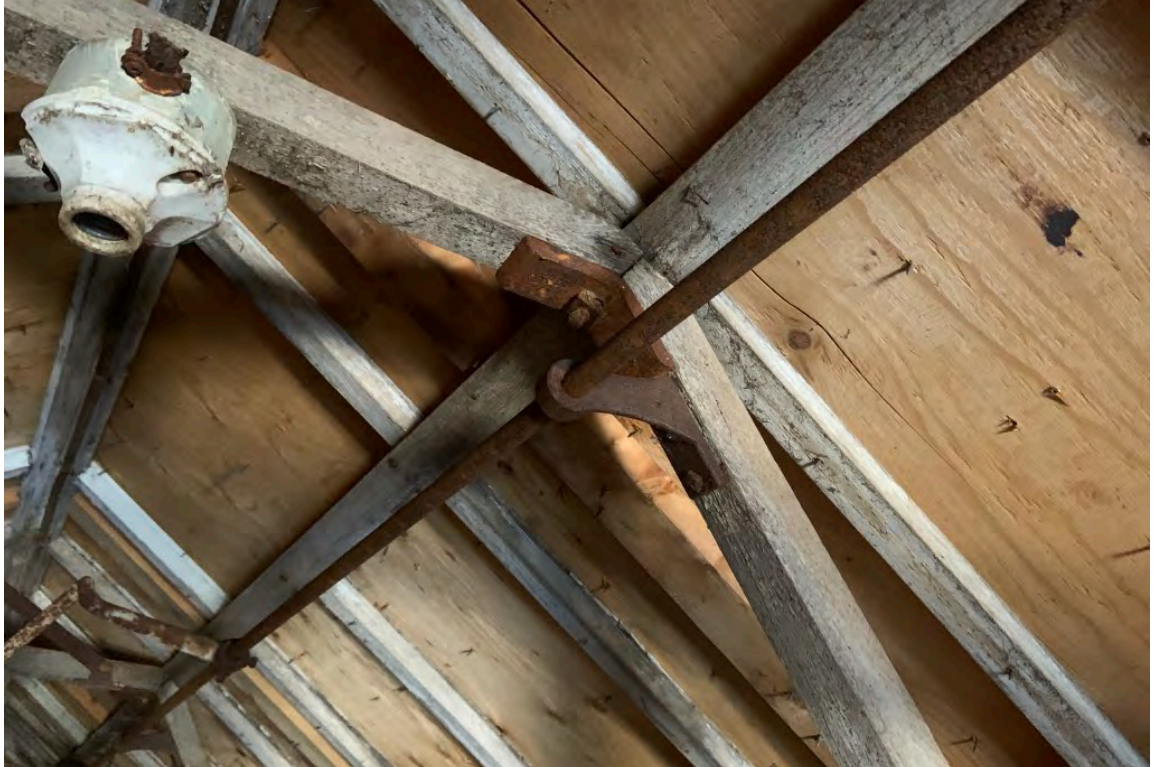
02.30 Truss connection with iron bracket / reinforcing plate. Note rod with crank arm at ridge is retained by the bracket without a bearing or bushing. The original octagon box with ceramic light fixture was fastened to the tie beam directly below the ridge. All connections are nailed and utilitarian, except for the bolted brackets at the underside of the collar tie / compression brace joint. The trusses supported the purlin before the glass bars were installed. These heavy pieces of hardware ensure a strong joint and support a longitudinal steel rod) 7/8" that has a pair of articulated cranks at the approximate center of the roof. The cranks have a hinged "knee" and a hinged "foot" at the end of the second segment. A square headed machine bolt is used to secure the large "knuckle" of the arm to the rotating rod. Looking more carefully at the rafters in this area we see that the rafters are missing above the "purlin" in the vicinity of these two cranks. This indicates that a pair of hinged vents were located on either side of the ridge, and that these vents were made to open via the cranks and rods.

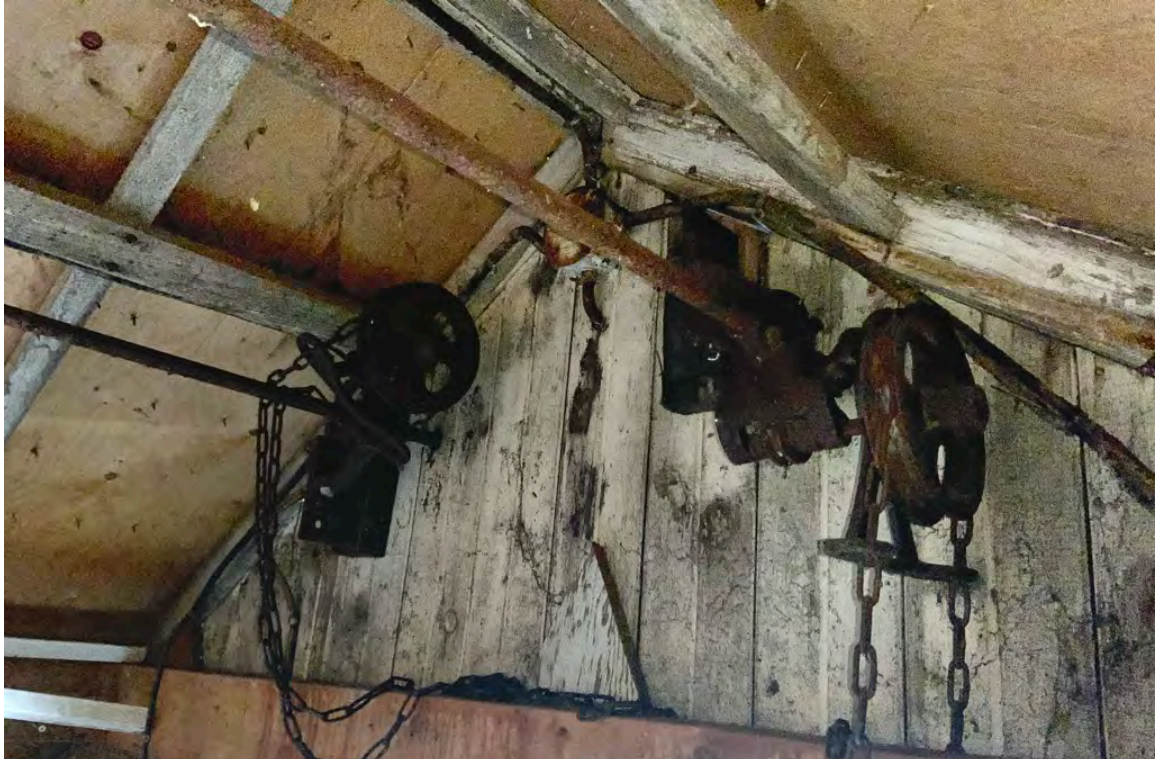
02.31 When looking back towards the partition, we see that the rods are supported by a complex iron mechanism that acts as a support for each rod and mechanical linkage to the large iron pulley wheel adjacent. A chain over the flanged wheel was used to rotate the wheel, and cause the horizontal rod to drive a differential gear in the bearing to rotate the crank shaft. This manual mechanism can still be seen today in some commercial overhead doors. It is an elaborate method to open two roof vents that could be reached more simply with a broomstick. This mechanism was likely intended for commercial greenhouses instead of small garden glass houses. It would appear that builder of this little garden building had serious intentions of starting lots of flowers and plants in a greenhouse before setting them out in beds.

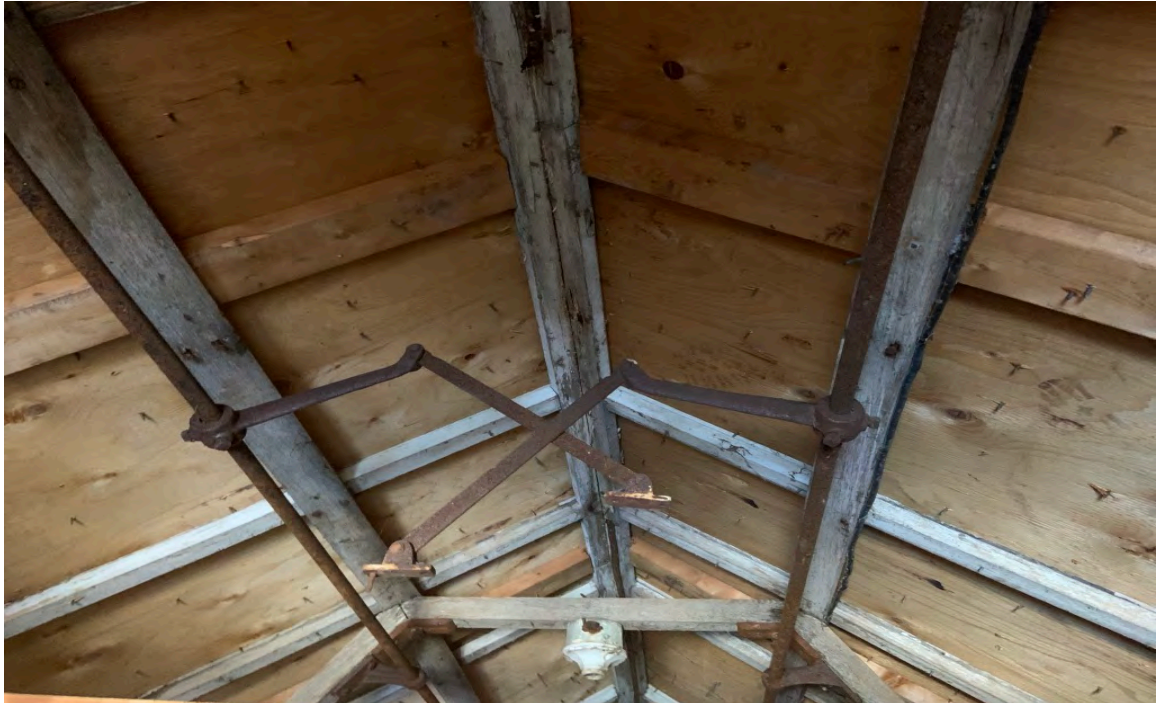
02.34 A block with a ceramic lightbulb socket is screwed to the center of each collar tie to provide electric light to the space below. The fixtures appear to be contemporary to the early knob and tube type wiring. Note new plywood sheathing on roof to support shingles.

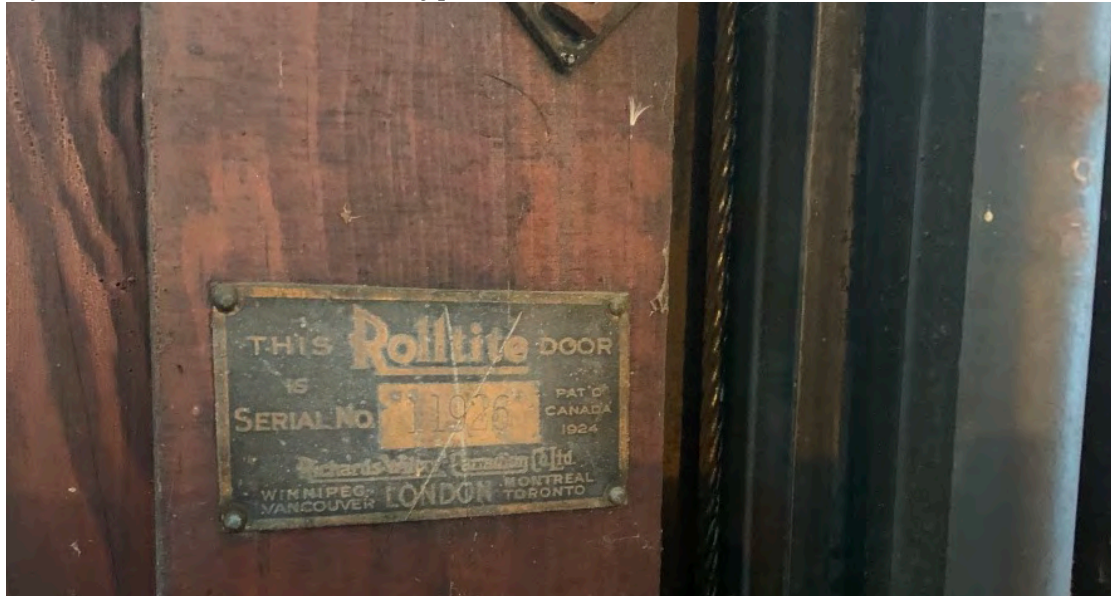
03.12 Builders Plate: "This Rolltite Door"
 Serial No. 11926 Pat. "D" Canada 1924
 Richards Wilcox Canadian Co. Ltd. Winnipeg Vancouver London Montreal Toronto
 Two doors have sequential number plates.
 They were likely installed in 1924, 1925 or 1926.

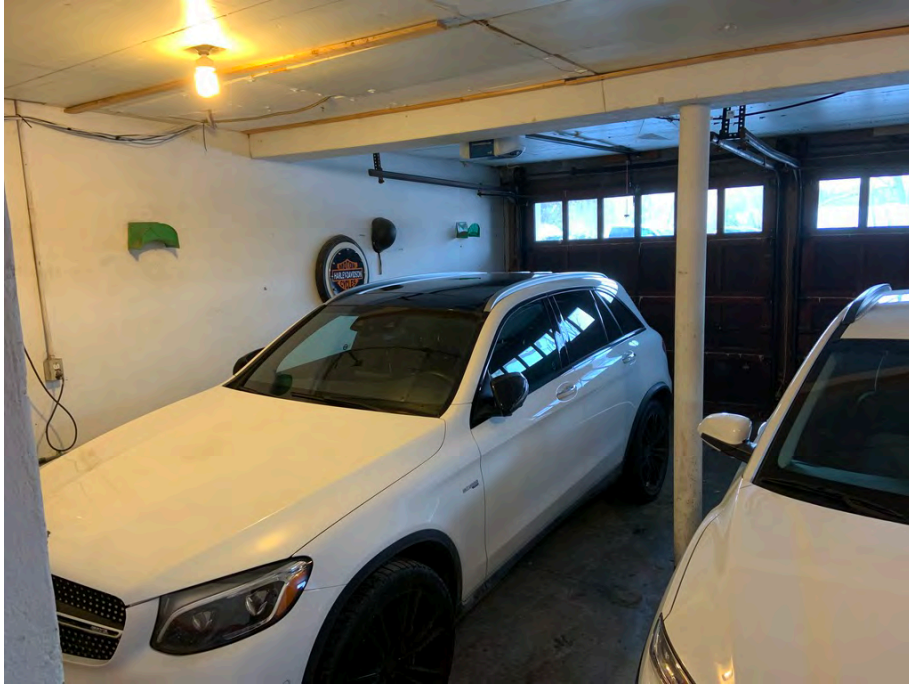
View of three car garage with steel pipe column and steel beam supporting joists in the floor above. The roll up doors are only 8' wide, with narrow posts supporting the lintel above. The concrete floor is original, and buried the footings for the posts in the manner of contemporary houses. Steel beams were rarely used in residential houses before WW1 and were still uncommon until after WW2. The ceiling is insulated above the unheated garage. The concrete foundation wall has a stucco finish inside the garage.

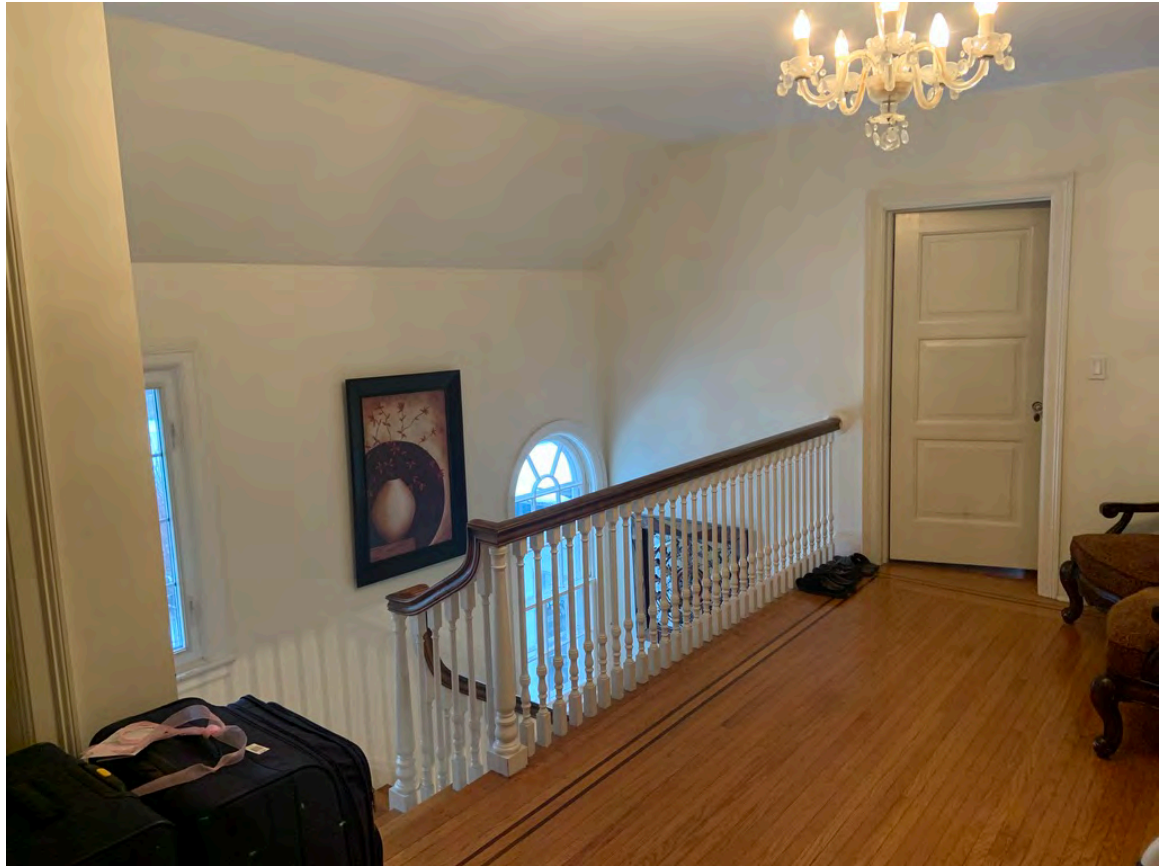
Second floor hall and sloping roof above the stairwell. The window heads are uncomfortably different and below eye level when standing on the second floor.
