CULTURAL HERITAGE IMPACT ASSESSMENT (CHIA)

for
**392, 398, 406, 412 Wilson Street East and 15
Lorne Avenue**
Ancaster, Ontario

GBCA Project No: 21006

Date of issue: Friday, June 4, 2021

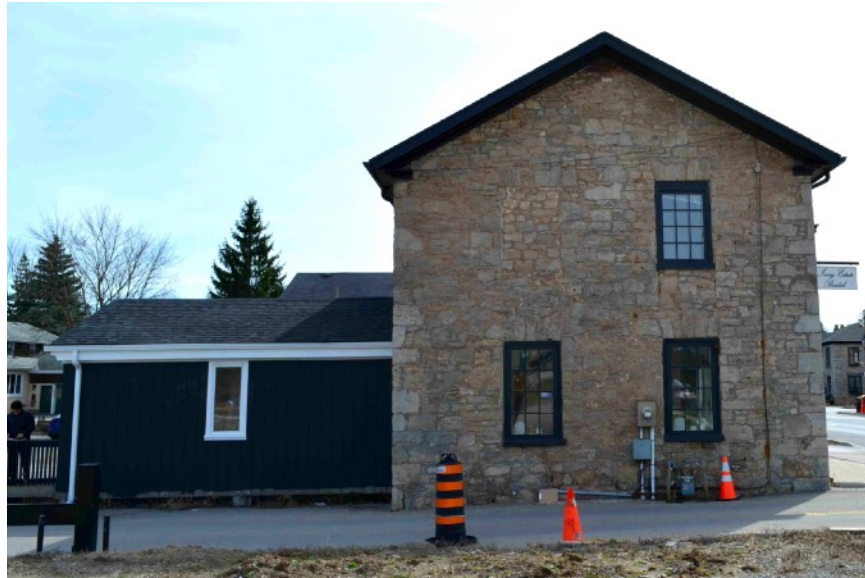
Marr House, 2021 (GBCA). North Elevation. Top left window opening closed in.

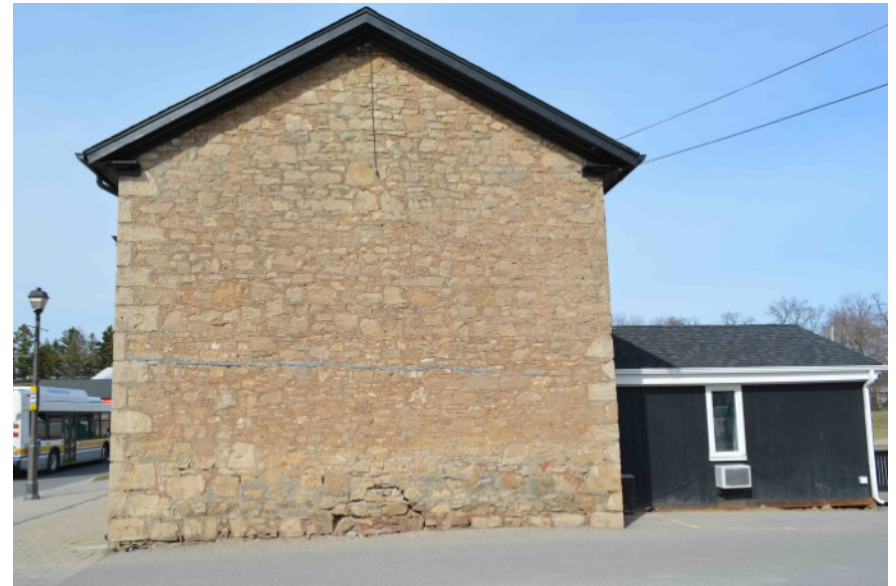
Marr House, 2021 (GBCA). South Elevation. Blank wall with tail extending to the east. Foundation issues notable from a distance.

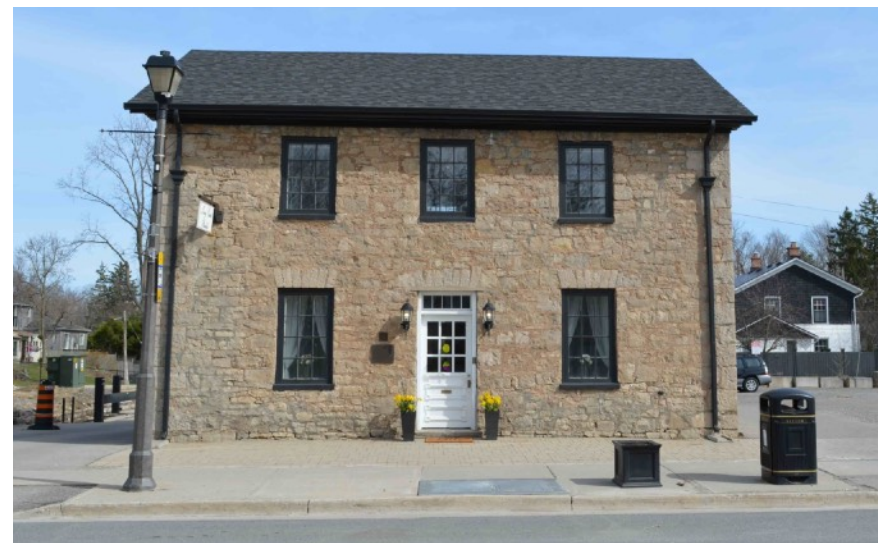
Marr House, 2021 (GBCA). West Elevation 2.4 meters from Wilson Street East. Although the designation by-law notes that chimneys are a contributing heritage attribute, in its current state these are no longer present.

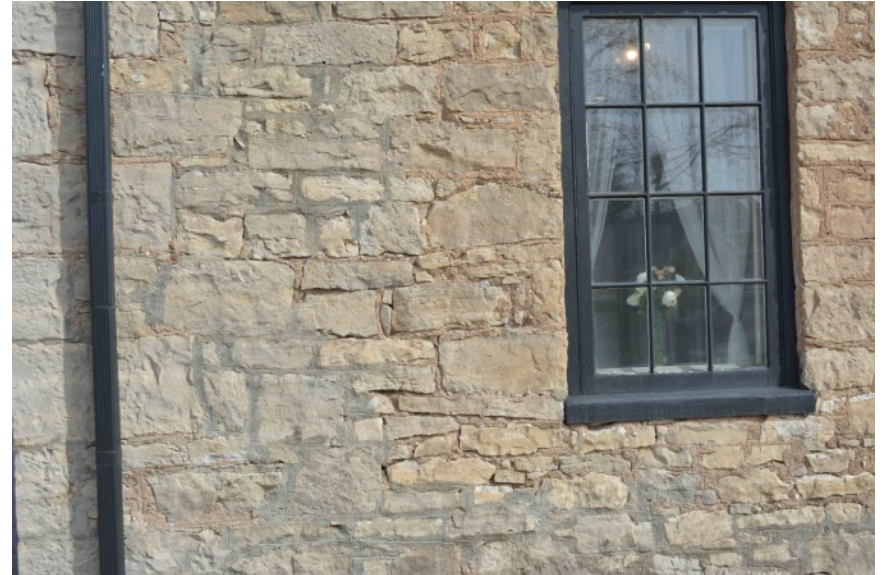
West elevation: ground level showing cementitious parging applied at the northern edge of the building.

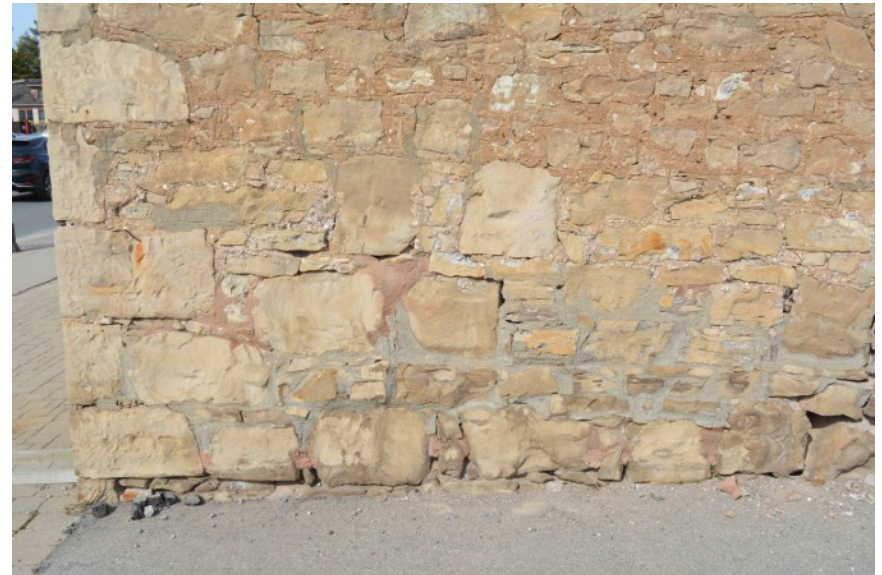
South elevation: ground level showing open joints, and repair work.

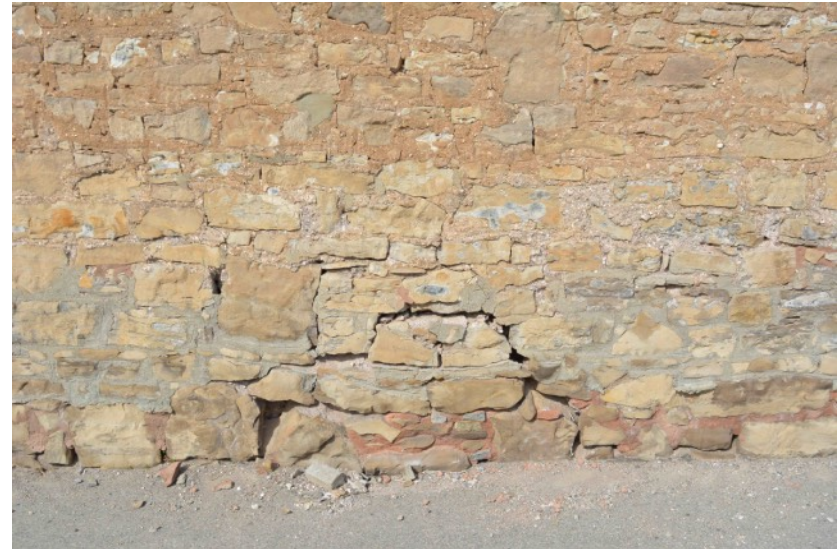
South elevation: ground level failed and open joints with previous repair work also visible.

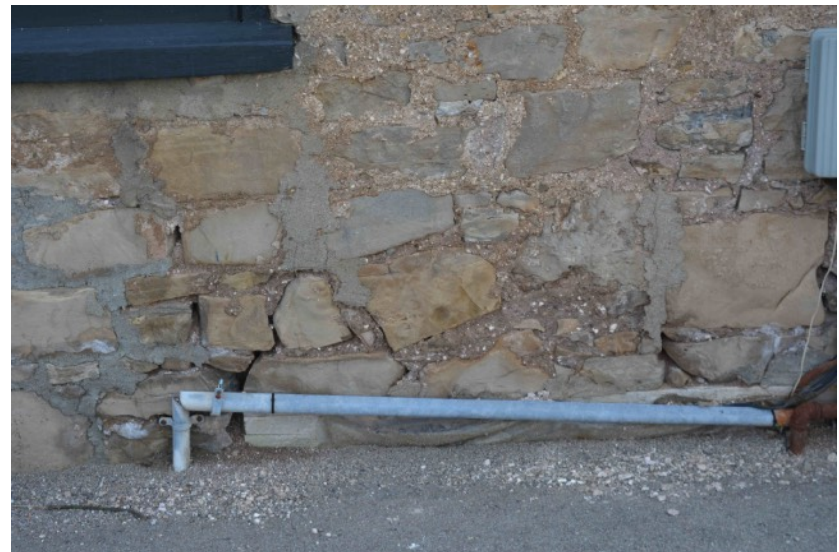
North elevation: failed and open joints, oxidization and metal anchors near foundation.

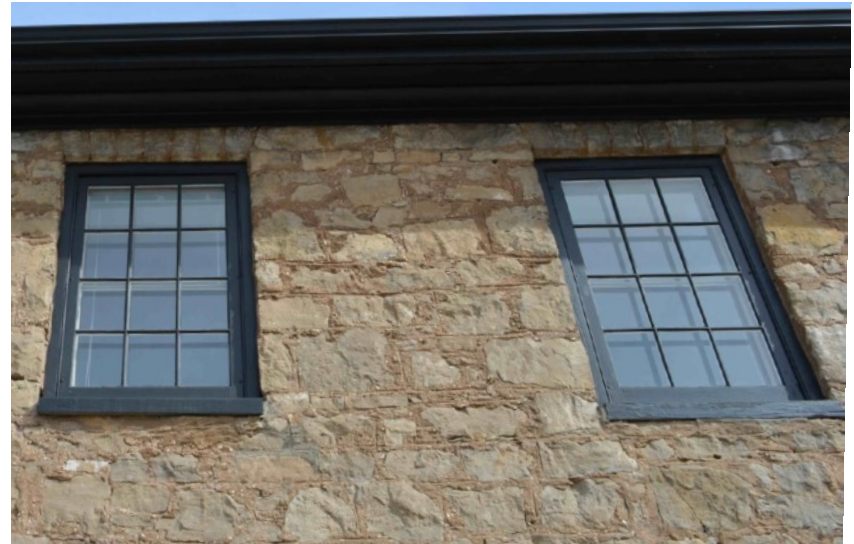
West elevation: window frames on 2nd storey appear to be in good repair upon visual review..

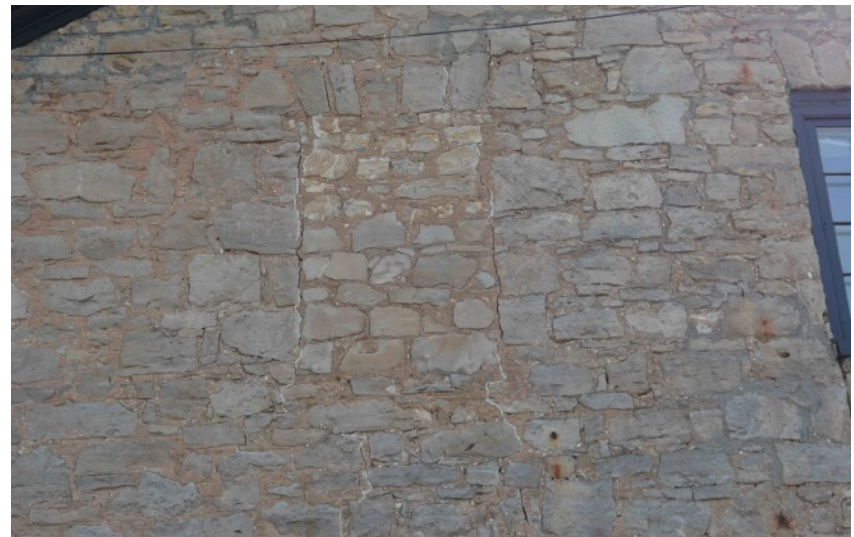
North elevation: eastern-most window opening on 2nd storey has been closed in.

- Repair, replacement and painting of windows, and sills where required;
- Repair and replacement of awnings;
- Reinstall blocked in window openings;
- Repairs to exterior stone masonry;
- Repairs to exterior woodwork – fascia, soffits, etc.;
- Removal of unsympathetic cladding;
- Repairs or replacement to - metal railing, eaves and troughs;
- Replacement of visible roof area with new high quality shingles.

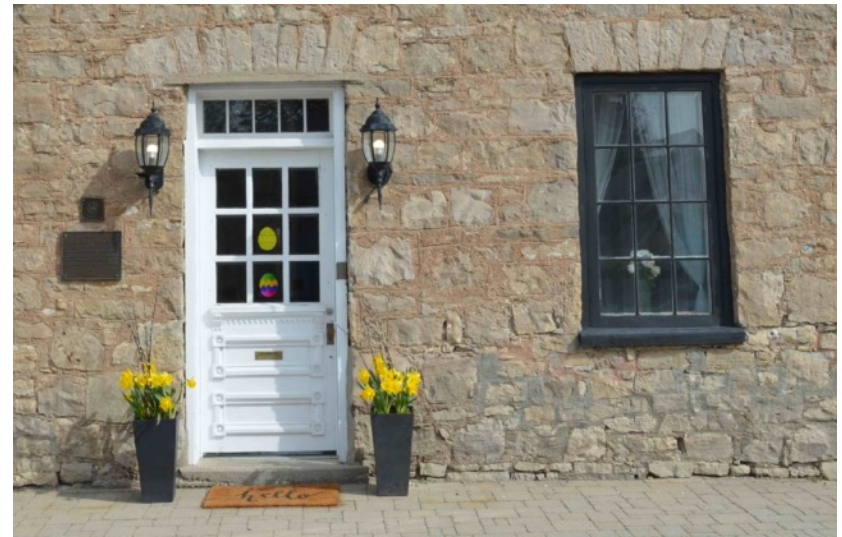
West elevation: Central door with 12-over-12 sash and five-pane toplight is in good repair.

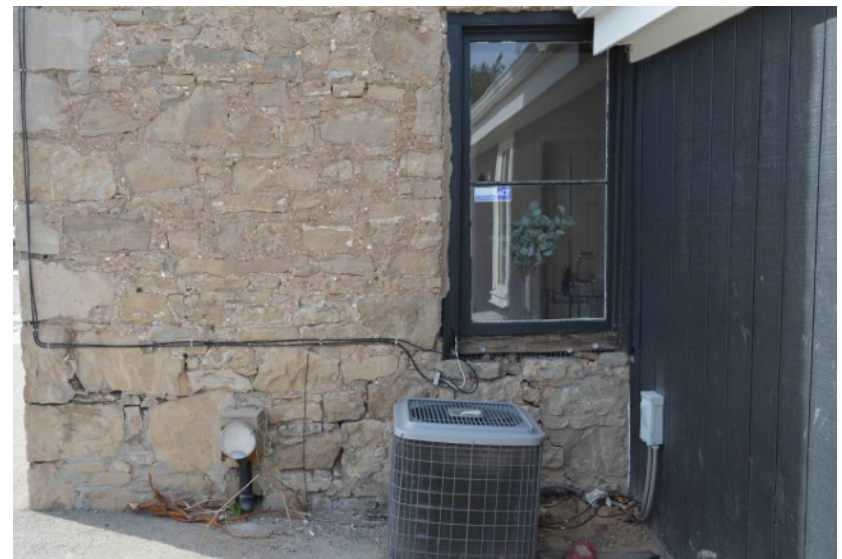
East elevation: Openings at rear elevation have been obscured by the later addition of a one-storey tail.

- The removal of the tail from the main residence will require repair, infill of new stone, reinstatement of original openings, refinishing and repainting upon removal of the extension. Restoration and conservation of the former Marr House will involve rehabilitating the rear facade based on archival material, in keeping with the original design intent which would be further explored in a forthcoming Conservation Plan.

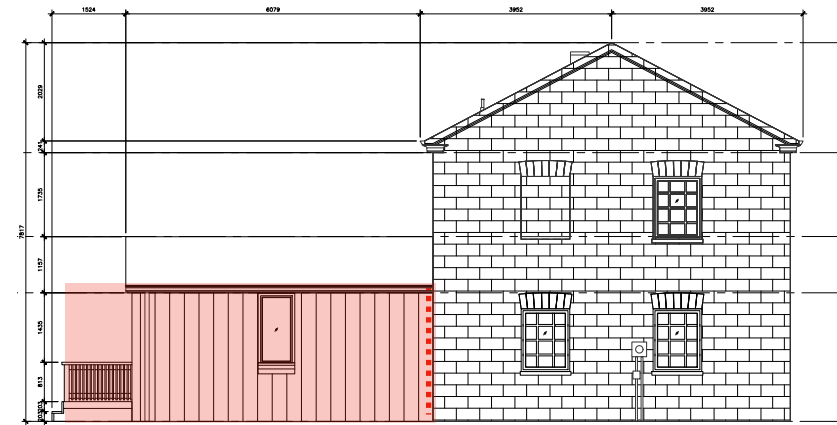
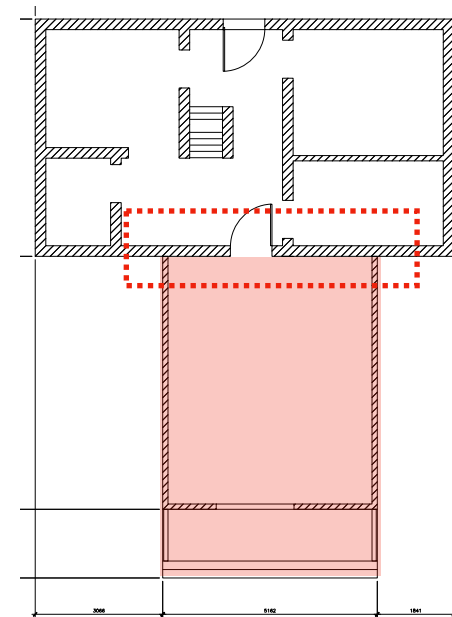
The above plan and elevation illustrate the proposed tail to be removed from the Marr House. Areas with a dashed line will require infilling of new stone and reinstatement of original openings upon removal of the extension.

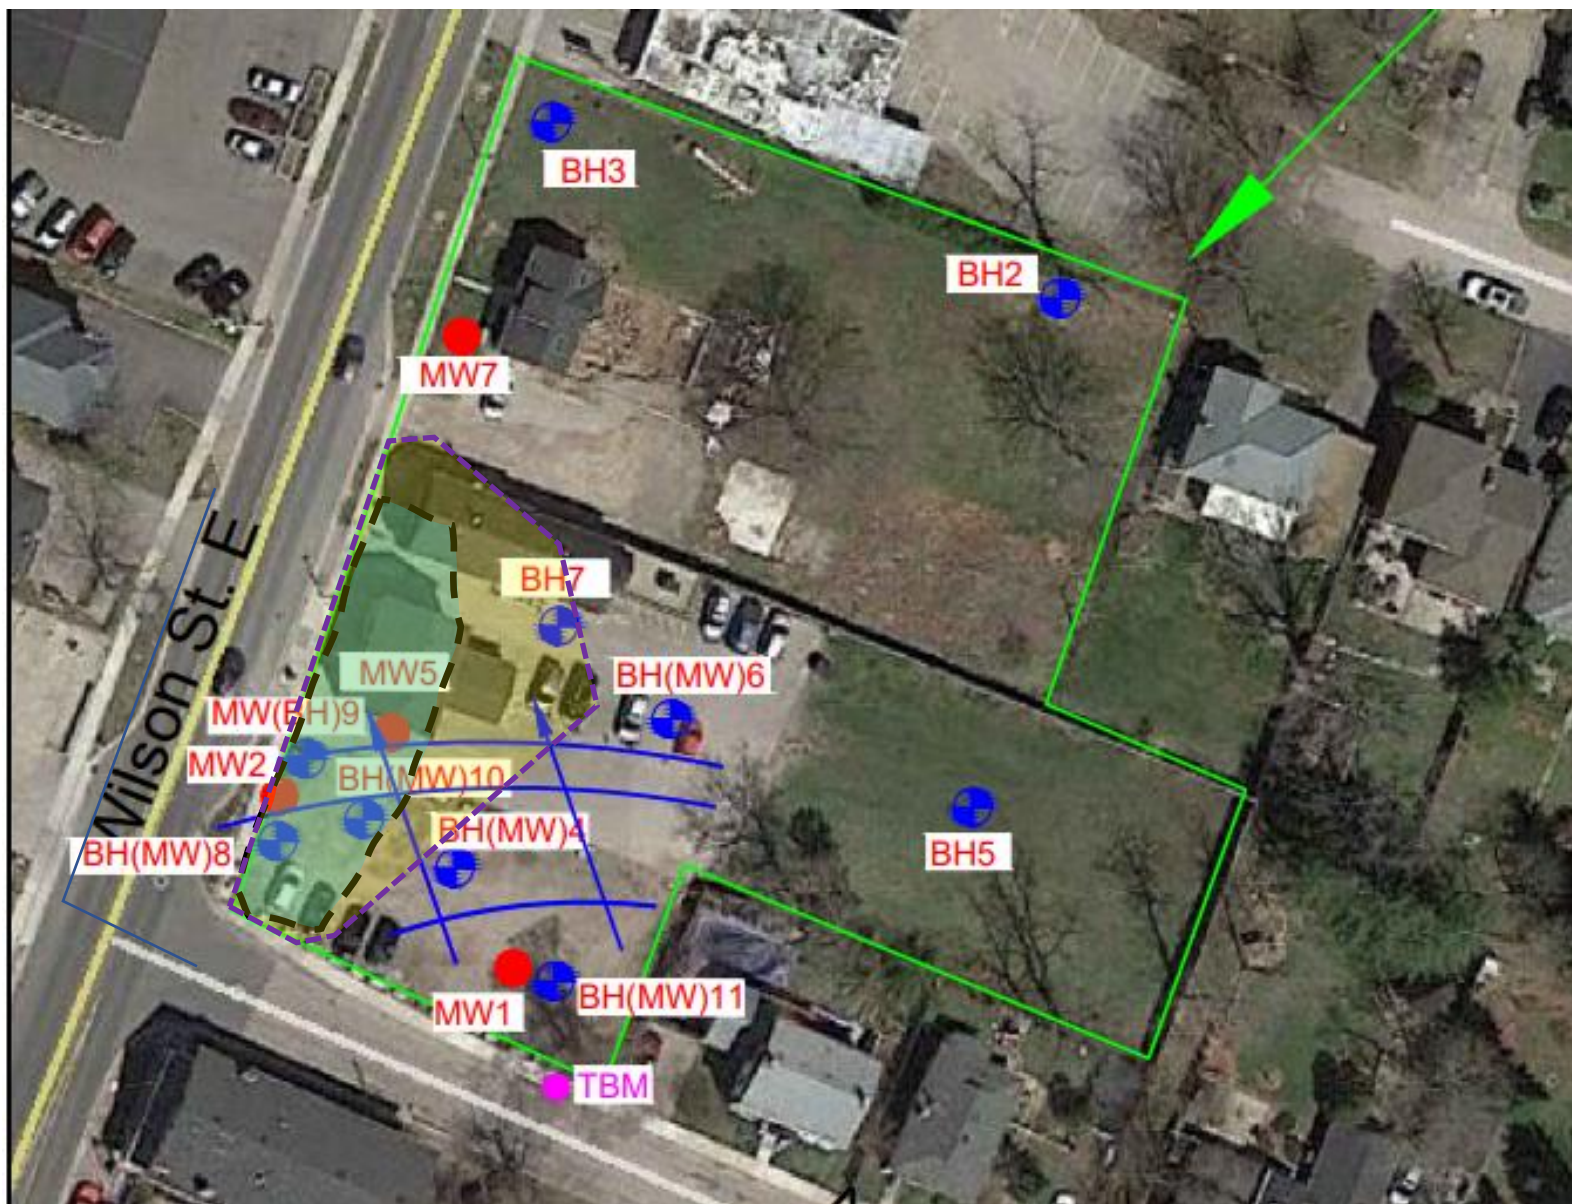
Based on the environmental investigations completed to date at the above site which previously included the location of a gas station, subsurface soil and groundwater impacts due to historical operations have been identified/confirmed. Impact plumes have migrated throughout several areas of the site and include areas beneath existing structures. Contamination has been found to depths of up to approximately 6 m to 8 m in some areas.

Estimated extent of on-Site groundwater contamination

With regards to the above conditions, it is our recommendation that demolition/removal or relocation of the building structures be completed to allow for safe and effective environmental remediation to proceed in accordance with the Ministry of the Environment, Conservation and Parks (MECP) regulation for filing/acceptance of a Record of Site Condition (RSC).
