CHIA ADDENDUM

GORE BUILDINGS 18-30 KING STREET EAST HAMILTON, ONTARIO

06 JULY 2021

MEGAN HOBSON CAHP
M.A. DIPL. HERITAGE CONSERVATION
BUILT HERITAGE CONSULTANT
mhobson@bell.net

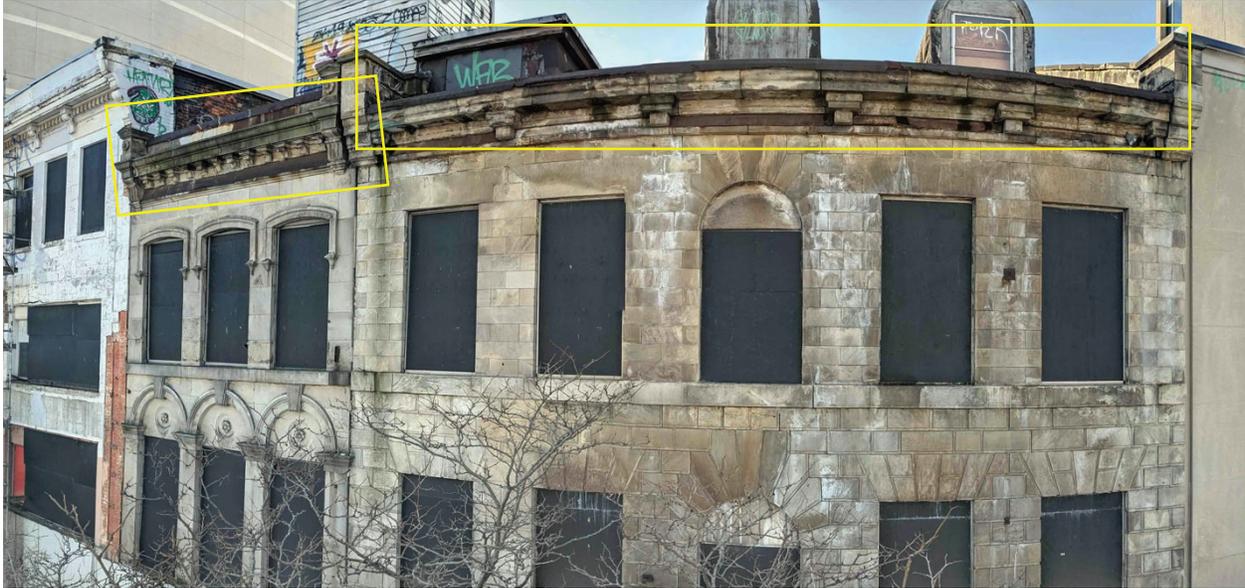
18-22 KING E (KERR BUILDINGS) – significant deterioration of stone cornice due to failure of the roof and gutters

Detailed investigation carried out by John G. Cooke and Historia Restoration confirm that the stone cornices and stone parapets on the roof are badly deteriorated. The stone cornices will be carefully dismantled prior to demolition of the rear portions of the buildings. Individual stones will be catalogued and labelled so that they can be reinstated in their original locations when the new roof is constructed. This approach allows for repairs to be made off-site in Historia's climate-controlled workshop over the winter and while site work and new construction are underway. Further details regarding the removal, safe handling and storage of dismantled elements will be provided in a separate *Documentation & Salvage Plan*.

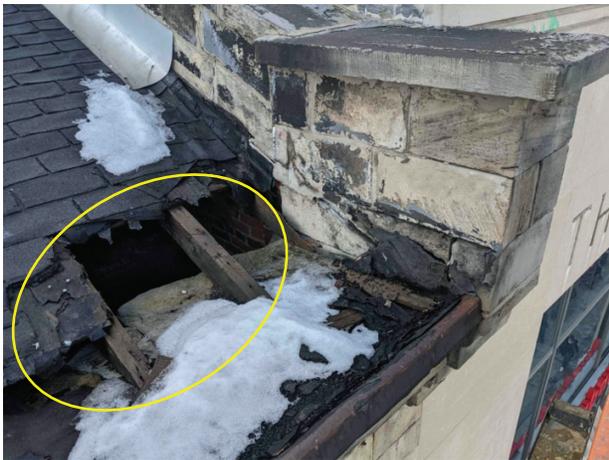
18-22 KING E (KERR BUILDINGS)

Left: further failure of the roof behind the cornice

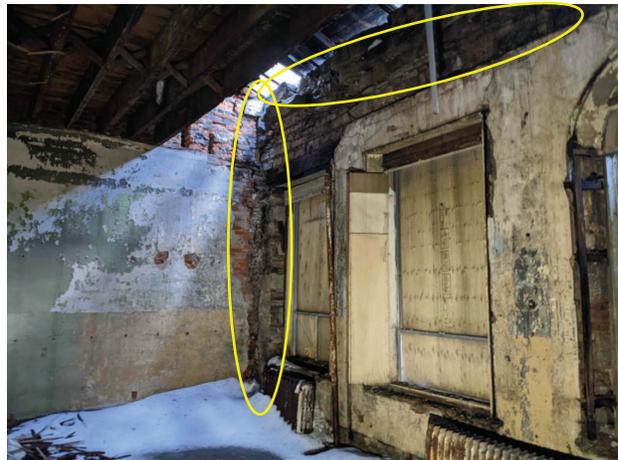
Right: significant masonry deterioration exposed on the interior now that finishes have been removed

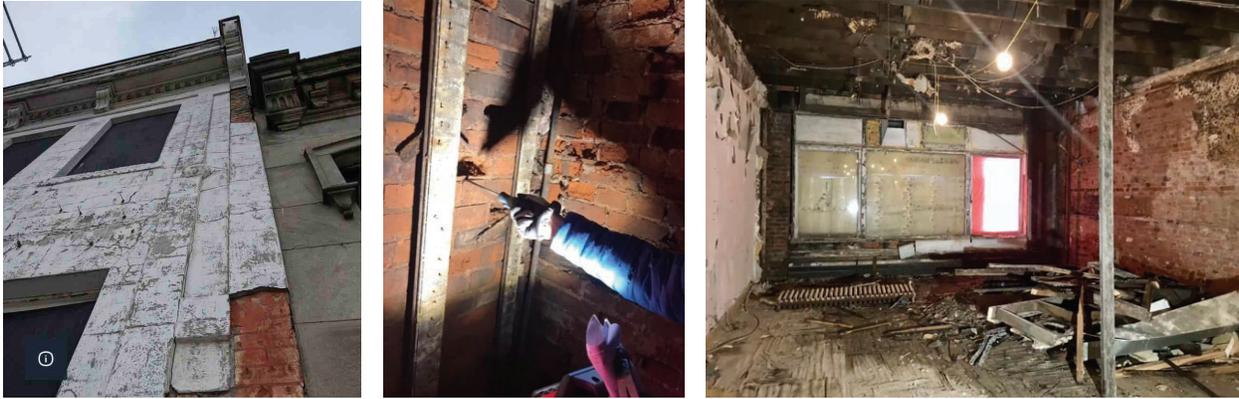
24 KING E (SKINNER BUILDING)

The brick façade of 24 King Street East is so extensively deteriorated that retention is not feasible. This façade has been extensively and irreversibly altered and most of the original features have been removed. Therefore, this façade will be rebuilt with new brick that replicates all of the original design details. The original cornice will be taken down and repaired off site by Historia Restoration and will be reinstated on the replicated façade. The replication of this façade will provide an opportunity to reinstate the original window openings on the 2nd & 3rd floor. This is considered an improvement that will restore the original rhythm of the fenestration and be more consistent with the adjacent heritage façades. More detailed information about the current condition of the brick and why repair is not recommended is provided by Jonathan Dee of John G. Cooke & Associates and is included in the Appendix of this report.

Left: cracked and delaminating cement render on the brick façade

Right: severe deterioration of the brick is evident now that finishes have been removed from the interior

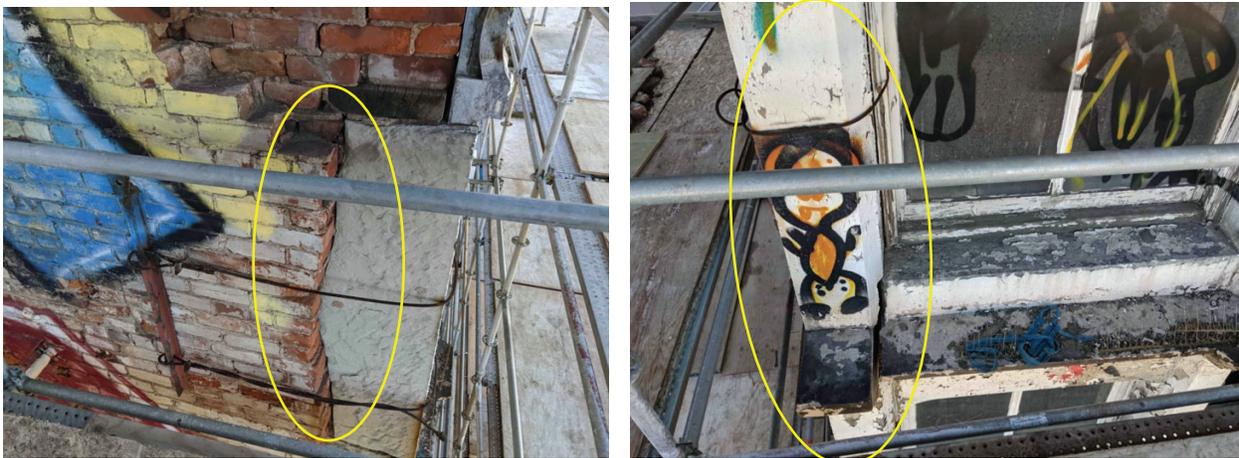
28 KING E (GLASSCO BUILDING)

The stone façade of 28 King Street East has significant condition issues along the full height of the east pier. Investigation undertaken by John G. Cooke Associates and Historia Restoration confirms that there are open joints in the masonry due to eastward movement. The deflection of the east wall was measured using a plumb line and is significant and appears to be ongoing. Given the extent of the damage and the limited amount of masonry on this façade, dismantling and rebuilding is being proposed rather than stabilization *in situ*. Original masonry on the 1st floor of 28 King Street East (Glassco Building), previously covered with modern cladding, will be preserved and integrated into the new storefront. More detailed information about the current condition of this façade and the recommended approach to conserving it through dismantling and rebuilding is provided by Jonathan Dee of John G. Cooke & Associates and is included in the Appendix of this report.

Left: temporary cabling installed to secure the masonry on the northeast corner has not prevented ongoing movement of the east wall

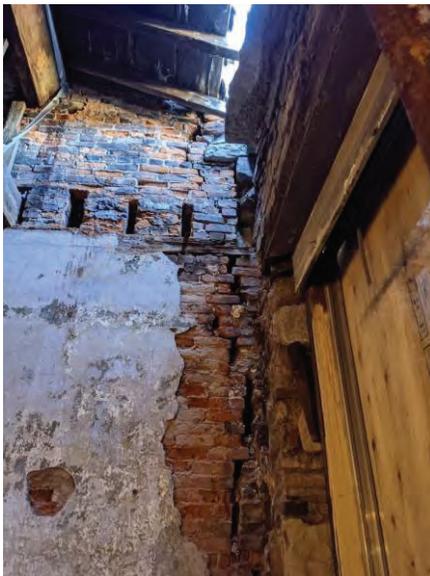
The façade is generally intact and plumb but some out-of-plane movement is apparent at the west end. Though the displacement does not register conclusively on the 3D scan, the façade is quite clearly separating from the west return wall and a continuous crack is visible at the interior from the third floor where the return wall is constructed of brick (see Fig. 1). On the most recent inspection, interior finish removals allowed access to view the keying/interface between at the second floor, which at this level

Fig 1: 18-20, 3rd floor, West return wall separation

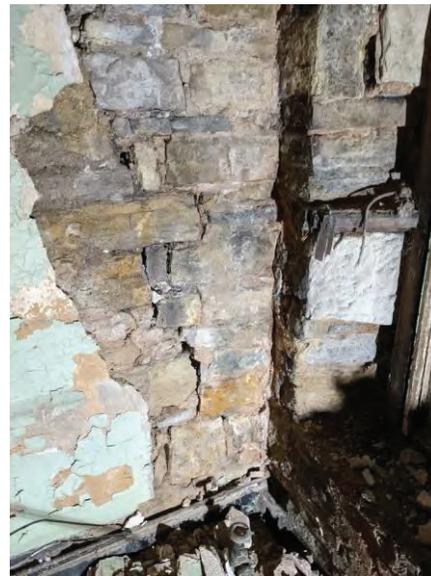
consisted of stone masonry. While at this level keying of the stone was again noted, the continuation of the crack was visible (see Fig. 2). The separation of the façade from the return wall would be a significant concern if left unaddressed. As the conservation intent, described below, is to introduce both temporary and permanent lateral restraint to the faced, and we understand the plan is to move forward with the project promptly, we believe the interim risk posed by this condition is relatively low.

Fig 2: 18-20, 2nd floor, West return wall separation

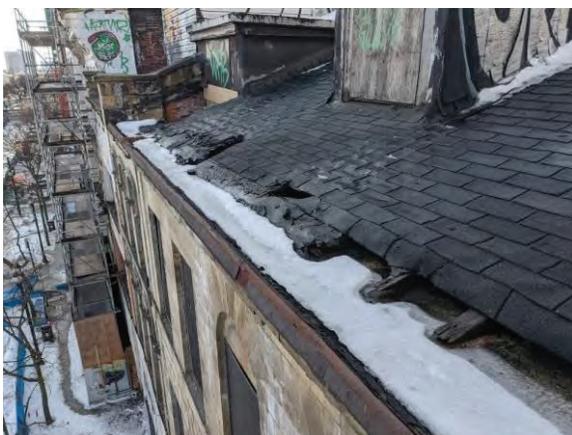
Generally, the wall masonry is in fair-to-good condition, with the notable exception of the upper courses. These are in poor condition, owing to the water entry from the failed roof along the full length of the wall. The roof includes a gutter profile along its edge, which was roofed using the same shingles as the balance of the roof, and which has rotted and failed along the full length. This is directing all water that flows down the roof onto the tops of the cornice stones. These cornice stones and the courses immediately under them have many washed out joints and must be reset. The stones themselves are in better condition than one might otherwise expect, and are repairable. The piers to either side of the upper masonry must also be rebuilt. See Figures 3, 4, and 5.

Fig 3: 18-20, failed roof rotted framing above cornice

- Removal and salvage of cornice and upper level masonry for off-site storage and repairs.
- Repointing of several courses of masonry below the upper level to be removed (to be completed in advance of removals above in order to limit removal extent).

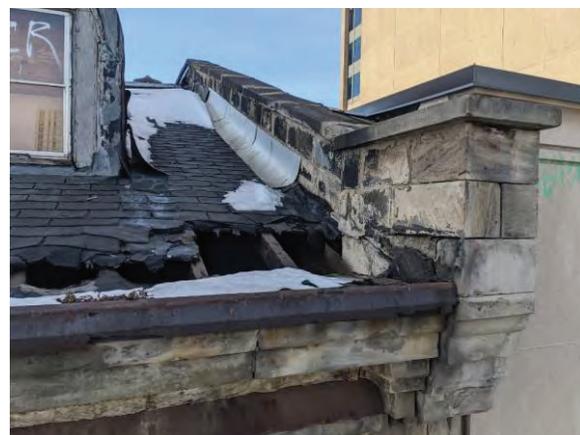
Fig 4: 18-20. Failed roof, pier at upper corner of façade

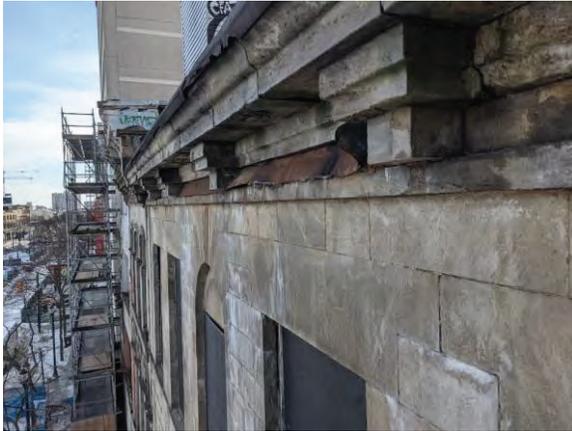
Fig 5: 18-20, cornice and bands of stone below.

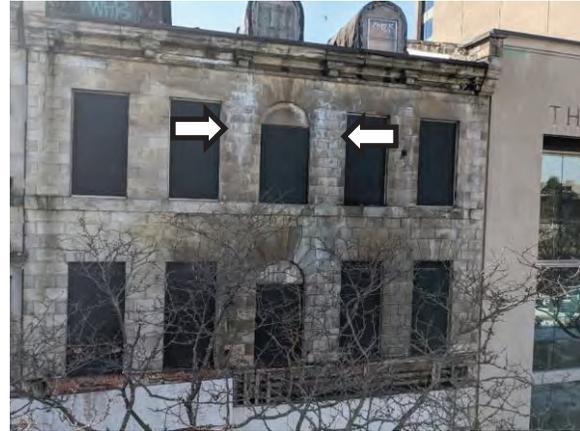
The large amount of water that has been directed at this wall has resulted in areas of efflorescence on the façade. This is caused by moisture within the wall being transported to the surface of the masonry, where it dries. When the water dries it leaves behind any dissolved salts on the surface. We expect that the masonry is currently quite saturated and masonry can take many years to dry fully. As a result,

we would expect that even if removed from the surface today, these salt deposits will quickly return. See Figure 6.

Fig 6: 18-20, upper façade, efflorescence noted

- Wall Assembly: The masonry is saturated in many upper areas and we expect this to take many years to fully resolve. While the damage to the stone from observed efflorescence appears to be fairly minimal so far, and we wouldn’t expect this to change, the result of continuing efflorescence would not be very attractive. If this is a serious concern, we believe that providing a means for moisture to dry towards the interior would help mitigate the issue. This could be done formally by having a building science consultant design a dynamic buffer zone, or less so by ensuring the project architects leave an air space with some natural ventilation on the interior side of the masonry wall. Though contrary to sustainability goals in general, the more waste heat that can be allowed to pass through this wall will help with overall drying, and mitigating future deterioration.

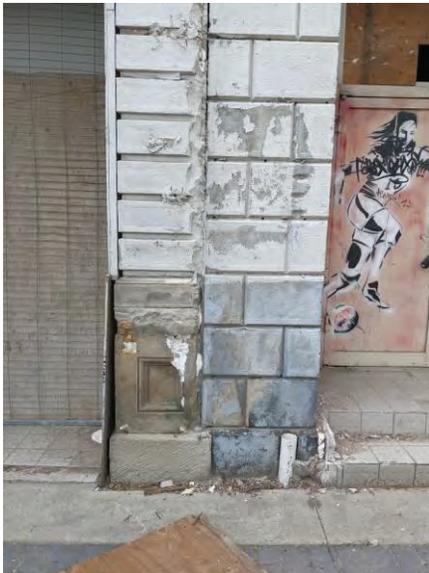
The ground level masonry that remains was not treated with much consideration during previous interventions. Generally, stones were chipped or partially cut to receive new material, including the beams. If the intention were to restore this stone to its original appearance, a large number of Dutchman and other similar repairs would be required, introducing new material matching to the old. Paint is also present and ought to be removed. See Figure 7.

Fig 7: 18-20 & 22, example of ground level masonry

- **Ground Level Masonry:** Given the condition of the ground level masonry, a high percentage of stones will require Dutchman or other repair. While this is more of an architectural consideration, we can confidently say that a perfect match between new and existing materials will be very difficult to achieve, and an imperfect result may give a mottled or otherwise unpleasant look. It may be appropriate to leave these stones as an artifact, or integrate them into the new façade material in a way that is complementary, and without expecting them to look perfect.

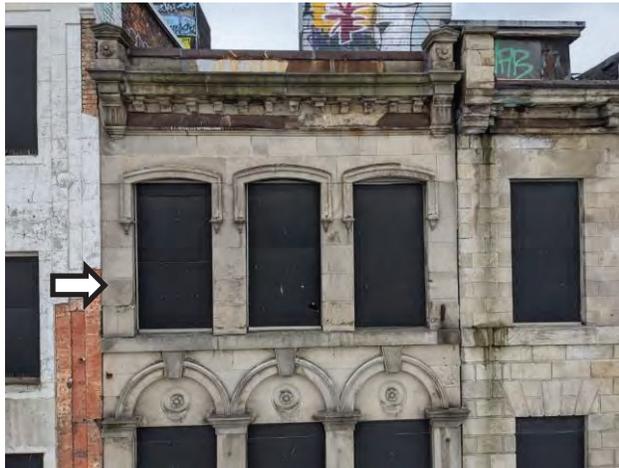
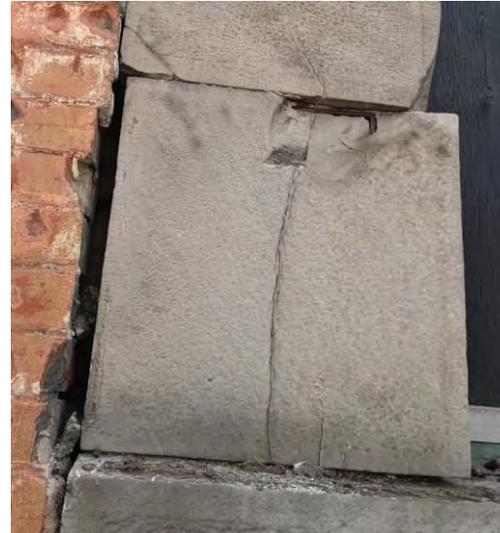
In term of general stability, the façade at 22 King appears to be plumb in the out-of-plane direction. However, the upper level appears to have moved laterally, in-plane, to the east, towards the building at 24 King. This is most evident at the third-floor pier adjacent to that building, where one stone has slid along its bed joint with the stone below (see Figs 8 and 9). The stones above have slid east, towards the building at 24, while the stones below have remained in place. There is a significant crack visible in the interior backup brick at this location.

Fig 8: 22, cornice and bands of stone below. Sliding indicated. Fig 9: 22, sliding at base of 3rd flr pier, E side.

The differential movement at the upper level of the façade is due to differences in construction between levels. Within the second level, the third floor framing is visible and is supported by a series of beams and piers along the east and west sides of the building. These piers and the façade backup masonry appear to be independent from the building at 24 King. However, at the roof framing, this condition is different. The roof joists are let into the brick return wall to the east (24 King) and plaster removals revealed keying between the façade backup and the east return wall. We believe this difference in construction and connectivity explains the observed displacement. It suggests that the upper level of 22 King is being pulled eastward by 24 King. The lower levels are structurally separate and are not.

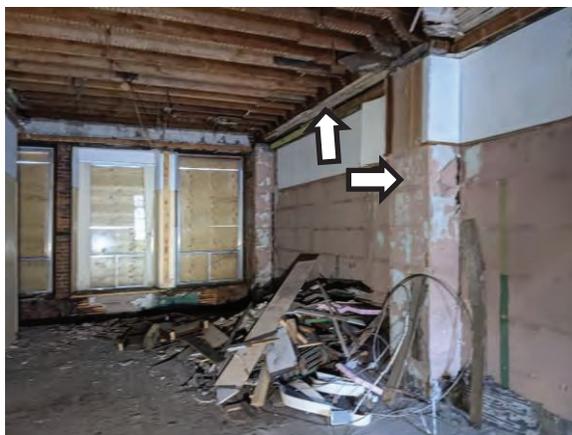
Fig 10: 22, beam and piers underside 3rd floor framing

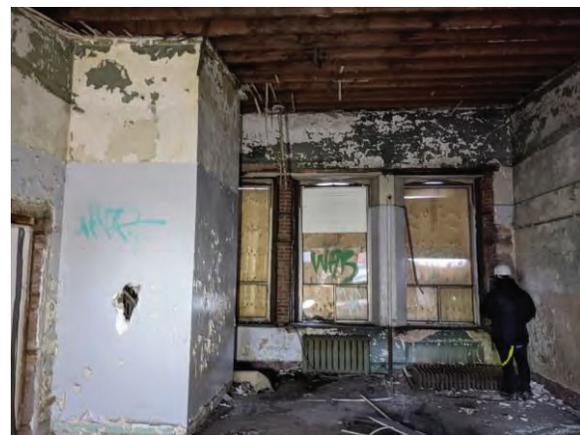
Fig 11: 22, roof framing, connected to adjacent bldg's.

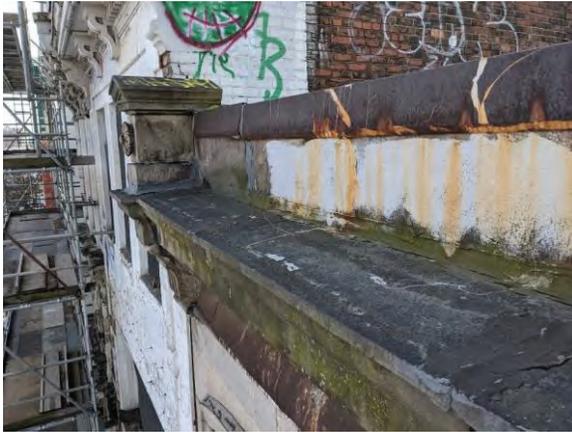
Fig 12: Cornice and stones above, at 22 King

Aside from the above issue, much of the masonry of the façade is in fairly good condition given the circumstances, and certainly is repairable in-situ, with the notable exception of the cornice and the courses immediately above and below it. As with 18-20 King, the upper courses must be removed and reset, and we again recommend they be removed off-site for repair, with the wall to be capped temporarily. Unlike 18-20 King, the band of stones immediately below the cornice is in very poor condition in this case, and the stones are not repairable. Small corbels set into this band of stone are similarly deteriorated. This has been caused by moisture transmission leading to subflorescence and possibly freeze-thaw damage, resulting in extensive flaking and delamination of the stone. In some places it is possible to remove a delaminated piece of the sandstone and expose a layer of white salt behind it. This band of stone will require replacement with a new stone units, cut from a similar sandstone. See Figures 12 to 14.

- Removal and salvage of cornice and upper level masonry for off-site storage and repairs.
- Removal of the band below the cornice and eventual replacement with new stone cut to suit.

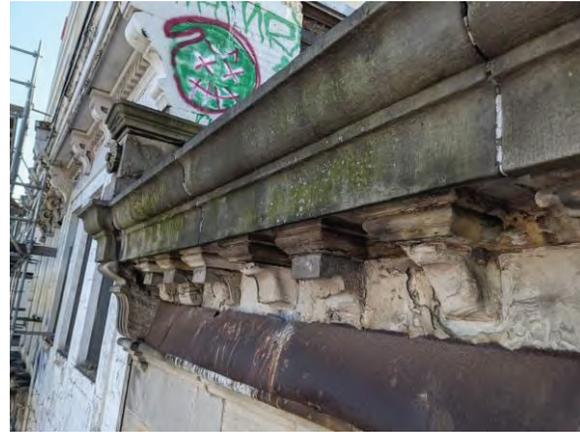
Fig 13: Deteriorated stone below cornice.

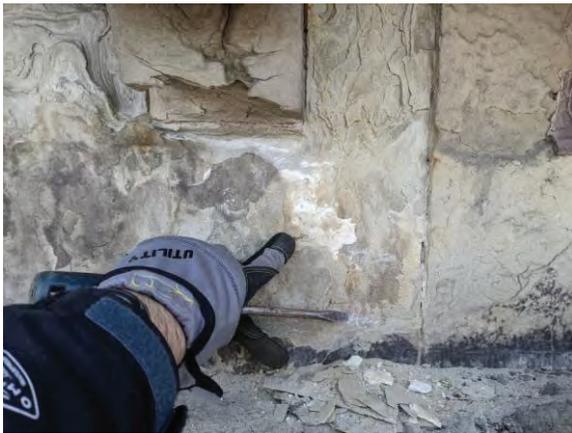
Fig 14: Subflorescence and stone flaking

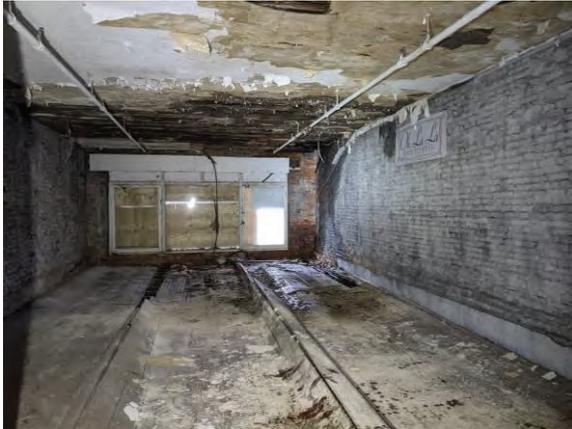
masonry piers in these locations was noticeably saturated throughout. This is causing significant deterioration of the brick – not just spalling, but complete loss of integrity in many cases – likely due to repeated freeze-thaw cycles while in a saturated condition (see Fig. 16).

Fig 15: 24 King, 3rd floor level, severe water damage.

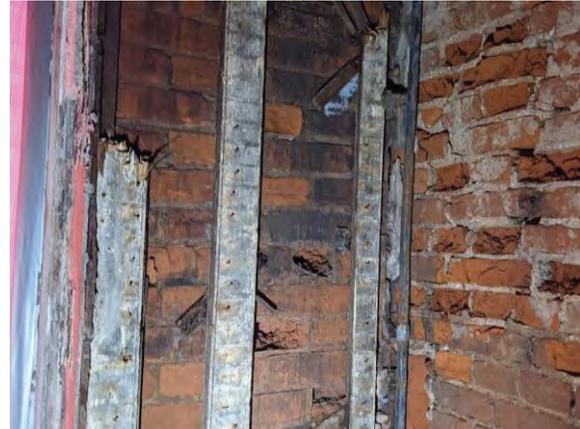
Fig 16: 24 King, saturated, deteriorated brick.

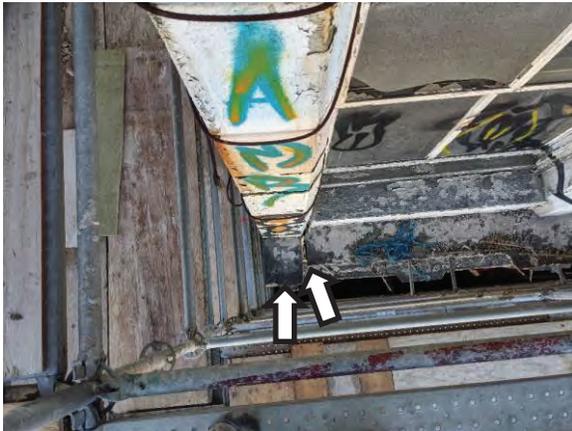
The entire easternmost pier and easternmost spandrel panel of the façade at 28 are displaced and in need of rebuilding. The east pier stones are keyed into the east wall which itself is significantly out of plumb. The east wall has pulled on the façade, causing issues that are most apparent in the east bay (see Figs. 17 and 18). The uppermost level remains a question, and we expect significant rebuilding to be required here too. Finally, there is evidence of racking in this façade.

Fig 17: 28 King, E-most pier, looking down, note rotation, and gaps

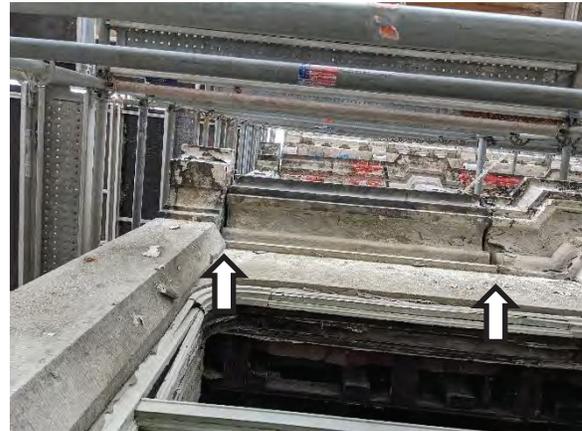
Fig 18: 28 King, E-most pier/spandrel, looking up note gaps in head joints.
