**Re: Heritage Permit Application  
392, 398, 406, 412 Wilson Street East and 15 Lorne Avenue, Ancaster  
Request to Relocate 398 Wilson Street East, Ancaster**

In order to assess the impacts on the heritage attributes of the relocation of the Marr House, Goldsmith Borgal & Company Ltd. Architects (GBCA) were retained to complete a Cultural Heritage Impact Assessment (CHIA) to evaluate the impacts on the heritage property arising from the relocation of the house. Appendix D includes the CHIA report for your review and consideration.

GBCA Project No. 21006 - 392- 412 Wilson Street East and 15 Lorne Avenue Ancaster

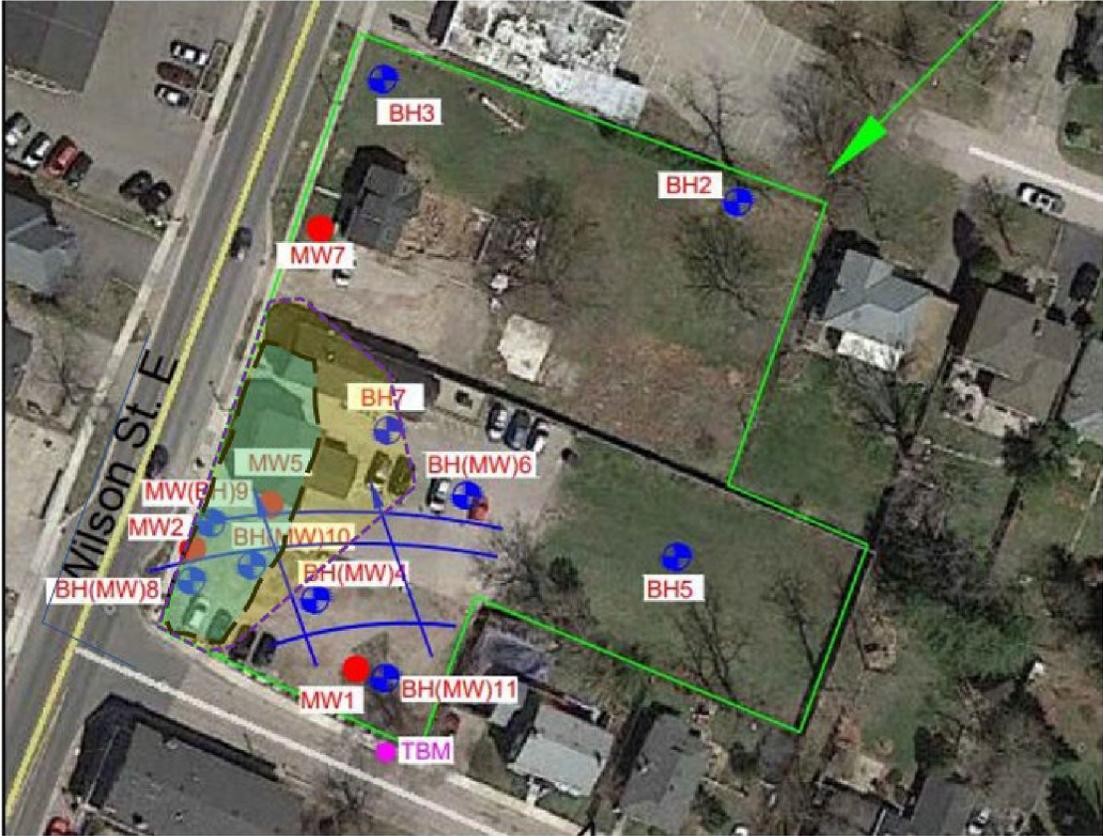
Estimated extent of on-Site groundwater contamination

Estimated extent of on-Site soil contamination

Estimated groundwater flow direction

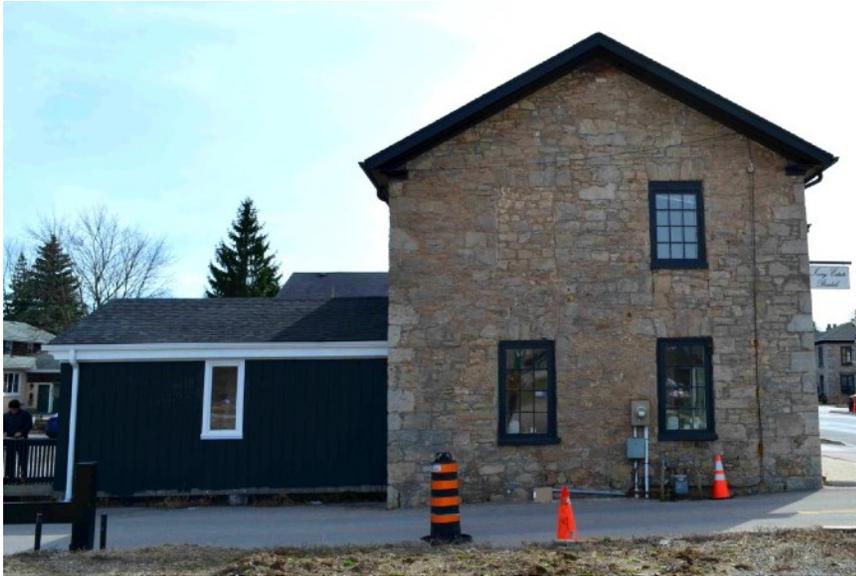
*Marr House, 2021 (GBCA). North Elevation. Top left window opening closed in.*

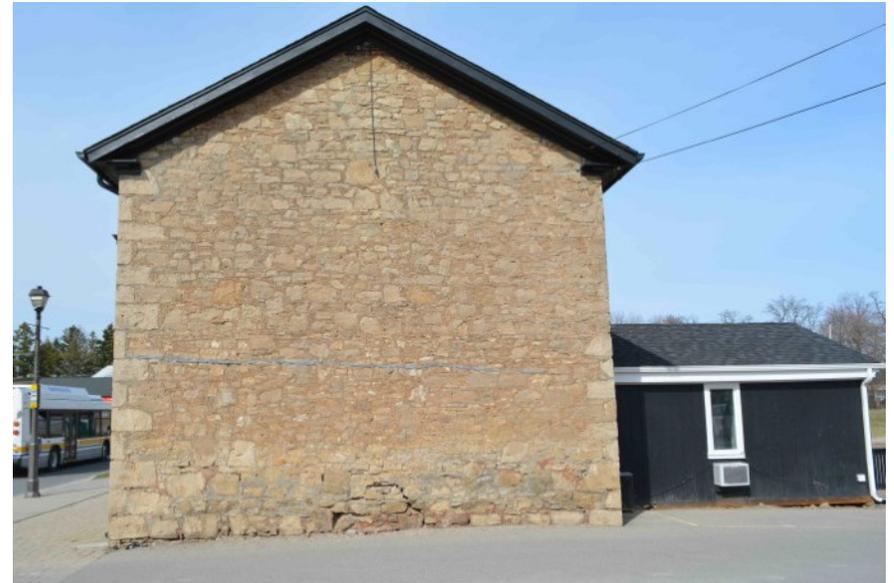
*Marr House, 2021 (GBCA). South Elevation. Blank wall with tail extending to the east. Foundation issues notable from a distance.*

While there is no direct correlation with the soil contamination, the building's long-term stability is also in question. Portions of the south elevation have begun to show evidence of failure, which may be a result of settlement. Excavating nearby can generate vibrations that may highly compromise the structural and heritage integrity of the small structure. Although it is acknowledged that relocation is not typically favoured, in this particular case, relocation can be seen as a mitigation strategy for the building's long-term preservation. Relocation to a properly designed foundation will ensure the conservation of the building.

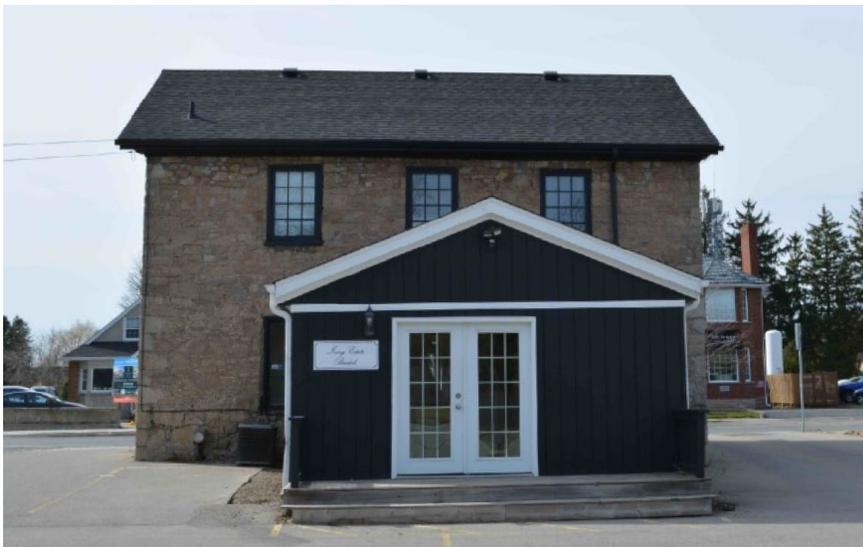
*Marr House, 2021 (GBCA). East Elevation. Rear tail covers to ground level openings.*

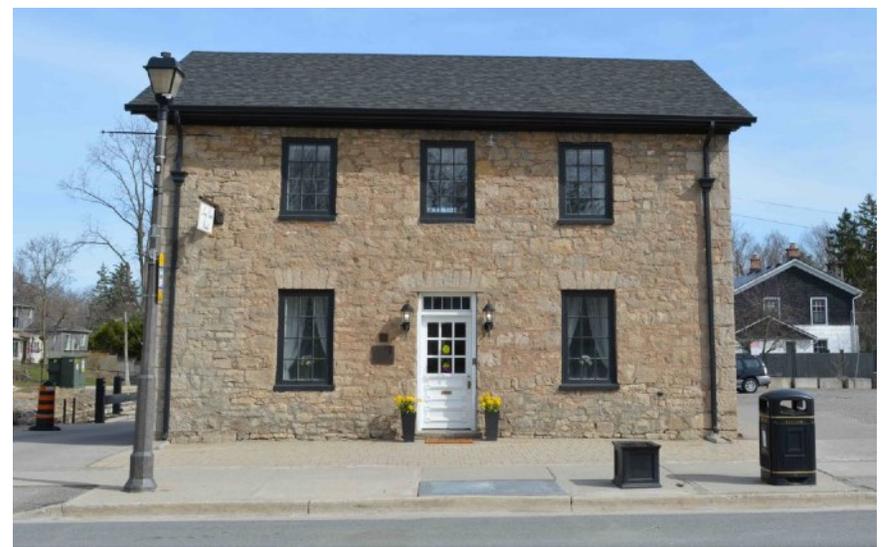
*Marr House, 2021 (GBCA). West Elevation 2.4 meters from Wilson Street East. Although the designation by-law notes that chimneys are a contributing heritage attribute, in its current state these are no longer present.*

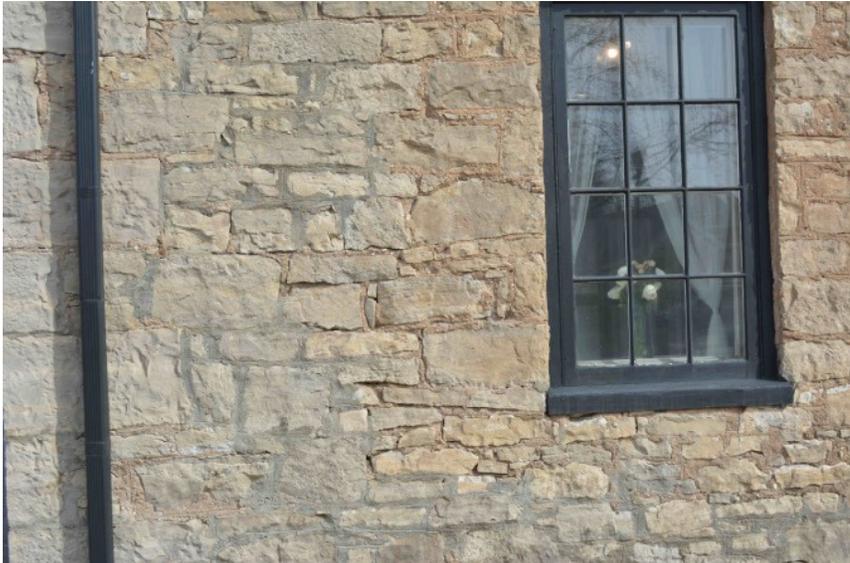
*West elevation: ground level showing cementitious parging applied at the northern edge of the building.*

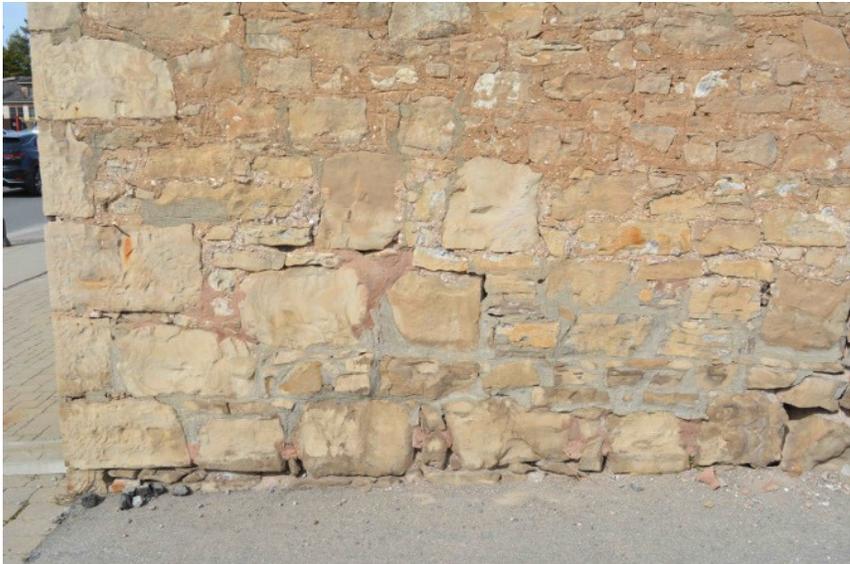
*South elevation: ground level showing open joints, and repair work.*

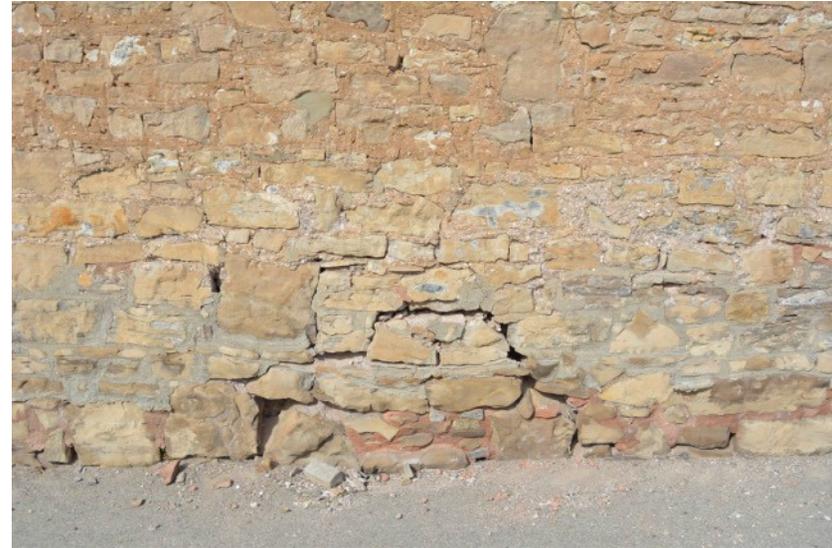
*South elevation: ground level failed and open joints with previous repair work also visible.*

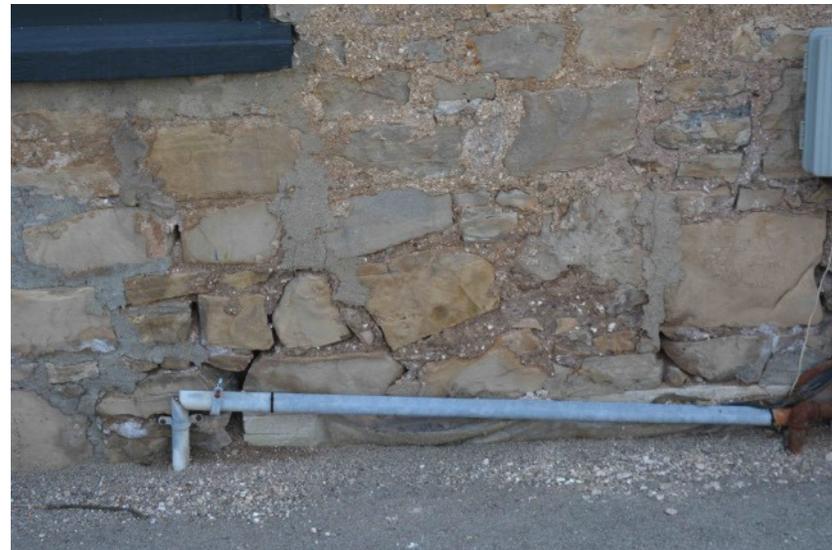
*North elevation: failed and open joints, oxidization and metal anchors near foundation.*

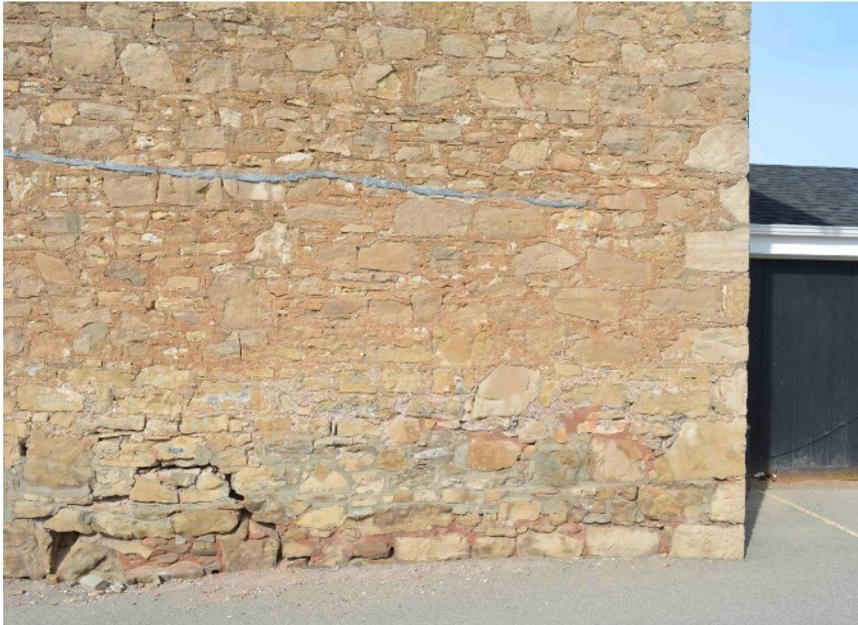
Settlement cracking and movement lines are present at the midpoints of the north and south facades consistent with the rotation of the rear part of the building. Other cracking and displacement is found on the east end of the north and south walls and the base of the east wall which is consistent with the slow-motion rotation of half of the house.

*South elevation: failed and open joints at foundation. Movement lines are present at the midsection of this elevation.*

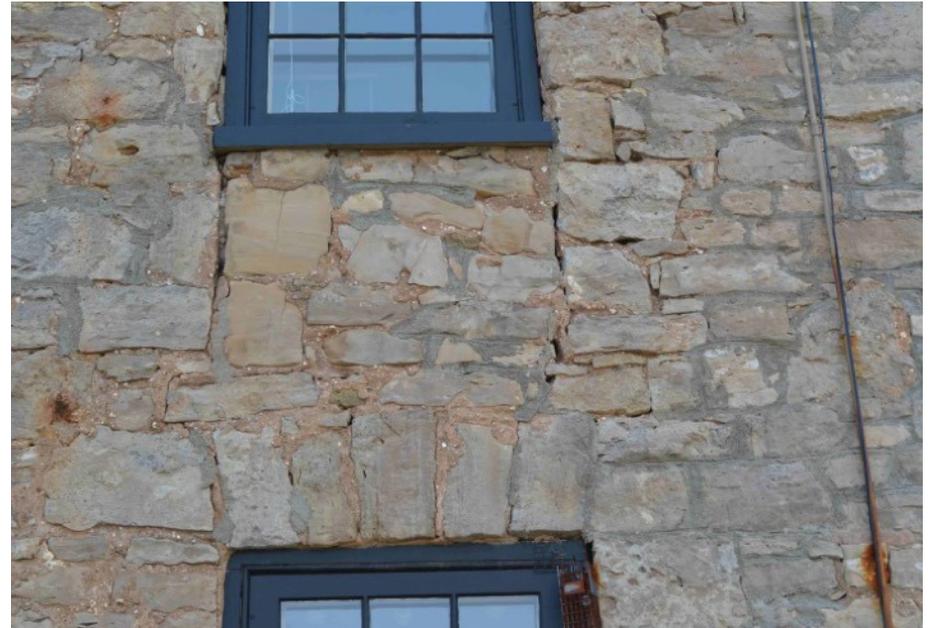
*West elevation: Recent repair and pointing work, parging and entire sections of stone removed below the 2nd storey window.*

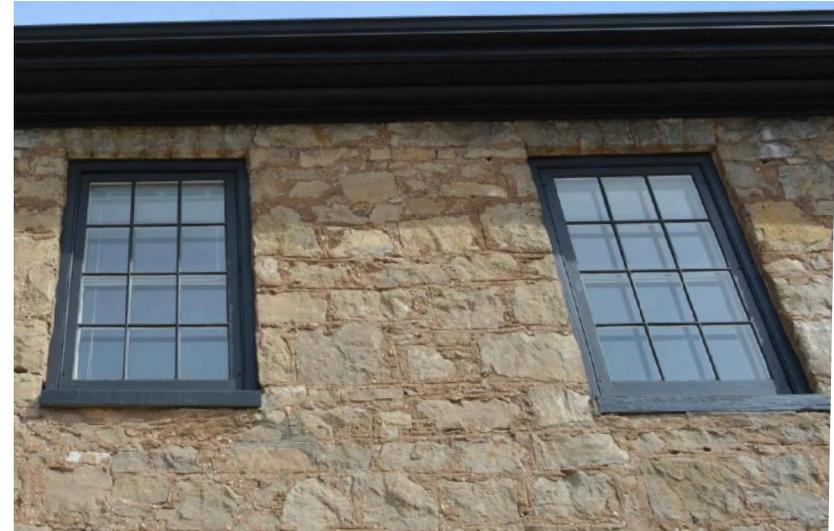
*West elevation: window frames on 2nd storey appear to be in good repair upon visual review..*

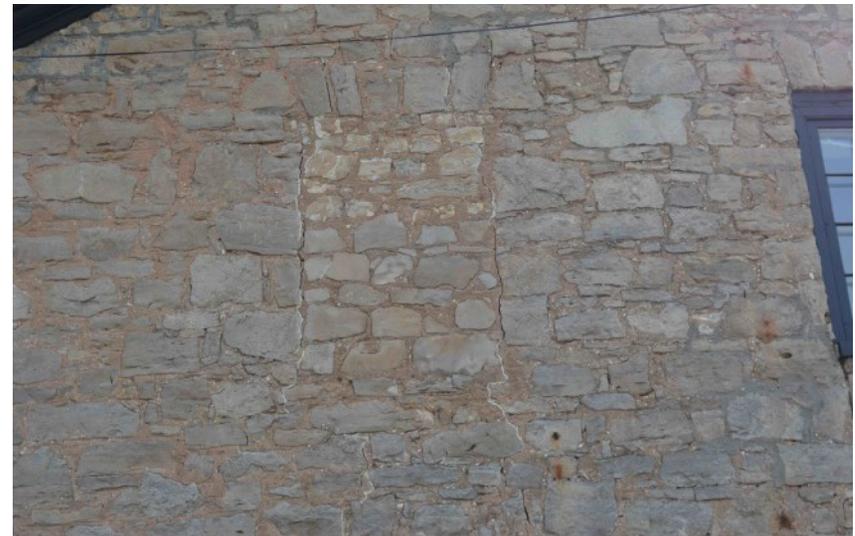
*North elevation: eastern-most window opening on 2nd storey has been closed in.*

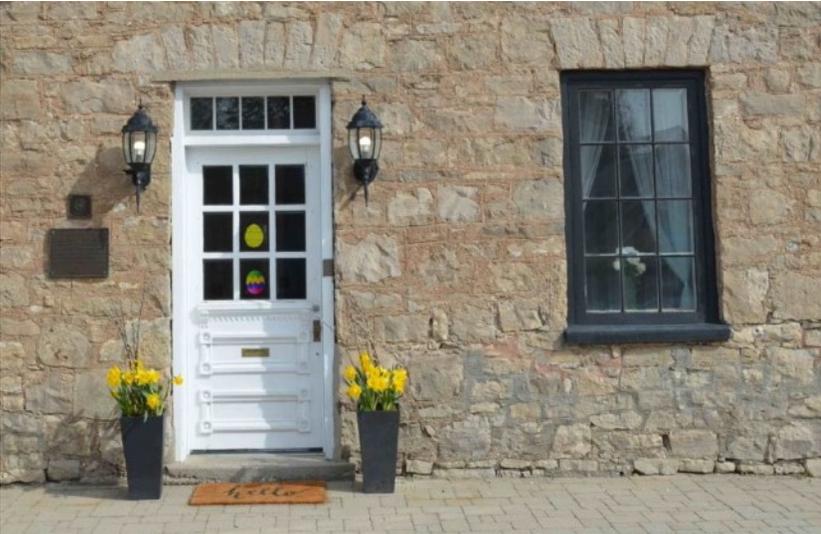
*West elevation: Central door with with 12-over-12 sash and five-pane toplight is in good repair.*

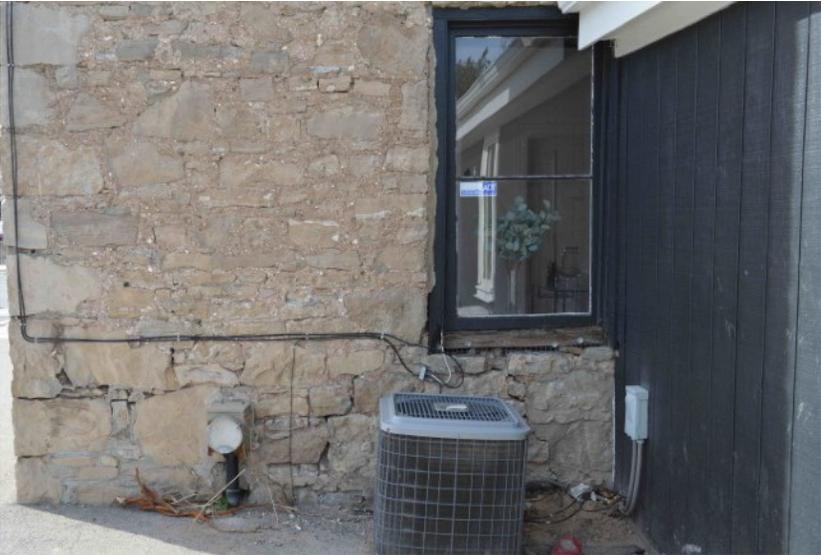
*East elevation: Openings at rear elevation have been obscured by the later addition of a one-storey tail.*

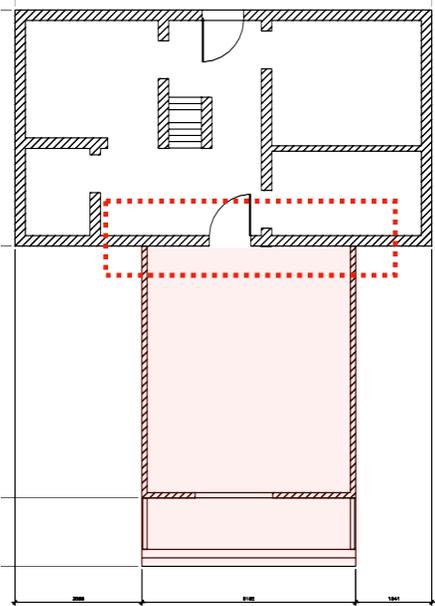
*The above plan and elevation illustrate the proposed tail to be removed from the Marr House. Areas with a dashed line will require infilling of new stone and reinstatement of original openings upon removal of the extension.*

- The removal of the tail from the main residence will require repair, infill of new stone, reinstatement of original openings, refinishing and repainting upon removal of the extension. Restoration and conservation of the former Marr House will involve rehabilitating the rear facade based on archival material, in keeping with the original design intent which would be further explored in a forthcoming Conservation Plan.
