## Heritage Permit Application

EFI Global File No.: 9496 6034 7028

Original Building Permit: 20 197441 00 R9: Impact Damage – Accessory Structure

Loss Location: 124 St. Clair Avenue, Hamilton, ON

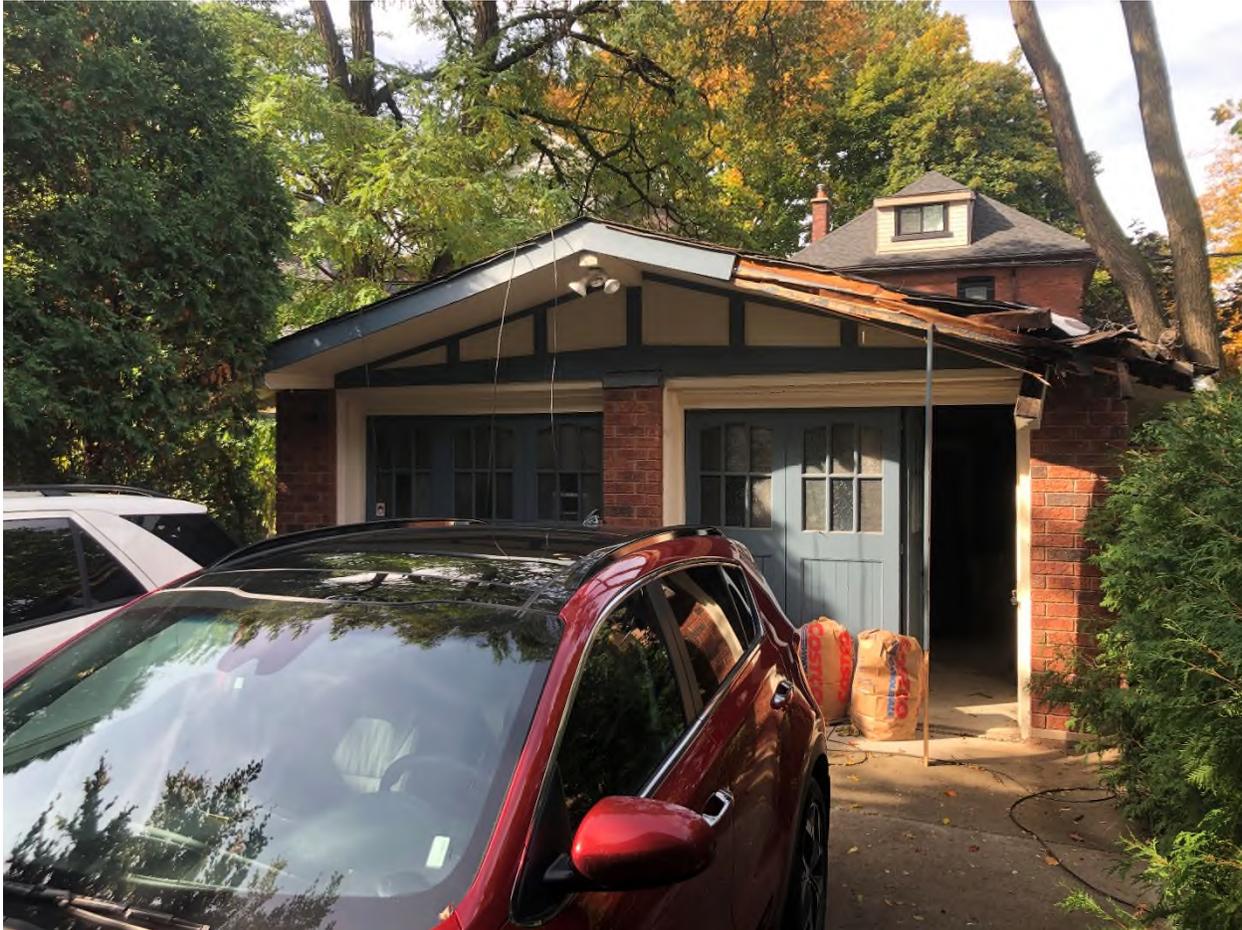
The front façade of the accessory structure consisted of a brown brick installed between door openings. This brick was a type of "Meridian Brick - Heritage Brown" and approximately 36 square feet of brick was installed along the front façade. Images of the original brick have been appended for review (photographs 1-2). At the time of inspection, the structure was damaged. Review of the brick consistency, color and texture provided evidence the brick is not original to the structure / property. The observed brick was a

Image 1: Front of Building – Original Brick (October 20, 2020)

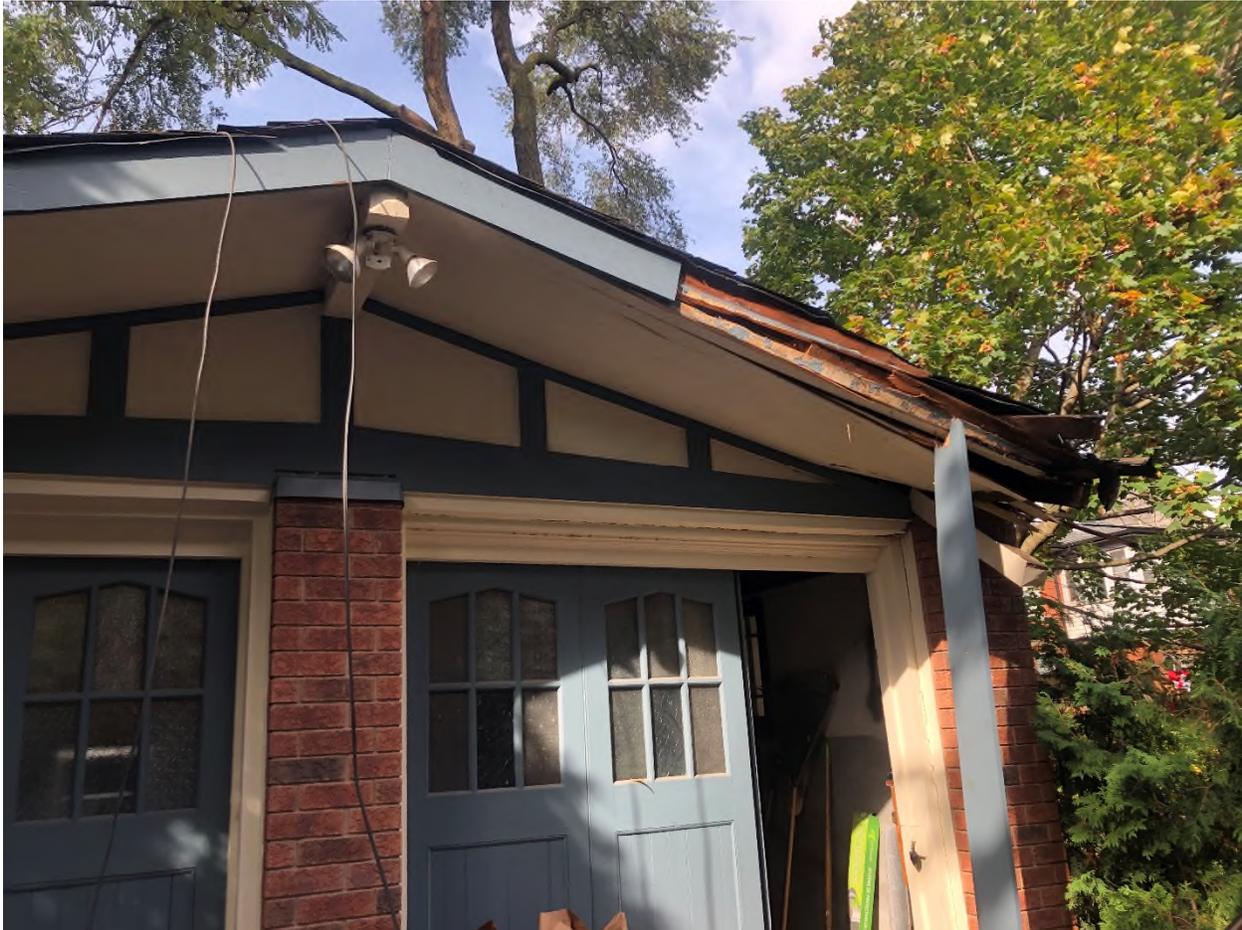
popular type of brick in the 1970s – 1980s. The brick did not match the brick currently on the primary residential structure, which appears to be original to the building (photograph 3). Further, the method of installation of the accessory structure's original brick is not consistent with historical construction since the brick is installed in a "veneer" type application with the brick being tied back to the superstructure. While not confirmed by EFI Global, it was reported by the installing contractor, ProBert Construction Inc. that the brick was overhanging the supporting foundation by a substantial amount of brick thickness.

Photograph 2: Front Elevation - Original Brick (October 20, 2020)

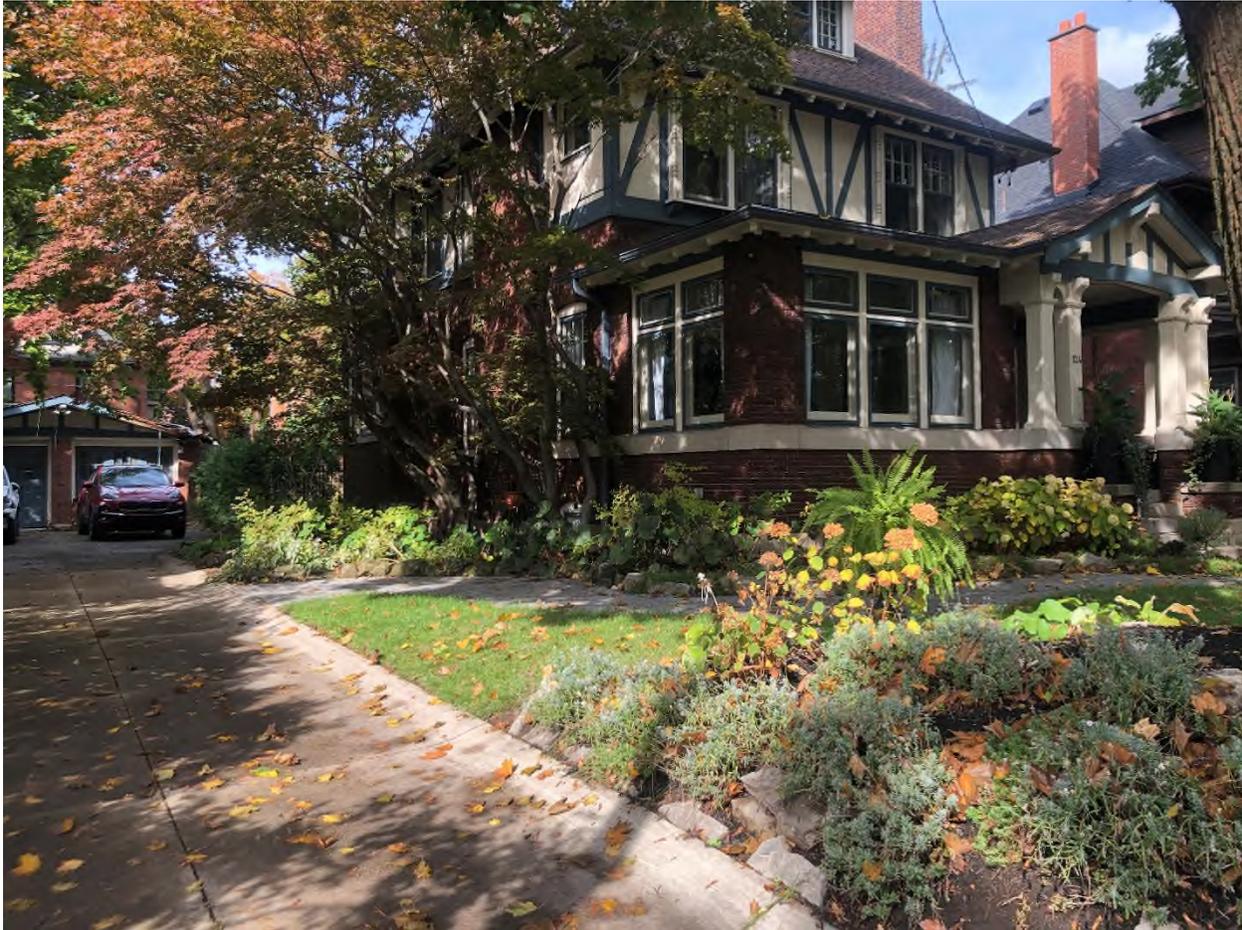
Photograph 3: Property (October 20, 2020)

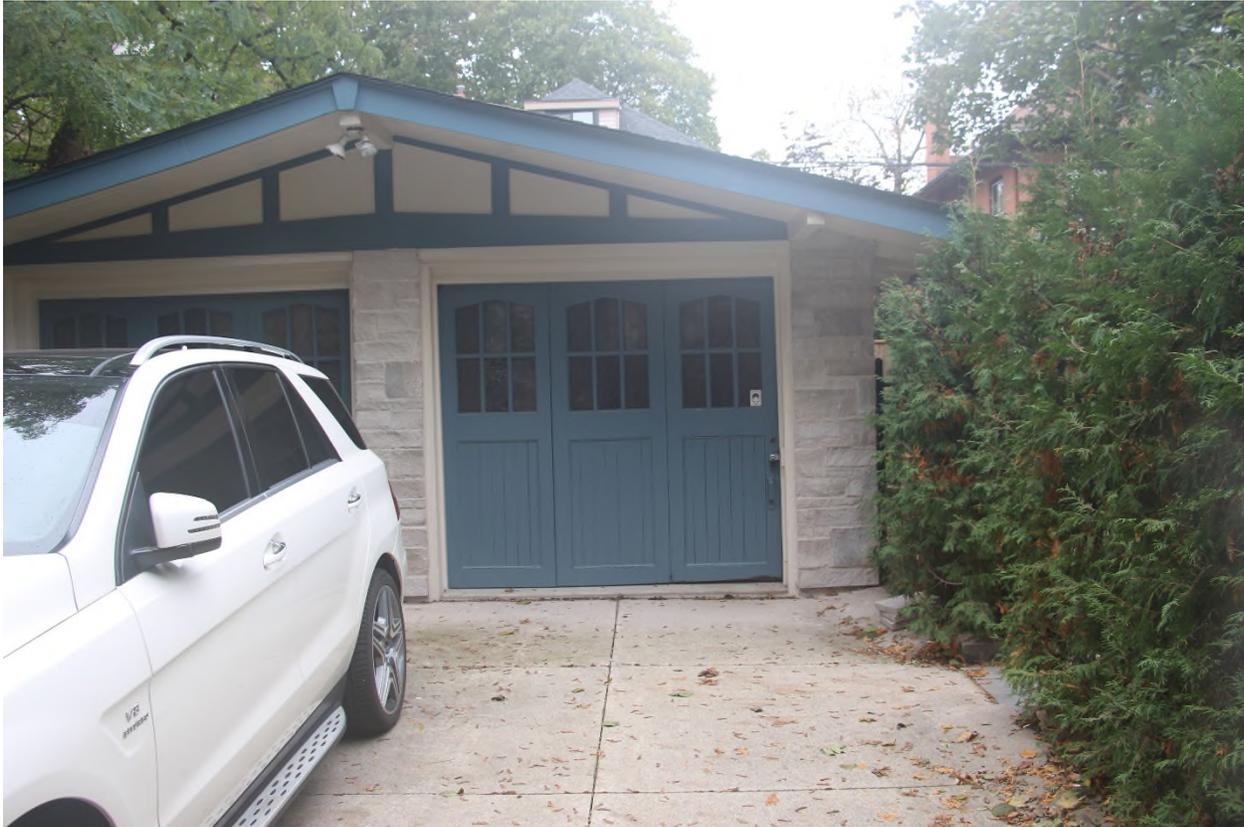
The new front façade brick was installed using "Indiana Split Veneer Limestone". The veneer was approximately 1" thick and was installed using wire mesh lathe backing. Images of the new front façade have been provided (photographs 4-5). As confirmed by the installing contractor, ProBert Construction Inc., the reasoning for choosing the installed materials was that the material was thinner than the original and could be better supported by the foundation. Further, the new material closely matched the existing primary structure's foundation walls. Additional fascia installation, trim and painting was also performed for the building.

Photograph 4: New Wall Application (October 29, 2021)

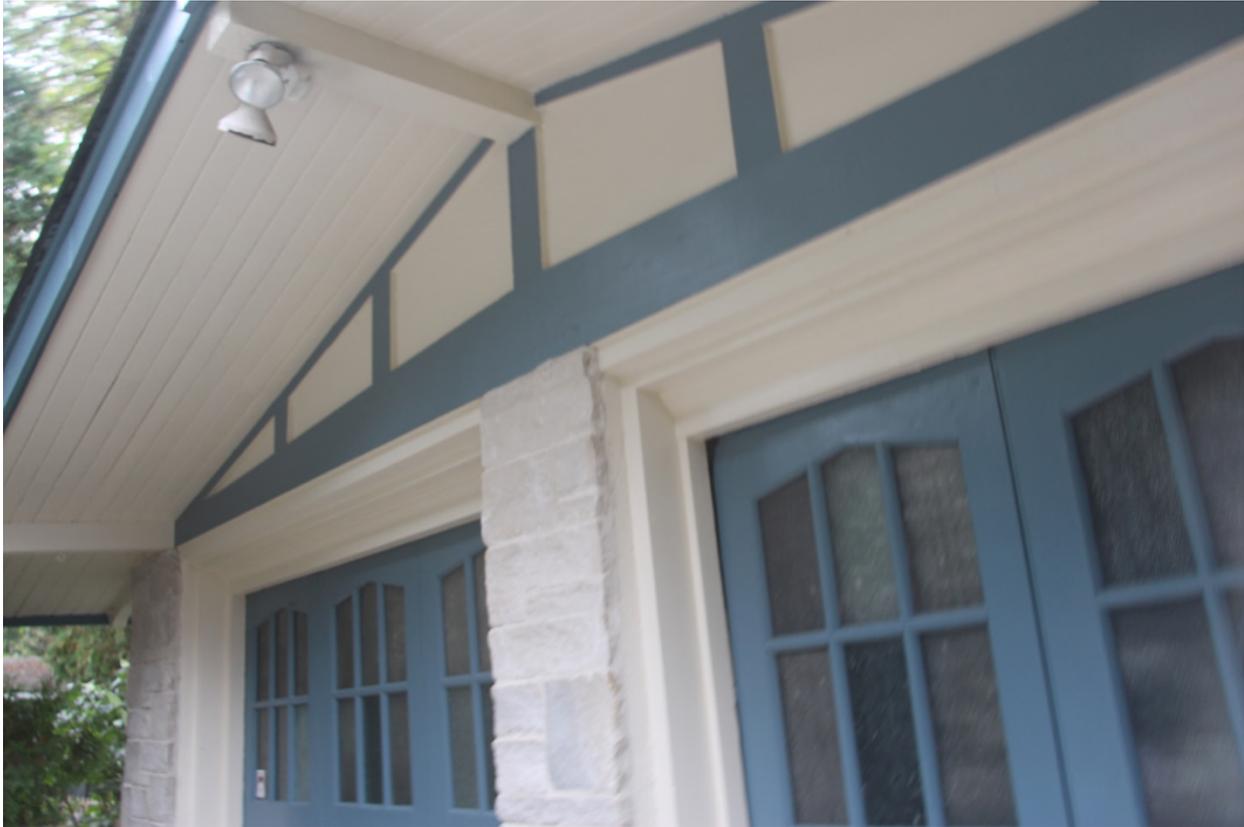
Photograph 5: New Wall Application Close-up (October 29, 2021)

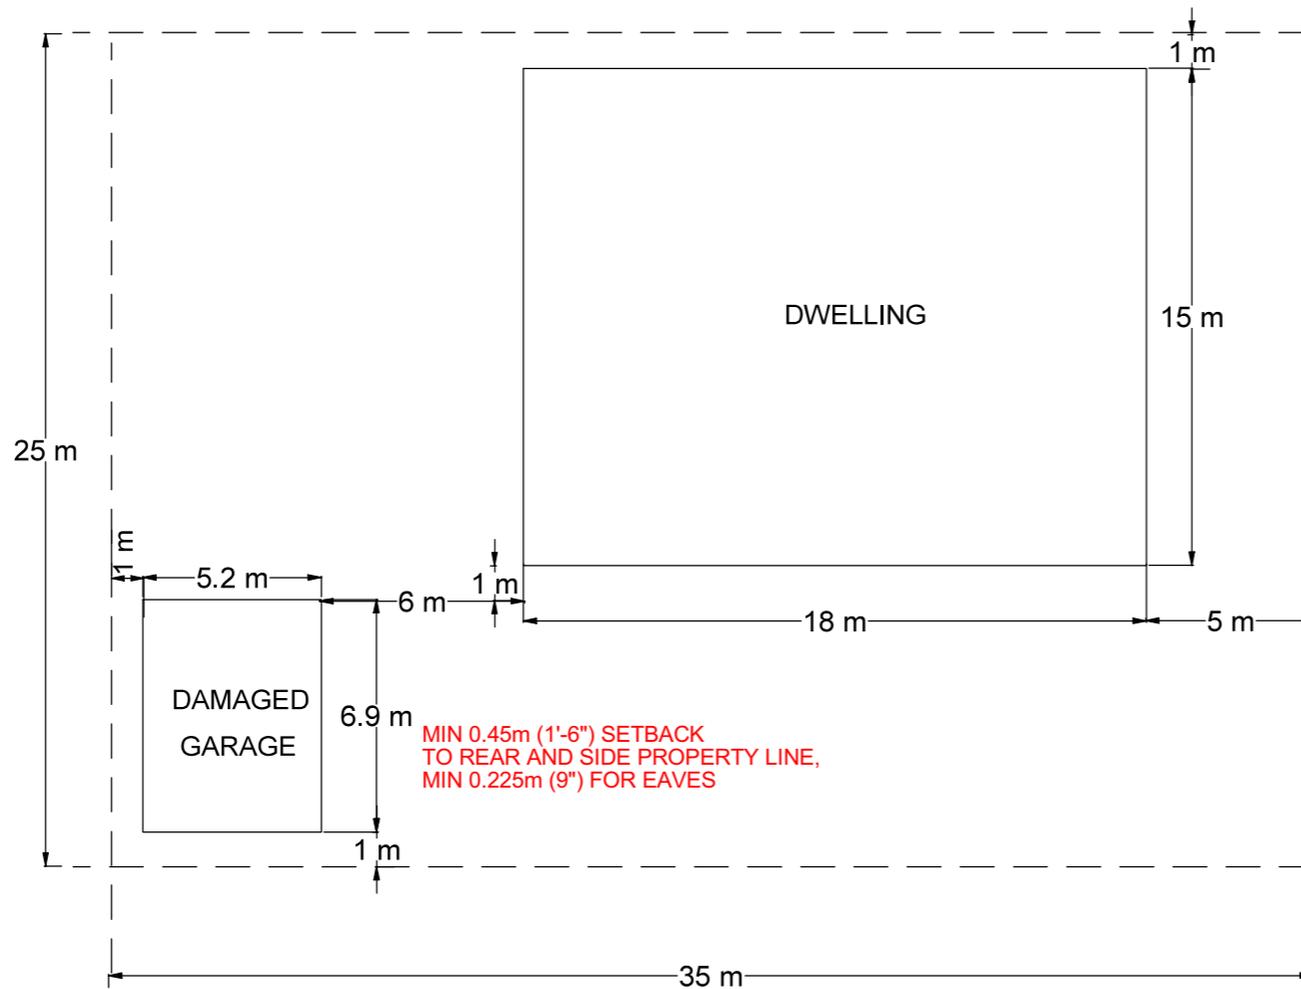
# SITE PLAN FOR 124 ST CLAIR AVE, HAMILTON

REPAIRS TO DAMAGED GARAGE ARE IN PLACE, WITH 1-1 REPLACEMENT OF DAMAGED 4-5 ROOF RAFTER TAILS
