24 Griffin Street

EXISTING FRONT ENTRANCE

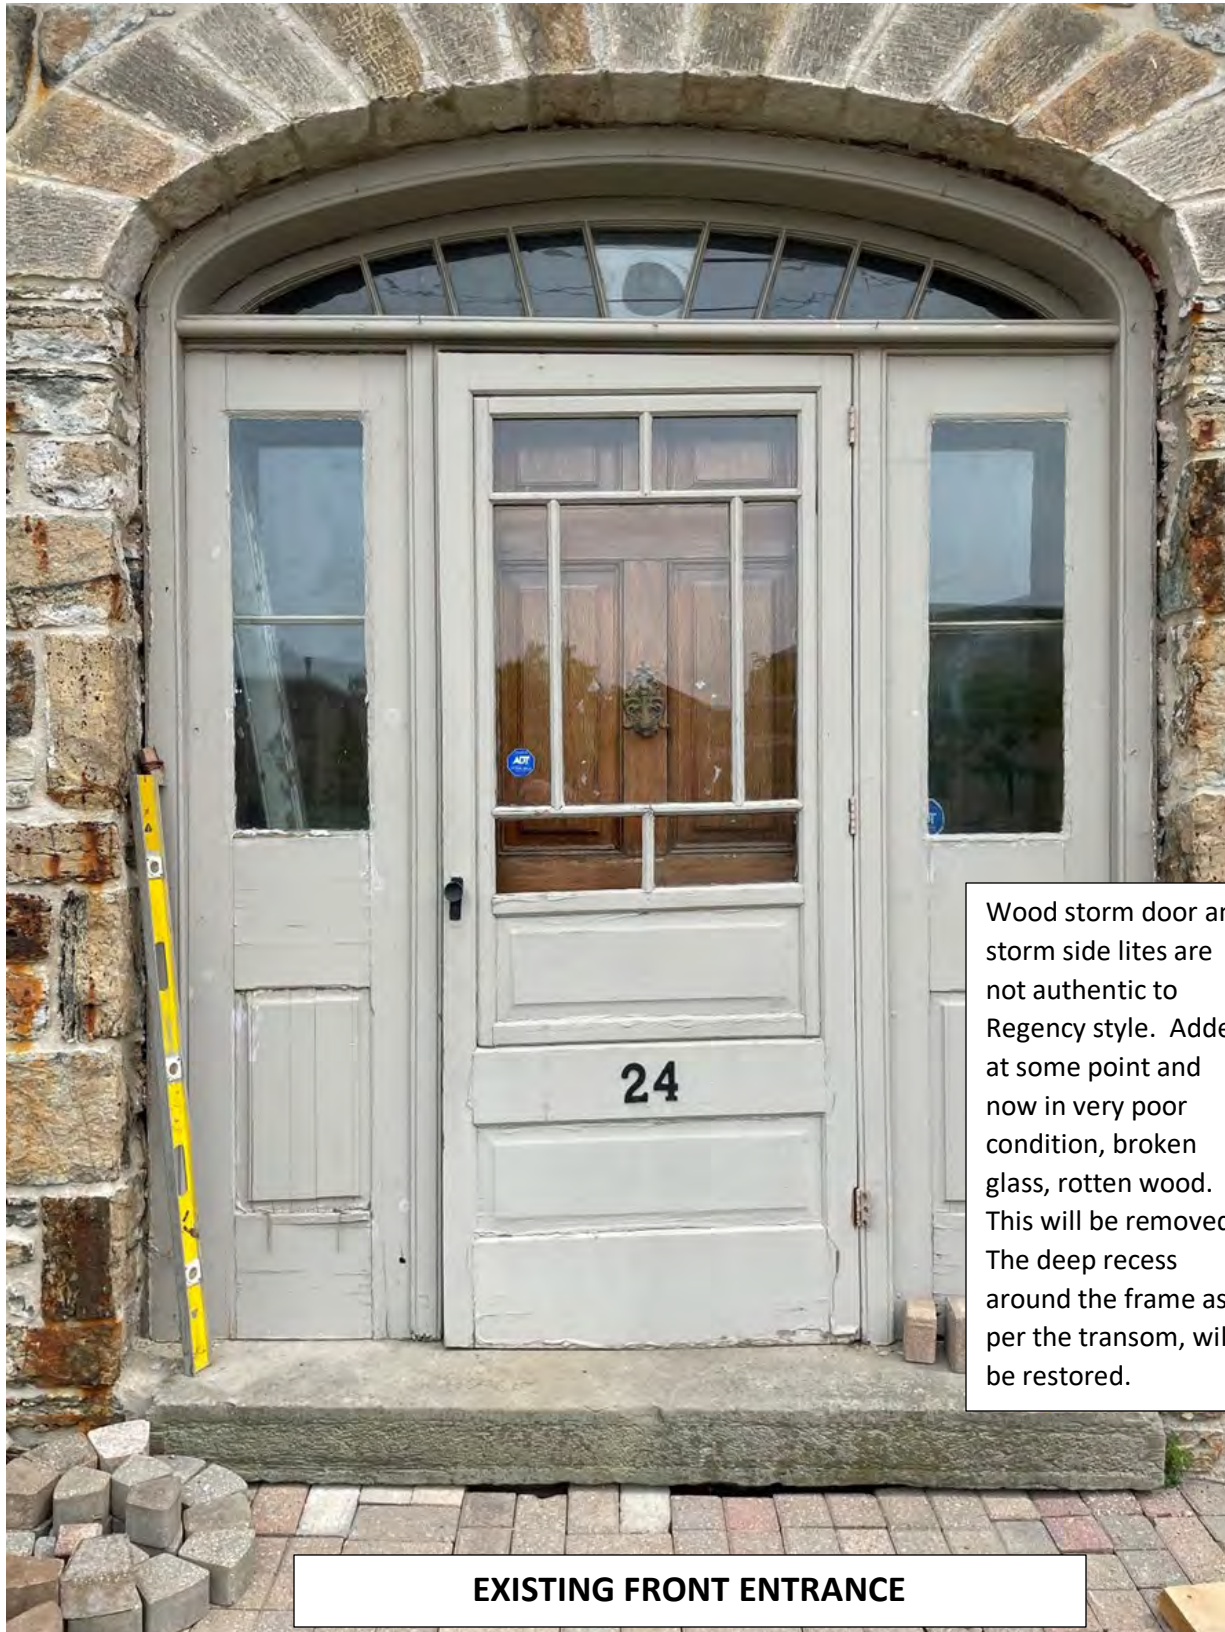
Wood storm door and storm side lites are not authentic to Regency style. Added at some point and now in very poor condition, broken glass, rotten wood. This will be removed. The deep recess around the frame as per the transom, will be restored.

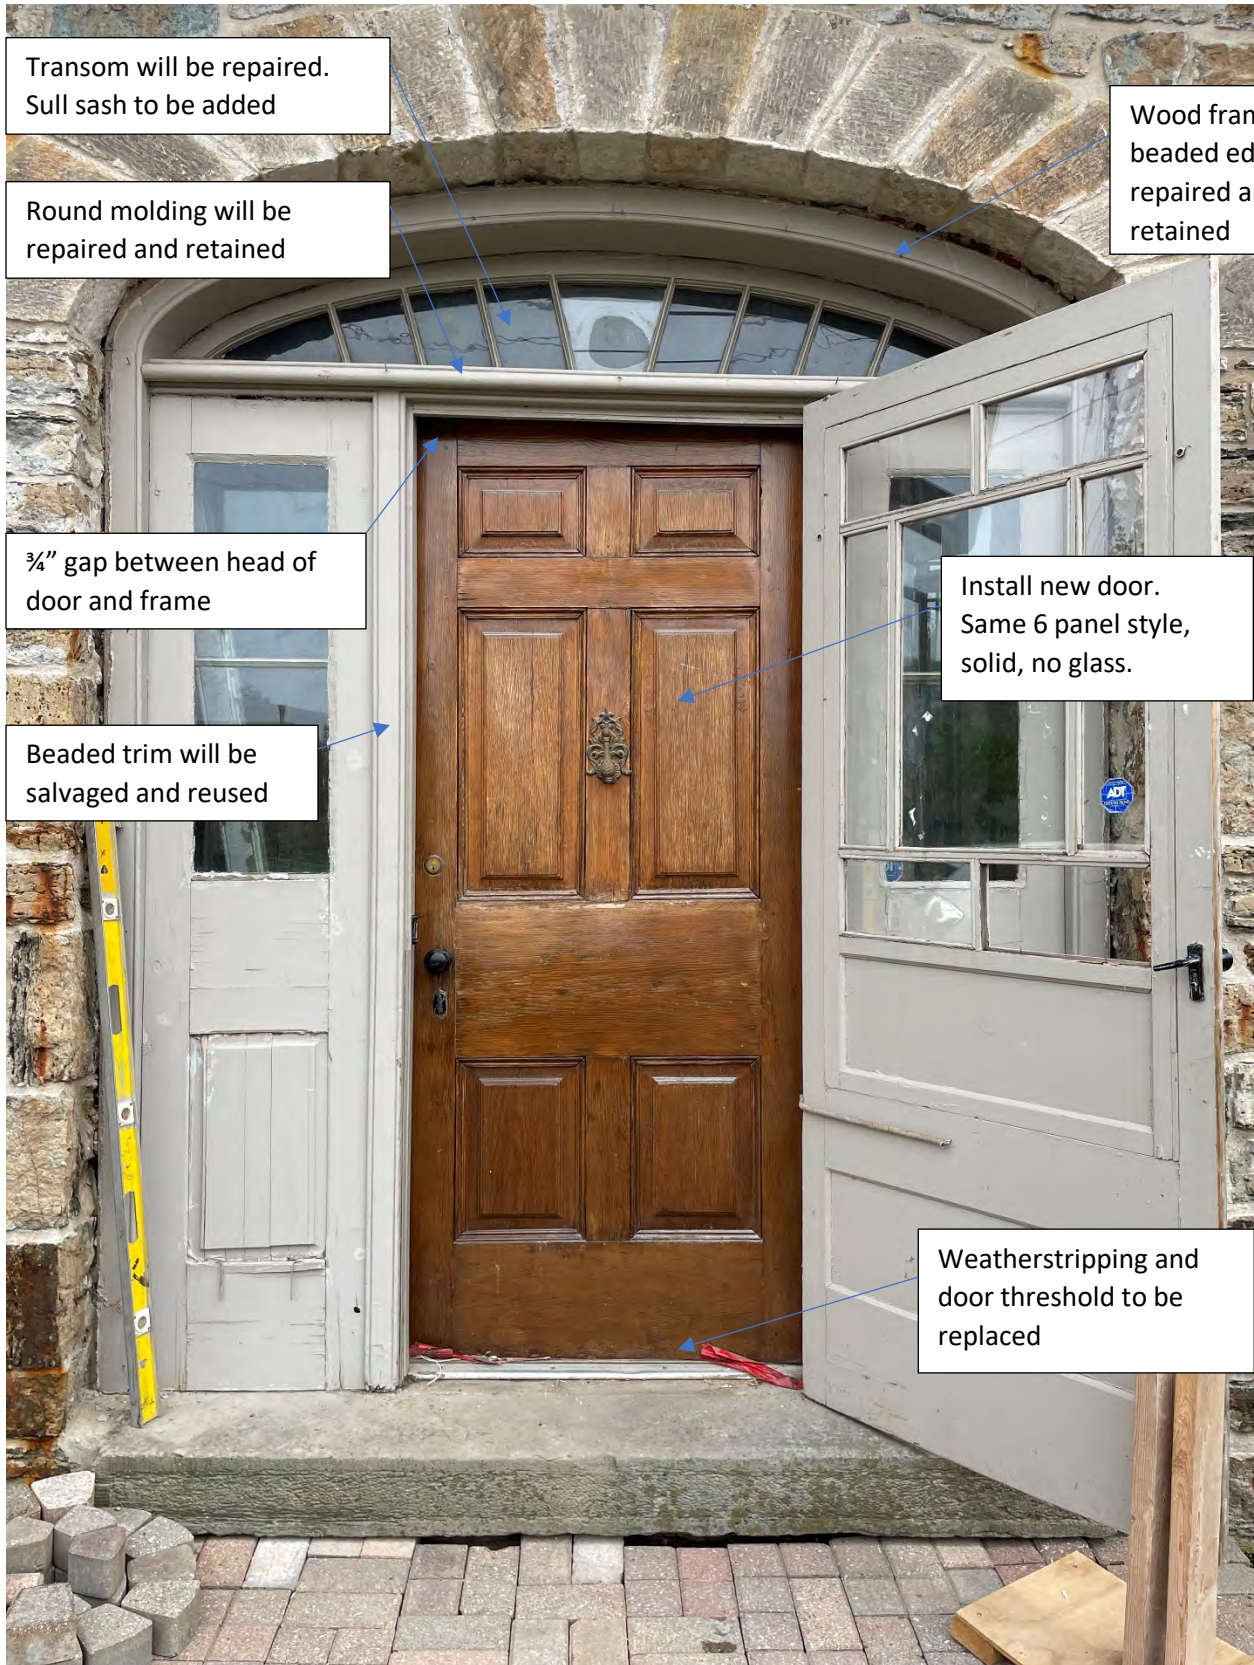
Round molding will be
repaired and retained

Wood frame with
beaded edge can be
repaired and will be
retained

$\frac{3}{4}$ " gap between head of
door and frame

Transom will be repaired.
Sull sash to be added

Install new door.
Same 6 panel style,
solid, no glass.

Beaded trim will be
salvaged and reused

Weatherstripping and
door threshold to be
replaced

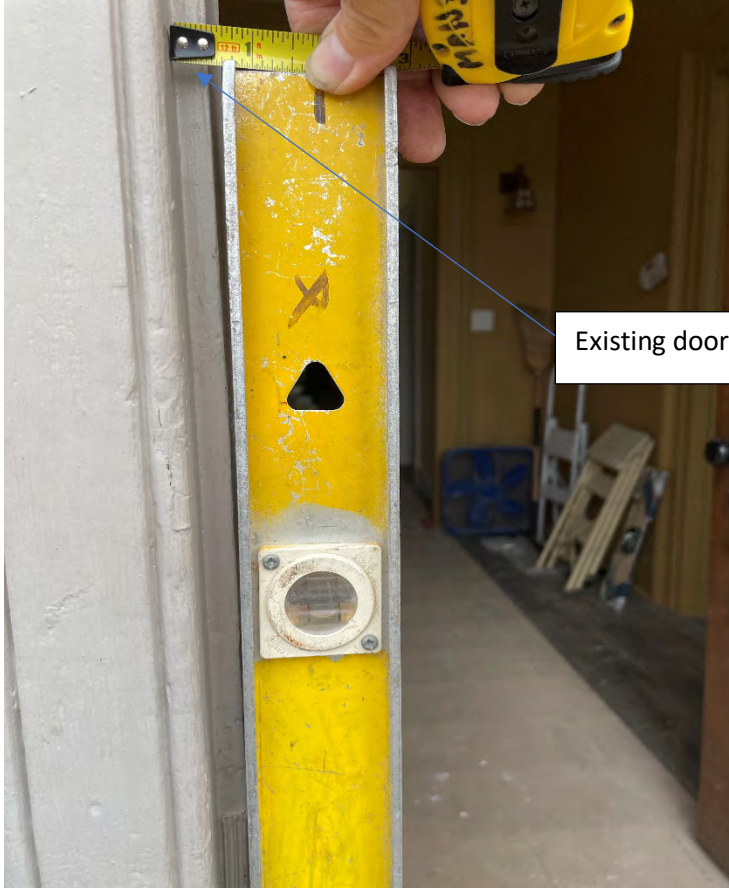
Existing door frame is 5/8" out of plumb over 4 ft.

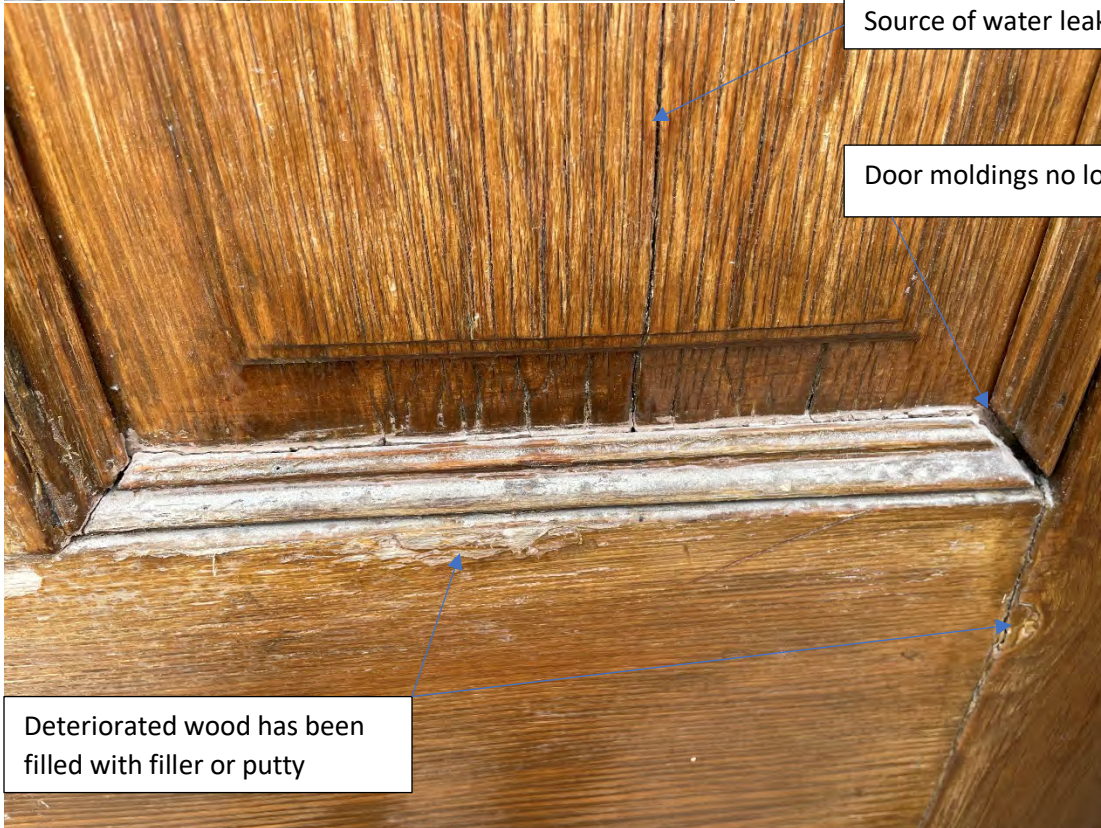
Wood door panels are split.
Source of water leaks.

Door moldings no longer fit

Deteriorated wood has been
filled with filler or putty

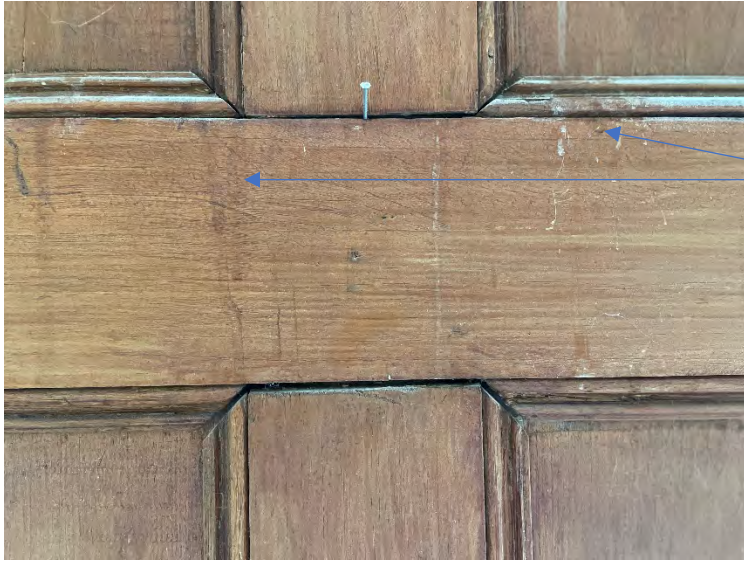
Numerous stains from water leaks

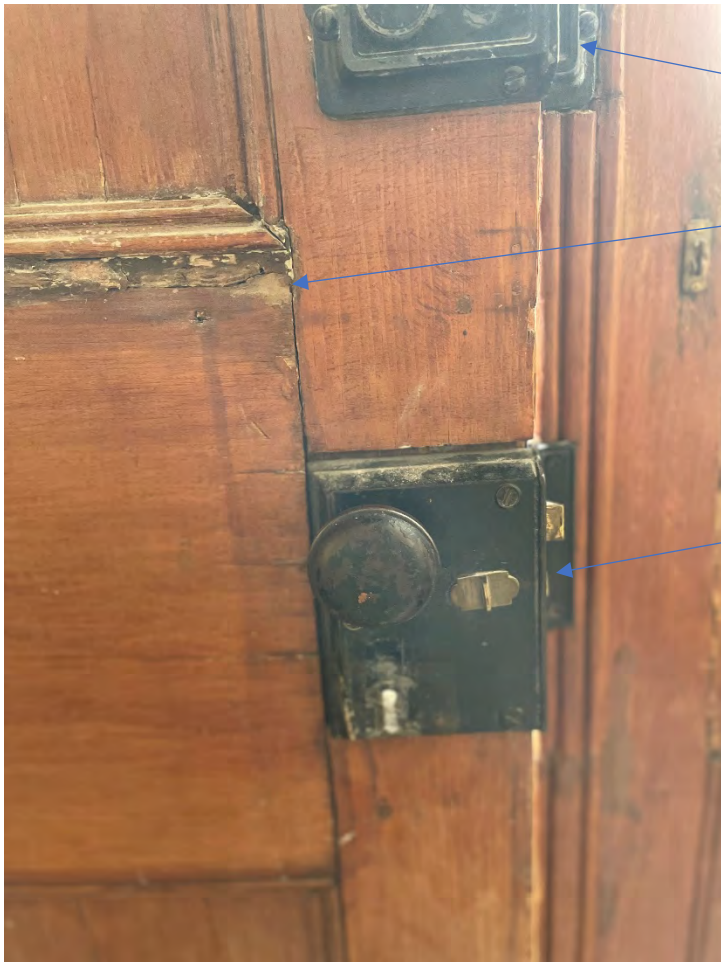
No key for lock

Rotten wood. Filler falling out.
Rain water leaks in

Hardware to be replaced

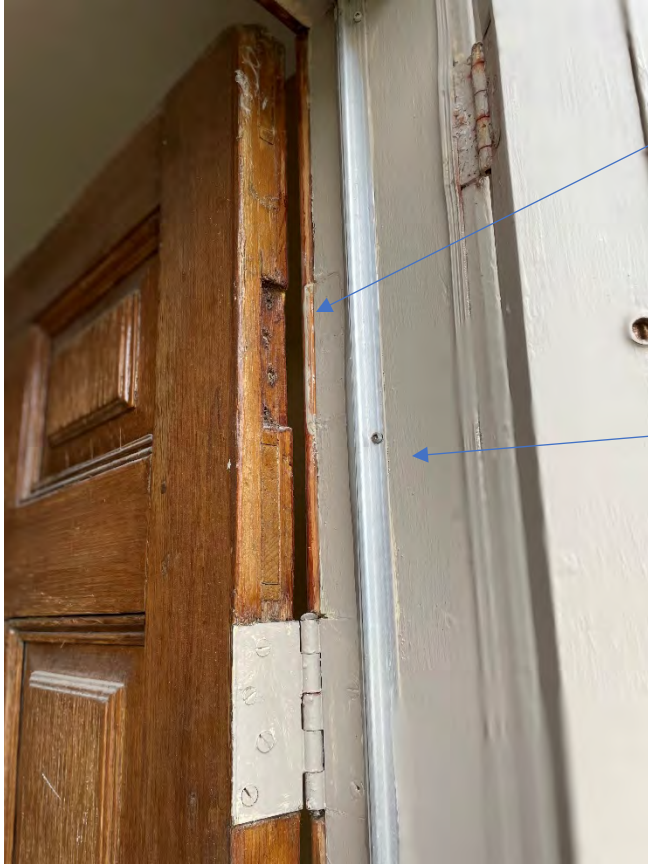
At some point the hinge position has been changed. Wood is rotten and will not hold a screw. New location below tenon is weak. Propose new 1 ½ pr hinges in lieu of 1 pr existing.

Install new frame, door, hardware and weatherstripping. Salvage and reuse all trim and moldings.
