24 Griffin Street
Revised Application - January 28, 2020

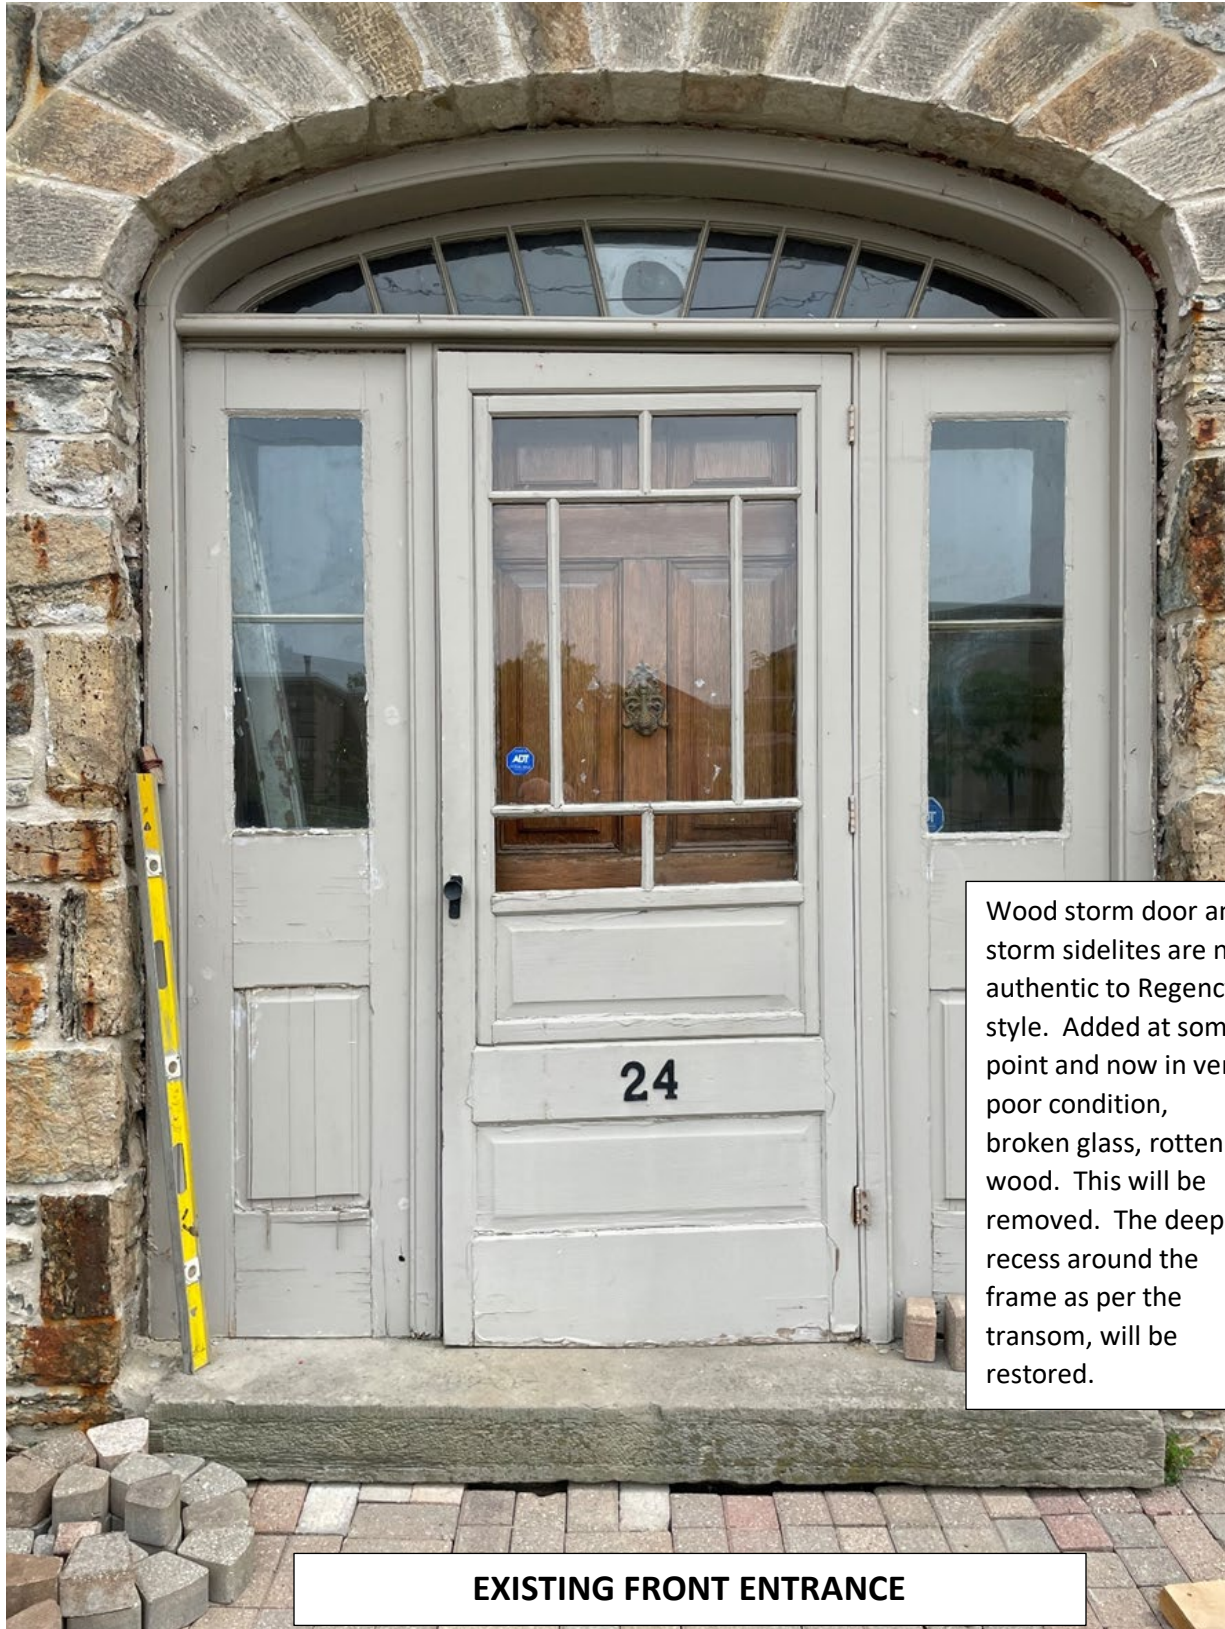
EXISTING FRONT ENTRANCE

Wood storm door and storm sidelites are not authentic to Regency style. Added at some point and now in very poor condition, broken glass, rotten wood. This will be removed. The deep recess around the frame as per the transom, will be restored.

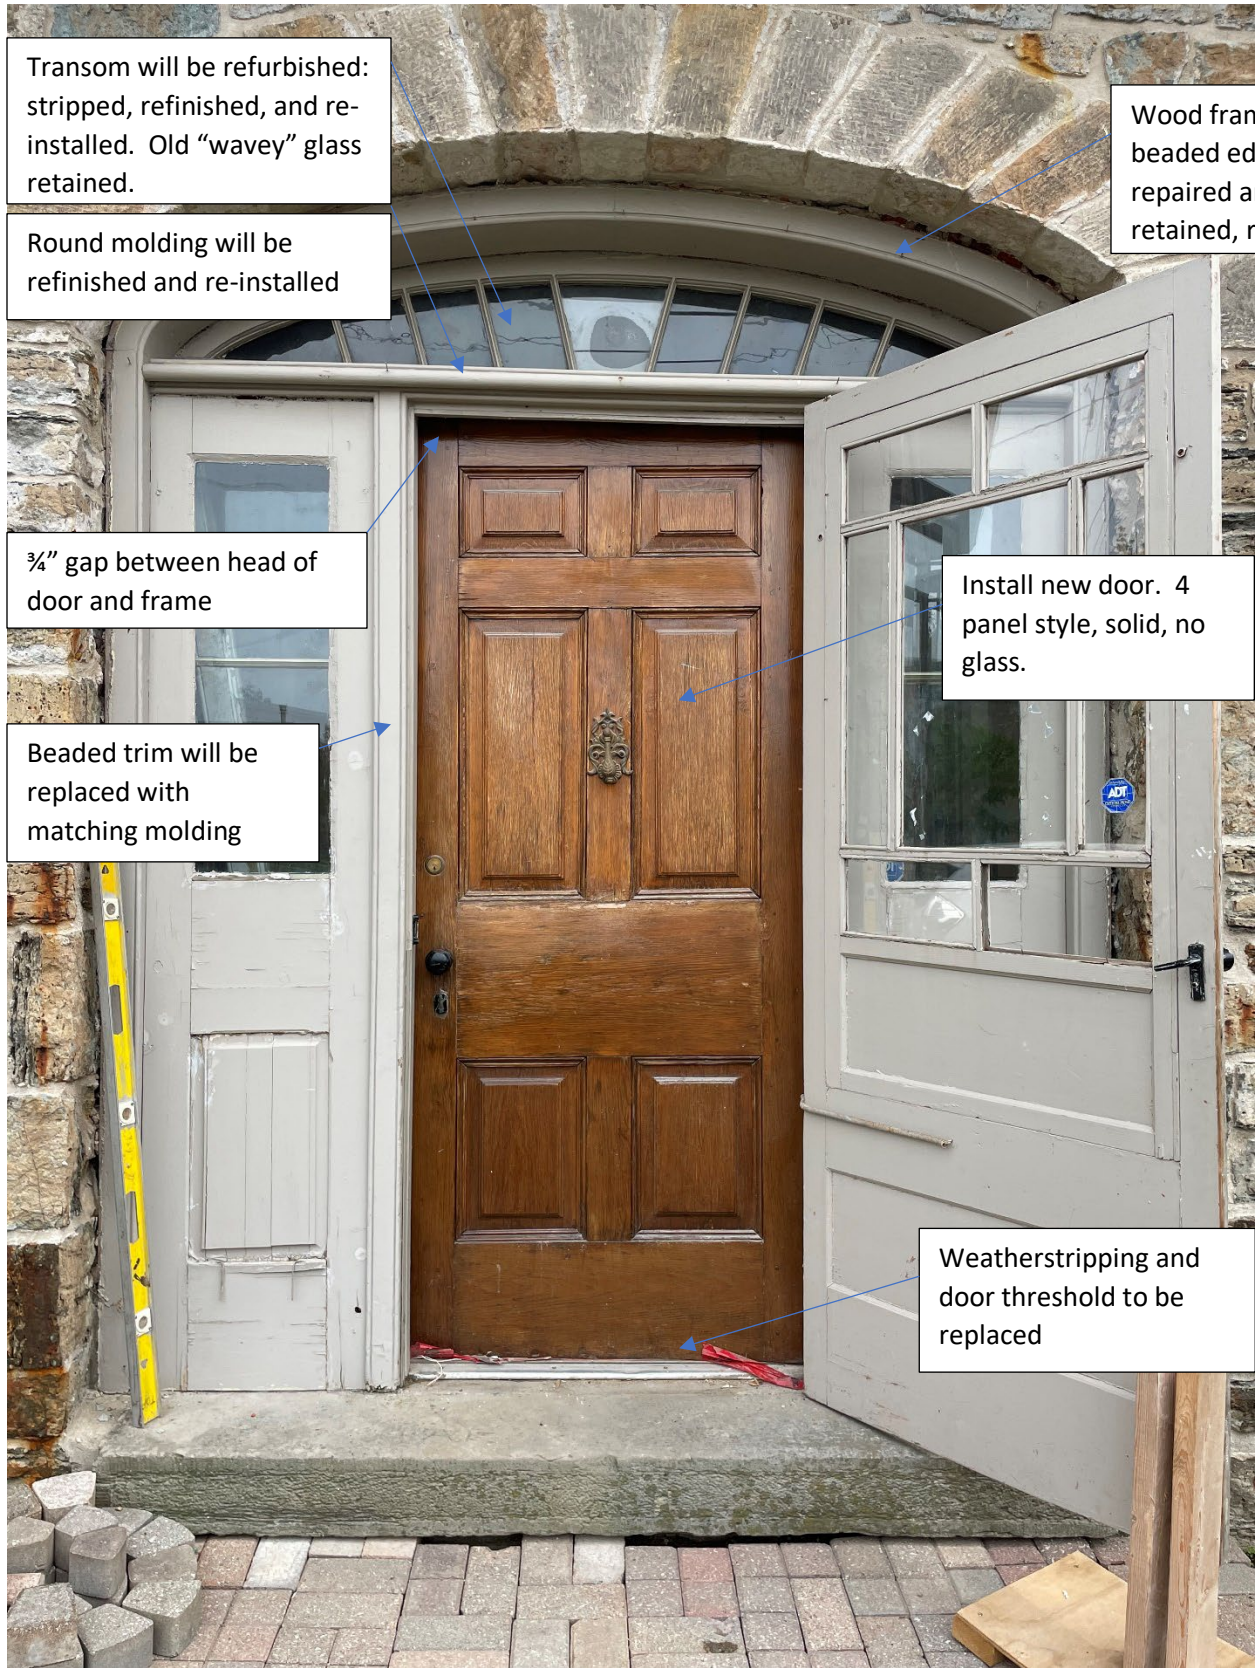
Wood frame with beaded edge can be repaired and will be retained, refinished

3/4" gap between head of door and frame

Beaded trim will be replaced with matching molding

Transom will be refurbished: stripped, refinished, and re-installed. Old "wavey" glass retained.

Round molding will be refinished and re-installed

Install new door. 4 panel style, solid, no glass.

Weatherstripping and door threshold to be replaced

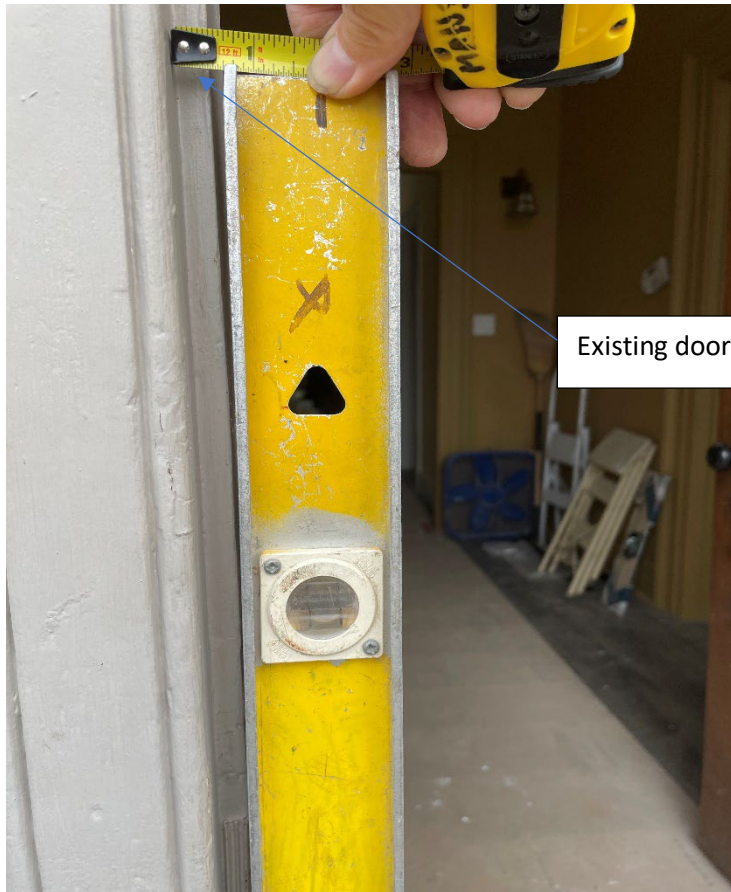
Existing door frame is 5/8" out of plumb over 4 ft.

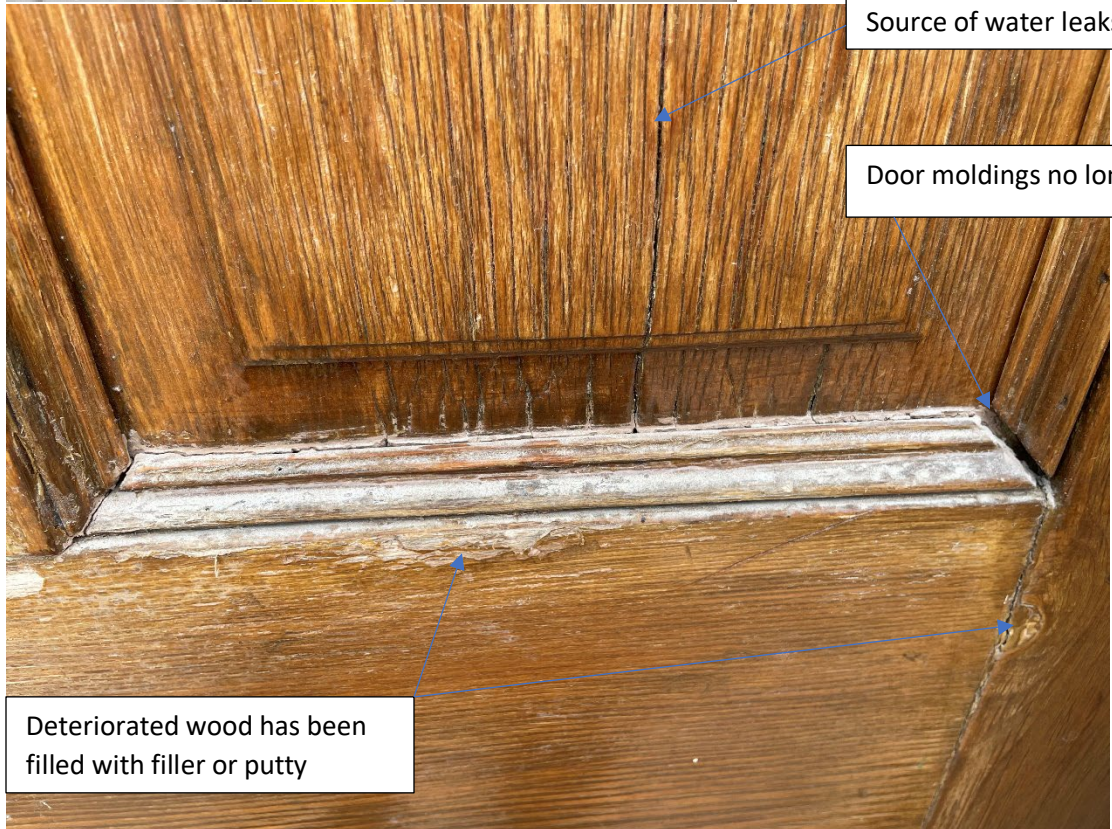
Wood door panels are split.
Source of water leaks.

Door moldings no longer fit

Deteriorated wood has been
filled with filler or putty

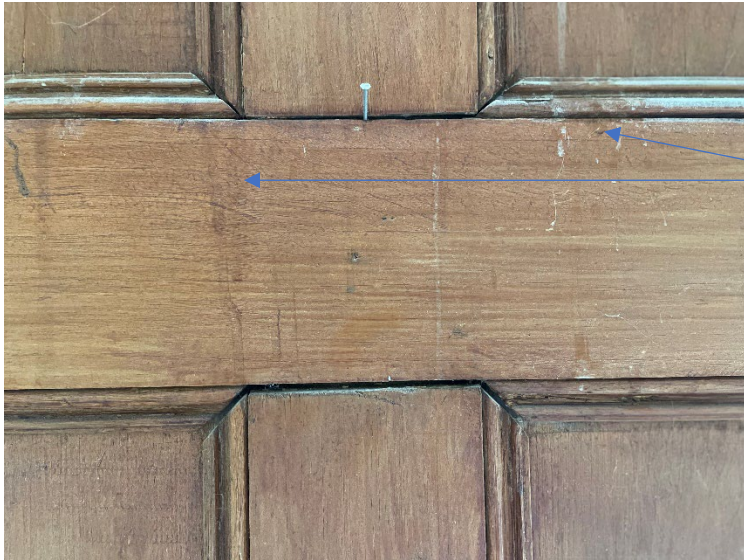
Numerous stains from water leaks

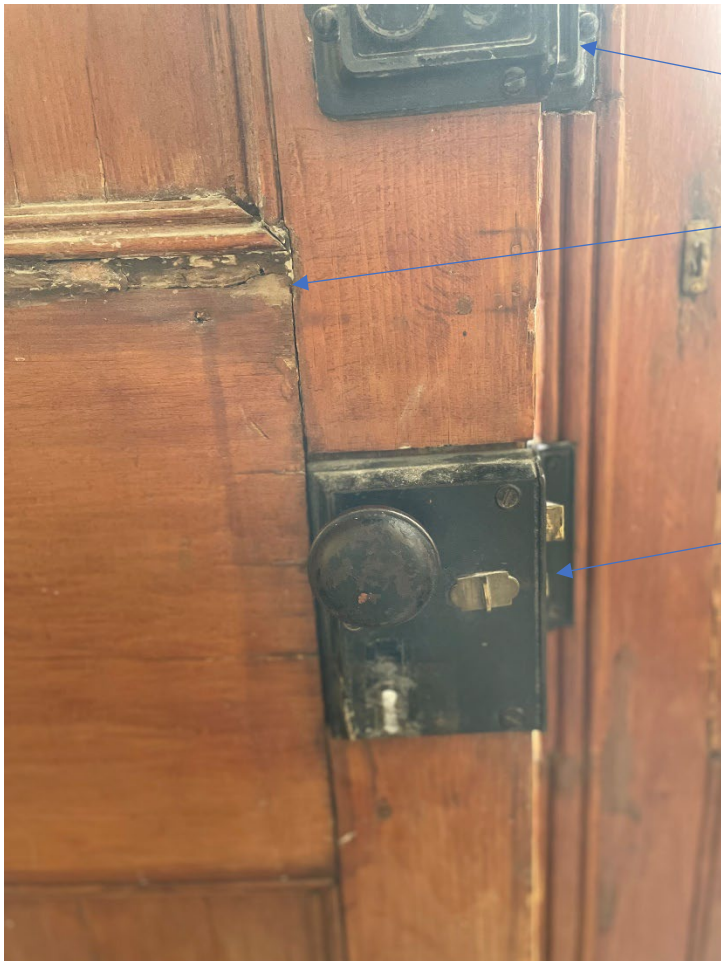
No key for lock

Rotten wood. Filler falling out.
Rain water leaks in

Hardware to be replaced

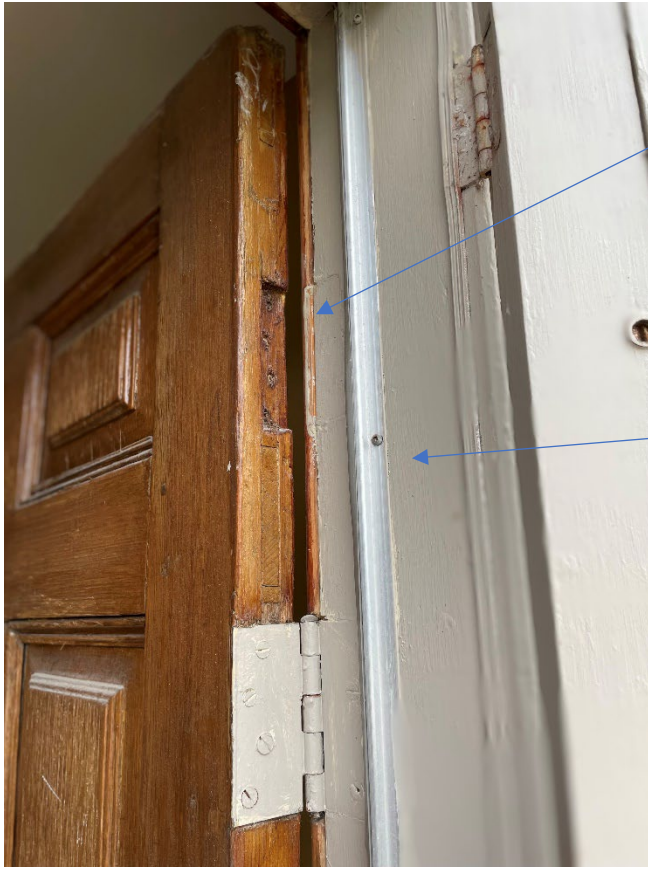
At some point the hinge position has been changed. Wood is rotten and will not hold a screw. New location below tenon is weak. Propose new 1 ½ pr hinges in lieu of 1 pr existing.

Install new frame, door, hardware and weatherstripping. Salvage and reuse trim and moldings where possible. Install new as required to match existing.
