# HERITAGE IMPACT ASSESSMENT

164 - 168 KING STREET EAST  
HAMILTON, ON

25 JULY 2022

MEGAN HOBSON CAHP  
M.A. DIPL. HERITAGE CONSERVATION  
Built Heritage Consultant  
[mhobson@bell.net](mailto:mhobson@bell.net)

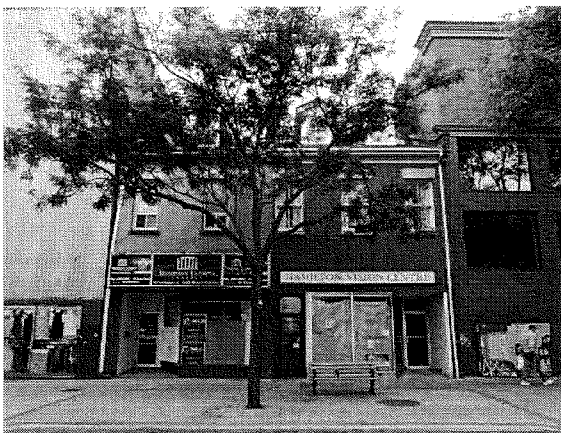
FRONT ELEVATION

Both buildings have been subjected to unsympathetic alterations and inappropriate repairs. The distinctive roofline of the original design with its dormers, brick parapets and brick chimneys are intact, but these elements are in very poor condition. The 2<sup>nd</sup> floor is generally intact and has symmetrically placed window openings with plain stone lintels and sills, but the masonry at #168 has been painted and the lower portion of the masonry at #164 has been parged over with stucco. The painting and patching of the masonry are 20<sup>th</sup> century interventions that were done as cheaper alternatives to re-pointing the wall or repairing areas that were damaged when signage was removed. There does not appear to be any original fabric remaining on the ground floor.

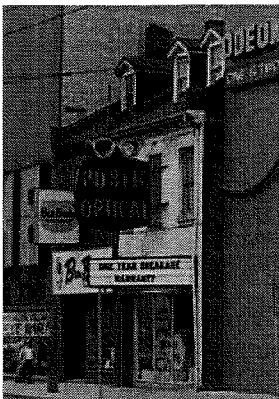
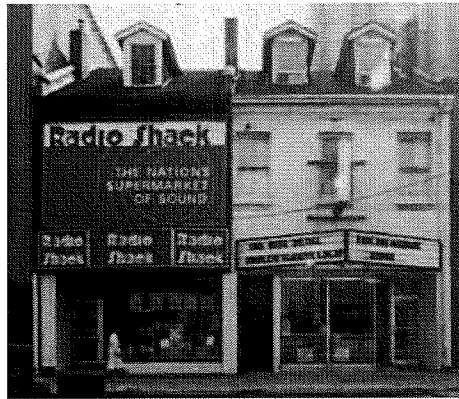
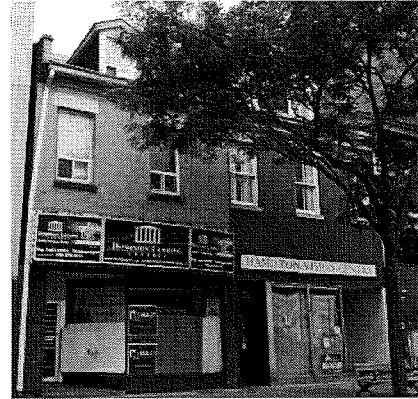
164 - masonry above the storefront was parged after the Public Optical signage was removed

168 - masonry on the 2<sup>nd</sup> floor was painted after the Radio Shack cladding and signage was removed

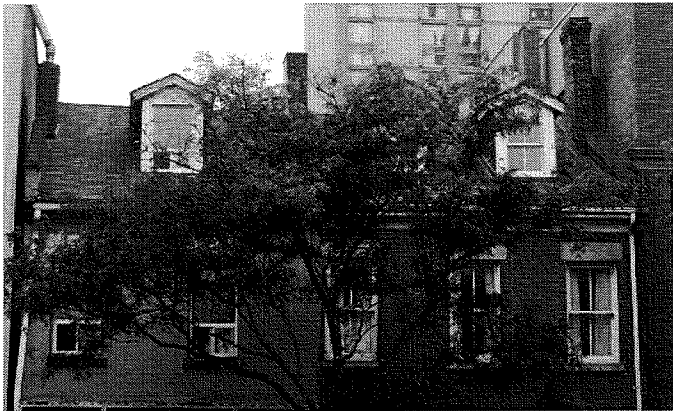
Original roofline is intact but is in very poor condition

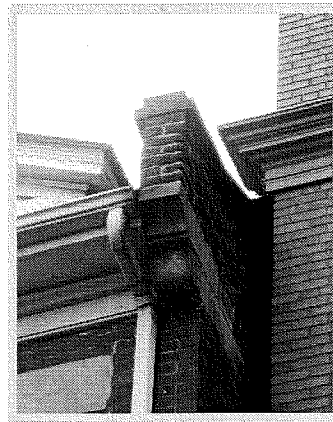
\*Potential salvage item: carved stone corbel

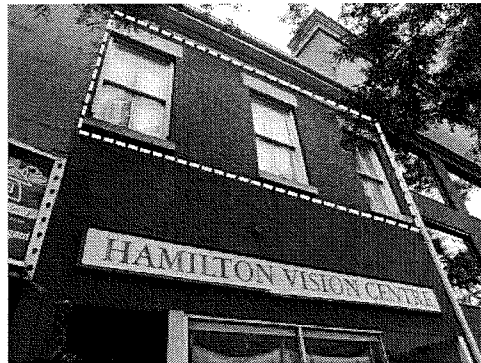
\* limit of historic fabric

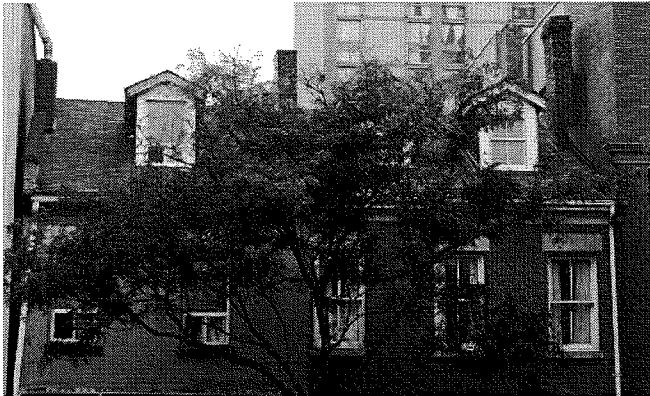
Original roofline is intact but is in very poor condition

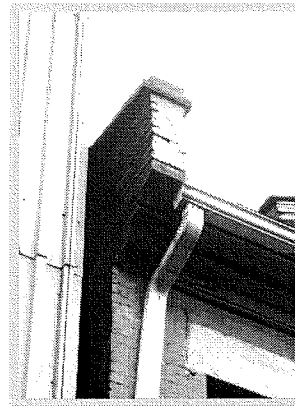
\*Potential salvage item: carved stone corbel

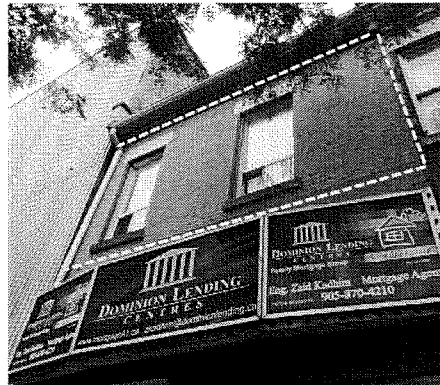
\*limit of historic fabric – masonry has been painted

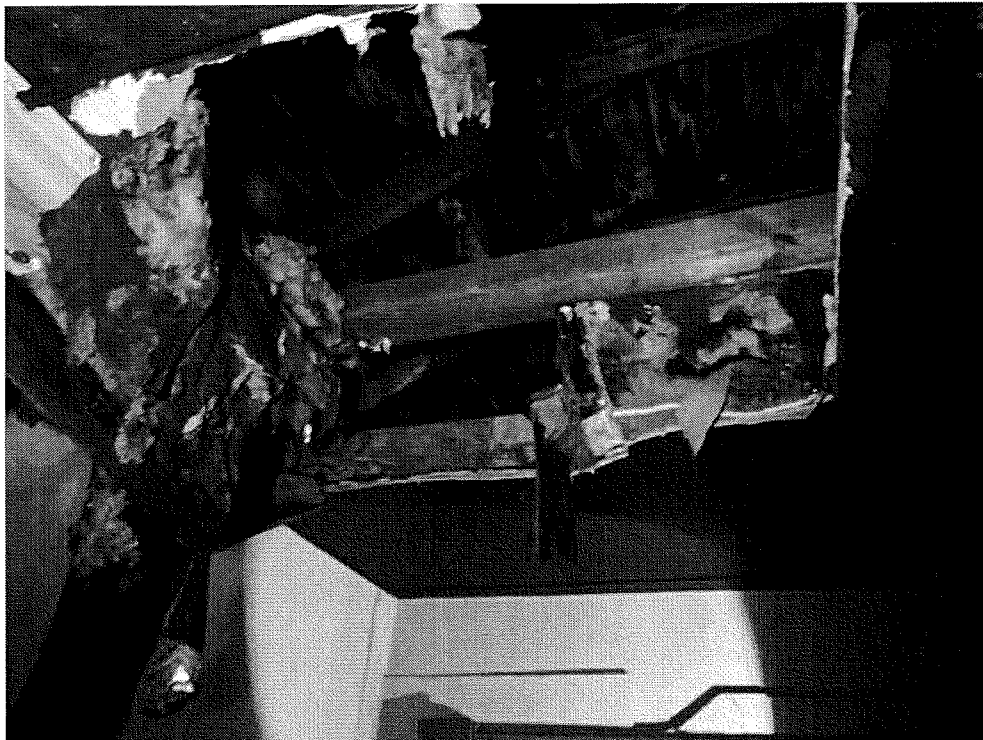
2<sup>nd</sup> FLOOR – rear section – original roof framing visible through a hole in the ceiling – evidence of water and fire damage

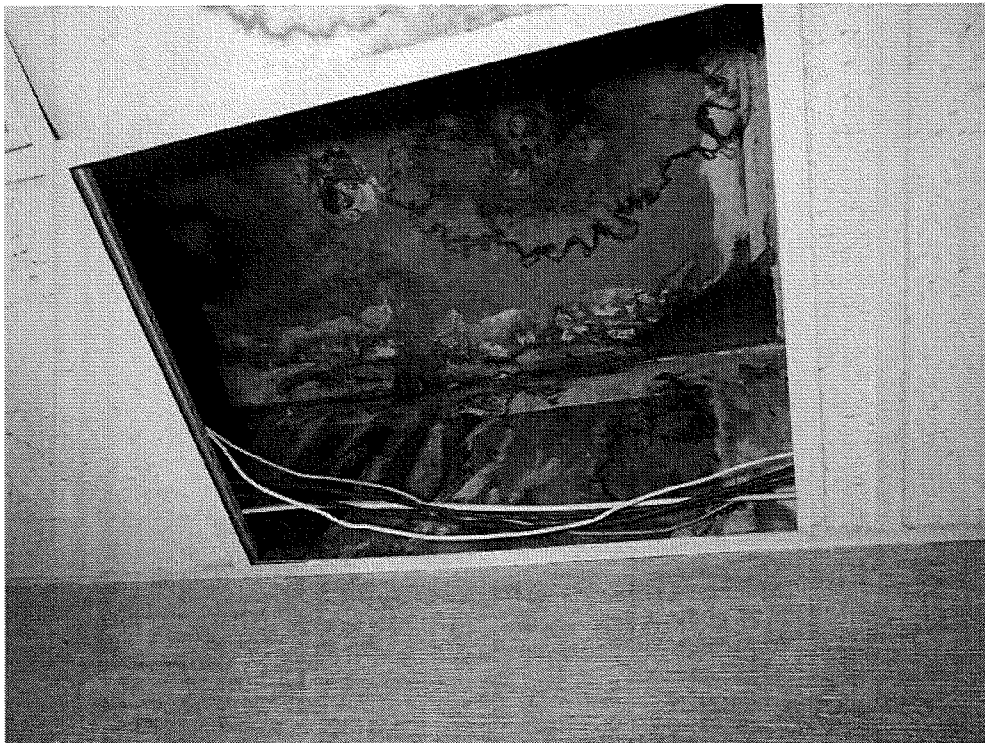
2<sup>nd</sup> FLOOR DENTAL OFFICE – evidence of water damage and mould above the acoustic tile ceiling

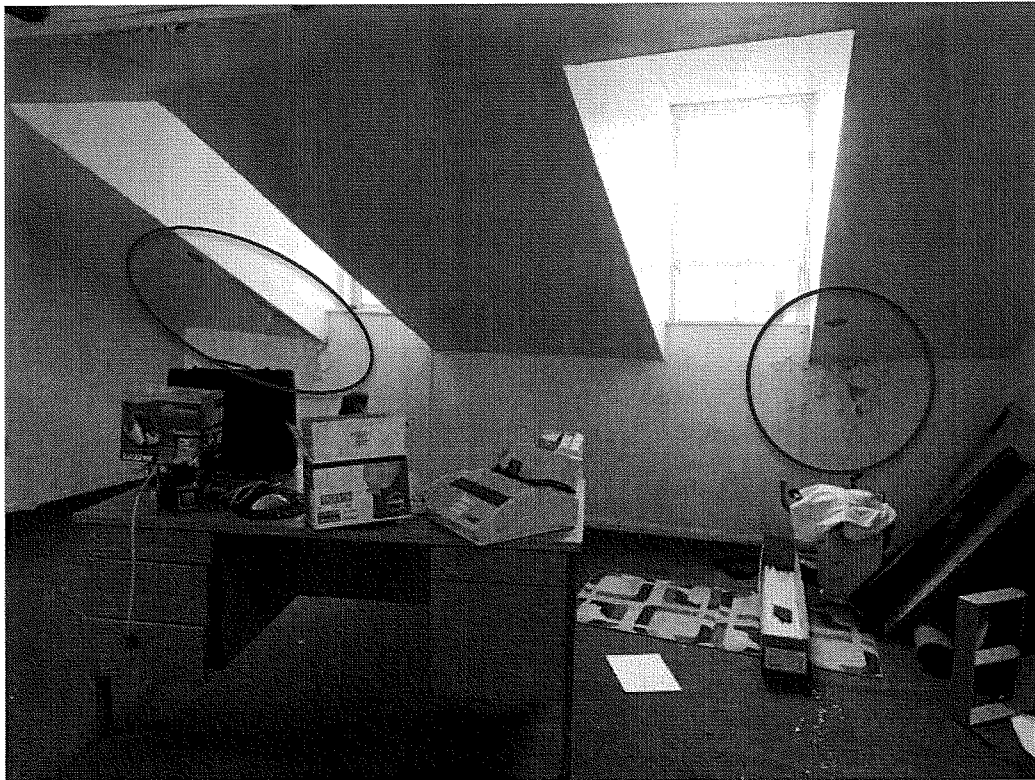
ATTIC – evidence of water damage around the roof dormers – no historic fabric

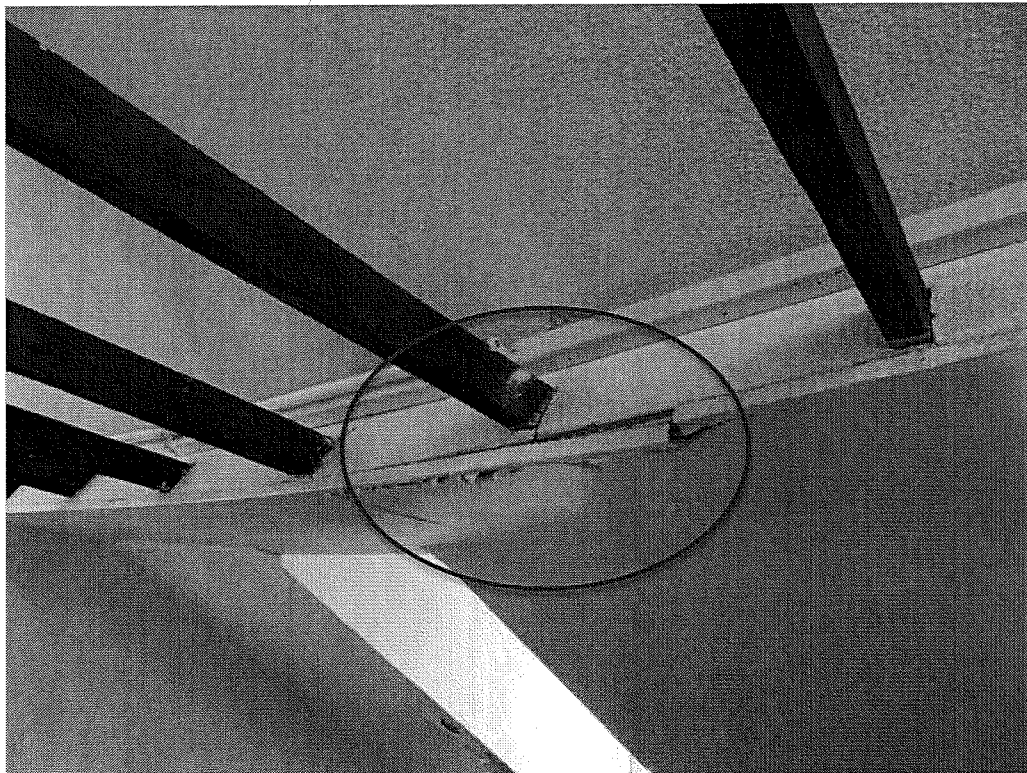
ATTIC – evidence of structural issues that has cause deflection of structural beams

The roof support above Unit 164 is overstressed (excessive deflection and rotation). It is likely that the beam is under-designed or compromised during past renovations. Temporary shoring is recommended.

- ii.) Provide temporary support until further decision are made  
Shores are recommended for Unit 164 for the roof support system.
- iii.) Restore building  
This option is possible but deemed to be expensive. Replacement of structure is required (roof support of Unit 164) as well as reinforcing required to ensure structure is capable of supporting the Building Code specified loading. Structural analysis has not been completed but ground floor will require a  $4.8 \text{ kN/m}^2$  (100 psf) live load capacity if commercial. The second floor will require  $2.4 \text{ kN/m}^2$  (50 psf) live load capacity if office space or  $1.9 \text{ kN/m}^2$  (40 psf) live if residential. It is estimated that the office or residential load capacity can be readily achieved. Even if the structure is restored, it is still an old building, attention to building envelope and roofing must be considered in regard to thermal efficiency and long term integrity.

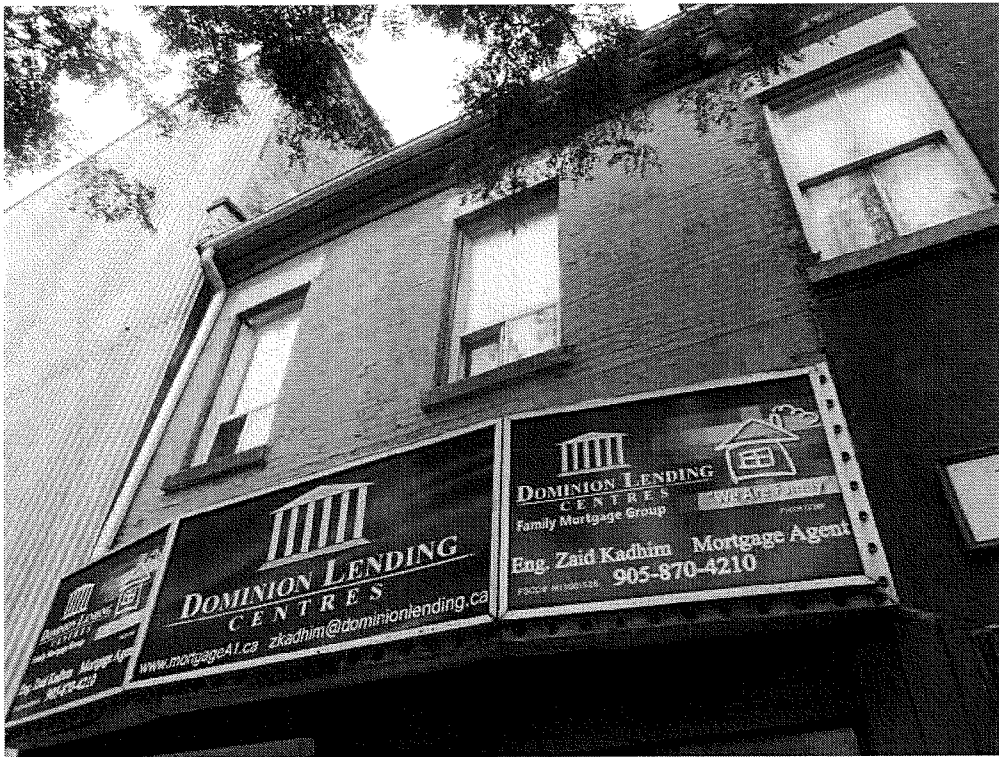
MAIN FAÇADE – original exterior wall and two window openings on the 2<sup>nd</sup> floor are intact but the masonry has been painted and vinyl windows have been installed

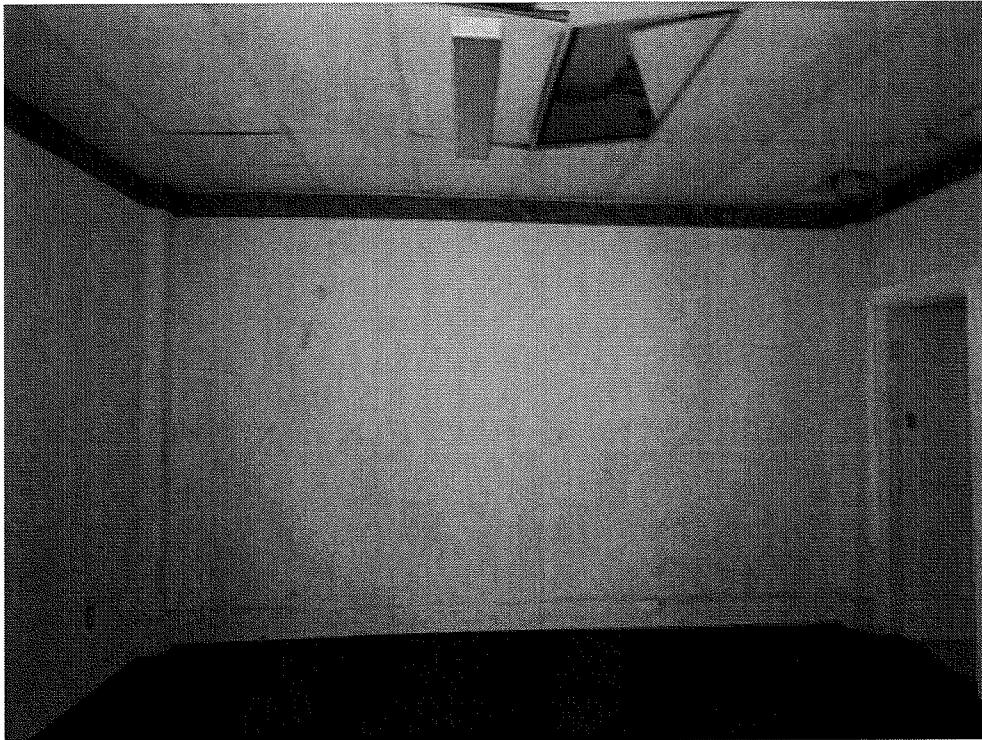
2<sup>nd</sup> FLOOR LIVING ROOM – no historic fabric – evidence of water damage to ceiling

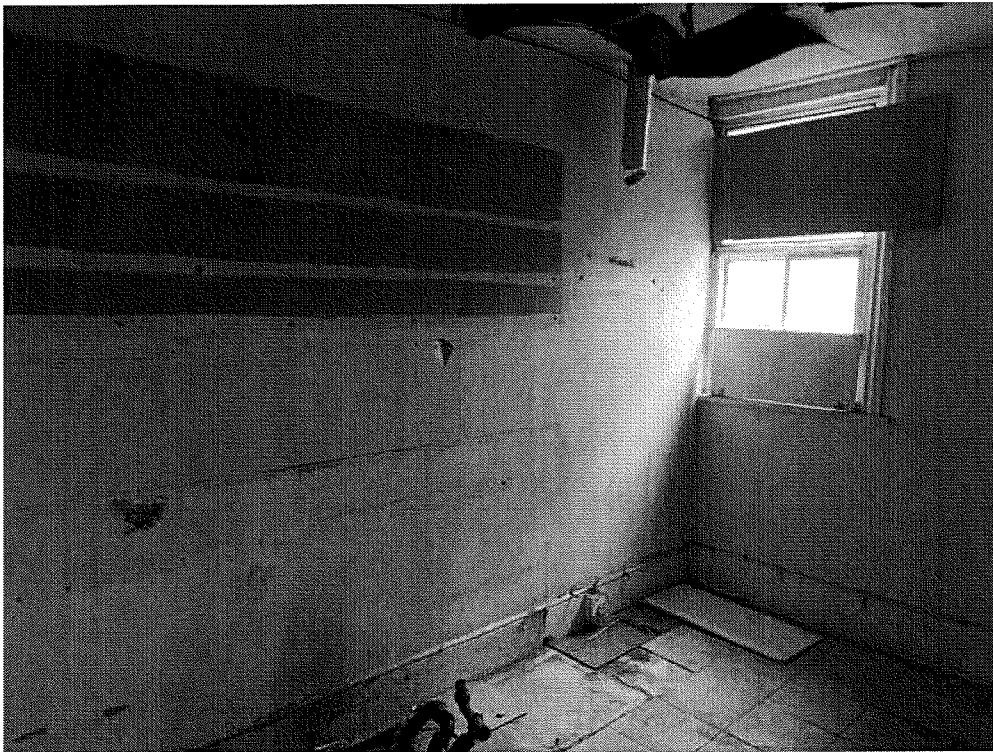
2<sup>nd</sup> FLOOR KITCHEN – window trim is late 19<sup>th</sup> century – evidence of extensive water damage to ceiling and floors

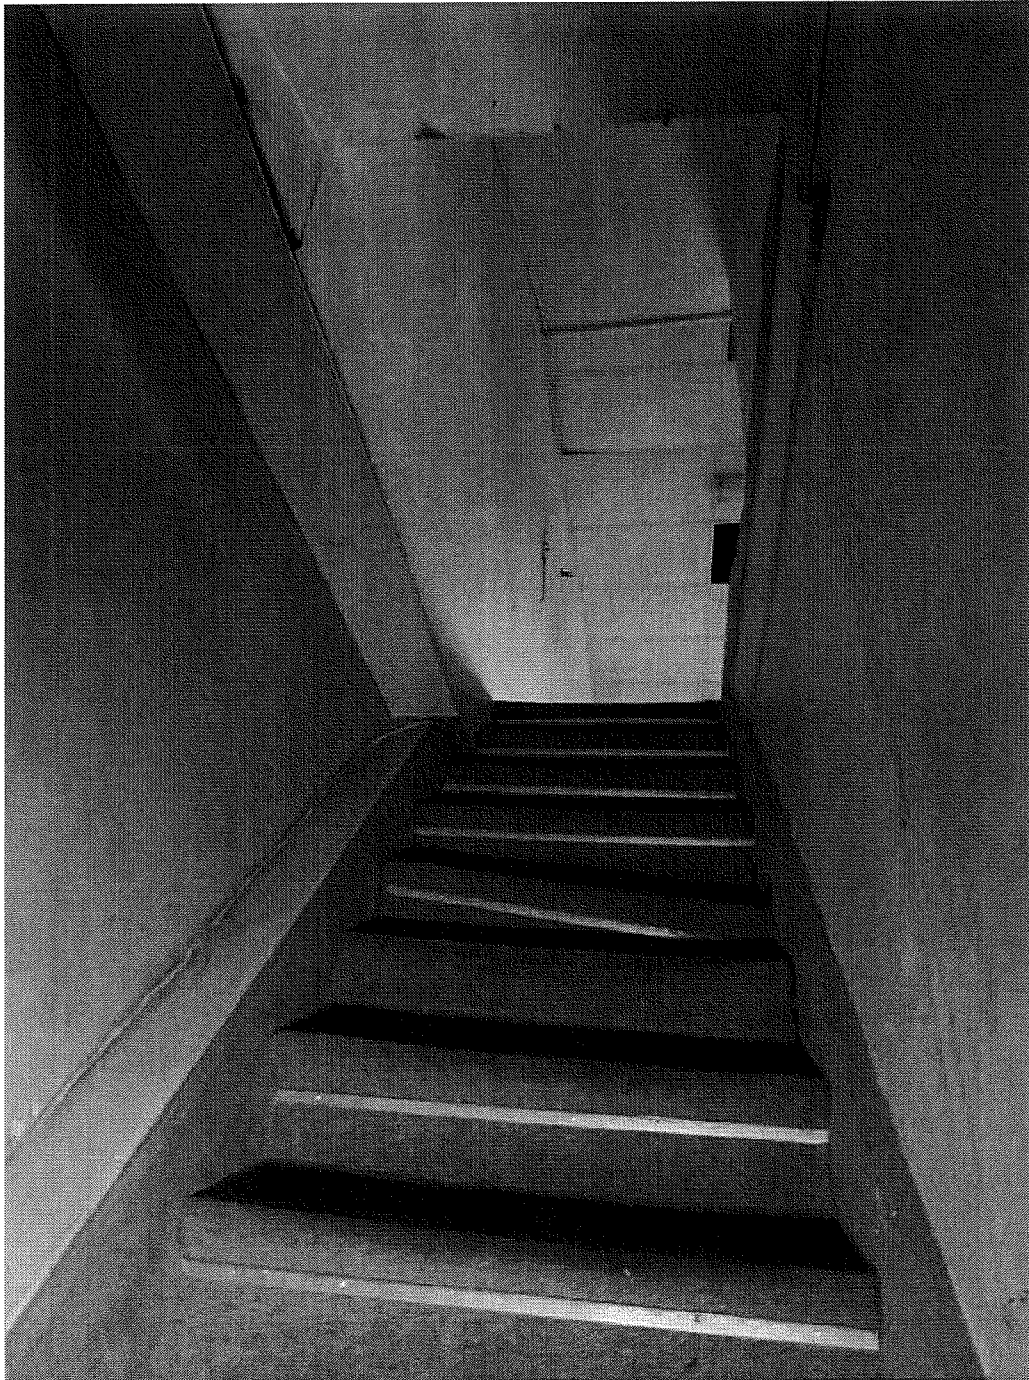
ATTIC STAIRS – steep staircase to the attic with no handrails – evidence of rot in the stair treads & stringer
