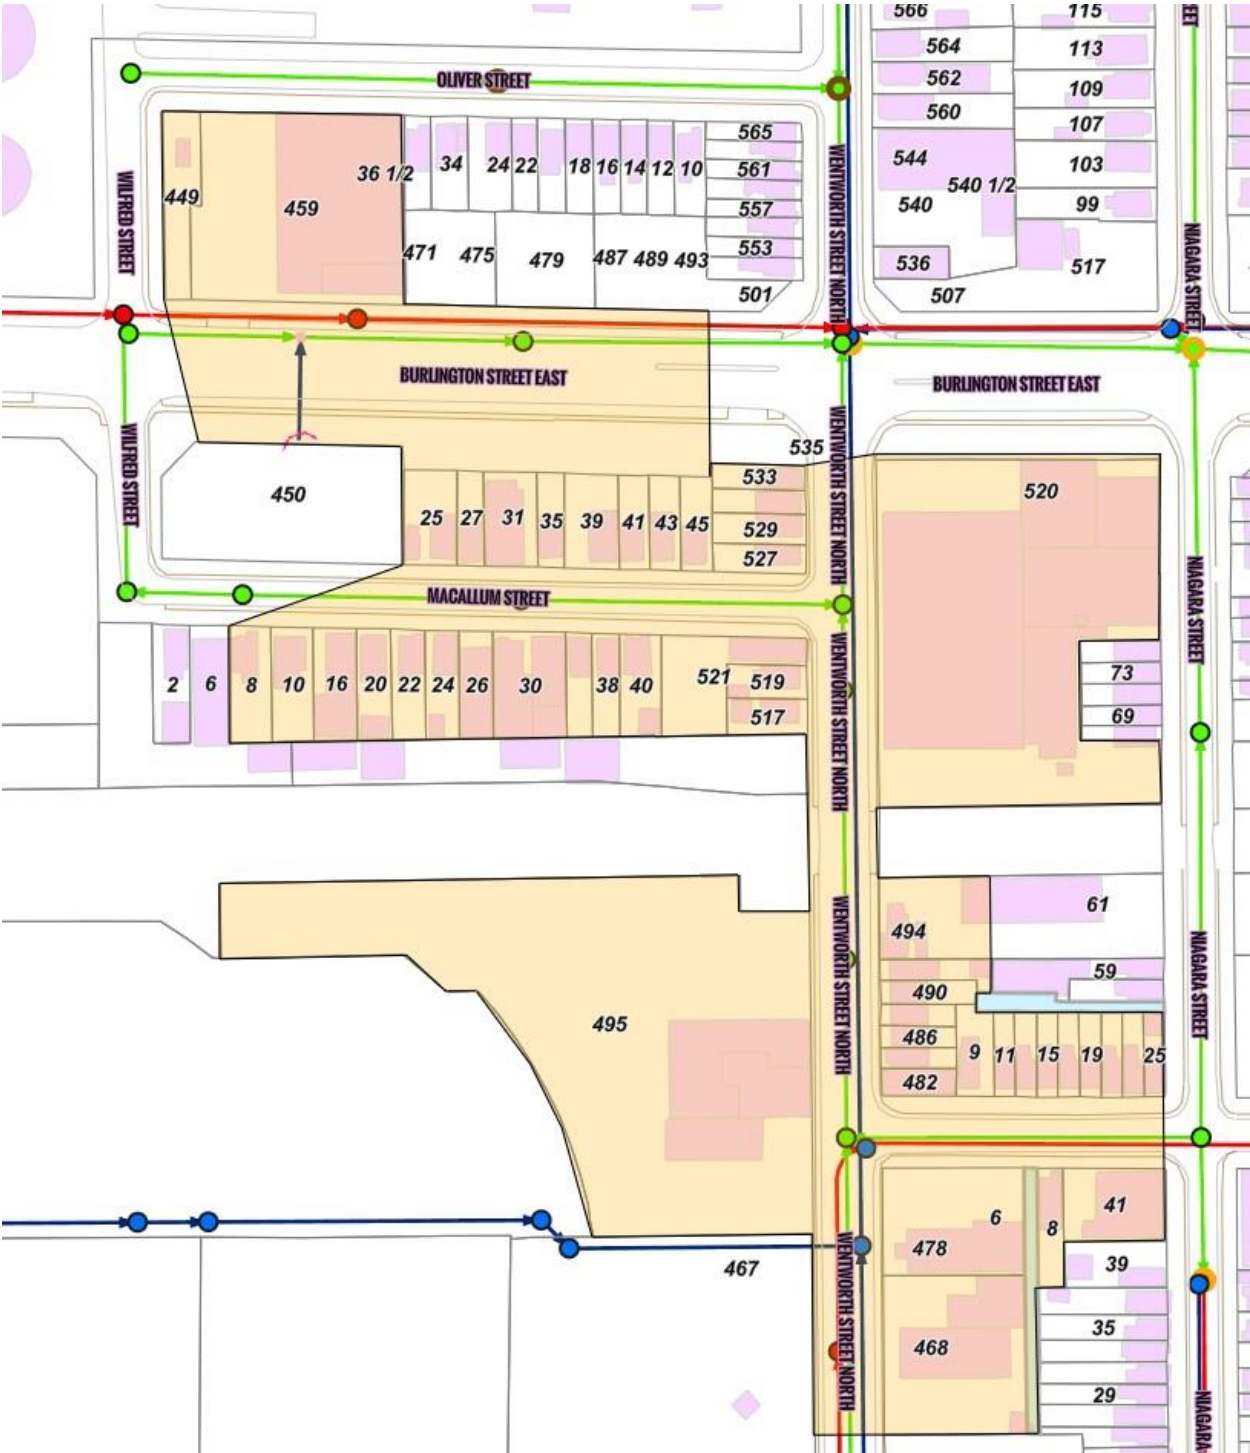
Properties within the shaded area below were identified as being connected to the combined sewer causing the spill.
