Russel Christie House Condition Assessment Rev1

1541 Fiddlers Green Road
Ancaster, Ontario

August 17, 2023

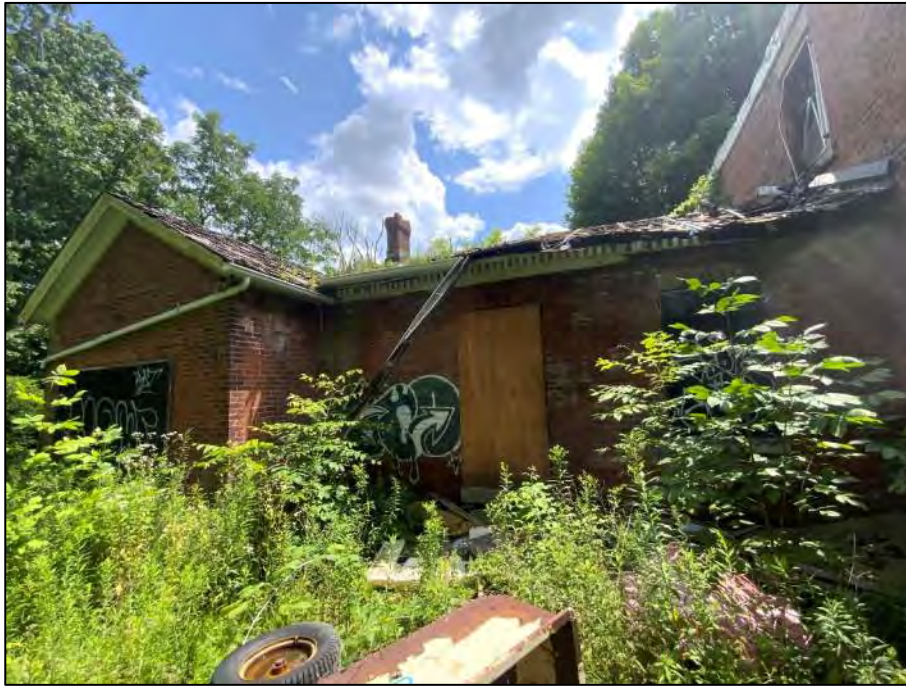
Photograph 1: Rear Link Roof

The main house roof framing was completely consumed in the c. 2017 fire. The roof of the rear link to the garage was in an advanced state of disrepair with holes in the roof. This roof structure is at risk of collapse and was found to be in poor condition. Prolonged exposure to water and the environment has damaged the rafters to the state that they are no longer considered sound.

- The roof framing of the main house and rear link requires complete replacement, along with associated sheathing and shingles.

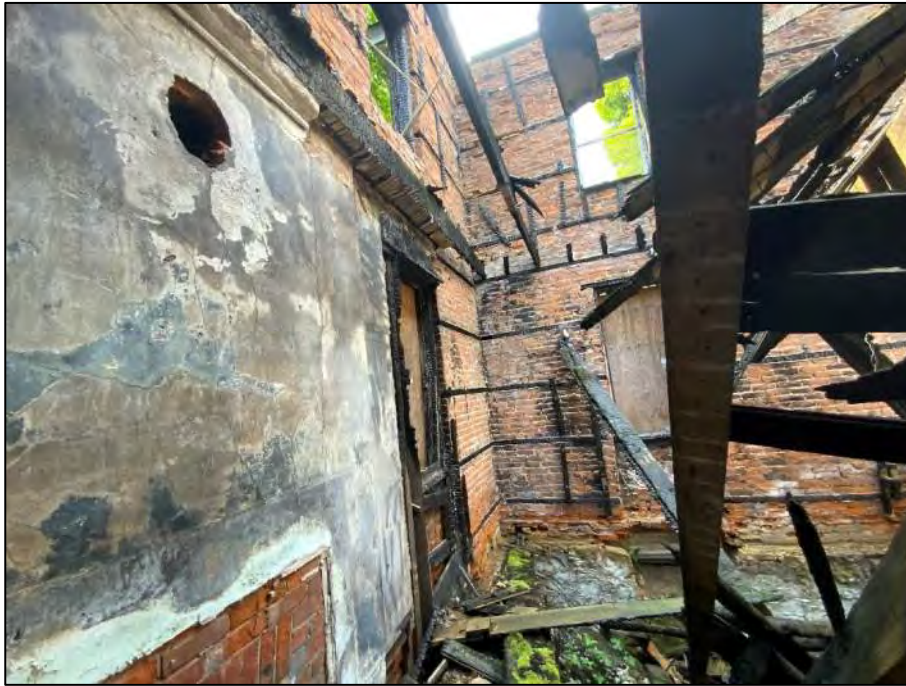
Photograph 2: Interior Framing

The main floor framing has collapsed into the basement in the majority of the house and is not considered safe to enter. It was found to be in poor condition. The upper floor framing was mostly consumed in the c. 2017 fire and the remnants were at risk of collapse. The heavy timber basement beams have structurally failed and as such, were also in poor condition.

- The entire interior framing requires complete replacement, along with associated floor sheathing and finishes.
- The entire interior framing of the building poses a safety hazard. Removal of the remaining framing material is required prior to safe working conditions being established.
