Forest Lane Farms House
(also known as Russell Christie House)
1541 Fiddlers Green Road, Ancaster, Ontario

Documentation & Salvage Report
Prepared for: Leanne Dekaneas

Revision 1: August 18, 2023

Re: 1541 Fiddlers Green Road, Ancaster, ON – Documentation & Salvage Report – Revision 1

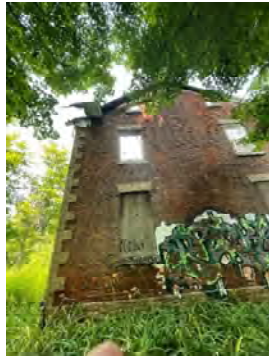
Figure 7 East Façade Graffiti

Graffiti is a common sight throughout the building. Most are on the interior but some larger ones are seen prominently displayed on the façade of the house and on the garage walls.

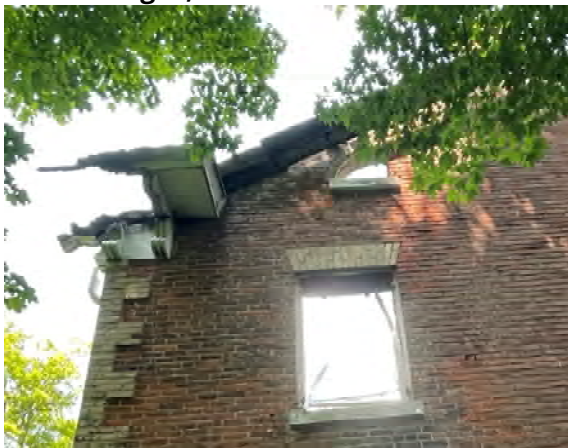
Figure 9 View of the damaged eaves trough and brackets. This is a typical condition of the soffits, fascia and brackets.

The fire has destroyed the roof above the main house. There remains little examples of carpentry. See Figures 9 – 13. Eaves troughs have completely burnt away along with all other supporting members over the main house. All rainwater leaders are no longer visible. Fascias have been destroyed. The same case remains for most of the soffits except for what remains above the garage.

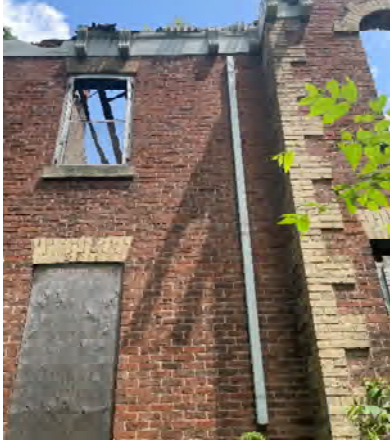
The exterior carpentry above the garage has some portions intact however still sustained a large amount of damage and is thus not feasibly intact enough for salvaging. Wood appears to be rotted or in the process of rotting. What remains has continued to deteriorate along with the rest of the house.

Figure 10 Remnants of the front facades' soffits

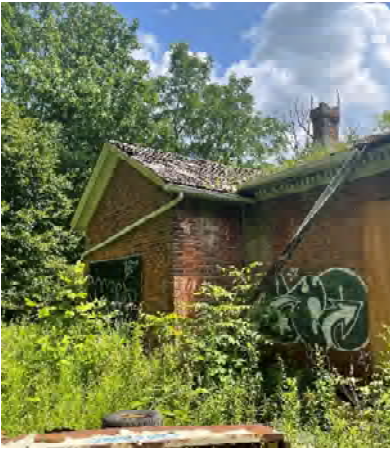
Figure 11 View of remaining damaged soffits to the rear of the house above the garage.

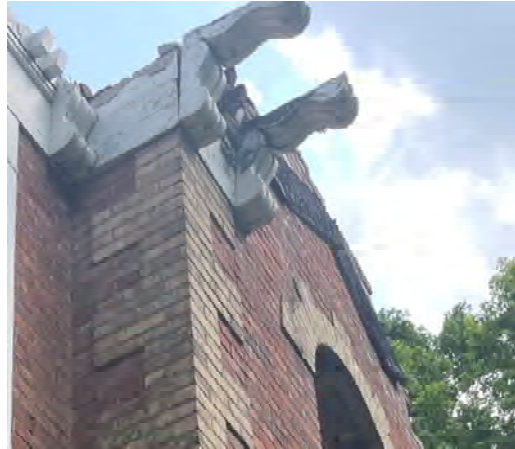
Figure 13 View of damaged brackets at the second level of the front façade.

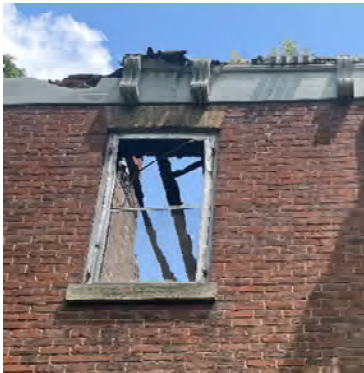
There remain no examples of the original carpentry and glass. Frames that remain such as the one of two examples seen in figure 14 and figure 15, are not original.

Figure 14 View of one of the remaining window frame on the front façade. These do not appear to be original and are in a damaged state.

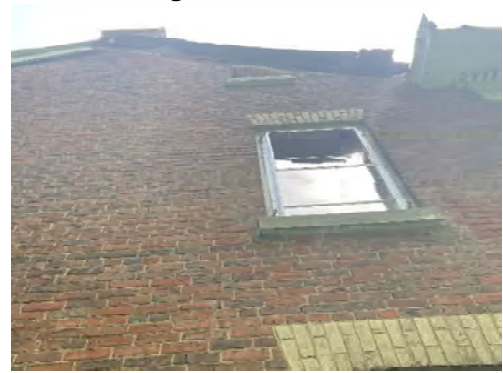
Figure 15 One of the remaining windows was damaged by the fire (West façade second-floor)

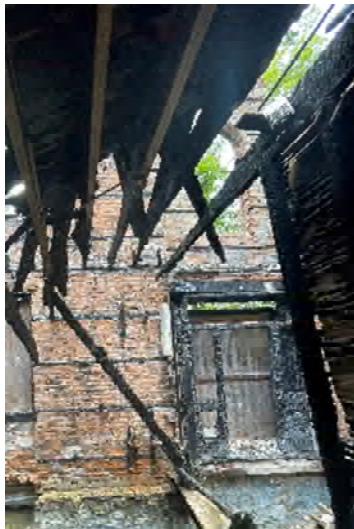
Figure 17 Interior view of the front of the house showing the charred remains of the front door. This is not in a salvageable condition.

The front door, including side lights and fan lights, and all related woodwork, has been destroyed by the fire in 2017. There remains no evidence of these elements.

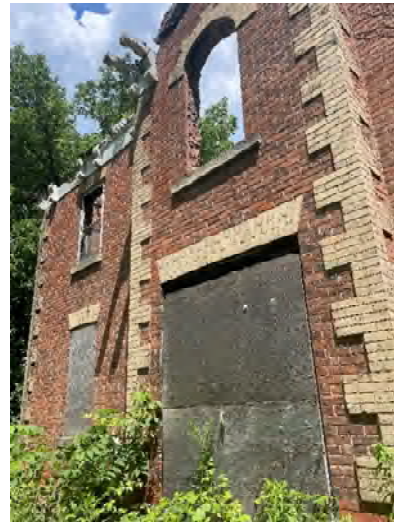
Figure 18 Exterior view of the front of the house showing the boarded front door entry.

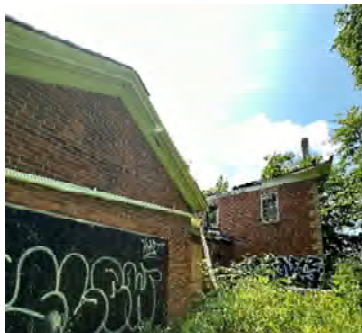
Figure 20 View of the existing chimney at the front of the building.

The chimneys were found to be in very poor condition. As shared in structural assessment report prepared by Tacoma Engineers dated August 17, 2023 'The three chimneys were found to be in intact, but in very poor condition. The chimneys have loose bricks at the top that are considered a fall hazard.' Hence the existing chimneys are not in a salvageable condition and would need to be removed.

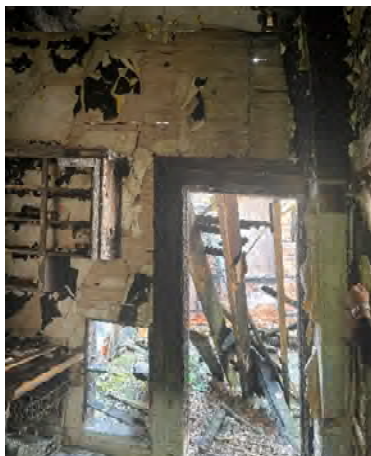
Figure 21 Condition of interior elements - heavily deteriorated and not intact.

All these elements have been destroyed or damaged by the fire. What is left after the fire has decayed or has been vandalized. Please refer to Appendix C for more interior photos.

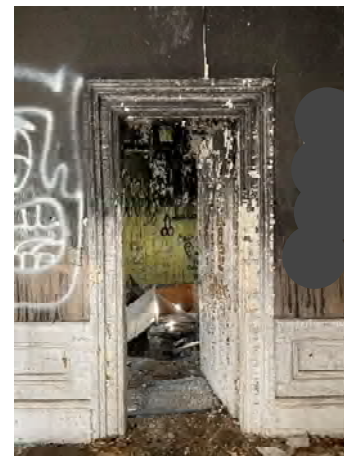
Figure 22 Damaged door surround and adjacent walls.

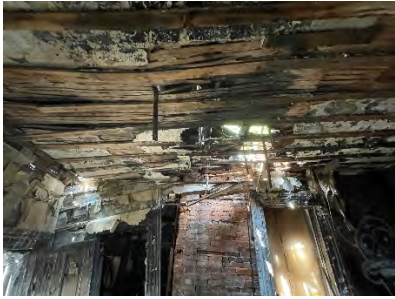
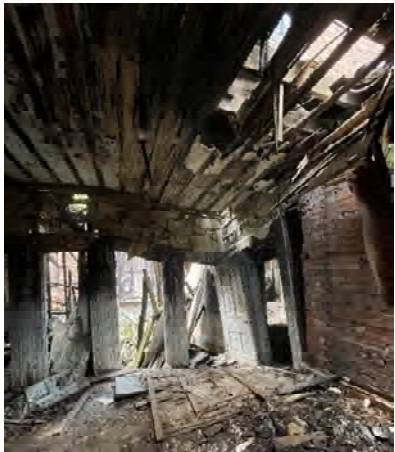
Figure 23 Interior view of the house showing the collapsed second floor. The second floor has collapsed down to the basement in the main portion of the house.

All the Pine floors on the second floor were destroyed by the fire and collapsed down to the first floor. There remains no evidence of the second floor, other than the collapsed remains of burnt rotting wood.

Given the second floor is sinking at site, the interior conditions are highly unstable and unsafe. Please refer to Appendix C for more interior photos.

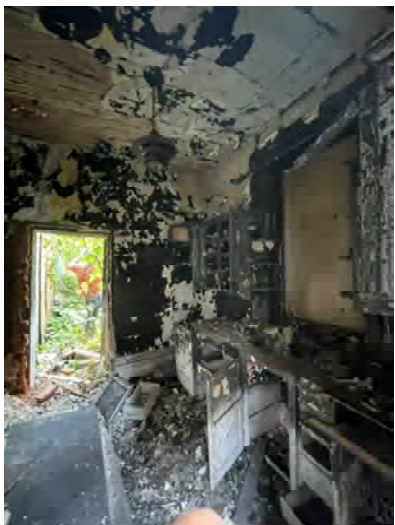
Figure 24 Photo showing existing damage to interior plaster and ceiling moldings.

There remains no physical example of the plasterwork. All the plaster and interior walls has since been destroyed by being exposed to the weather where it would have absorbed moisture in the air and deteriorated in the 6 years since the fire in 2017. Plaster is naturally fire resistant due to its porous nature. However, this means that the material acts like a sponge when exposed to fluids. (National Fire Chiefs Council, n.d.) Over time the plaster has crumbled away as it continuously absorbed and releasing moisture when it dried.

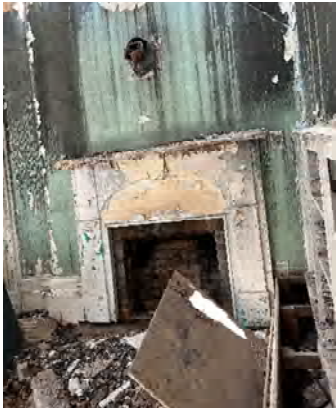
<p>Figure 25 View of the Fireplace located in the North Room. The Mantle has sustained significant damage.</p>	<p>The fireplace remains in the original location. All decorative elements have been destroyed. The mantle remains significantly damaged having been exposed to the weather and damaged by the fire. The chimney for this fireplace is a falling hazard and would need to be removed.</p>
<p>11. The main stairway, including stringers, treads, risers, banister, and handrail, spindles and newel post</p>

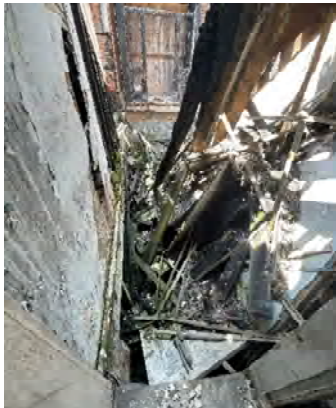
<p>Figure 26 View of what remains of the collapsed staircase.</p>	<p>The interior stairs were destroyed by the 2017 fire. There remains no salvageable evidence.</p> <p>Given the second floor is sinking at site, the interior conditions are highly unstable and unsafe. Please refer to Appendix C for more interior photos.</p>
