1284 Main Street East
Hamilton, ON

CULTURAL HERITAGE IMPACT ASSESSMENT

August 1, 2023

1284 MAIN STREET HAMILTON CONDITION ASSESSMENT

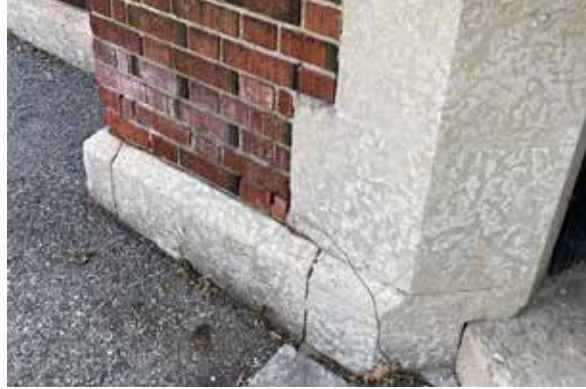
Fig. 1. Example of minimal spalling and efflorescence.

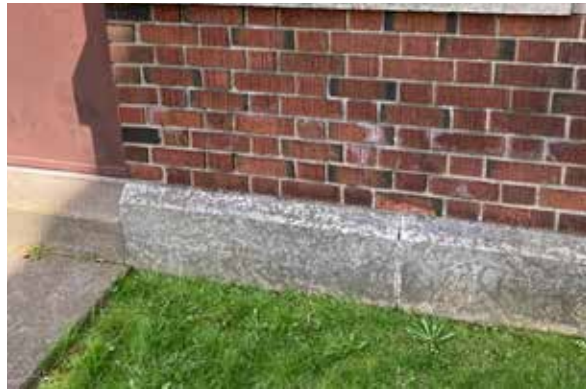
Fig. 2. Example of minimal spalling.

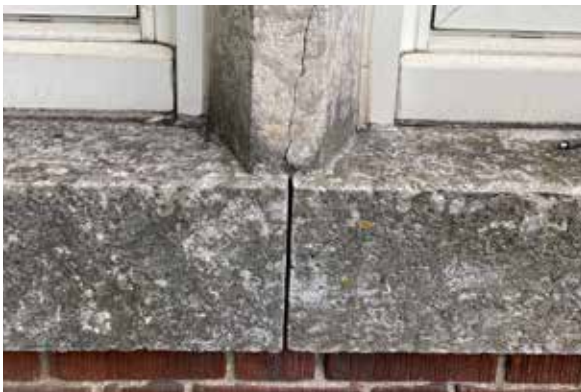
Fig. 12. Example of stone cracking.

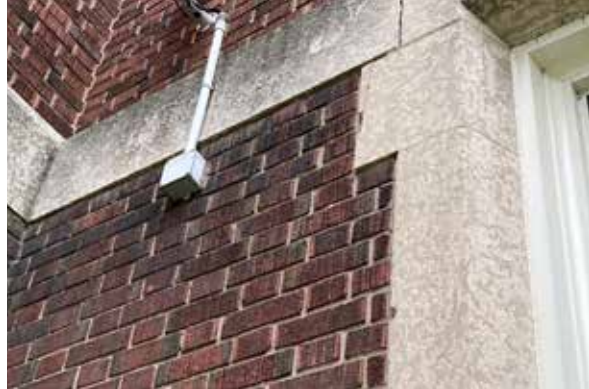
Stone elements on the exterior walls are generally in good condition, with only minor cracking and chipping in select areas (Fig. 12 - Fig. 14). Frequent staining, light surface pitting and occasional organic growth was observed at window sills (Fig. 15 - Fig. 17). A number of sills in the east and west parking lot areas have been overpainted (Fig. 18 - Fig. 20).

Fig. 13. Areas of minor stone chipping surrounding window.

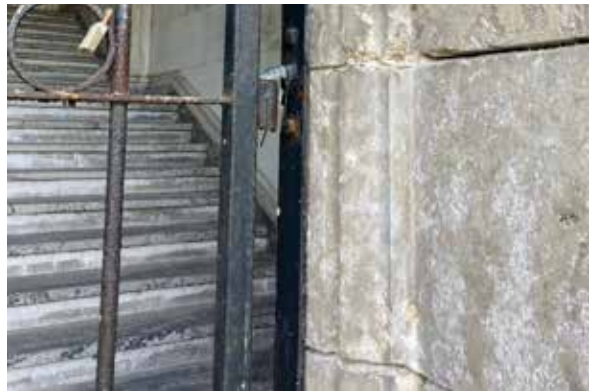
Fig. 14. Example of stone cracking.

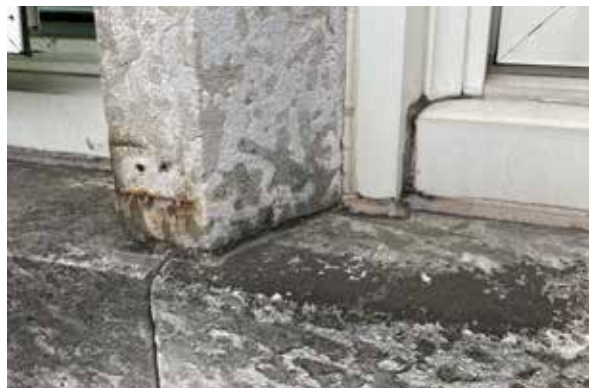
Fig. 15. Example of stone staining, holes and rust.

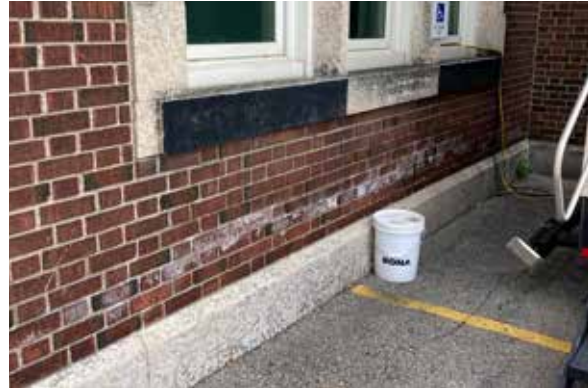
Fig. 18. Example of overpainting on exterior sills.

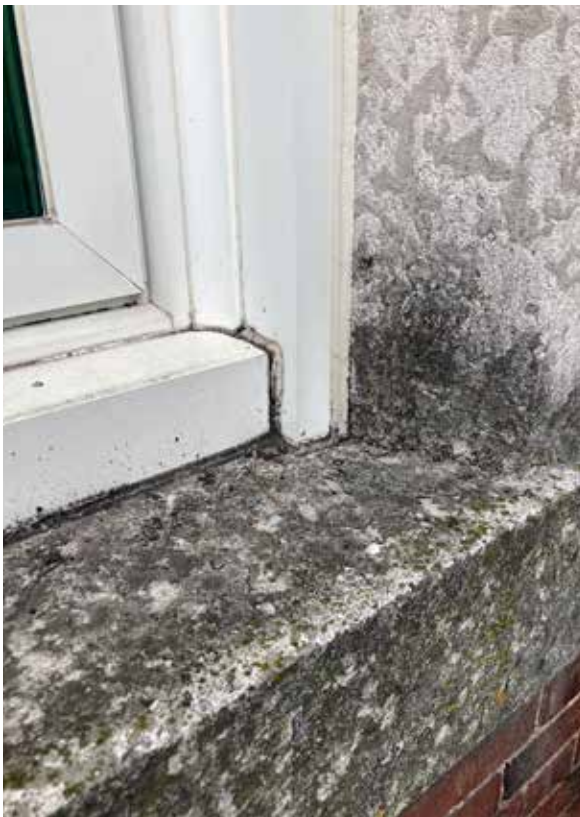
Fig. 17. Significant stone staining and organic growth.

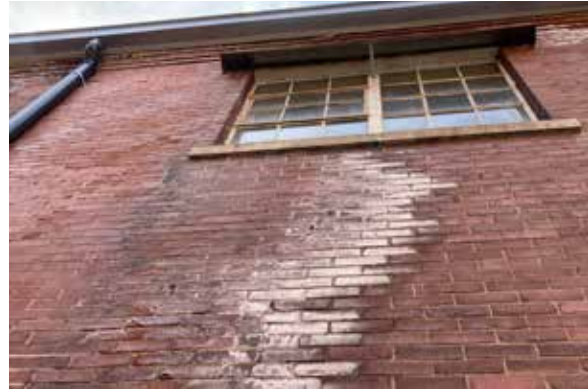
Fig. 47. Severe efflorescence and some spalling.

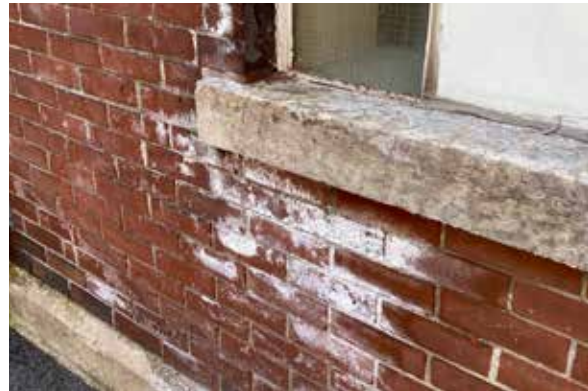
Fig. 48. Severe efflorescence and some spalling.

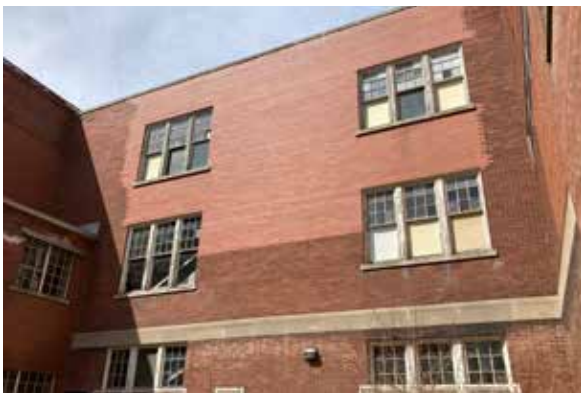
Fig. 53. Unsympathetic window replacements.

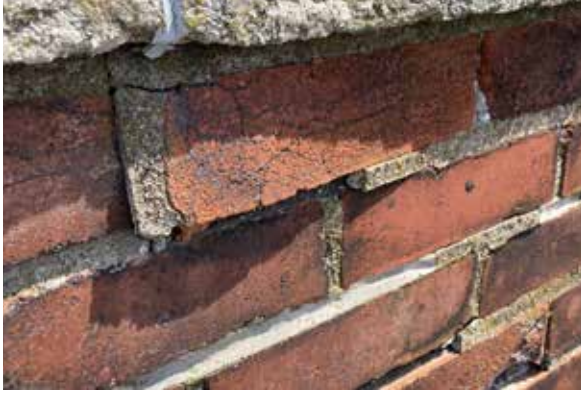
Moderate to severe surface pitting of the Tyndall coping stones was generally noted, with some areas exhibiting staining and organic growth (Fig. 59 - Fig. 61). Some older joint sealants at the coping stones and parapet wall flashing have generally reached the end of their service life (Fig. 62), while more recently applied sealants appear to be performing adequately (Fig. 63 & Fig. 64) with only a few areas exhibiting visible signs of stress and related degradation (Fig. 65 & Fig. 66). The smooth-faced brickwork ranges from good to poor condition generally, with some sections exhibiting varying degrees of spalling and surficial loss (Fig. 67 - Fig. 70). Mortar joints are in fair condition overall, with occasional erosion and loss of material (Fig. 69 & Fig. 71). Other sections of the parapet wall have cracked along joints (Fig. 72). Some previous spalls and open joints have been patched with an incompatible cement (Fig. 70, Fig. 73- Fig. 76).

Fig. 70. Brick and mortar failure underneath parapet stone.

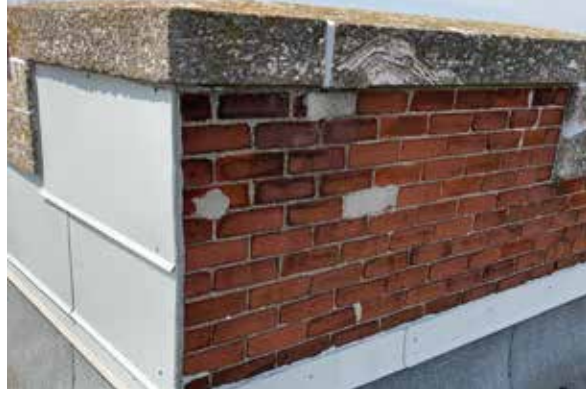
Fig. 73. Incompatible spall repair.

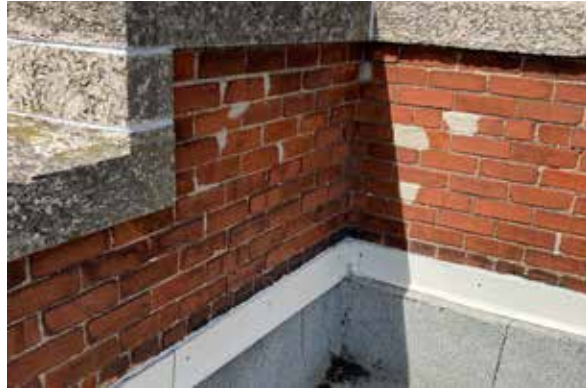
Fig. 74. Incompatible spall repair.

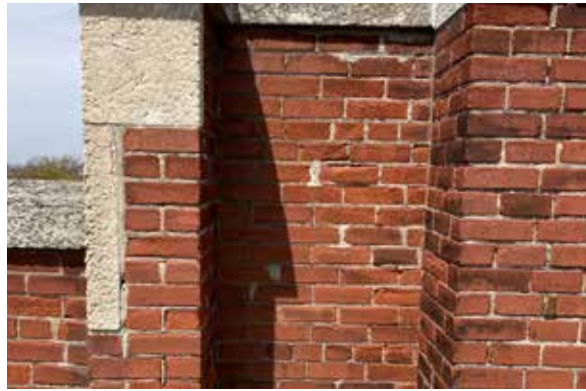
Fig. 75. Incompatible brick replacement (left).

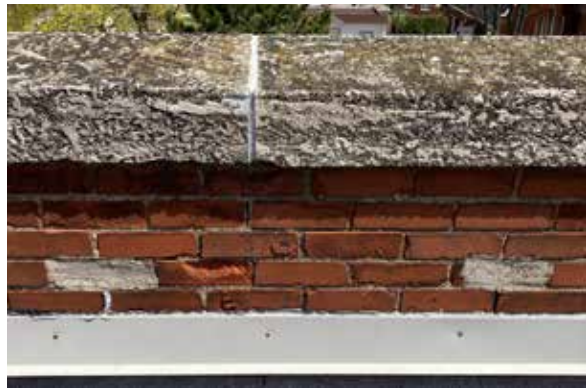
Fig. 76. Incompatible brick replacements.

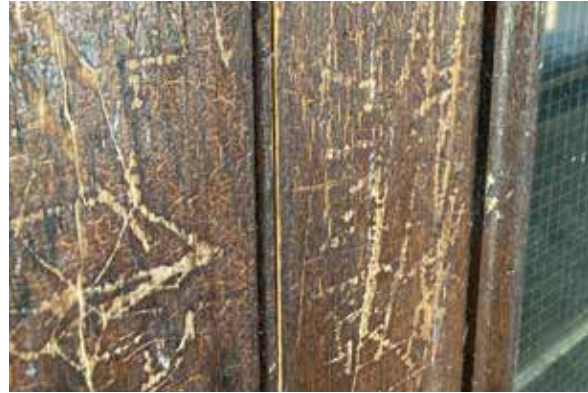
The north entrance doors are original and appear to be in fair condition generally, with some surface scratching present on the exterior facing stiles and bottom rails through repeated use and vandalism (Fig. 77 - Fig. 79). The exterior clear coat over the stain has begun to degrade, as evidenced by the general presence of crazing (Fig. 80 & Fig. 81). The top transom windows are in good condition, with original glass still present and few signs of disrepair aside from bird droppings along the sill line (Fig. 82). One small section of the moulding on the east transom has broken away (Fig. 83). Door hardware appears to be original, and glazing inserts have been previously replaced with wired safety glass (Fig. 84).

Fig. 77. Surface scratching of northern entrance door.

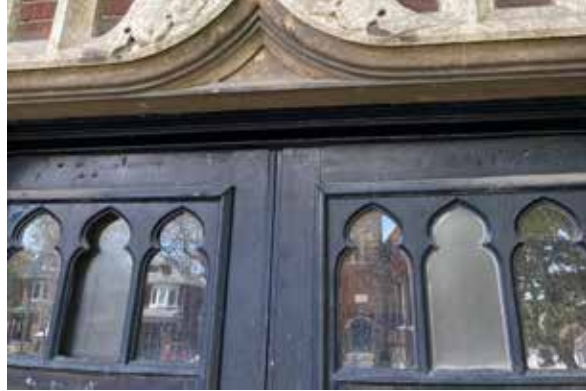
The east facing exterior wood doors are original and remain in fair condition. Two of the transom lites have been replaced with acrylic substitutes (Fig. 85). The glazing insert on the left has been previously replaced with wired safety glass, while the right insert has been boarded up with plywood (Fig. 86 - Fig. 87). One original bronze handset remains intact, while the other has been replaced with a steel pull plate (Fig. 88). Wood surfaces have been painted and are showing signs of moderate wear through repeated use, with previous red paint layers showing through in several spots (Fig. 88). Further paint deterioration has occurred at and around the inset panels and bottom rails (Fig. 89 - Fig. 91). Weatherstripping is not original and appears to be in serviceable condition. There is a small section at the corner of the left lower panel moulding that has separated and is being held in place with a machine screw (Fig. 92).

Fig. 85. Replaced transom lites.

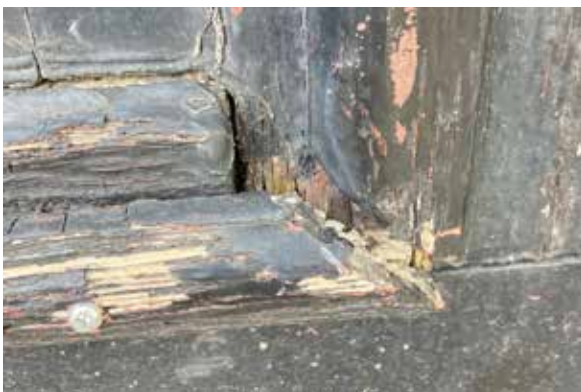
Fig. 92. Separated moulding attached via screw.

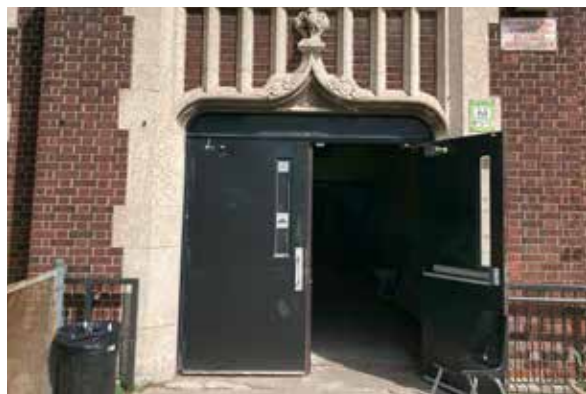
The west facing exterior doors and frames are not original and have been replaced with hollow metal doors (Fig. 93).

Fig. 93. Replaced double doors.

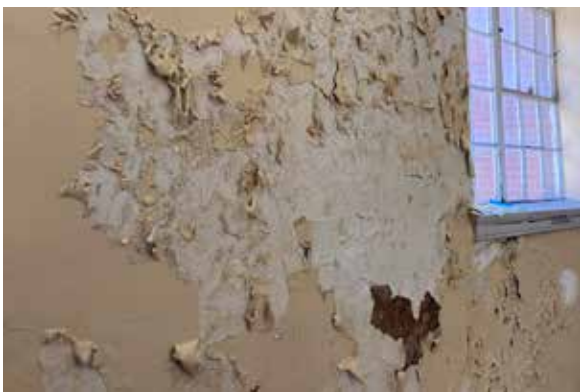
Fig. 104. Moisture damage to plaster and paint.

Where the primer coat has broken away, there is visible staining of the substrate and occasional crystallized salt formations (Fig. 104).

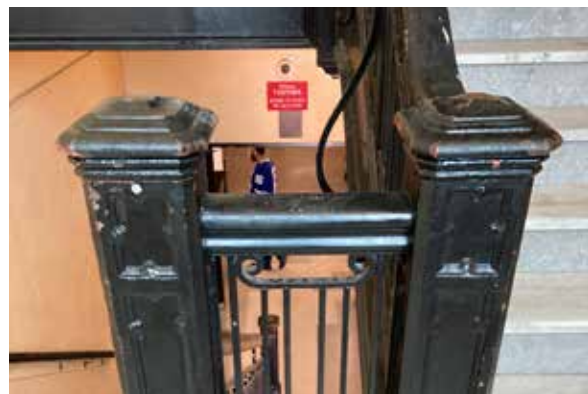
Fig. 105. Minor flaking on railings.

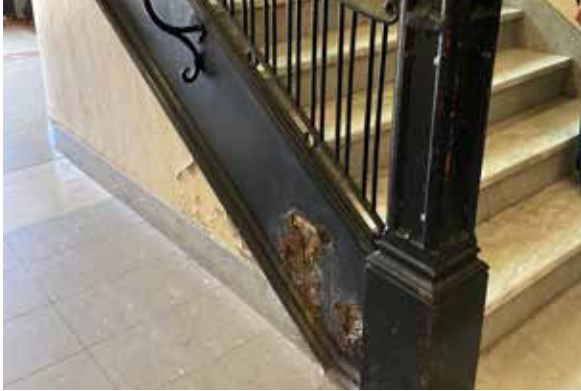
Fig. 106. Corrosion at base of west stair.

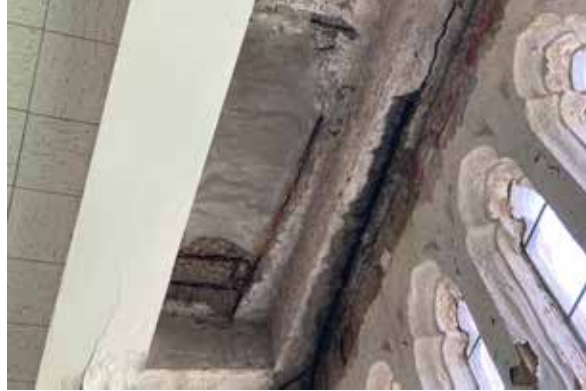
Fig. 110. Deteriorated cement finish.

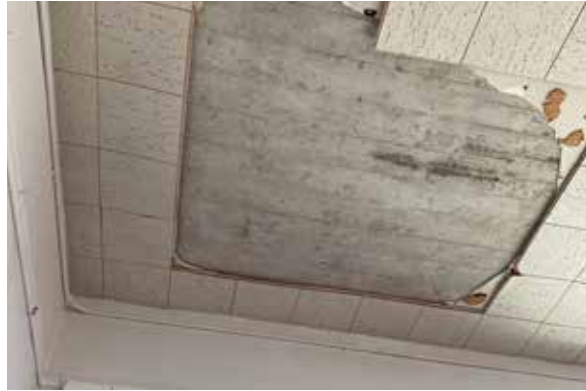
The alumni room, which is situated at the top level of the central tower, is generally in a poor state of repair due to the infiltration of moisture at the windows and roof. An opening above the west A/C unit has led to the entry of birds and rodents, leading to general soiling of the carpet. There is general flaking and blistering of paint at the window mullions, sills, jambs and headers, and some lower sections of the concrete have failed locally due to thermal expansion and corrosion of the expanded metal lath (Fig. 108 & Fig. 109). Above the windows, the concrete structure is partially visible. In the areas exposed, reinforcing bars have corroded, leading to cracking and delamination of the cement finish coat (Fig. 110). The ceiling of the room has been overlaid with tiles, which are adhered to a flat plaster substrate, presumably the original ceiling finish. In one location, the plaster has fallen away exposing the board-formed concrete roof deck (Fig. 111).

Fig. 111. Missing ceiling tiles and exposed roof deck.

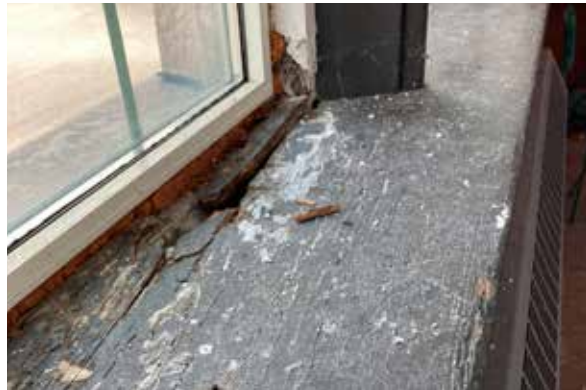
Fig. 112. Deteriorated wooden sills.

Interior wood sills have generally deteriorated near the windows (Fig. 112). The trefoil arched single glazed openings above the window appear to be original and intact (Fig. 113). Below these openings, fixed vinyl replacement windows have been installed.
