Re 535 Old Dundas Rd, Ancaster – Intent to Demolish

Summary of Building Inspection 535 Old Dundas Rd Ancaster, Ontario

Project: 23263
535 Old Dundas Road
Ancaster, Ontario

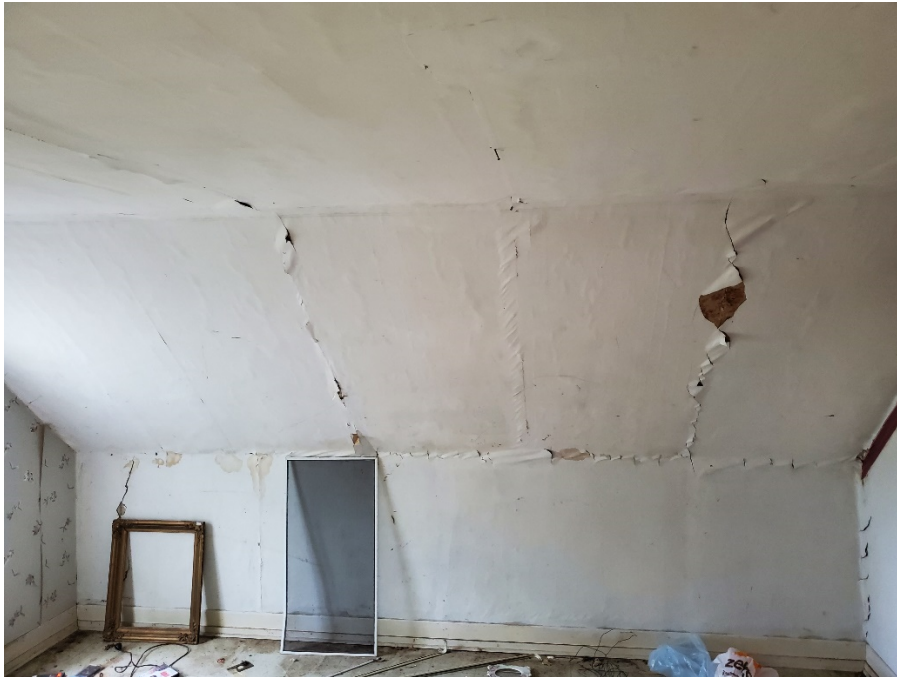
The building is constructed using wood framing. The roof is constructed as a conventional wood rafter with collar ties partway up the rafters. It could not be determined if the floor joists act as ties at the base of the rafter. The roof framing over the kitchen bears on knee walls. The knee walls were supported on what appeared to be wood beams from below. See **Photo No 01 & 02**.

Photo No 01: 2nd Floor North Wall above Kitchen

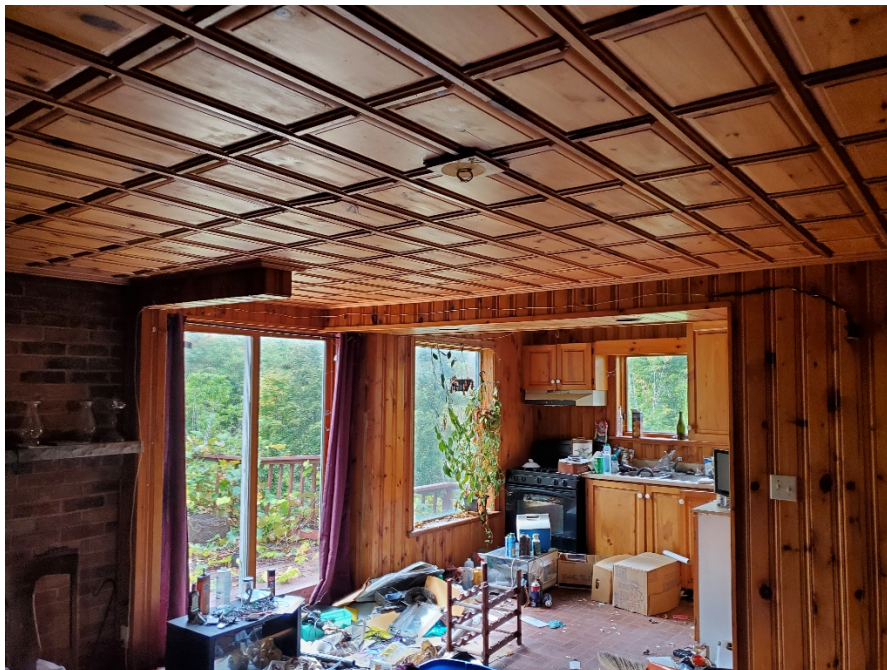
Photo No 02: North Kitchen Wall below Photo No:01

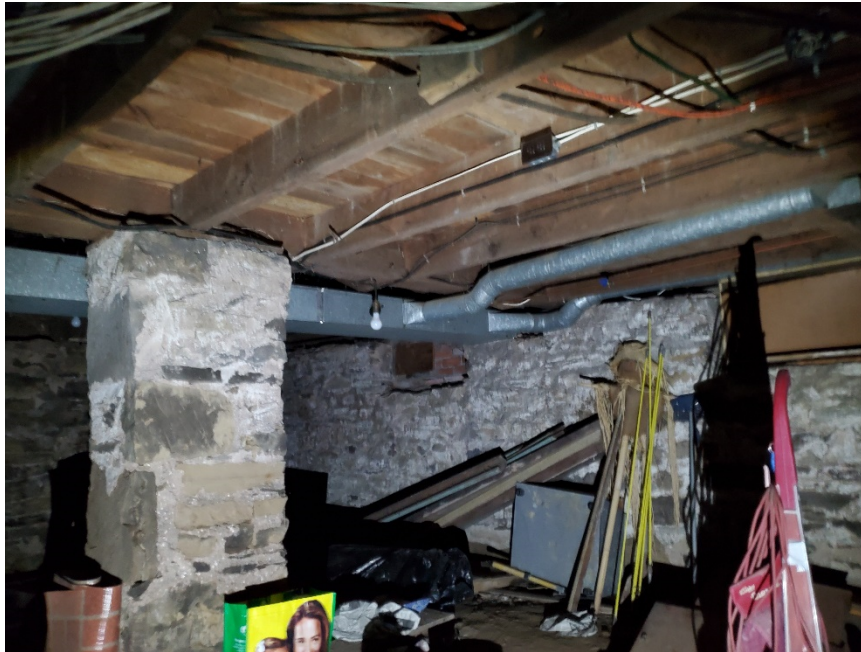
During the site review, the framing of the floor structure was recorded to get a better understanding of the building and tracking the loads to foundation. Where visible, the framing was recorded including the member sizes, spans and the bearing locations. The underside of the main floor was completely exposed. See **Photo No 03** for part main floor framing.

The west end of the east side main 8x8 timber floor beam, See **Photo No 03**, does have adequate support at the interior foundation wall.

Photo No 03: Main Floor Framing (Original House)

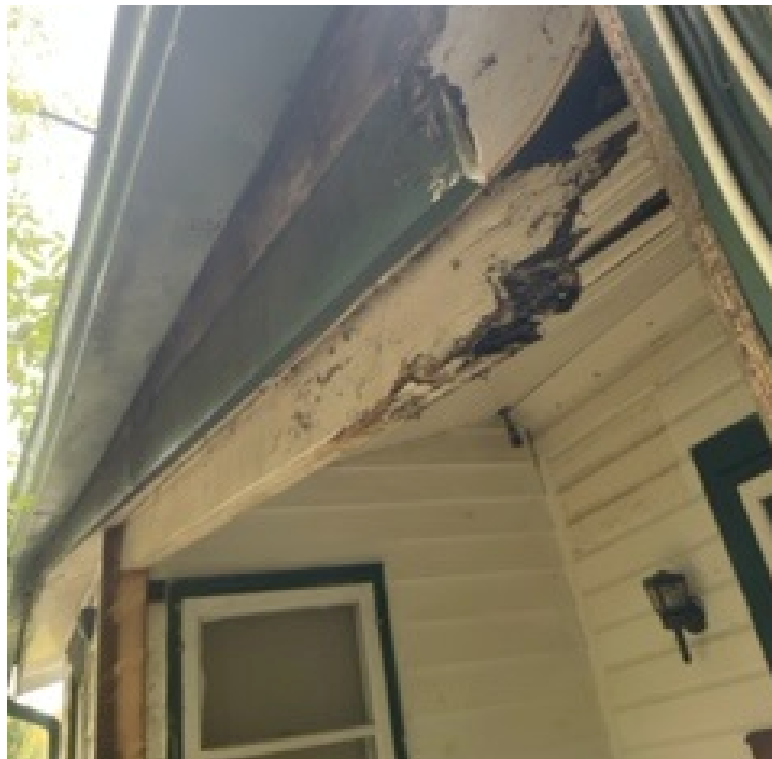
Review of the exterior was completed. The framing of the covered veranda at the south side of the house had collapsed. See **Photo No 04 & 05**. It was apparent that the end of the wood beam at the east side of the veranda had rotted and collapsed.

Photo No 04: Collapsed Roof

The exterior wood siding has many areas of decomposition. In one location the veranda roof has failed and collapsed. If this structure is to remain, we recommend removing the plaster and lath at the base of the main floor walls to determine if the studs and sill plates are decomposed.

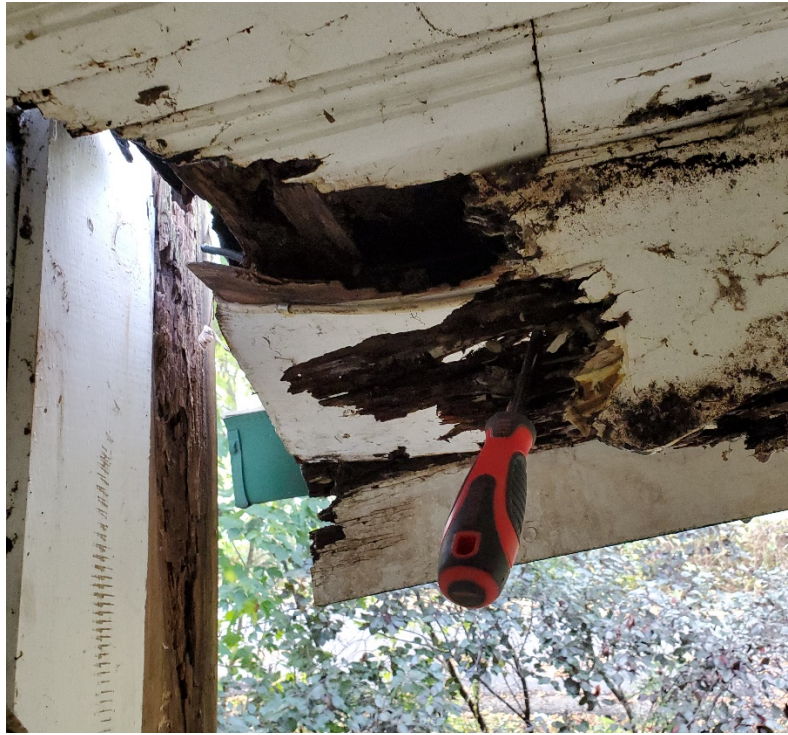
Photo No 05: Rotten Wood

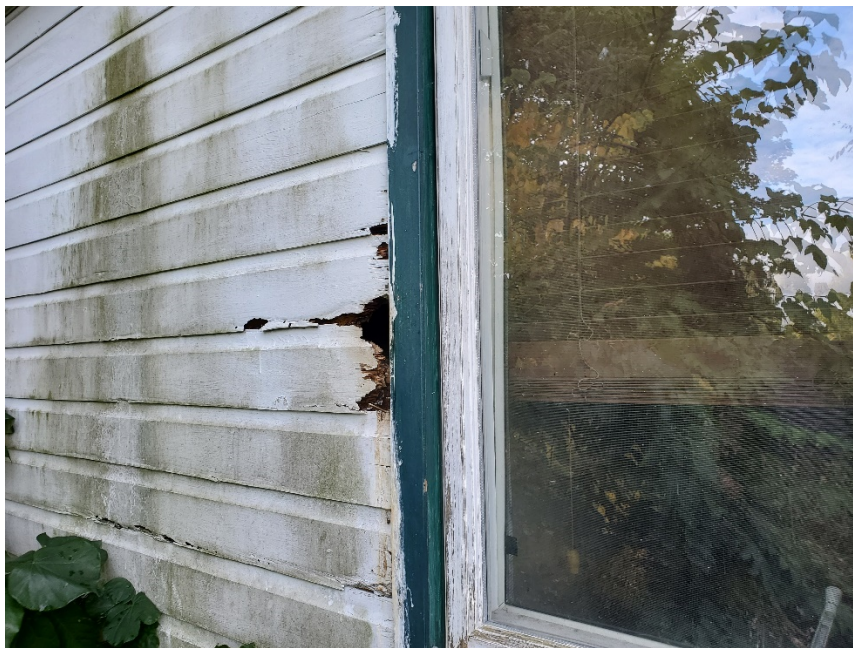
There were many areas around the perimeter of the exterior where the wood siding, and wood window sills were rotted as well. See **Photo No 06 & 07**. Photos 06 & 07 show a couple of locations of many where the exterior wood siding, sills or window jambs were decomposed.

Photo No 06: Rotted Siding

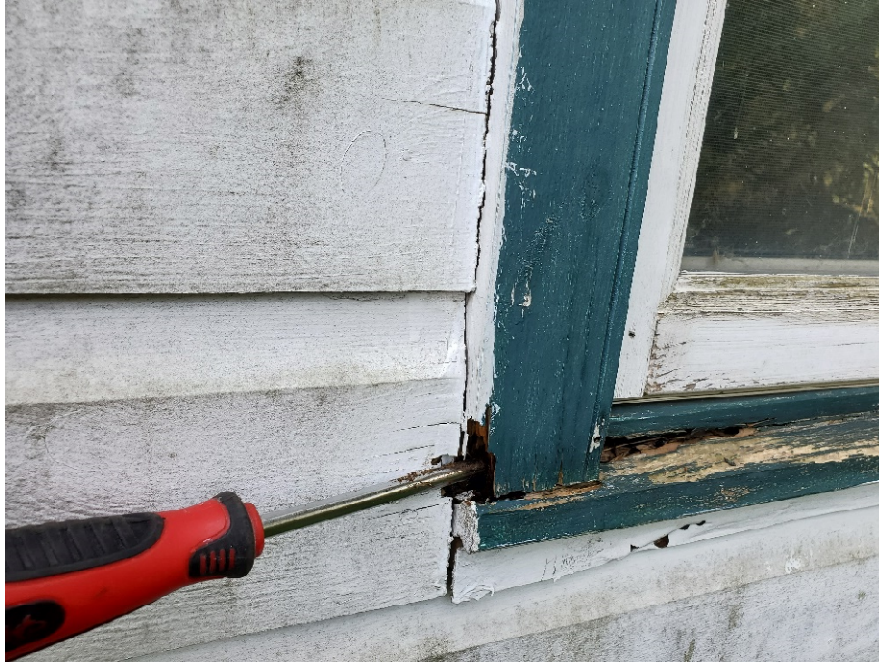
Photo No 07: Rotted Sill

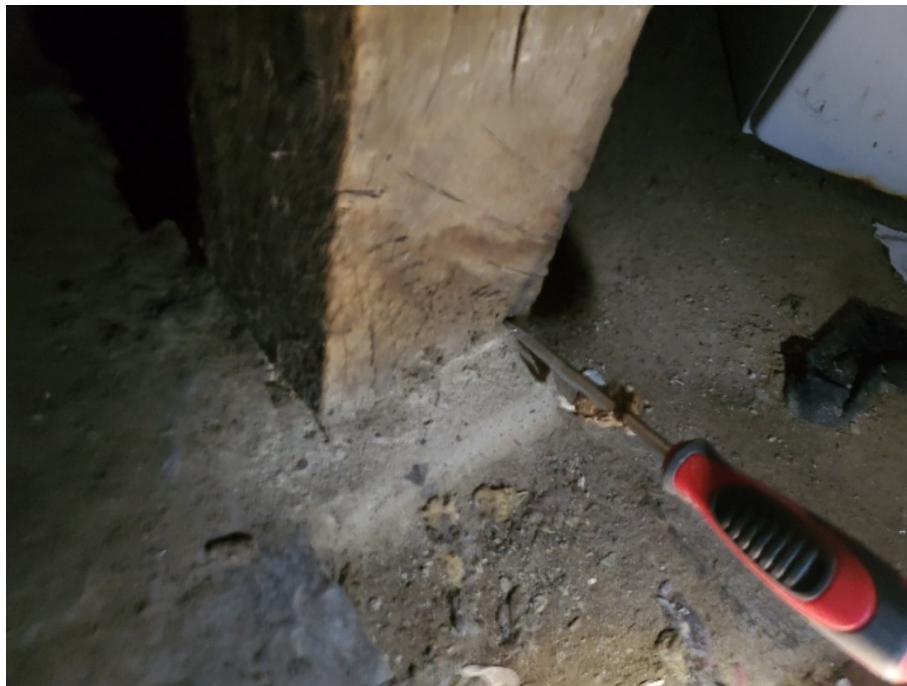
At the west side structure, an existing wood post at the west end of the beam was partially rotted at the base and a wood knot that was severely rotted. See **Photo No 08 & 09**.

Photo No 08: Rotted Post Base

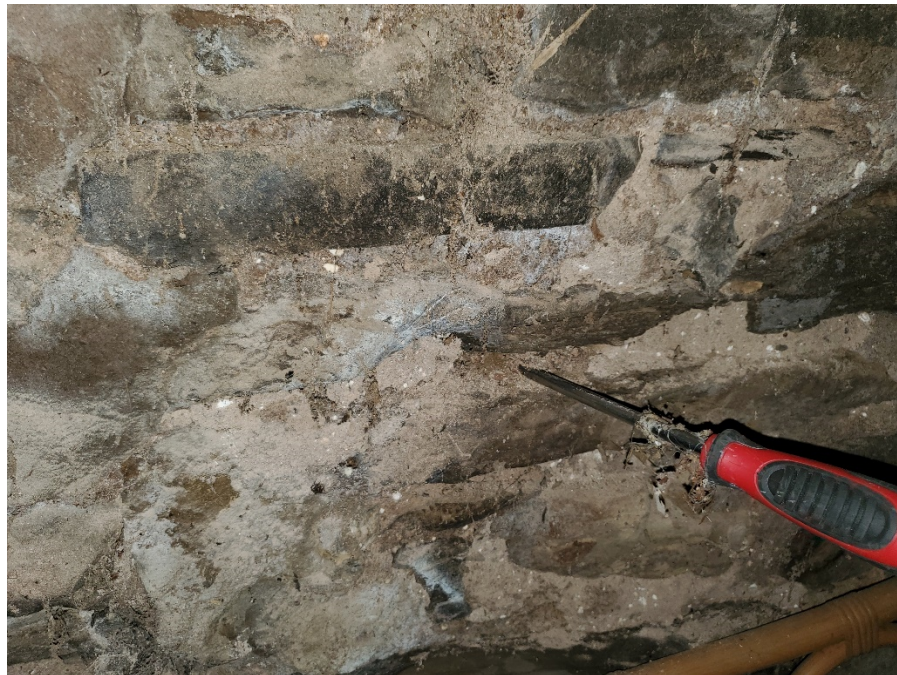
For two of the 3 areas of the basement, the foundations are constructed of stone and mortar. Upon closer inspection of the foundation, it was quite evident that the mortar is severely spalled. See **Photo No 10 & 11**. The photos show how easily the screwdriver penetrates the spalled mortar joints.

Photo No 10: Spalled Mortar Joint

The mortar joints in stone foundations are severely spalled. Repairing the foundation would also require a lot of financial resources. An option would be the temporary support of the house with a complete demolition and replacement of the stone foundation to cast-in-place or block foundation and footing.

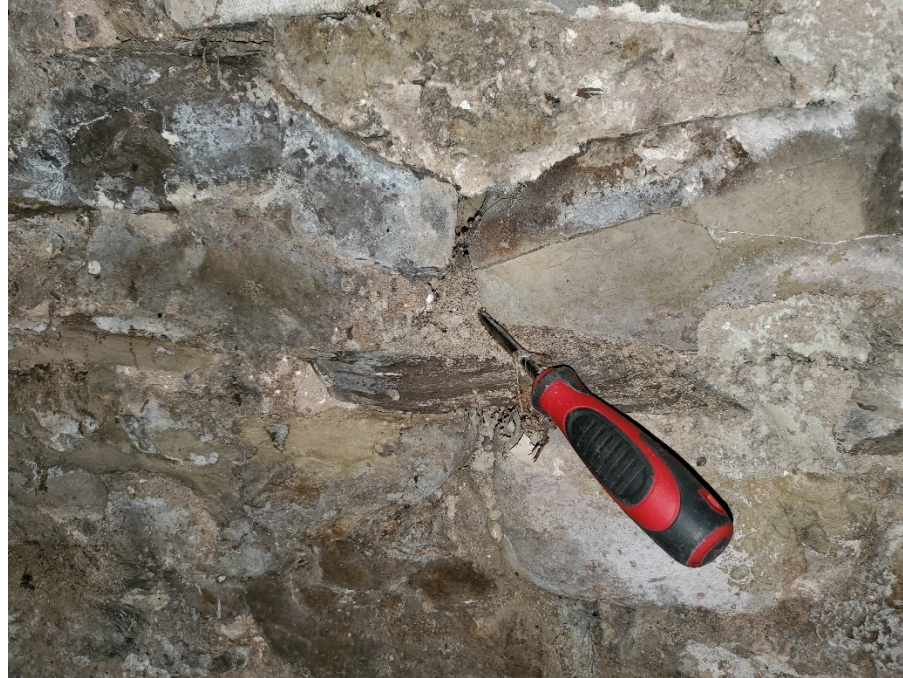
Photo No 11: Spalled Mortar Joint
