Photo-Documentation of 535 Old Dundas Road, Ancaster
(All photographs taken by City staff on November 6, 2023)

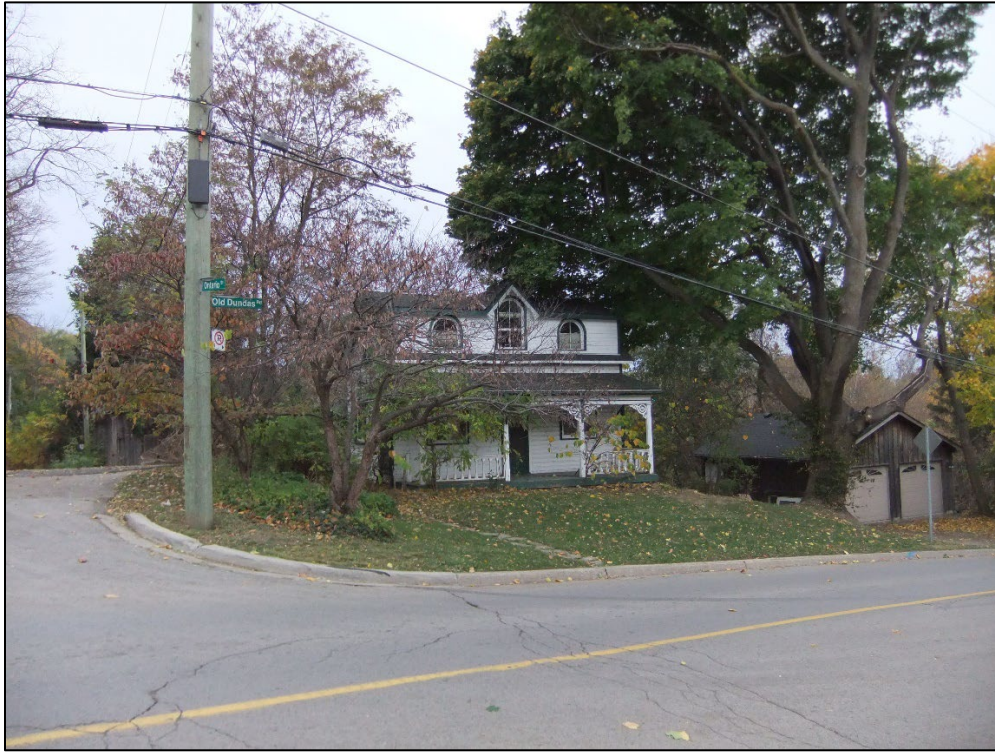
Figure 1: View of Front (East) Elevation facing Old Dundas Road

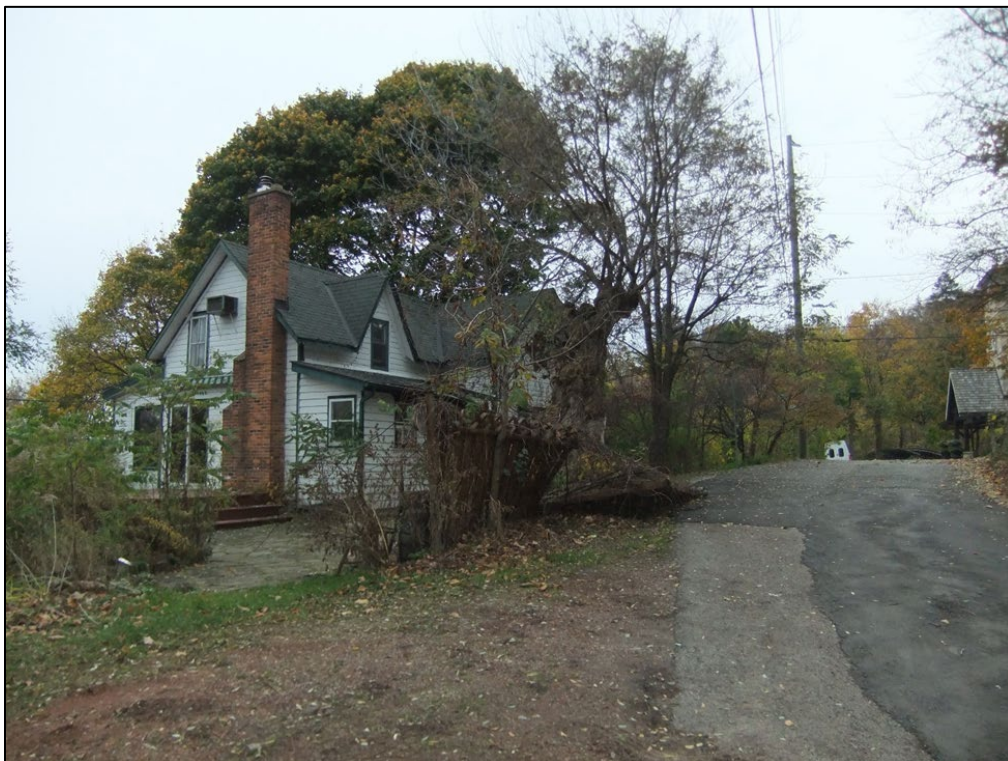
Figure 2: View of South Elevation along Ontario Road

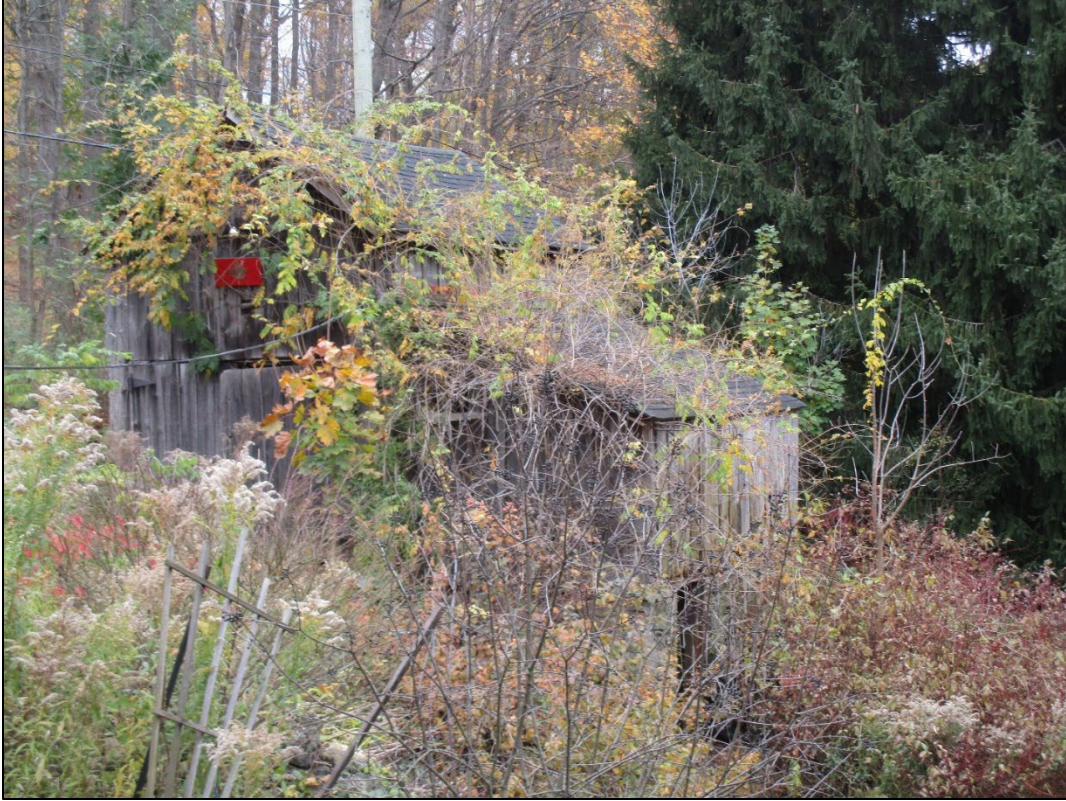
Figure 3: View of Two Level Shed in rear yard

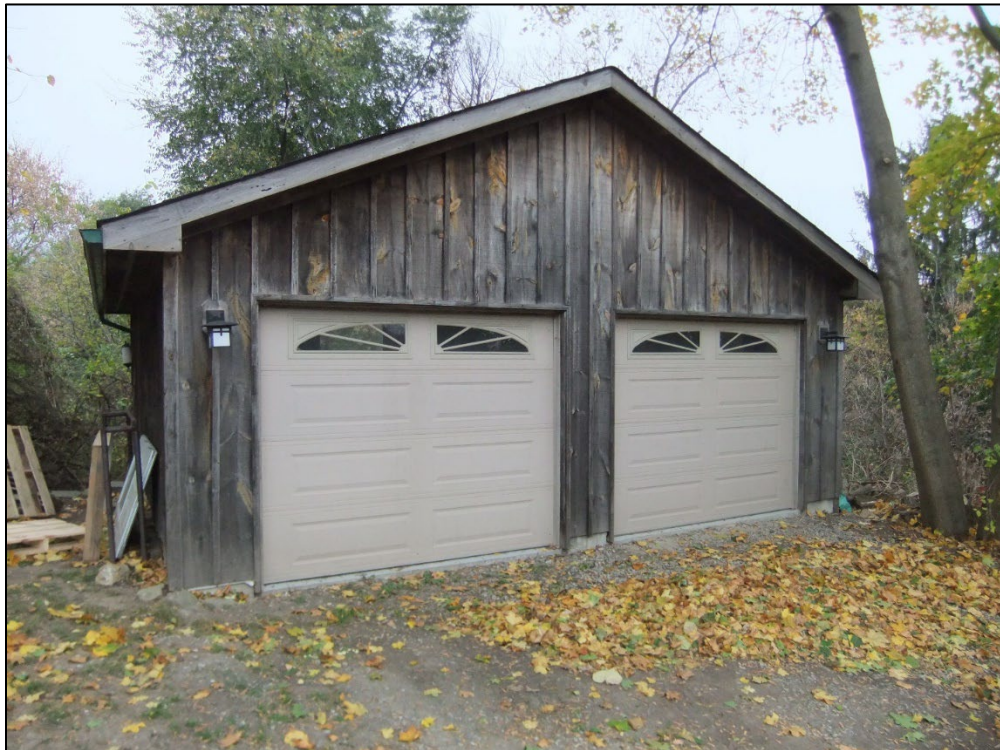
Figure 4: View of existing contemporary side garage

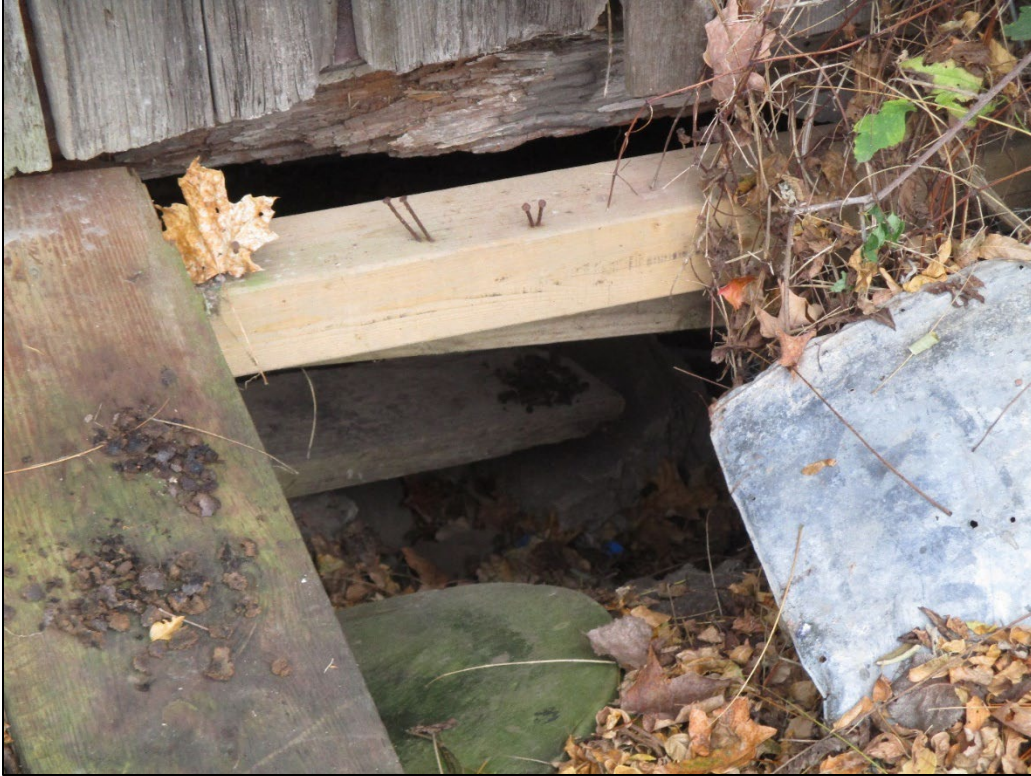
Figure 5: View of damage to shed foundation

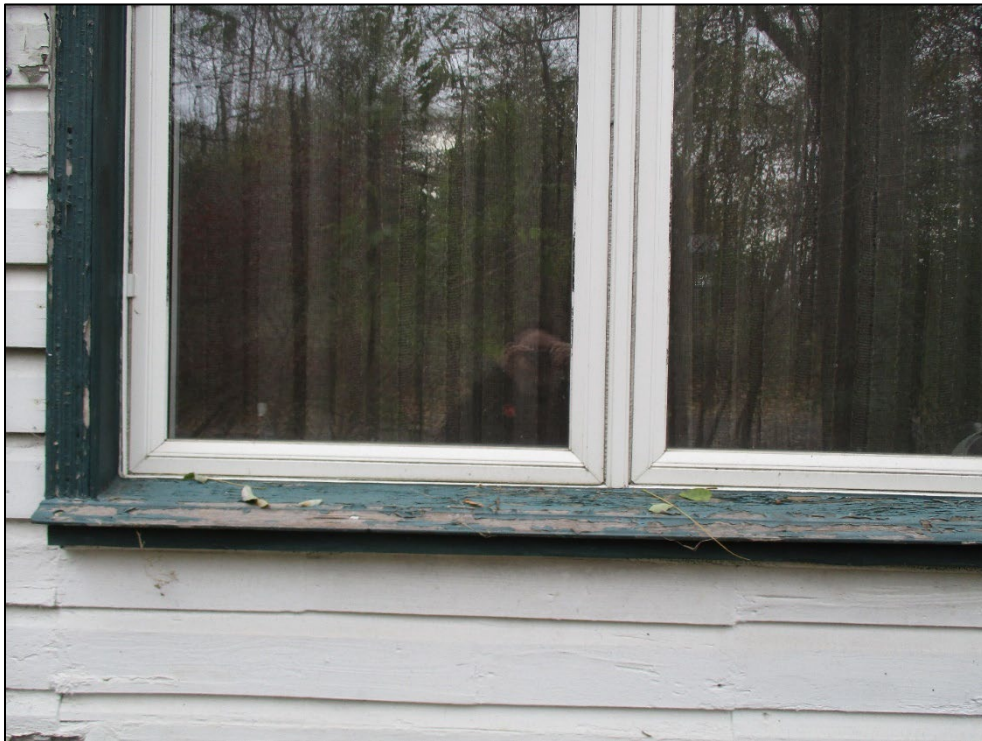
Figure 6: View of deteriorating window frames with contemporary replacement windows

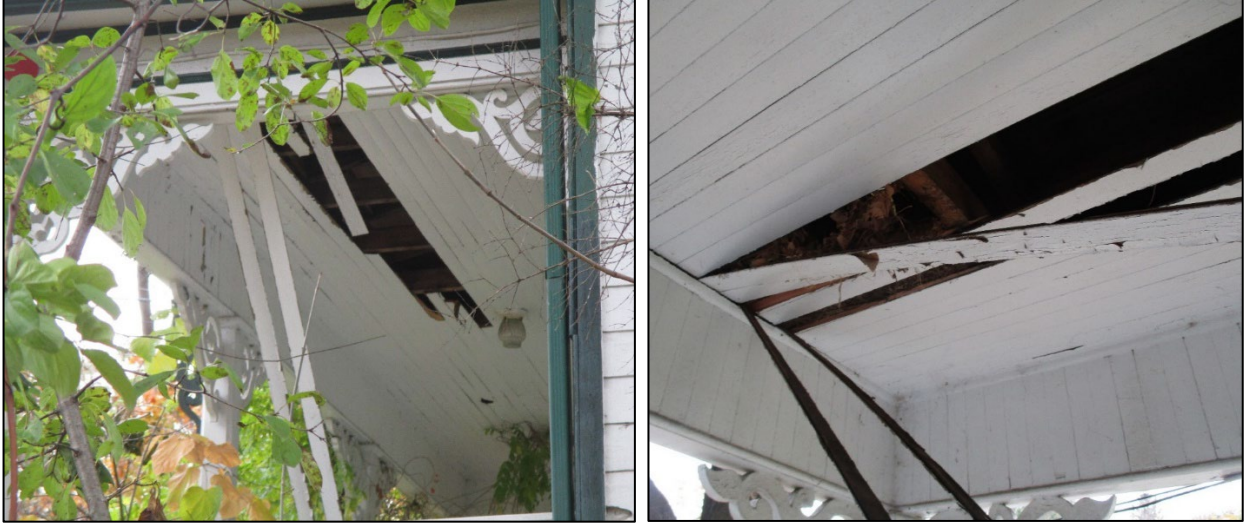
Figure 7: Views of damage to front porch ceiling

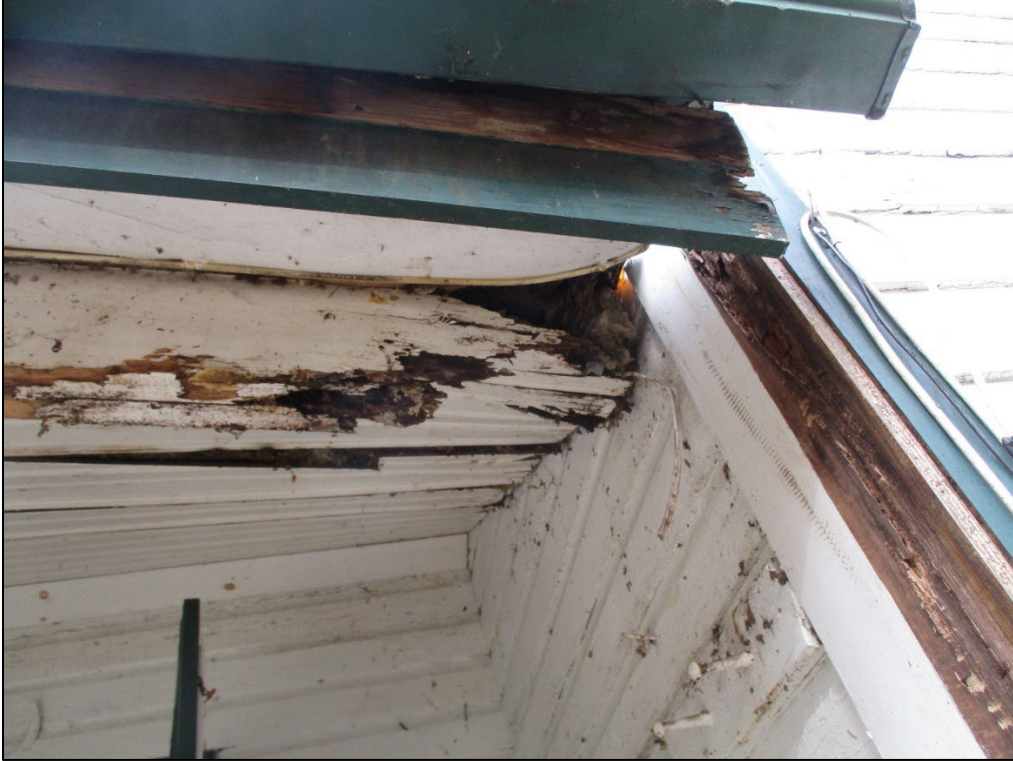
Figure 11: Detail View of damage to side porch

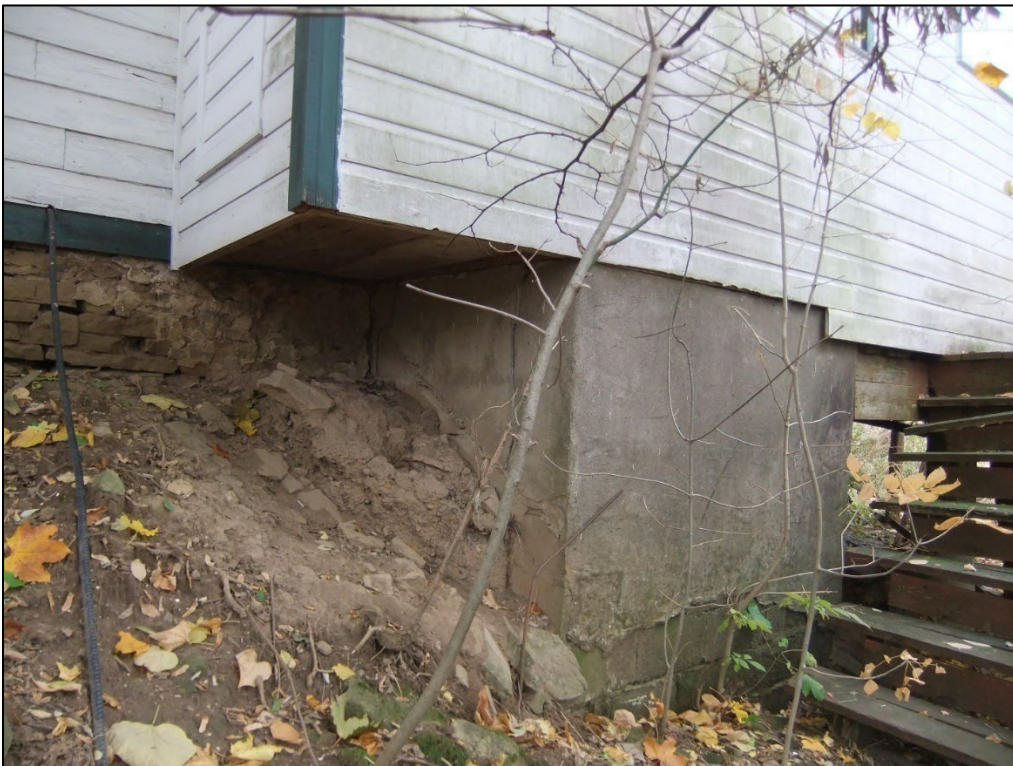
Figure 12: View of contemporary side addition and foundation

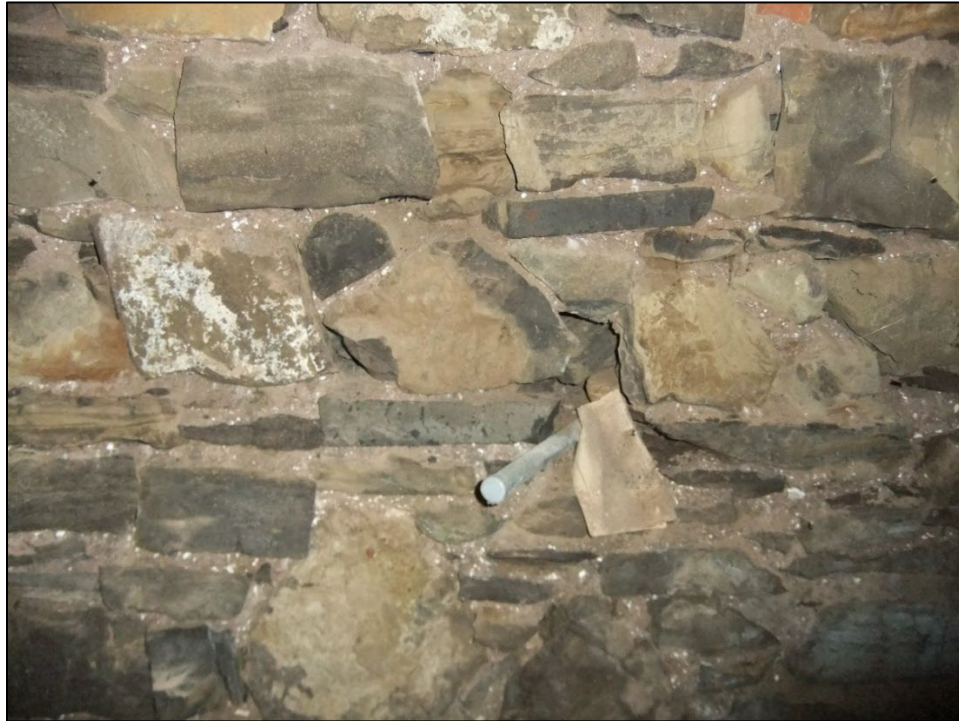
Figure 14: View of stone foundation wall in basement

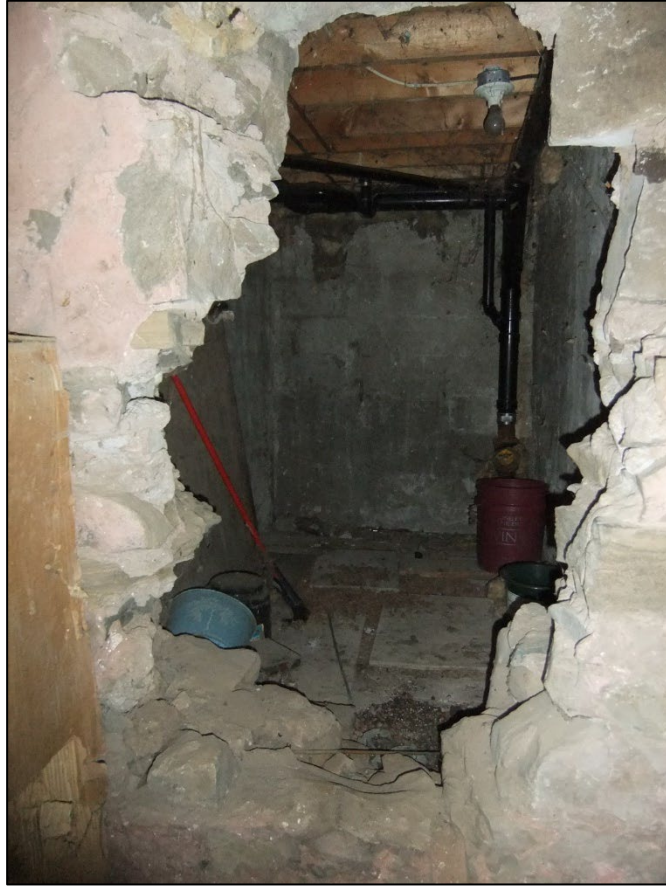
Figure 15: View of foundation wall in basement, looking into side addition

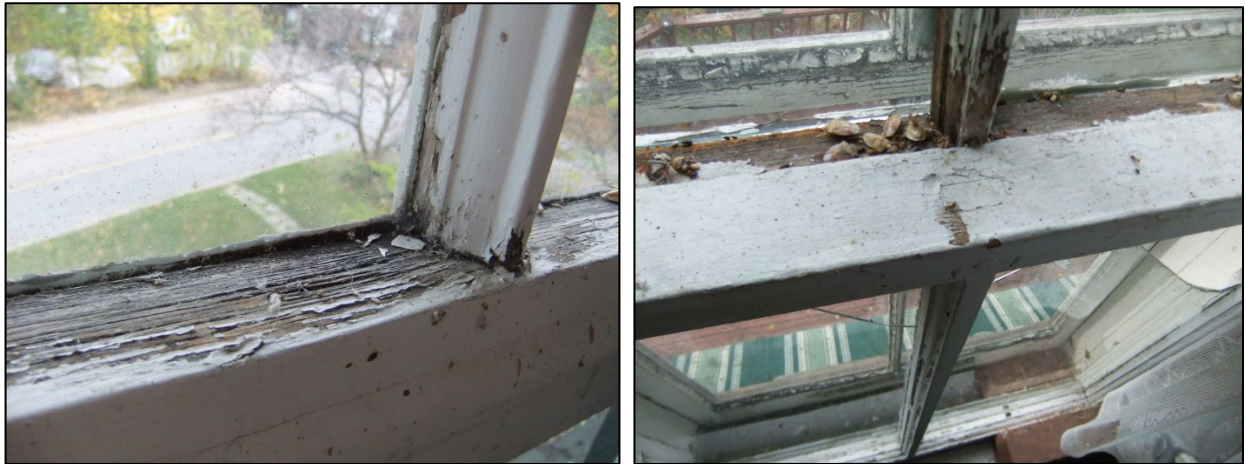
Figure 16: View of deterioration of upper-storey wood windows
