CULTURAL HERITAGE IMPACT ASSESSMENT

**89 Park Street North,
Hamilton**

Date:
October 2023

Prepared by:
**MacNaughton Hermesen Britton Clarkson
Planning Limited (MHBC)**
200-540 Bingemans Centre Drive
Kitchener, ON N2B 3X9
T: 519 576 3650
F: 519 576 0121

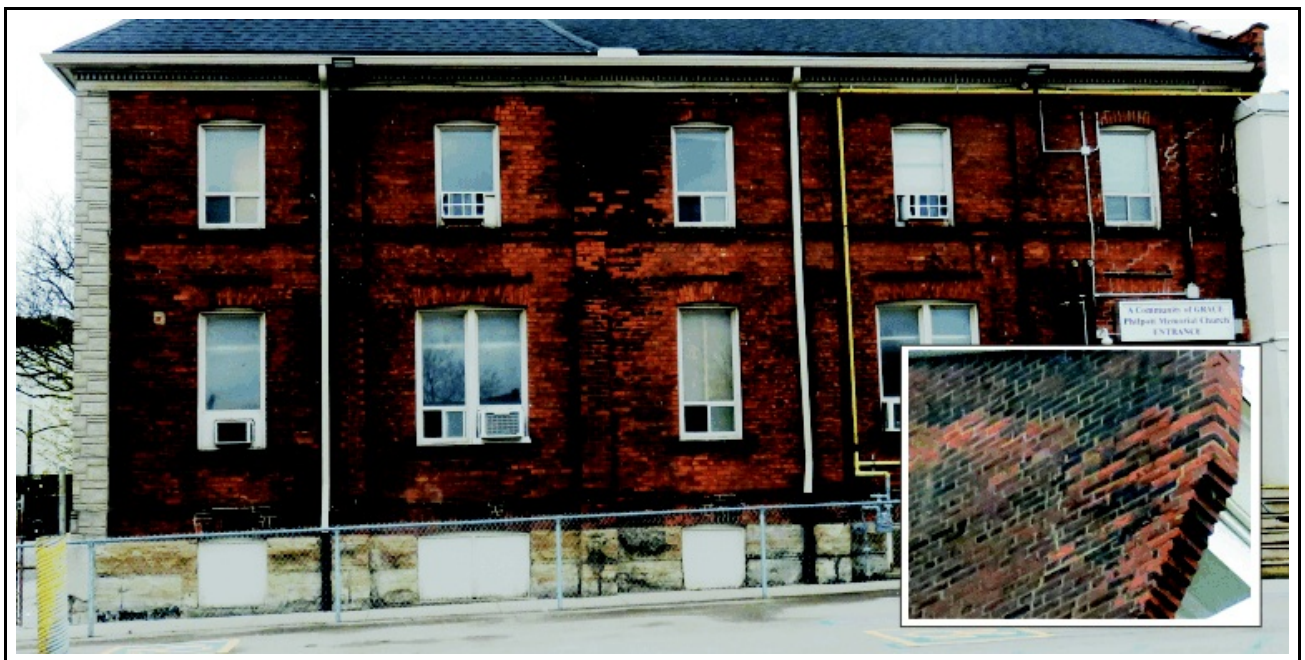
- 4.2 Although sounding techniques were not used during the on-site assessment, from visual observations, the mortar appeared to be well-bonded to the brickwork - there was no visible evidence of delaminations.
- 4.3 The author does not know the reason why the plaster was applied to the then approximately forty to fifty-year-old brickwork. However, following a review of the side and rear elevations - where there was much evidence of badly weathered masonry and brick replacement - it is the author's opinion that the most likely and logical reason was therefore a concern regarding the evident poor quality of the bricks. (Photograph 2)

Photo 2 with inset image: There was much evidence of badly-weathered masonry and brick replacement within the side and rear elevations.

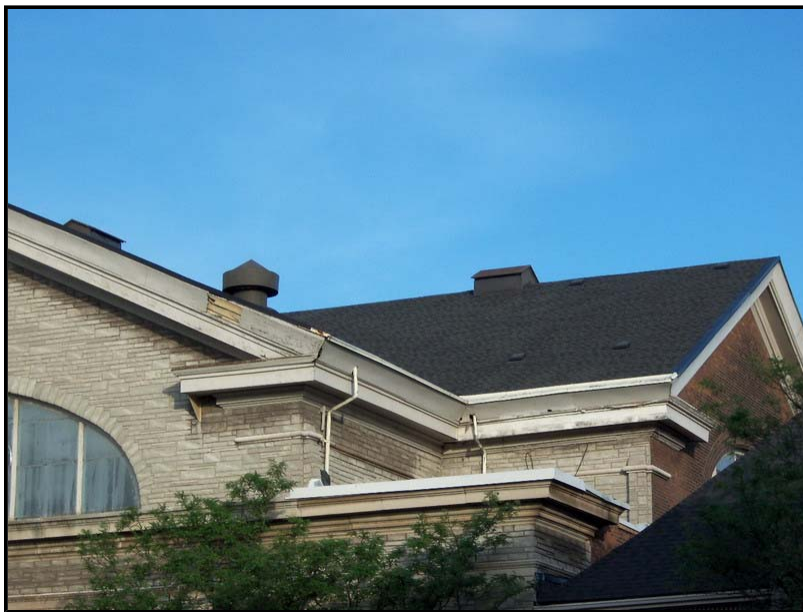
Photo No. 14: Sanctuary sloped roof deteriorated fascia

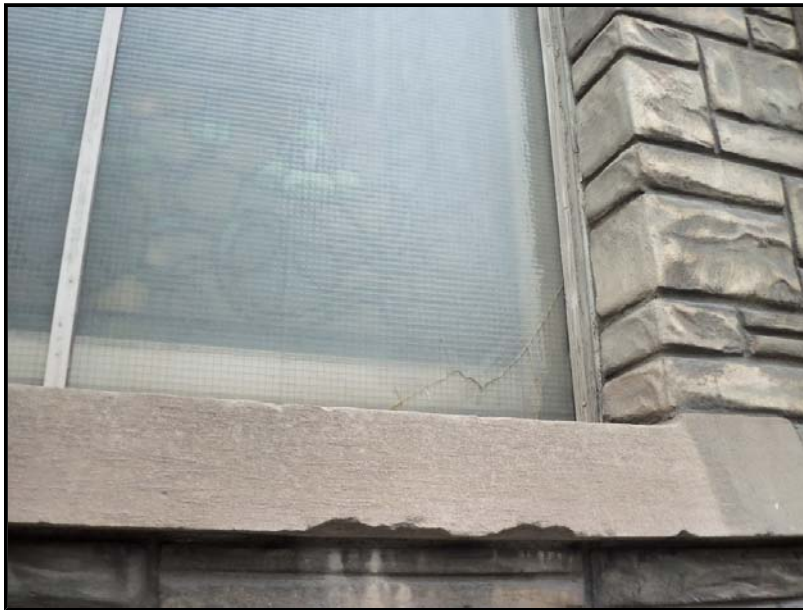
Photo No. 19: Cracked Windows

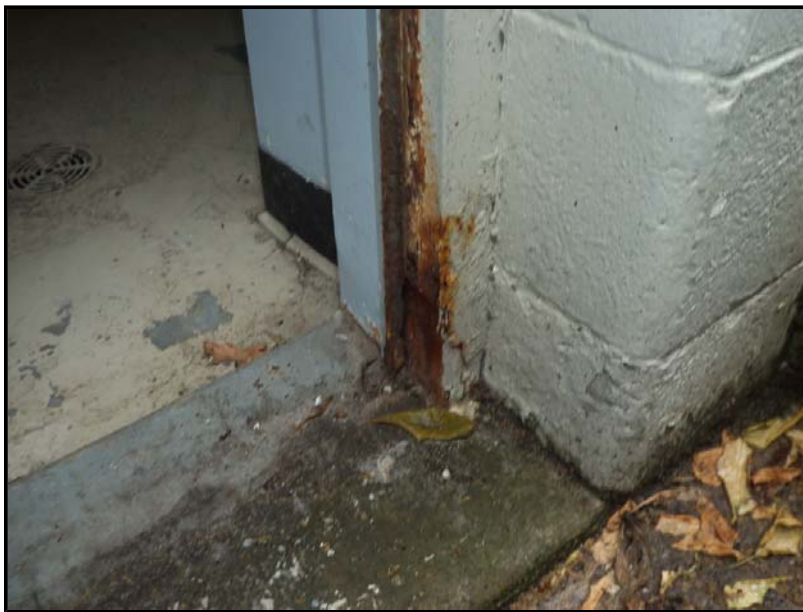
Photo No. 20: Corroded Door Frame at Emergency Basement Exit

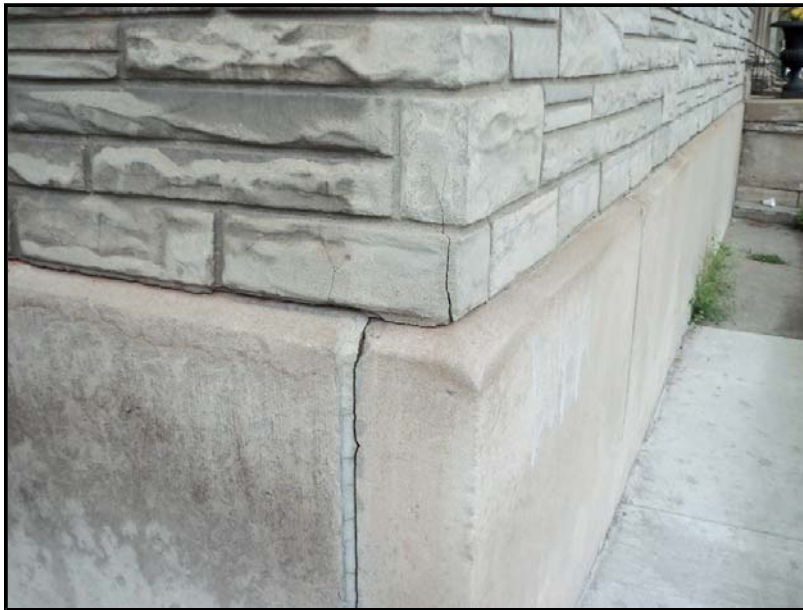
Photo No. 21: Cracks in Cementious Wall

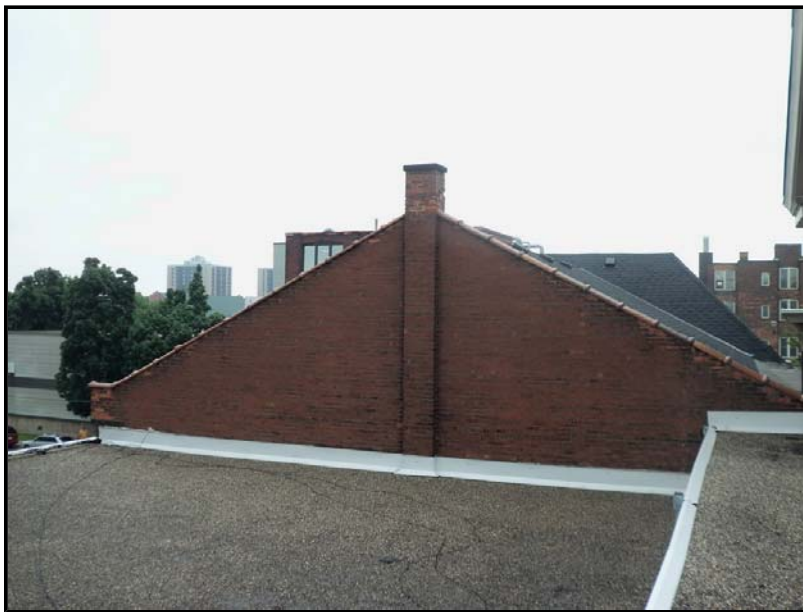
Photo No. 22: Deteriorated Chimney

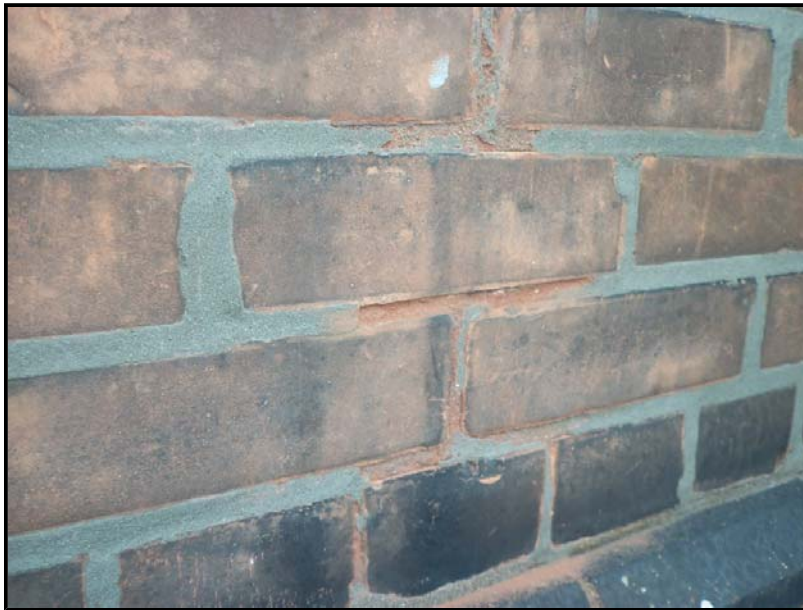
Photo No. 23: Deteriorated Mortar

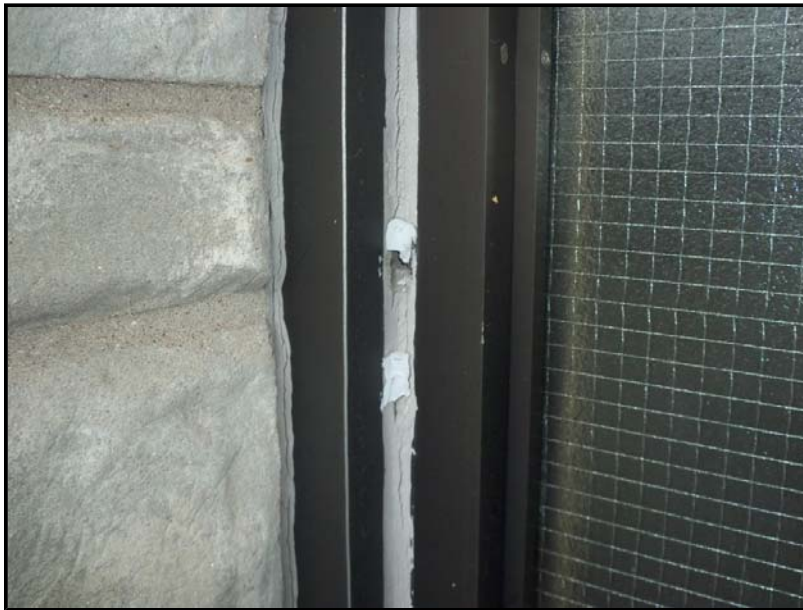
Photo No. 24: Deteriorated Sealant

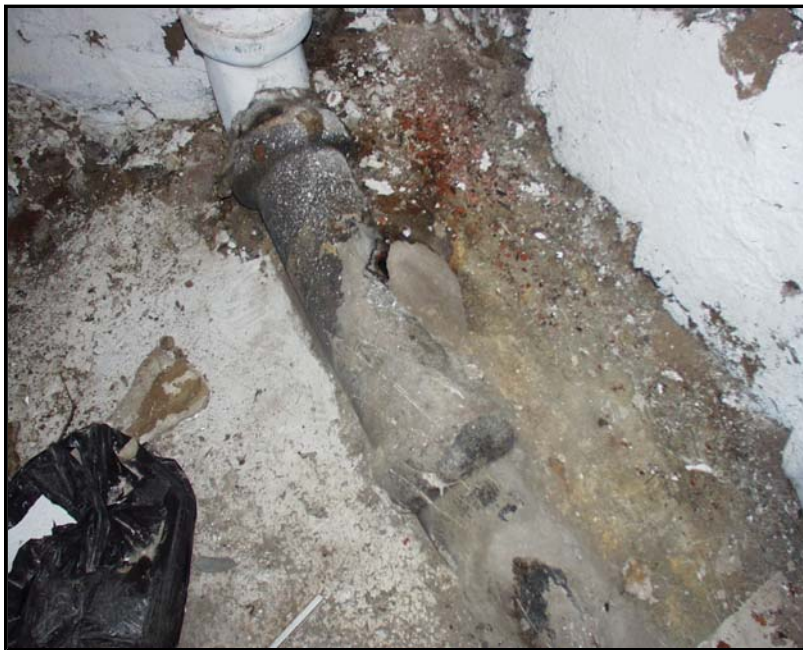
Photo No. 40: Broken Drain Pipe

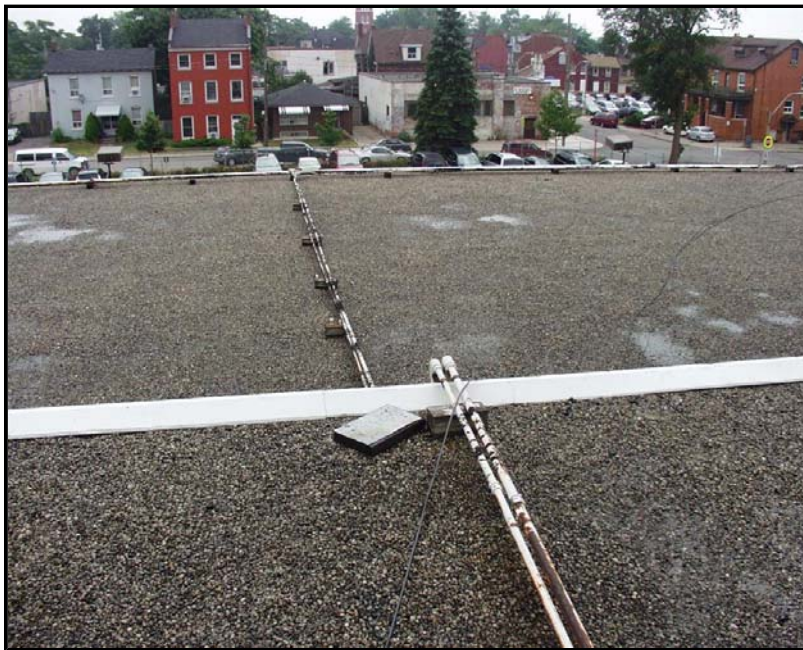
Photo No. 42: Corroded Electrical Conduit

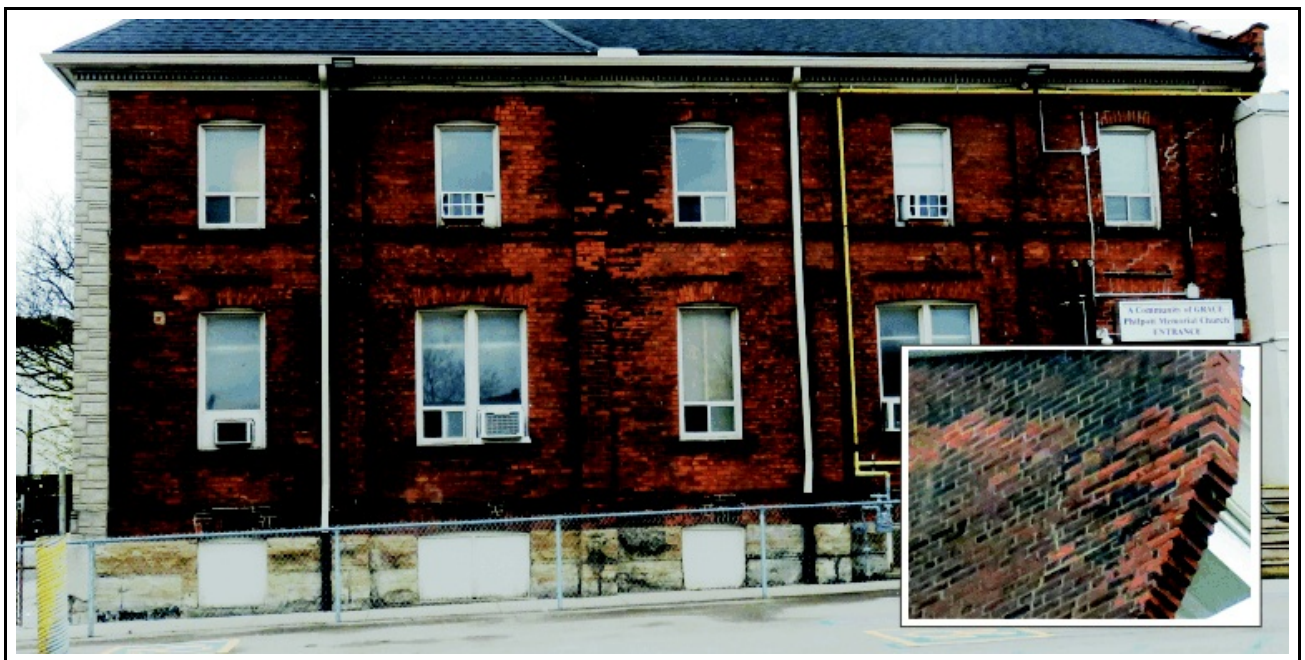
- 4.2 Although sounding techniques were not used during the on-site assessment, from visual observations, the mortar appeared to be well-bonded to the brickwork - there was no visible evidence of delaminations.
- 4.3 The author does not know the reason why the plaster was applied to the then approximately forty to fifty-year-old brickwork. However, following a review of the side and rear elevations - where there was much evidence of badly weathered masonry and brick replacement - it is the author's opinion that the most likely and logical reason was therefore a concern regarding the evident poor quality of the bricks. (Photograph 2)

Photo 2 with inset image: There was much evidence of badly-weathered masonry and brick replacement within the side and rear elevations.

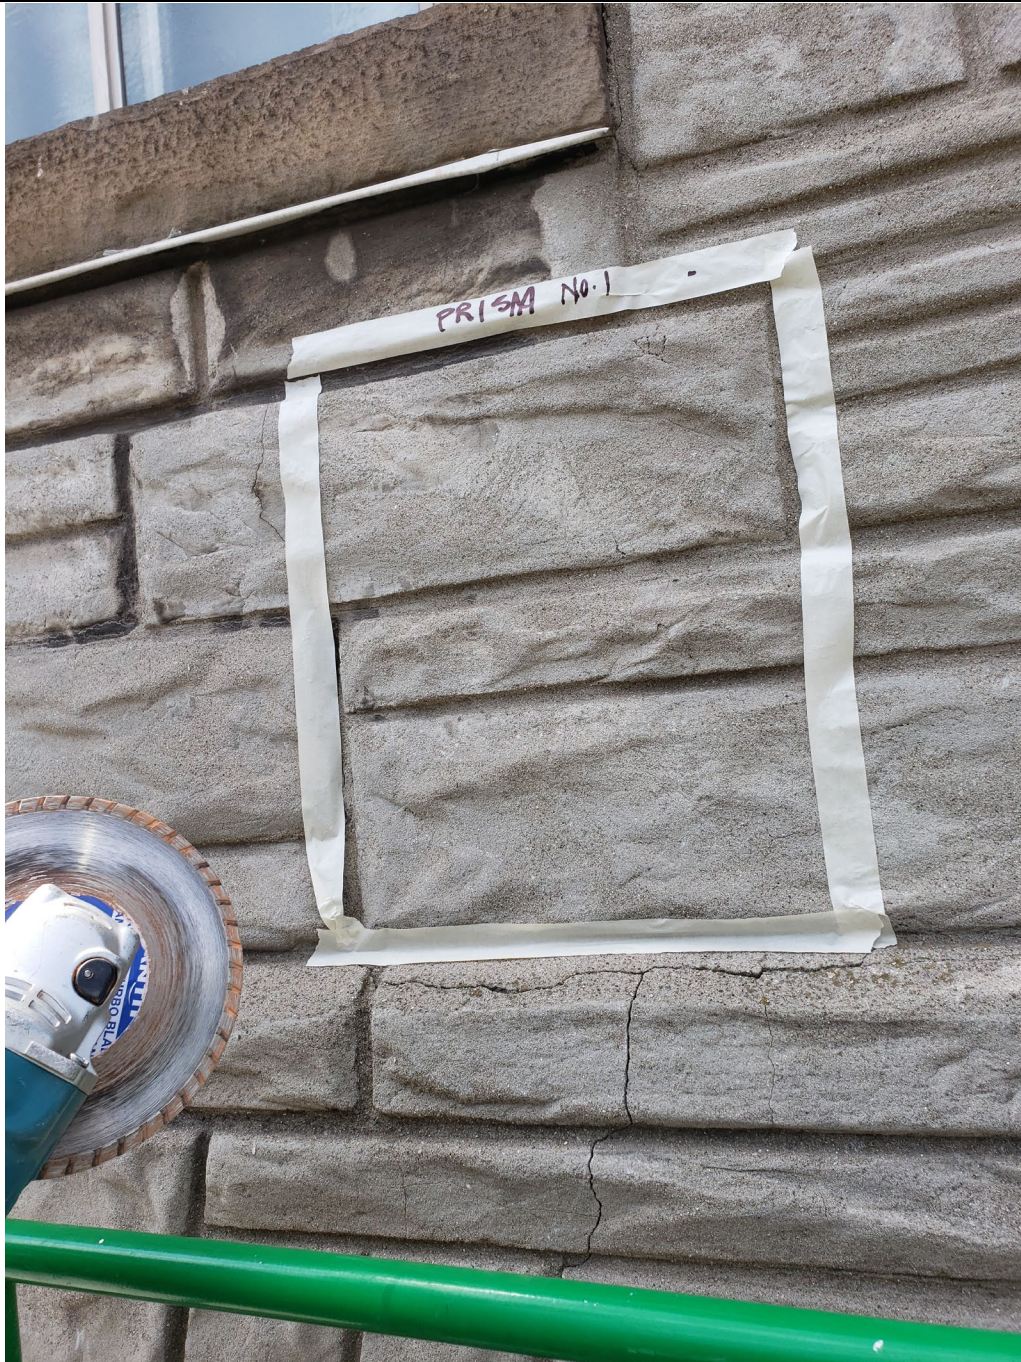
Photograph No. 4, showing test location for Brick Prism No. 1, upon removal of the stone work. Note the visible rusted steel mesh and rusted steel concrete nail heads holding the mesh to the brick. Stonework base mortar was still bonded to the brickwork for most of the area.

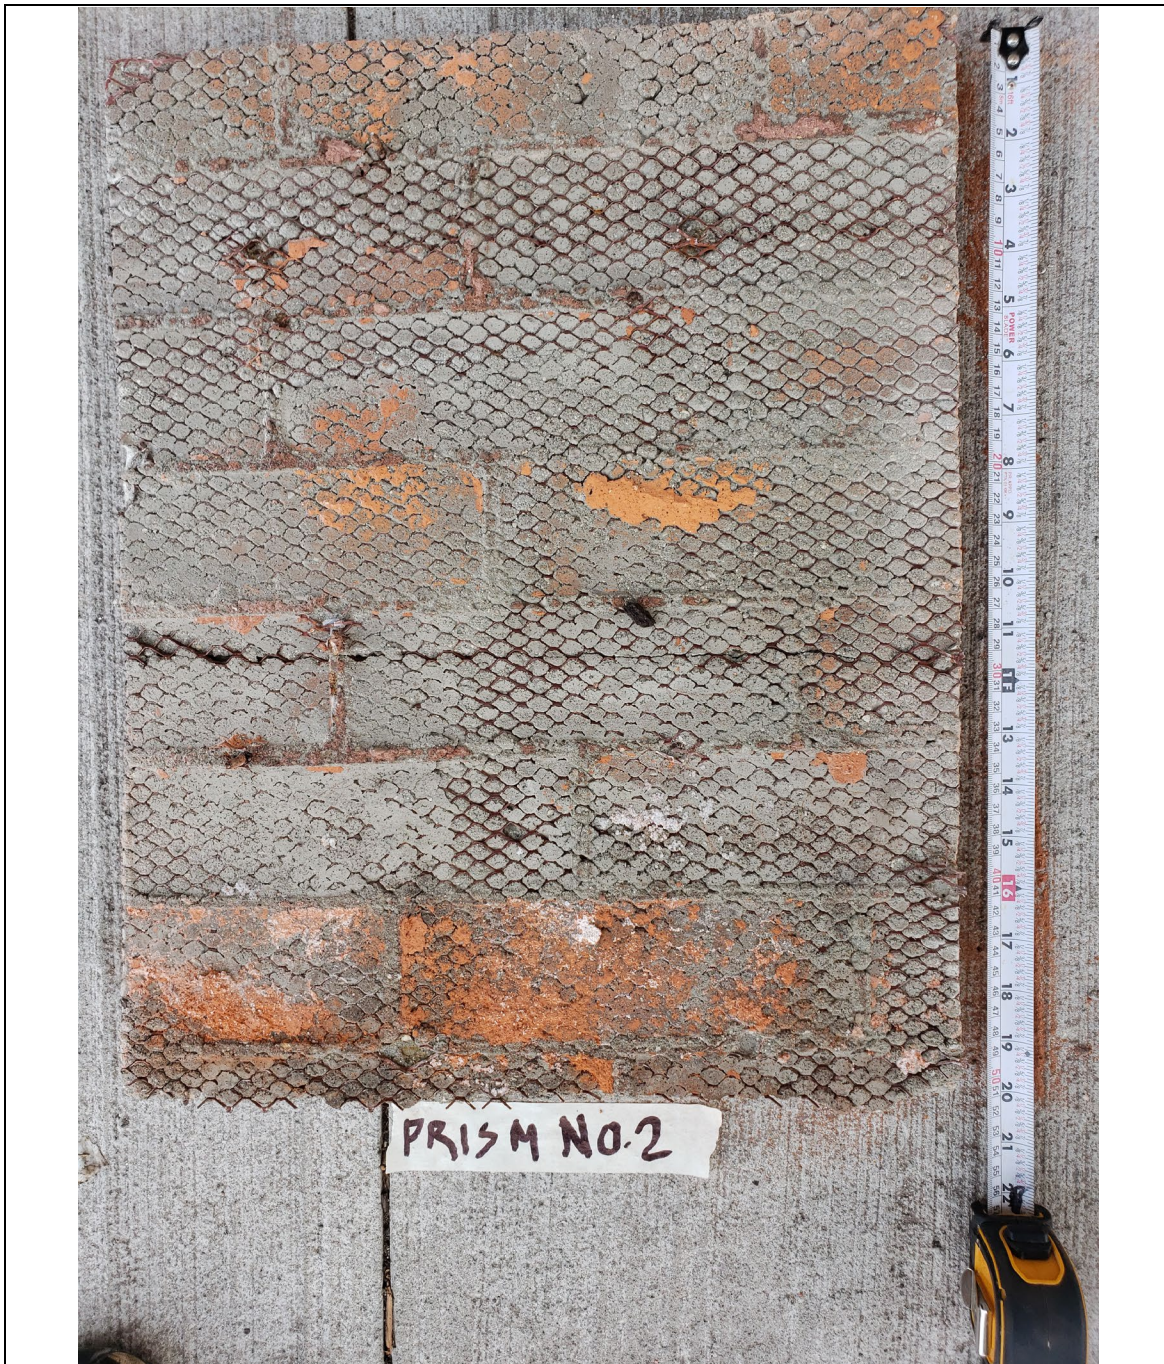
Photograph No. 7, showing the interior face of the stonework upon removal from the wall, for Brick Prism No. 2. Note the rusted expanded steel mesh, and adhering brick facing.

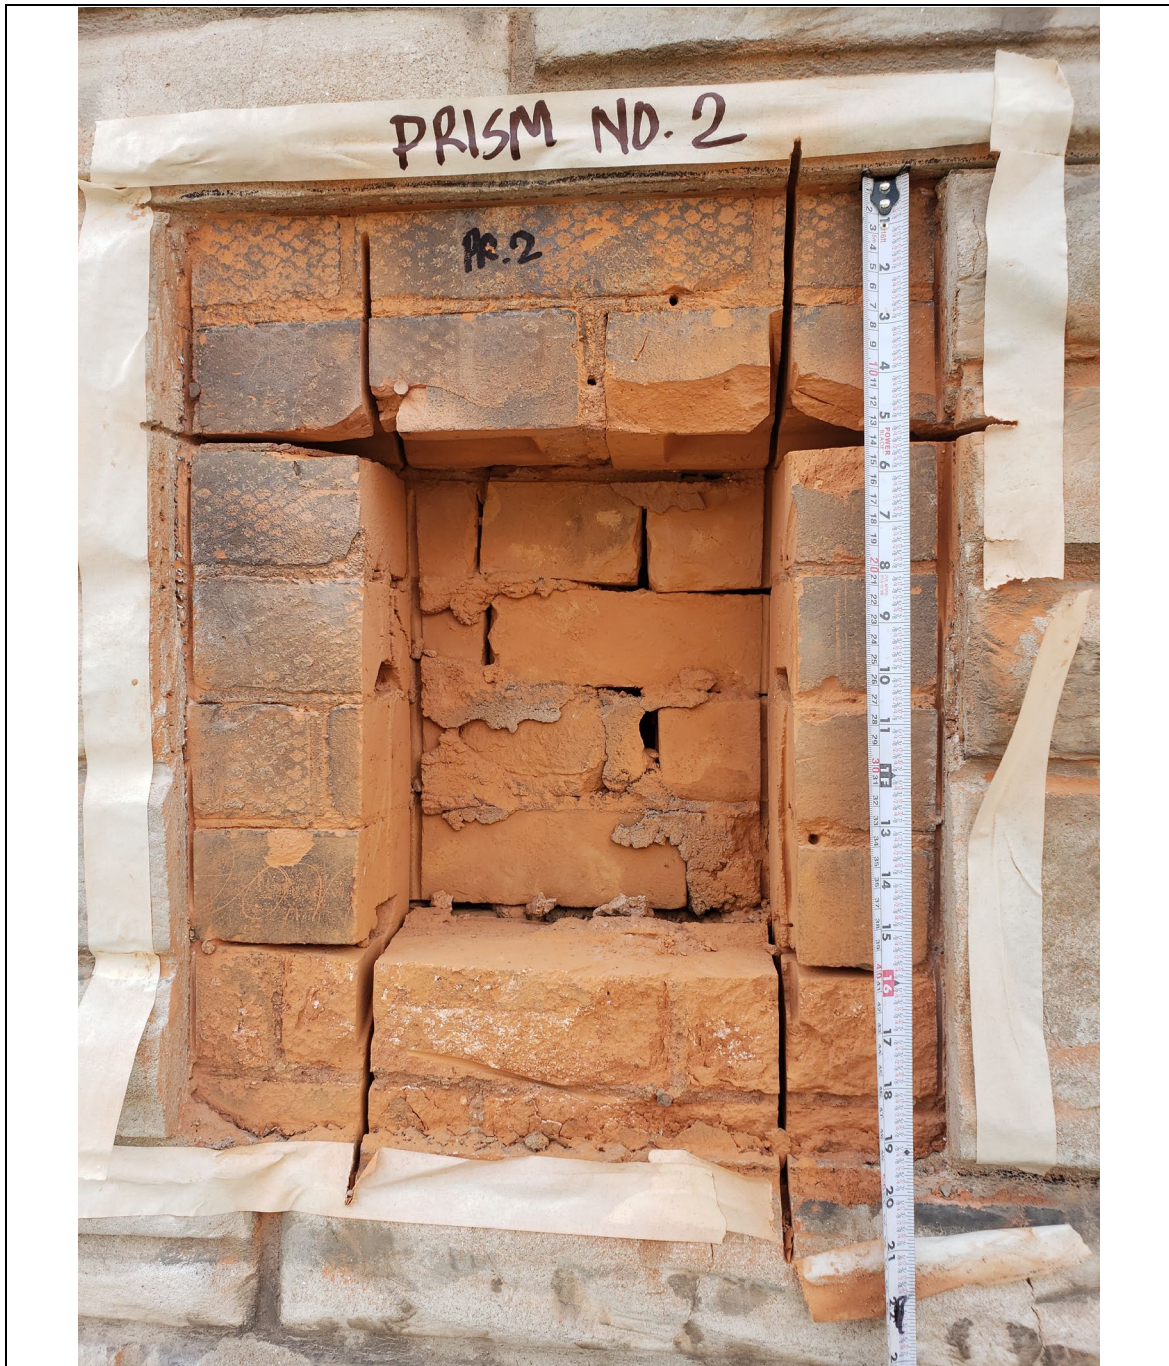
Photograph No. 8, showing test location after removal of Brick Prism No. 2. Note some vertical interior mortar joints were not completely filled with mortar.

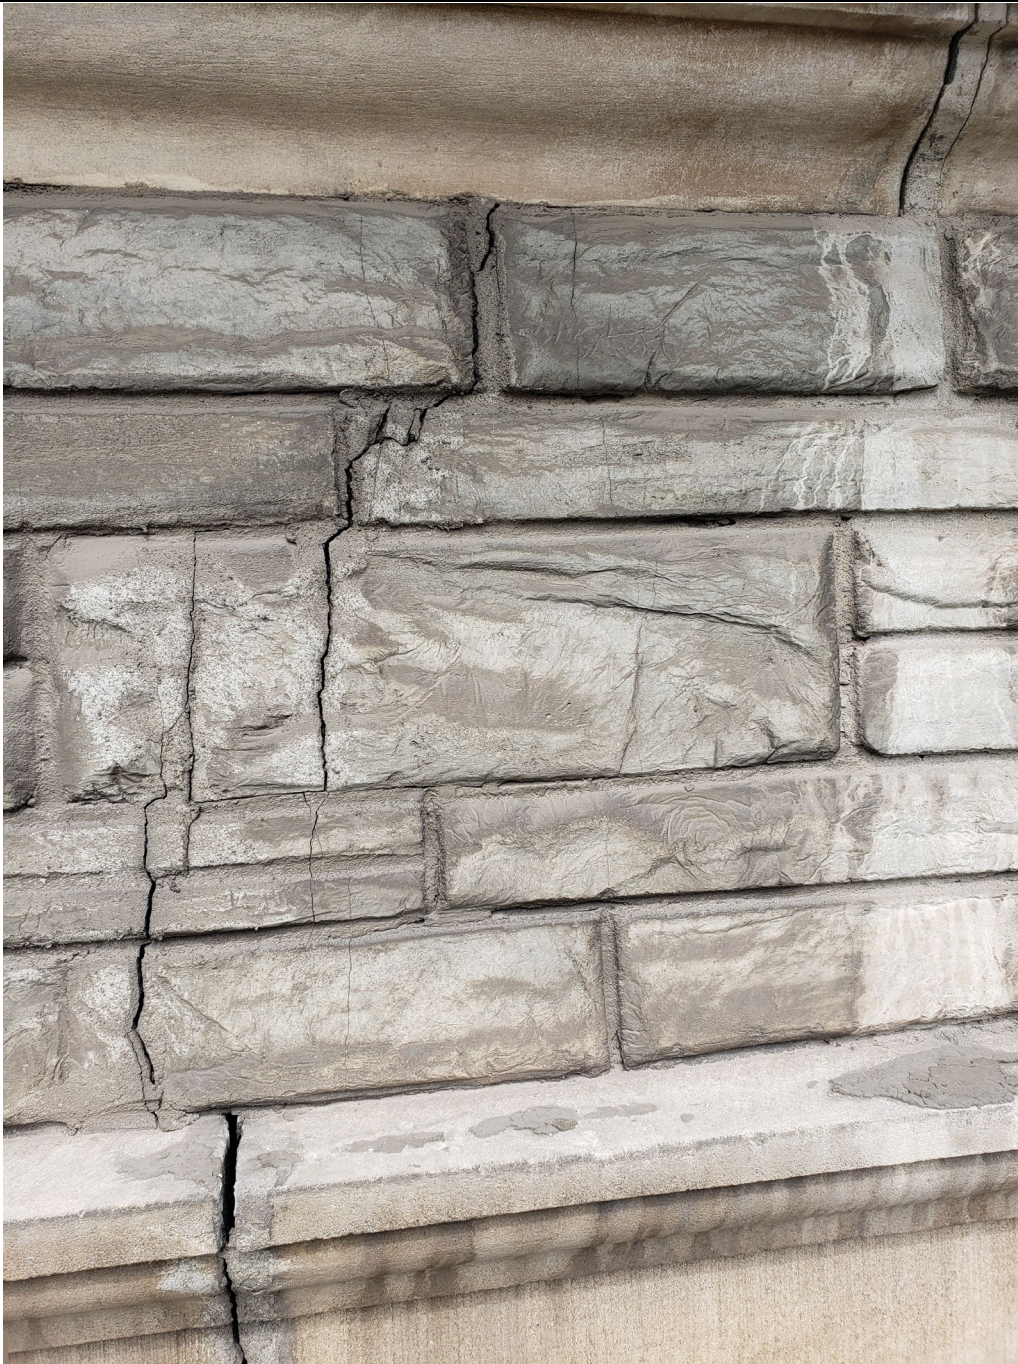
Photograph No. 17, showing a view of the stonework for Exploratory Opening No. 1 after removal of the stone. Note the spalling and cracking seen in the brickwork.

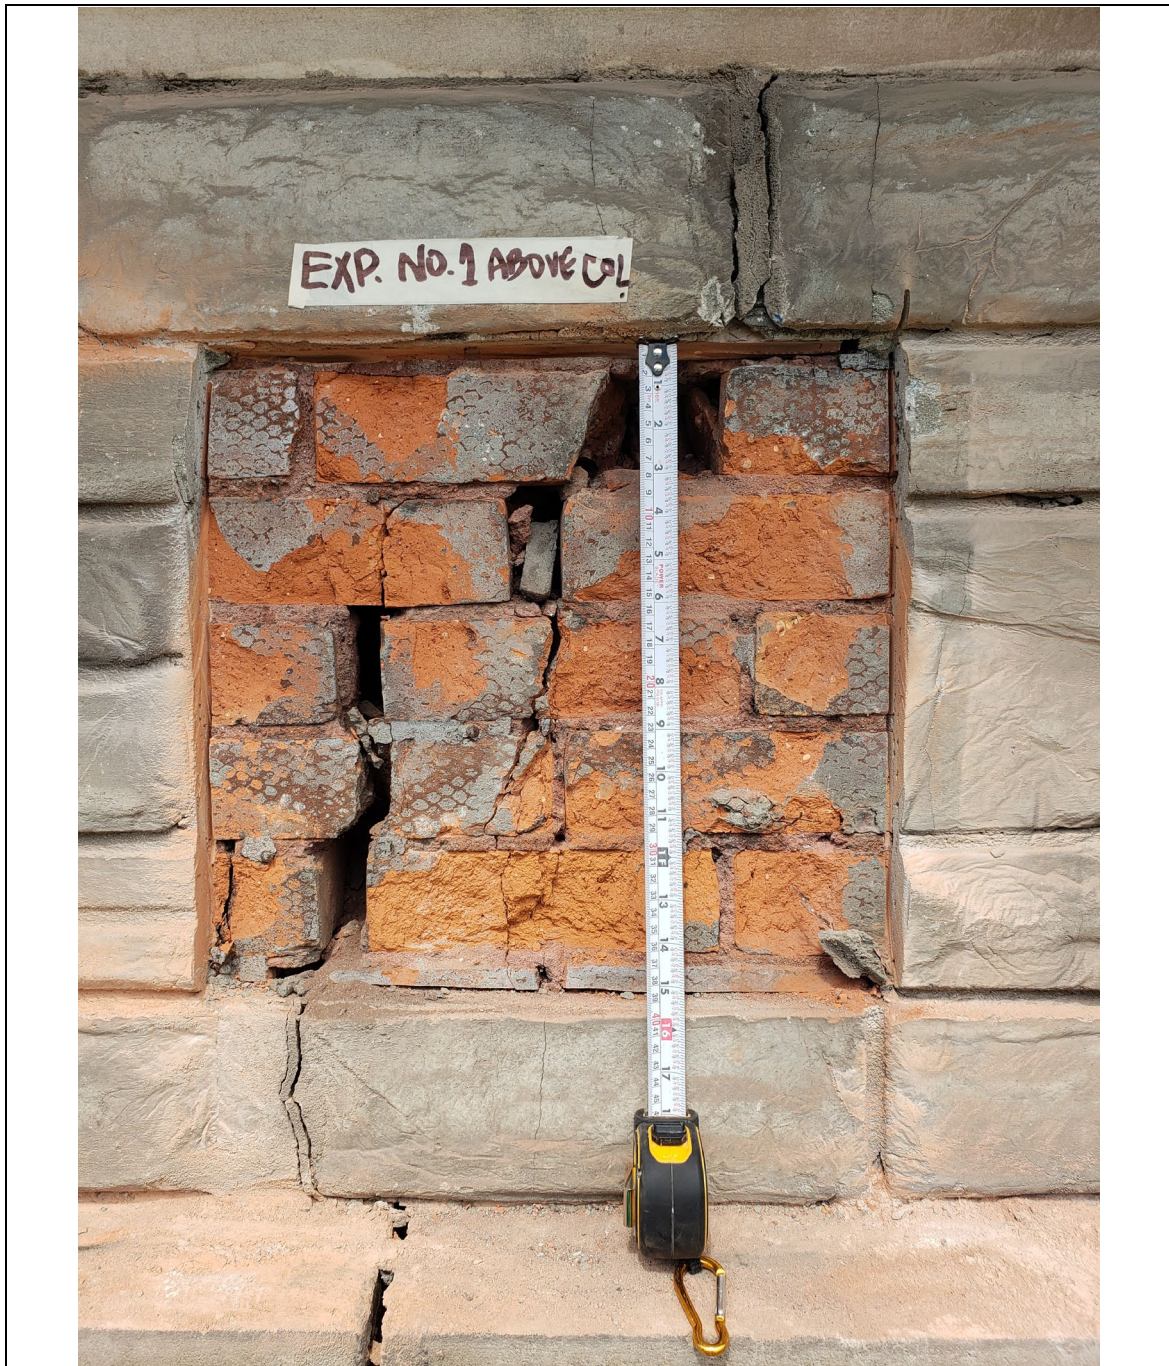
Photograph No. 18,
showing the interior view of the removed stonework for Exploratory Opening No. 1.
Note the spalled brick, and rusted expanded steel mesh.

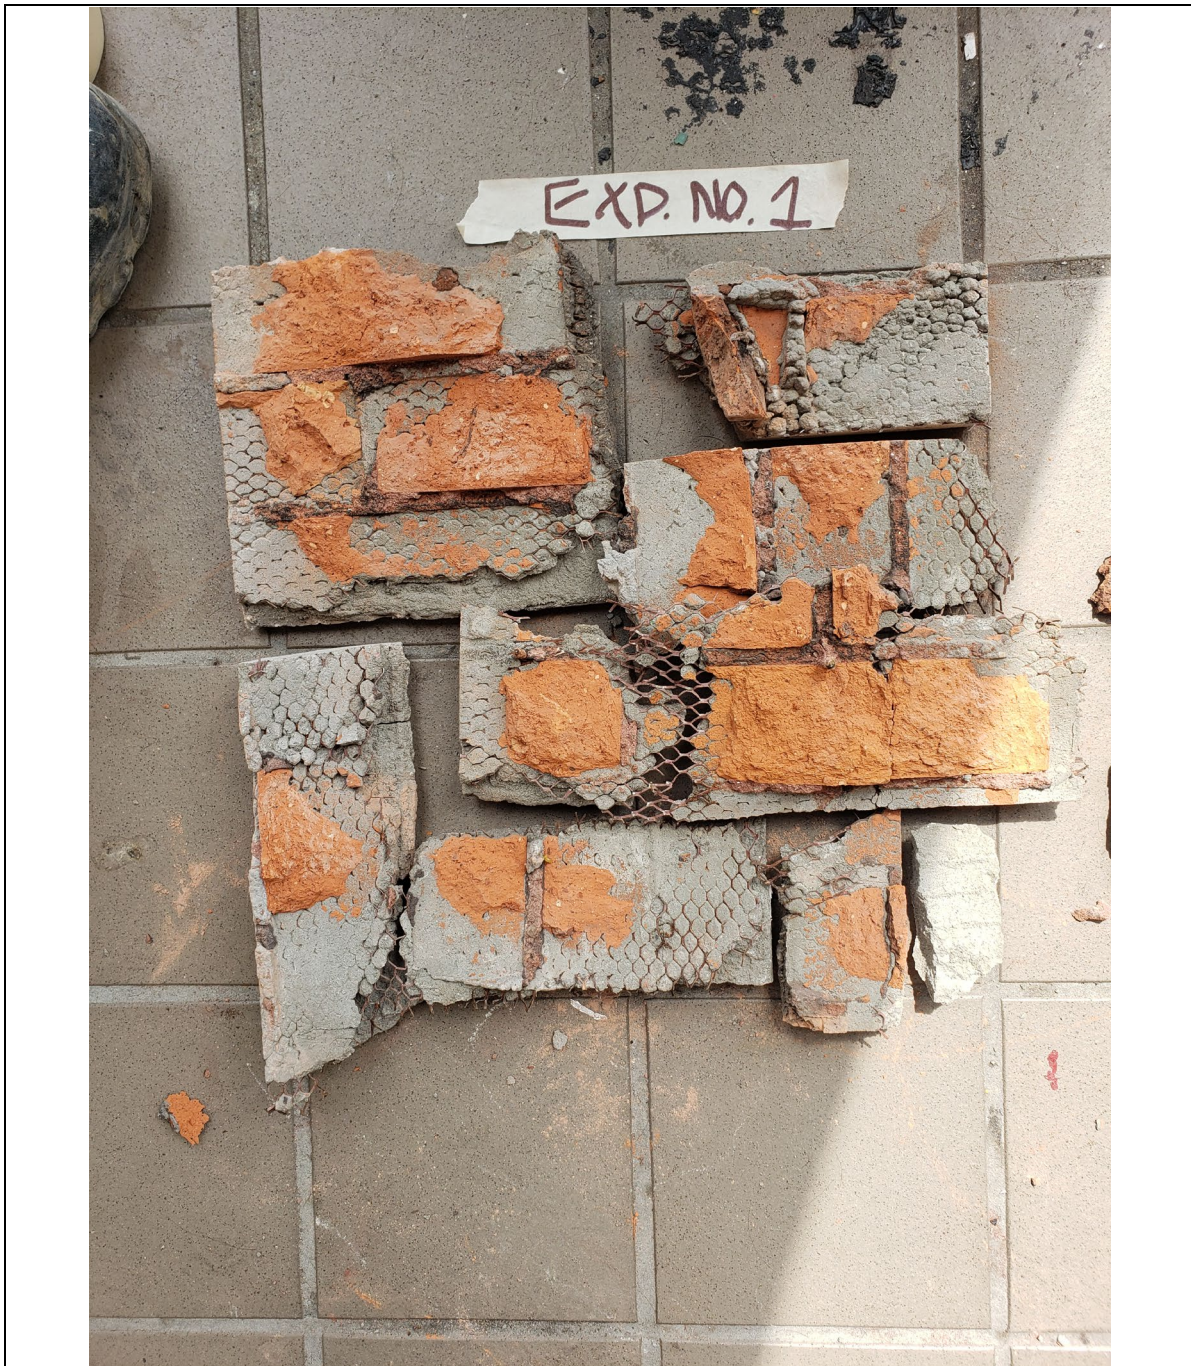
Photograph No. 19, showing an overall view of the stonework for Exploratory Opening No. 1 after removal of the stone. Note the open joints above and below the opening, which likely allows water to penetrate the masonry work and cause freeze-thaw damage to the brick work.

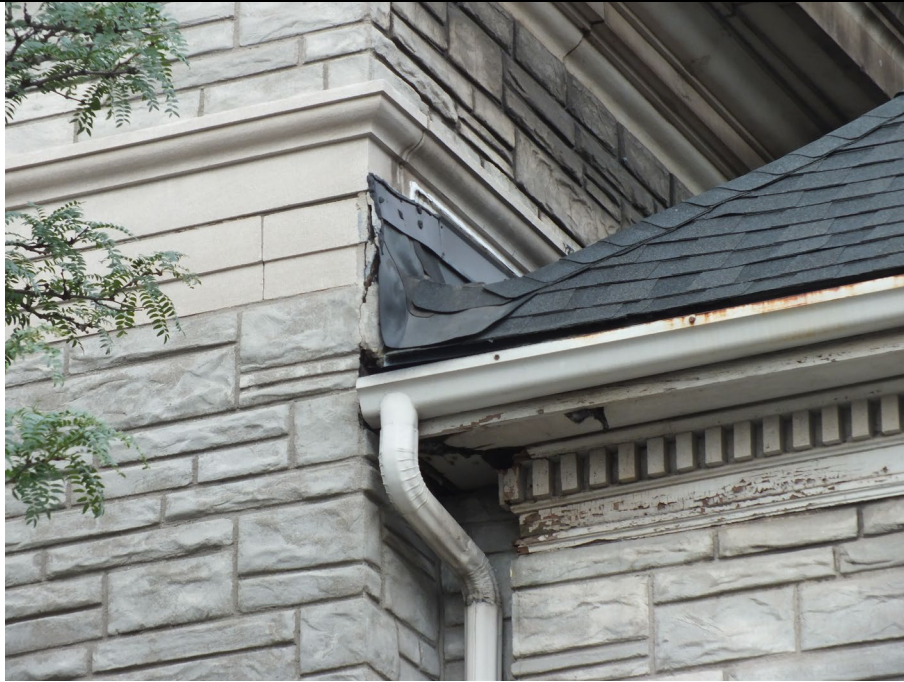
Photograph No. 20, immediately above the eave's trough, separation of the stonework was noted. Note the shingles covering this area.

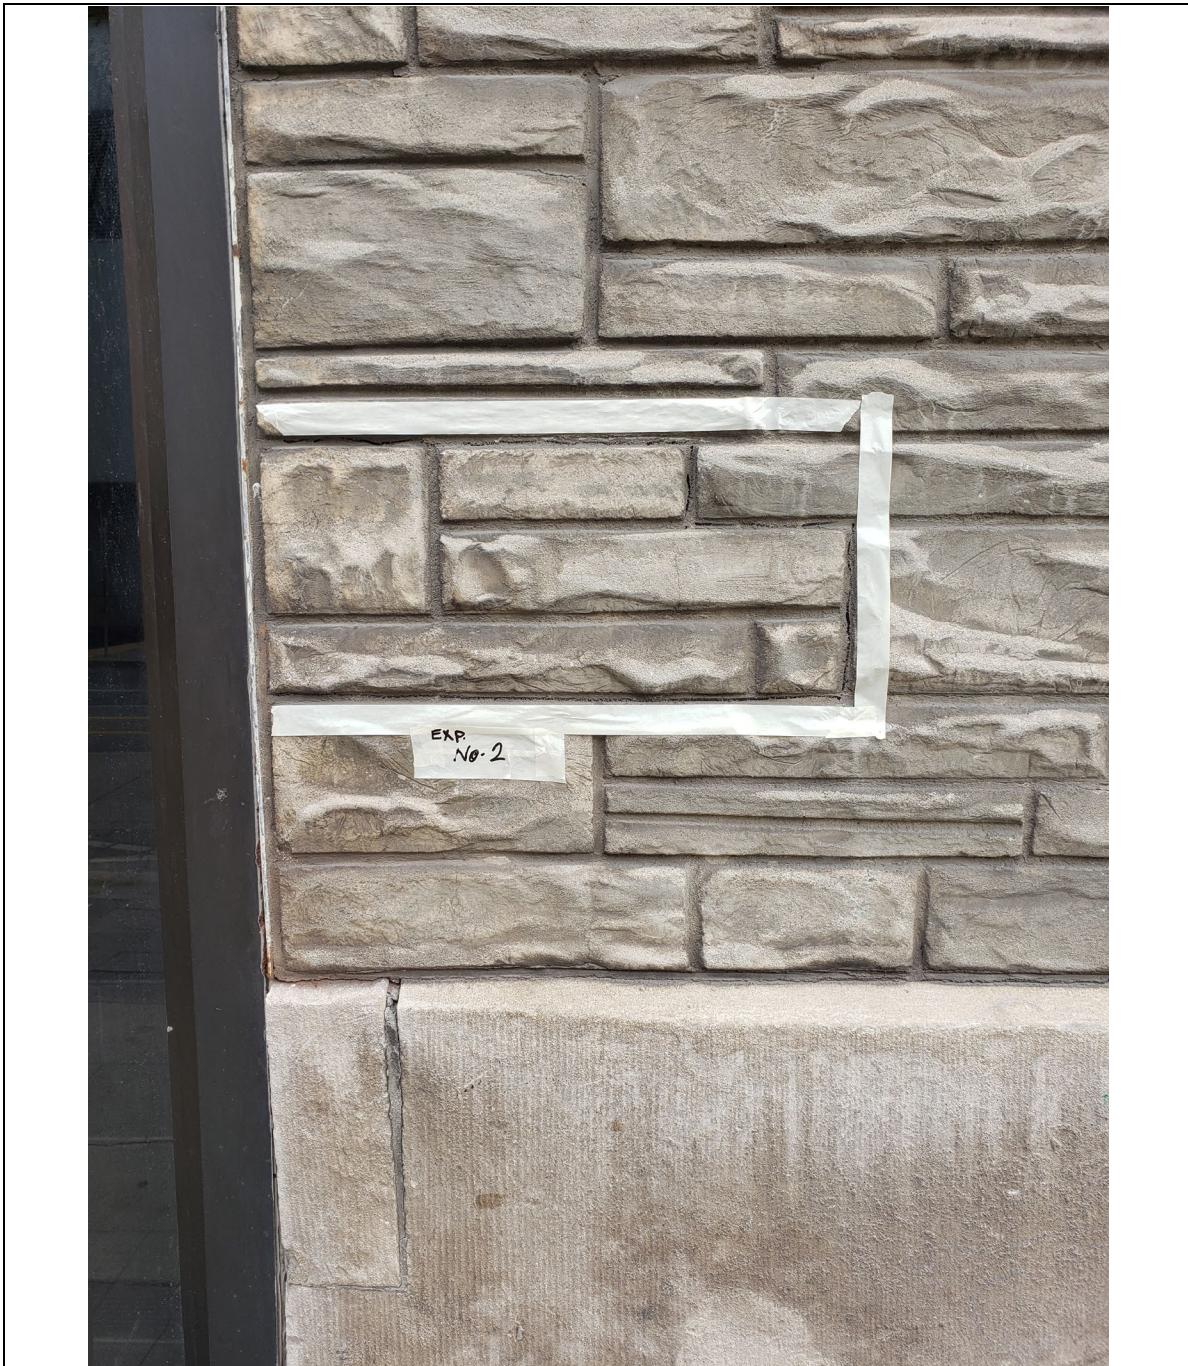
Photograph No. 23, showing a side view of the stonework for Exploratory Opening No. 2, adjacent to the door, prior to removal of the stone. Note the separation of the stonework to the brickwork, and visible freeze-thaw damage to the brick.

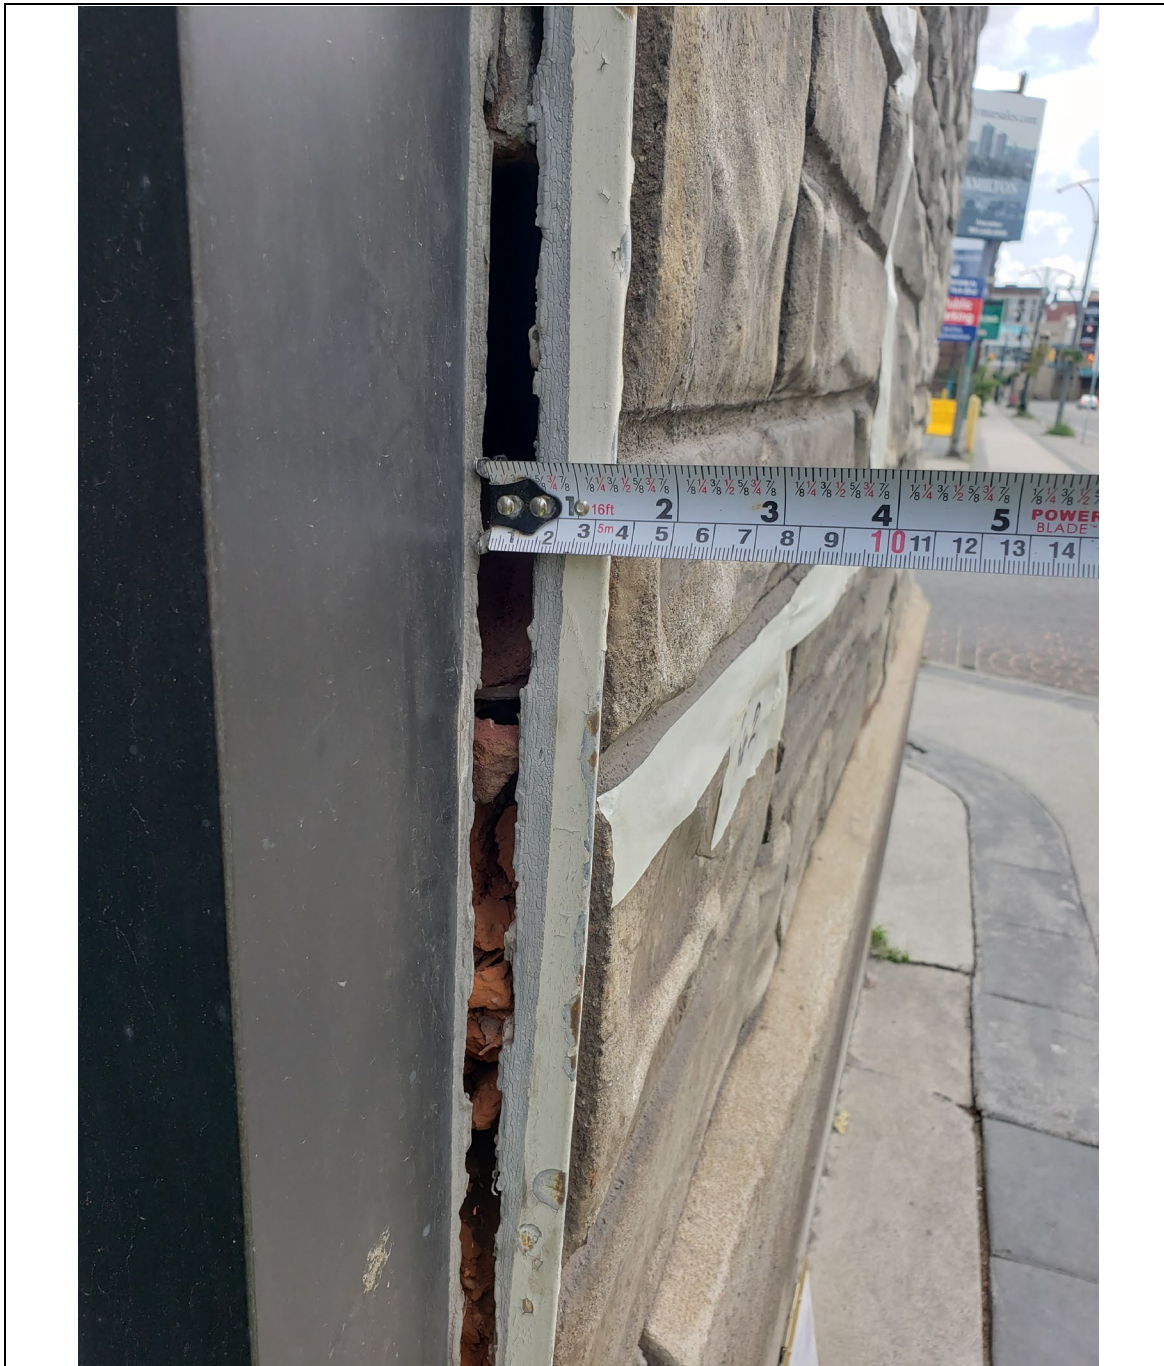
Photograph No. 24, showing a view of Exploratory Opening No. 2 after removal of the stonework. Note the spalled and missing (disintegrated) brick, likely due to freeze-thaw damage.

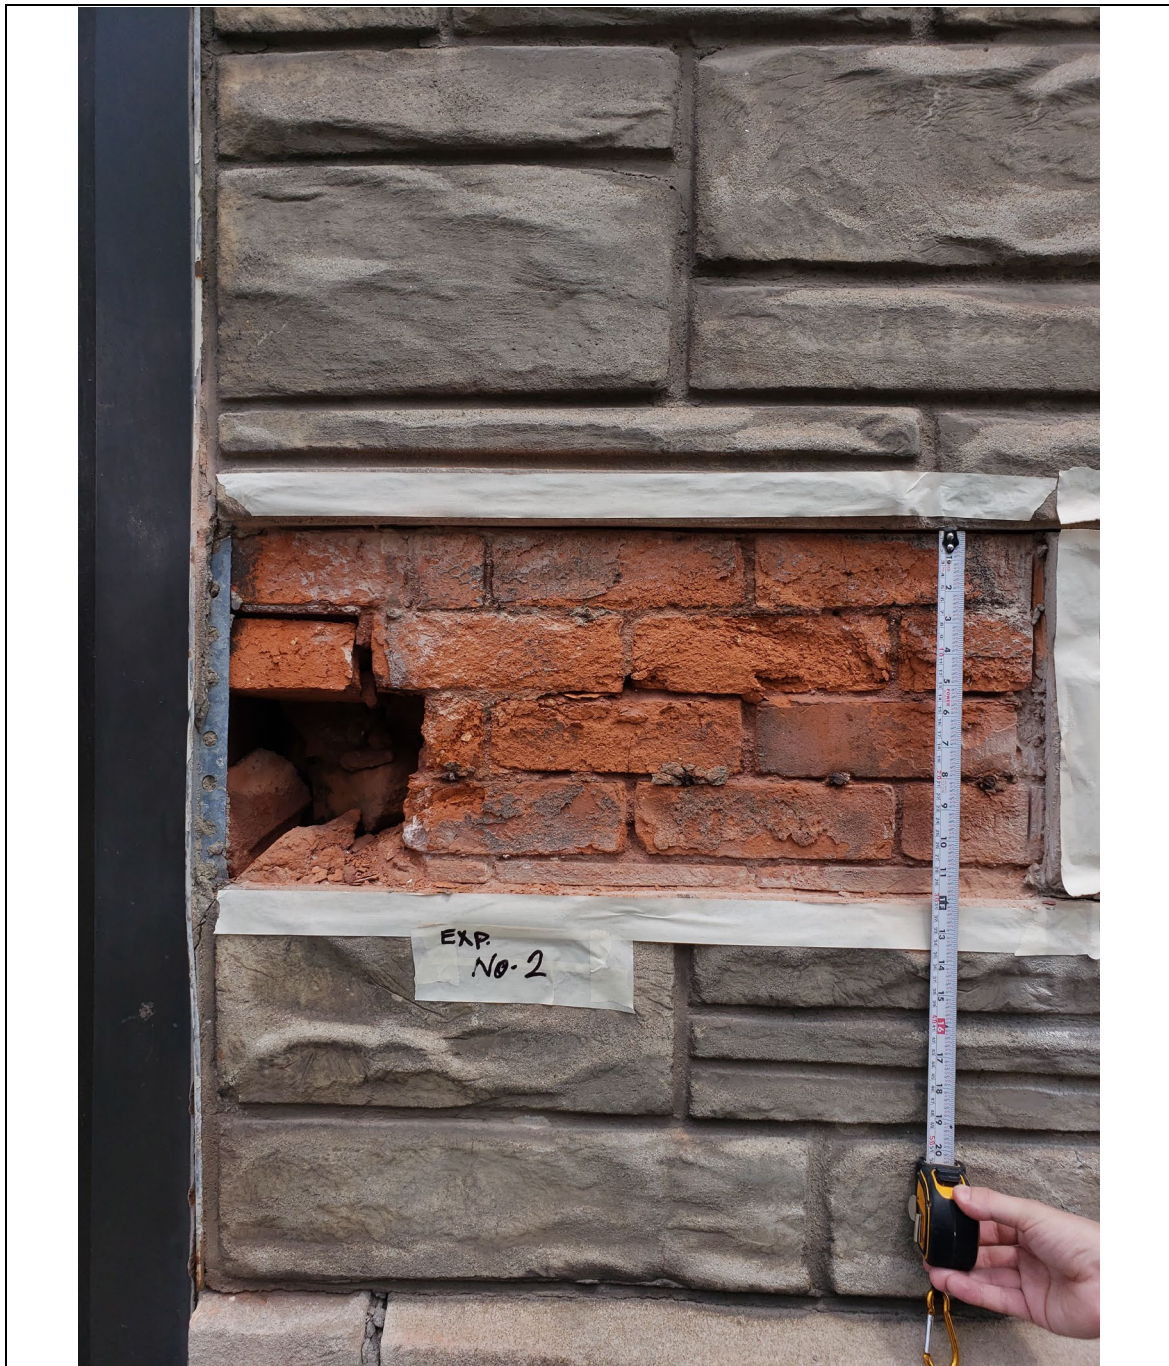
Photograph No. 25, showing a close-up view of Exploratory Opening No. 2 after removal of the stonework. Note the spalled and missing (disintegrated) brick, likely due to freeze-thaw damage.
