CULTURAL HERITAGE IMPACT ASSESSMENT

**89 Park Street North,
Hamilton**

Date:
October 2023

Prepared by:
**MacNaughton Hermesen Britton Clarkson
Planning Limited (MHBC)**
200-540 Bingemans Centre Drive
Kitchener, ON N2B 3X9
T: 519 576 3650
F: 519 576 0121

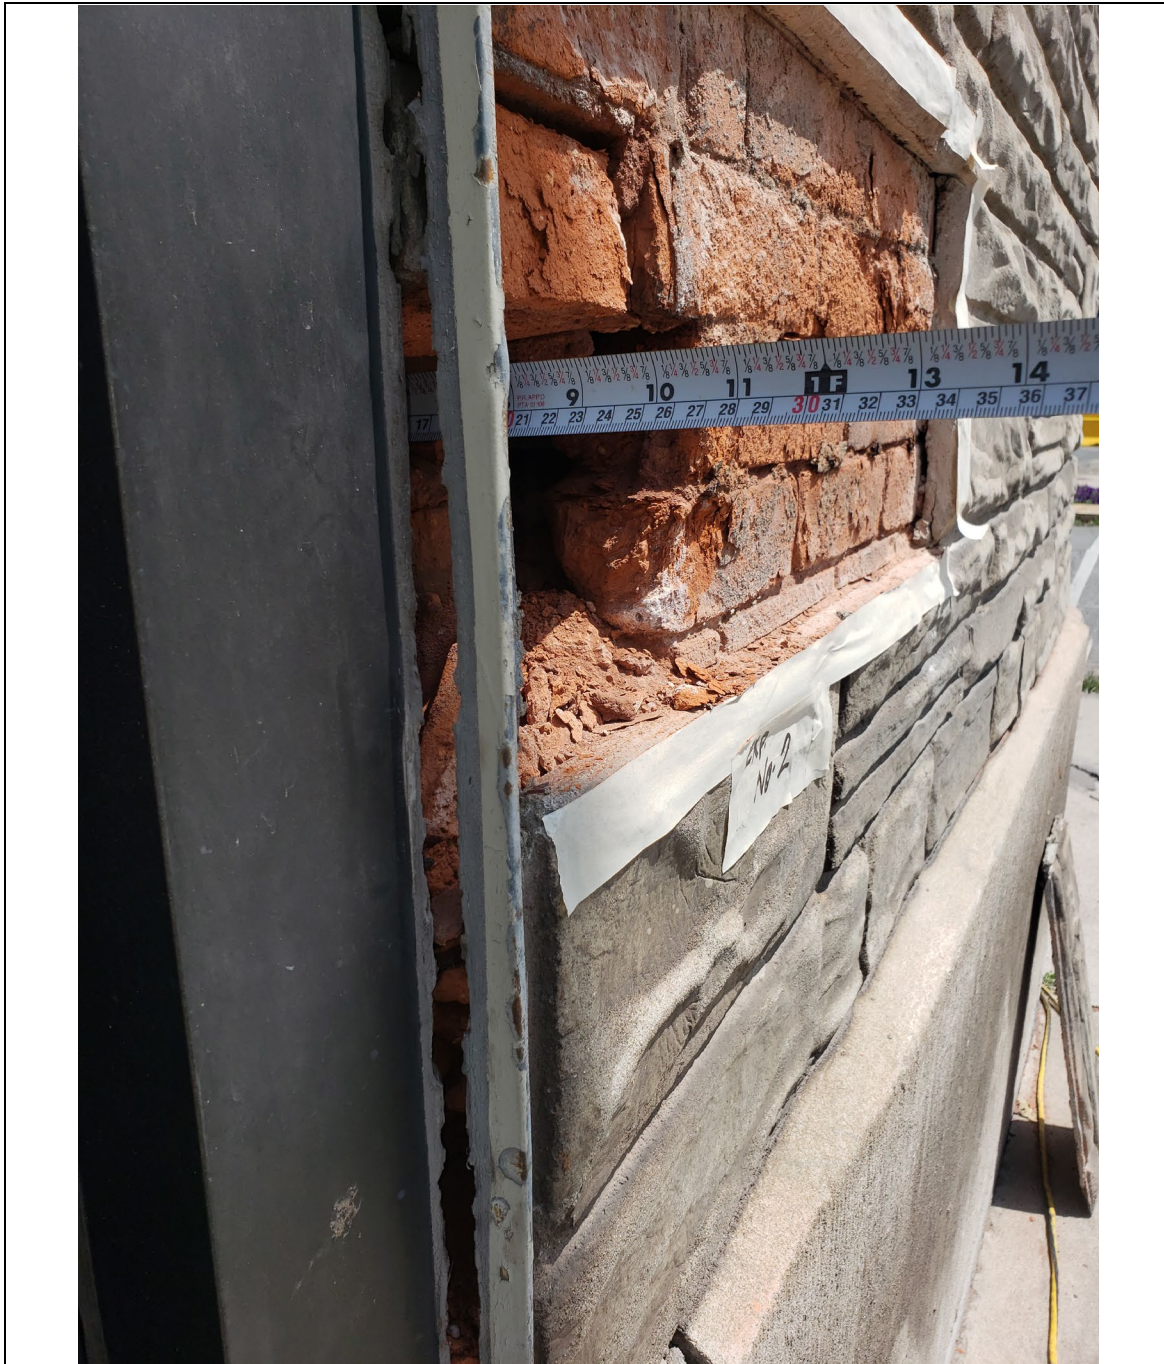
Photograph No. 26, showing a close-up view of Exploratory Opening No. 2 after removal of the stonework. Note the spalled and missing (disintegrated) brick, likely due to freeze-thaw damage.

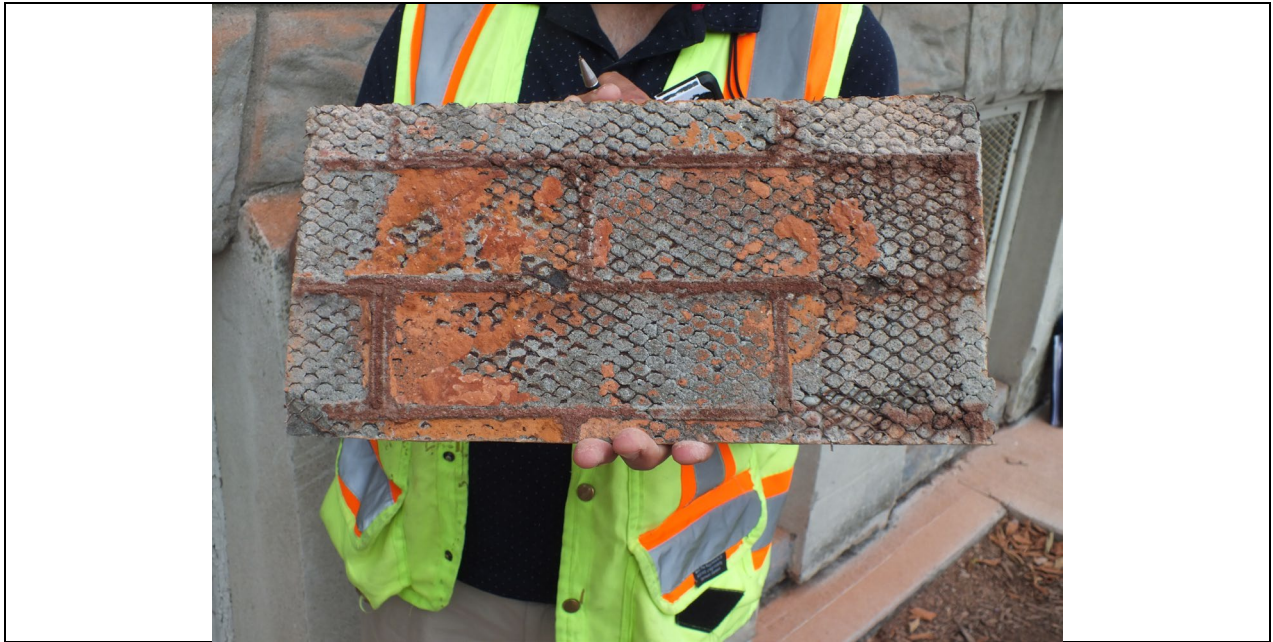
Photograph No. 38, showing the back side of the 1st. piece stonework for Anchor Pull-Out Location No. 1. Note the rusted expanded steel mesh and rusted concrete steel nails, and spalled brick pieces.

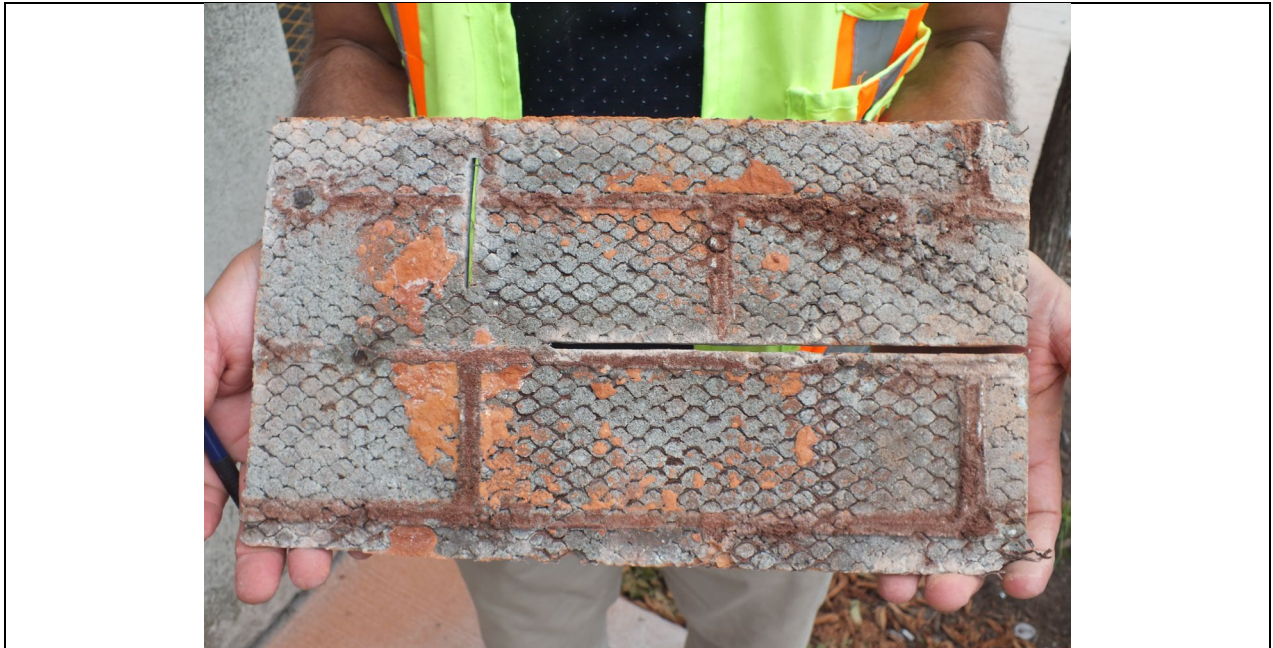
Photograph No. 39, showing the back side of the 2nd. piece stonework for Anchor Pull-Out Location No. 1. Note the rusted expanded steel mesh and rusted concrete steel nails, and spalled brick pieces.

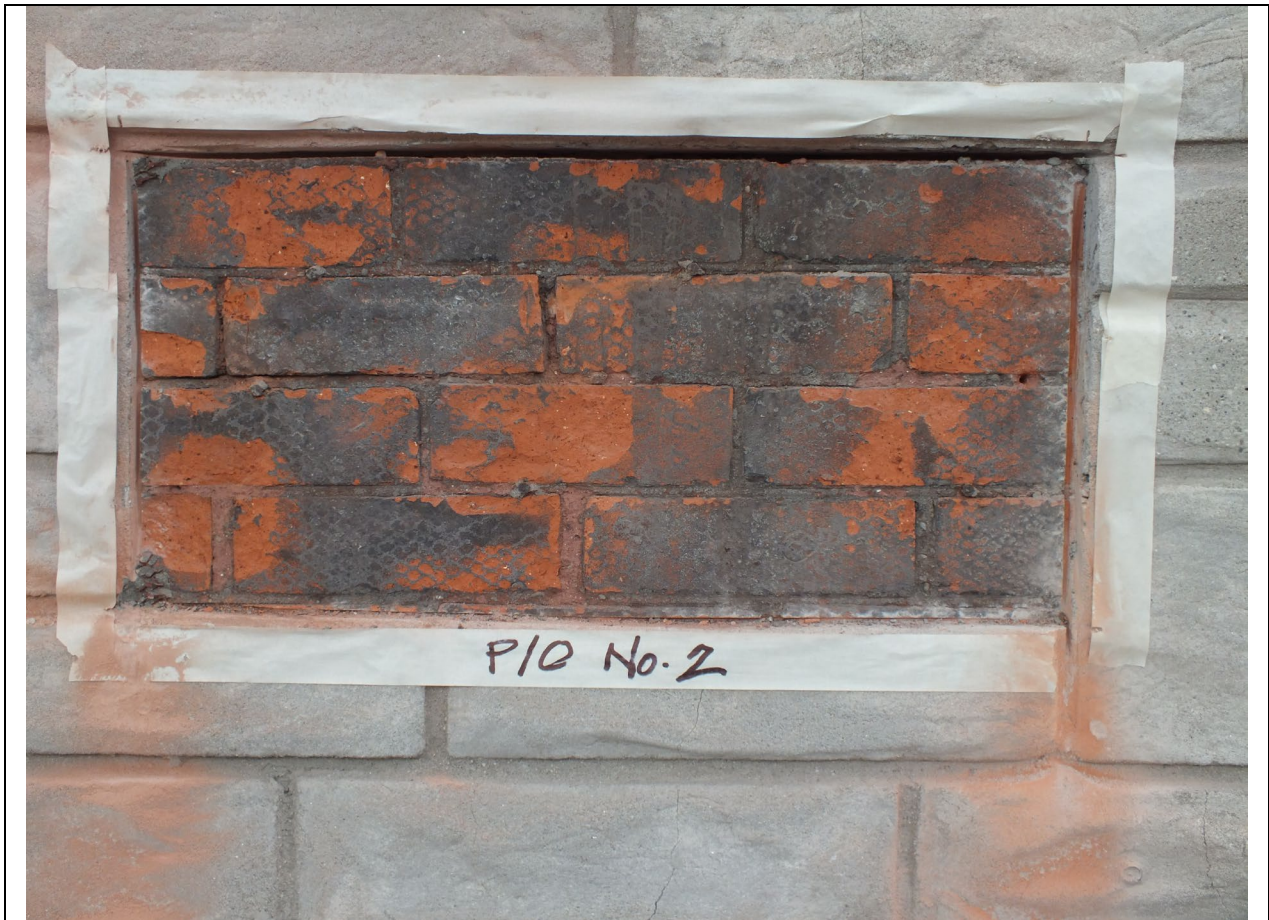
Photograph No. 40, showing the brick work in behind stone facing for Anchor Pull-out Location No. 2. Note the spalled portions of brick.

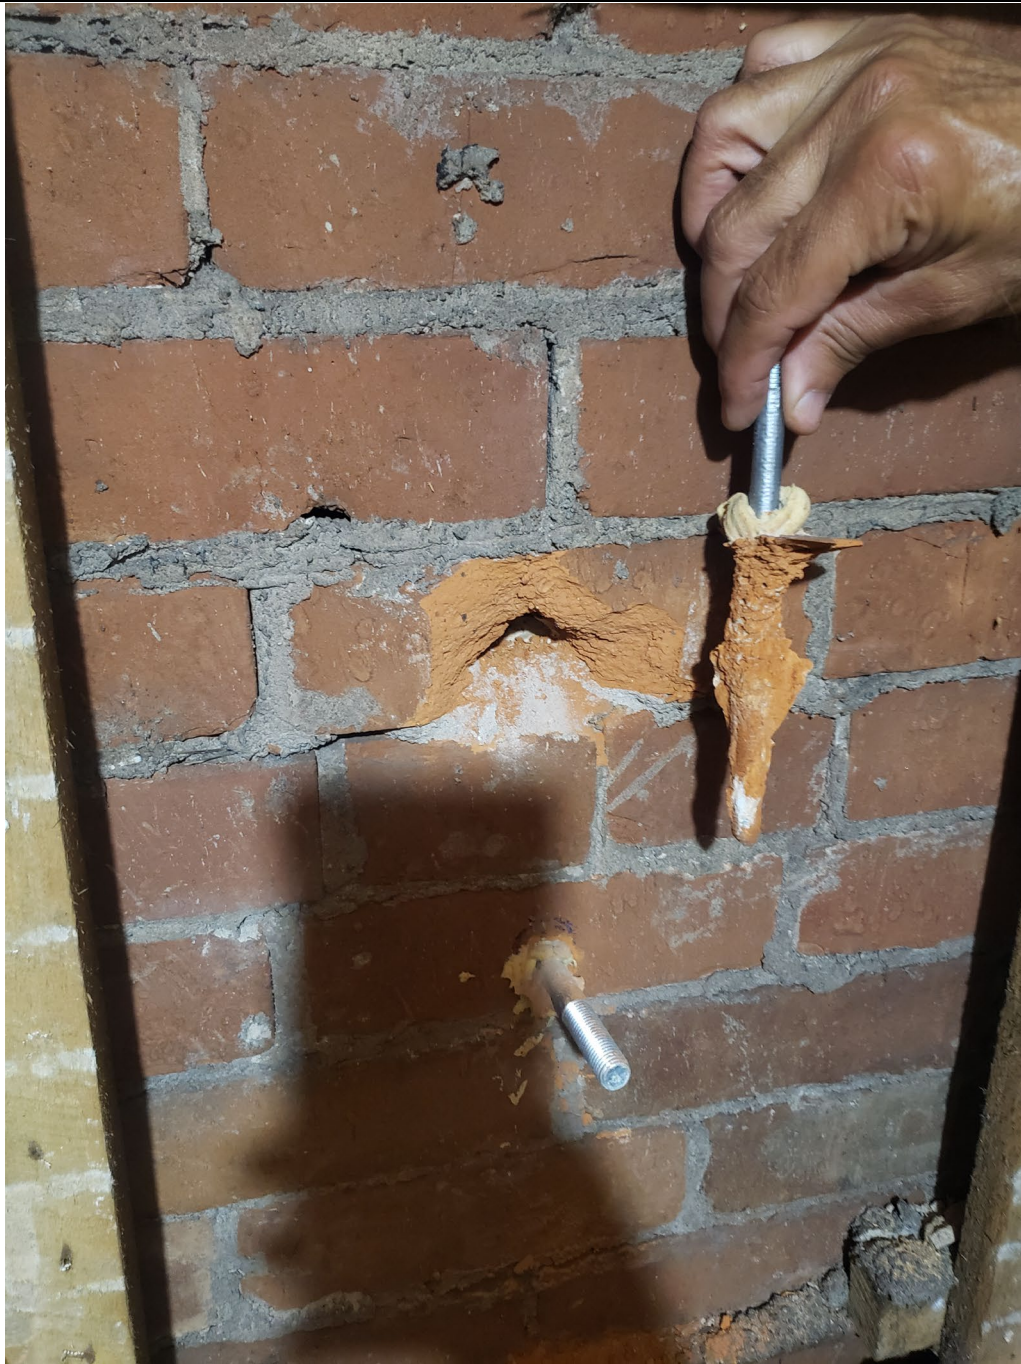
**Photograph No. 42,
showing conical failure of the brick for Anchor Pull-Out Location No. 4.**

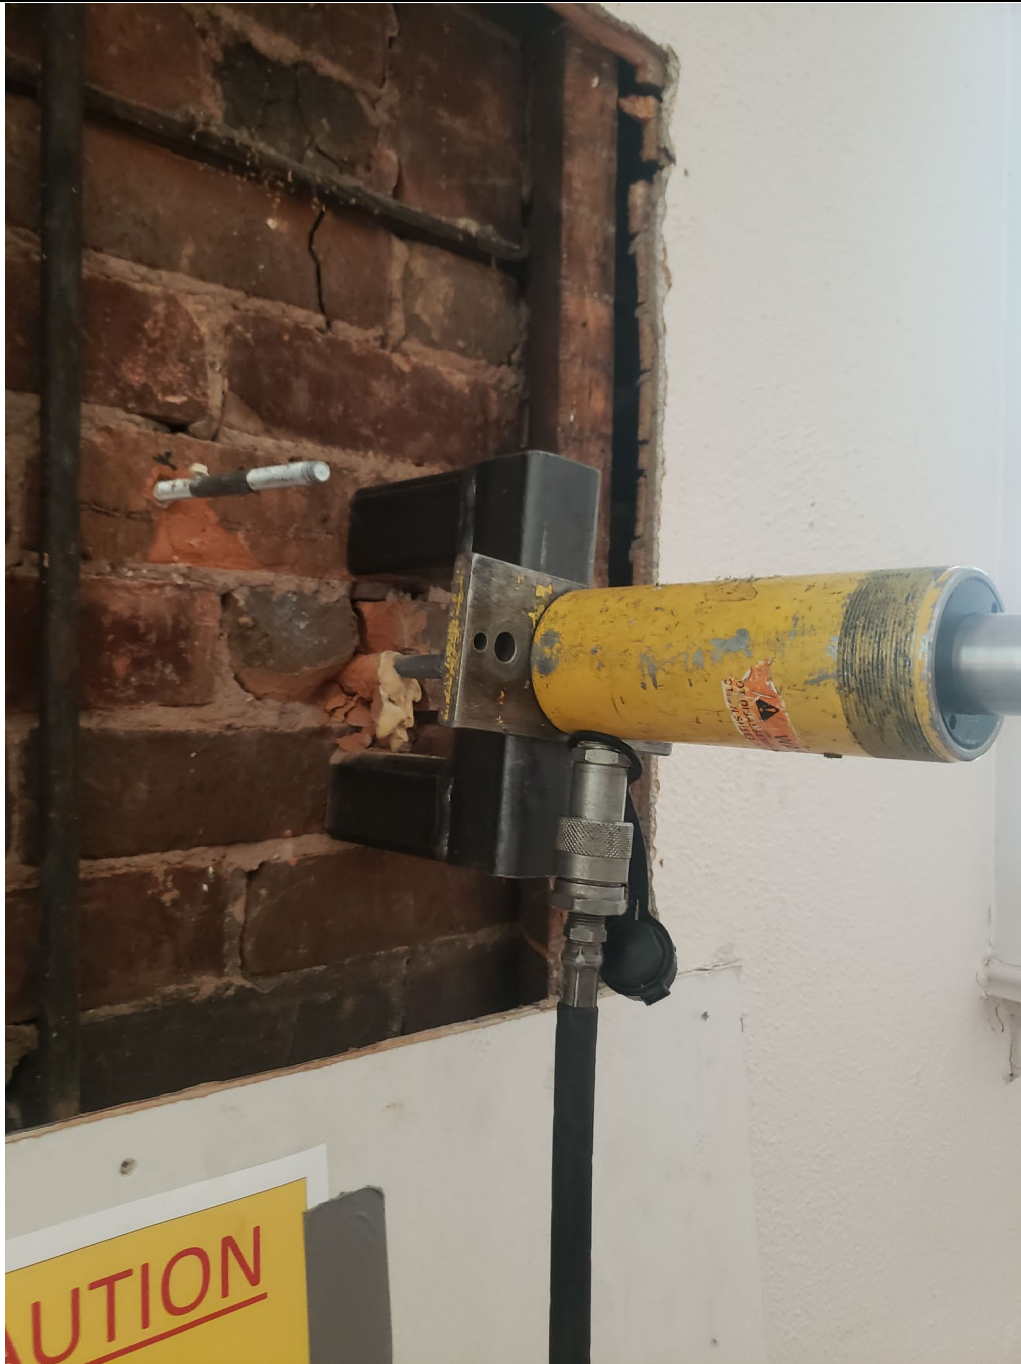
**Photograph No. 43,
showing pull-out failure of the brick for Anchor Pull-Out Location No. 5.**

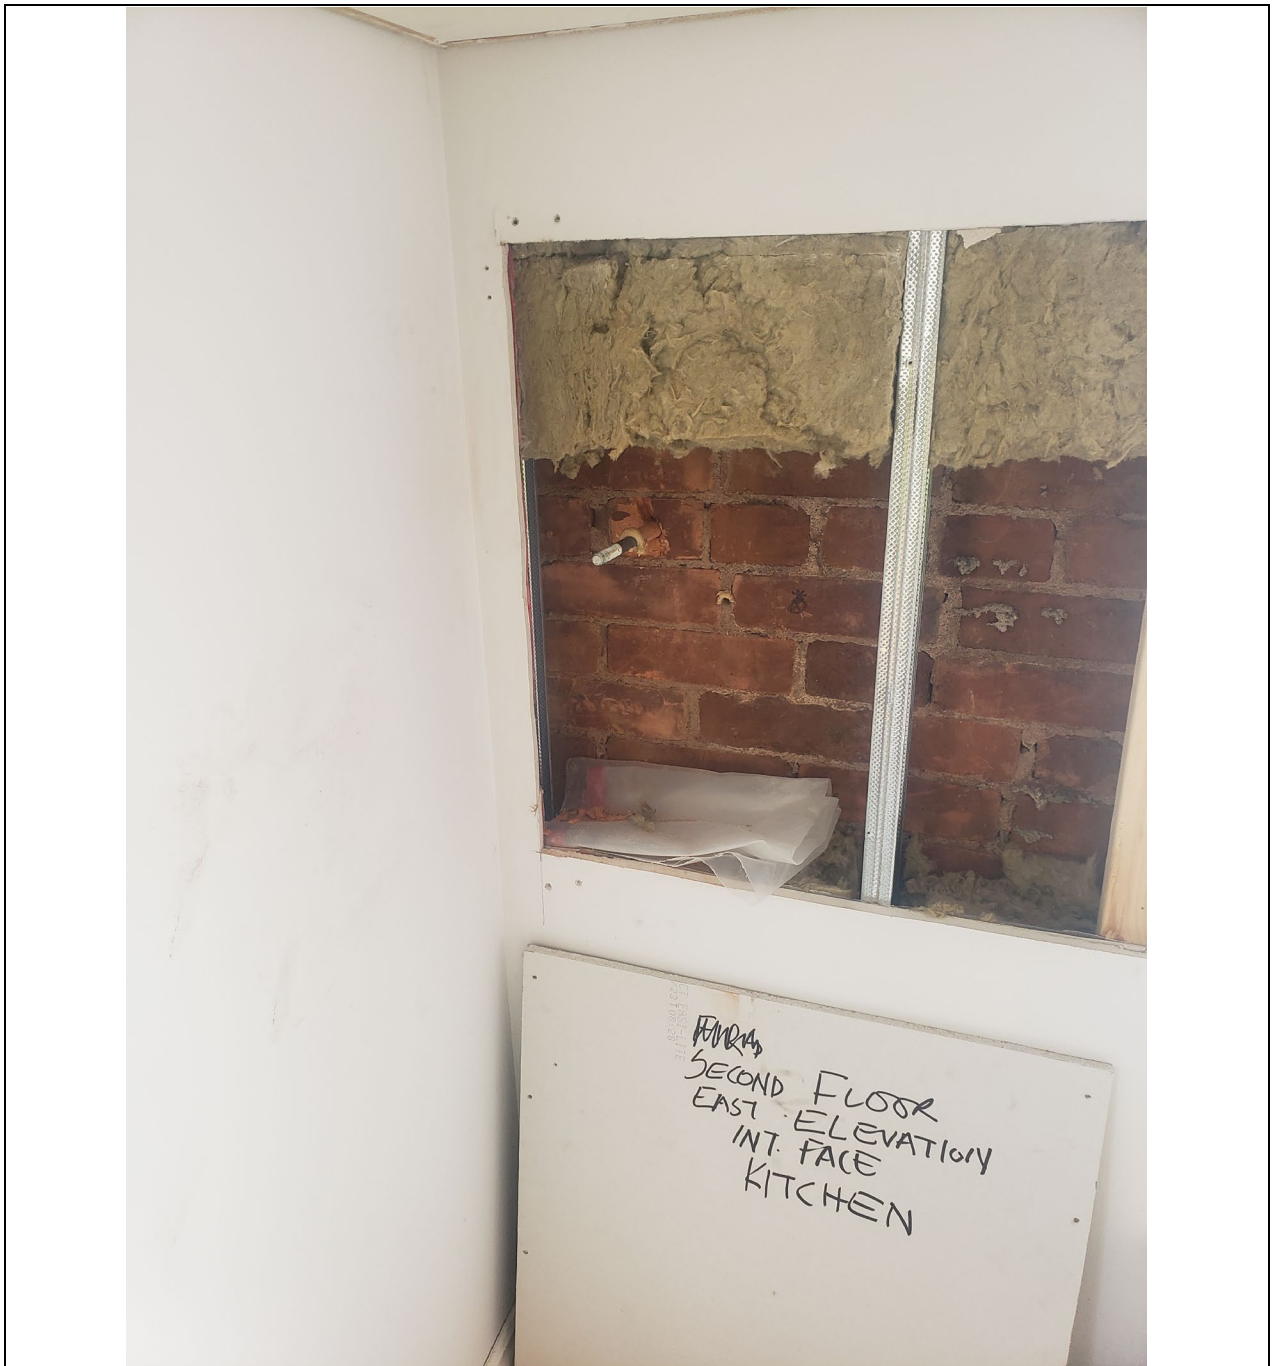
**Photograph No. 44,
showing pull-out failure of the brick for Anchor Pull-Out Location No. 6.**
