JABLONSKY, AST AND PARTNERS
 Consulting Engineers

Re: 89 Park Street North, Hamilton
 Condition Assessment of Existing Structure
 Addendum to Structural Report
Our Project No. 23195

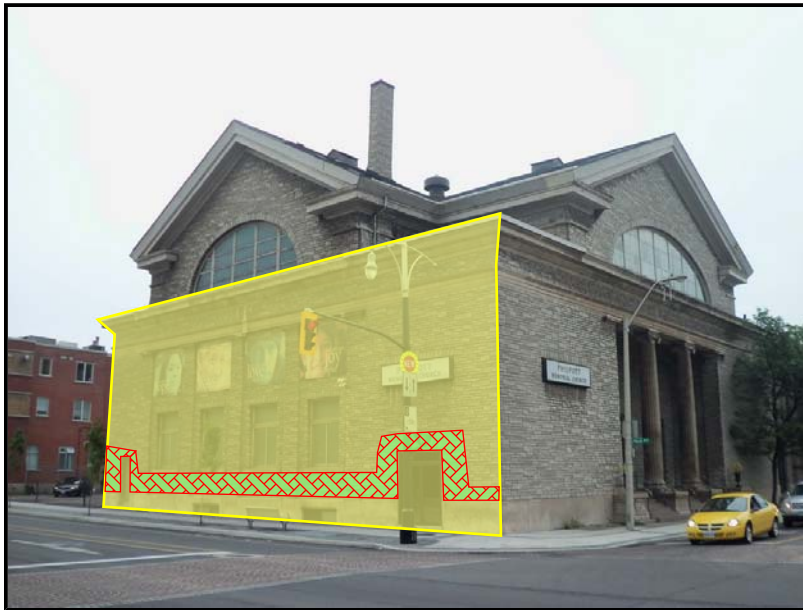
Photo No. 1: Southeast Corner

6. The cement-based mortar has severely degraded the exterior face of the entire exterior wythe of masonry (see SK-1, yellow portions). Further degradation has resulted in approximately 15-20% of the bricks likely needing replacement/repair (see SK-1, green portions).

100 % REMOVAL OF MORTAR AND 100%
REPLACEMENT OF EXTERIOR WYTHE

REBUILDING/REPOINTING (APPROXIMATELY
15-20% ANTICIPATED)
