CITY OF HAMILTON PLANNING AND ECONOMIC DEVELOPMENT DEPARTMENT Planning Division

то:	Chair and Committee Members Hamilton Municipal Heritage Committee
COMMITTEE DATE:	January 26, 2024
SUBJECT/REPORT NO:	Recommendation to Designate 84 York Boulevard, Hamilton (Philpott Memorial Church), under Part IV of the <i>Ontario Heritage Act</i> (PED24007) (Ward 2)
WARD(S) AFFECTED:	Ward 2
PREPARED BY:	Emily Bent (905) 546-2424 Ext. 6663
SUBMITTED BY:	Shannon McKie Acting Director, Planning and Chief Planner Planning and Economic Development Department
SIGNATURE:	Adulia

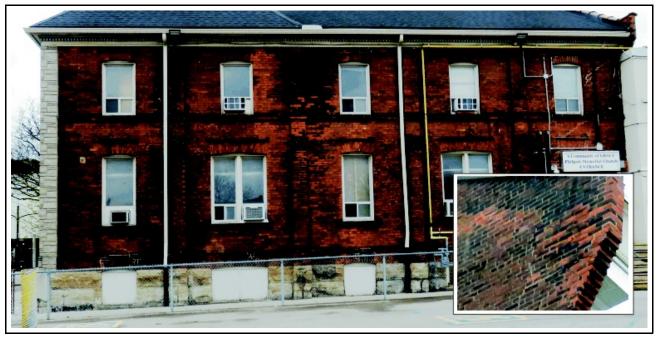
- 4.2 Although sounding techniques were not used during the on-site assessment, from visual observations, the mortar appeared to be well-bonded to the brickwork there was no visible evidence of delaminations.
- 4.3 The author does not know the reason why the plaster was applied to the then approximately forty to fifty-year-old brickwork. However, following a review of the side and rear elevations where there was much evidence of badly weathered masonry and brick replacement it is the author's opinion that the most likely and logical reason was therefore a concern regarding the evident poor quality of the bricks. (Photograph 2)

Photo 2 with inset image: There was much evidence of badly-weathered masonry and brick replacement within the side and rear elevations.

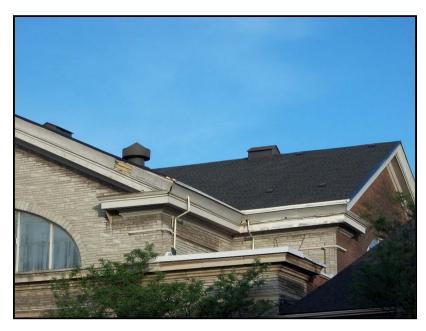
Photo No. 14: Sanctuary sloped roof deteriorated fascia

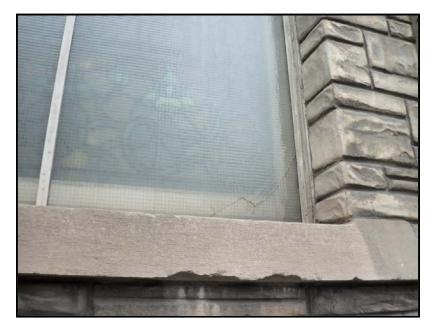
Photo No. 19: Cracked Windows

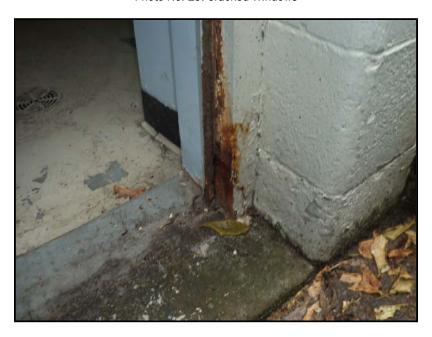
Photo No. 20: Corroded Door Frame at Emergency Basement Exit

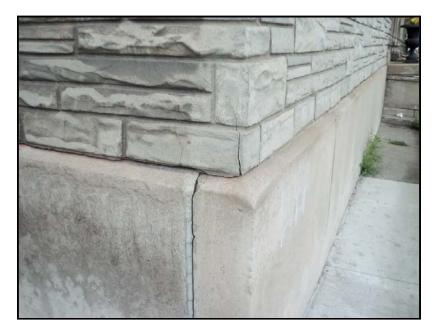
Photo No. 21: Cracks in Cementious Wall

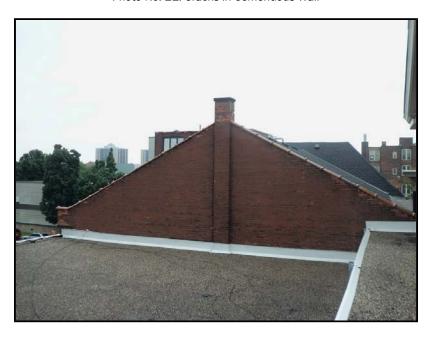
Photo No. 22: Deteriorated Chimney

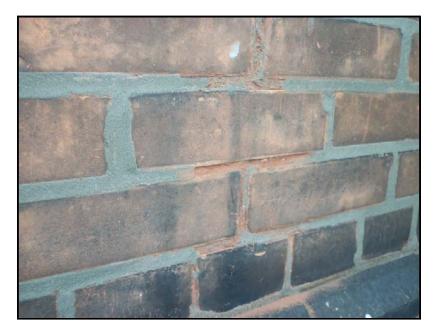
Photo No. 23: Deteriorated Mortar

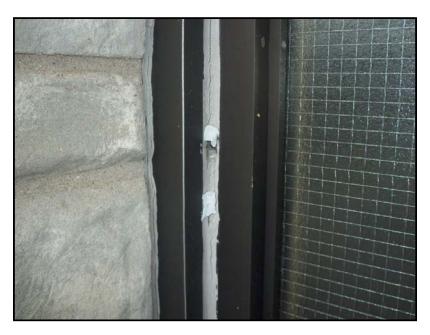
Photo No. 24: Deteriorated Sealant

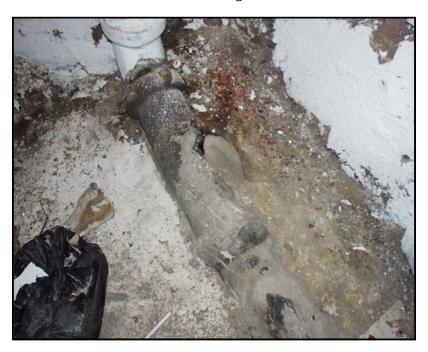
Photo No. 40: Broken Drain Pipe

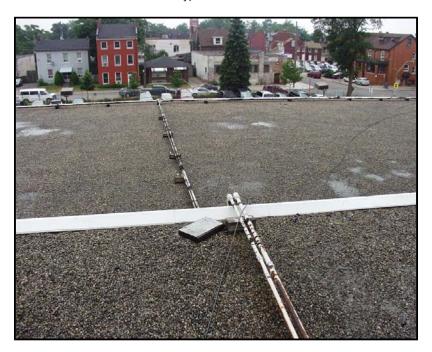
Photo No. 42: Corroded Electrical Conduit

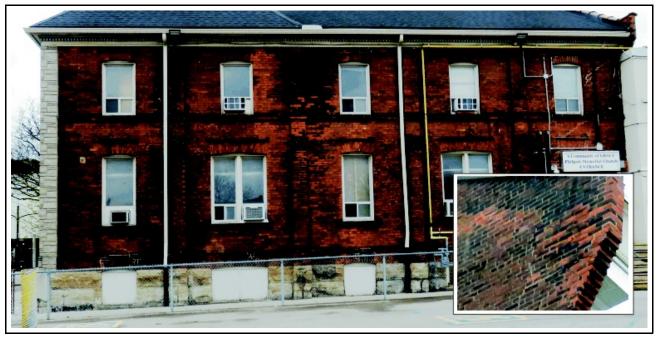
- 4.2 Although sounding techniques were not used during the on-site assessment, from visual observations, the mortar appeared to be well-bonded to the brickwork there was no visible evidence of delaminations.
- 4.3 The author does not know the reason why the plaster was applied to the then approximately forty to fifty-year-old brickwork. However, following a review of the side and rear elevations where there was much evidence of badly weathered masonry and brick replacement it is the author's opinion that the most likely and logical reason was therefore a concern regarding the evident poor quality of the bricks. (Photograph 2)

Photo 2 with inset image: There was much evidence of badly-weathered masonry and brick replacement within the side and rear elevations.

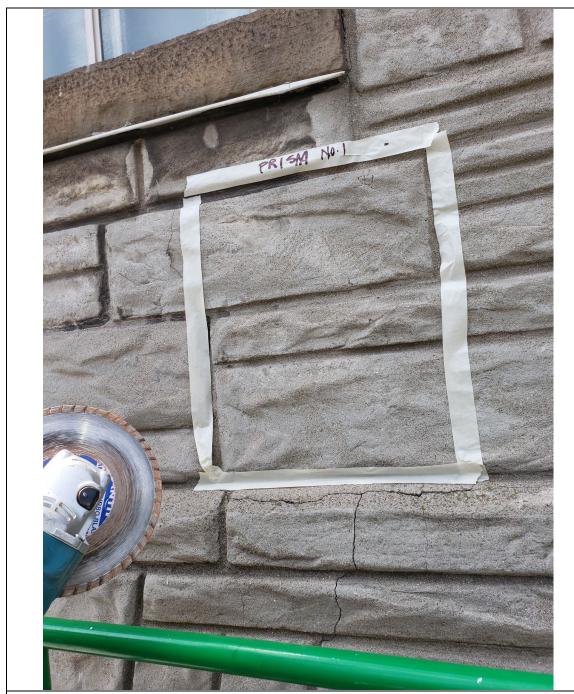
Photograph No. 3, showing test location for Brick Prism No. 1. Note the horizontal and vertical cracking seen in the stone work.

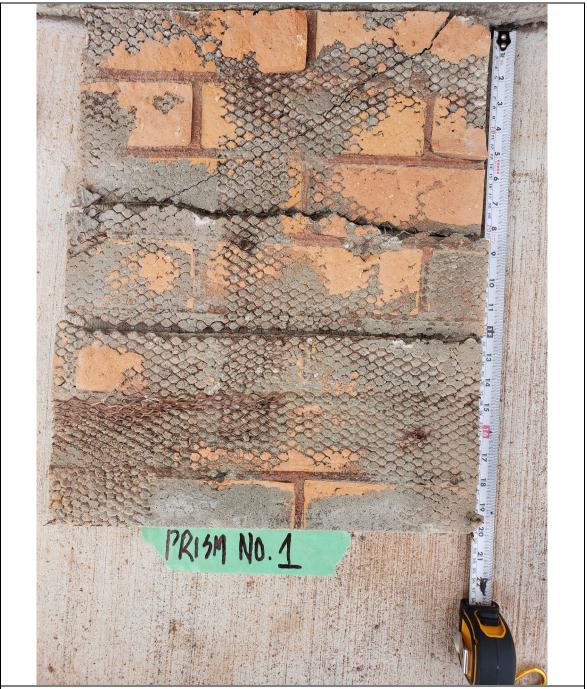
Photograph No. 4, showing test location for Brick Prism No. 1, upon removal of the stone work. Note the visible rusted steel mesh and rusted steel concrete nail heads holding the nesh to the brick. Stonework base mortar was still bonded to the brickwork for most of the area.

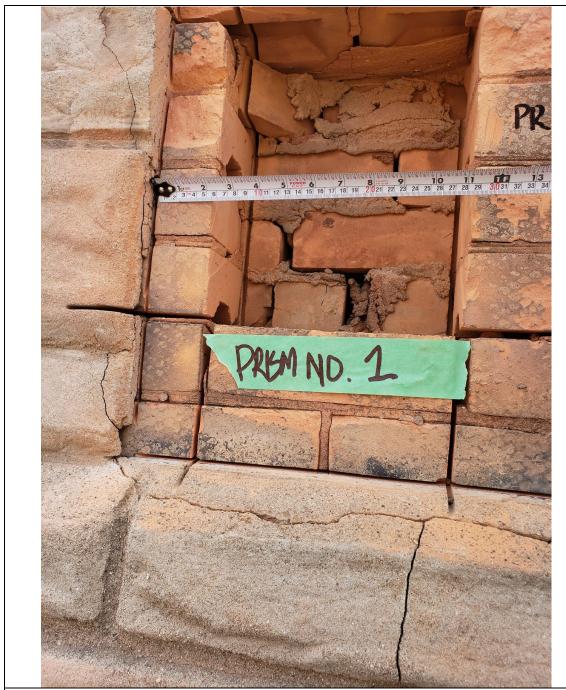
Photograph No. 5, showing test location after removal of Brick Prism No. 1. Note some vertical interior mortar joints were not completely filled with mortar.

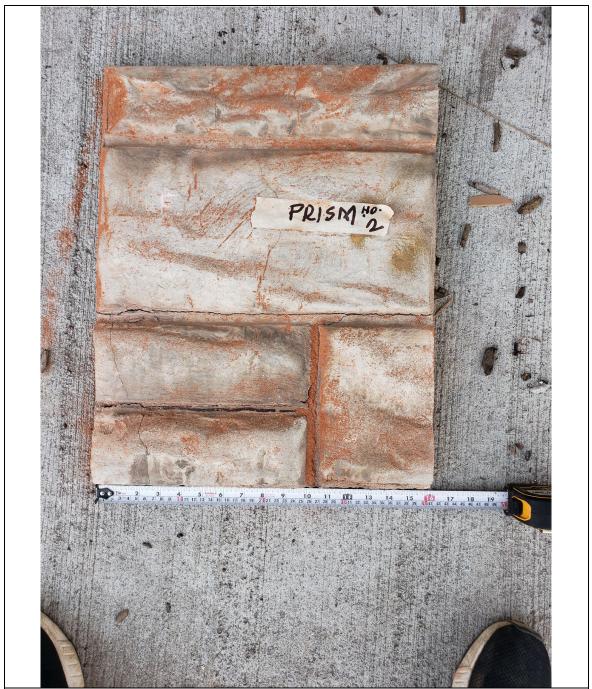
Photograph No. 6, showing the front face of the stonework upon removal from the wall, for Brick Prism No. 2. Note the cracking seen in the stone work.

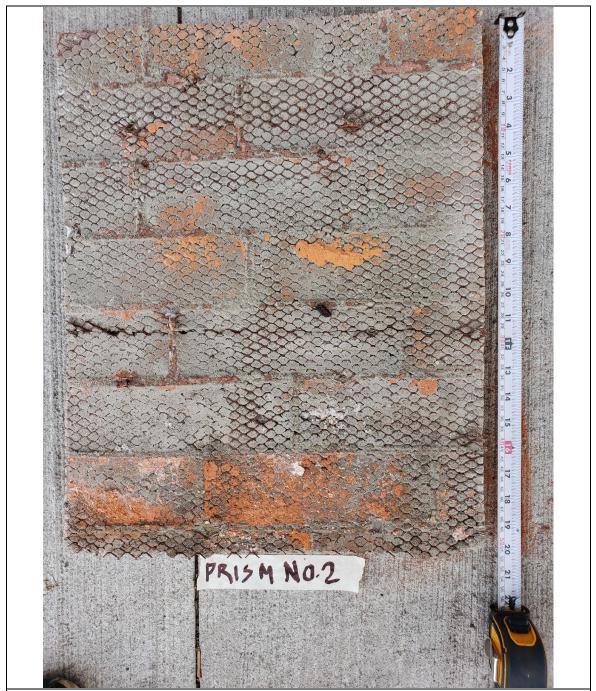
Photograph No. 7, showing the interior face of the stonework upon removal from the wall, for Brick Prism No. 2. Note the rusted expanded steel mesh, and adhering brick facing.

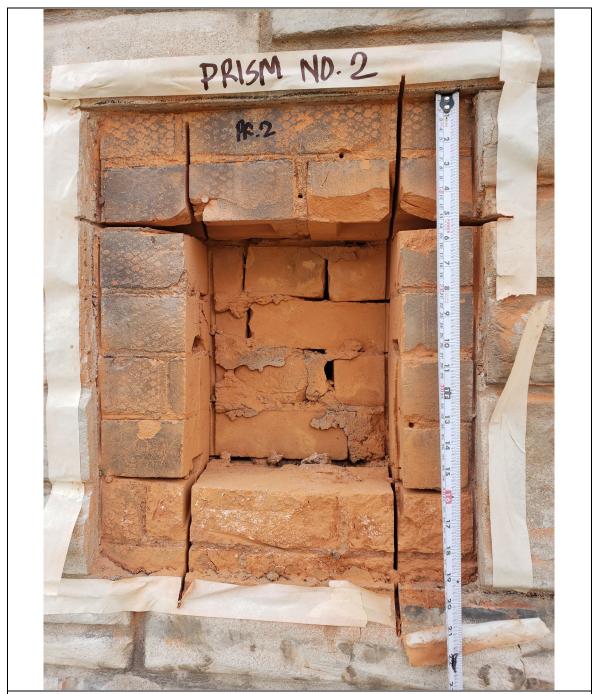
Photograph No. 8, showing test location after removal of Brick Prism No. 2. Note some vertical interior mortar joints were not completely filled with mortar.

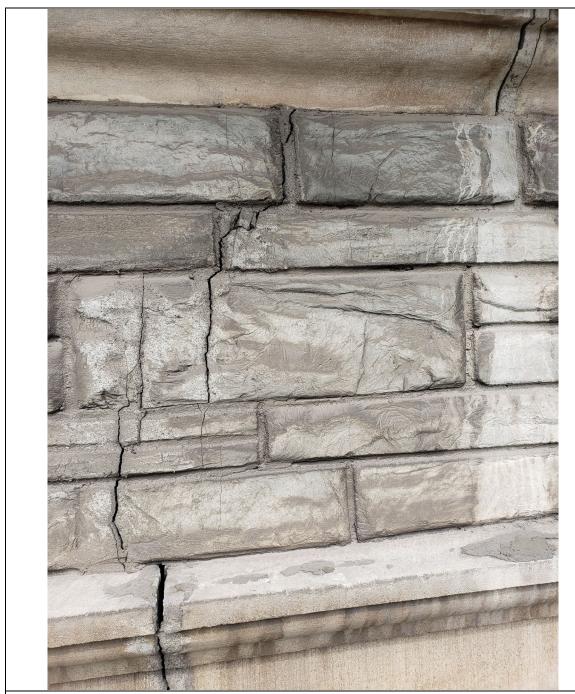
Photograph No. 16, showing a view of the stonework for Exploratory Opening No. 1 prior to removal of the stone. Note the cracking seen in the stonework.

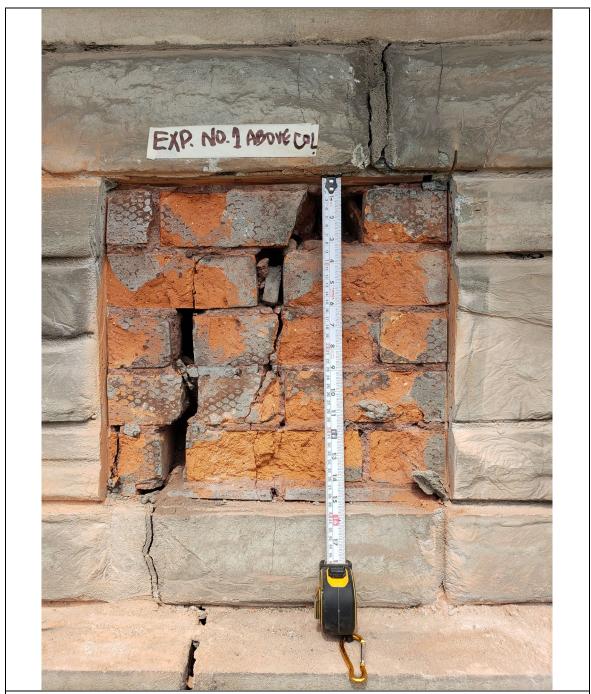
Photograph No. 17, showing a view of the stonework for Exploratory Opening No. 1 after removal of the stone. Note the spalling and cracking seen in the brickwork.

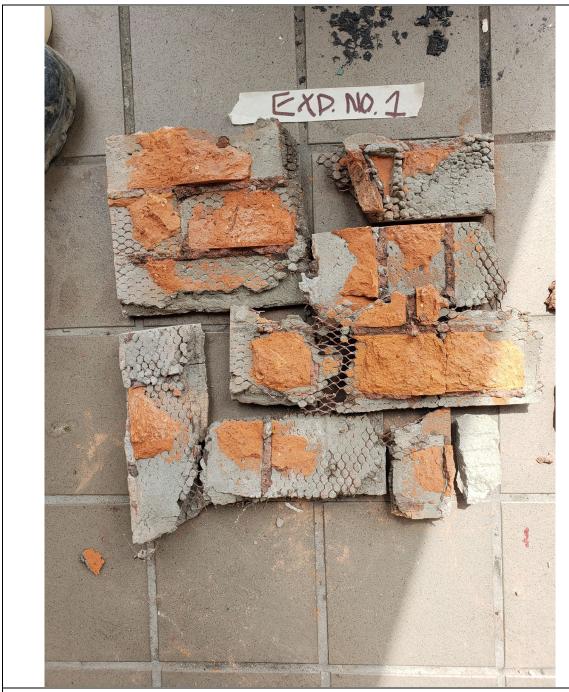
Photograph No. 18, showing the interior view of the removed stonework for Exploratory Opening No. 1. Note the spalled brick, and rusted expanded steel mesh.

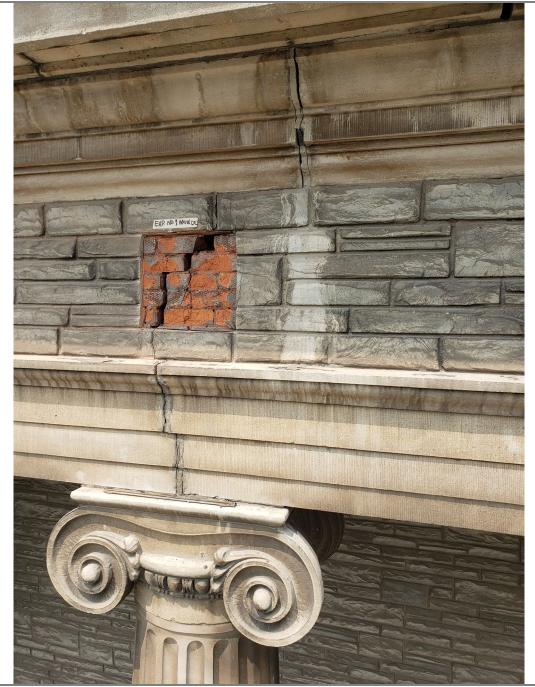
Photograph No. 19, showing an overall view of the stonework for Exploratory Opening No. 1 after removal of the stone. Note the open joints above and below the opening, which likely allows water to penetrate the masonry work and cause freeze-thaw damage to the brick work.

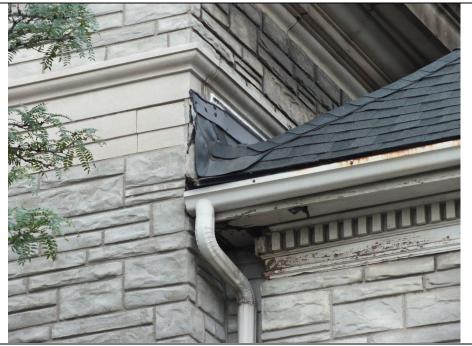
Photograph No. 20, immediately above the eve's trough, separation of the stonework was noted. Note the shingles covering this area.

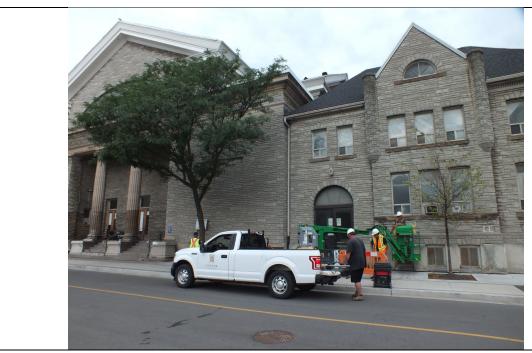
Photograph No. 21, showing the approximate location of the eve's trough down spout shown in Photographs No. 19, where the separation in the stonework was noted.

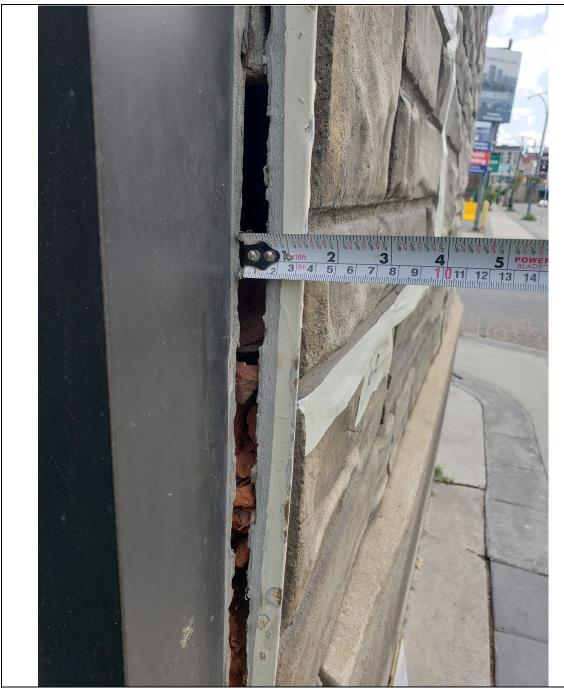
Photograph No. 23, showing a side view of the stonework for Exploratory Opening No. 2, adjacent to the door, prior to removal of the stone. Note the separation of the stonework to the brickwork, and visible freeze-thaw damage to the brick.

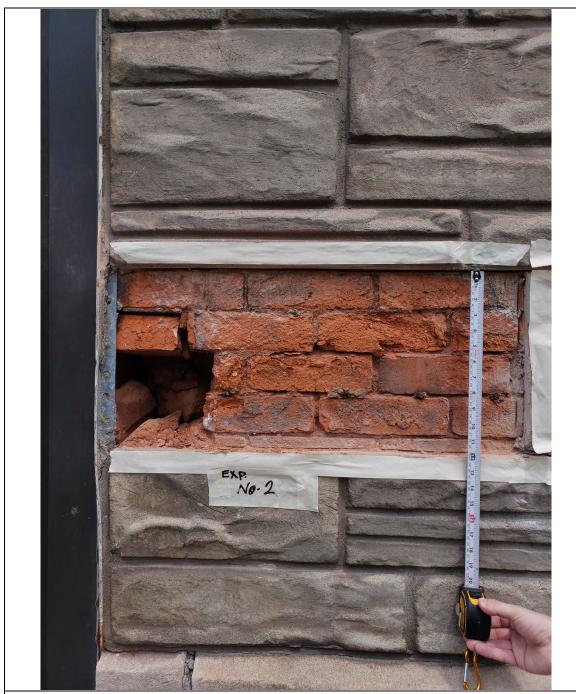
Photograph No. 24, showing a view of Exploratory
Opening No. 2 after removal of the stonework. Note the spalled and missing
(disintegrated) brick, likely due to freeze-thaw damage.

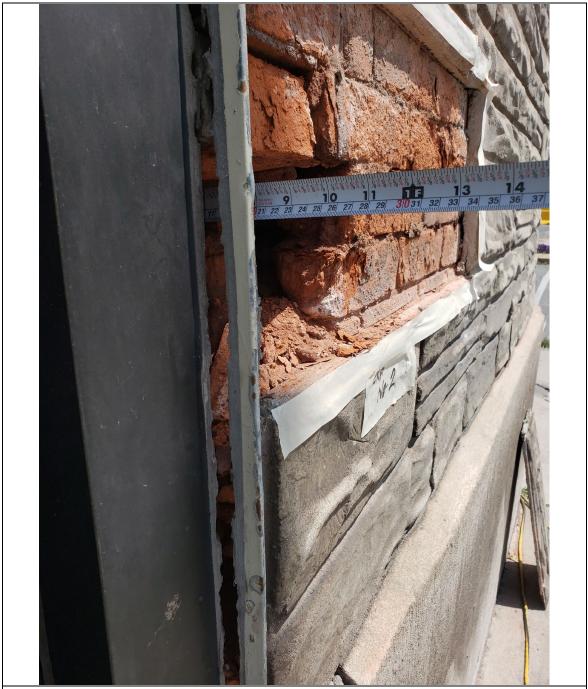
Photograph No. 25, showing a close-up view of Exploratory
Opening No. 2 after removal of the stonework. Note the spalled and missing
(disintegrated) brick, likely due to freeze-thaw damage.

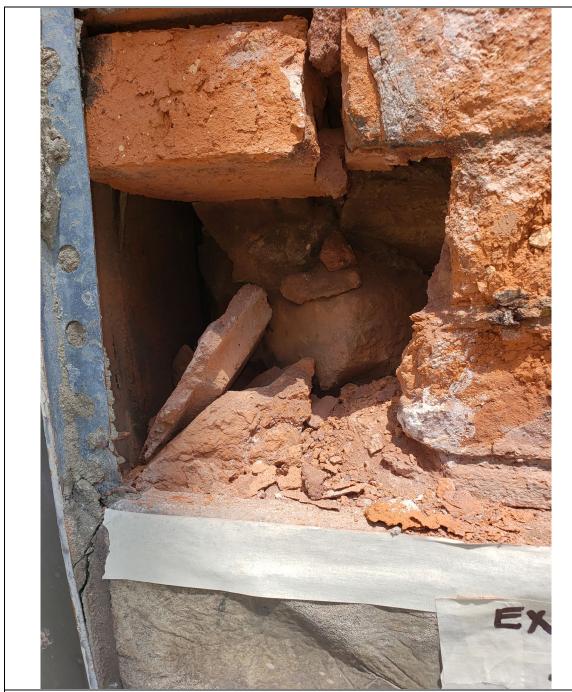
Photograph No. 26, showing a close-up view of Exploratory
Opening No. 2 after removal of the stonework. Note the spalled and missing
(disintegrated) brick, likely due to freeze-thaw damage.

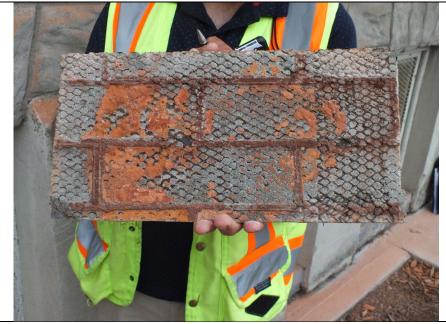
Photograph No. 38, showing the back side of the 1st. piece stonework for Anchor Pull-Out Location No. 1. Note the rusted expanded steel mesh and rusted concrete steel nails, and spalled brick pieces.

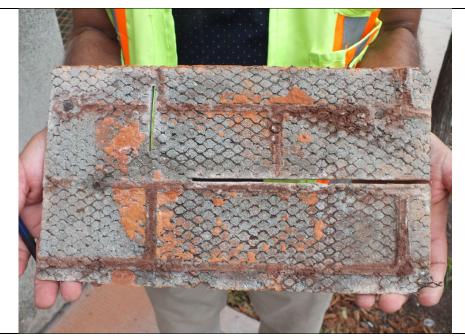
Photograph No. 39, showing the back side of the 2nd. piece stonework for Anchor Pull-Out Location No. 1. Note the rusted expanded steel mesh and rusted concrete steel nails, and spalled brick pieces.

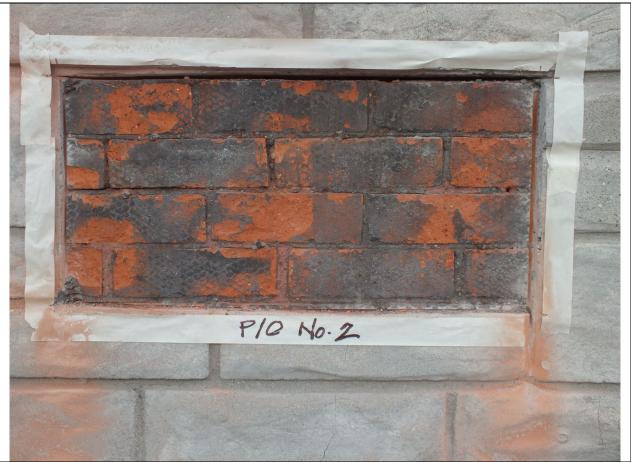
Photograph No. 40, showing the brick work in behind stone facing for Anchor Pull-out Location No. 2. Note the spalled portions of brick.

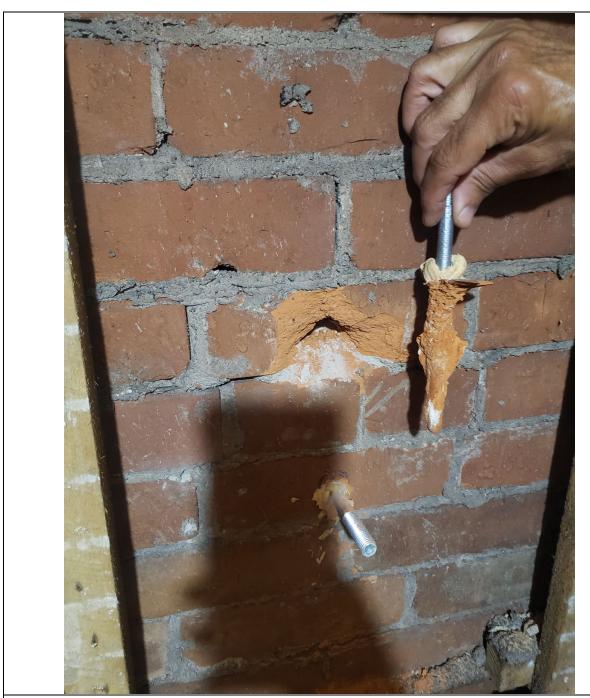
Photograph No. 42, showing conical failure of the brick for Anchor Pull-Out Location No. 4.

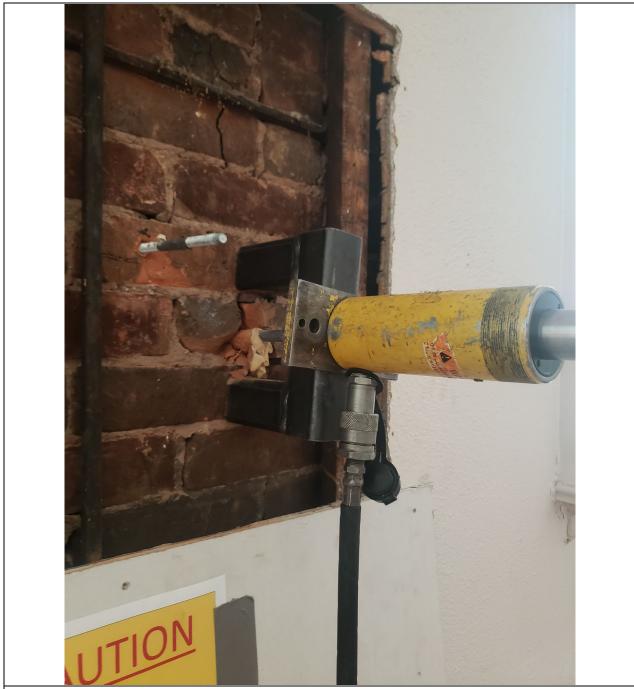
Photograph No. 43, showing pull-out failure of the brick for Anchor Pull-Out Location No. 5.

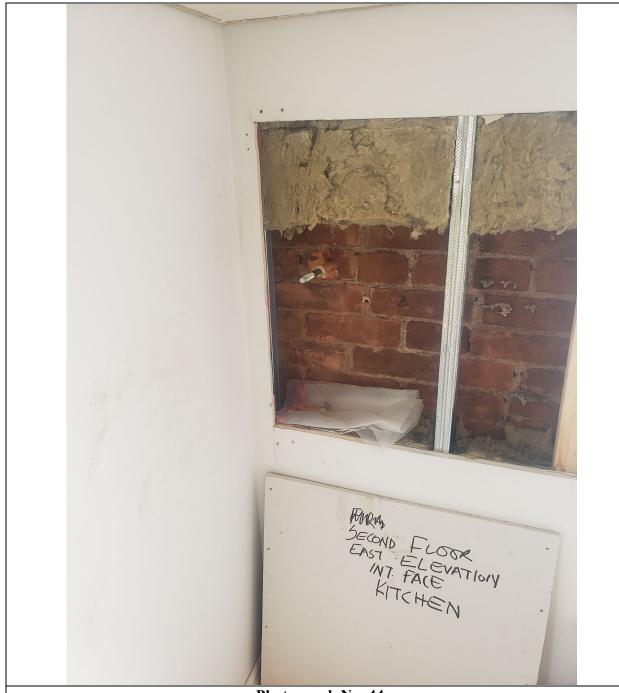
Photograph No. 44, showing pull-out failure of the brick for Anchor Pull-Out Location No. 6.
