TO:	Mayor and Members City Council
DATE:	December 6, 2022
SUBJECT:	City Hall Pedestrian Access Walkway (Wishbone Structure) Repairs Communication Update (Ward 2) (EFFM22-02)
WARD(S) AFFECTED:	Ward 2
SUBMITTED BY:	Craig Murdoch Acting Director, Energy Fleet & Facilities Maintenance Public Works Department
SIGNATURE:

**RE: Structural review of Existing Concrete Entrance Structure at the rear of the Building Located at 71 Main St. W, Hamilton, ON
Our Project No. 2022-JPS-101**

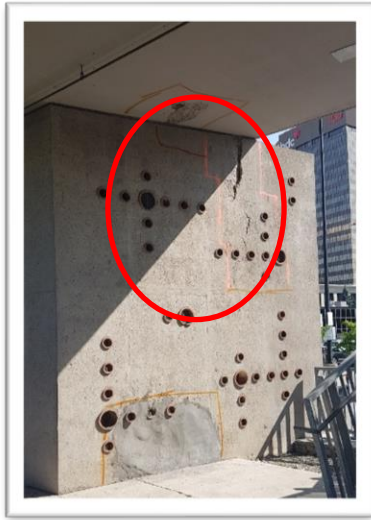
Figure 1: Partly Damaged Column and Slab

- The portion of the structural elements and areas identified in the attached drawings need to be repaired immediately as they may lead to a catastrophic structural damage and also are safety hazards.
- Barricades and adequate caution signage should be provided and not removed until concrete repairs identified in the drawings are undertaken.
- The deteriorated slab soffits are an immediate safety hazard and tenant/pedestrian access should be prohibited until repairs are completed.
- To prevent any catastrophic structural failures and to prevent injuries, it is our recommendation that concrete repairs should begin immediately in conjunction with the application of permit to perform the concrete repairs.

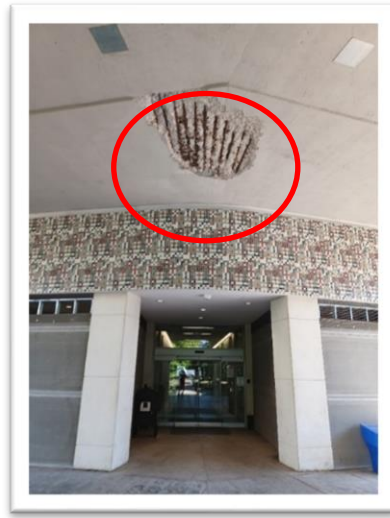
Figure 2: Spalled Concrete
