TO:	Chair and Committee Members Hamilton Municipal Heritage Committee
COMMITTEE DATE:	December 15, 2023
SUBJECT/REPORT NO:	Notice of Intention to Demolish the Building Located at 535 Old Dundas Road, Ancaster, being a Non-Designated Property Listed on the Municipal Heritage Register (PED23183) (Ward 12)
WARD(S) AFFECTED:	Ward 12
PREPARED BY:	Scott Dickinson (905) 546-2424 Ext. 7167 Alissa Golden (905) 546-2423 Ext. 1202
SUBMITTED BY:	Anita Fabac Acting Director, Planning and Chief Planner Planning and Economic Development Department
SIGNATURE:

Summary of Building Inspection 535 Old Dundas Rd Ancaster, Ontario

Project: 23263
535 Old Dundas Road
Ancaster, Ontario

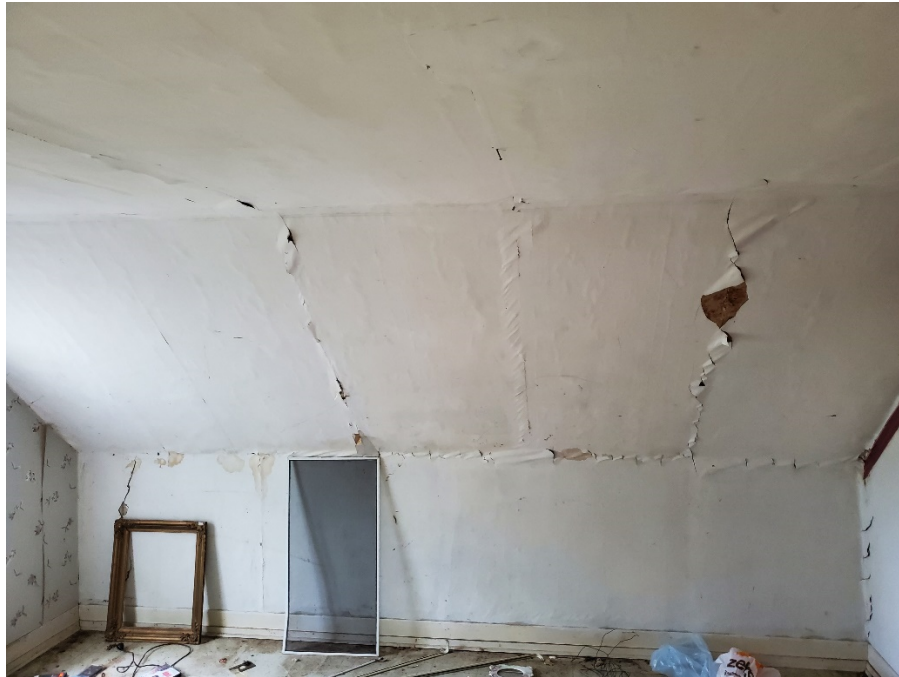
The building is constructed using wood framing. The roof is constructed as a conventional wood rafter with collar ties partway up the rafters. It could not be determined if the floor joists act as ties at the base of the rafter. The roof framing over the kitchen bears on knee walls. The knee walls were supported on what appeared to be wood beams from below. See **Photo No 01 & 02**.

Photo No 01: 2nd Floor North Wall above Kitchen

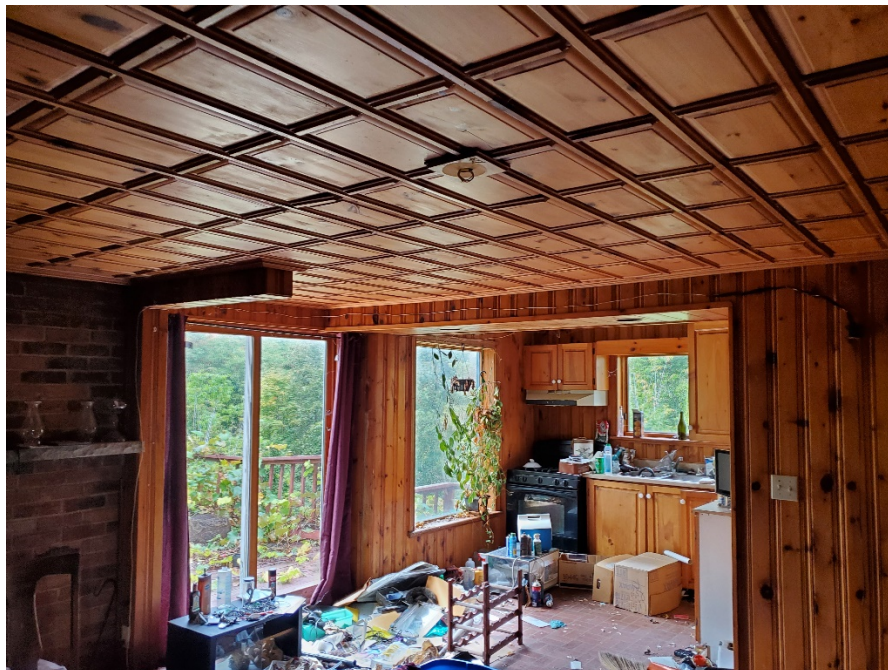
Photo No 02: North Kitchen Wall below Photo No:01

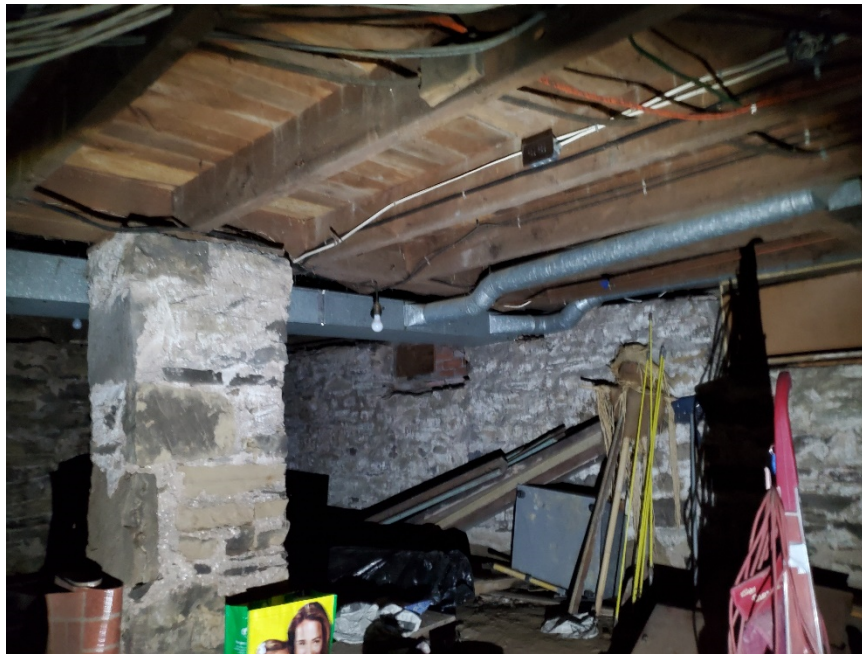
During the site review, the framing of the floor structure was recorded to get a better understanding of the building and tracking the loads to foundation. Where visible, the framing was recorded including the member sizes, spans and the bearing locations. The underside of the main floor was completely exposed. See **Photo No 03** for part main floor framing.

The west end of the east side main 8x8 timber floor beam, See **Photo No 03**, does have adequate support at the interior foundation wall.

Photo No 03: Main Floor Framing (Original House)

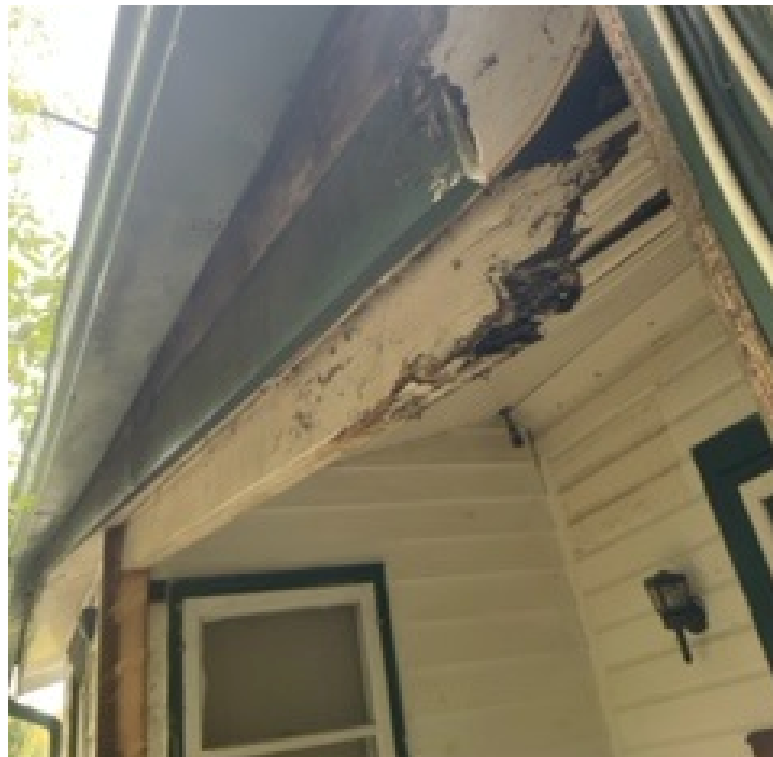
Review of the exterior was completed. The framing of the covered veranda at the south side of the house had collapsed. See **Photo No 04 & 05**. It was apparent that the end of the wood beam at the east side of the veranda had rotted and collapsed.

Photo No 04: Collapsed Roof

The exterior wood siding has many areas of decomposition. In one location the veranda roof has failed and collapsed. If this structure is to remain, we recommend removing the plaster and lath at the base of the main floor walls to determine if the studs and sill plates are decomposed.

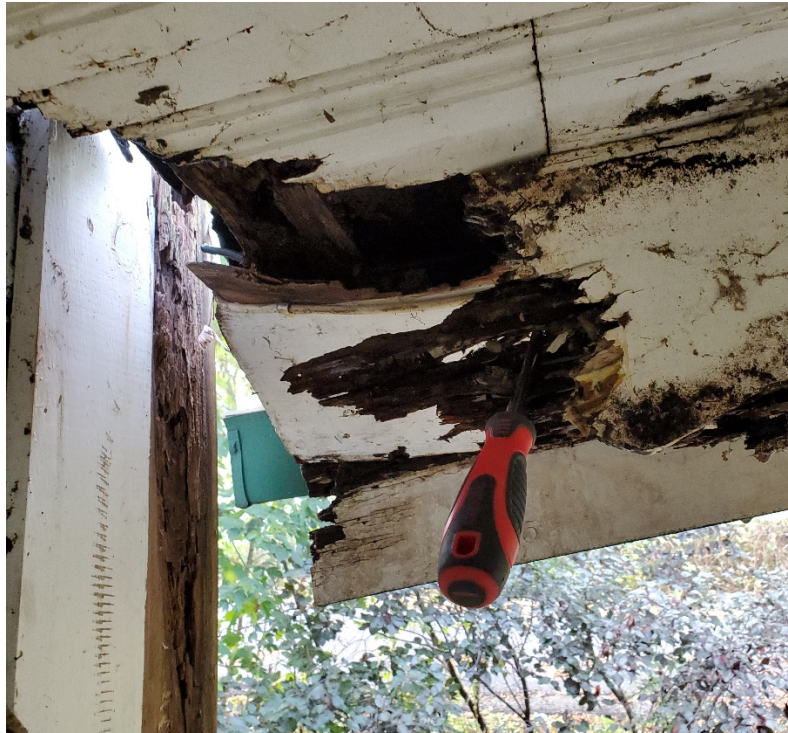
Photo No 05: Rotten Wood

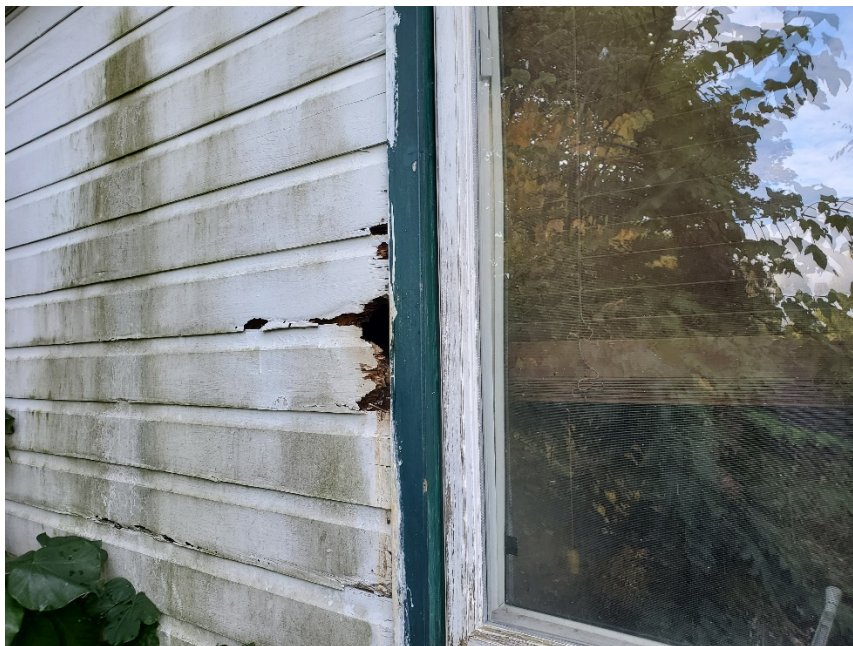
There were many areas around the perimeter of the exterior where the wood siding, and wood window sills were rotted as well. See **Photo No 06 & 07**. Photos 06 & 07 show a couple of locations of many where the exterior wood siding, sills or window jambs were decomposed.

Photo No 06: Rotted Siding

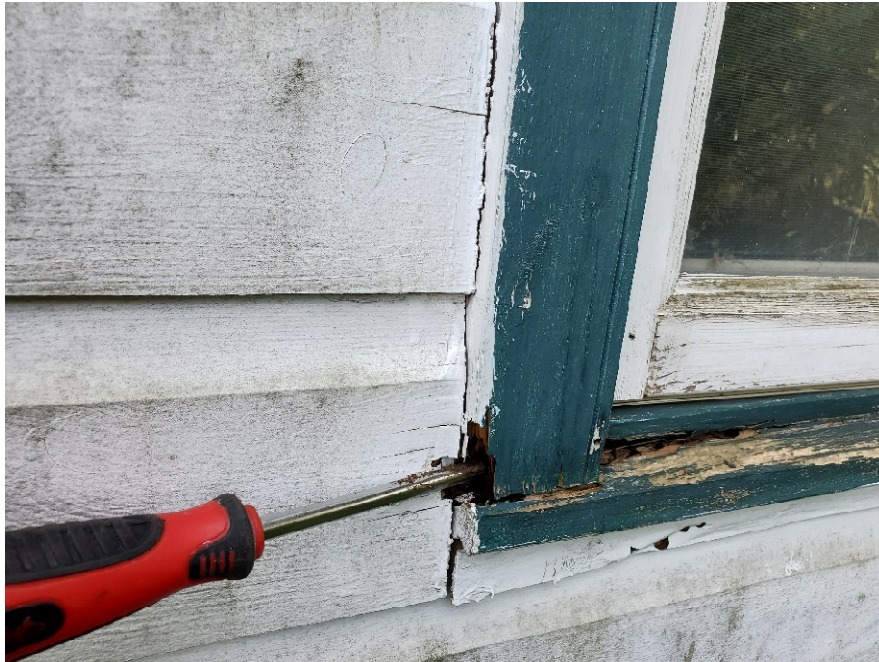
Photo No 07: Rotted Sill

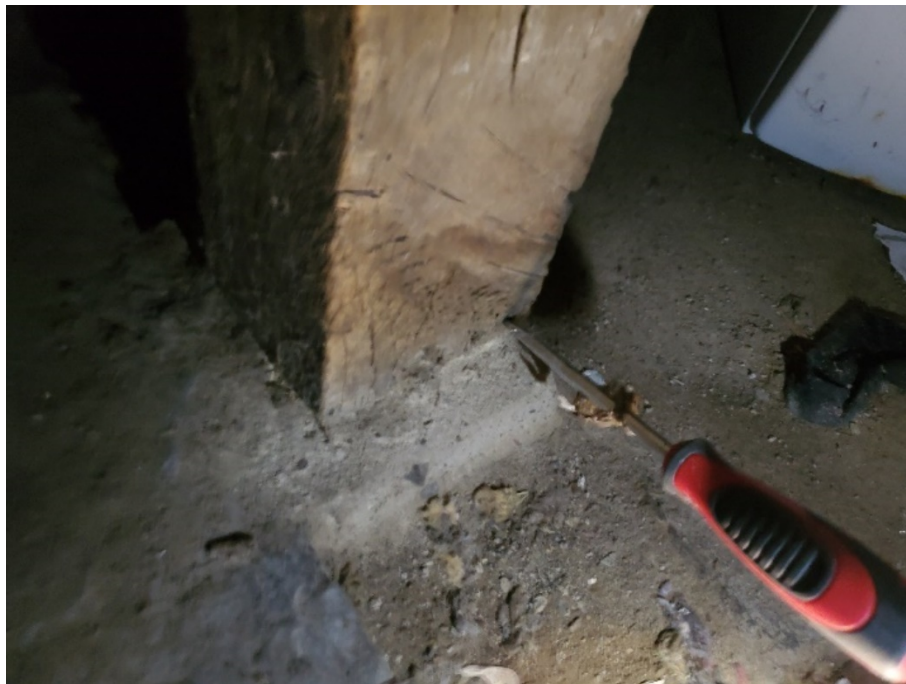
At the west side structure, an existing wood post at the west end of the beam was partially rotted at the base and a wood knot that was severely rotted. See **Photo No 08 & 09**.

Photo No 08: Rotted Post Base

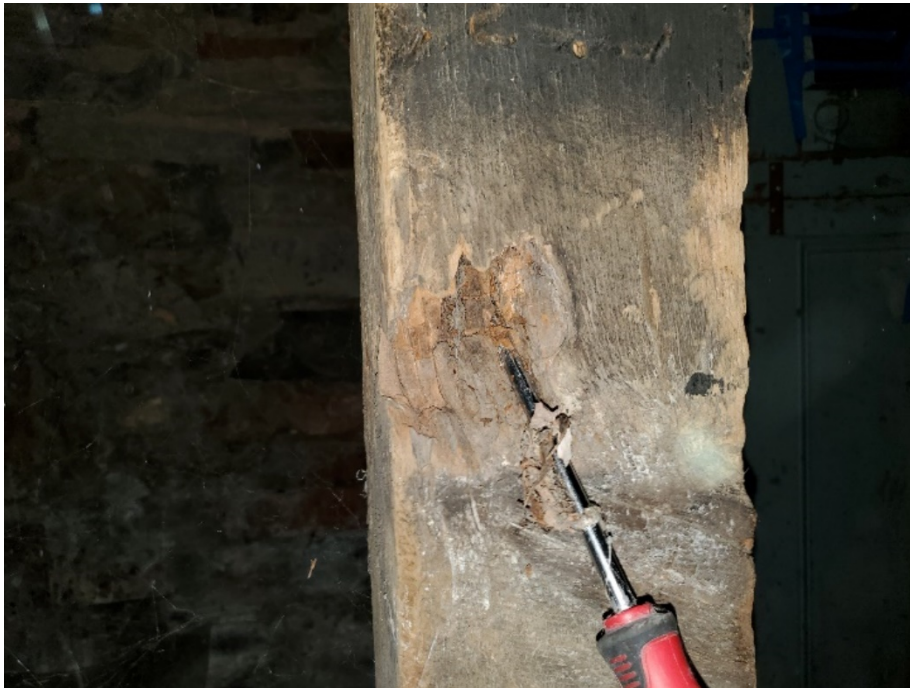
Photo No 09: Rotten Wood Knott

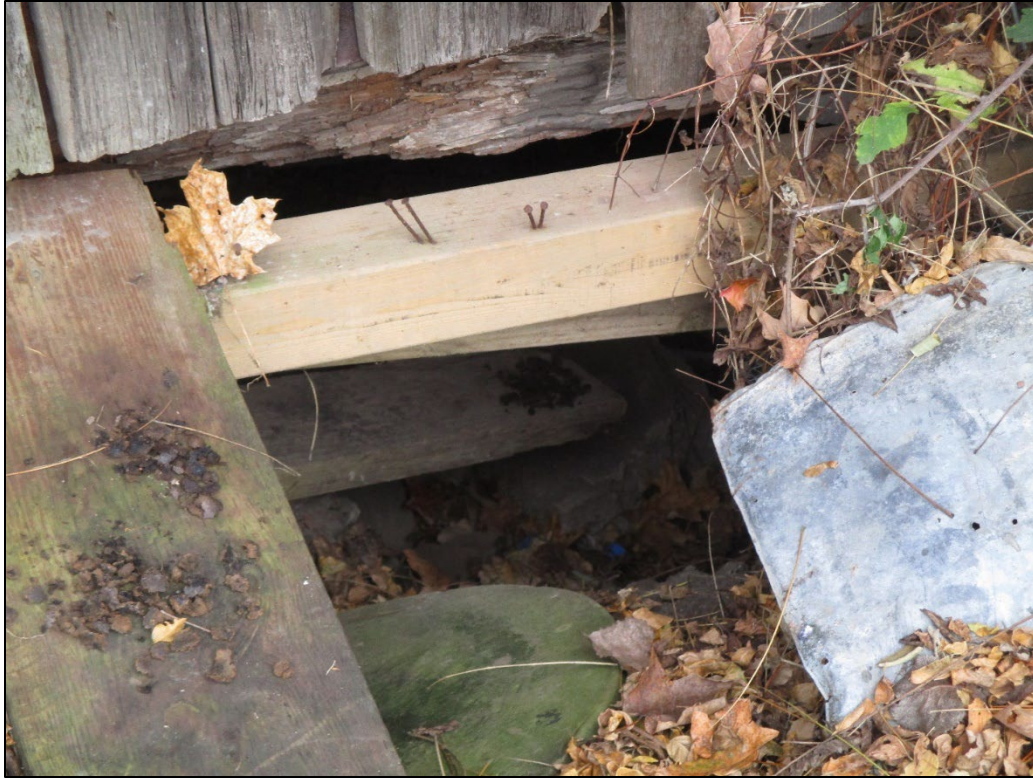
Figure 5: View of damage to shed foundation

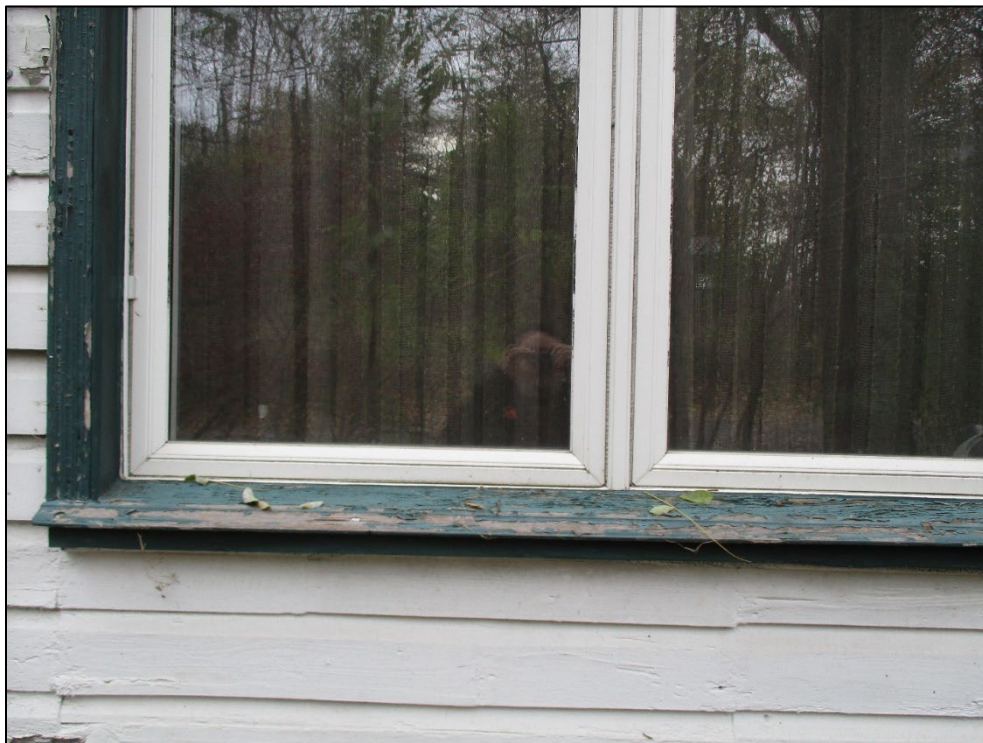
Figure 6: View of deteriorating window frames with contemporary replacement windows

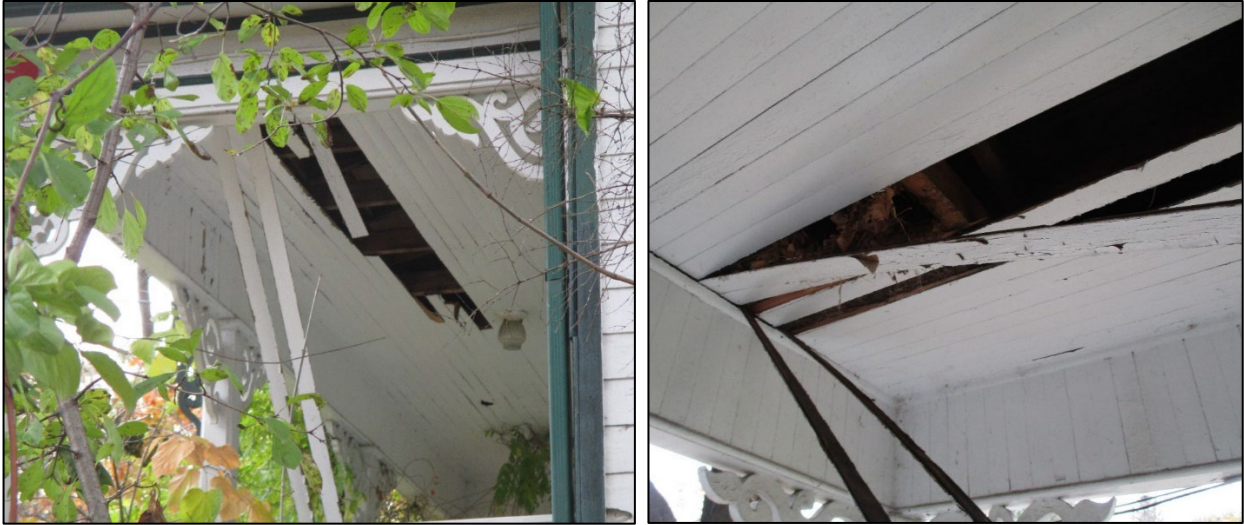
Figure 7: Views of damage to front porch ceiling

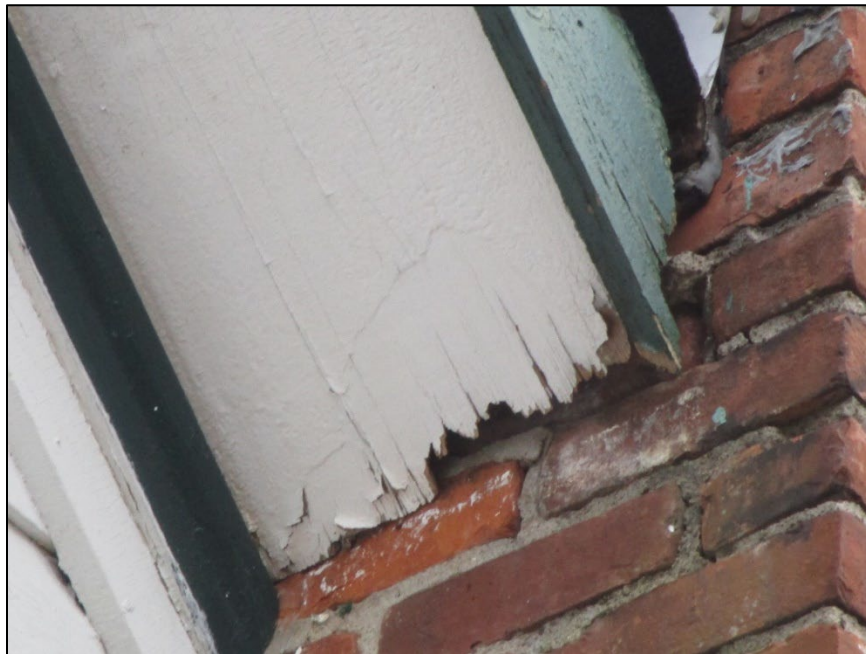
Figure 8: Detail View of damage to eaves

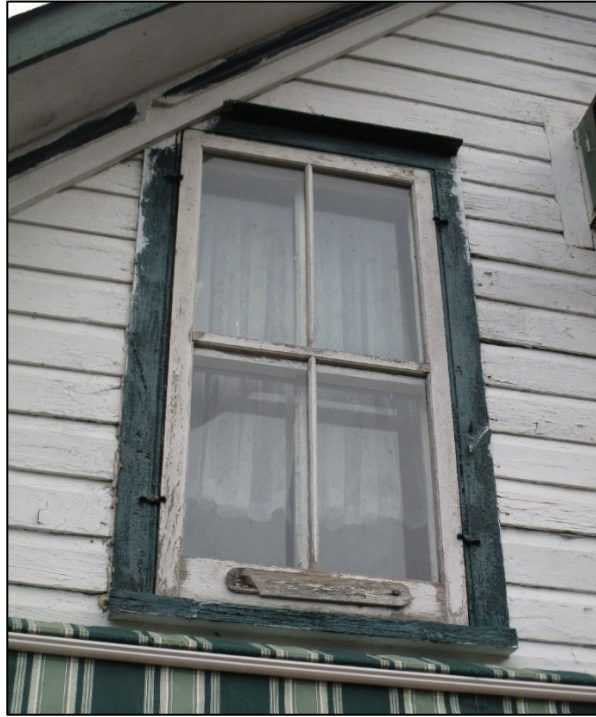
Figure 9: View of deterioration to wooden storm window

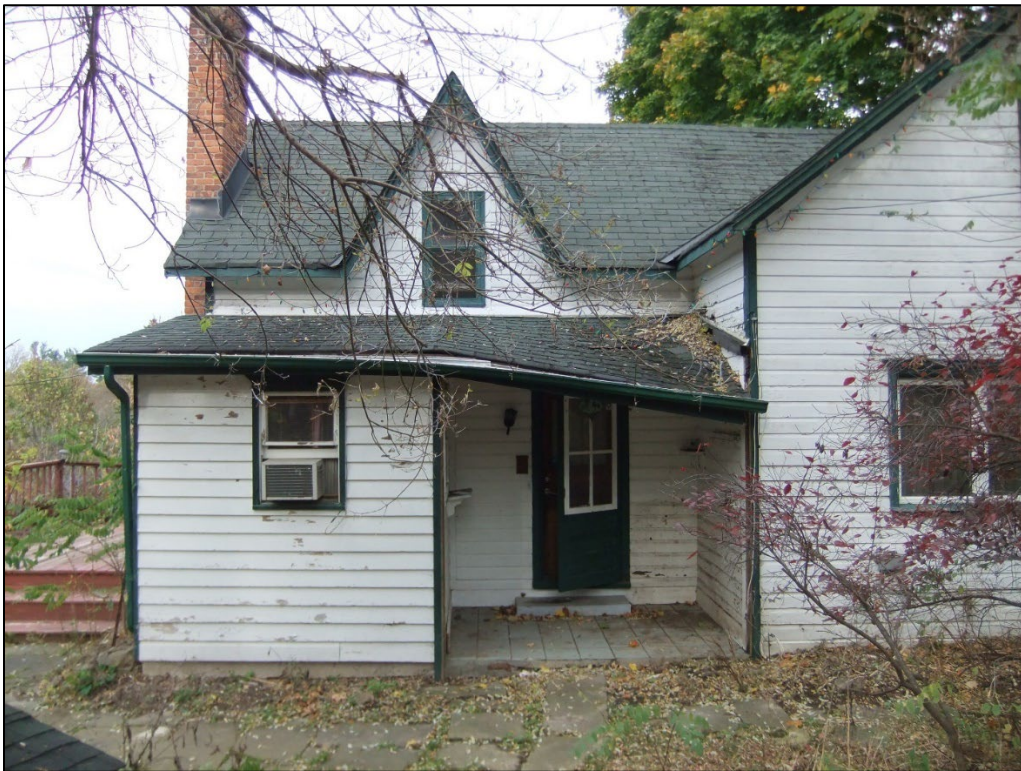
Figure 10: View of South Exterior and partially-collapsed side porch

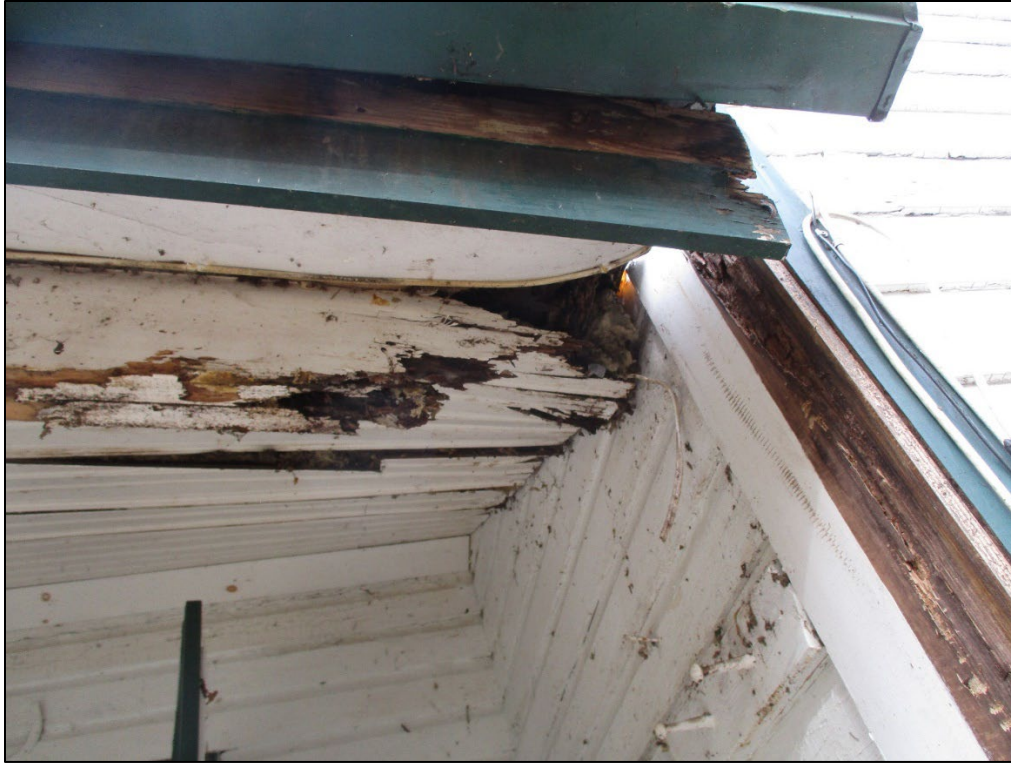
Figure 11: Detail View of damage to side porch

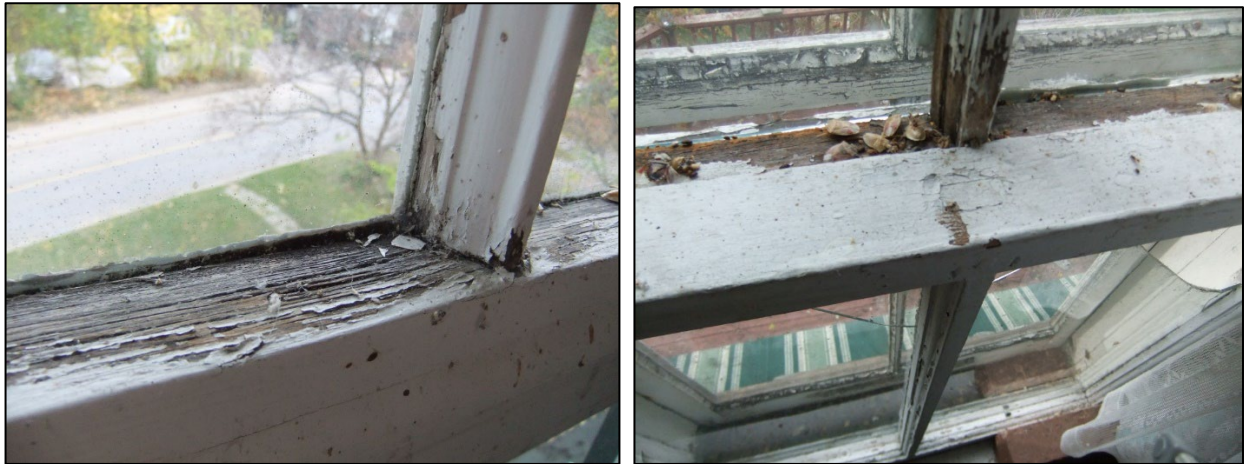
Figure 16: View of deterioration of upper-storey wood windows
