TO:	Mayor and Members City Council
DATE:	February 1, 2024
SUBJECT:	Longwood Road Bridge (Bridge 282) Upcoming Reconstruction (ENG24001) (City Wide)
WARD(S) AFFECTED:	City Wide
SUBMITTED BY:	Jackie Kennedy Director, Engineering Services Public Works Department
SIGNATURE:

Appendix "A" to Communication Update ENG24001: BRIDGE 282_2020_OSIM

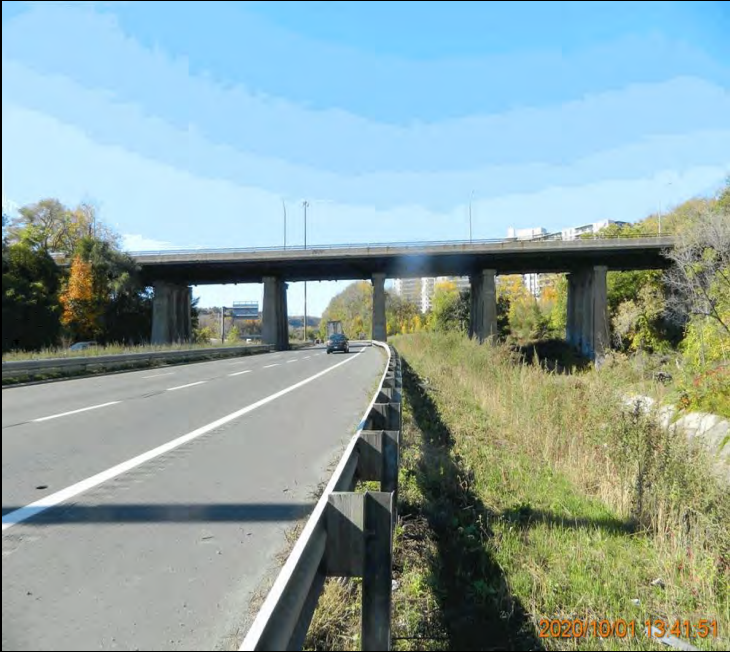
Description East Elevation		
	Elem Grp/Class Elem Type Sub Element Material Type Locator Defect Descript1 Defect Descript2 Defect Other	General	
File Name	01 East Elevation.JPG

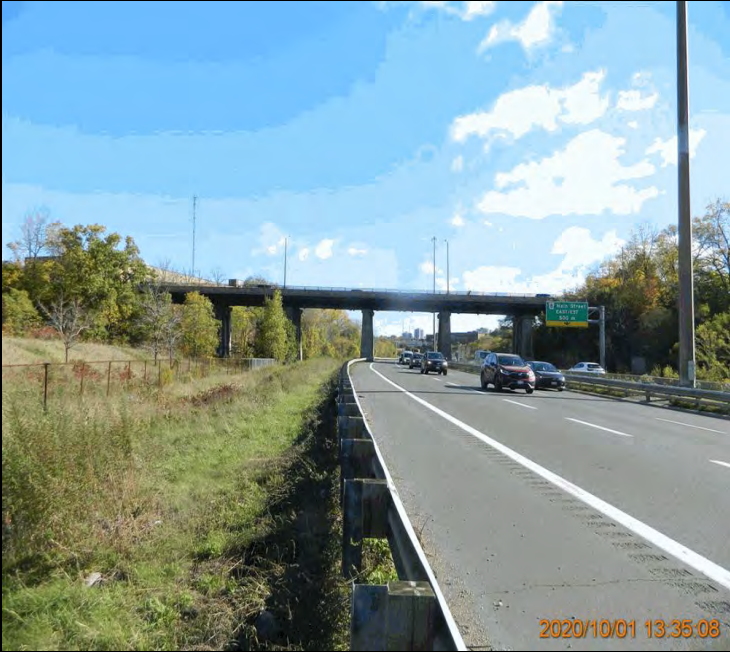
Description West Elevation		
	Elem Grp/Class Elem Type Sub Element Material Type Locator Defect Descript1 Defect Descript2 Defect Other	General	
File Name	02 West Elevation.JPG

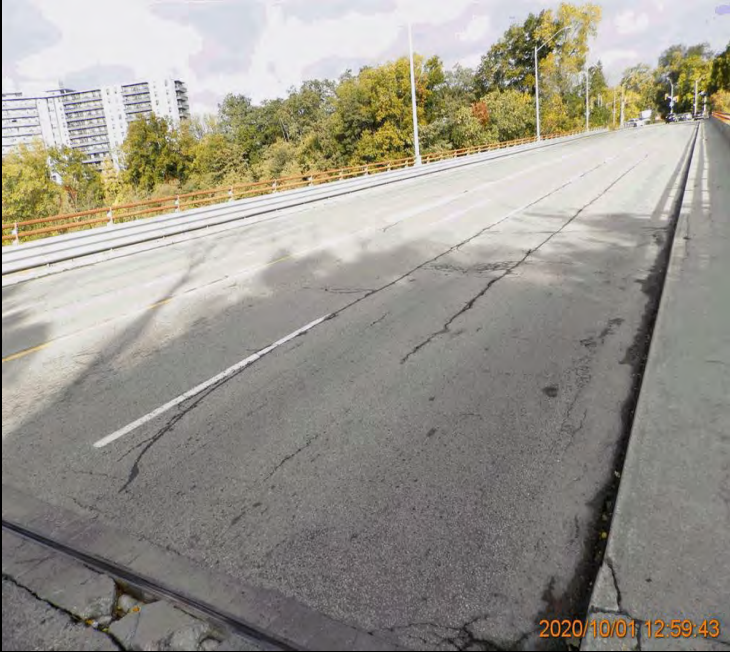
Description		
	Bridge Deck From Southeast Corner. Note: M-S unsealed longitudinal cracks and M-S pattern cracks.		
Elem Grp/Class		Decks/Wearing surface	
Elem Type			
Sub Element			
Material Type		Asphalt	
Locator		General	
Defect Descript1		Poor condition	
Defect Descript2			
Defect		Cracks	
Other			
File Name	03 Bridge Deck From Southeast Corner.JPG

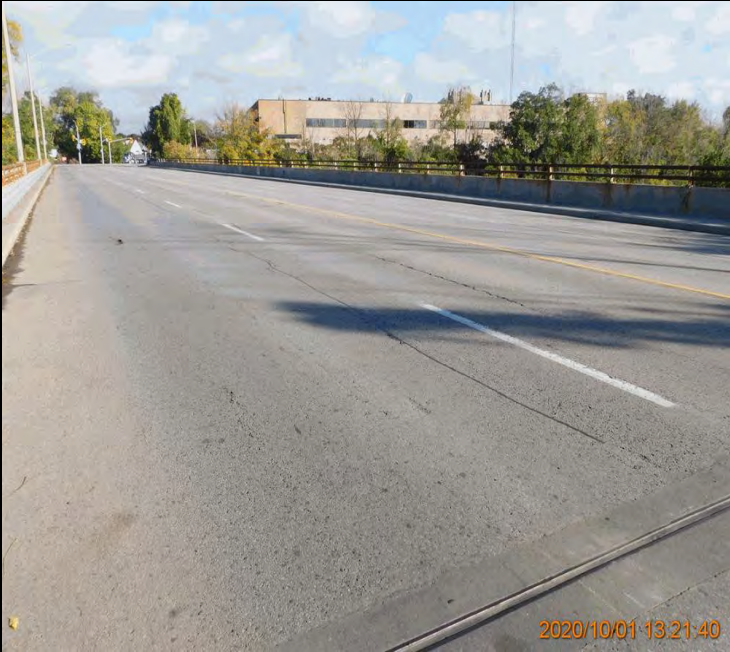
Description		
	Bridge Deck From Southwest Corner. Note: Sealed longitudinal cracks and M-S unsealed longitudinal cracks.		
Elem Grp/Class		Decks/Wearing surface	
Elem Type			
Sub Element			
Material Type		Asphalt	
Locator		General	
Defect Descript1		Poor condition	
Defect Descript2			
Defect		Cracks	
Other			
File Name	04 Bridge Deck From Southwest Corner.JPG

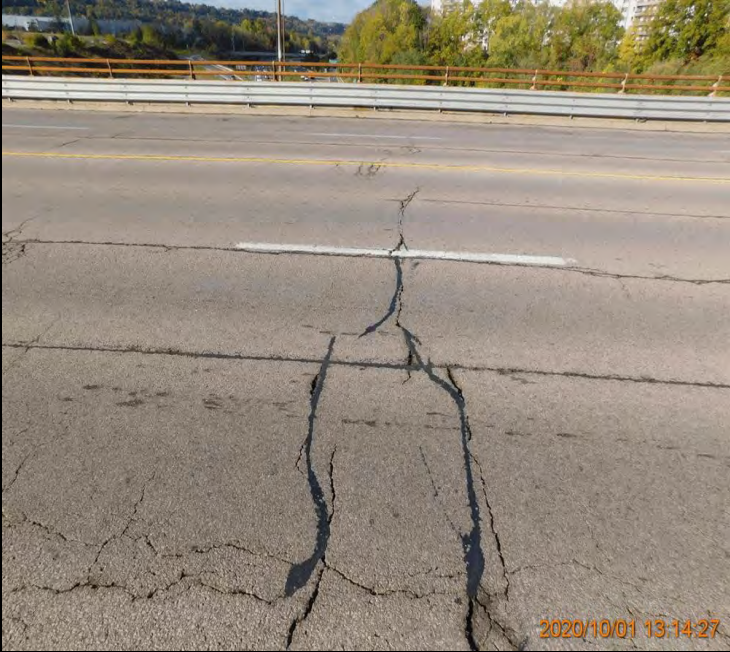
Description Sealed & Unsealed Trans&Longit Cracks @ Pier 3, Looking West		
	Elem Grp/Class Elem Type Sub Element Material Type Locator Defect Descript1 Defect Descript2 Defect Other	Decks/Wearing surface Asphalt Poor condition Cracks	
File Name	09 Sealed & Unsealed Trans&Longit Cracks @ Pier 3, Looking West.JPG

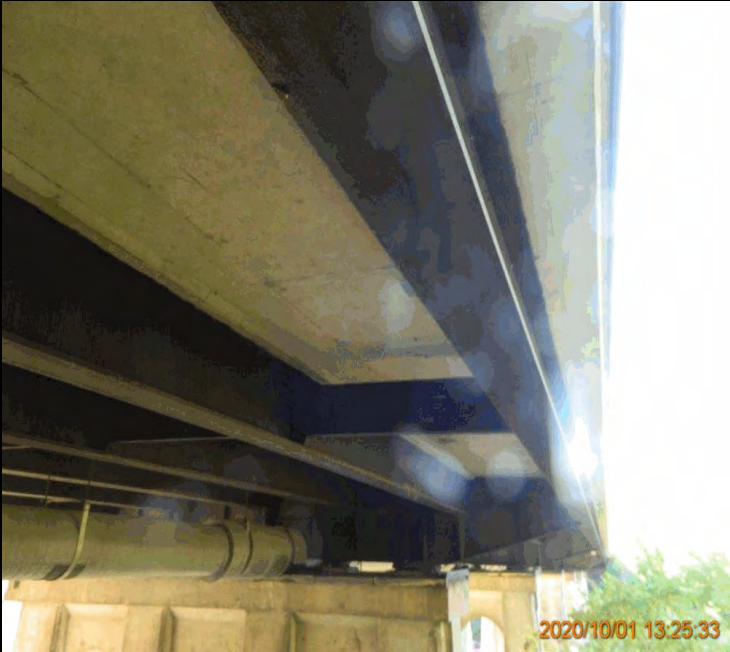
Description West Exterior Soffit at North Abutment, Looking South		
	Elem Grp/Class Elem Type Sub Element Material Type Locator Defect Descript1 Defect Descript2 Defect Other	Decks/Soffit - Thin Slab Exterior Cast-in-place concrete General	
File Name	10 West Exterior Soffit at North Abutment, Looking South.jpg

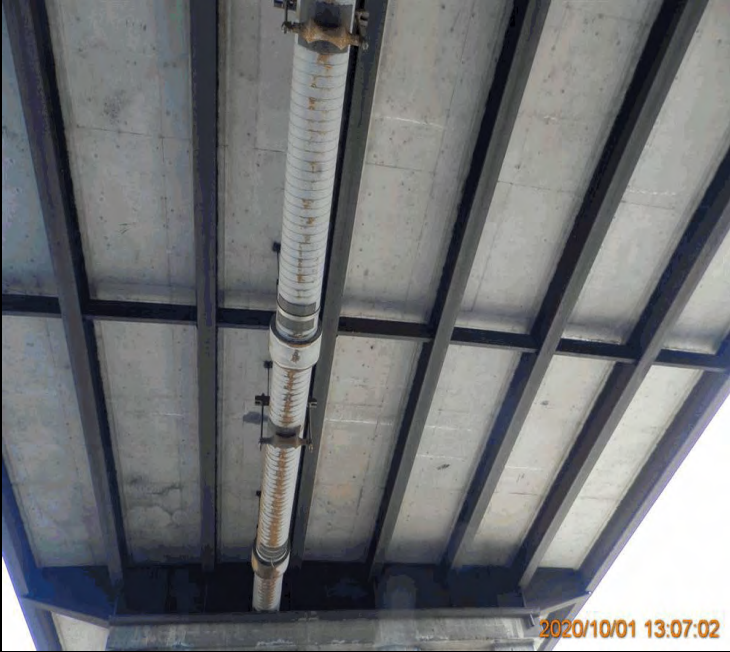
Description Interior Soffit and Girders @ Pier 1, Looking North. Note: N-M efflorescence stained transverse cracks.		
	Elem Grp/Class Elem Type Sub Element Material Type Locator Defect Descript1 Defect Descript2 Defect Other	Decks/Soffit - Thin Slab Interior Cast-in-place concrete General Poor condition Transverse Cracks	
File Name	13 Interior Soffit and Girders @ Pier 1, Looking North.JPG

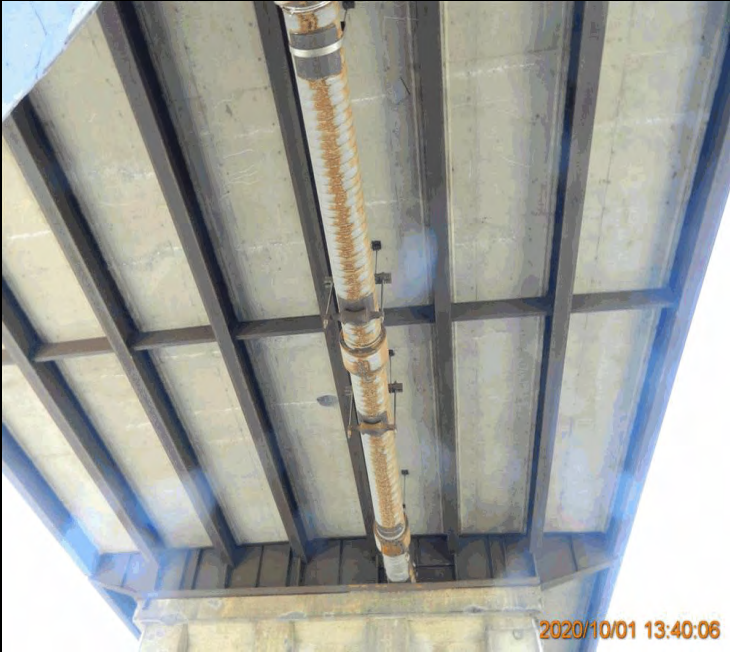
Description Interior Soffit and Girders @ Pier 3, Looking South. Note: N-M efflorescence stained transverse cracks.		
	Elem Grp/Class Elem Type Sub Element Material Type Locator Defect Descript1 Defect Descript2 Defect Other	Decks/Soffit - Thin Slab Interior Cast-in-place concrete General Poor condition Transverse Cracks	
File Name	14 Interior Soffit and Girders @ Pier 3, Looking South.JPG

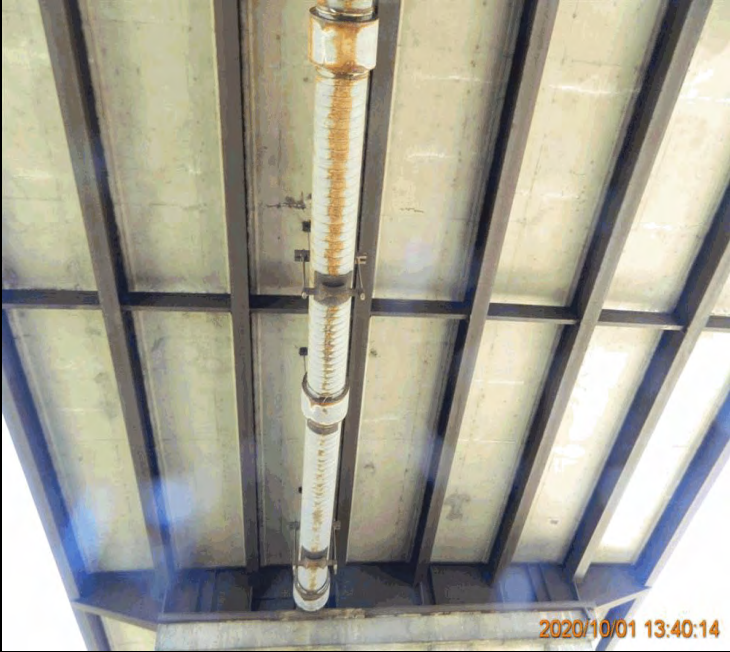
<p style="text-align: right; color: orange; font-size: small;">2020/10/01 13:40:14</p>	Description		
	Interior Soffit at Pier 3, Looking North. Note: N-M efflorescence stained transverse cracks.		
	Elem Grp/Class	Decks/Soffit - Thin Slab	
	Elem Type	Interior	
	Sub Element	Cast-in-place concrete	
	Material Type	General	
	Locator	Poor condition	
	Defect Descript1	Cracks	
	Defect Descript2		
	Defect		
	Other		
File Name	15 Interior Soffit at Pier 3, Looking North.JPG

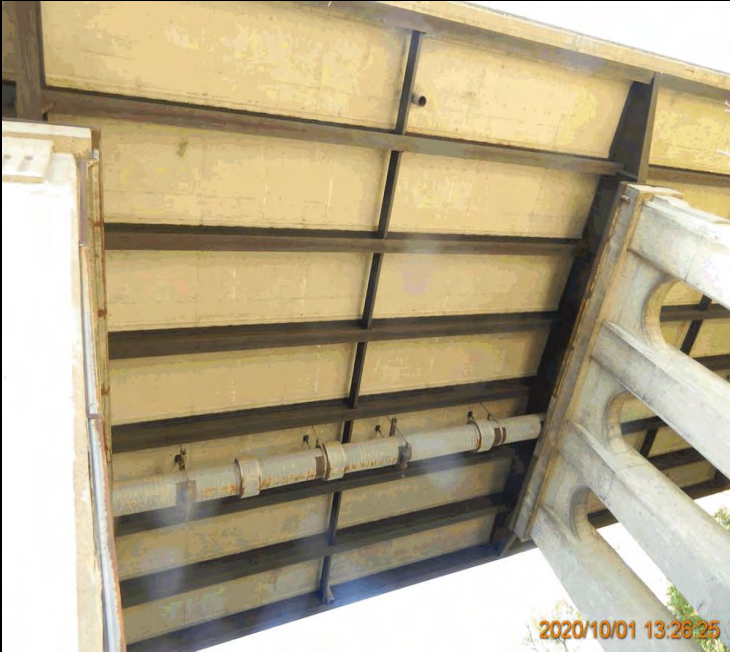
<p style="text-align: right; color: orange; font-size: small;">2020/10/01 13:28:25</p>	Description		
	Interior Soffit and Girders at Pier 4 (Span 5), Looking West. Note: N-M transverse cracks.		
	Elem Grp/Class	Decks/Soffit - Thin Slab	
	Elem Type	Interior	
	Sub Element	Cast-in-place concrete	
	Material Type	General	
	Locator	Poor condition	
	Defect Descript1	Cracks	
	Defect Descript2		
	Defect		
	Other		
File Name	16 Interior Soffit and Girders at Pier 4 (Span 5), Looking West.JPG

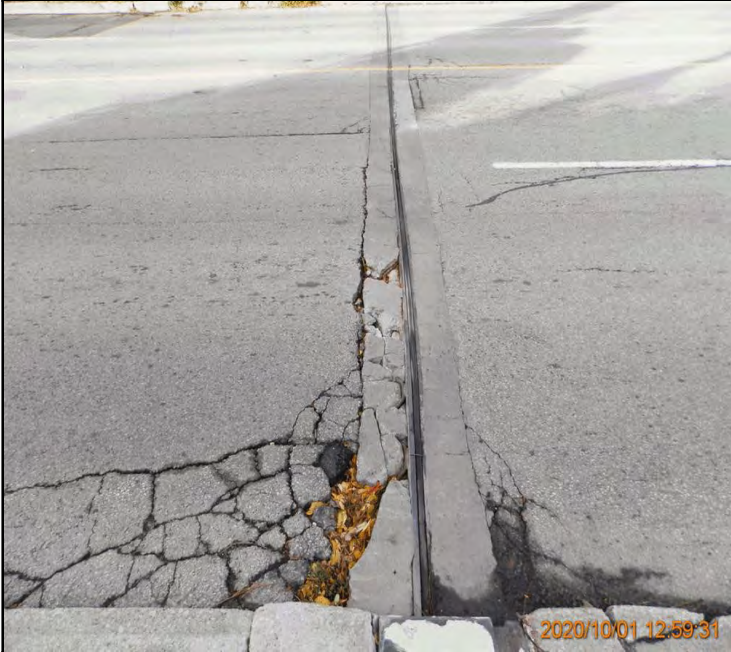
<p>Description</p> <p>South Expansion Joint, Looking West. Note: Severe spalling on end dam.</p>

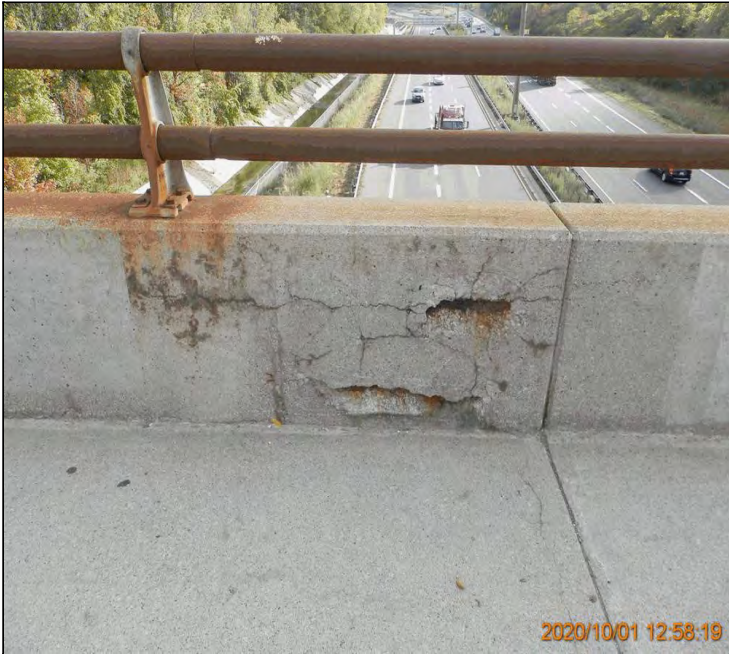
Severe spall & delam on east wall in span 3. W crack & severe delam @ top section of E wall @ N approach. S delam & W crack on top face of W Wall behind Thrie-Beam. Local areas of L-M scaling. (Ref Photos: #31-38).

Description Severe Spall and Delam on East Wall in North Section of Span 3	
Elem Grp/Class	Barriers/Barrier/Parapet Walls
Elem Type	Parapet Wall with two rails
Sub Element	Interior
Material Type	Cast-in-place concrete
Locator	
Defect Descript1	Poor condition
Defect Descript2	
Defect	Spalling
Other

Recommended Work	Category	Timing	Quantity	Unit Cost	Total Cost (\$)
CO201 Repair Concrete (sqm)	Major Rehab	1 - 5 year	12.000	780	9360

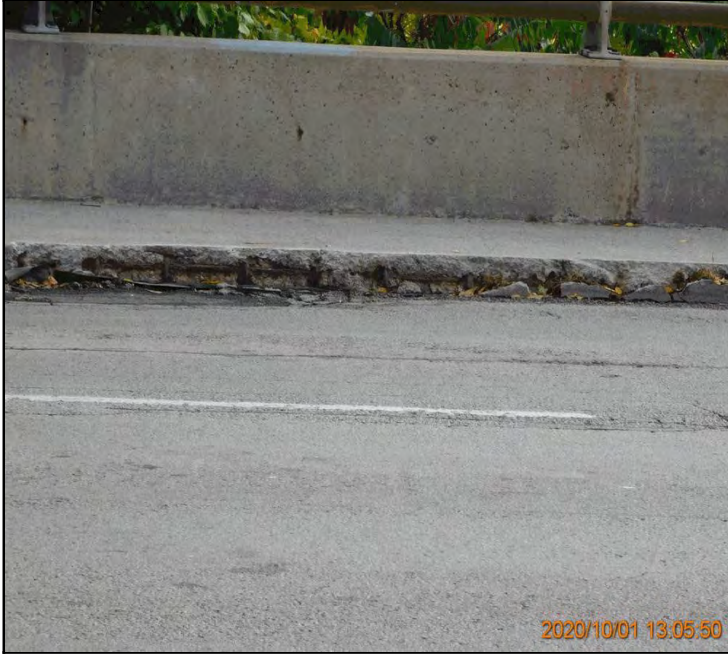
Description Very Severe Spall & Delam on East Curb @ North End of Deck	
Elem Grp/Class	Sidewalks/curbs/Sidewalk and
Elem Type	
Sub Element	
Material Type	Cast-in-place concrete
Locator	
Defect Descript1	Poor condition
Defect Descript2	
Defect	Spalling
Other

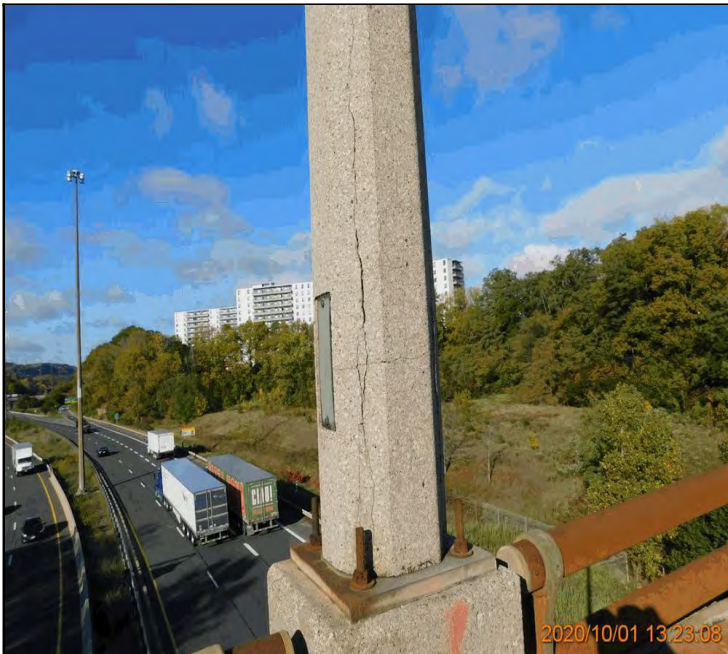
Multiple N-M vertical cracks on both barrier walls. Wide vertical cracks at bottom of light pole. Few patched areas on west wall over Hwy 403 median. (Ref Photo: #41).

Description Wide Vertical Cracks on Bottom of Light Pole over Hwy 403 Median	
Elem Grp/Class	Barriers/Barrier/Parapet Walls
Elem Type	Parapet Wall with two rails
Sub Element	Exterior
Material Type	Cast-in-place concrete
Locator	
Defect Descript1	Poor condition
Defect Descript2	
Defect	Cracks
Other

Recommended Work	Category	Timing	Quantity	Unit Cost	Total Cost (\$)
CO301 Rehab Concrete (sqm)	Major Rehab	1 - 5 year	7.000	650	4550

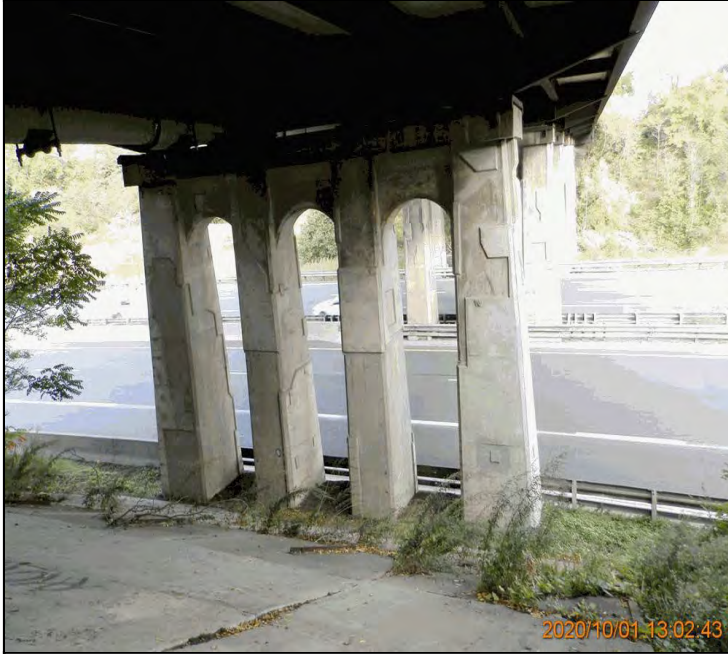
Description South Elevation of Pier 1. Note: Narrow stained shrinkage cracks on patch repairs.	
Elem Grp/Class	Piers/Shfts/columns/Pile Bent
Elem Type	Conc rectangular columns with
Sub Element	
Material Type	Cast-in-place concrete
Locator	General
Defect Descript1	Fair condition
Defect Descript2	
Defect	Cracks
Other

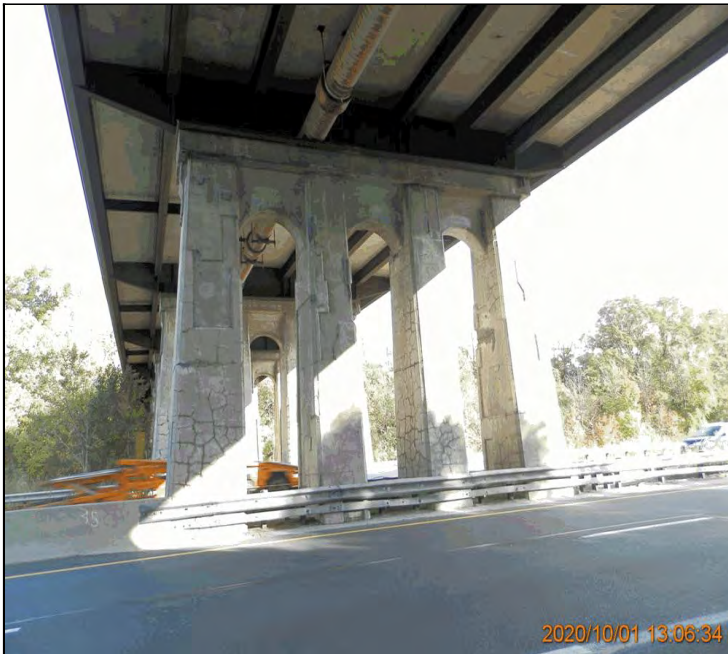
Description South Elevation of Pier 2. Note: Narrow stained shrinkage cracks.	
Elem Grp/Class	Piers/Shfts/columns/Pile Bent
Elem Type	Conc rectangular columns with
Sub Element	
Material Type	Cast-in-place concrete
Locator	General
Defect Descript1	Fair condition
Defect Descript2	
Defect	Cracks
Other

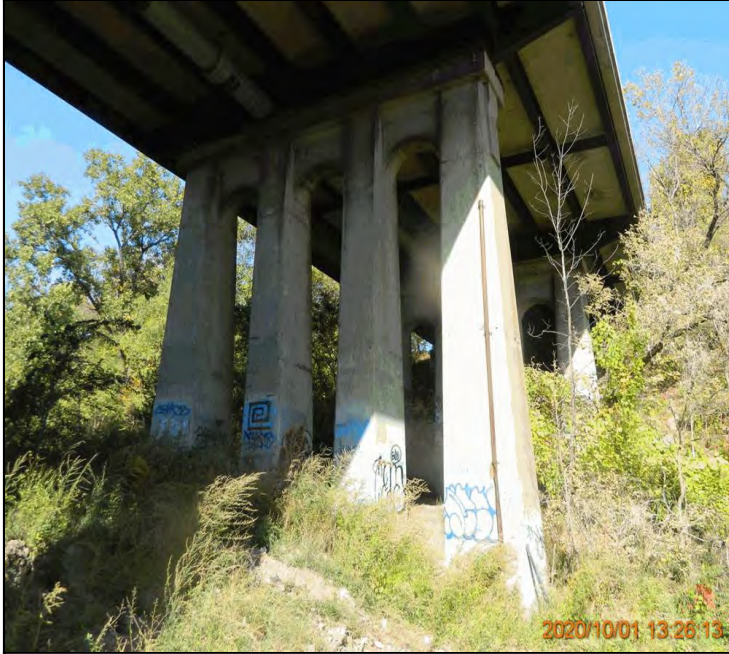
Description
South Elevation of Pier 5. Note: Local severe spall on 2nd column from west.

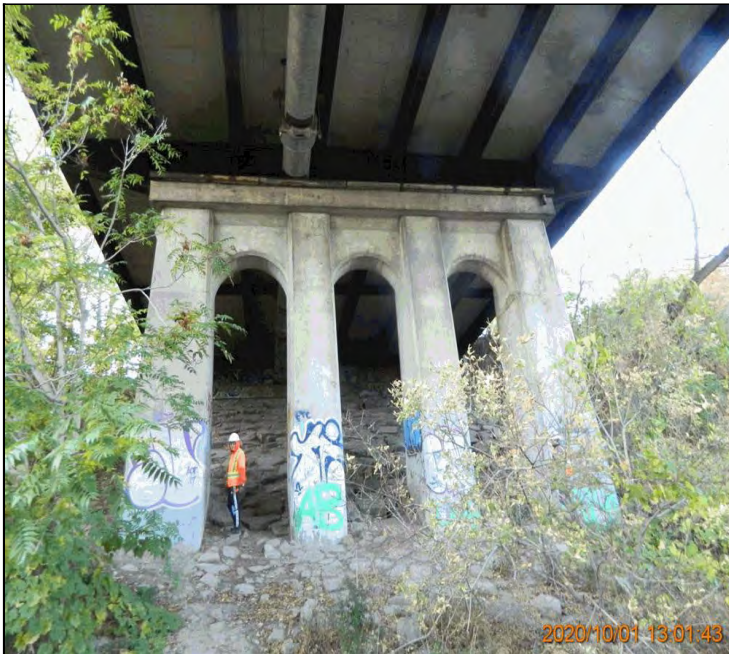
Description
South Elevation of Pier 6. Note: Graffiti on pier columns.

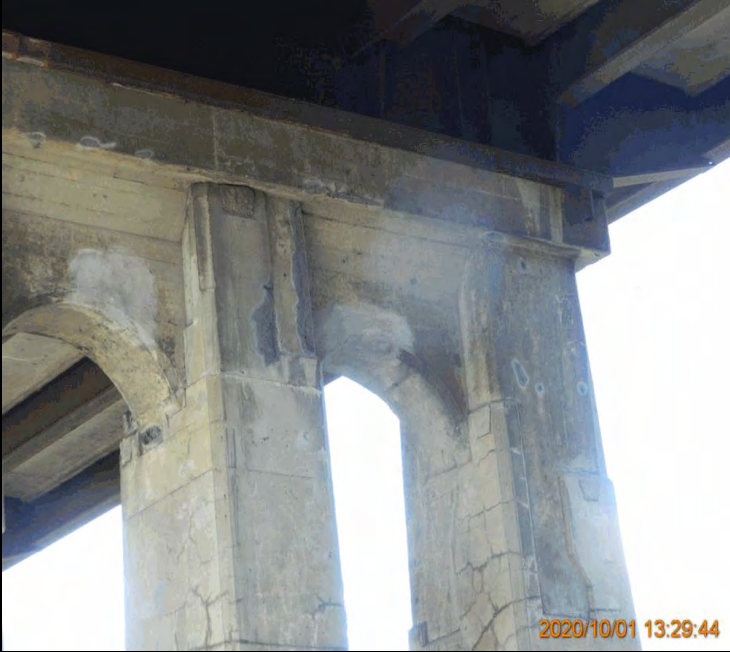
<p style="text-align: right; color: orange; font-size: small;">2020/10/01 13:29:44</p>	<p>Description M-S Spalls on South Face of Pier 2 Columns and Cap</p>

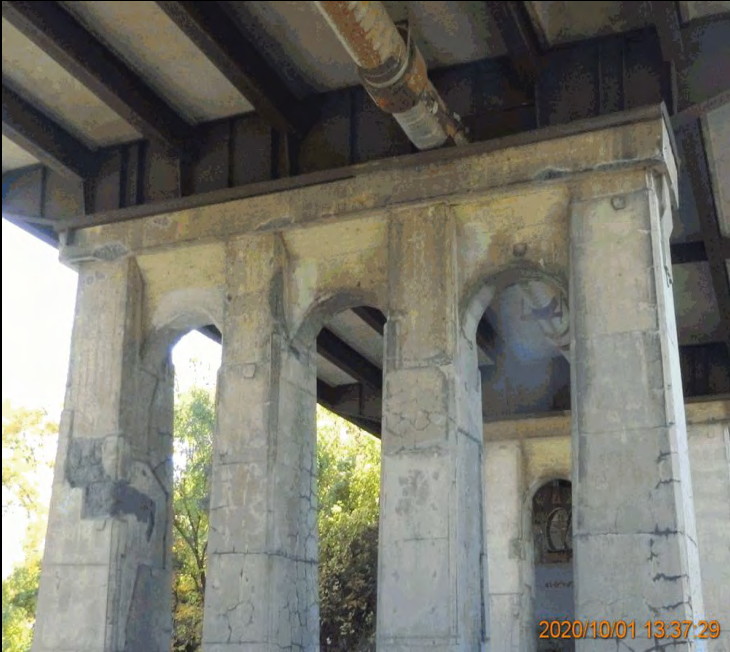
<p style="text-align: right; color: orange; font-size: small;">2020/10/01 13:37:29</p>	<p>Description Severe Spalls on N Face of Pier 2 Columns and Cap</p>

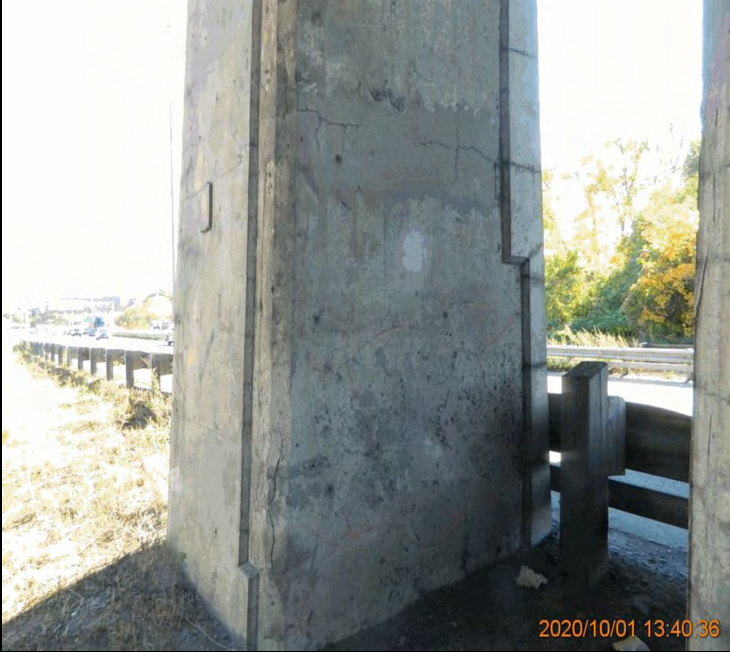
<p style="text-align: right; color: orange; font-size: small;">2020/10/01 13:40:36</p>	Description		
	Very Severe Delam on Column 4 From West @ Pier P3 (TYP)		
Elem Grp/Class	Piers/Shfts/columns/Pile Bent	Elem Type	Conc rectangular columns with
Sub Element		Material Type	Cast-in-place concrete
Locator		Defect Descript1	Poor condition
Defect Descript2		Defect	Delamination
Other			
File Name	51 Very Severe Delam on Column 4 From West @ Pier P3 (TYP).JPG

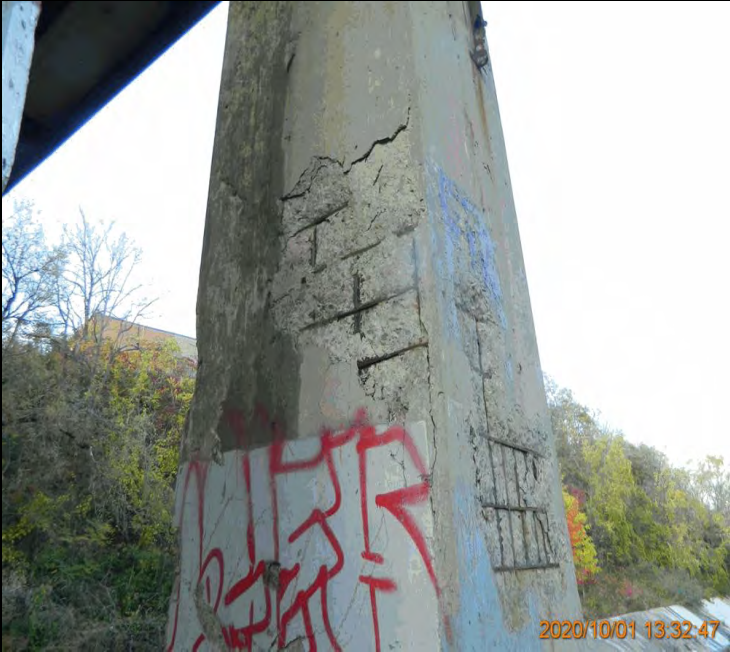
<p style="text-align: right; color: orange; font-size: small;">2020/10/01 13:32:47</p>	Description		
	Very Severe Spalls on South & West Face of Column @ Pier 4 (TYP).		
Elem Grp/Class	Piers/Shfts/columns/Pile Bent	Elem Type	Conc rectangular columns with
Sub Element		Material Type	Cast-in-place concrete
Locator		Defect Descript1	Poor condition
Defect Descript2		Defect	Spalling
Other			
File Name	52 Very Severe Spalls on South & West Face of Column @ Pier 4 (TYP).JPG

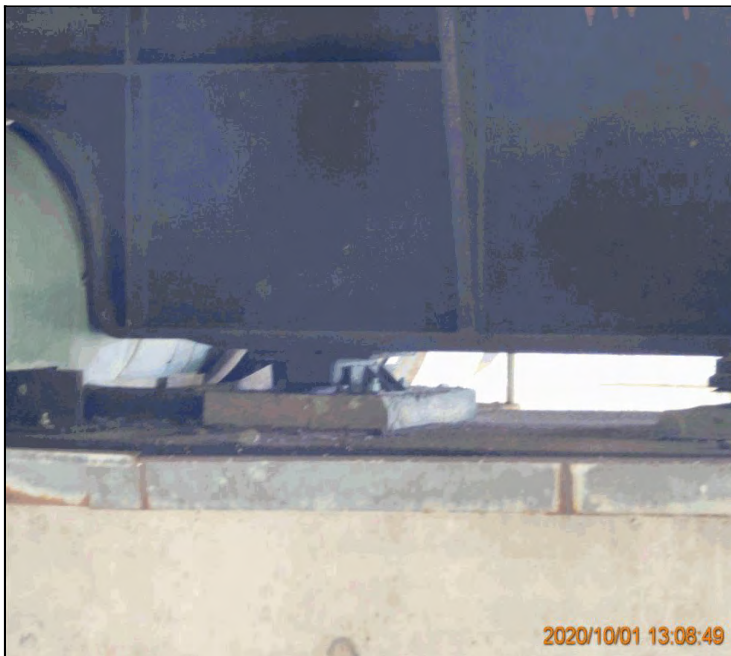
Description Typical Guide Assembly at Piers P1, P2, P3, P5, & P6, Pier 6 Shown	
Elem Grp/Class	Piers/Bearings
Elem Type	Elastomeric pad
Sub Element	
Material Type	
Locator	General
Defect Descript1	
Defect Descript2	
Defect	
Other

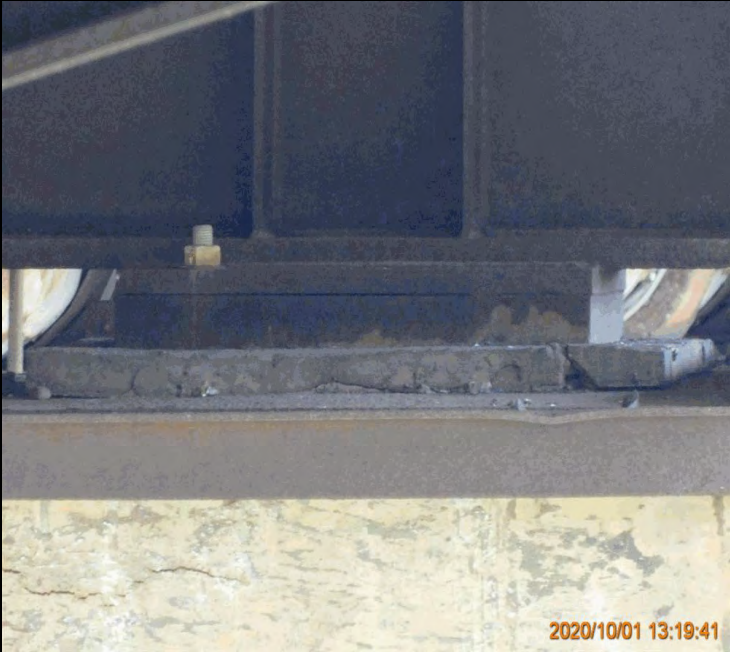
<p>Description Typical Fixed Bearing at Pier 4. Note: Wide cracks in grout pad.</p>

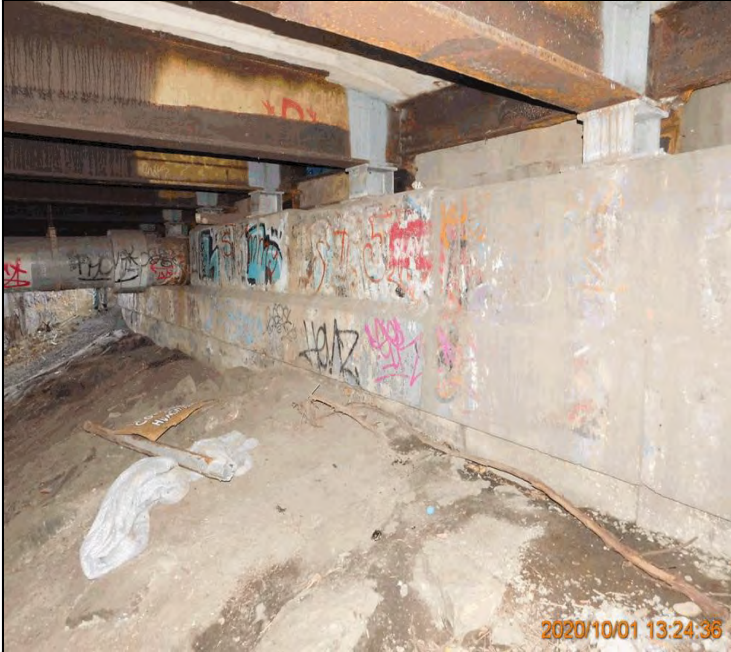
Description		
North Abutment, Looking West. Note: Graffiti markings.			
	Elem Grp/Class	Abutments/Abutment walls	
	Elem Type	Conventional closed	
	Sub Element		
	Material Type	Cast-in-place concrete	
	Locator	General	
	Defect Descript1		
	Defect Descript2		
	Defect		
	Other		
File Name	58 North Abutment, Looking West.JPG

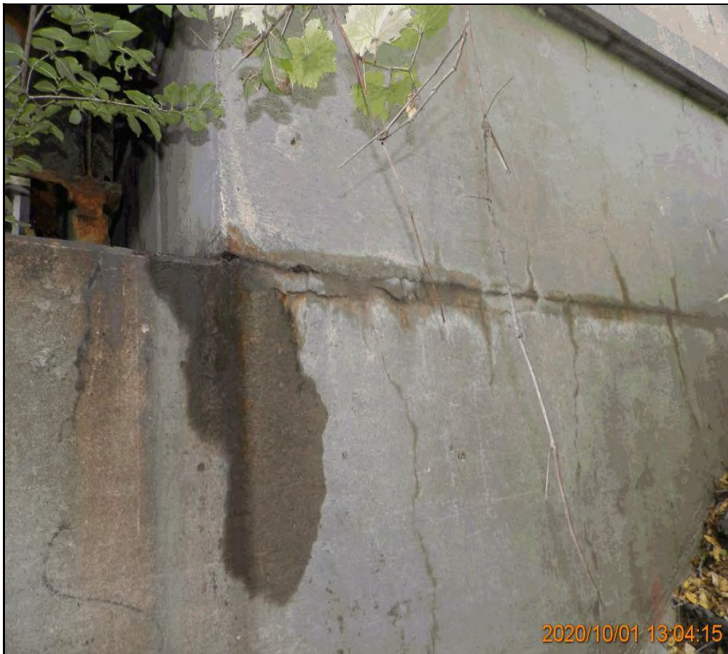
Description Narrow Wet Stained Vertical Cracks and Wet Staining on SW Wingwall	
Elem Grp/Class	Abutments/Wingwalls
Elem Type	Reinforced concrete
Sub Element	
Material Type	Cast-in-place concrete
Locator	
Defect Descript1	Fair condition
Defect Descript2	
Defect	Cracks
Other

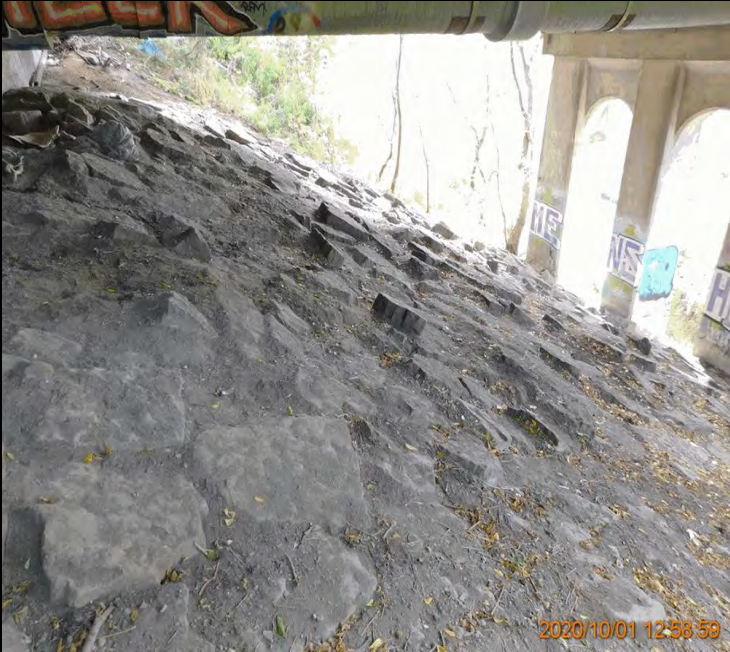
<p style="text-align: right; font-size: small; color: orange;">2020/10/01 12:58:59</p>	Description		
	Rock Slope Protection @ North Embankment		
	Elem Grp/Class	Embankments & Streams/Slop	
	Elem Type	Other	
	Sub Element		
	Material Type		
	Locator	General	
	Defect Descript1		
	Defect Descript2		
	Defect		
	Other		
File Name	70 Rock Slope Protection @ North Embankment.JPG

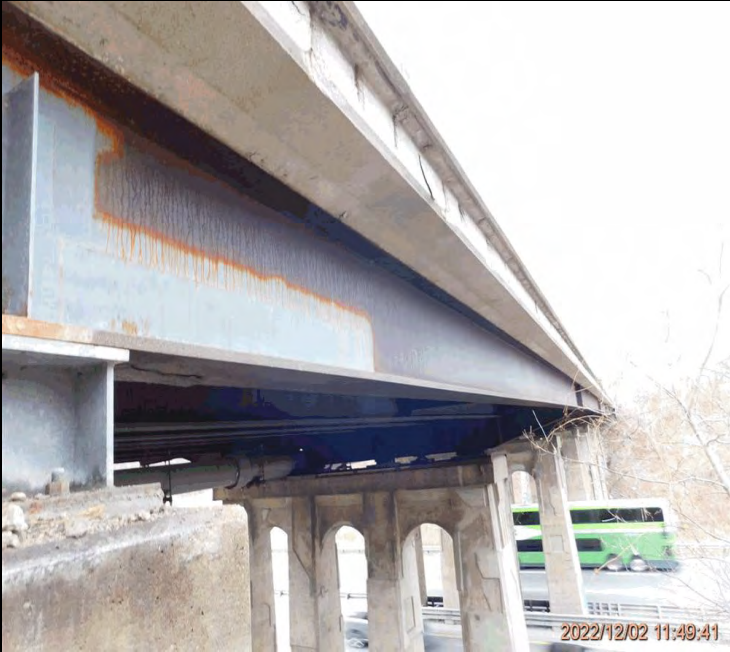
<p>Description East Exterior Soffit from South</p>
