TIVOLI THEATRE | CULTURAL HERITAGE IMPACT ASSESSMENT

September 30, 2024

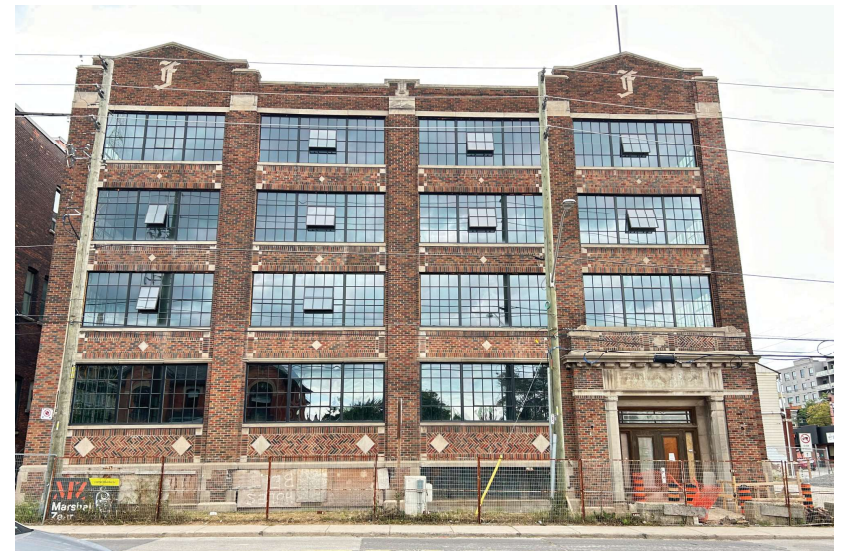
Source: +VG Architects

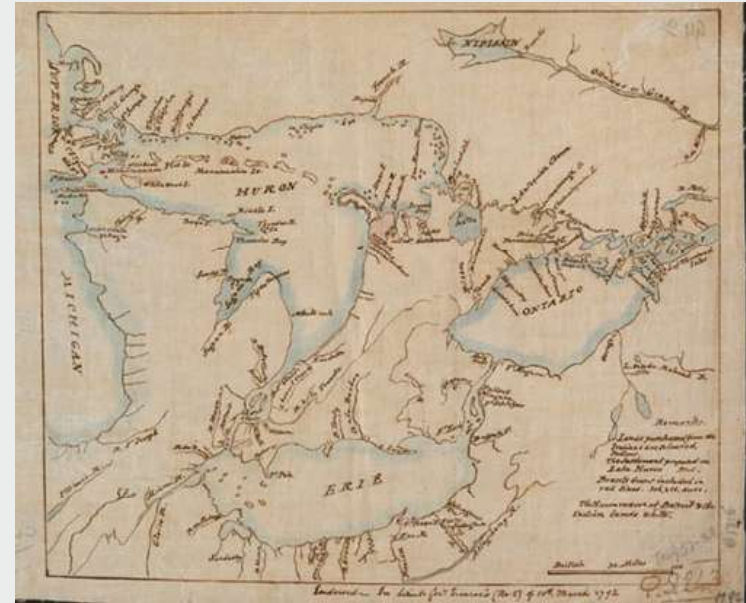
Grant to Joseph Brant, 1792 map showing the "Between the Lakes" area of Treaty No. 3. Library and Archives Canada, 2000215462

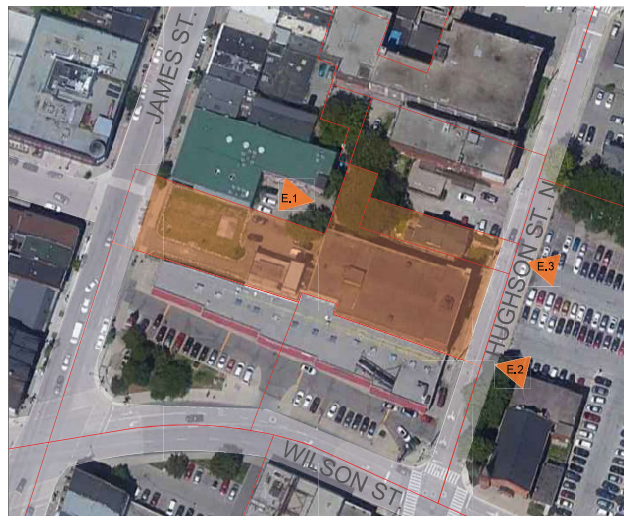
Tivoli Property exterior keyplan [Source: +VG Architects]

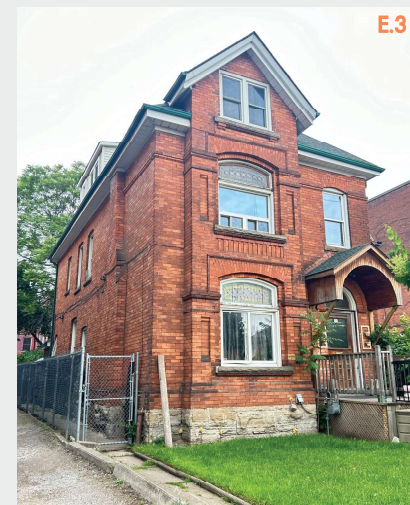
Exterior images [Source: +VG Architects]

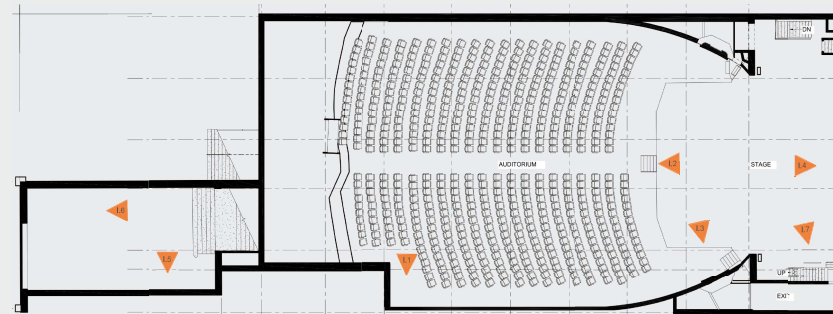
Tivoli Property interior keyplan [Source: +VG Architects]

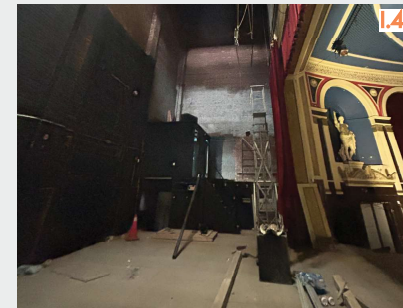
- plaster on walls, ceilings, ornamental mouldings throughout subject building (see note below)
- mastic on the floor throughout the front lobby area
- texture finish on walls and ceilings in storage room at the back right corner of backstage area

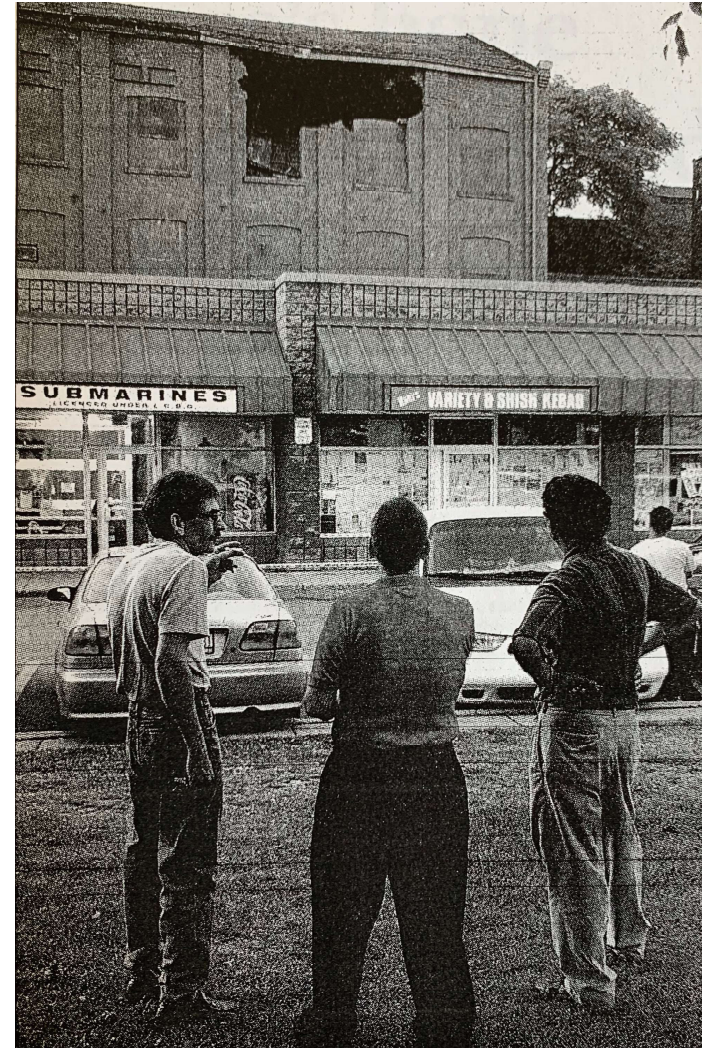
Passerby observe the damage in the Tivoli wall [Source: Hamilton Public Library]

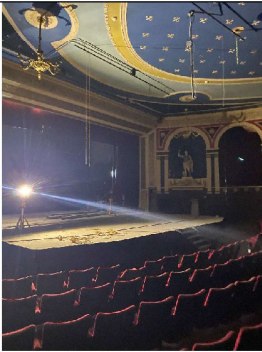
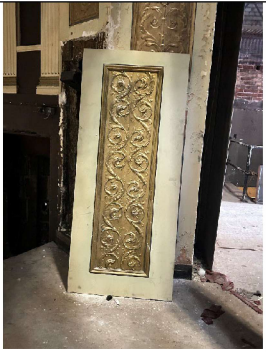
2 Ceiling w elliptical design	Auditorium house	General Condition: Good with areas of heavy damage or missing structure. Areas of damaged and missing ceiling are around penetrations from equipment or fixtures, and areas of water (likely from the failing roof) where plaster has fallen off.	Documentation: Detailed scanning, drawings and descriptions. Ornamental plaster requires careful documentation of the designs, spacing, scale, and location. Note: Two environmental reports identify designated substances and hazardous building materials found throughout the building. Specific to plaster and interior finishes are asbestos and lead paint. Due to deteriorated conditions of the interior, asbestos fibers are noted as having widespread on the interior. Abatement methods may be detrimental to the historic features and further study is required.

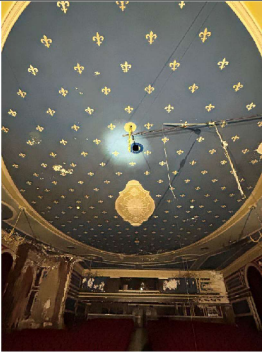
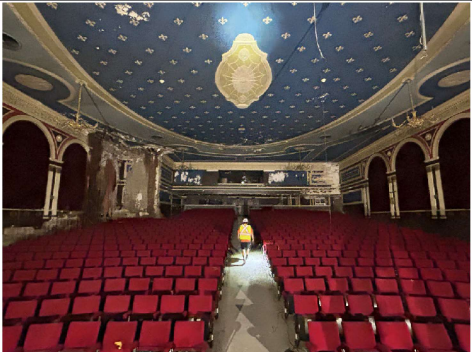
TIVOLI THEATRE | DOCUMENTATION + SALVAGE

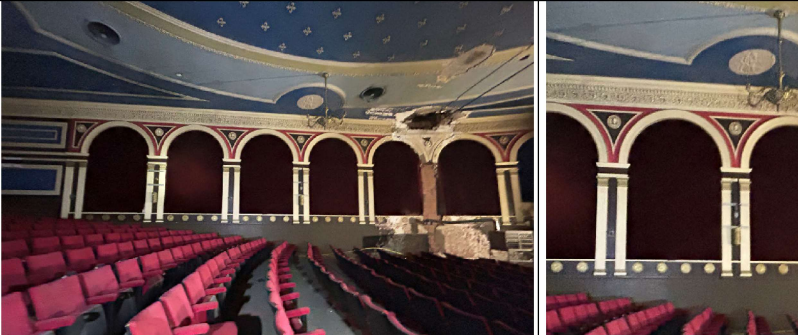
TIVOLI THEATRE | DOCUMENTATION + SALVAGE

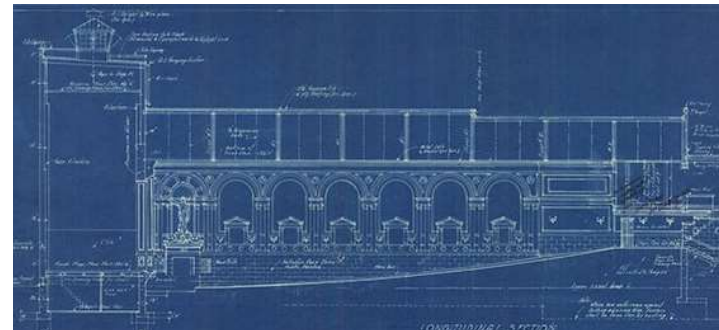
7. CONSERVATION STRATEGY

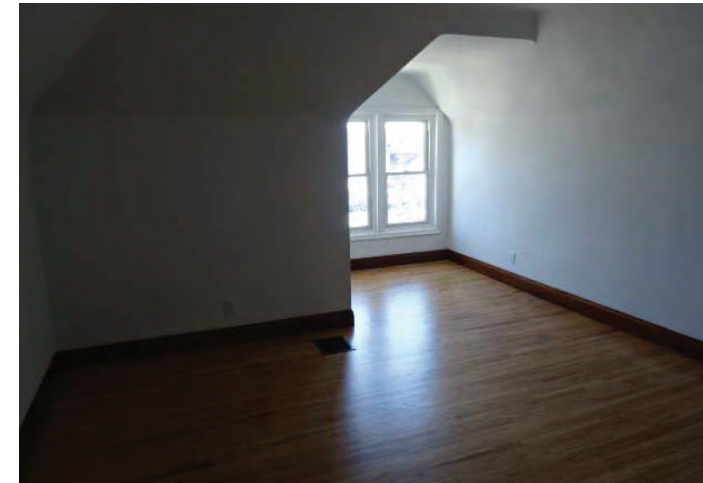
View of Level 3 under roof space with gable window, wood trims and wood flooring. [Source: Aventus]

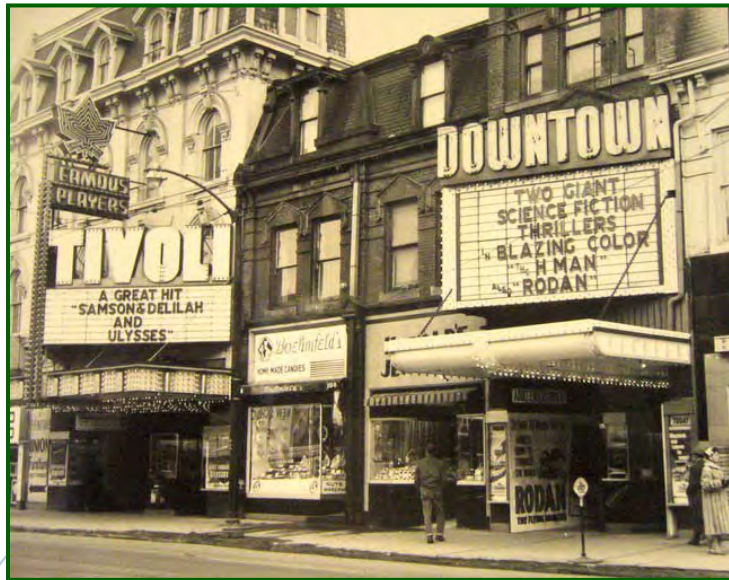
Tivoli Condo Development 108 James Street North, Hamilton Building Condition Assessment February 2024

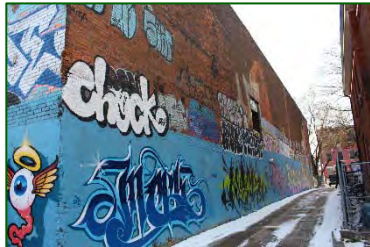
A. General Description of the Facility

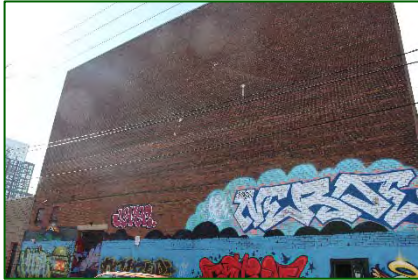
<p>Item 1.2 North Elevation</p> <p><u>Observation</u> North elevation of the building consists of brick and a parge coat approximately 3m above grade. Brick wall is in poor condition.</p> <p>Some deterioration of brick and cracking was observed.</p>

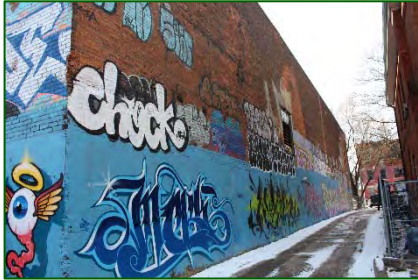
<p>Item 1.3 North Elevation</p> <p><u>Observation</u> Significant mortar loss at brick joints throughout wall. Significant staining throughout wall.</p>

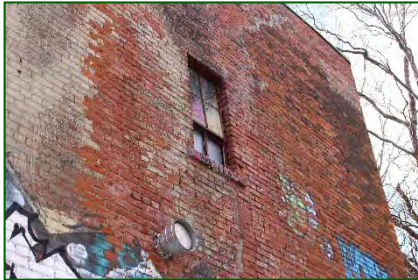
**Tivoli Condo Development
108 James Street North, Hamilton
Structural Building Condition Assessment, February 2024**

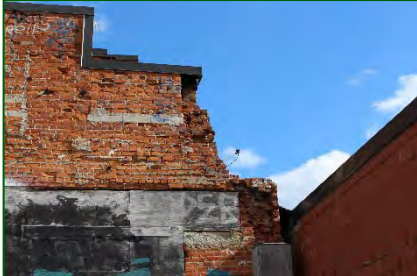
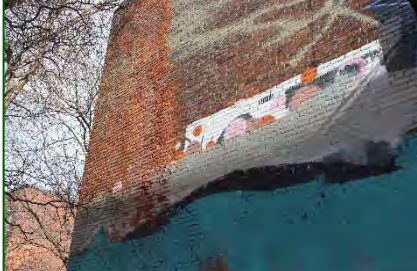
Tivoli Condo Development
108 James Street North, Hamilton
Structural Building Condition Assessment, February 2024

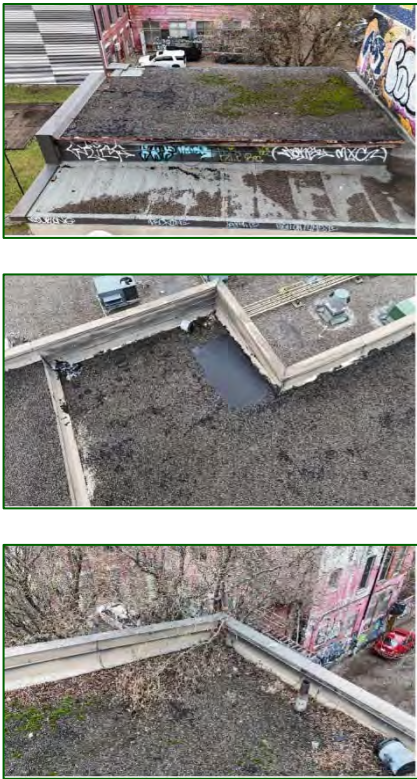
Tivoli Condo Development
108 James Street North, Hamilton
Structural Building Condition Assessment, February 2024

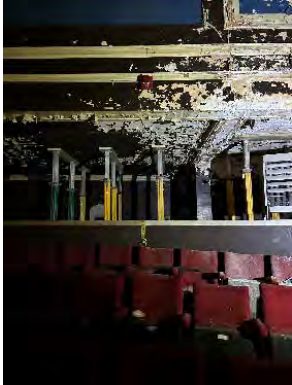
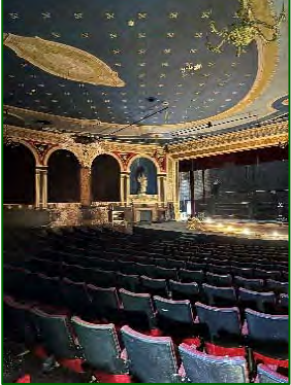
<p>Item 2.3 Floor Structure</p> <p><u>Observation</u> Clay tile ceiling at shoring locations.</p>

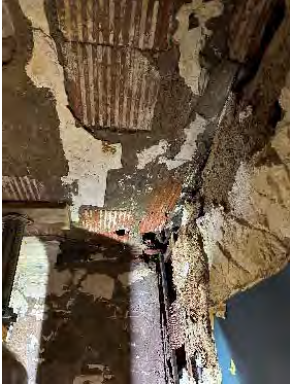
<p>Item 2.4 Walls</p> <p><u>Observation</u> Moisture damage to wall.</p>

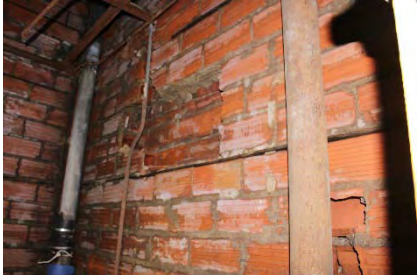
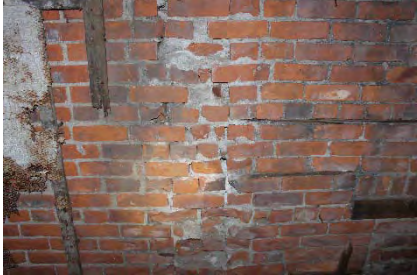
<p>Item 2.7 Roof Framing</p> <p><u>Observation</u> Siporex roof structure with damage at penetrations, several areas are stained suggesting moisture damage. Siporex roof structure loses significant structural integrity when wet.</p> <p><u>Action</u> Shore areas of damaged Siporex immediately.</p>

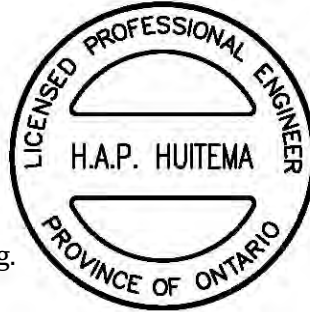
Per: Harjot Dev, B.E.Sc., E.I.T.
Junior Structural Designer

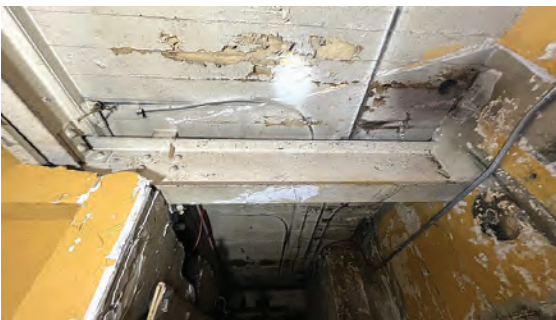
Photo 1: Example of peeling and flaking paint on wood ceilings below stage area.

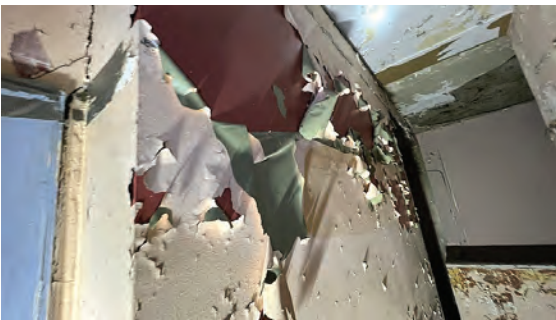
Photo 5: Example of damaged paint on plaster walls on second floor.

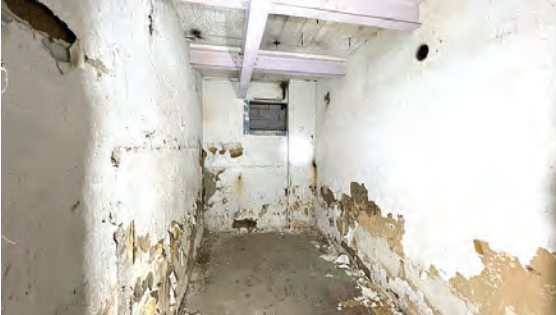
Photo 9: Example of moisture damage and mould growth on lower walls throughout rooms below stage area.

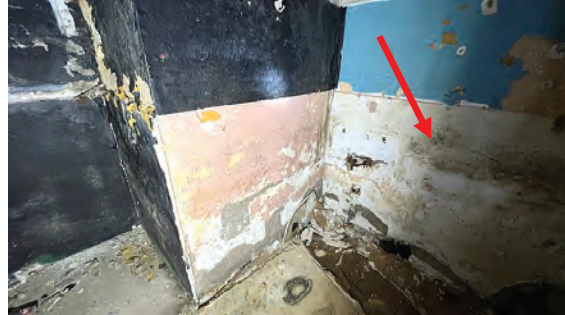
Photo 10: Example of moisture damage on lower walls throughout rooms below stage area.

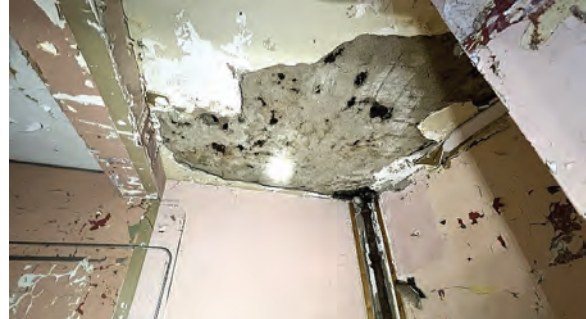
Photo 12: Water-damaged ceiling and mould growth on second floor.

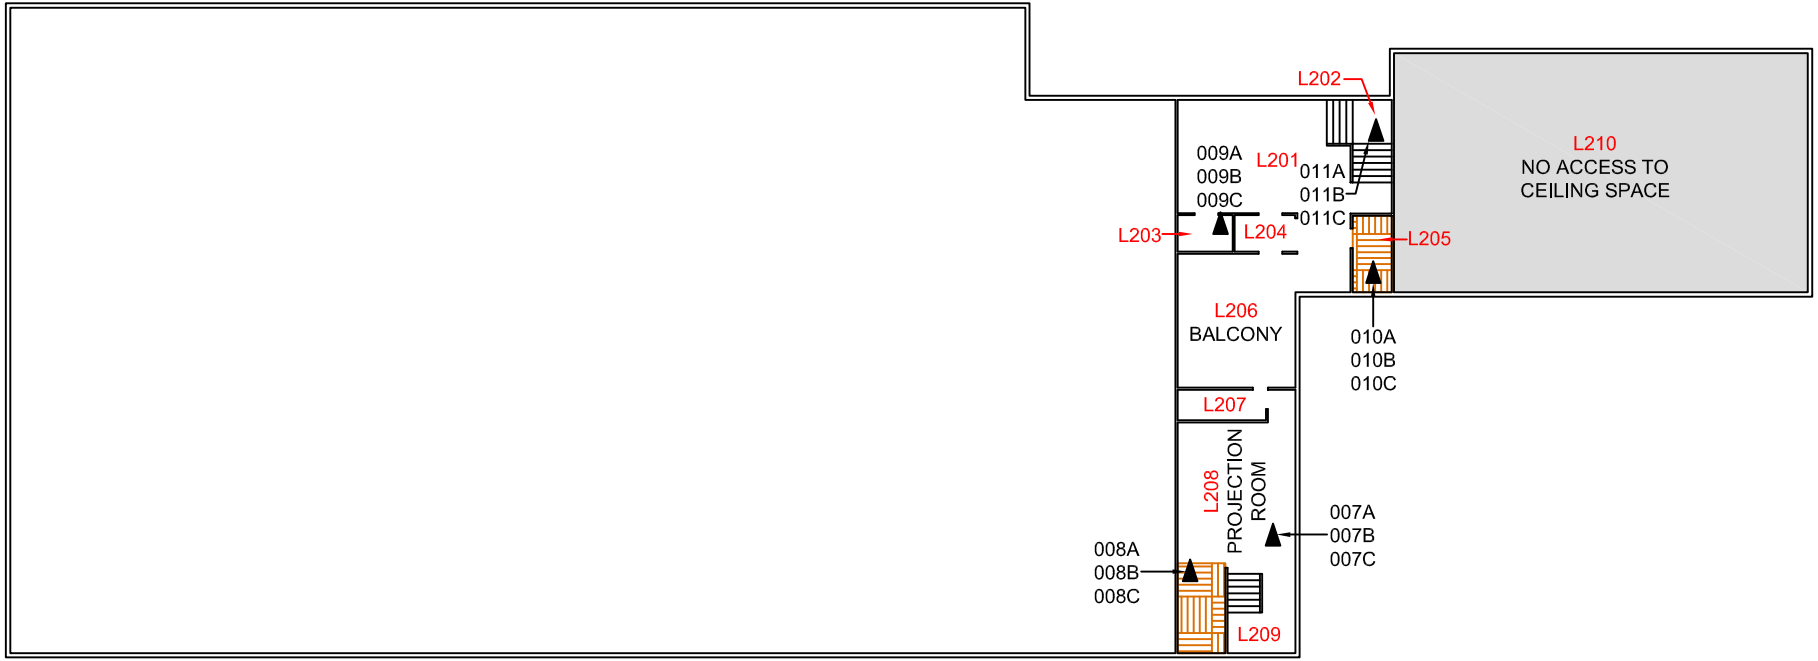
<p>DESIGNATED SUBSTANCES AND HAZARDOUS BUILDING MATERIALS ASSESSMENT</p> <p>FORMER TIVOLI THEATRE, 108 JAMES STREET NORTH, HAMILTON, ONTARIO</p>	Project No.: 10113.002	<p>Dwg. No.:</p> <p style="font-size: 2em; font-weight: bold;">2</p>	
	Scale: N.T.S.		
	Date: 24/04/08		
	Dwn. By: CD _{CS} AC2024040014		
Client: AVENTUS DEVELOPMENTS, 1418 ONTARIO STREET, BURLINGTON, ONTARIO L7S 1G4	App'd By: AA

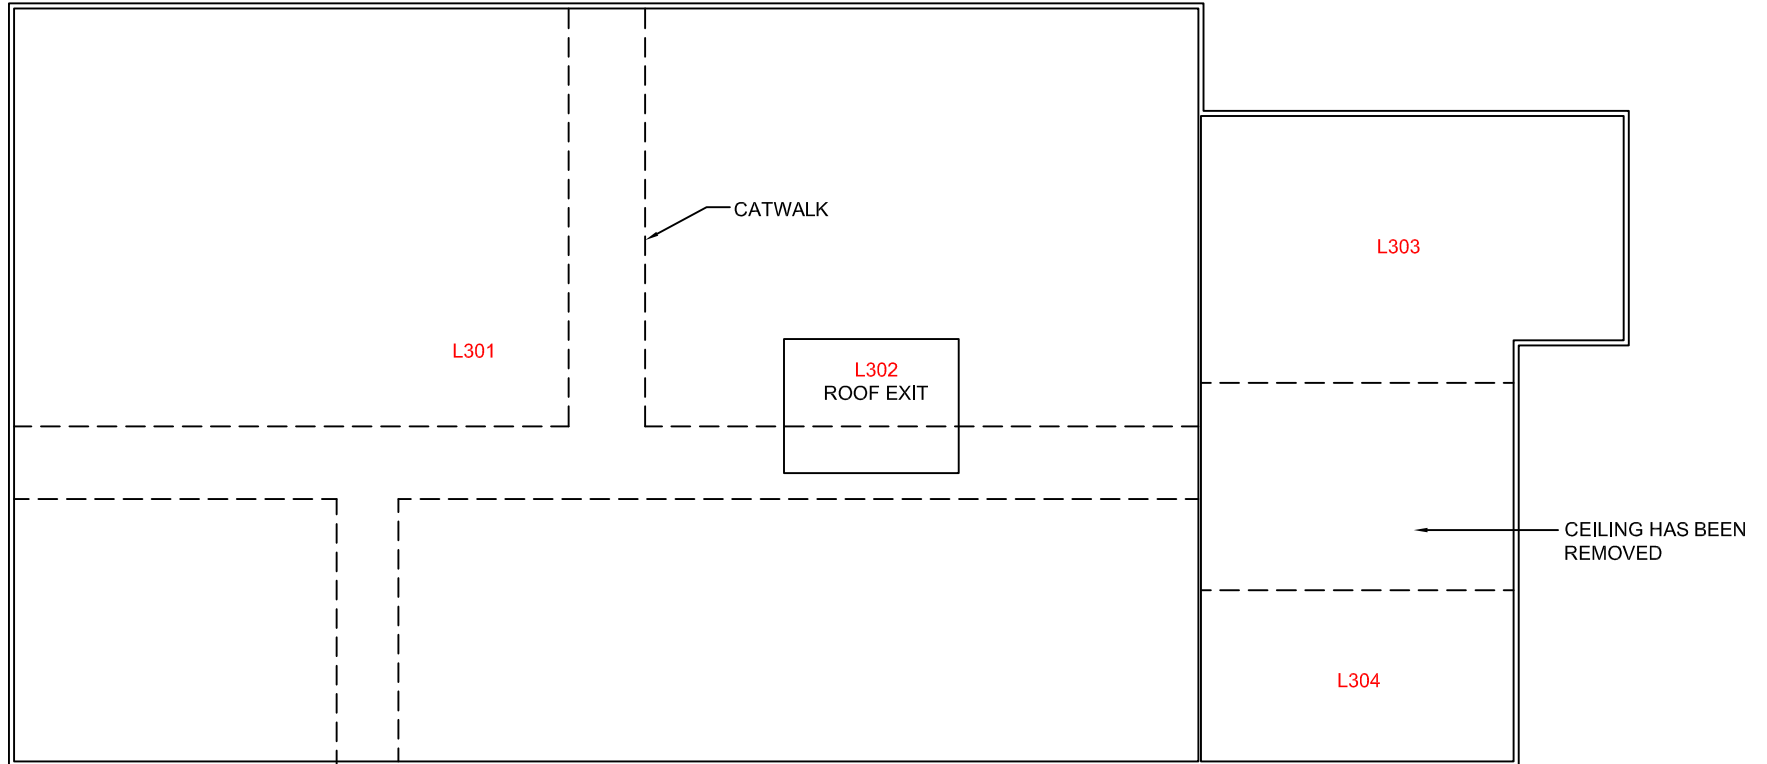
CATWALK / CEILING SPACE

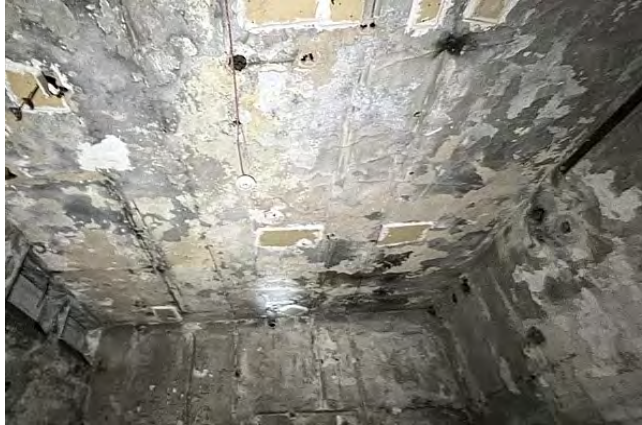
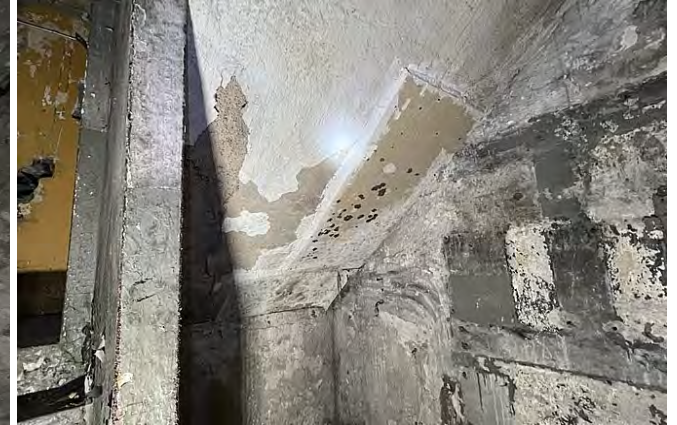
Summary of ACMs and PACMs

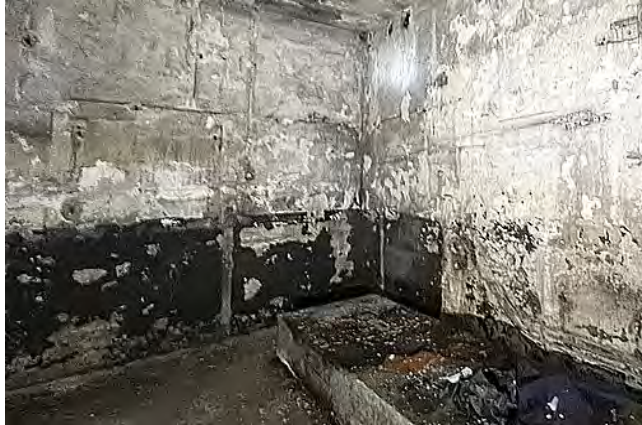
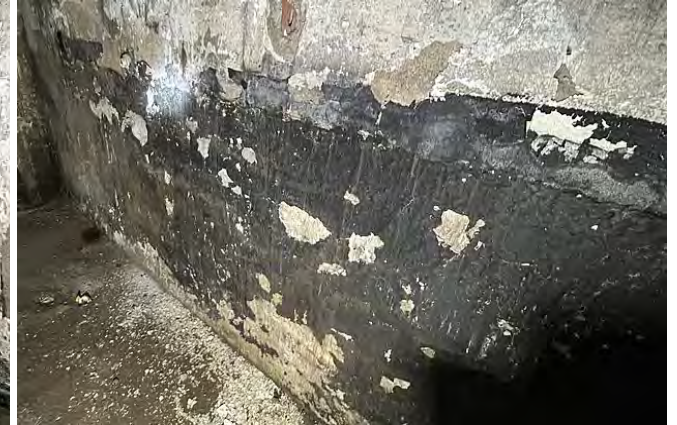
Summary of ACMs and PACMs

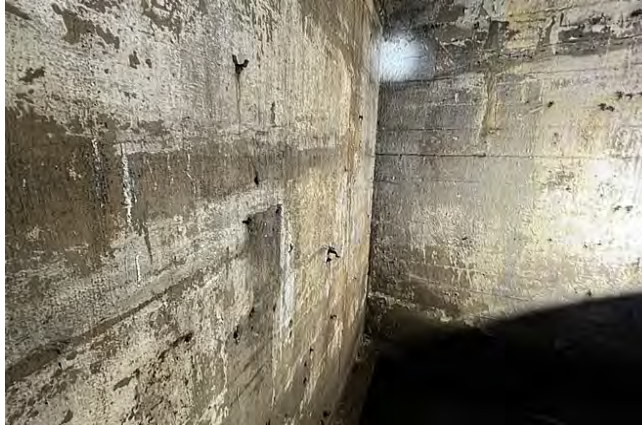
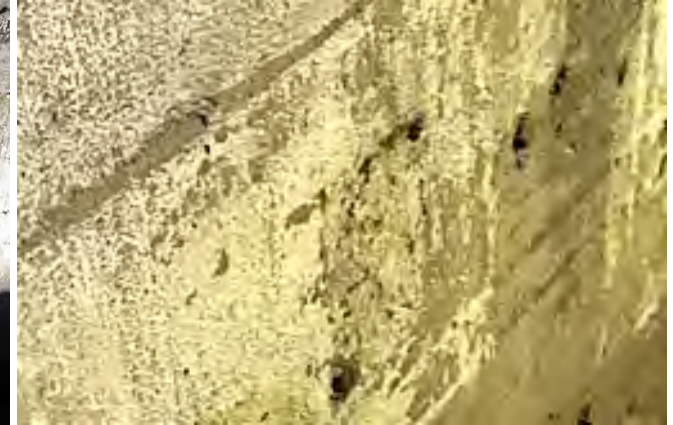
Summary of ACMs and PACMs

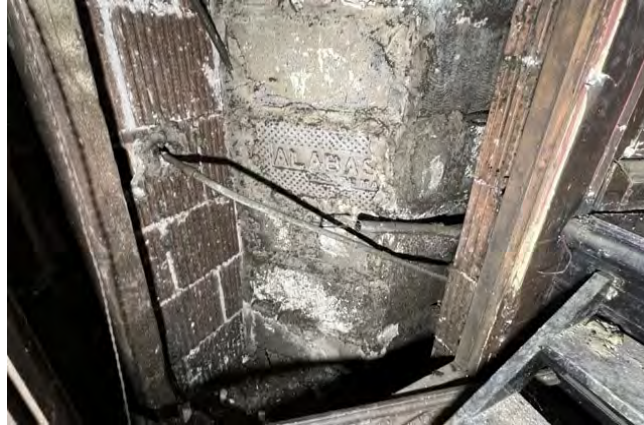
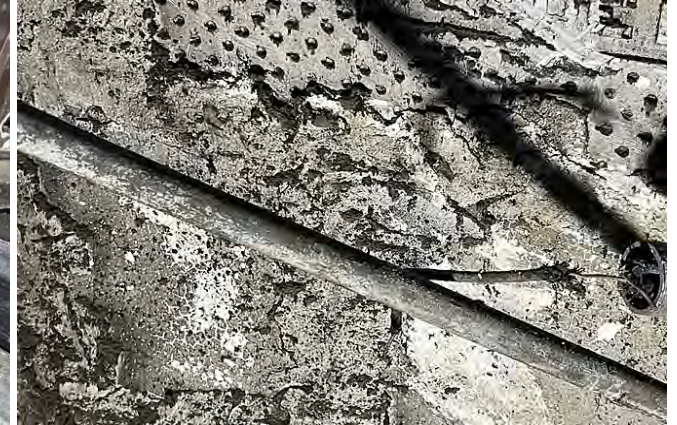
Summary of ACMs and PACMs

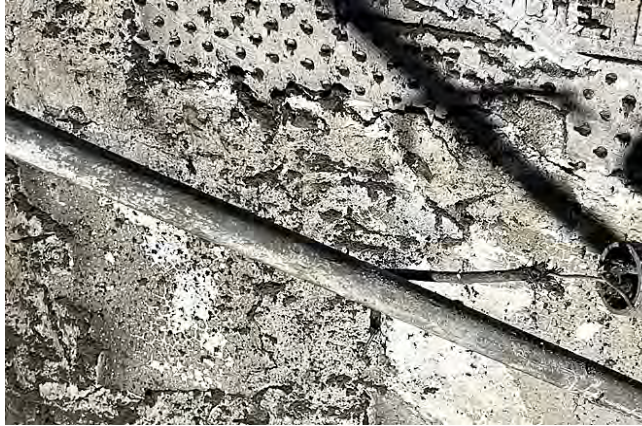
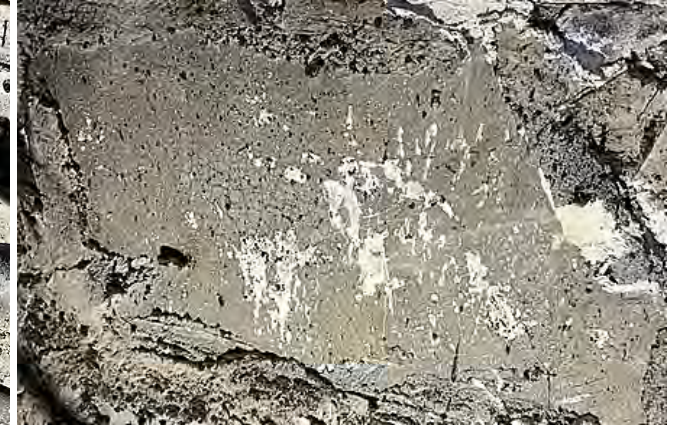
Summary of ACMs and PACMs

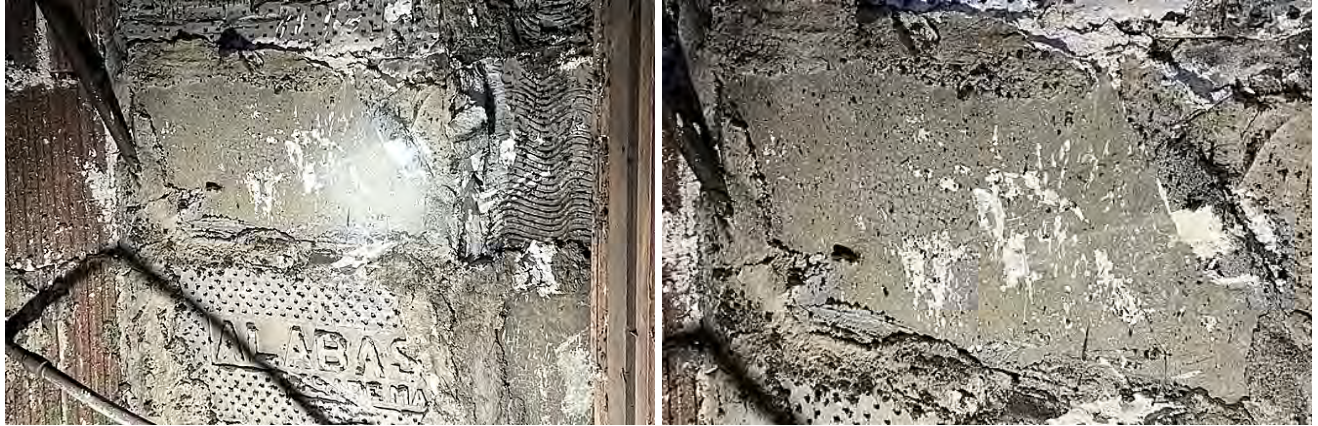
Summary of ACMs and PACMs

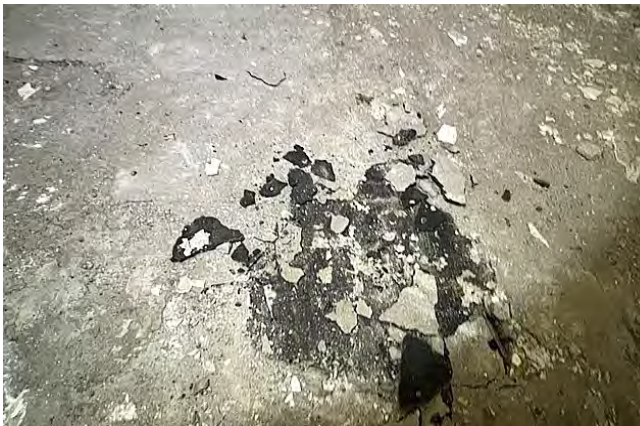
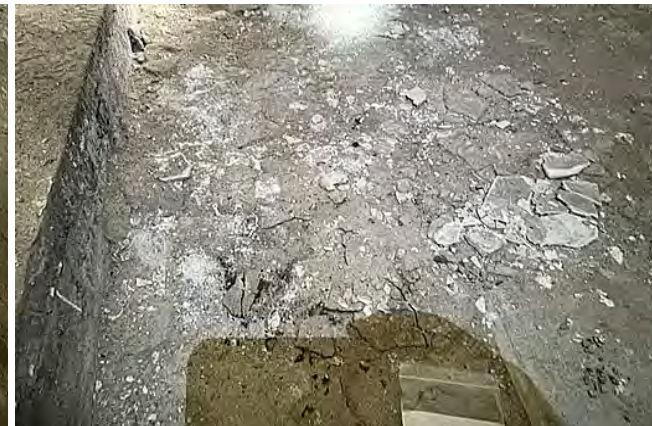
Summary of ACMs and PACMs

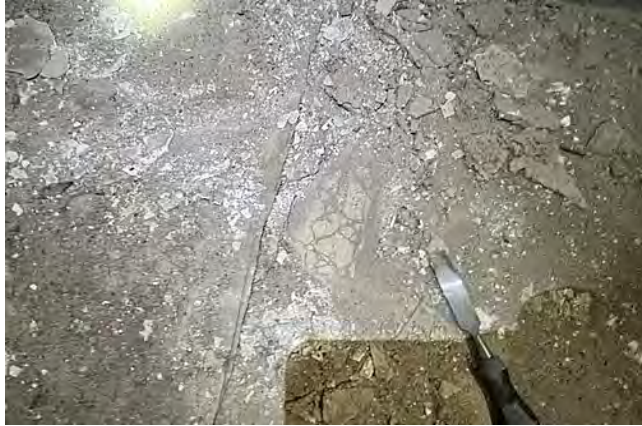
Summary of ACMs and PACMs

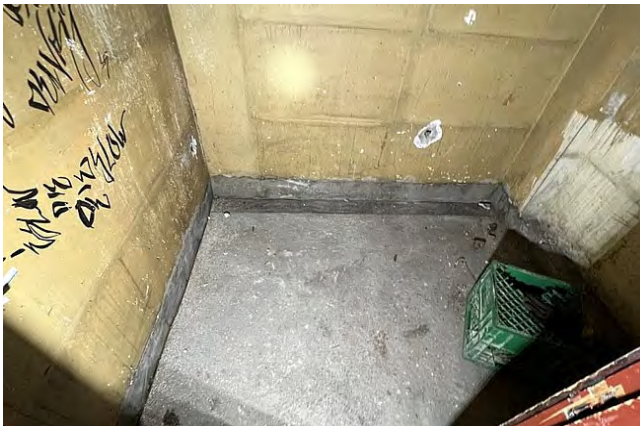
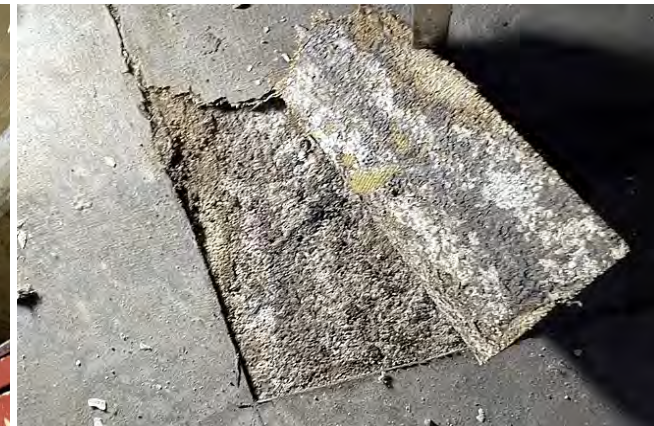
Summary of ACMs and PACMs

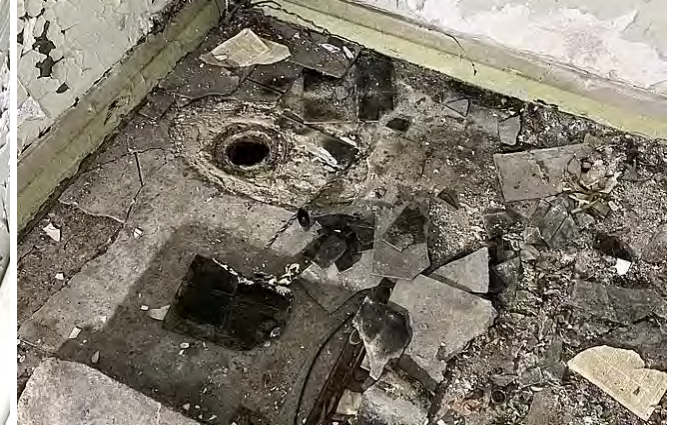
Summary of ACMs and PACMs

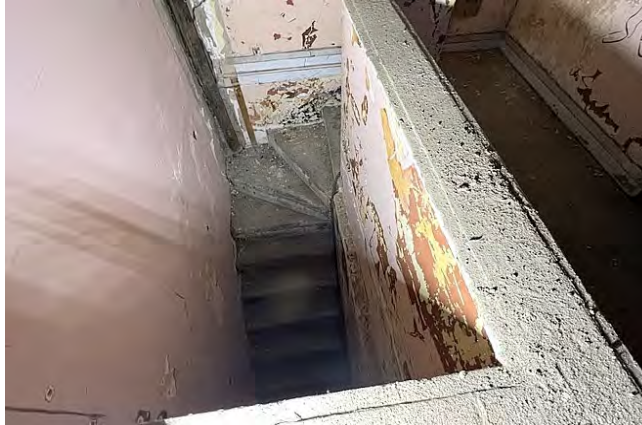
Summary of ACMs and PACMs

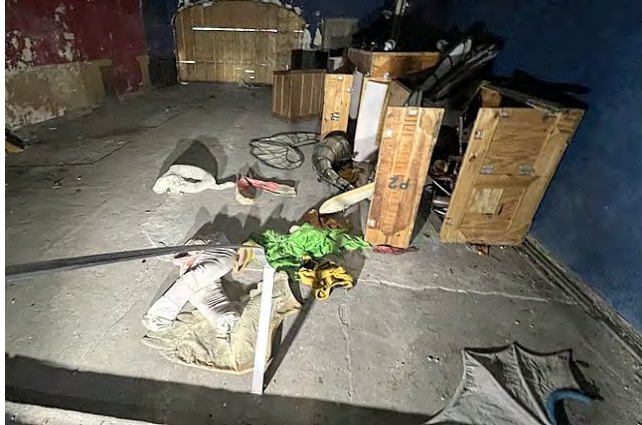
Summary of ACMs and PACMs

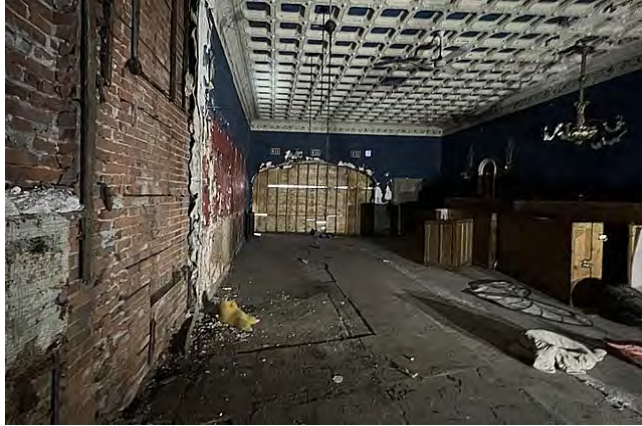
Summary of ACMs and PACMs

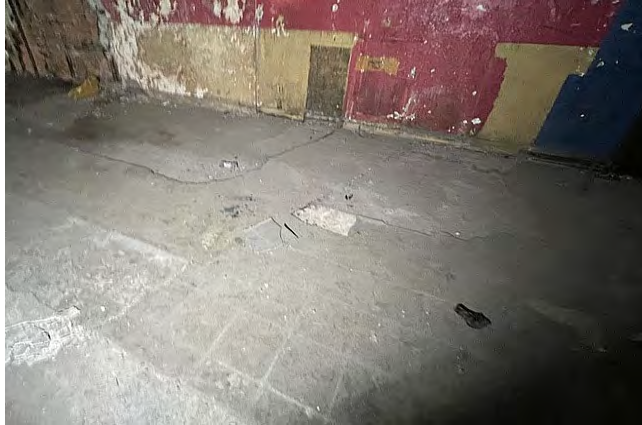
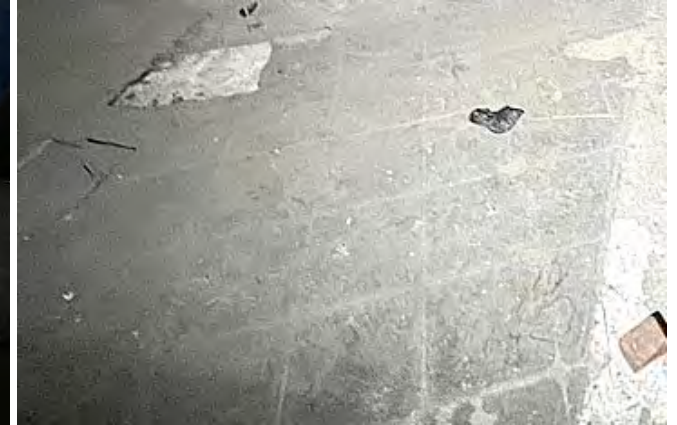
Summary of ACMs and PACMs

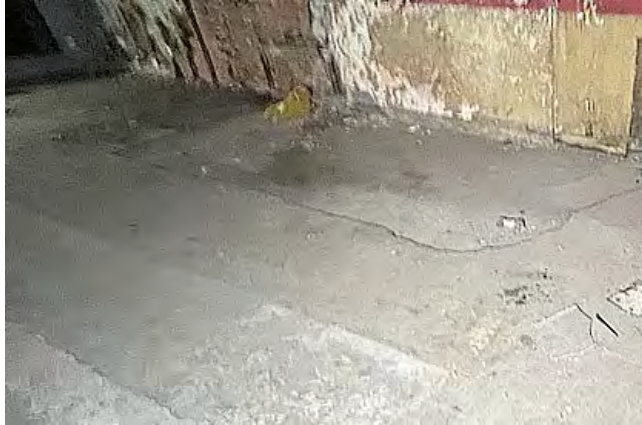
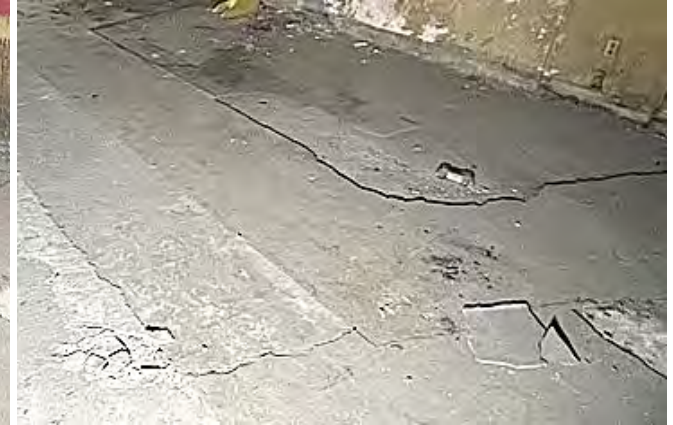
Summary of ACMs and PACMs

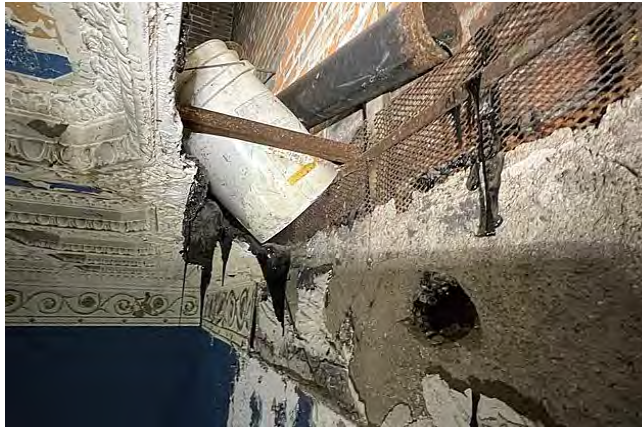
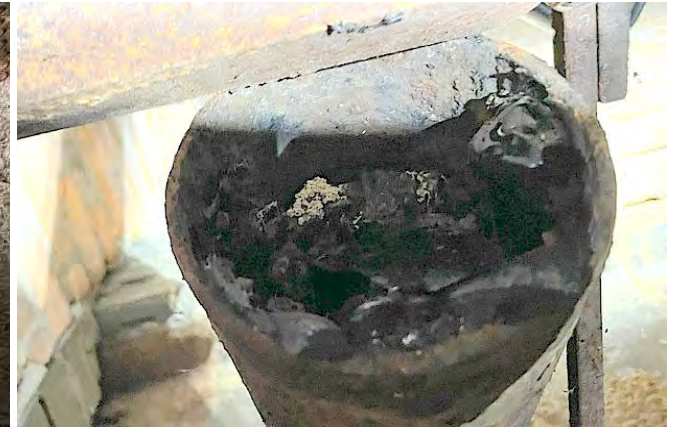
Summary of ACMs and PACMs

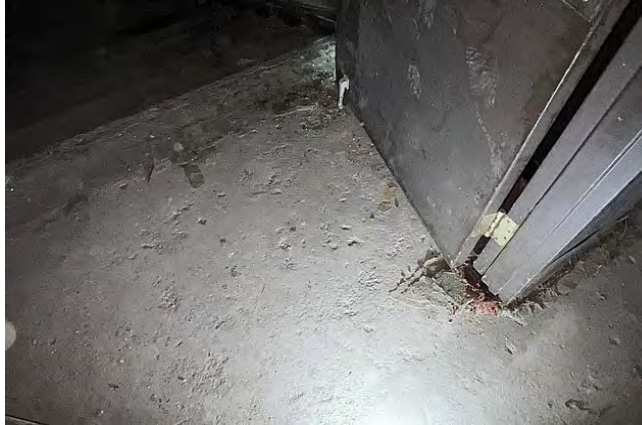
Summary of ACMs and PACMs

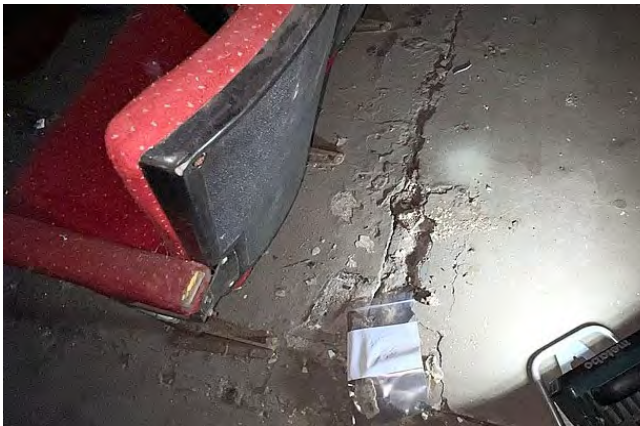
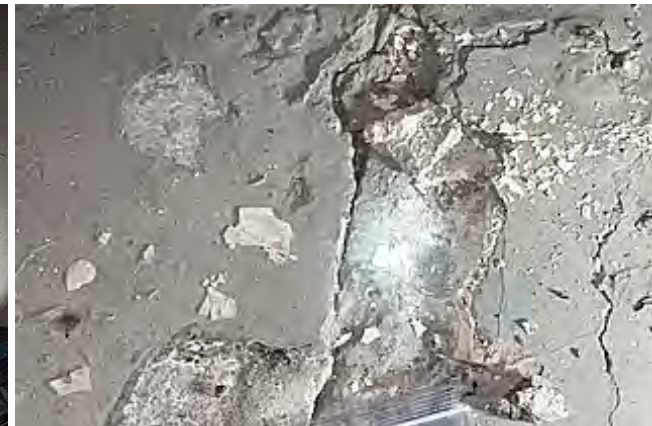
Summary of ACMs and PACMs

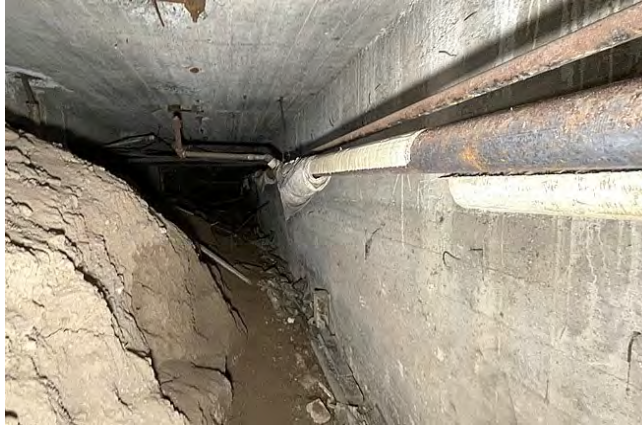
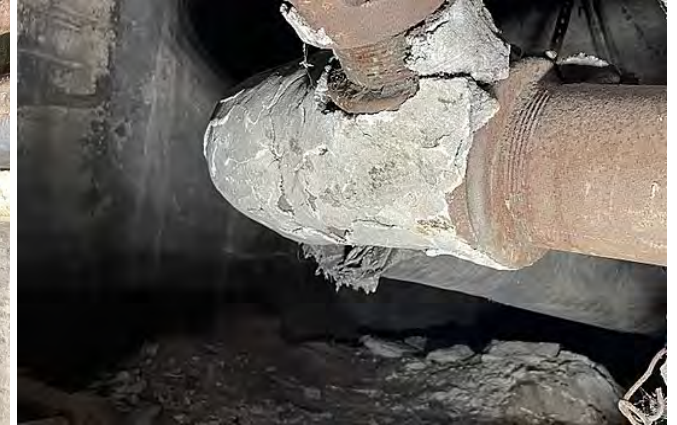
Summary of ACMs and PACMs

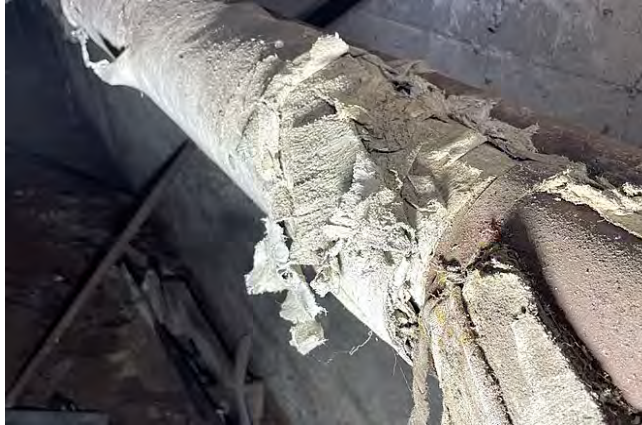
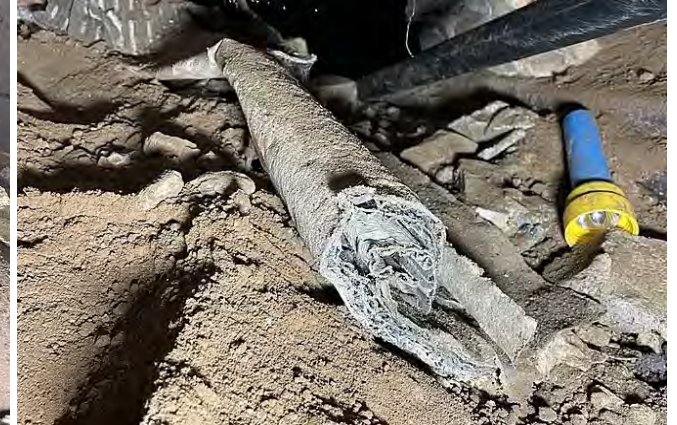
Summary of ACMs and PACMs

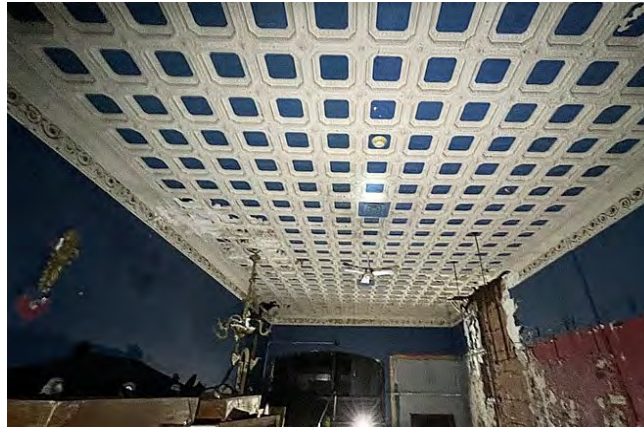
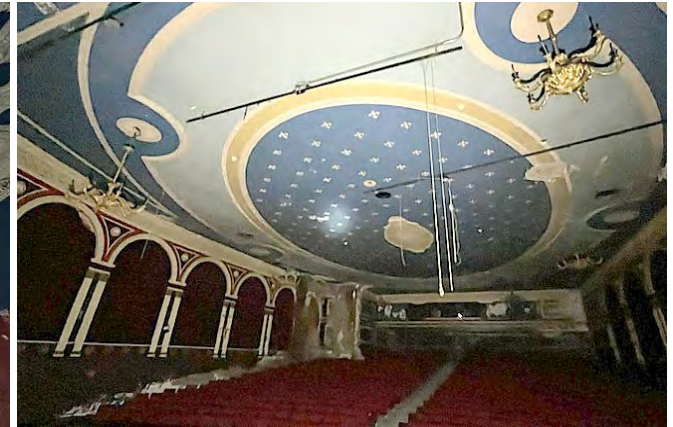
Summary of ACMs and PACMs

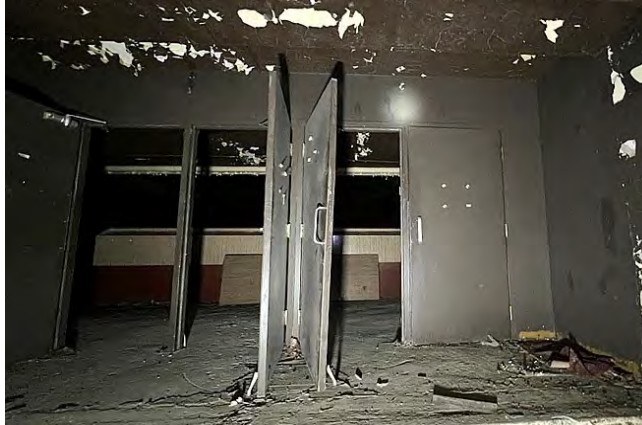
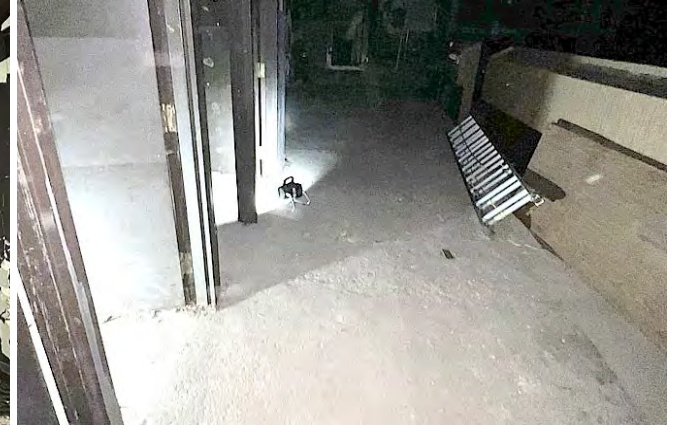
Summary of ACMs and PACMs

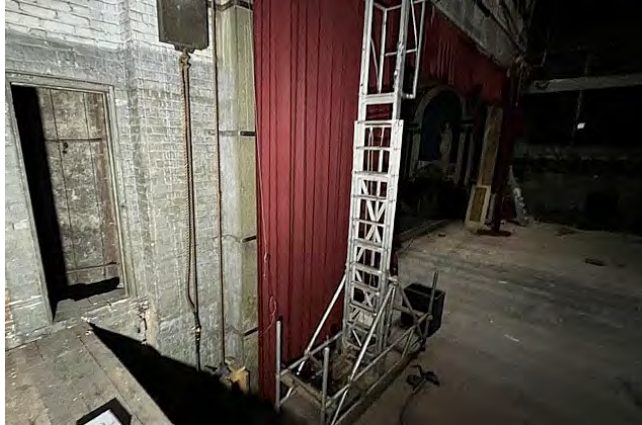
Summary of ACMs and PACMs

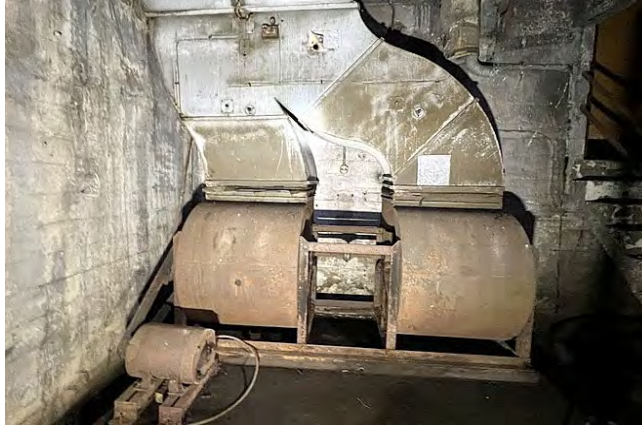
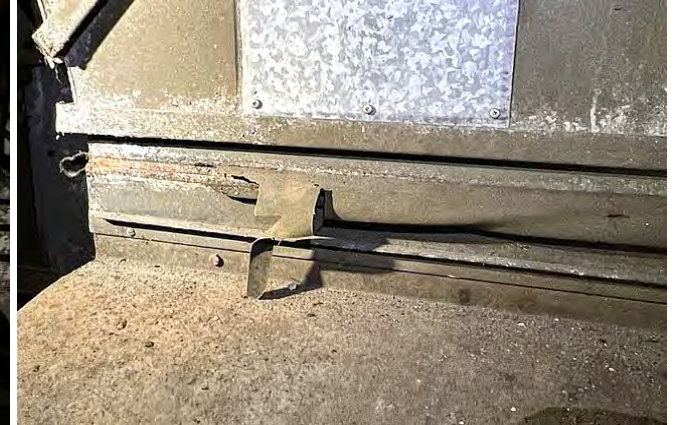
Summary of ACMs and PACMs

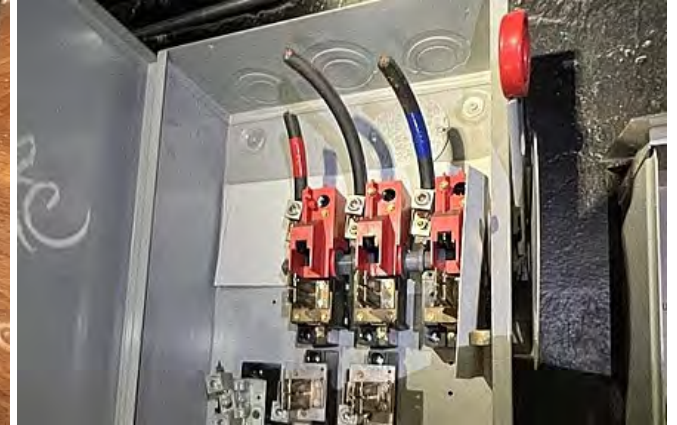
Summary of ACMs and PACMs

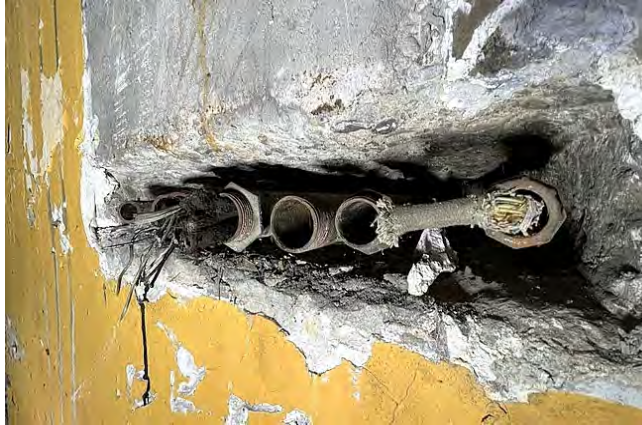
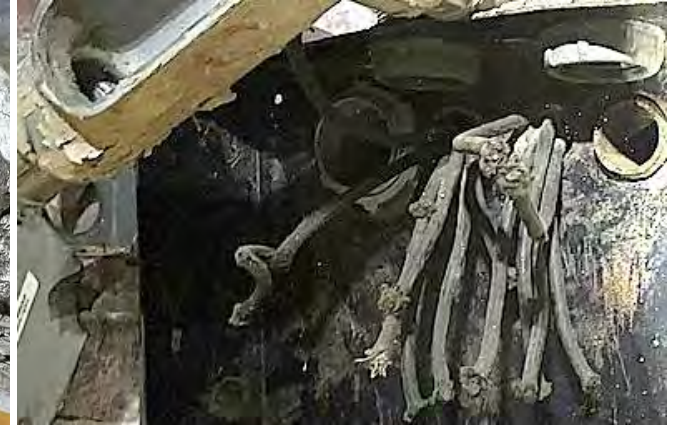
Summary of ACMs and PACMs
