TIVOLI THEATRE | CULTURAL HERITAGE IMPACT ASSESSMENT

September 30, 2024

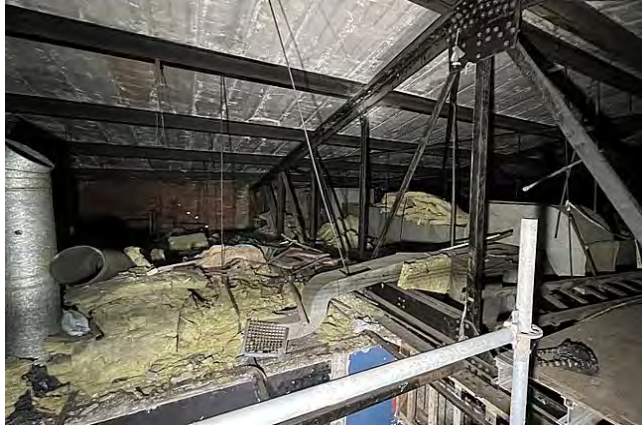
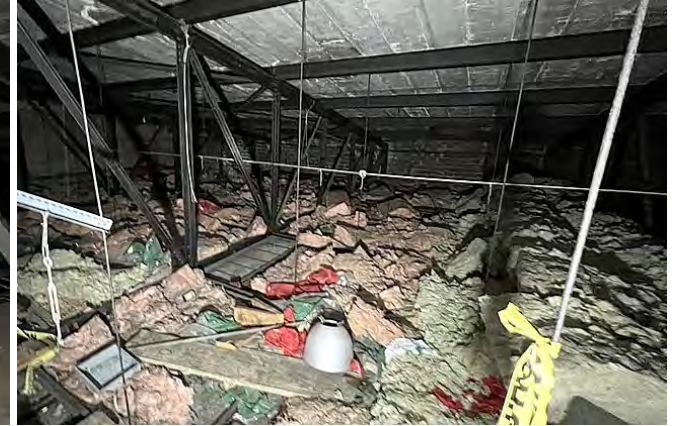
Summary of ACMs and PACMs

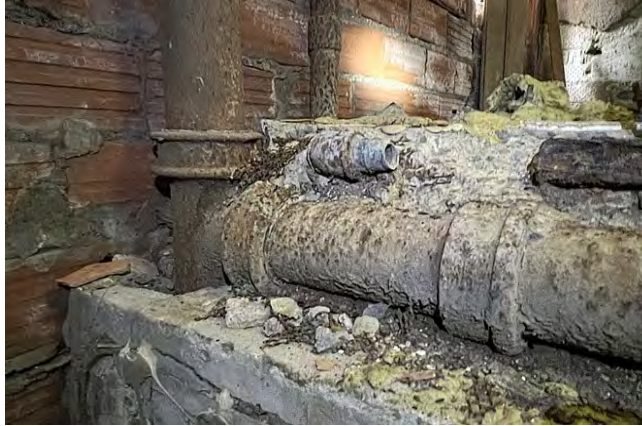
Summary of ACMs and PACMs

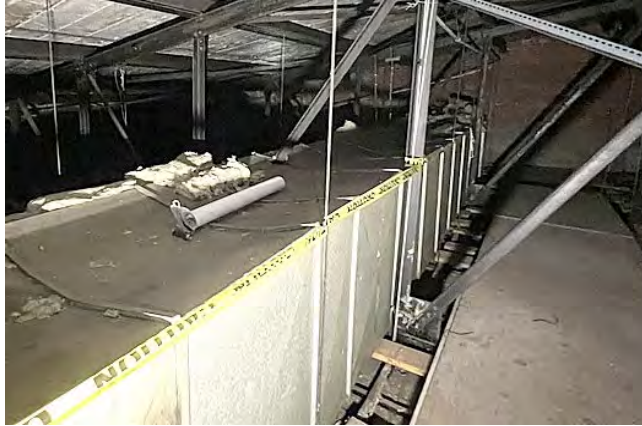
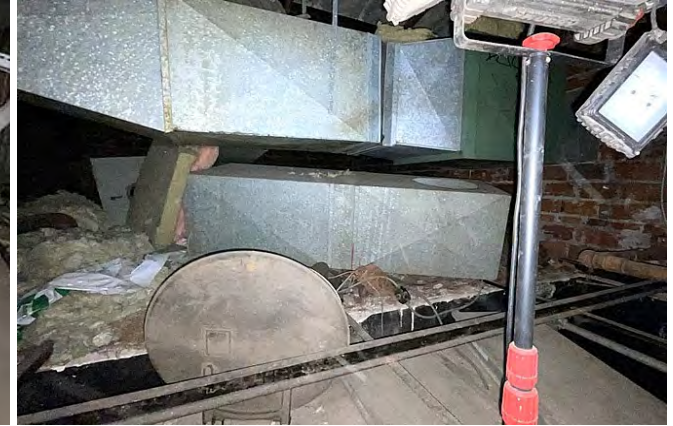
Summary of ACMs and PACMs

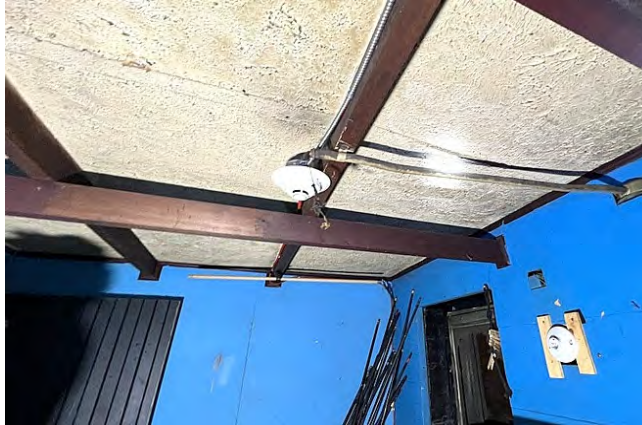
Summary of ACMs and PACMs

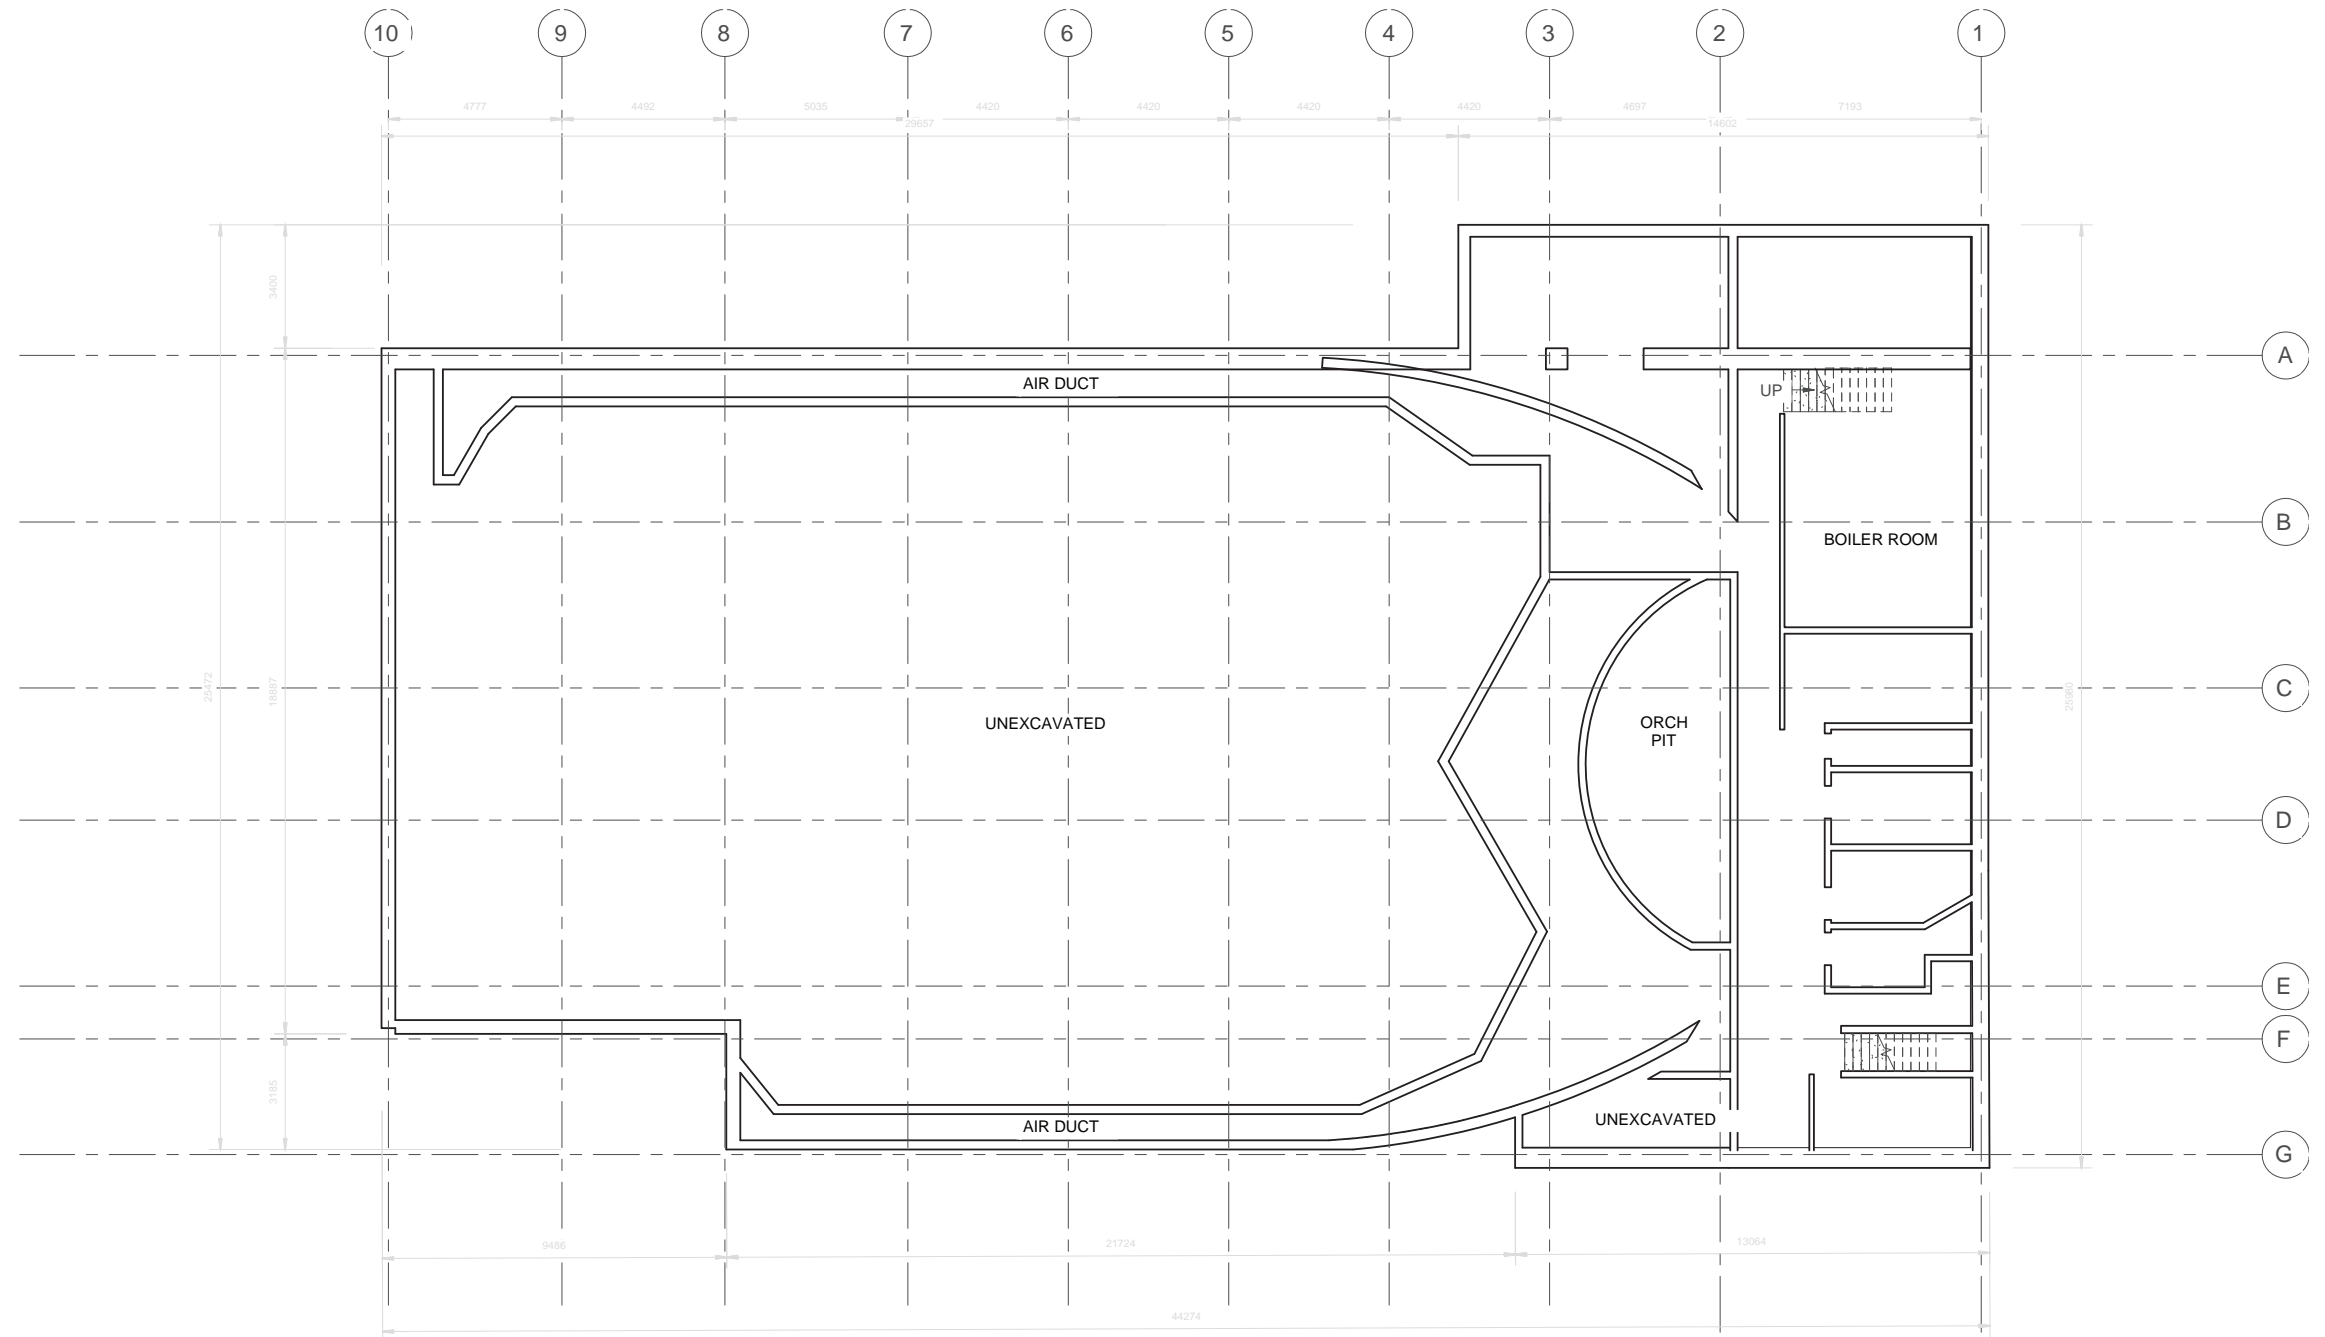
Tivoli Theatre - Basement floor plan [Source: Aventus Developments]

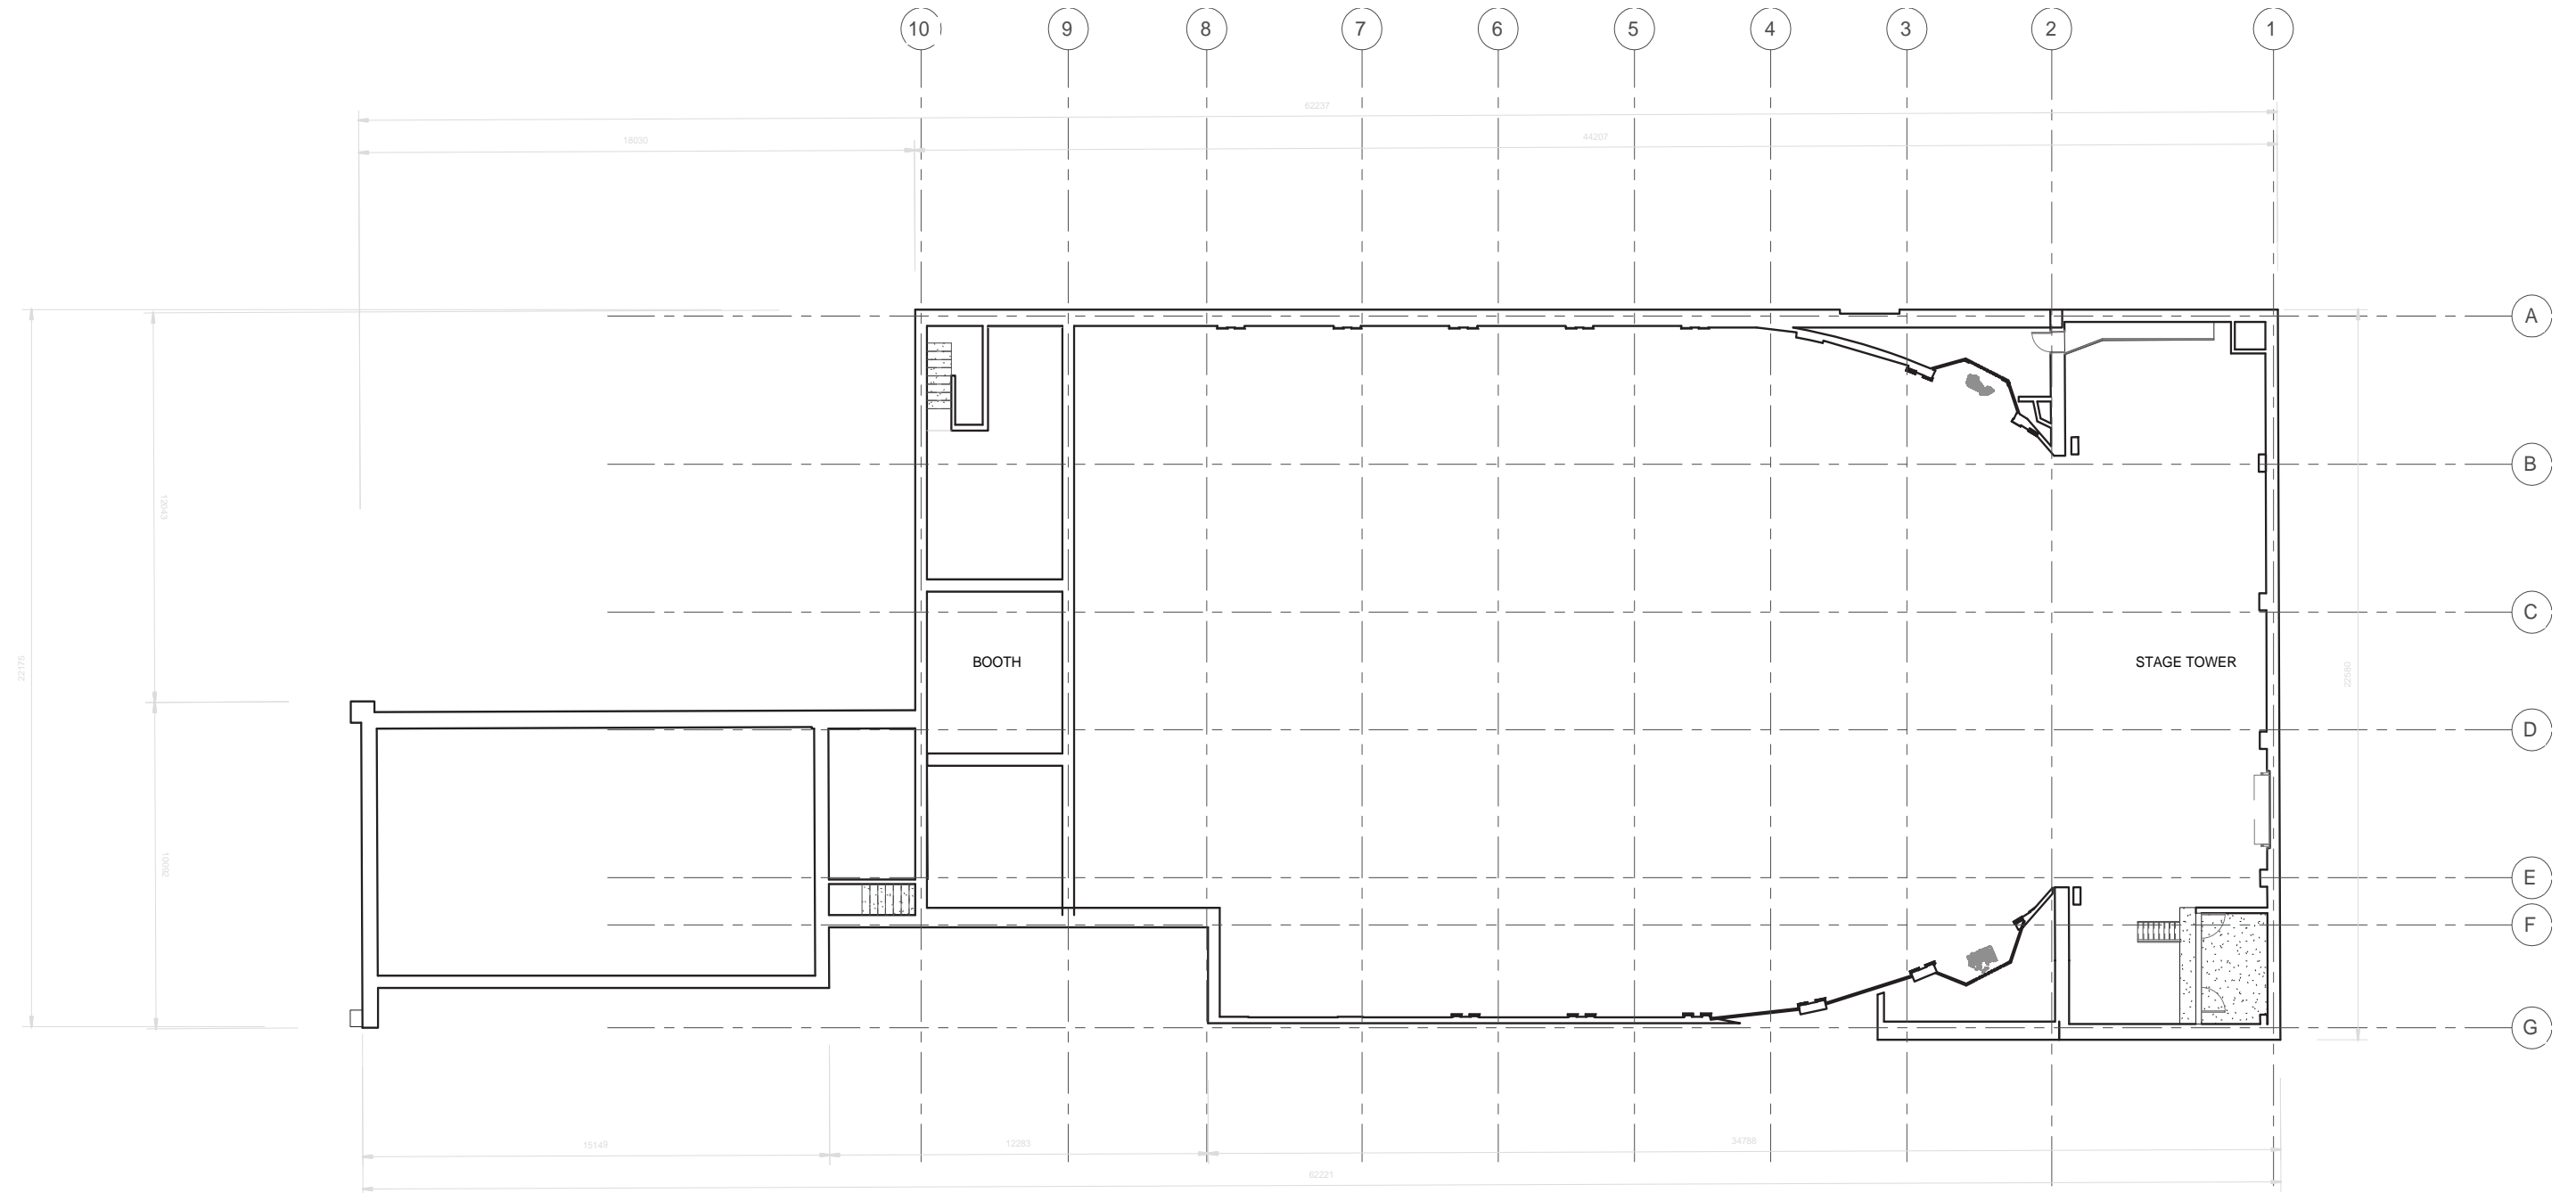
Tivoli Theatre - Basement floor plan [Source: Aventus Developments]

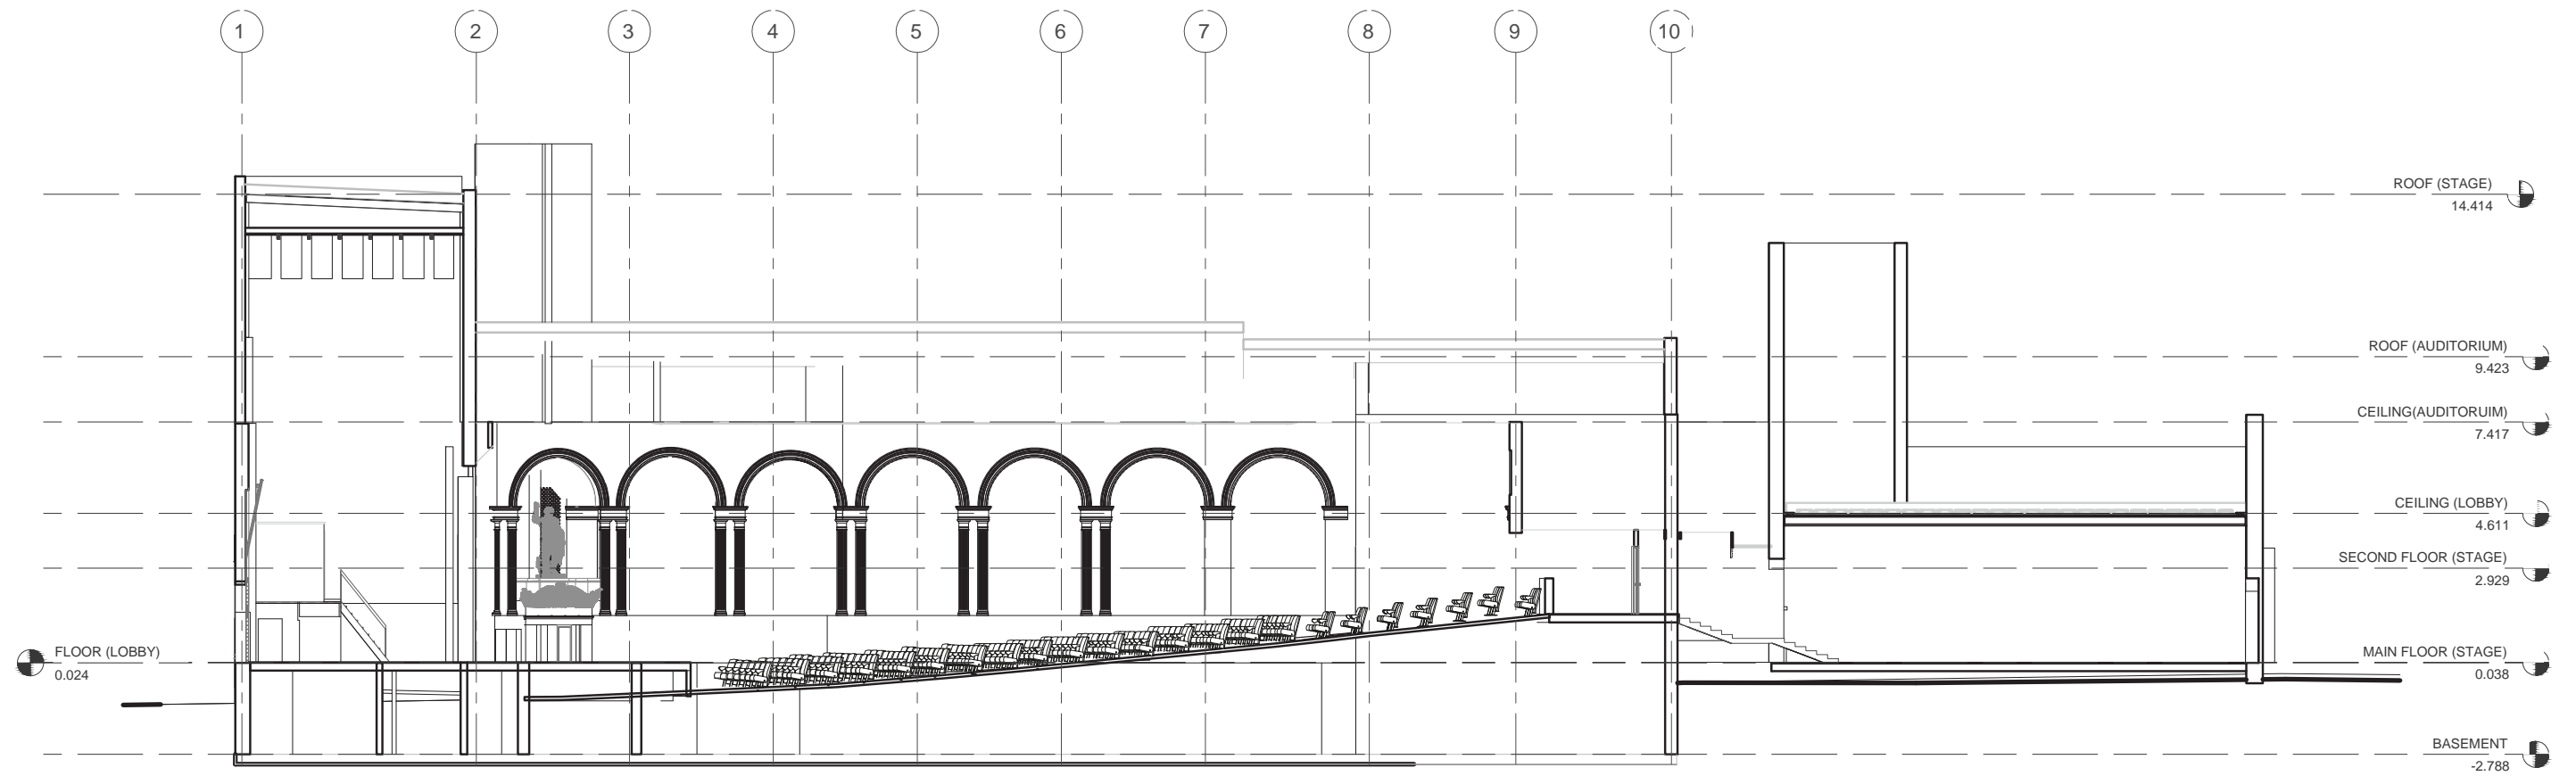
Tivoli Theatre - Section [Source: Aventus Developments]
