City of Hamilton - Heritage Permit Application Note Sheet

Address: 24 Main Street West, Hamilton (New Vision United Church, Part IV)

Permit Number: HP2024-039

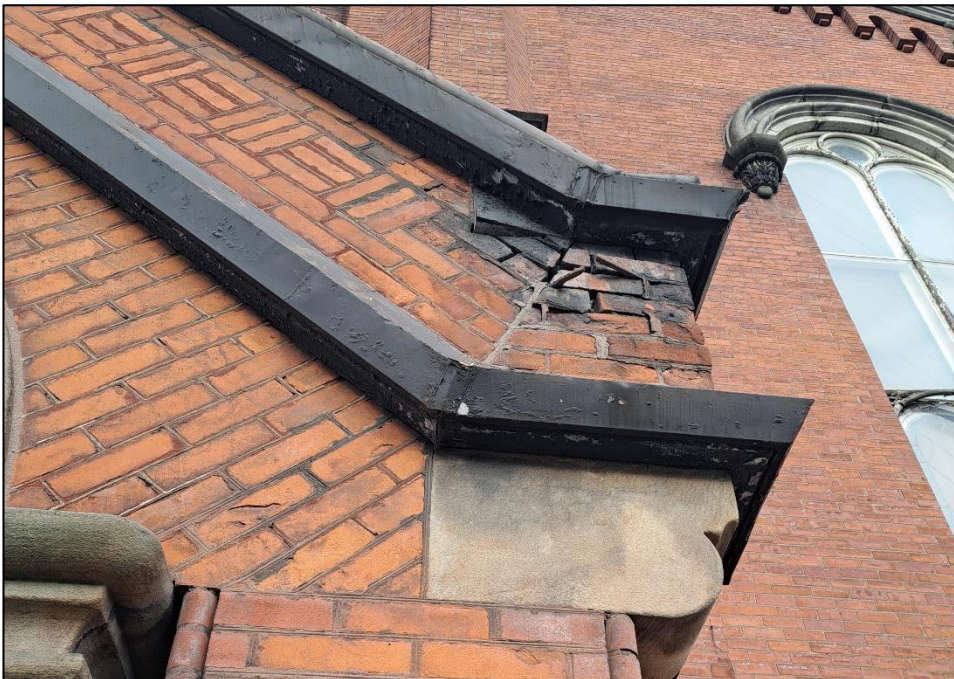
Figure 3: Area on the front portico requiring localized repointing and repairs

- Selective masonry repointing using Type O mortar, including in the front portico gable and southeast corner;
 - Interim repairs and installation of plywood hoarding in lower portions of front (south) windows to prevent further damage; and,
 - Repair of the northwest turret, subject to further investigation, which may include dismantling, temporary storage and reconstruction.
-

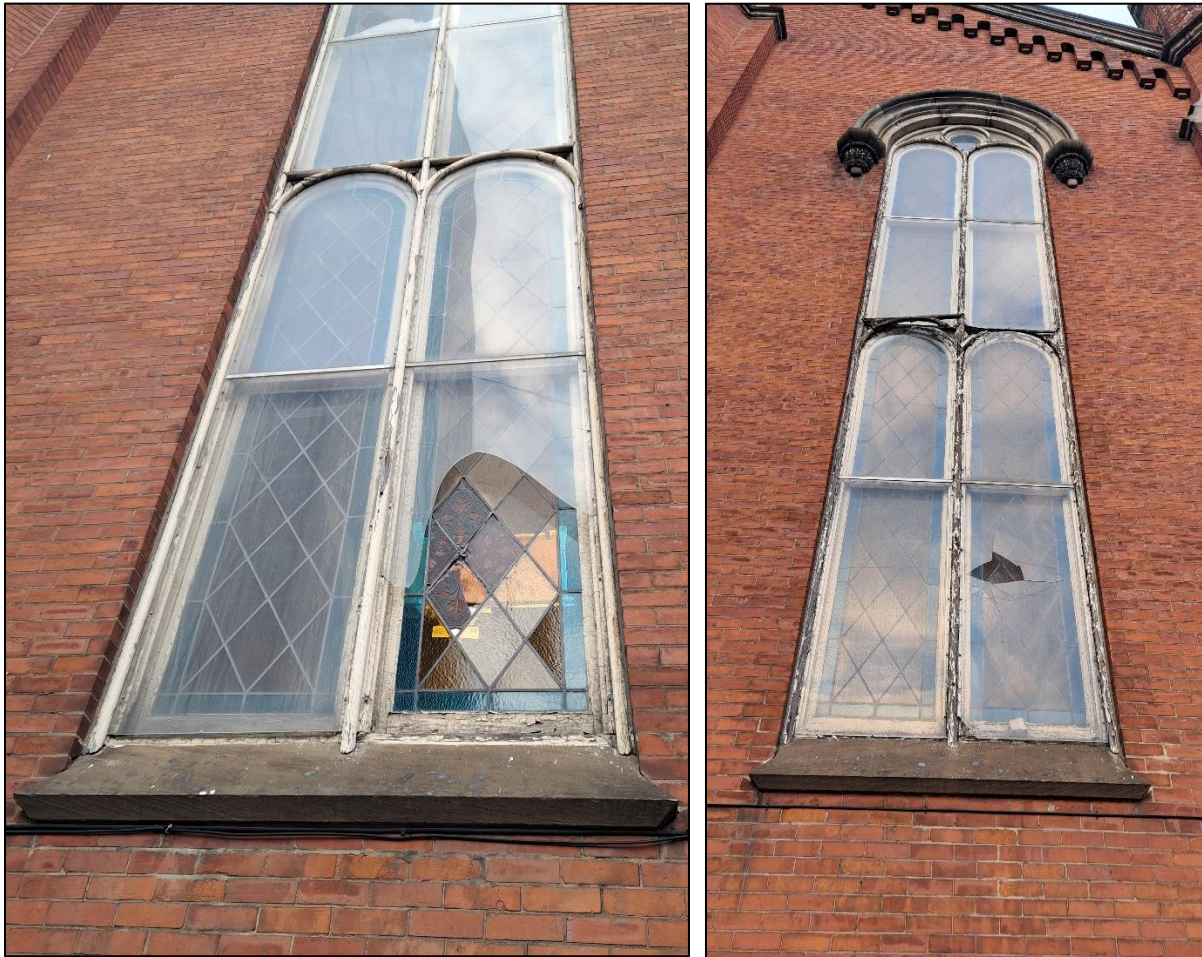
Figure 4: Damaged windows in the front (south) elevation, showing damaged protective storms to be temporarily covered by plywood hoarding and damaged wood to be removed (middle right)

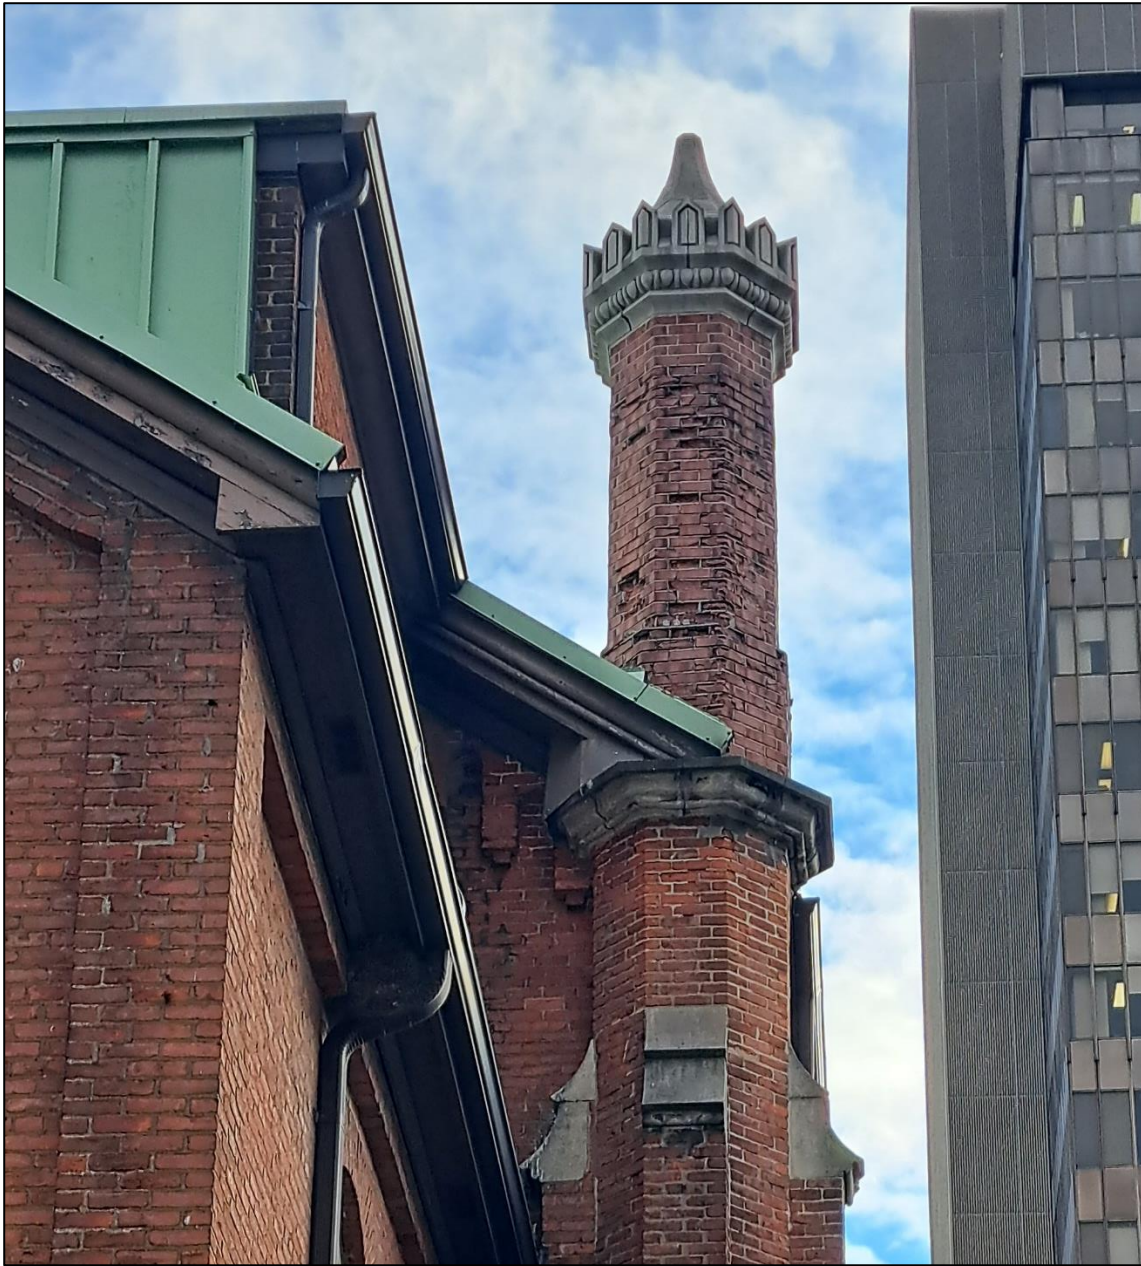
- An engineers review identified areas requiring localized repairs to mitigate risks until work for comprehensive masonry repairs can be undertaken next year.
 - The northwest turret was flagged for safety and needs to be investigated further.
 - Most of the work required is for the 1990s addition, which is not included in the designation and not subject to Heritage Permits.
-

Figure 5: Close-up of northwest turret requiring further investigation and repair, looking south

- ☐ That the final details, following further investigation, of the repair of the northwest turret be submitted, to the satisfaction and approval of the Director of Planning and Chief Planner, prior to submission as part of any application for a Building Permit and / or the commencement of any alterations;
