TIVOLI THEATRE | CULTURAL HERITAGE IMPACT ASSESSMENT

September 30, 2024

CULTURAL HERITAGE IMPACT ASSESSMENT | TIVOLI THEATRE

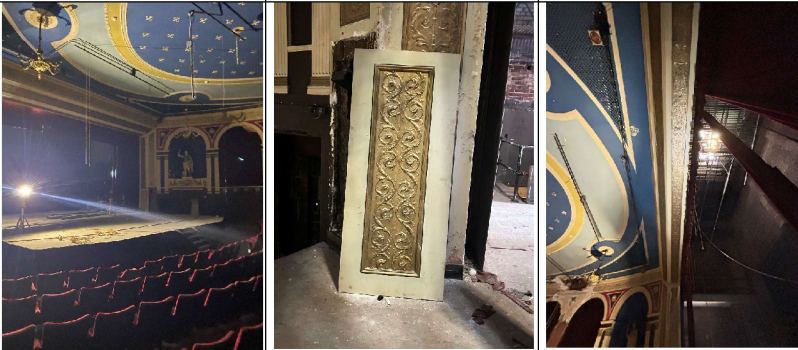
HERITAGE ATTRIBUTE	LOCATION	CONDITION	CURATION/ REUSE RECOMMENDATION	IMAGES
1 Proscenium	Stage arch	General Condition: Fair/ Good Some decorative panels are removed and deterioration of brick tile is evident.	Documentation: Detailed scanning, drawings and descriptions. Reuse: Decorative panels appear to be easily removed. Ideally they would be relocated into the new Tivoli. Note: Two environmental reports identify designated substances and hazardous building materials found throughout the building. Specific to plaster and interior finishes are asbestos and lead paint. Due to deteriorated conditions of the interior, asbestos fibers are noted as having widespread on the interior. Abatement methods may be detrimental to the historic features and further study is required.

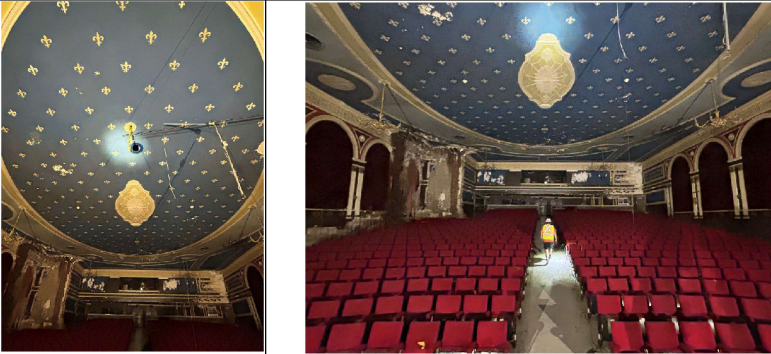
2 Ceiling w elliptical design	Auditorium house	General Condition: Good with areas of heavy damage or missing structure. Areas of damaged and missing ceiling are around penetrations from equipment or fixtures, and areas of water (likely from the failing roof) where plaster has fallen off.	Documentation: Detailed scanning, drawings and descriptions. Ornamental plaster requires careful documentation of the designs, spacing, scale, and location. Note: Two environmental reports identify designated substances and hazardous building materials found throughout the building. Specific to plaster and interior finishes are asbestos and lead paint. Due to deteriorated conditions of the interior, asbestos fibers are noted as having widespread on the interior. Abatement methods may be detrimental to the historic features and further study is required.

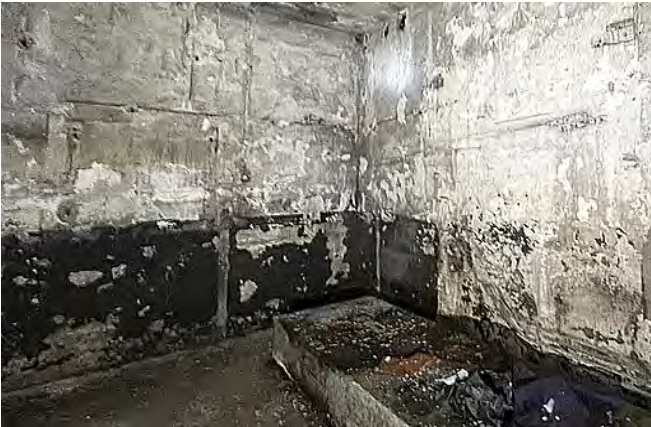
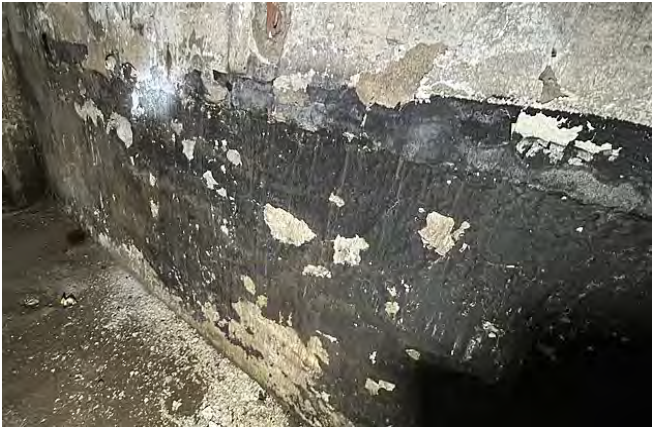
Lab Result: *<0.5% Chrysotile (cementitious material)*

Comment: *Although cementitious material contains asbestos at less than the O. Reg. 278/05 threshold of 0.5%, as a safety precaution it is recommended to be managed as an asbestos-containing material. Black tar material tested does not contain asbestos.*

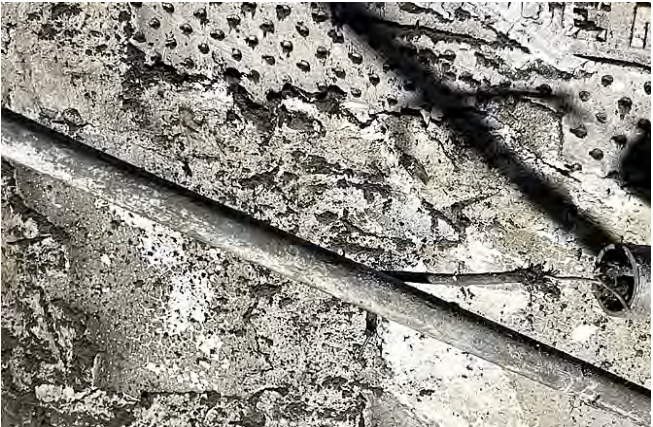
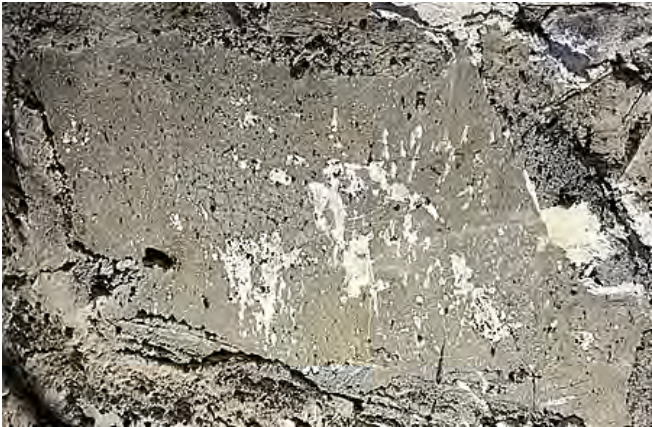
Samples: 005A.a)
Lab Result: 60% *Chrysotile*
Comment: *Parging cement tested contains asbestos.*

Location #	Area Description	Quantity	Condition	Damaged Qty.	Acc.	Vis.	Comments	Recommendation
L105	Alcove area to the left of the stage	~ 100 to 2,500 sf	-	-	A	Yes	Parging on brick likely extends from basement to roof (concealed).	Remove as part of the overall O. Reg. 278/05 Type 3 abatement operations within the building.

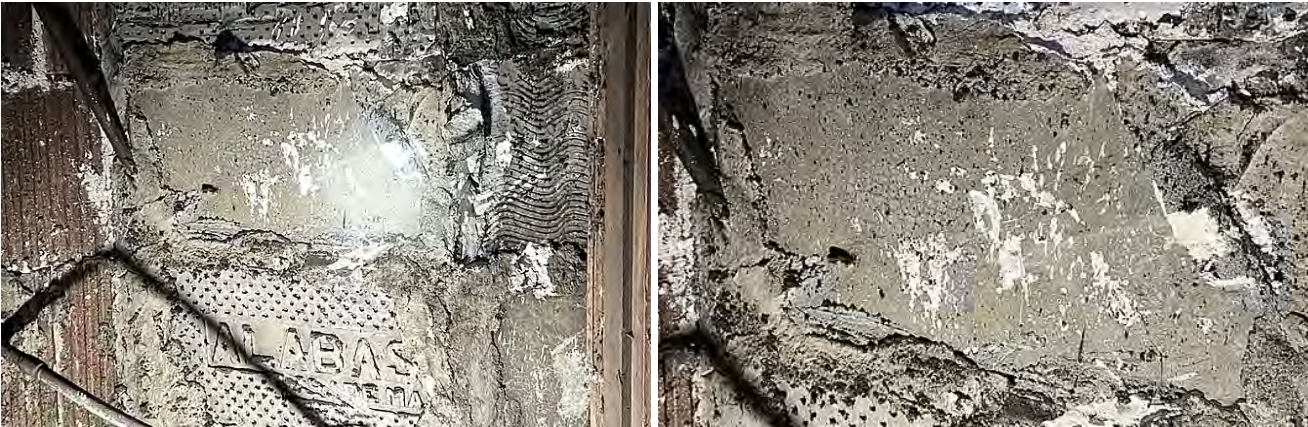
Comment: *Parging insulation tested contains asbestos. Plaster contains asbestos.*

Location #	Area Description	Quantity	Condition	Damaged Qty.	Acc.	Vis.	Comments	Recommendation
L105	Alcove area to the left of the stage	~ 100 to 2,500 sf	good	-	A	Yes	Parging on brick likely extends from basement to roof (concealed).	Remove as part of the overall O. Reg. 278/05 Type 3 abatement operations within the building.

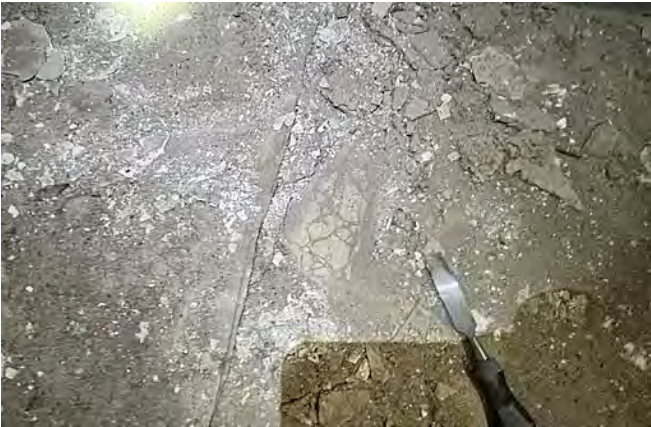
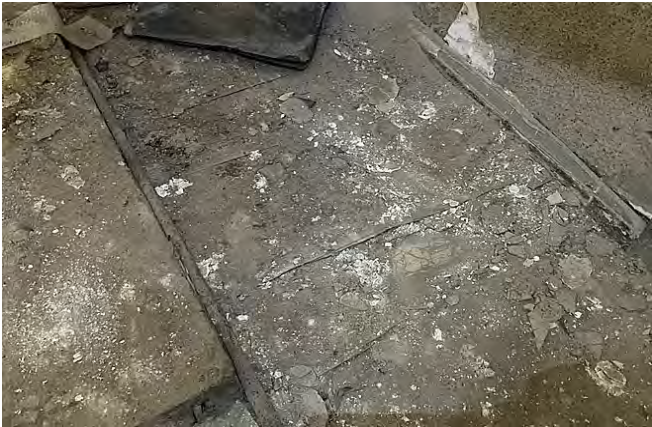
Comment: *Floor tile material tested contains asbestos. Mastic tested does not contain asbestos.*

Location #	Area Description	Quantity	Condition	Damaged Qty.	Acc.	Vis.	Comments	Recommendation
L208	Projection room	nq	poor	All	A	Yes		Remove as part of the overall O. Reg. 278/05 Type 3 abatement operations within the building.

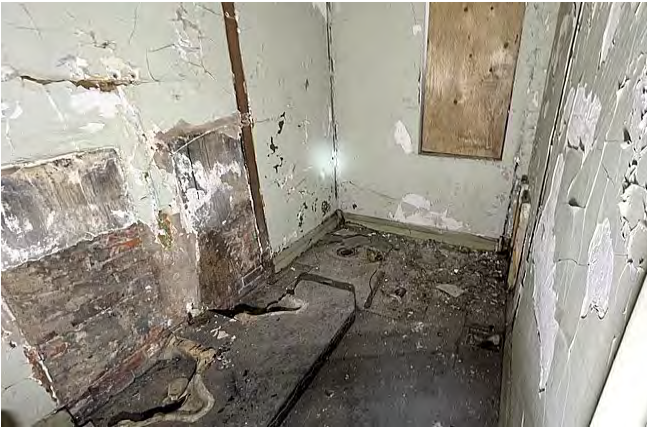
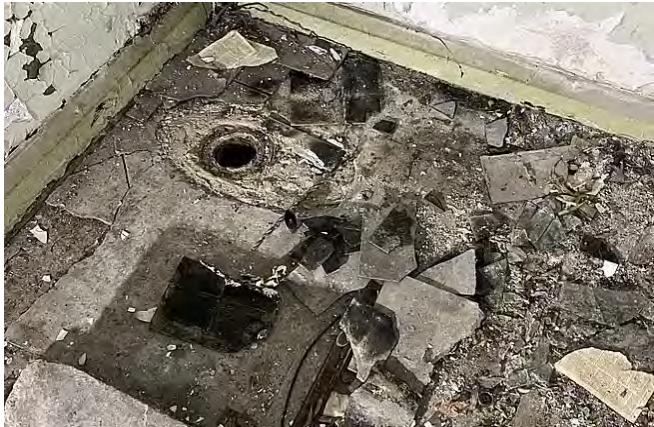
Comment: Floor tile and mastic tested contains asbestos.

Location #	Area Description	Quantity	Condition	Damaged Qty.	Acc.	Vis.	Comments	Recommendation
L206	Second floor bathroom	~50 sf	poor	All	A	Yes		Remove as part of the overall O. Reg. 278/05 Type 3 abatement operations within the building.

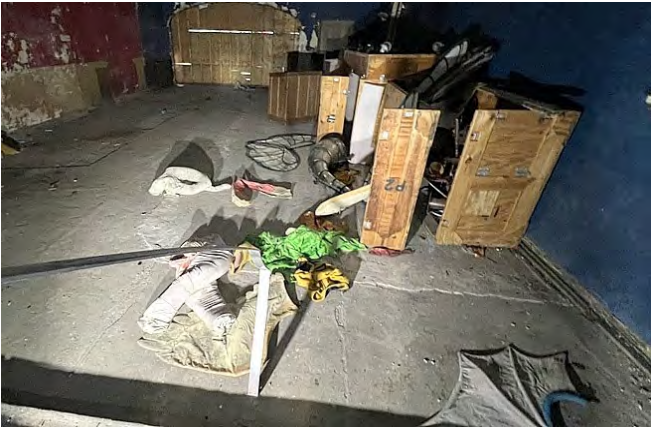
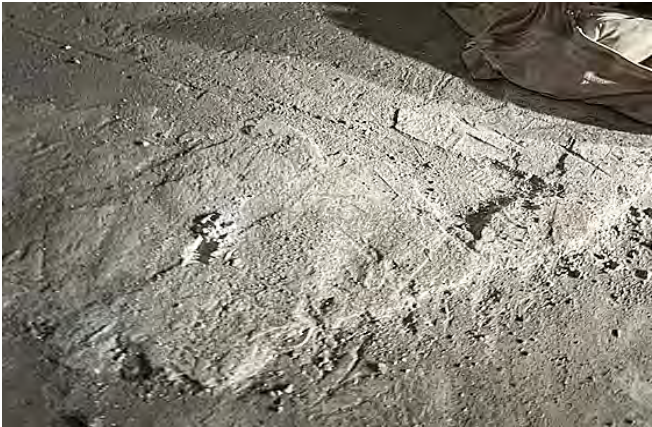
Samples: 012A.b)
Lab Result: 2% Chrysotile
Comment: Levelling compound tested contains asbestos.

Location #	Area Description	Quantity	Condition	Damaged Qty.	Acc.	Vis.	Comments	Recommendation
L101	Front entrance	~ 100 sf	good	-	A	Yes	Exact location of LC is difficult to determine. May be concealed elsewhere within the front entrance (L101).	Remove as part of the overall O. Reg. 278/05 Type 3 abatement operations within the building.

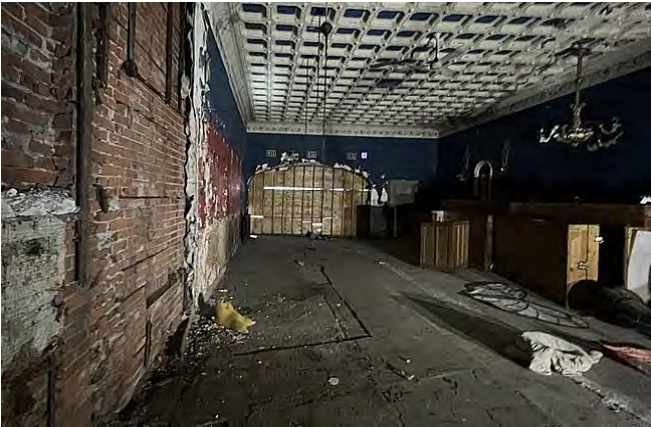
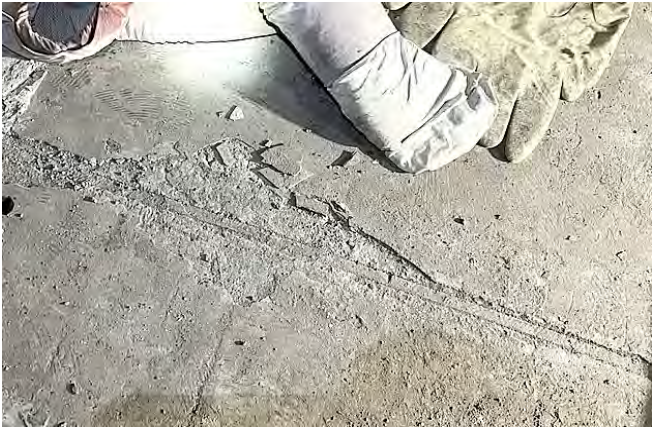
Comment: *Levelling compound tested does not contain asbestos. Mastic tested contains asbestos.*

Location #	Area Description	Quantity	Condition	Damaged Qty.	Acc.	Vis.	Comments	Recommendation
L101	Front entrance	nq	-	-	A	Yes	Exact location of mastic is difficult to determine and is likely present concealed elsewhere within the front entrance (L101).	Remove as part of the overall O. Reg. 278/05 Type 3 abatement operations within the building.

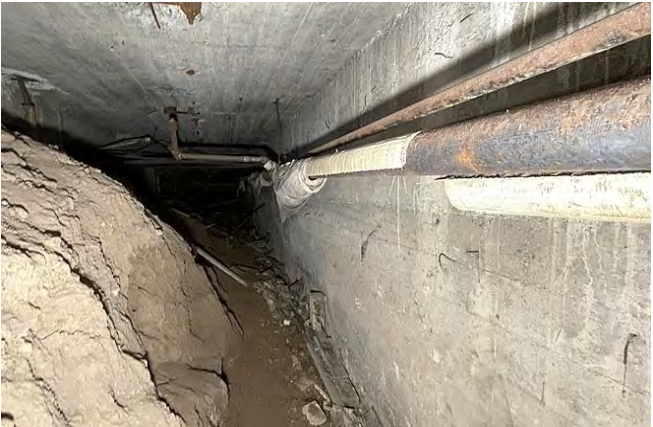
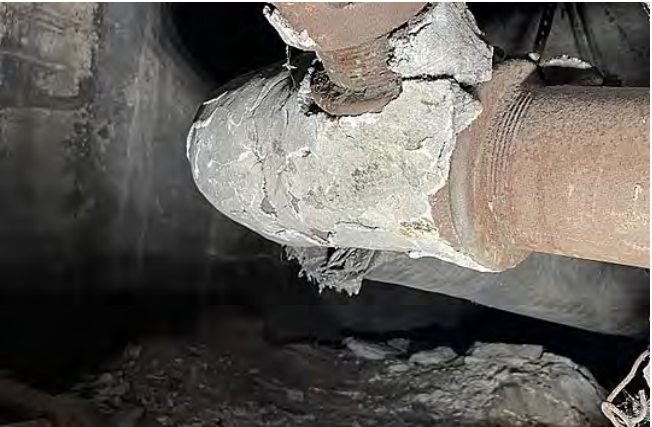
Samples: A001A (Reveal Report)
Lab Result: *40% Chrysotile (Reveal Report)*
Comment: *Parging cement fitting insulation contains asbestos (Reveal report).*

Location #	Area Description	Quantity	Condition	Damaged Qty.	Acc.	Vis.	Comments	Recommendation
L002	Crawl space below lobby area	nq	poor	Extensive	D	No	Refer to floor plans for approximate locations. Asbestos debris is mixed in with soil.	Remove insulation and debris in soil as part of the overall O. Reg. 278/05 Type 3 abatement operations within the building.

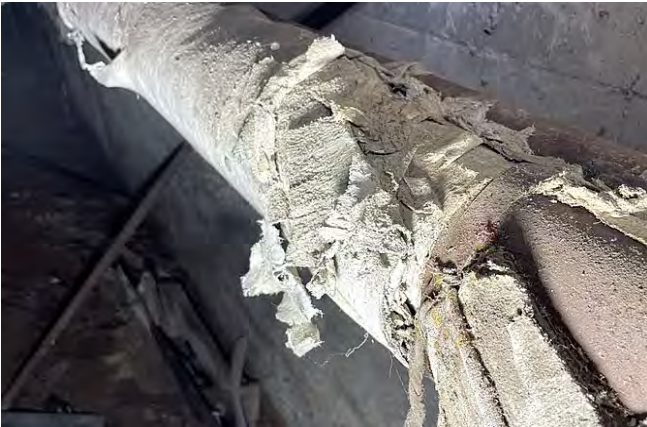
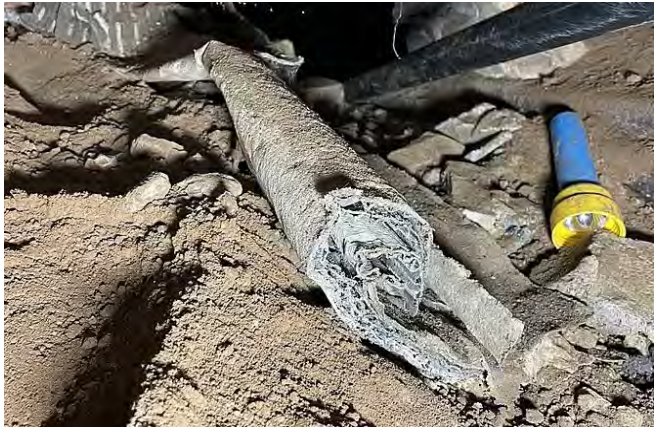
Samples: A002A (Reveal Report)
Lab Result: *60% Chrysotile (Reveal Report)*
Comment: *Aircell insulation contains asbestos (Reveal report).*

Location #	Area Description	Quantity	Condition	Damaged Qty.	Acc.	Vis.	Comments	Recommendation
L002	Crawl space below lobby area	nq	poor	Extensive	D	No	Refer to floor plans for approximate locations. Asbestos debris is mixed in with soil.	Remove insulation and debris in soil as part of the overall O. Reg. 278/05 Type 3 abatement operations within the building.

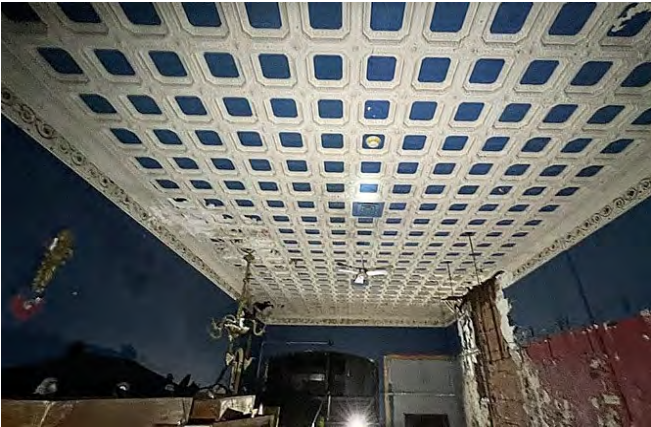
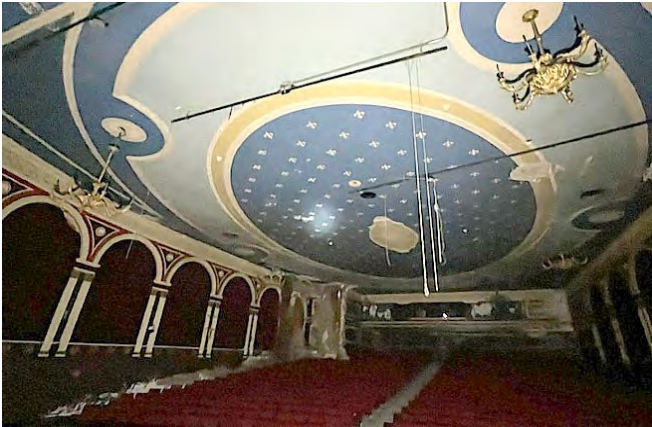
Comment: *Plaster contains asbestos (Reveal report).*

Location #	Area Description	Quantity	Condition	Damaged Qty.	Acc.	Vis.	Comments	Recommendation
All	Subject building	All	Fair to poor, debris	All	A	Yes	Intact plaster is non-friable. Damagned plaster and plaster debris is in a friable condition.	Remove as part of the overall O. Reg. 278/05 Type 3 abatement operations within the building.

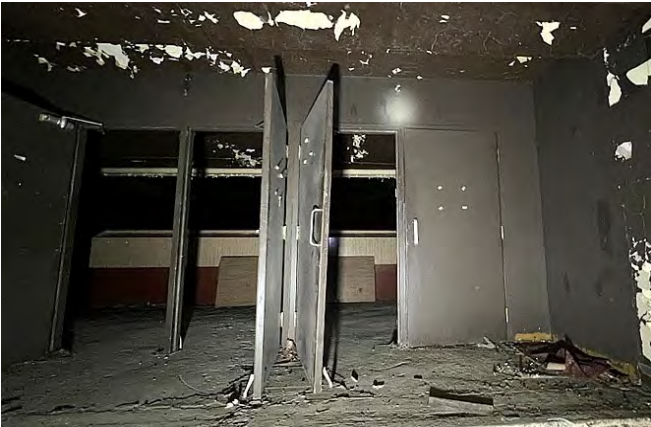
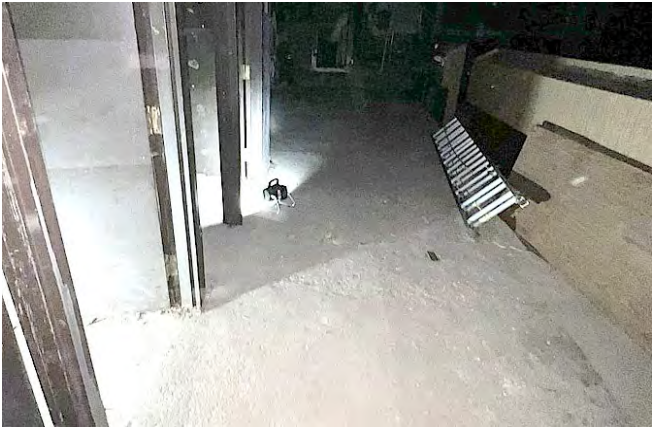
Samples: *A005A to C & A006A (Reveal Report)*
Lab Result: *1% Chrysotile (Reveal Report)*
Comment: *Mastic material tested contains asbestos (Reveal Report).*

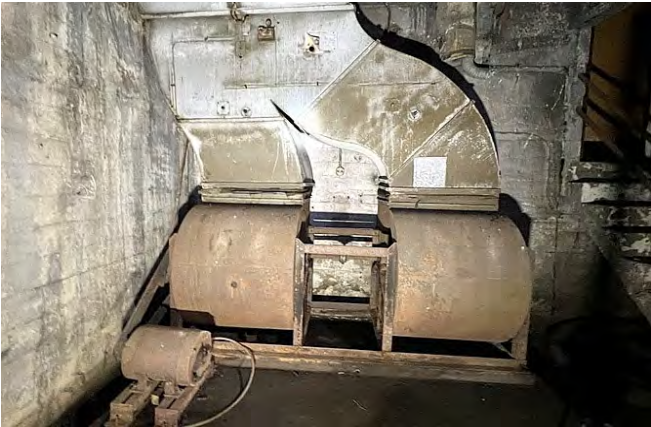
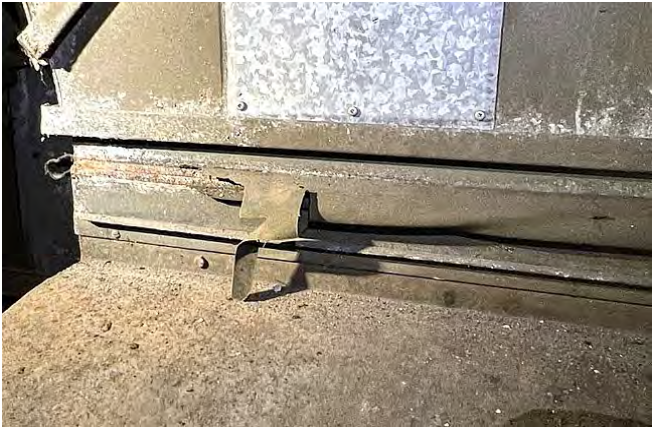
Comment: *Fabric connectors are known to contain asbestos.*

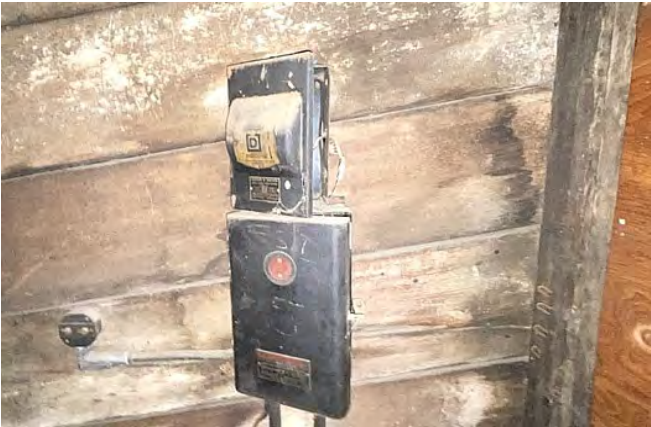
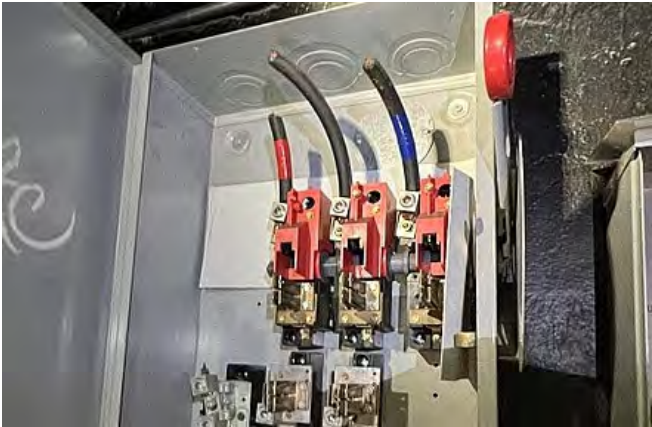
Comment: Electrical equipment is presumed to contain asbestos until testing proves otherwise.

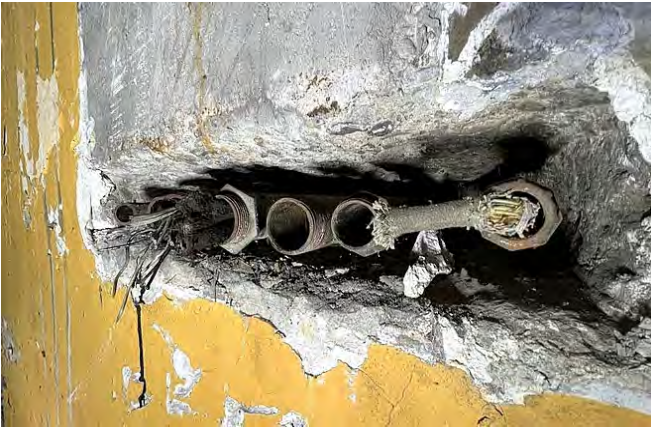
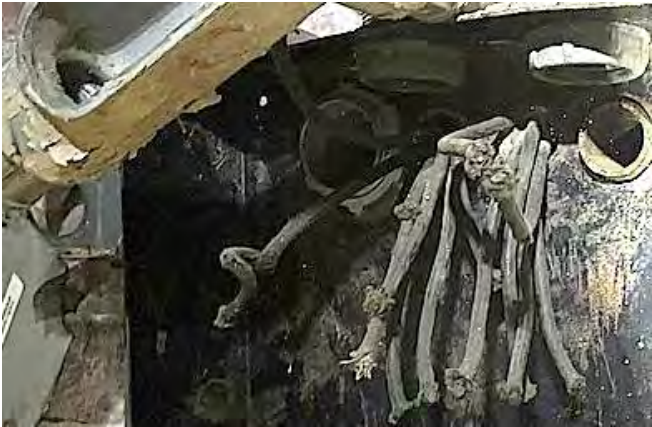
Comment: *Sheathing on electrical wiring is presumed to contain asbestos.*

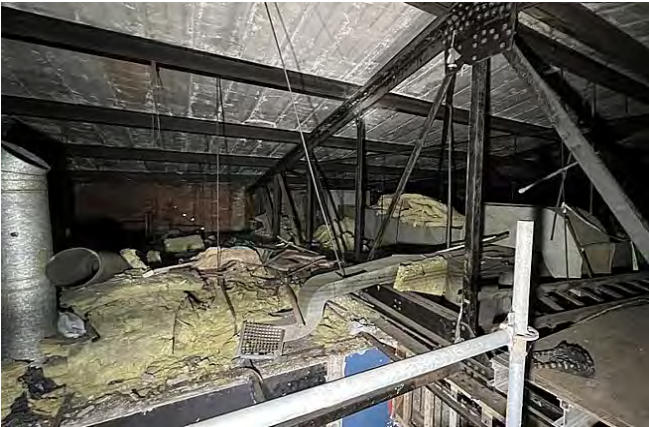
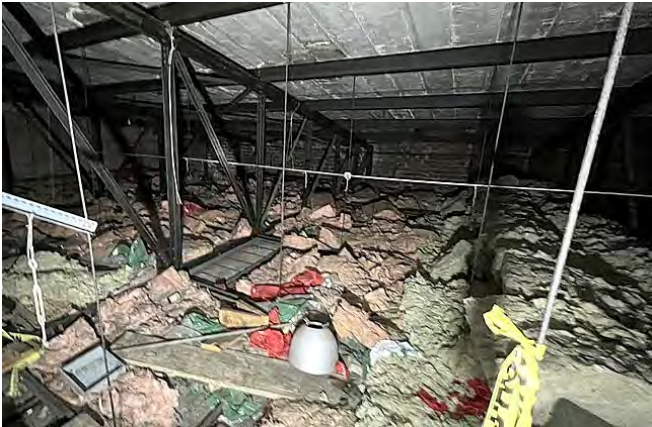
Comment: *Though fibreglass insulation is not asbestos containing, fibreglass batts should be treated as contaminated by asbestos fibres from extensive damage to asbestos-containing plaster and debris throughout the building.*

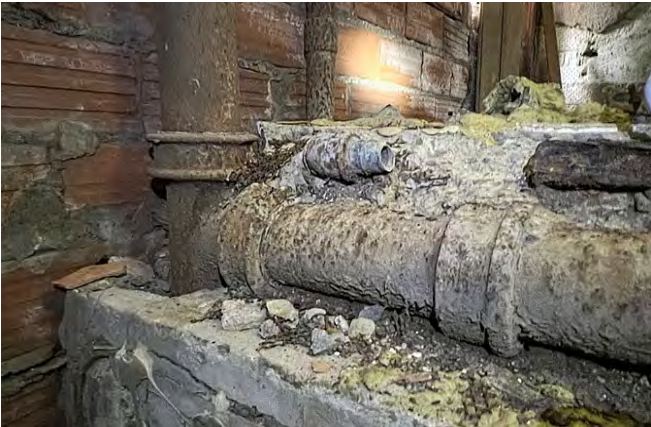
Samples: ns
Lab Result: PACM
Comment: *Oakum is presumed to contain asbestos until testing proves otherwise.*

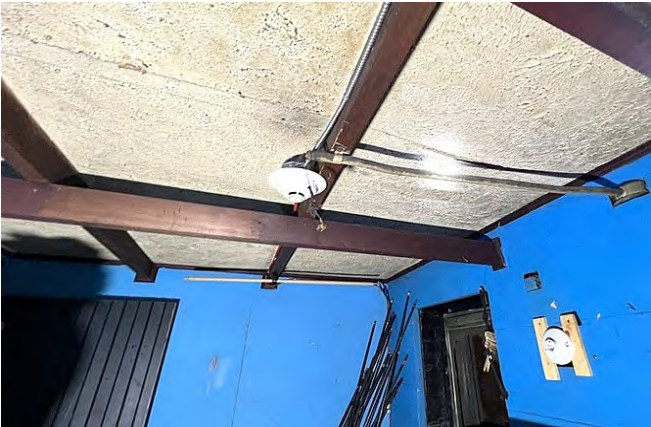
Samples: *A013A (Reveal Report)*
Lab Result: *2% Chrysotile (Reveal Report)*
Comment: *Texture finish tested contains asbestos (Reveal report).*
