RE CHIA Addendum for Heritage Committee

**RE: Tivoli Theatre  
 Update to Condition Assessment**

This letter is intended to provide additional requested information with respect to the building's structure and envelope, and to otherwise provide an update to the report on the condition of the Tivoli Theatre prepared by John G. Cooke & Associates Ltd. (JCAL) in January 2024 (our report). Our report was written in anticipation that it would form part of a broader document package that would include architectural considerations and discussion on the outcome for the building. As it ultimately did not, and as it is clear that there are differing views on what should happen with the building, this letter therefore seeks to highlight some of the findings of our report and otherwise provide some further observations and opinions that we believe should be considered as part of that debate.

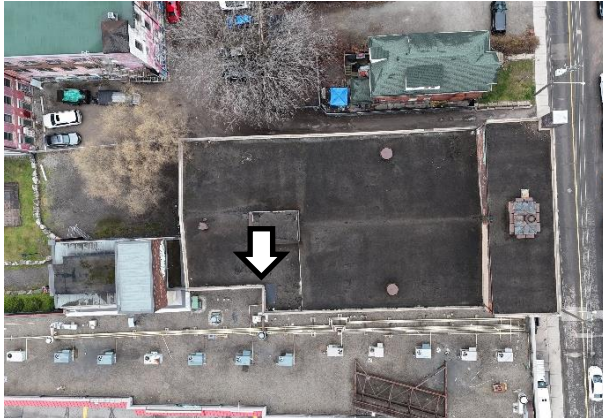
Foremost is to update regarding the risk posed by conditions at the re-entrant corner along the south wall of the auditorium (location marked in Fig. 1). In our report we identified concerns with movement of the pier at this corner, which at the top is displaced by approximately 3-4" towards the north, separating from the wall to its south (see Figs. 2, 3, and 4). The roof has failed adjacent to this pier and we identified the potential for corrosion of the steel column that we believe is embedded within it. In February 2024, we designed

Fig 1: Aerial view, with area of concern identified.

shoring for the truss that bears on this pier/column, including lateral attachment where the return wall meets the column pier. While we were advised that the shoring had been installed, our most recent review confirms this is not the case, and we understand that there was a miscommunication from employees previously with Aventus. You have confirmed that this shoring will be given utmost priority, and will be installed by Thursday November 28, 2024.

While no failure to the column or truss has occurred since our January review, it is very important to install this shoring immediately and for it to be in place before any significant snowfall would add load to the roof. Actively leaking in January, a roof repair above this pier has now fully failed and daylight is visible in the attic.

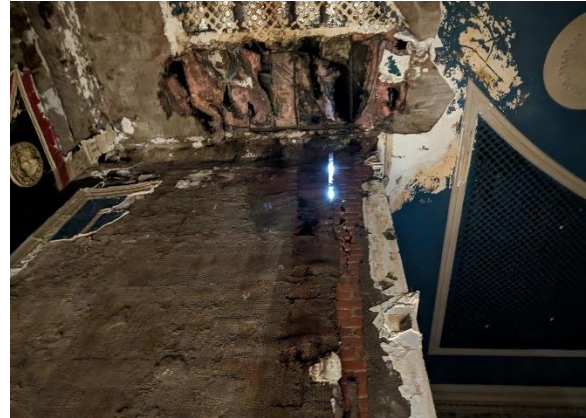
Fig 2: Pier separating from wall, from interior.

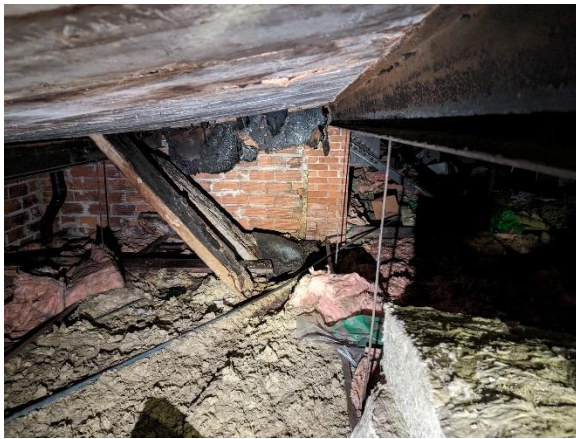
Fig 3: Pier separation, from attic, in Jan 2024.

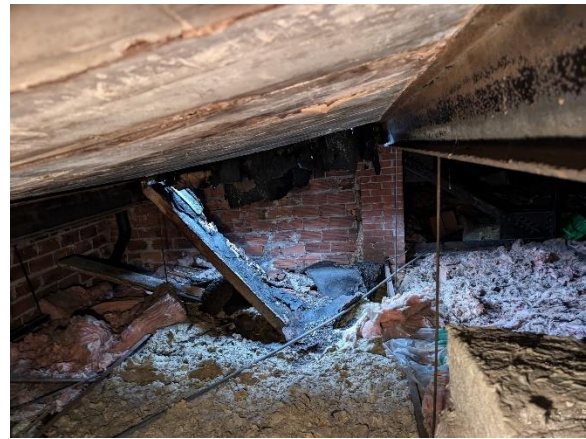
Fig 4: As Fig. 3, in Nov 2024, with failed roof.

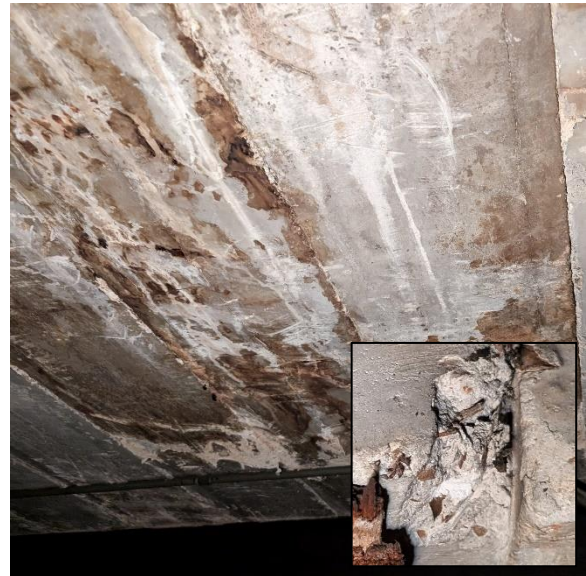
Fig. 6: Roof deck, inset w/ panel composition

The other key issue with the building's structure is the roof deck, which consists of gypsum panels. Leaks throughout the auditorium roof have resulted in deterioration of this deck (see Fig. 6). Gypsum roof deck panels were a relatively common cost-effective option in early 20<sup>th</sup> century construction, and consist essentially of plaster of Paris mixed with wood shavings (see inset on Fig. 6), cast into panels with integral steel reinforcing. The panels were fire resistant, lightweight, insulative, and minimized the potential for condensation at the underside of the deck. This latter absorptive quality is also the reason the material is very susceptible to moisture damage, making it a terrible choice as a durable roof deck, especially for a flat roof. We do not believe it is safe to walk on the roof of this building without fall protection, nor would we recommend the continued service of the roof deck.

- Exposed columns should also be protected from future corrosion with at least a marine epoxy paint.
- Replace all gypsum roof deck panels.
  - This would presumably be done with steel deck.
