2813102 Ontario Inc. (Benjamin Julius)

537 King Street East: Cultural Heritage Documentation and Salvage Report

Hamilton, Ontario

Date: October 2024

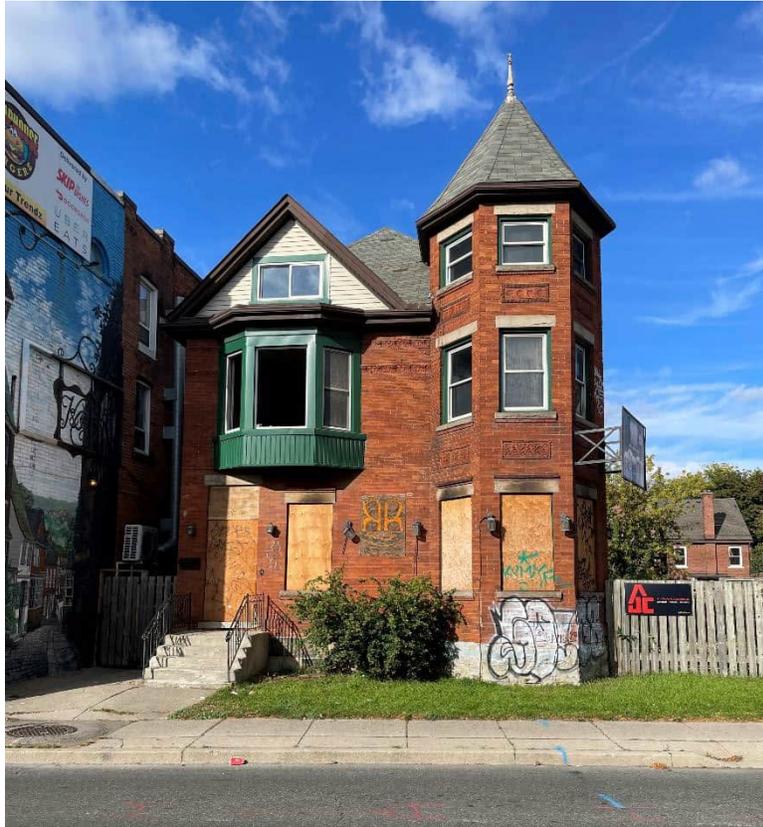
Photograph 1: South Elevation (AECOM, October 2024)

The south elevation is the front of the building, facing King Street East. The elevation is constructed from red terra cotta brick in a running (stretcher) bond pattern. The brick on this elevation is notably in poor condition and has signs of water and fire damage (i.e., spalling) as well as mortar loss.

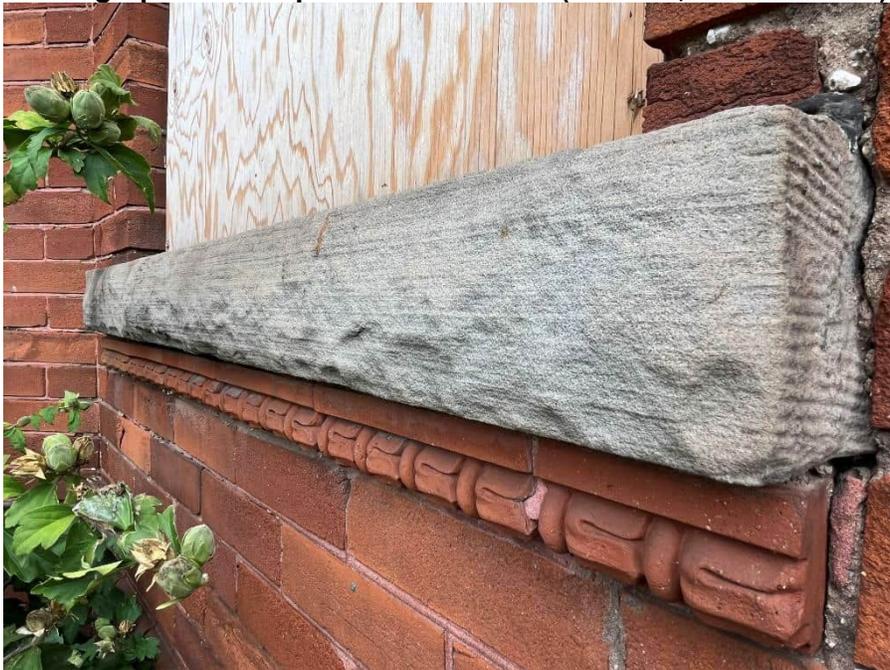
Along with the entrance, the first storey features four windows, one east of the entrance, and three on the heptagonal tower, one on each face. All four windows have pronounced rusticated concrete lintels and rusticated concrete sills. Close-up of the lintels and sills indicate that at some point the original stone lintels and sills were replaced, perhaps when the wood frames of the windows were replaced with vinyl (**Photograph 4**).

Photograph 4: Example of concrete sill (AECOM, October 2024)

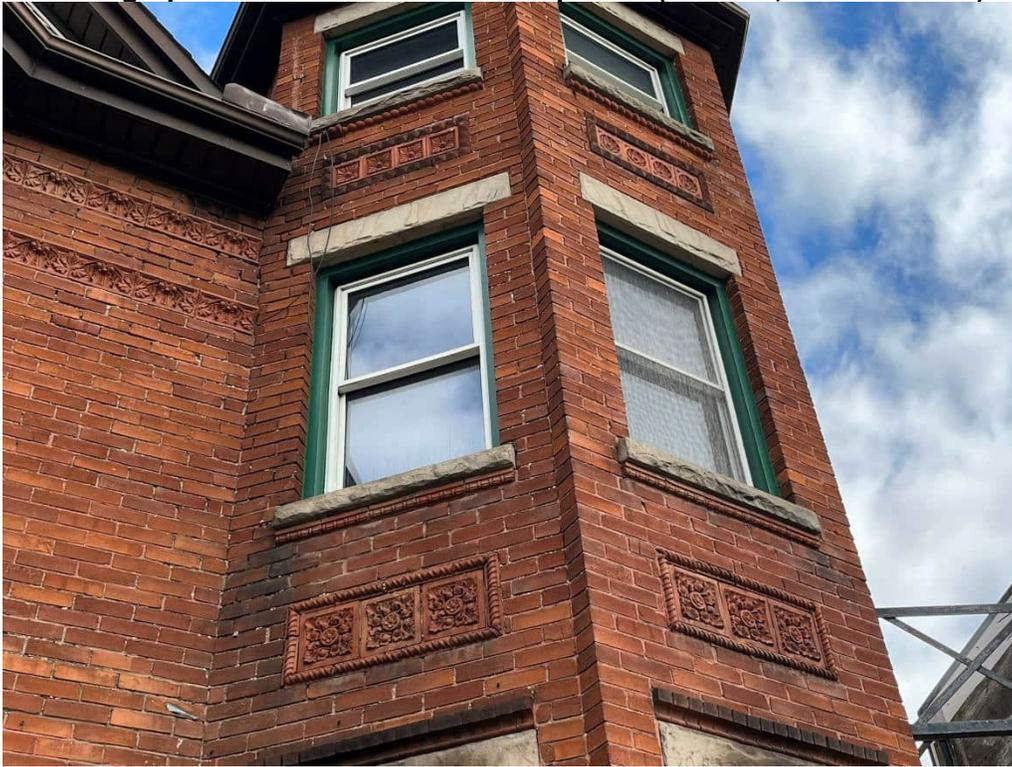
Between the first and second storey on the heptagonal tower are four decorative terra cotta panels (**Photograph 5**). All panels between the first and second storey of the tower have the same pattern and feature three Victorian quatrefoil panels with a scrolled border. The panel on the southeast face of the heptagonal tower is behind a metal sign advertising the former business. The terra cotta panels do not appear to be damaged by the fire.

Photograph 5: Tower with terra cotta panels (AECOM, October 2024)

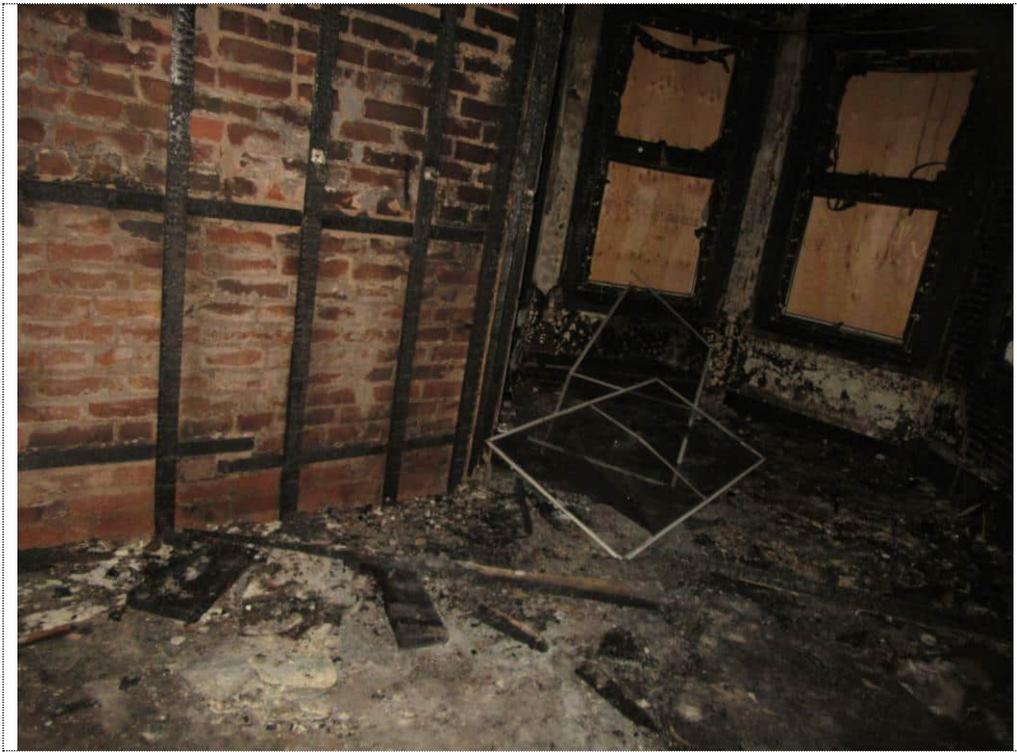
PHOTO NUMBER: 3 Interior of main floor of building
Note: Area of absent/burnt interior walls, exposed masonry.

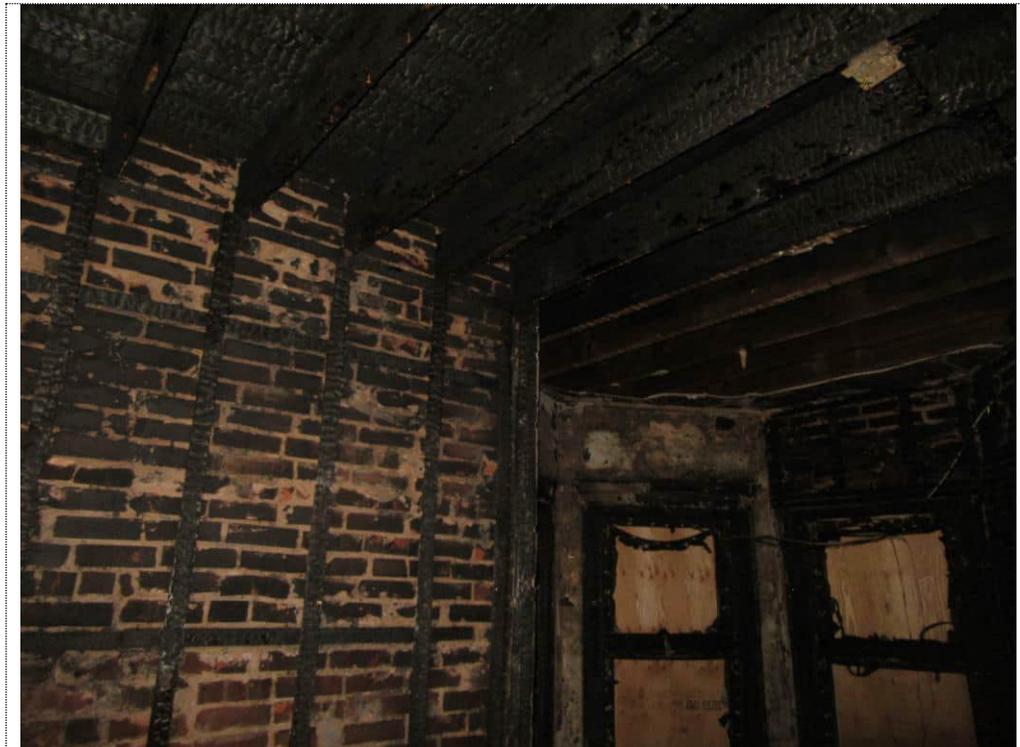
PHOTO NUMBER: 4 Interior of main floor of building (underside of second floor).
Note: Area of absent/burnt interior walls, exposed masonry, burnt floor joists.

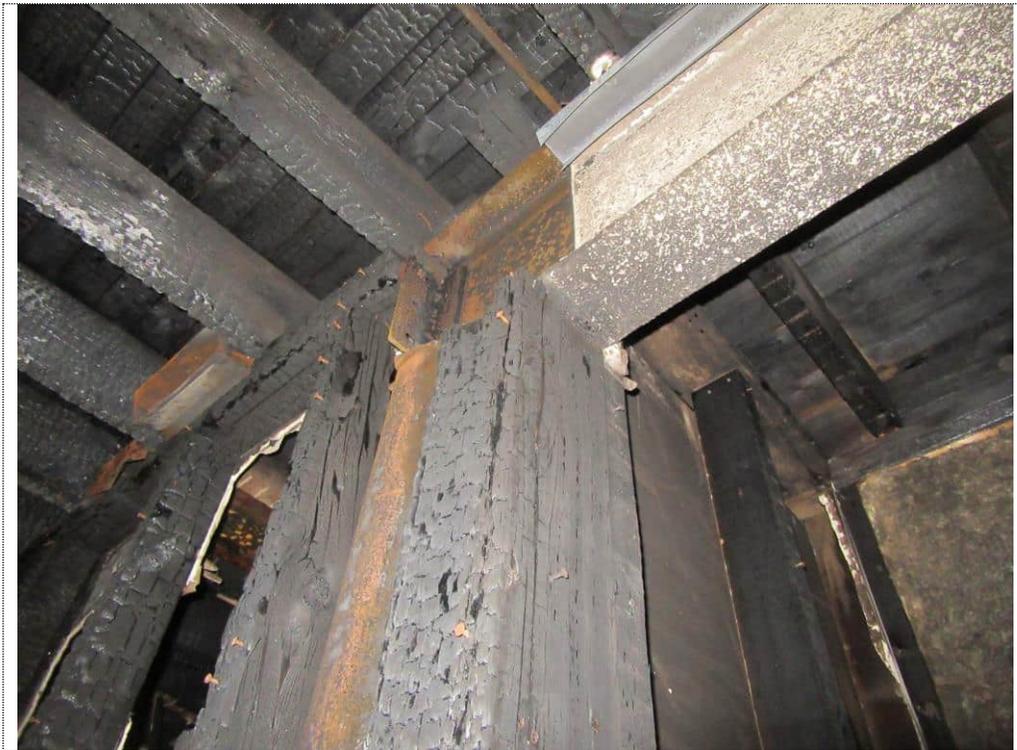
PHOTO NUMBER: 5 Interior of main floor of building (underside of second floor).
Note: Area of burnt floor joists, burnt framing walls.

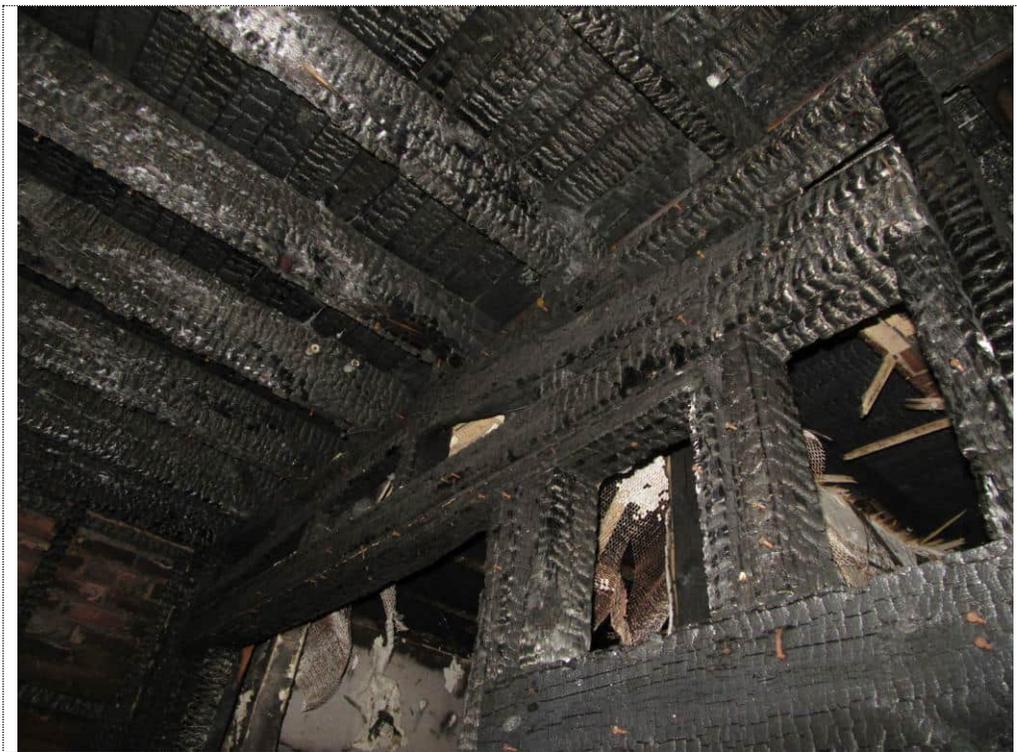
PHOTO NUMBER: 6 Interior of main floor of building (underside of second floor).
Note: Area of burnt floor joists, burnt framing walls.

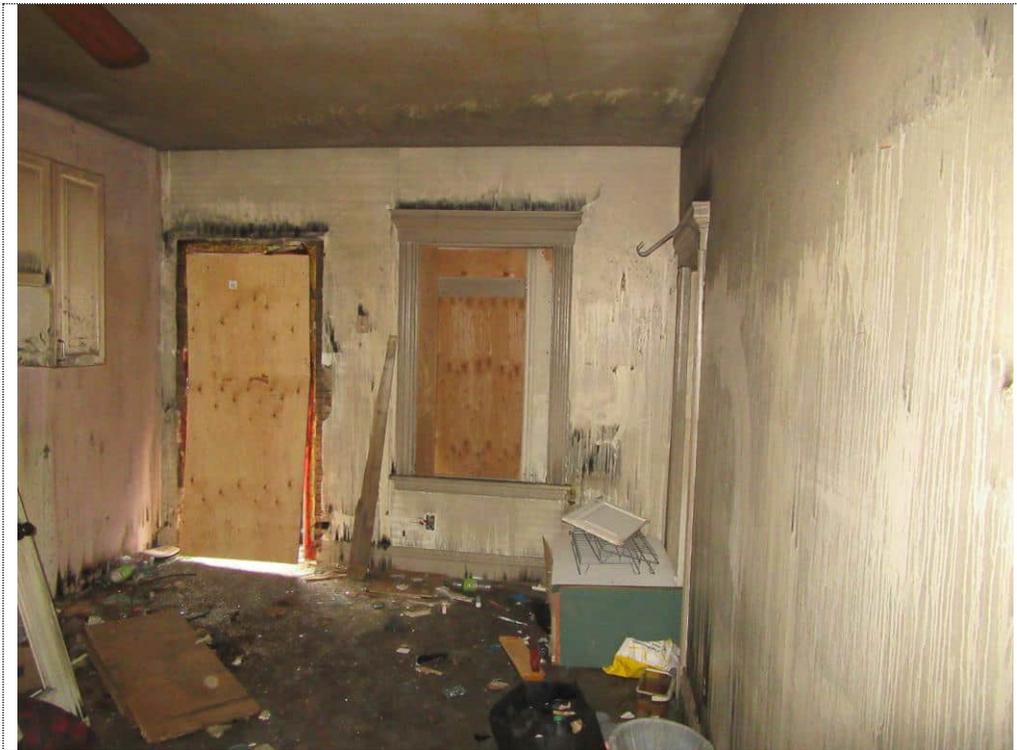
PHOTO NUMBER: 7 Typical conditions of second floor

Note: Abandoned belongings, moisture stains on walls

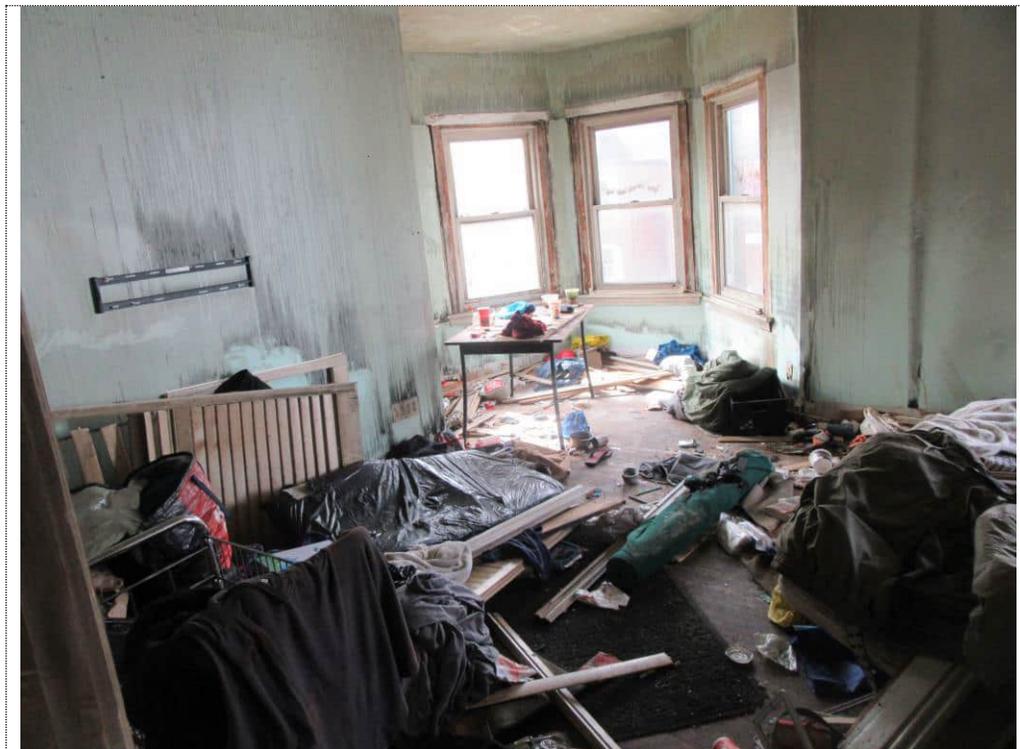
PHOTO NUMBER: 8 Typical conditions of second floor

Note: Abandoned belongings, moisture stains on walls

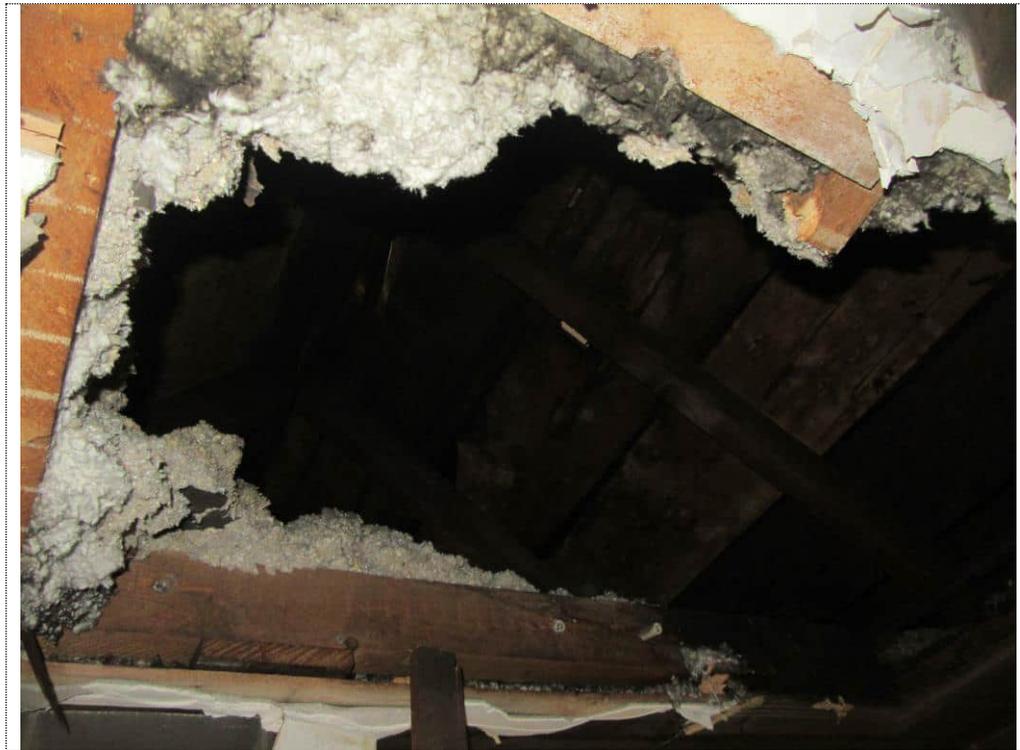
PHOTO NUMBER: 9 Ceiling of third floor

Note: Area of collapsed ceiling

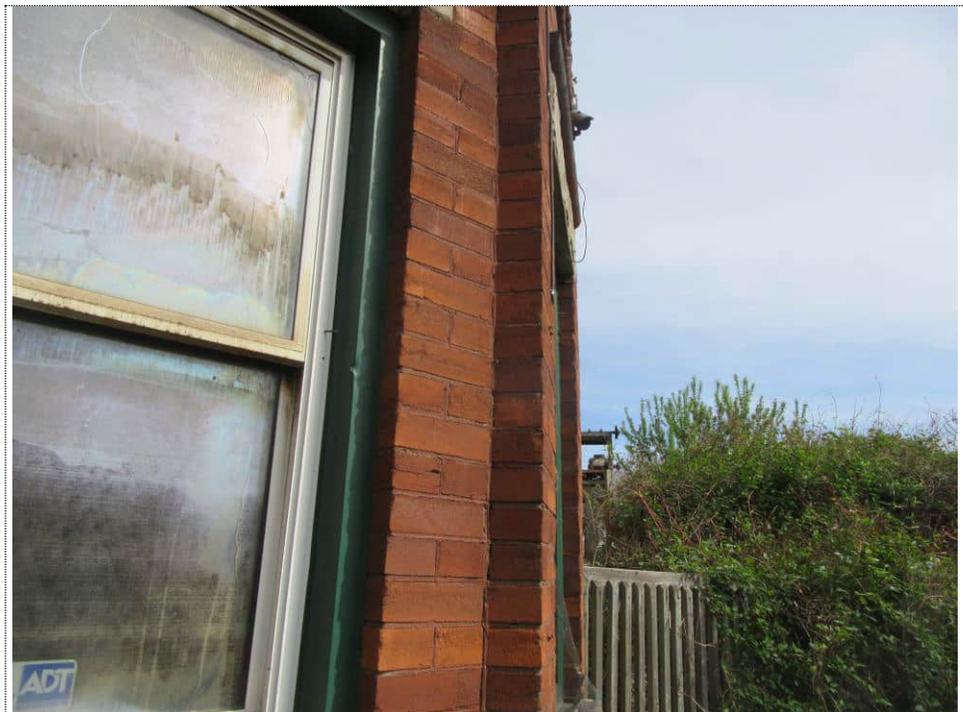
PHOTO NUMBER 10: Exterior of east face of building

- Vertical cracks and separation of masonry occurred on the front and east faces of the building, likely due to expansion from the heat of the fire; and
- Deterioration of unit masonry due to cycles of freezing and thawing.

Note: Separation of masonry at corner

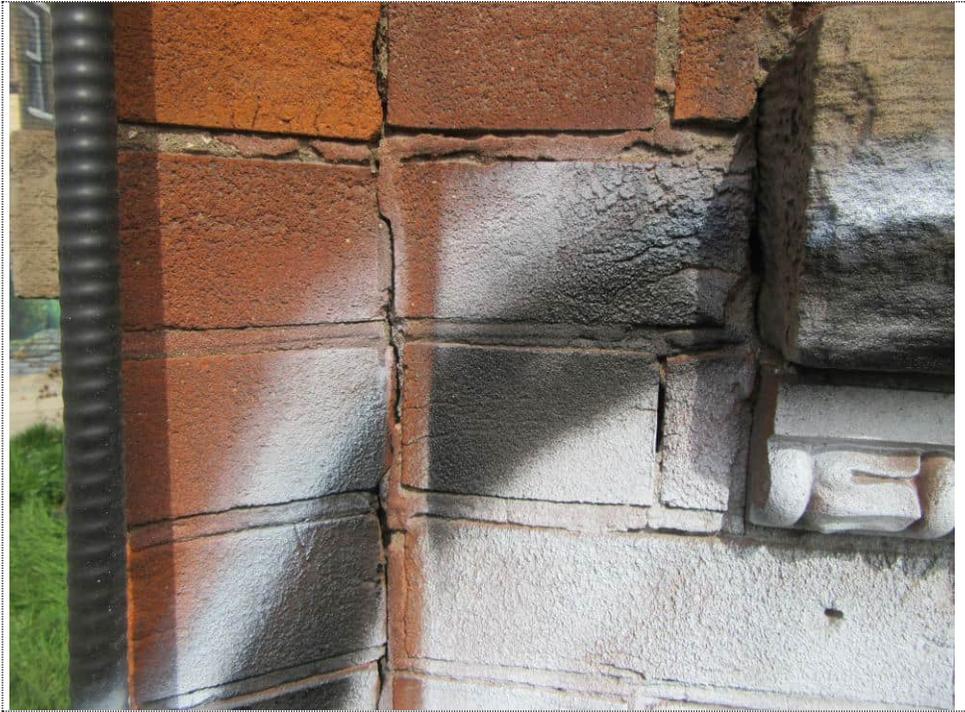
PHOTO NUMBER 11: Exterior of southeast corner of building

Note: Separation of masonry at corner

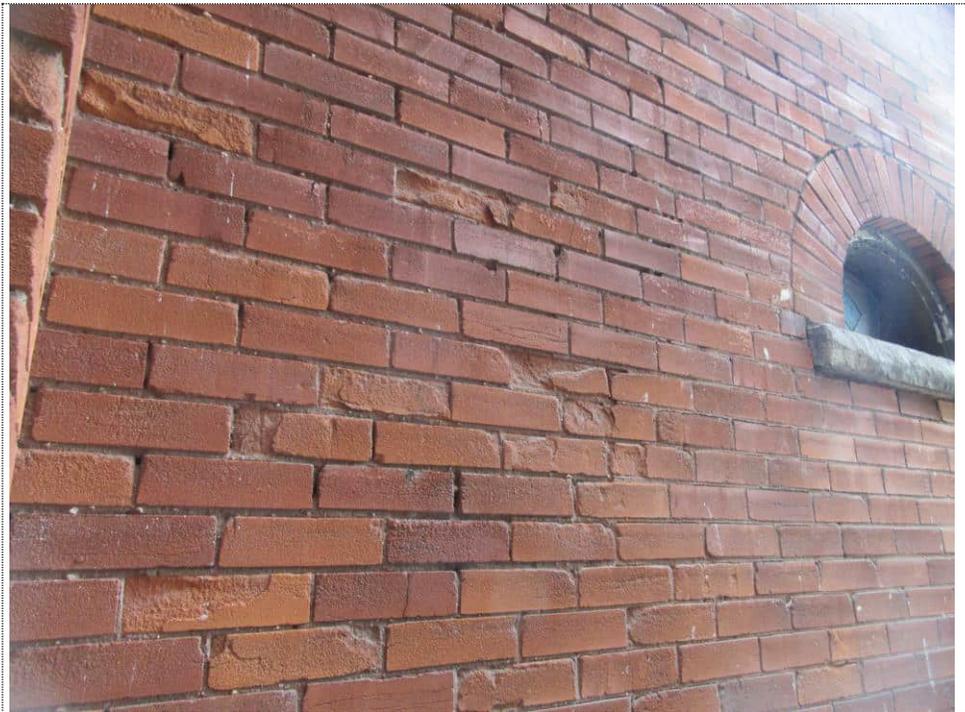
PHOTO NUMBER 12: Exterior of west face of building

Note: Areas of deteriorated masonry
