RE CHIA Addendum for Heritage Committee

**RE: Tivoli Theatre
 Update to Condition Assessment**

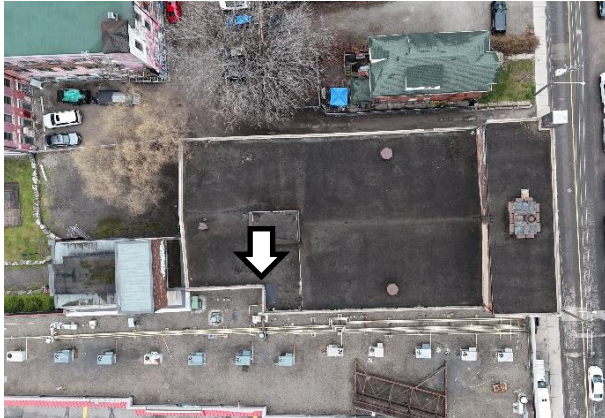
Foremost is to update regarding the risk posed by conditions at the re-entrant corner along the south wall of the auditorium (location marked in Fig. 1). In our report we identified concerns with movement of the pier at this corner, which at the top is displaced by approximately 3-4" towards the north, separating from the wall to its south (see Figs. 2, 3, and 4). The roof has failed adjacent to this pier and we identified the potential for corrosion of the steel column that we believe is embedded within it. In February 2024, we designed

Fig 1: Aerial view, with area of concern identified.

shoring for the truss that bears on this pier/column, including lateral attachment where the return wall meets the column pier. While we were advised that the shoring had been installed, our most recent review confirms this is not the case, and we understand that there was a miscommunication from employees previously with Aventus. You have confirmed that this shoring will be given utmost priority, and will be installed by Thursday November 28, 2024.

While no failure to the column or truss has occurred since our January review, it is very important to install this shoring immediately and for it to be in place before any significant snowfall would add load to the roof. Actively leaking in January, a roof repair above this pier has now fully failed and daylight is visible in the attic.

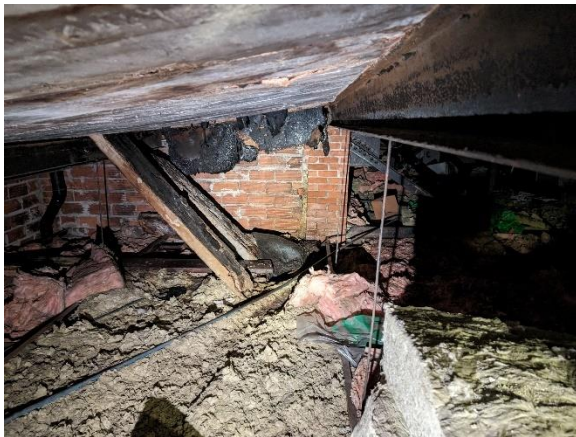
Fig 3: Pier separation, from attic, in Jan 2024.

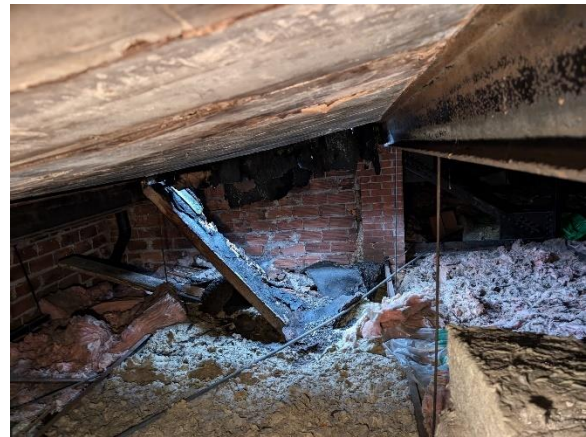
Fig 4: As Fig. 3, in Nov 2024, with failed roof.

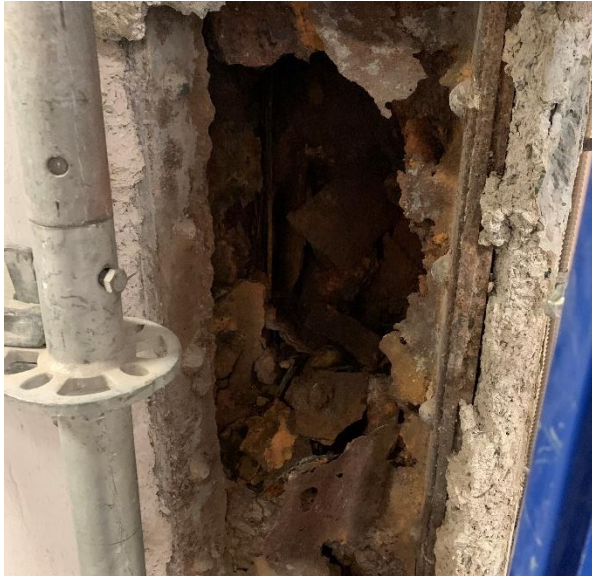
Corrosion of steel embedded in masonry is a very common problem for buildings constructed before modern rain screen wall systems. It is not possible to know the true extent of corrosion until it is exposed by removing the surrounding masonry. An example can be seen at Fig. 5, where after removing some cracked masonry and concrete around a column supporting eight levels below the wing of a historic hotel in Quebec City, we found the column to have completely failed. Given the roof leaks and the lack of heat in

the building to assist drying, we are concerned with the risk that corrosion of steel columns embedded in the walls of the Tivoli's auditorium is present and ongoing.

Fig 5: Example of severe concealed corrosion.

Any rehabilitation of the Tivoli should include the careful investigation of the embedded steel columns, which will likely require removal of exterior and interior finishes in order to repair.

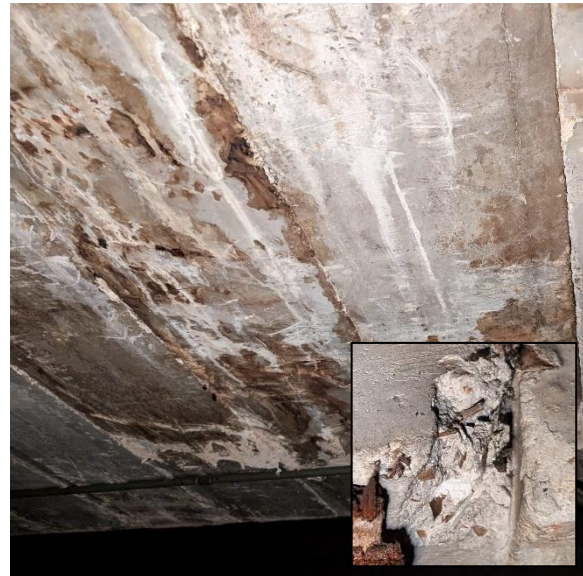
Fig. 6: Roof deck, inset w/ panel composition

The other key issue with the building's structure is the roof deck, which consists of gypsum panels. Leaks throughout the auditorium roof have resulted in deterioration of this deck (see Fig. 6). Gypsum roof deck panels were a relatively common cost-effective option in early 20th century construction, and consist essentially of plaster of Paris mixed with wood shavings (see inset on Fig. 6), cast into panels with integral steel reinforcing. The panels were fire resistant, lightweight, insulative, and minimized the potential for condensation at the underside of the deck. This latter absorptive quality is also the reason the material is very susceptible to moisture damage, making it a terrible choice as a durable roof deck, especially for a flat roof. We do not believe it is safe to walk on the roof of this building without fall protection, nor would we recommend the continued service of the roof deck.

- Exposed columns should also be protected from future corrosion with at least a marine epoxy paint.
- Replace all gypsum roof deck panels.
 - This would presumably be done with steel deck.
