TIVOLI THEATRE | CULTURAL HERITAGE IMPACT ASSESSMENT

September 30, 2024

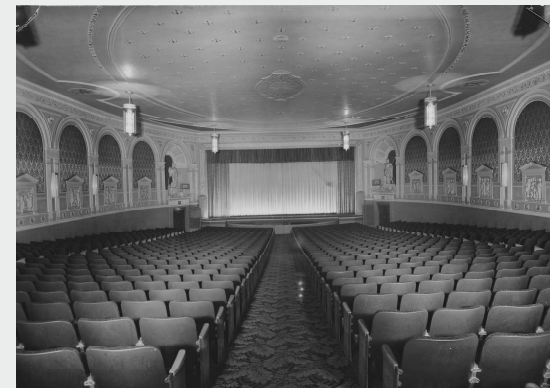
Tivoli Theatre [Source: Hamilton Public Library]

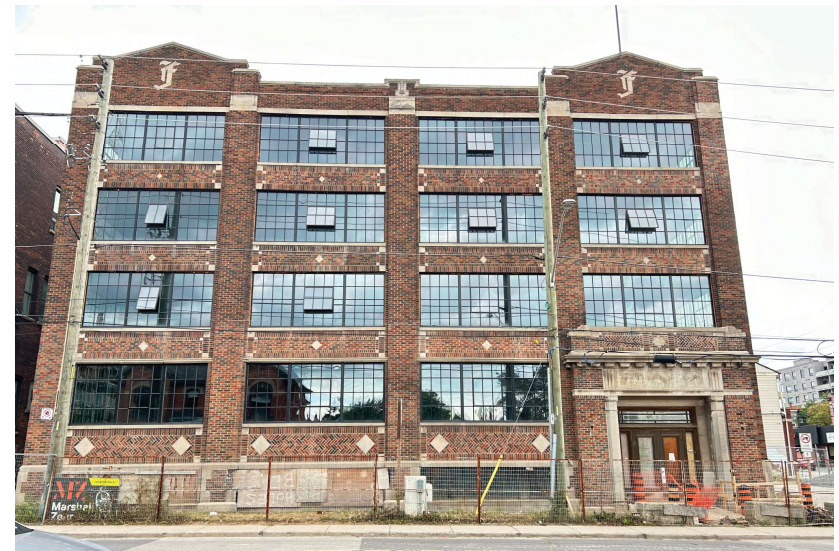
Source: +VG Architects

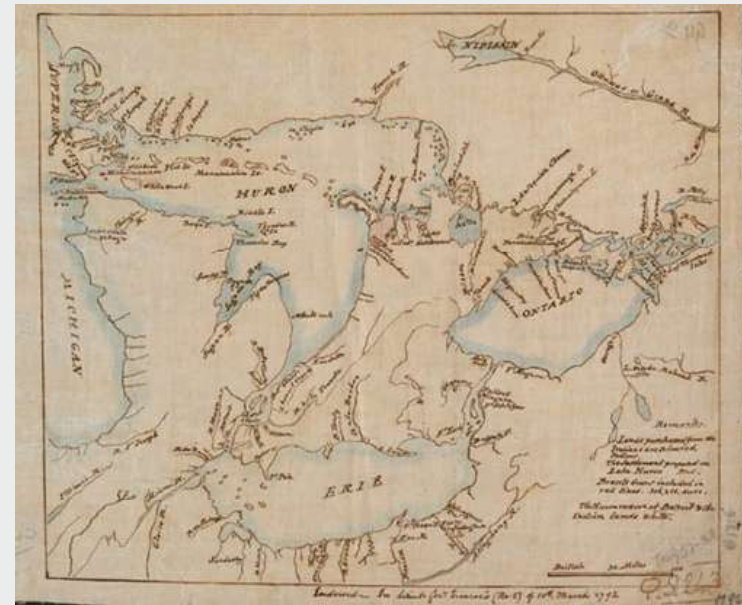
Grant to Joseph Brant, 1792 map showing the "Between the Lakes" area of Treaty No. 3. Library and Archives Canada, 2000215462

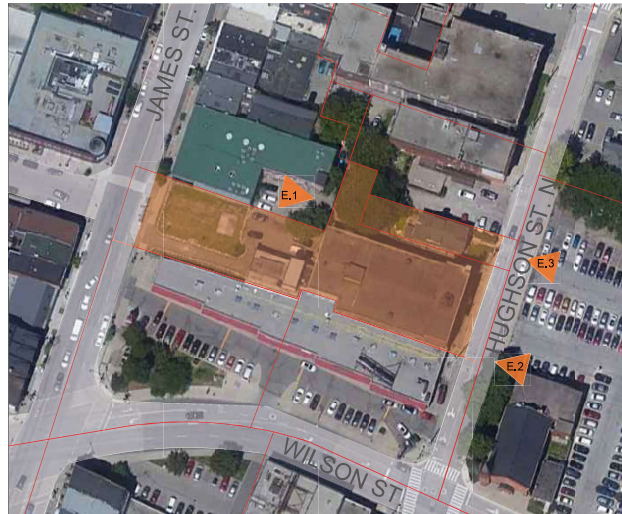
Tivoli Property exterior keyplan [Source: +VG Architects]

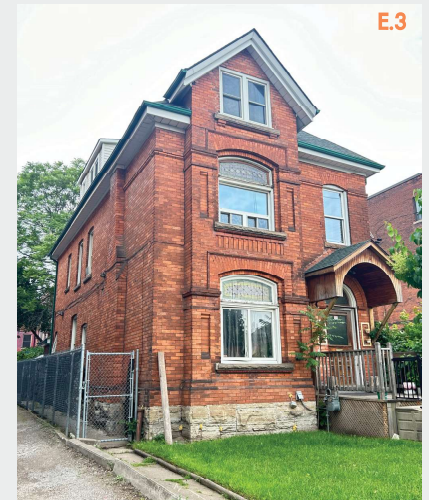
Exterior images [Source: +VG Architects]

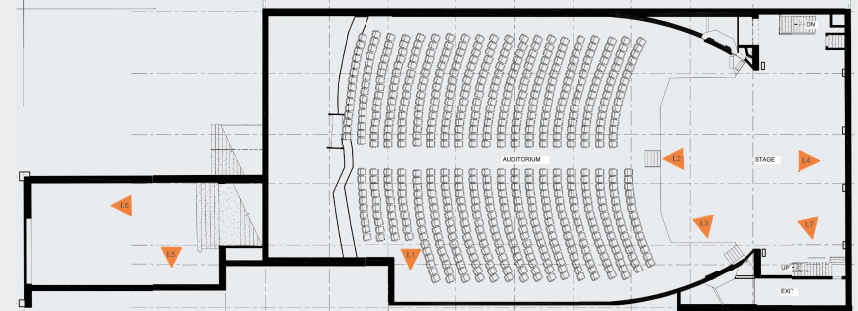
Tivoli Property interior keyplan [Source: +VG Architects]

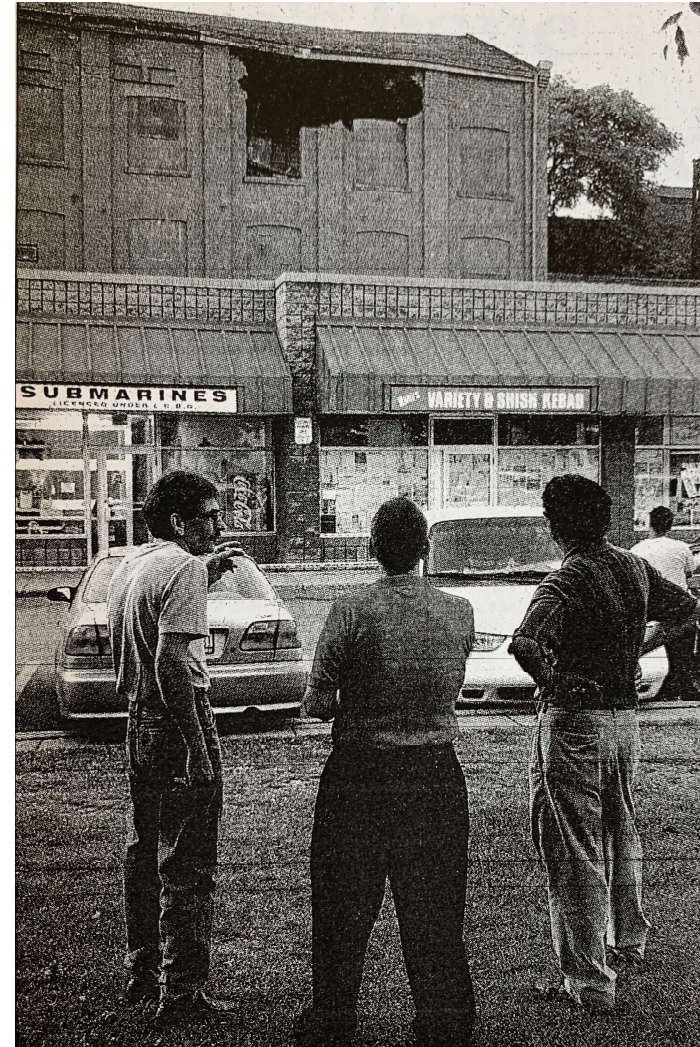
Passerby observe the damage in the Tivoli wall [Source: Hamilton Public Library]

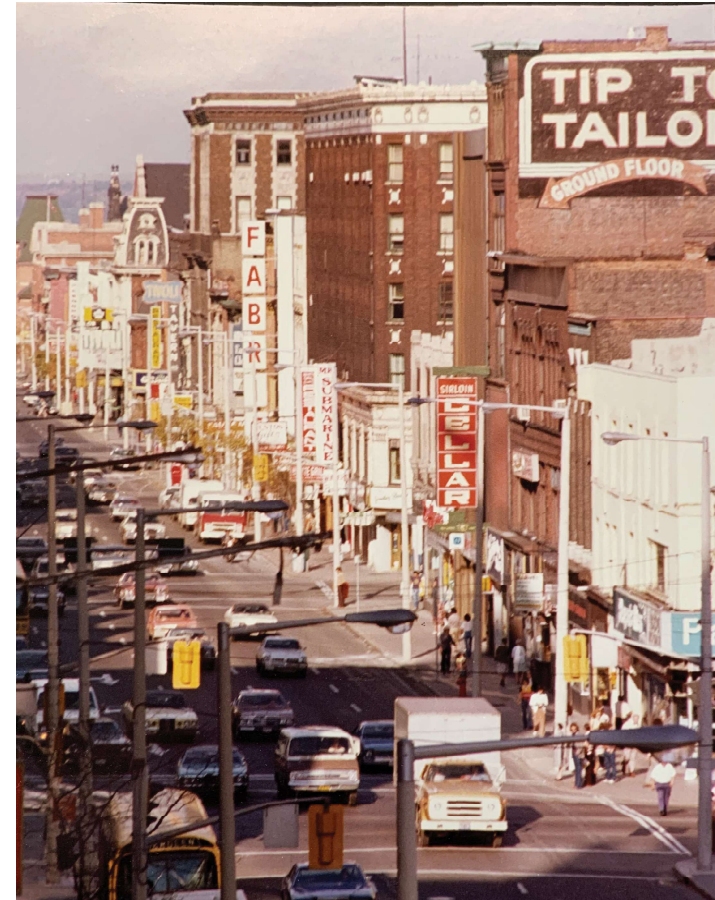
James Street View - 1979. Note the distinctive corner tower roof of the Tivoli Theatre in the distance.
[Source: Hamilton Public Library]

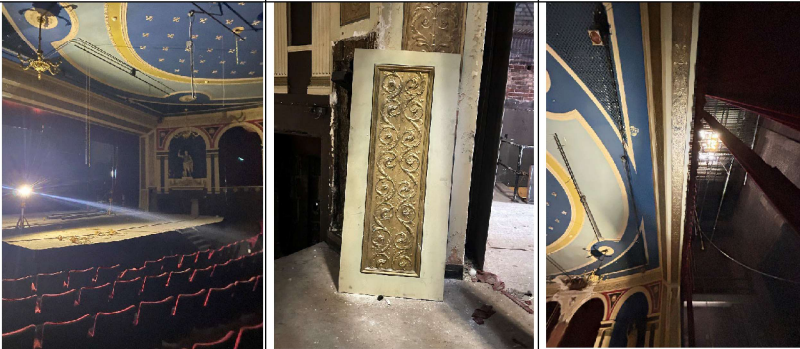
2 Ceiling w elliptical design	Auditorium house	General Condition: Good with areas of heavy damage or missing structure. Areas of damaged and missing ceiling are around penetrations from equipment or fixtures, and areas of water (likely from the failing roof) where plaster has fallen off.	Documentation: Detailed scanning, drawings and descriptions. Ornamental plaster requires careful documentation of the designs, spacing, scale, and location. Note: Two environmental reports identify designated substances and hazardous building materials found throughout the building. Specific to plaster and interior finishes are asbestos and lead paint. Due to deteriorated conditions of the interior, asbestos fibers are noted as having widespread on the interior. Abatement methods may be detrimental to the historic features and further study is required.

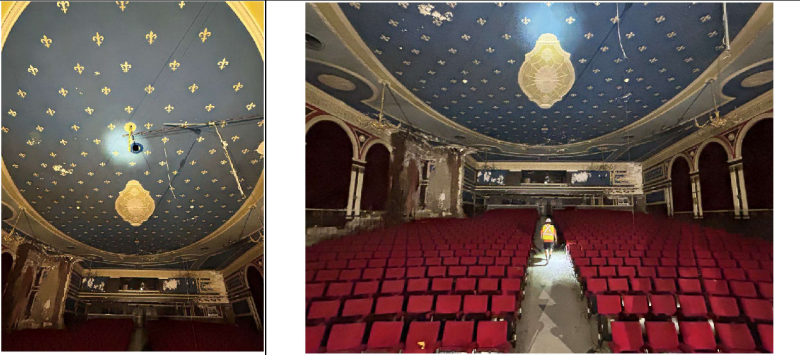
TIVOLI THEATRE | DOCUMENTATION + SALVAGE

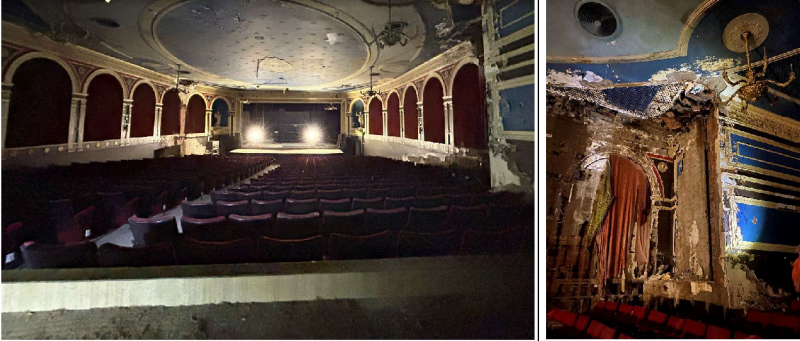
4 Wall colonnades each w five round arches sprung from coupled pilasters.	On the long walls of the auditorium.	<p>General Condition: Good in most areas, however severely damaged or missing in others.</p> <p>The wall colonnades each have six round arches plus the recessed arch with statutory beside the proscenium.</p>	<p>Documentation: Detailed scanning, drawings and descriptions.</p> <p>Ornamental plaster requires careful documentation of the designs, spacing, scale, and location.</p> <p>Note: Two environmental reports identify designated substances and hazardous building materials found throughout the building. Specific to plaster and interior finishes are asbestos and lead paint. Due to deteriorated conditions of the interior, asbestos fibers are noted as having widespread on the interior. Abatement methods may be detrimental to the historic features and further study is required.</p>

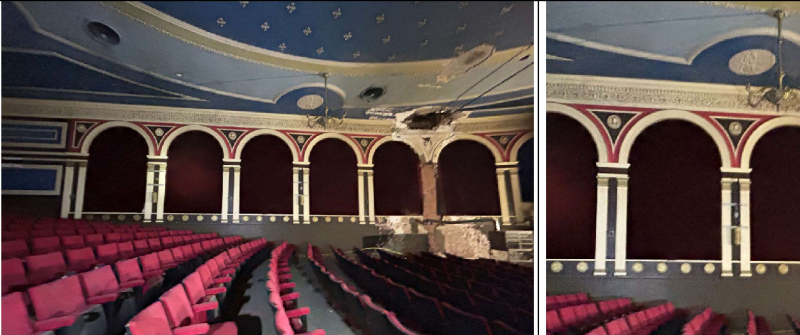
TIVOLI THEATRE | DOCUMENTATION + SALVAGE

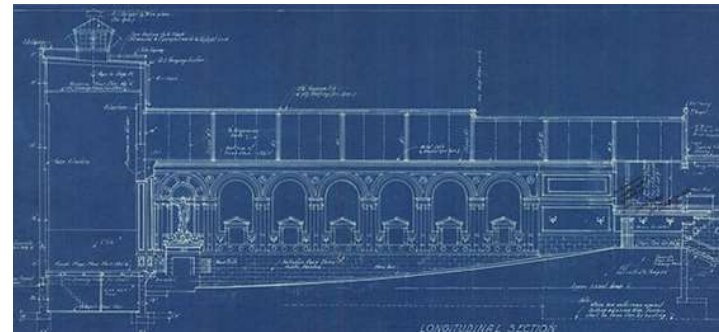
7. CONSERVATION STRATEGY

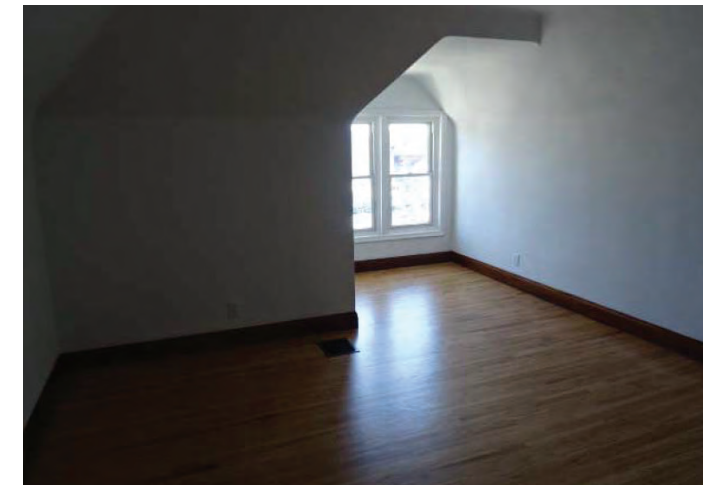
View of Level 3 under roof space with gable window, wood trims and wood flooring. [Source: Aventus]

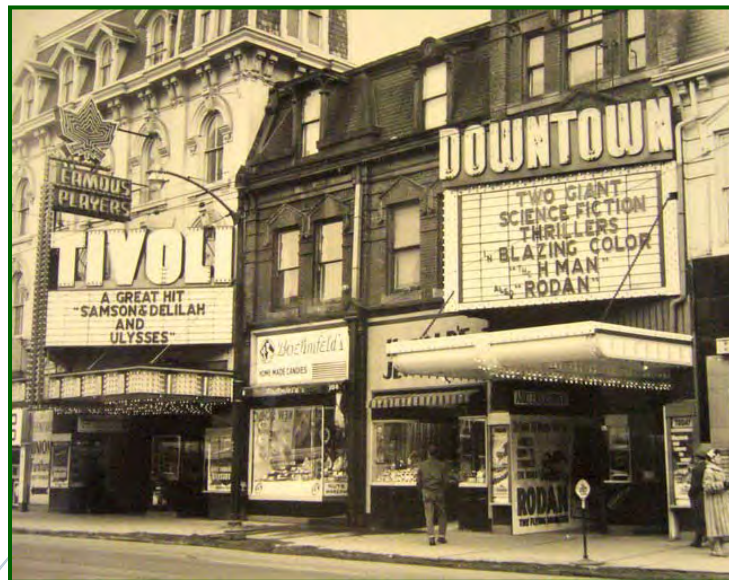
Tivoli Condo Development 108 James Street North, Hamilton Building Condition Assessment February 2024

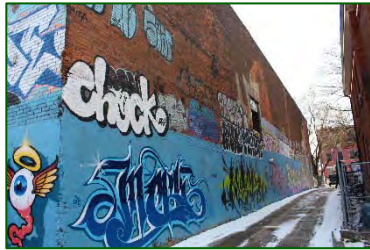
A. General Description of the Facility

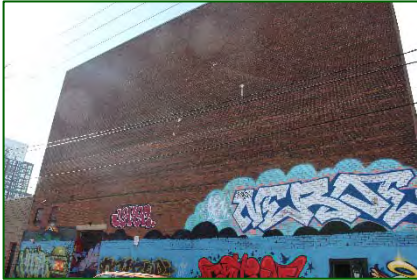
<p>Item 1.2 North Elevation</p> <p><u>Observation</u> North elevation of the building consists of brick and a parge coat approximately 3m above grade. Brick wall is in poor condition.</p> <p>Some deterioration of brick and cracking was observed.</p>

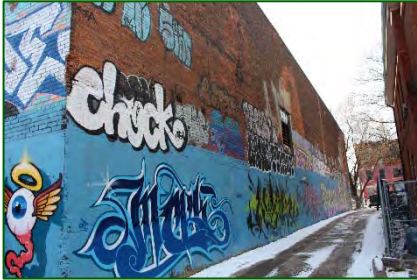
<p>Item 1.3 North Elevation</p> <p><u>Observation</u> Significant mortar loss at brick joints throughout wall. Significant staining throughout wall.</p>

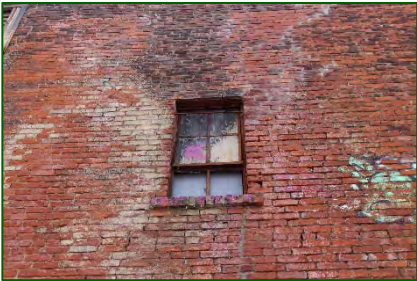
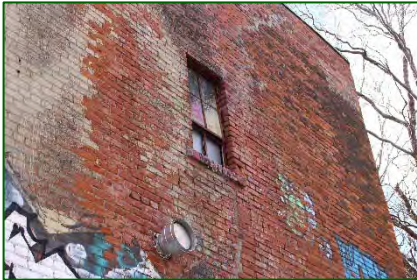
Area/Item Reviewed	Photograph
<p>Item 1.4 West Elevation</p> <p><u>Observation</u></p> <p>Brick wall with plywood used to infill majority of the wall. Wall is in poor condition.</p>

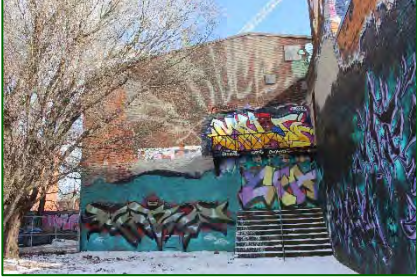
<p>Item 1.5 West Elevation</p> <p><u>Observation</u></p> <p>Brick is loose, crumbling and missing in several areas. Large portion of wall is missing in the south west corner. Area of wall missing in north west corner.</p>

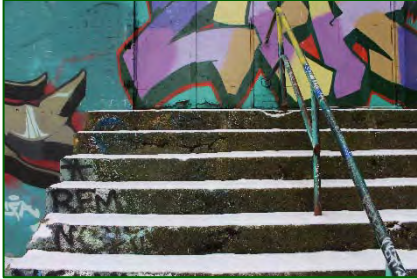
<p>Following the structural review several photos were shared by the building owner. Items from photos listed below.</p>	
<p>Item 1.7 Roof</p> <p><u>Observation</u></p> <p>Roof was not reviewed as part of this inspection. Photos of the roof were shared by owner. Roof is in poor condition, vegetation growth on roof suggest moisture problems.</p>

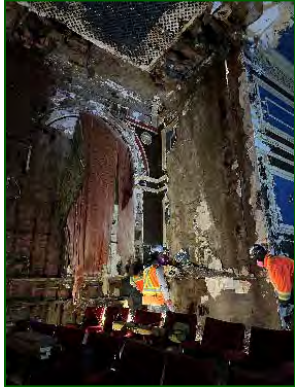
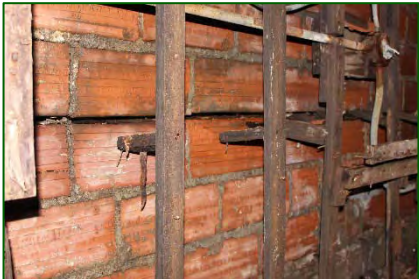
Area/Item Reviewed	Photograph
<p>Item 2.2 Back of Auditorium</p> <p><u>Observation</u> Shoring installed at back of auditorium to support second floor and roof structure above.</p>

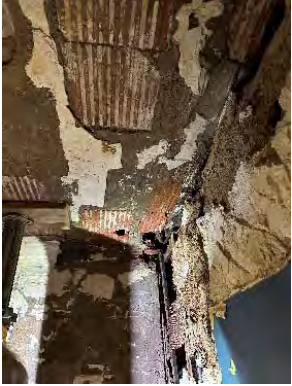
<p>Item 2.4 Walls</p> <p><u>Observation</u> Moisture damage to wall.</p>

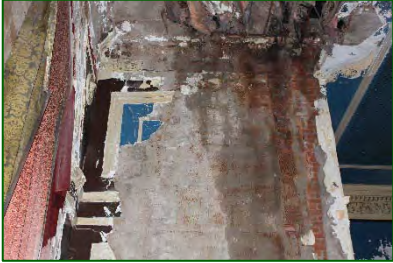
Area/Item Reviewed	Photograph
<p>Item 2.5 Roof Structure</p> <p><u>Observation</u> Shoring up to ceiling of roof structure. Ceiling has significant moisture damage and is on the verge of collapse. Shoring is installed but may not prevent collapse of moisture ridden gypsum panels.</p>

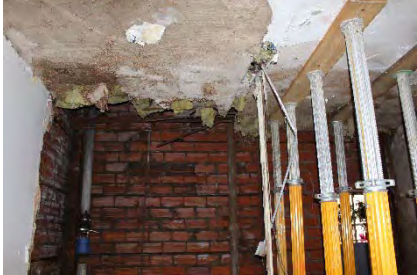
A photograph showing the interior of a roof structure. Several vertical metal shoring posts are in place, supporting a ceiling that appears to be made of gypsum panels. The ceiling shows signs of moisture damage, with some peeling and discoloration. A brick wall is visible in the background.
<p>Item 2.6 Walls</p> <p><u>Observation</u> Deterioration to clay tile and brick at inside of walls. Walls are in poor condition where viewed.</p> <p>Considerable cracking of brick walls was observed.</p>

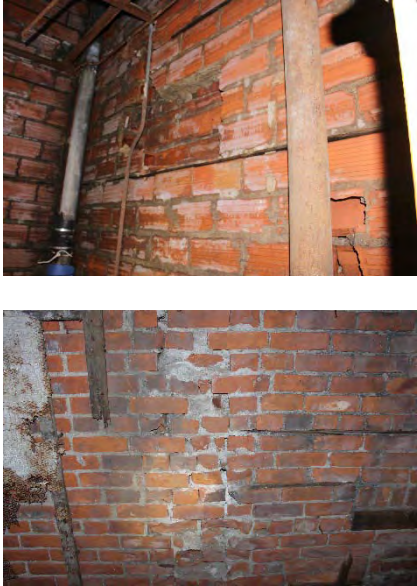
Two photographs showing the interior of a wall. The top photograph shows a brick wall with a wooden post and a pipe. The bottom photograph shows a close-up of a brick wall with significant cracking and deterioration of the mortar and bricks.

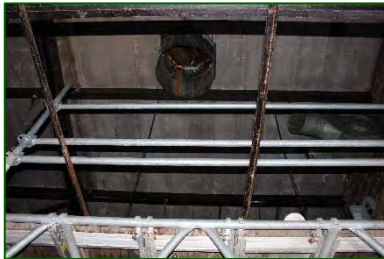
A photograph showing the roof framing structure. It consists of several horizontal metal beams supported by vertical posts. There is a dark, circular object (possibly a pipe penetration) in the center, and the surrounding area shows signs of staining and damage.

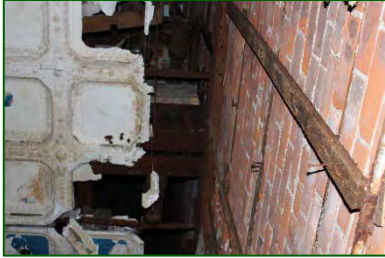
A photograph showing a brick wall on the right side, supported by a vertical steel beam. To the left, there is a grid of steel framing. The scene is dimly lit, with some debris visible on the floor.
<p>Item 2.9 Basement</p> <p><u>Observation</u> Wood framing supporting ground floor visible in basement. Wood beams are in fair condition.</p>

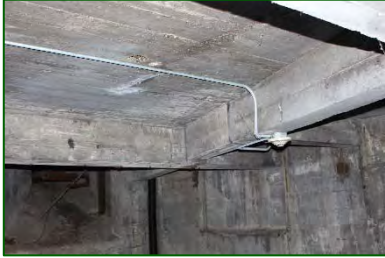
A photograph of a basement interior showing wooden joists and beams. A white pipe runs across the ceiling area. The walls are made of concrete or masonry.
<p>Item 2.10 Basement</p> <p><u>Observation</u> Steel beams supporting second floor visible in basement. Beams are painted and condition could not be confirmed.</p>

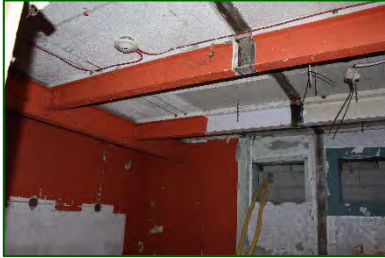
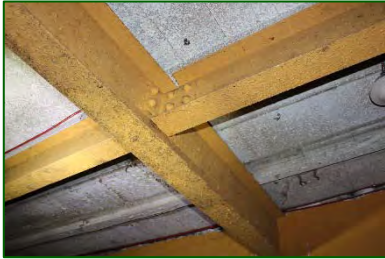
Two photographs are provided. The top one shows a red-painted steel beam running horizontally across the ceiling of a basement. The bottom one is a close-up of a steel beam joint, showing a yellow-painted beam crossing over another.

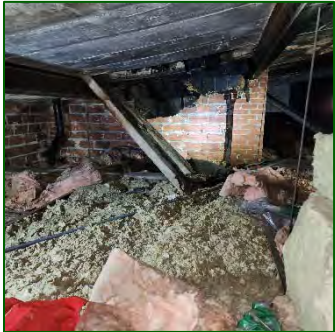
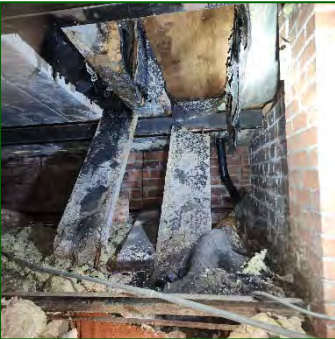
<p>Item 2.13 Steel Framing at Roof</p> <p><u>Observation</u></p> <p>Steel roof trusses with wood infill. Wood appears to be stained suggesting water damage.</p>

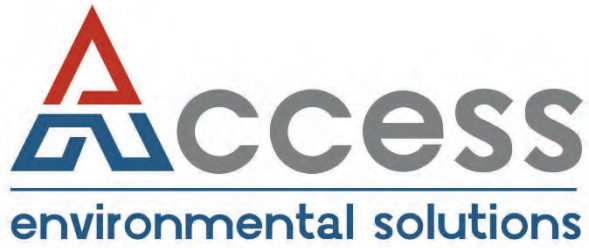
DESIGNATED SUBSTANCES AND HAZARDOUS BUILDING MATERIALS ASSESSMENT

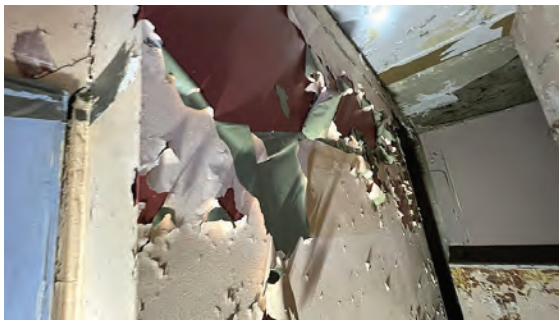
Photo 5: Example of damaged paint on plaster walls on second floor.

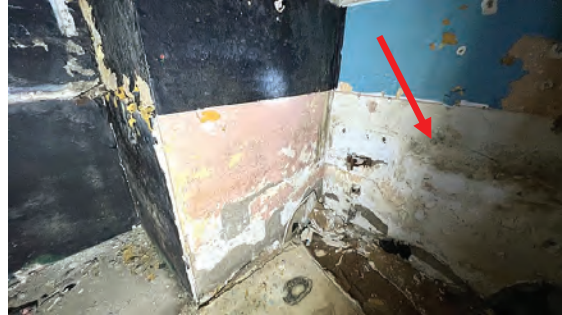
Photo 10: Example of moisture damage on lower walls throughout rooms below stage area.

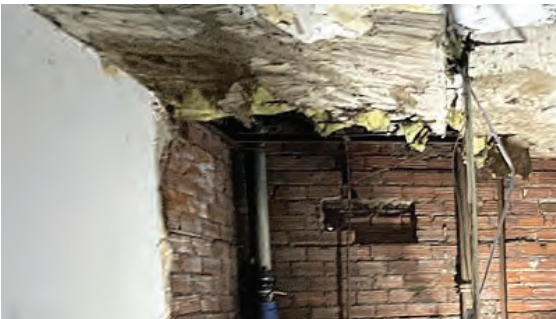
Photo 11: Water damage and mould growth in staircase area leading to projection room.

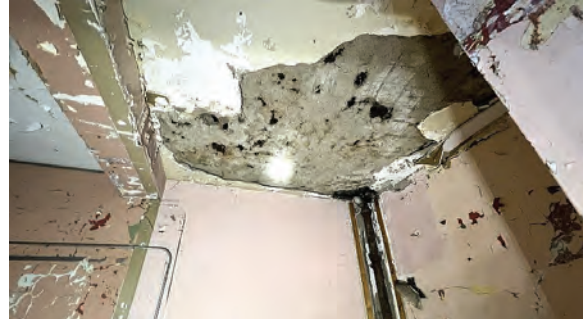
Photo 12: Water-damaged ceiling and mould growth on second floor.

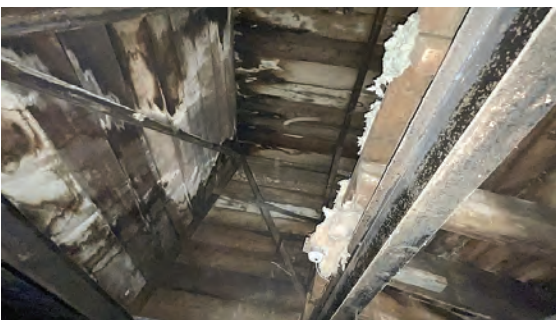
Photo 13: Water damage and mould growth on roofing above catwalk area.

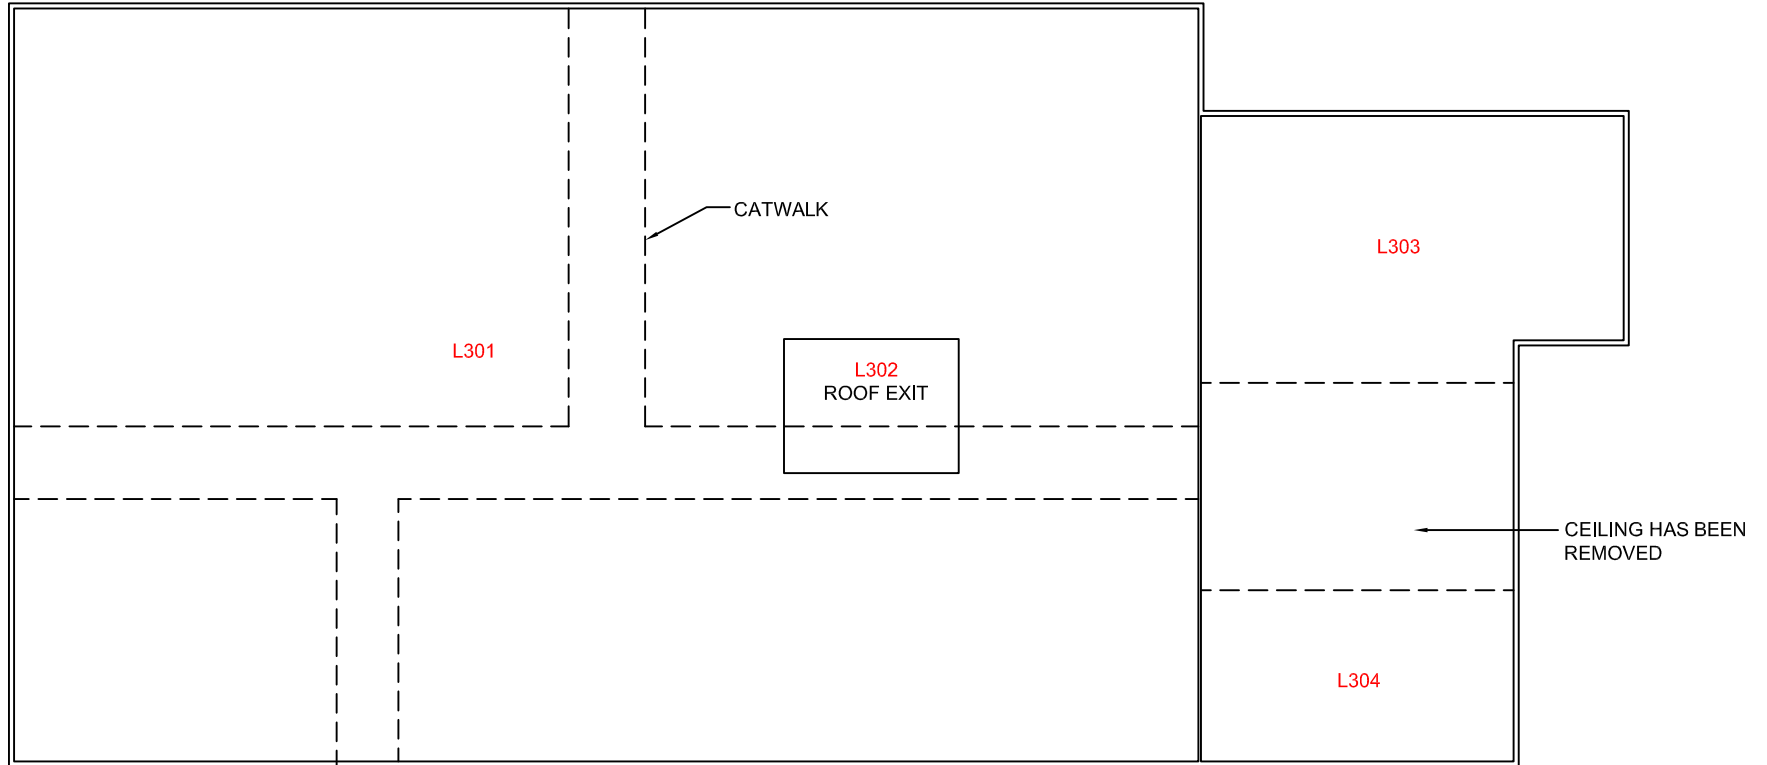
CATWALK / CEILING SPACE

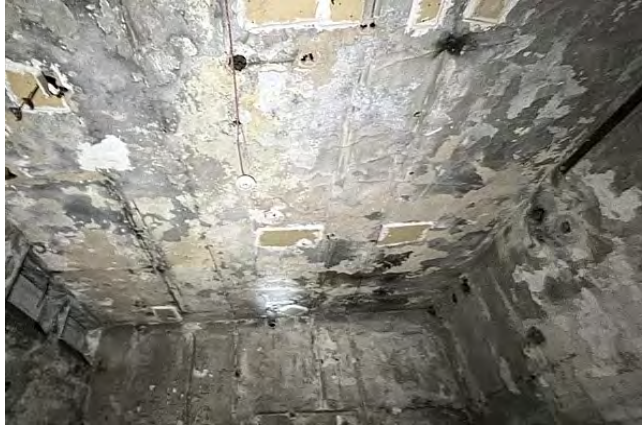
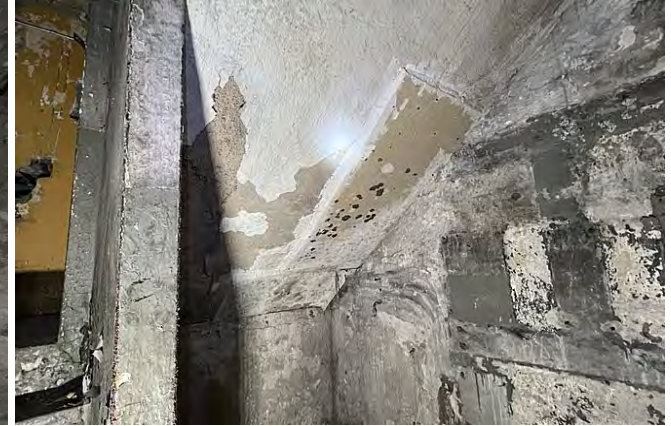
Summary of ACMs and PACMs

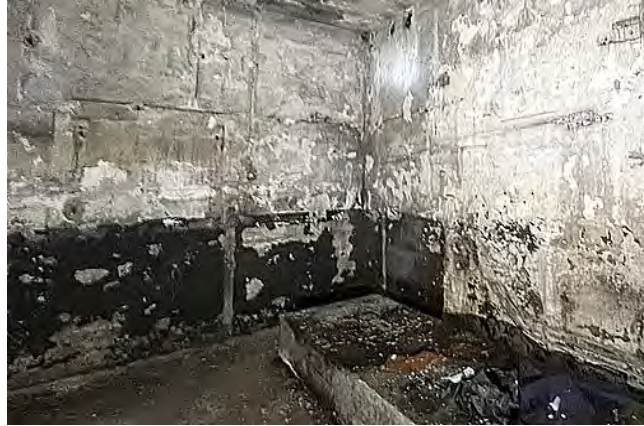
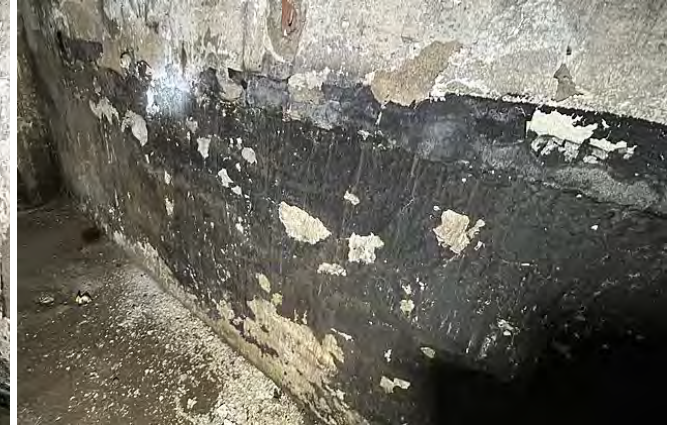
Summary of ACMs and PACMs

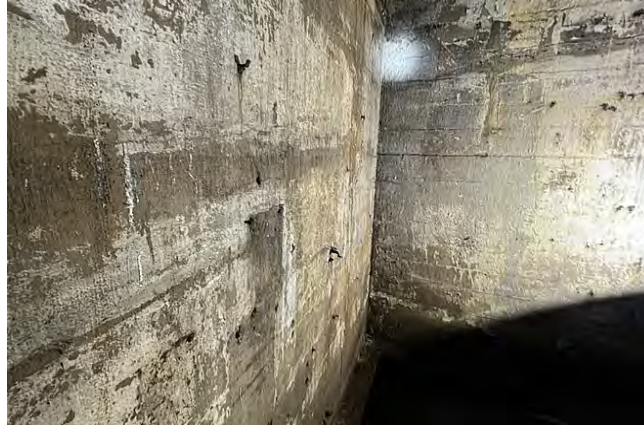
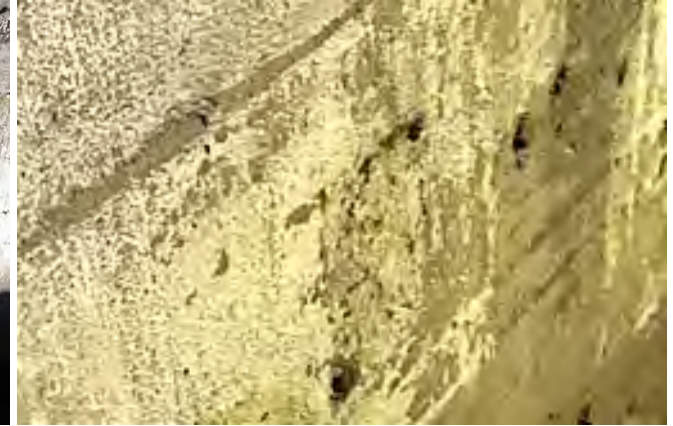
Summary of ACMs and PACMs

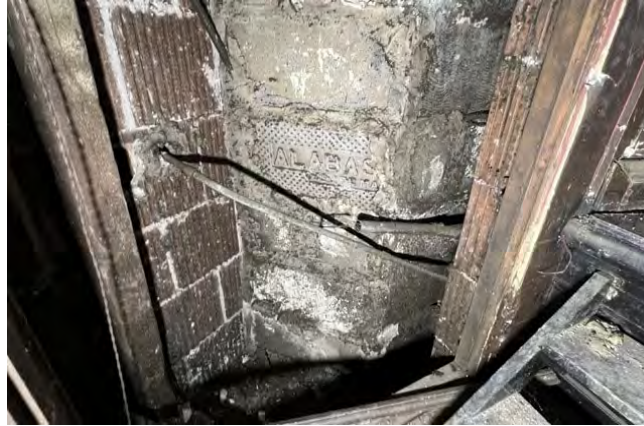
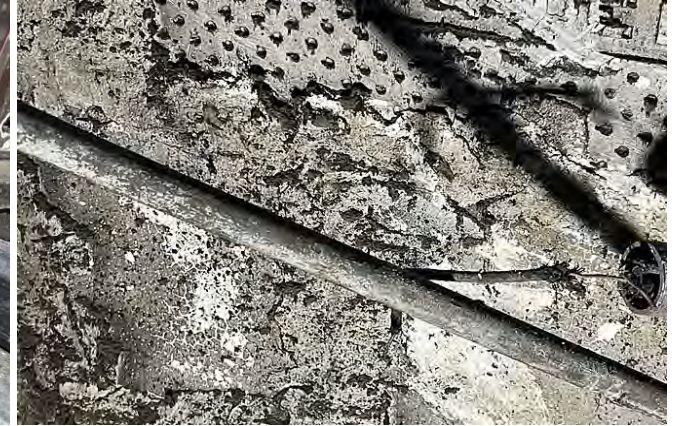
Summary of ACMs and PACMs

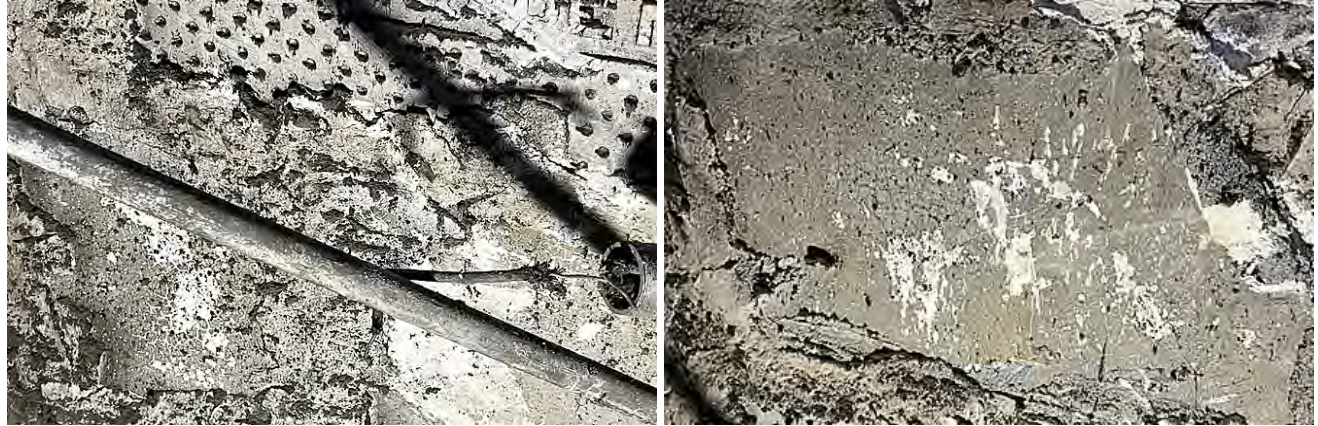
Summary of ACMs and PACMs

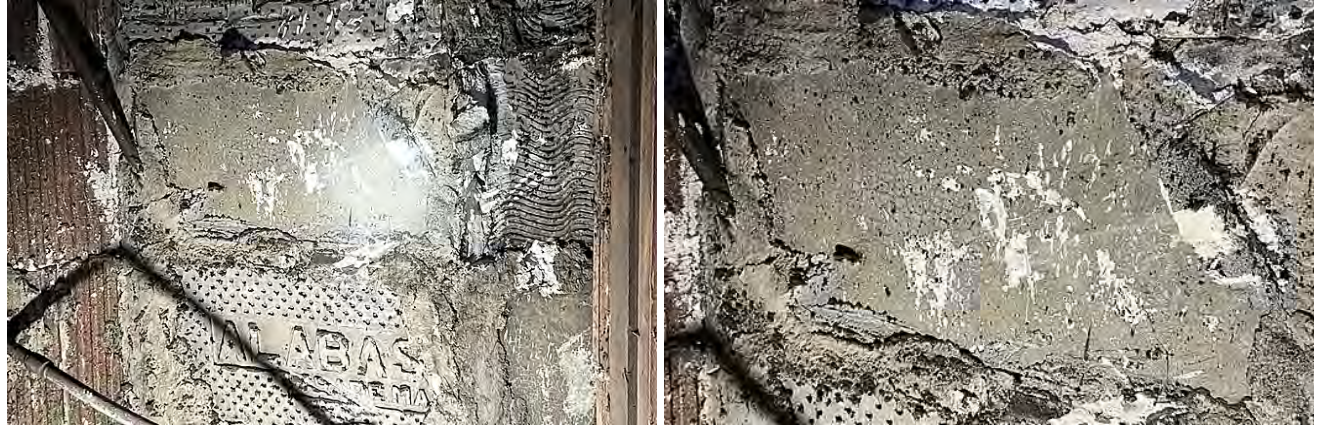
Summary of ACMs and PACMs

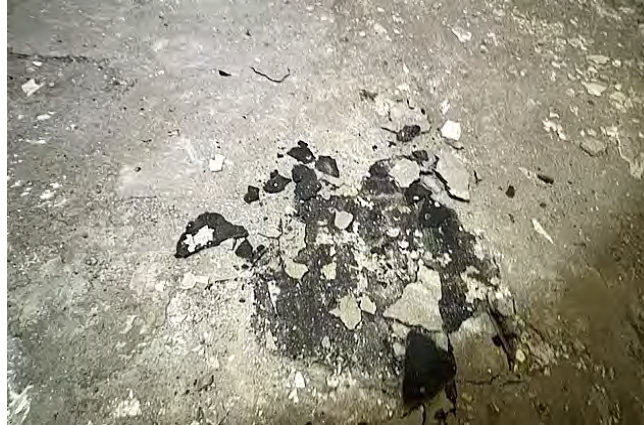
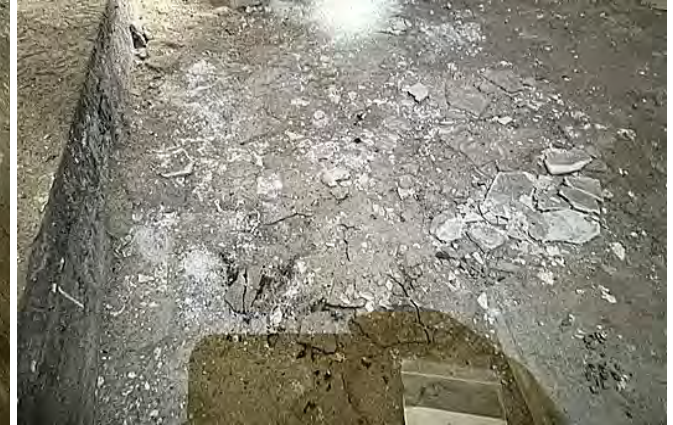
Summary of ACMs and PACMs

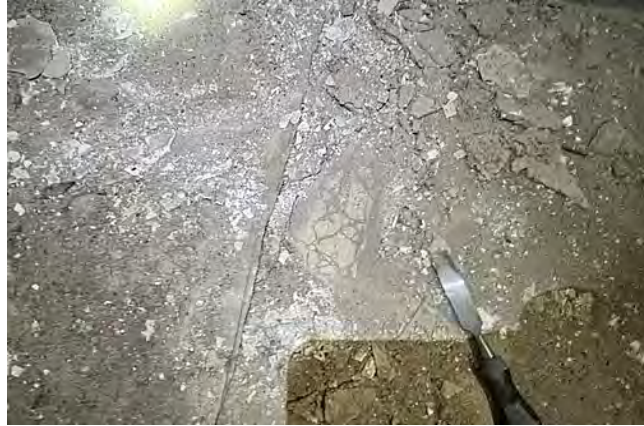
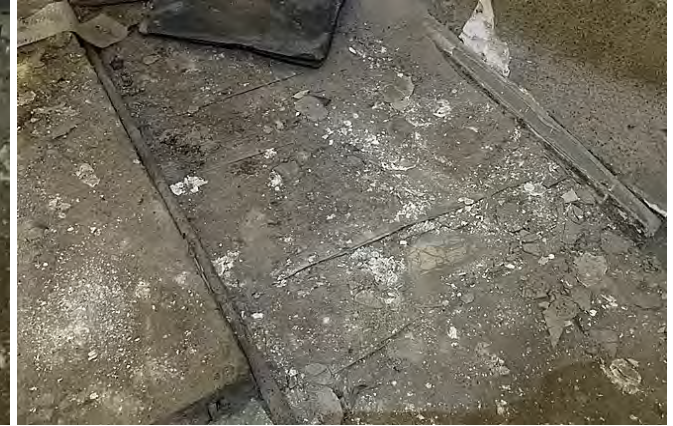
Summary of ACMs and PACMs

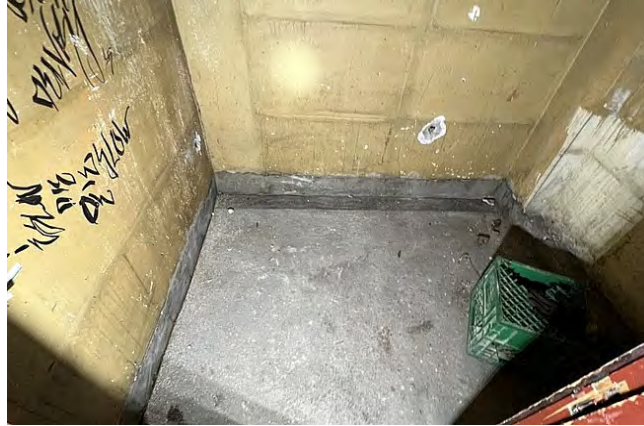
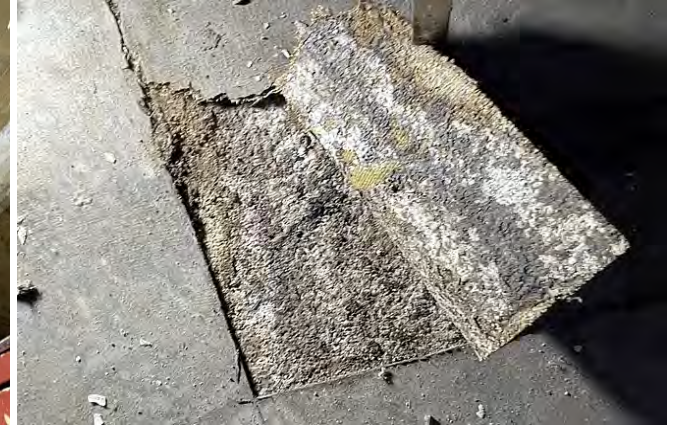
Summary of ACMs and PACMs

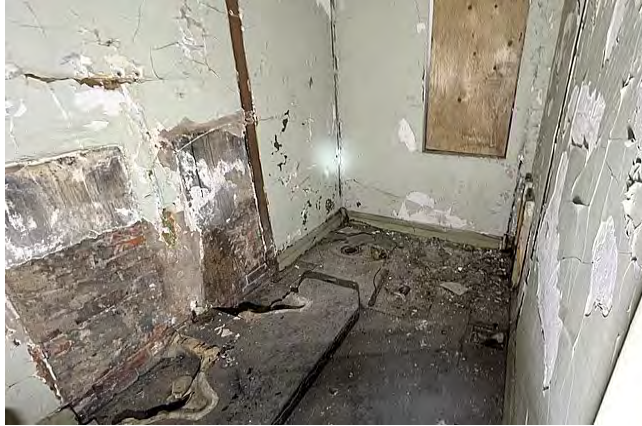
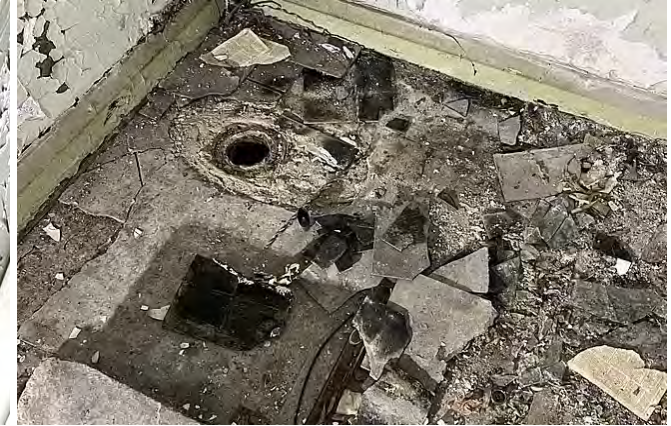
Summary of ACMs and PACMs

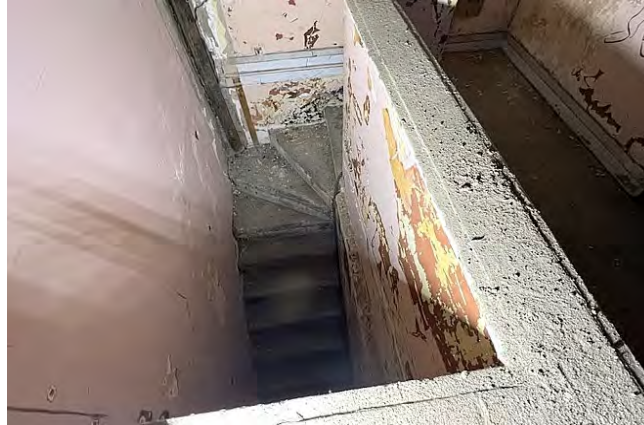
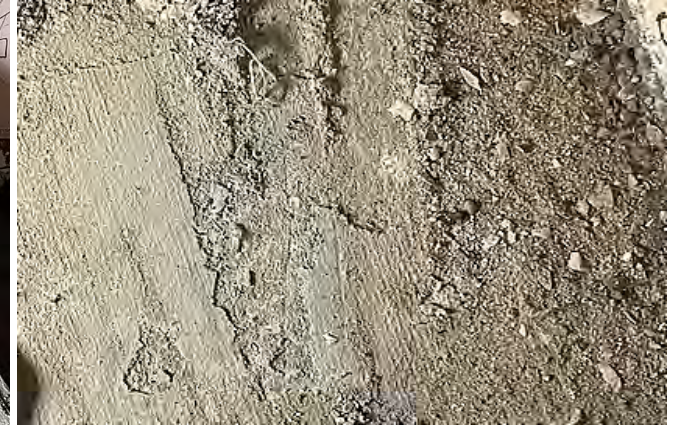
Summary of ACMs and PACMs

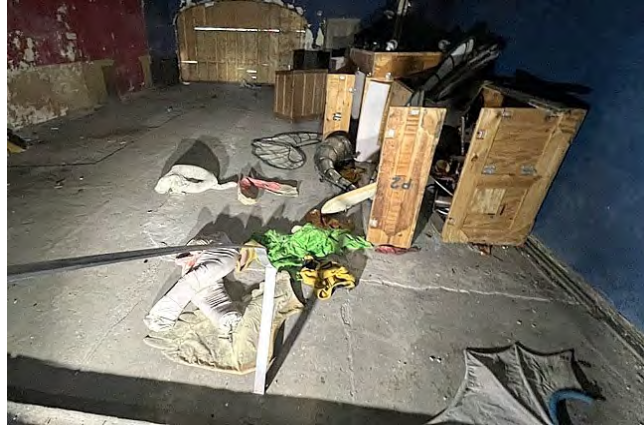
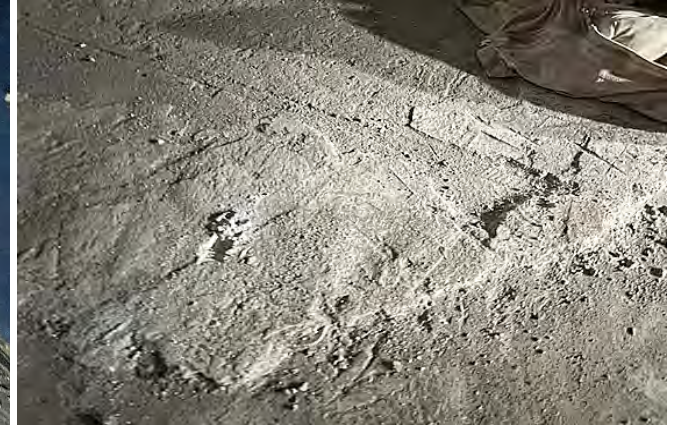
Summary of ACMs and PACMs

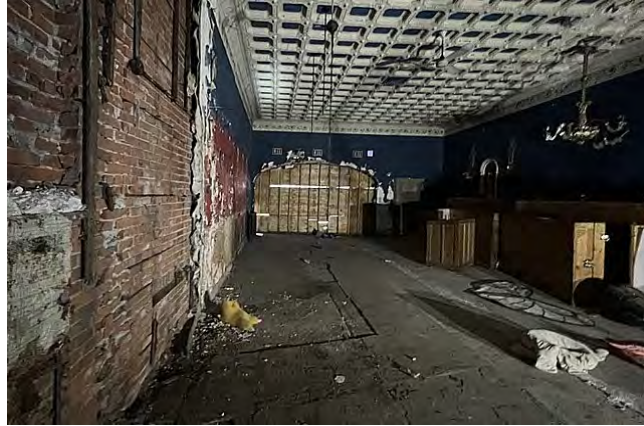
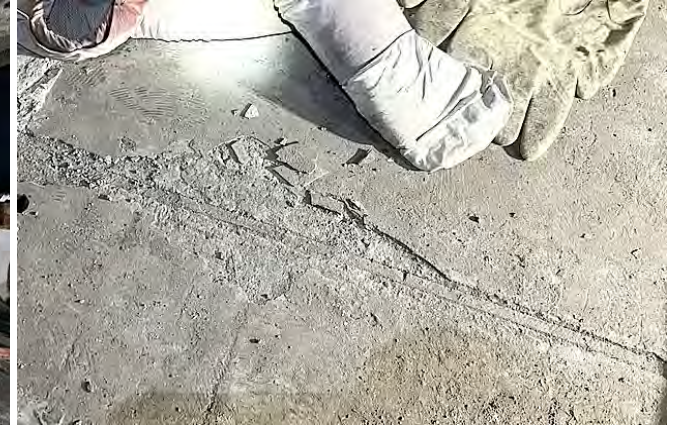
Summary of ACMs and PACMs

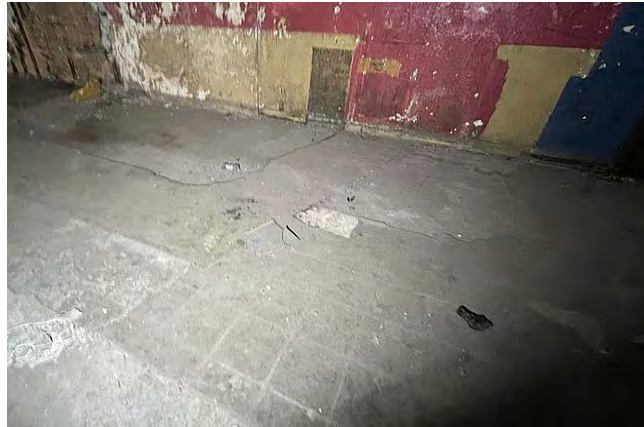
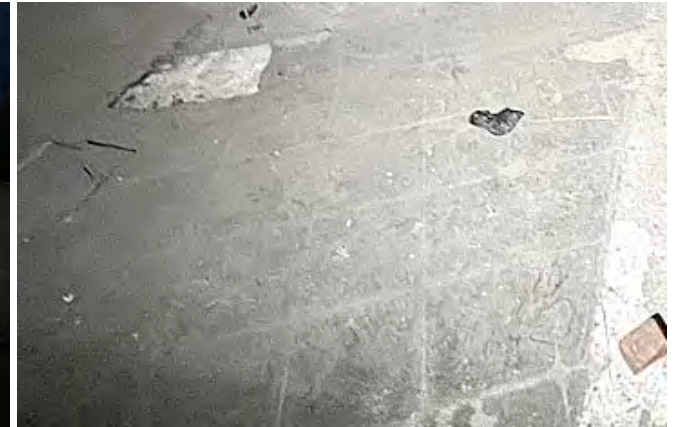
Summary of ACMs and PACMs

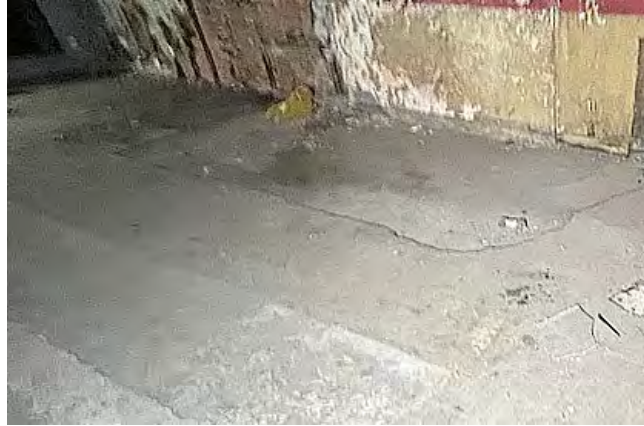
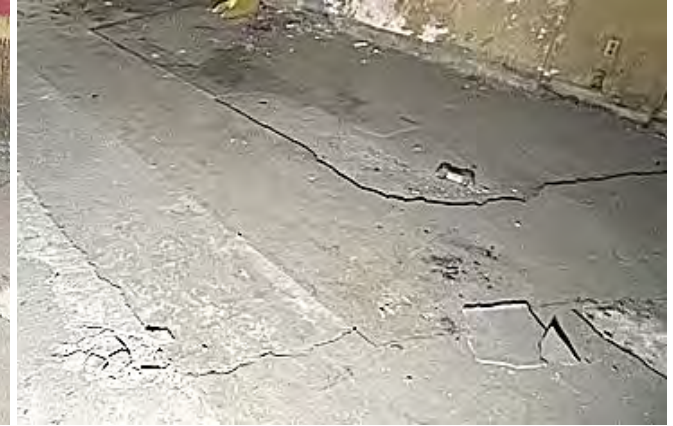
Summary of ACMs and PACMs

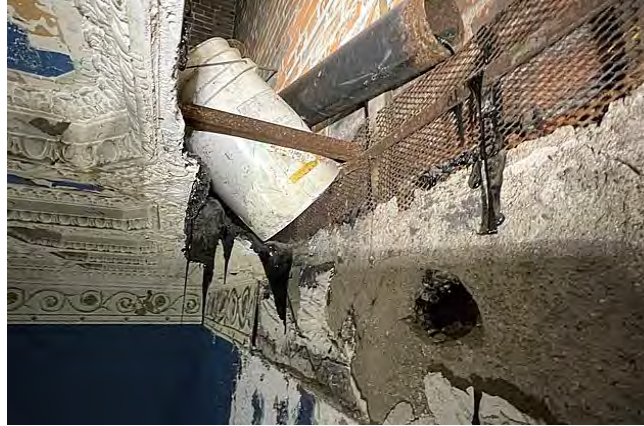
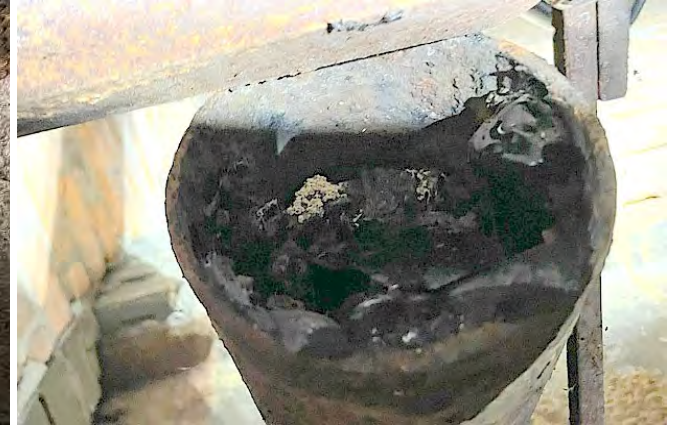
Summary of ACMs and PACMs

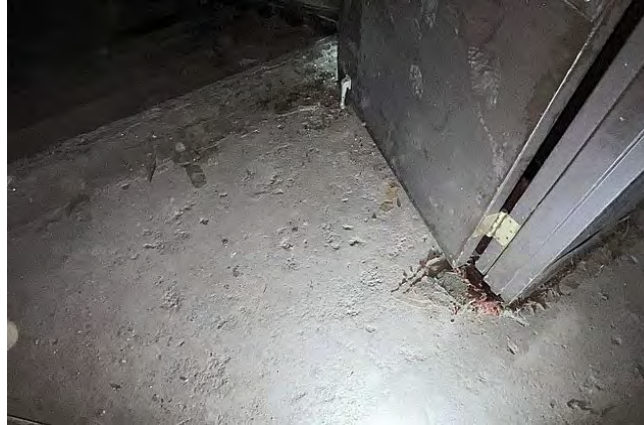
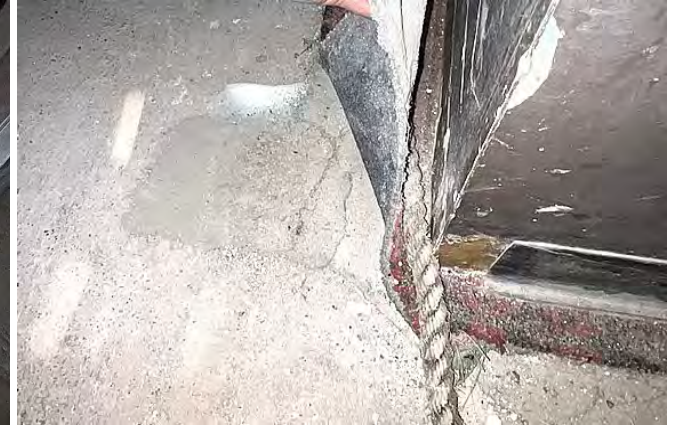
Summary of ACMs and PACMs

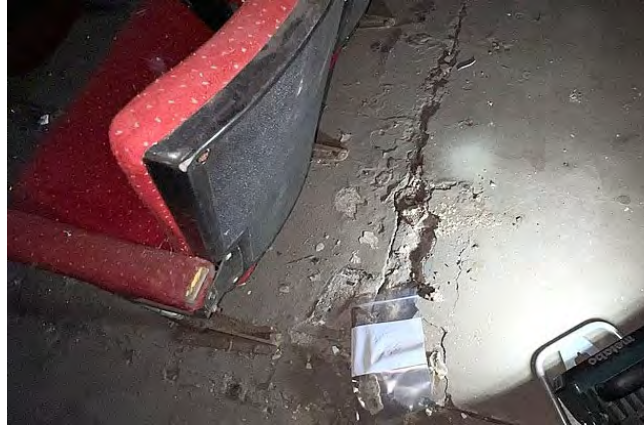
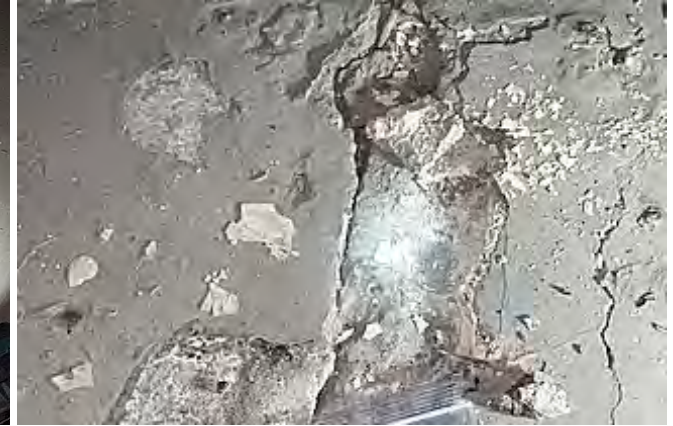
Summary of ACMs and PACMs

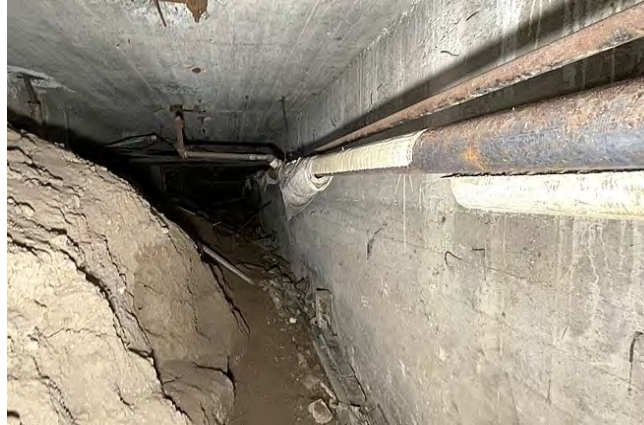
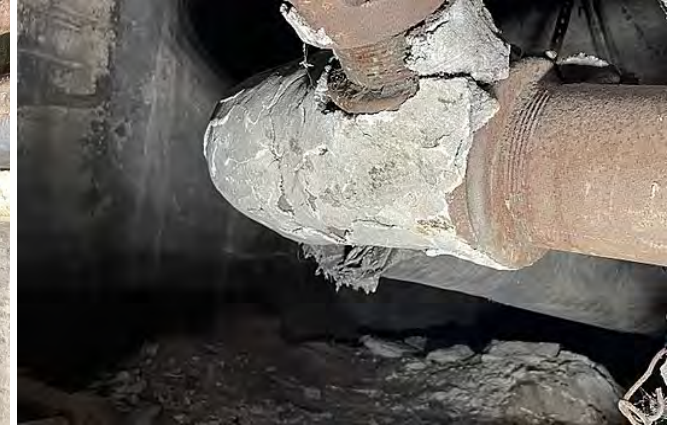
Summary of ACMs and PACMs
