TIVOLI THEATRE | CULTURAL HERITAGE IMPACT ASSESSMENT

September 30, 2024

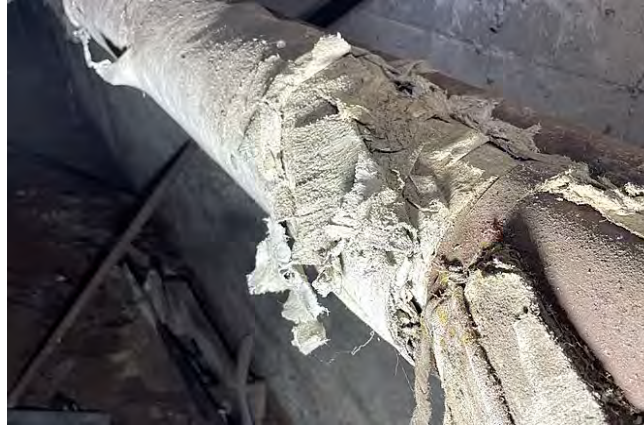
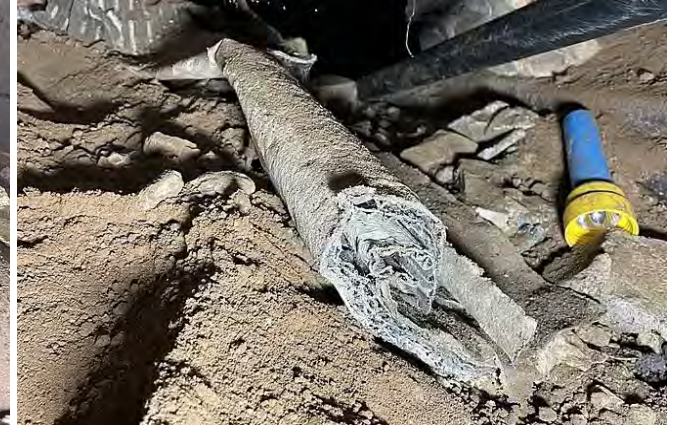
Summary of ACMs and PACMs

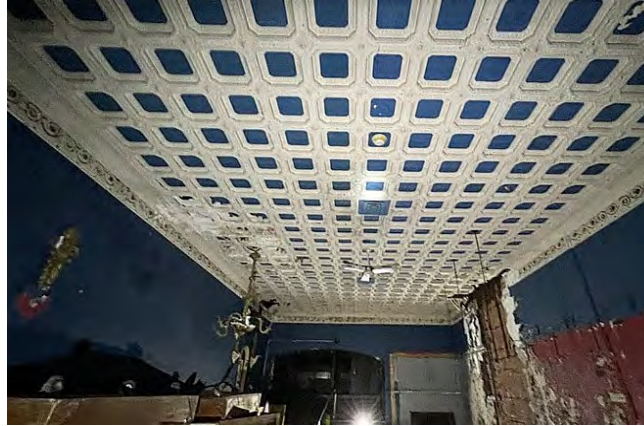
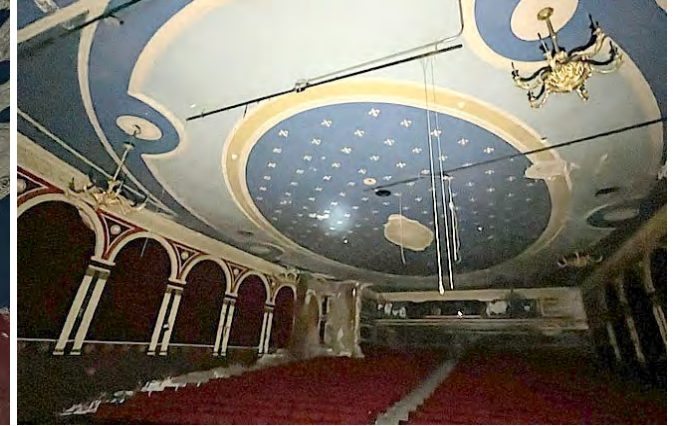
Summary of ACMs and PACMs

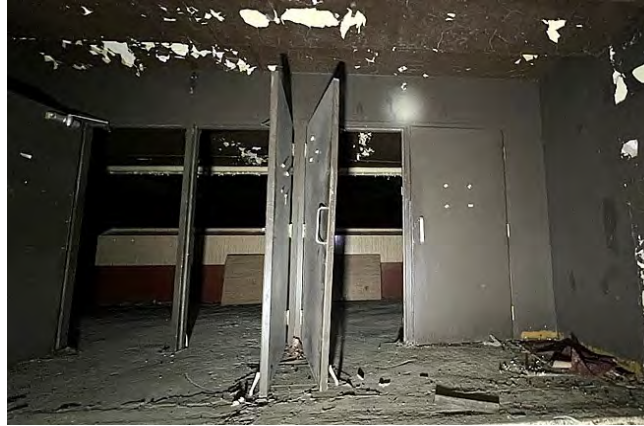
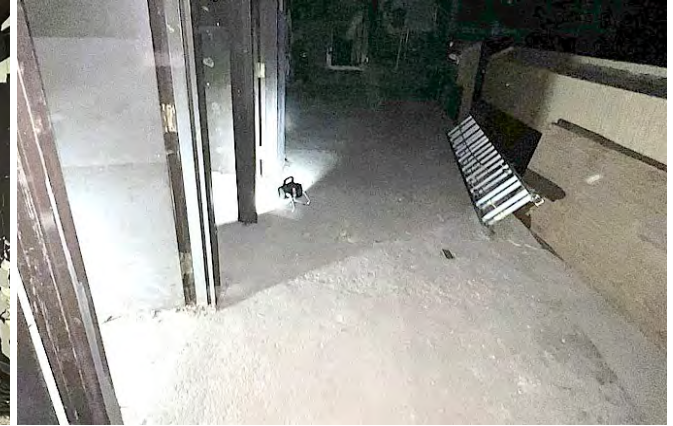
Summary of ACMs and PACMs

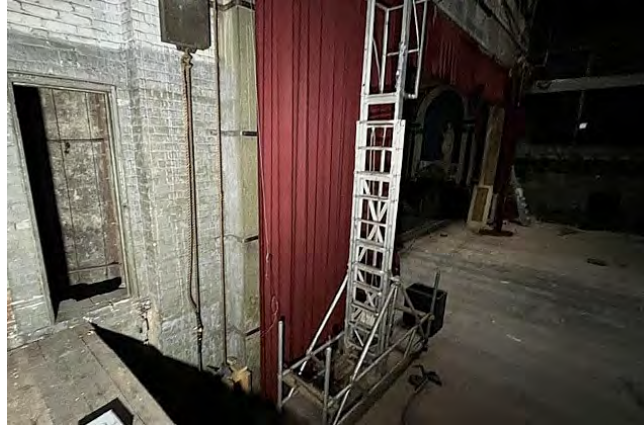
Summary of ACMs and PACMs

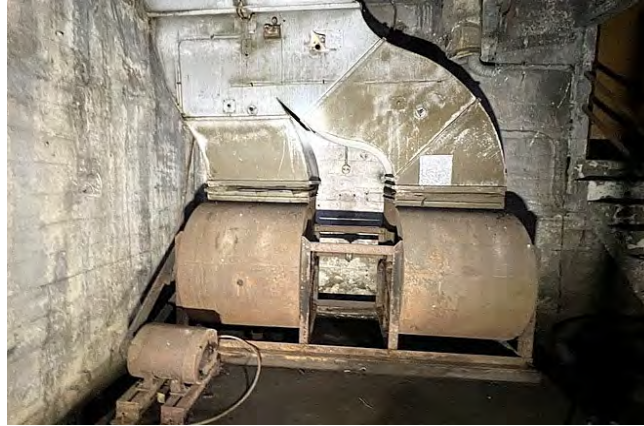
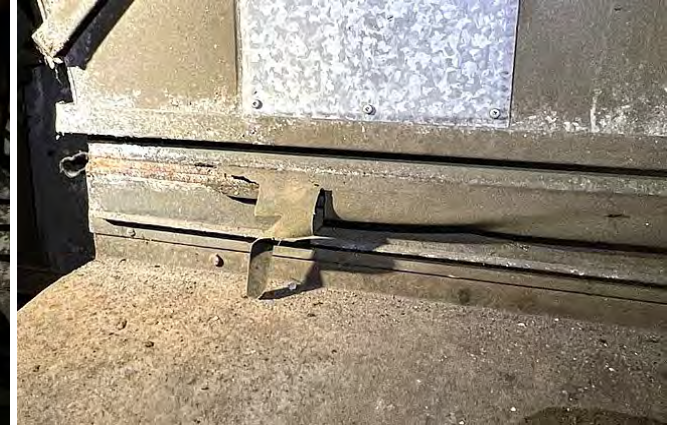
Summary of ACMs and PACMs

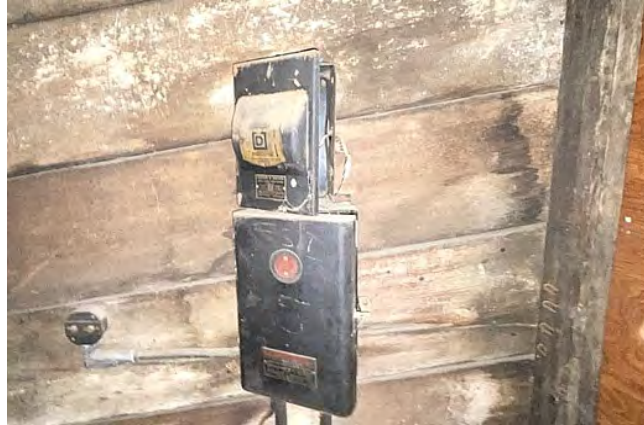
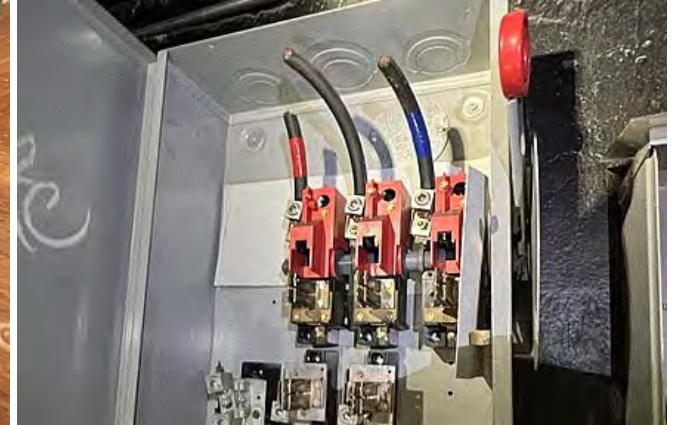
Summary of ACMs and PACMs

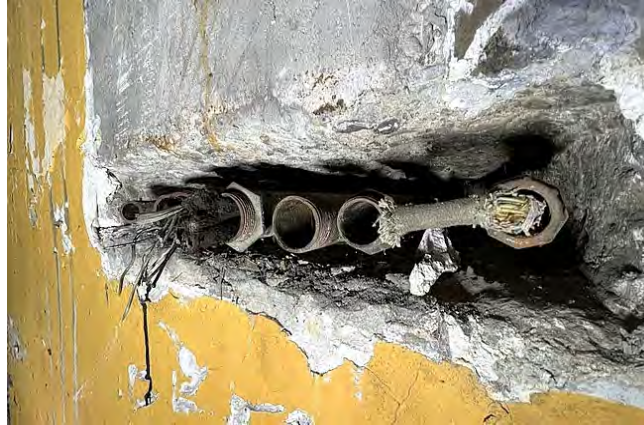
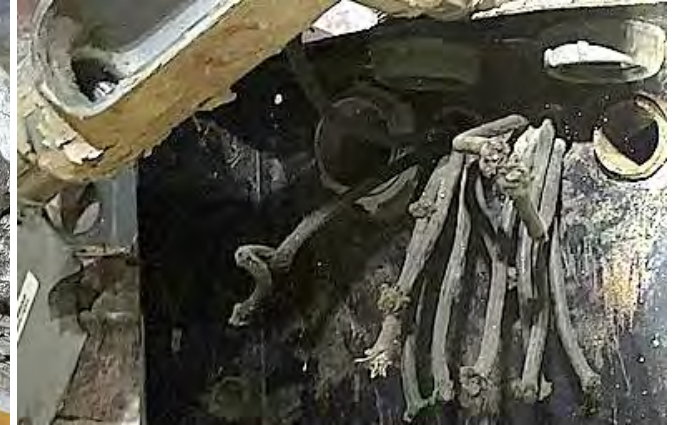
Summary of ACMs and PACMs

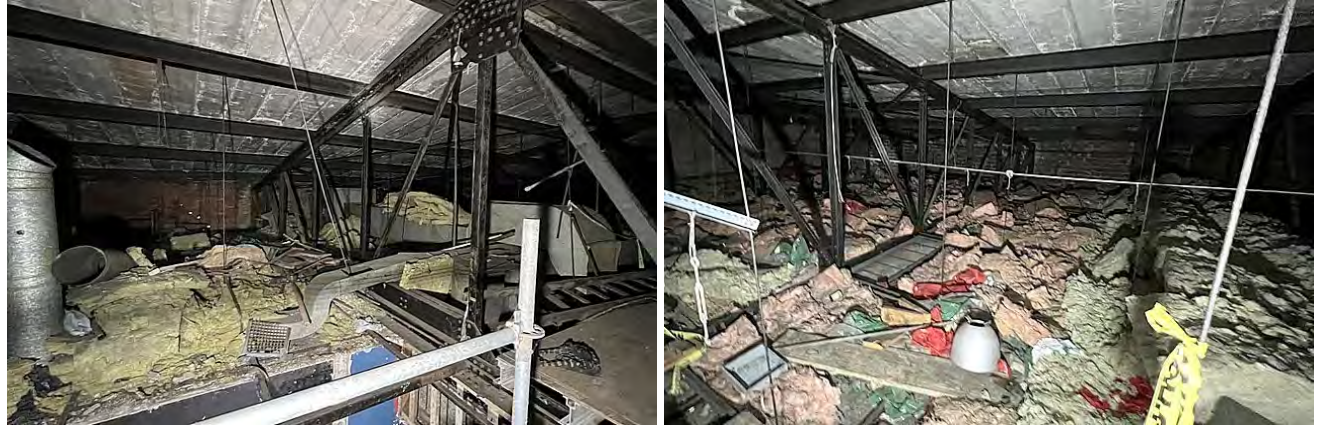
Summary of ACMs and PACMs

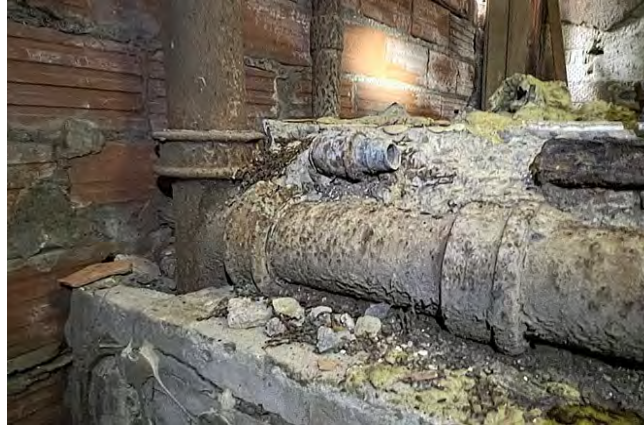
Summary of ACMs and PACMs

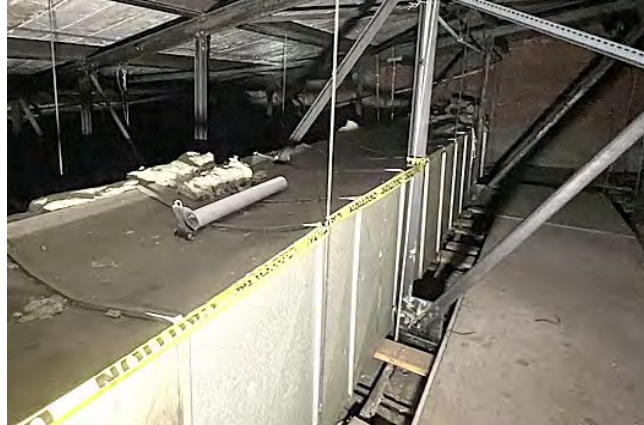
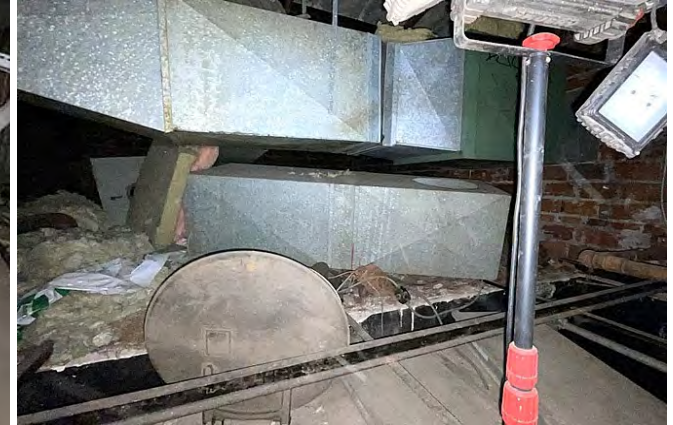
Summary of ACMs and PACMs

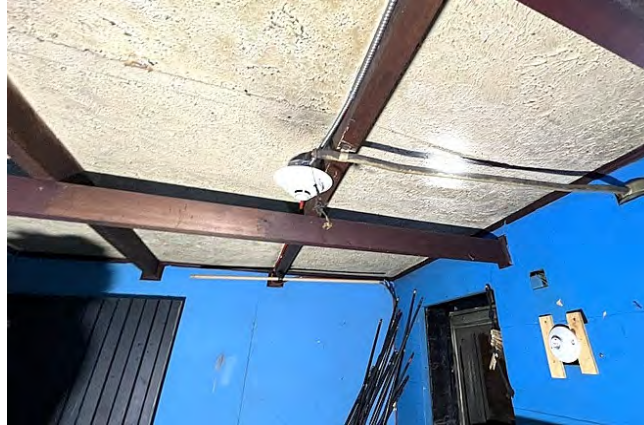
Summary of ACMs and PACMs

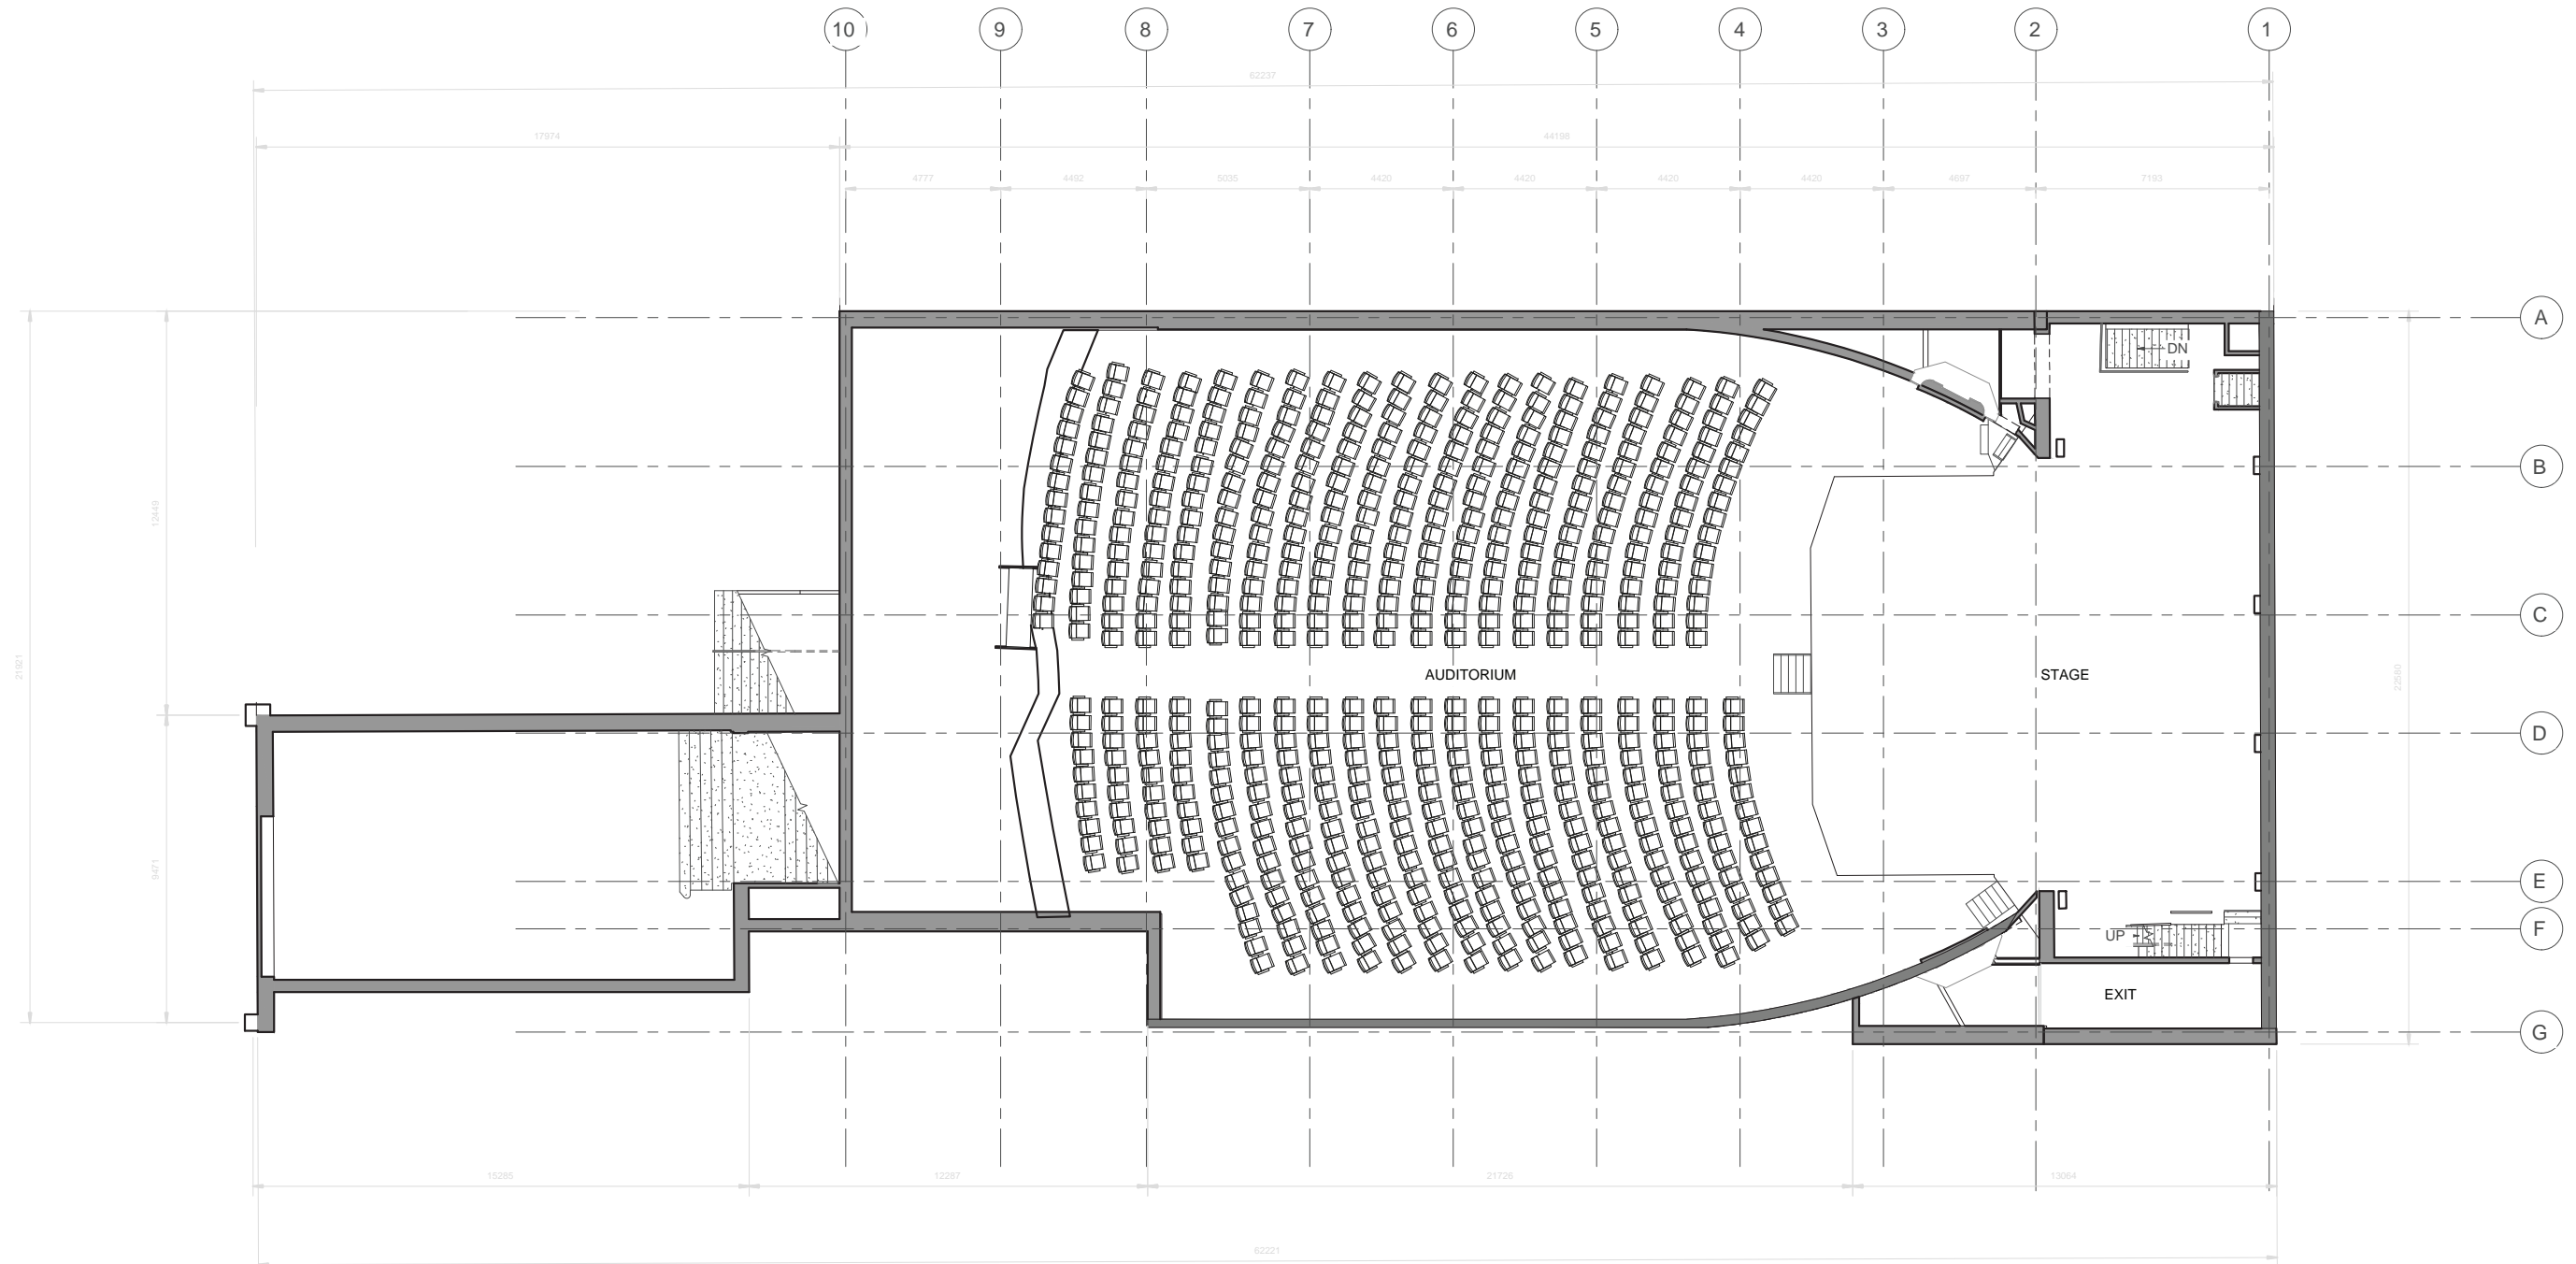
Tivoli Theatre - Ground floor plan [Source: Aventus Developments]

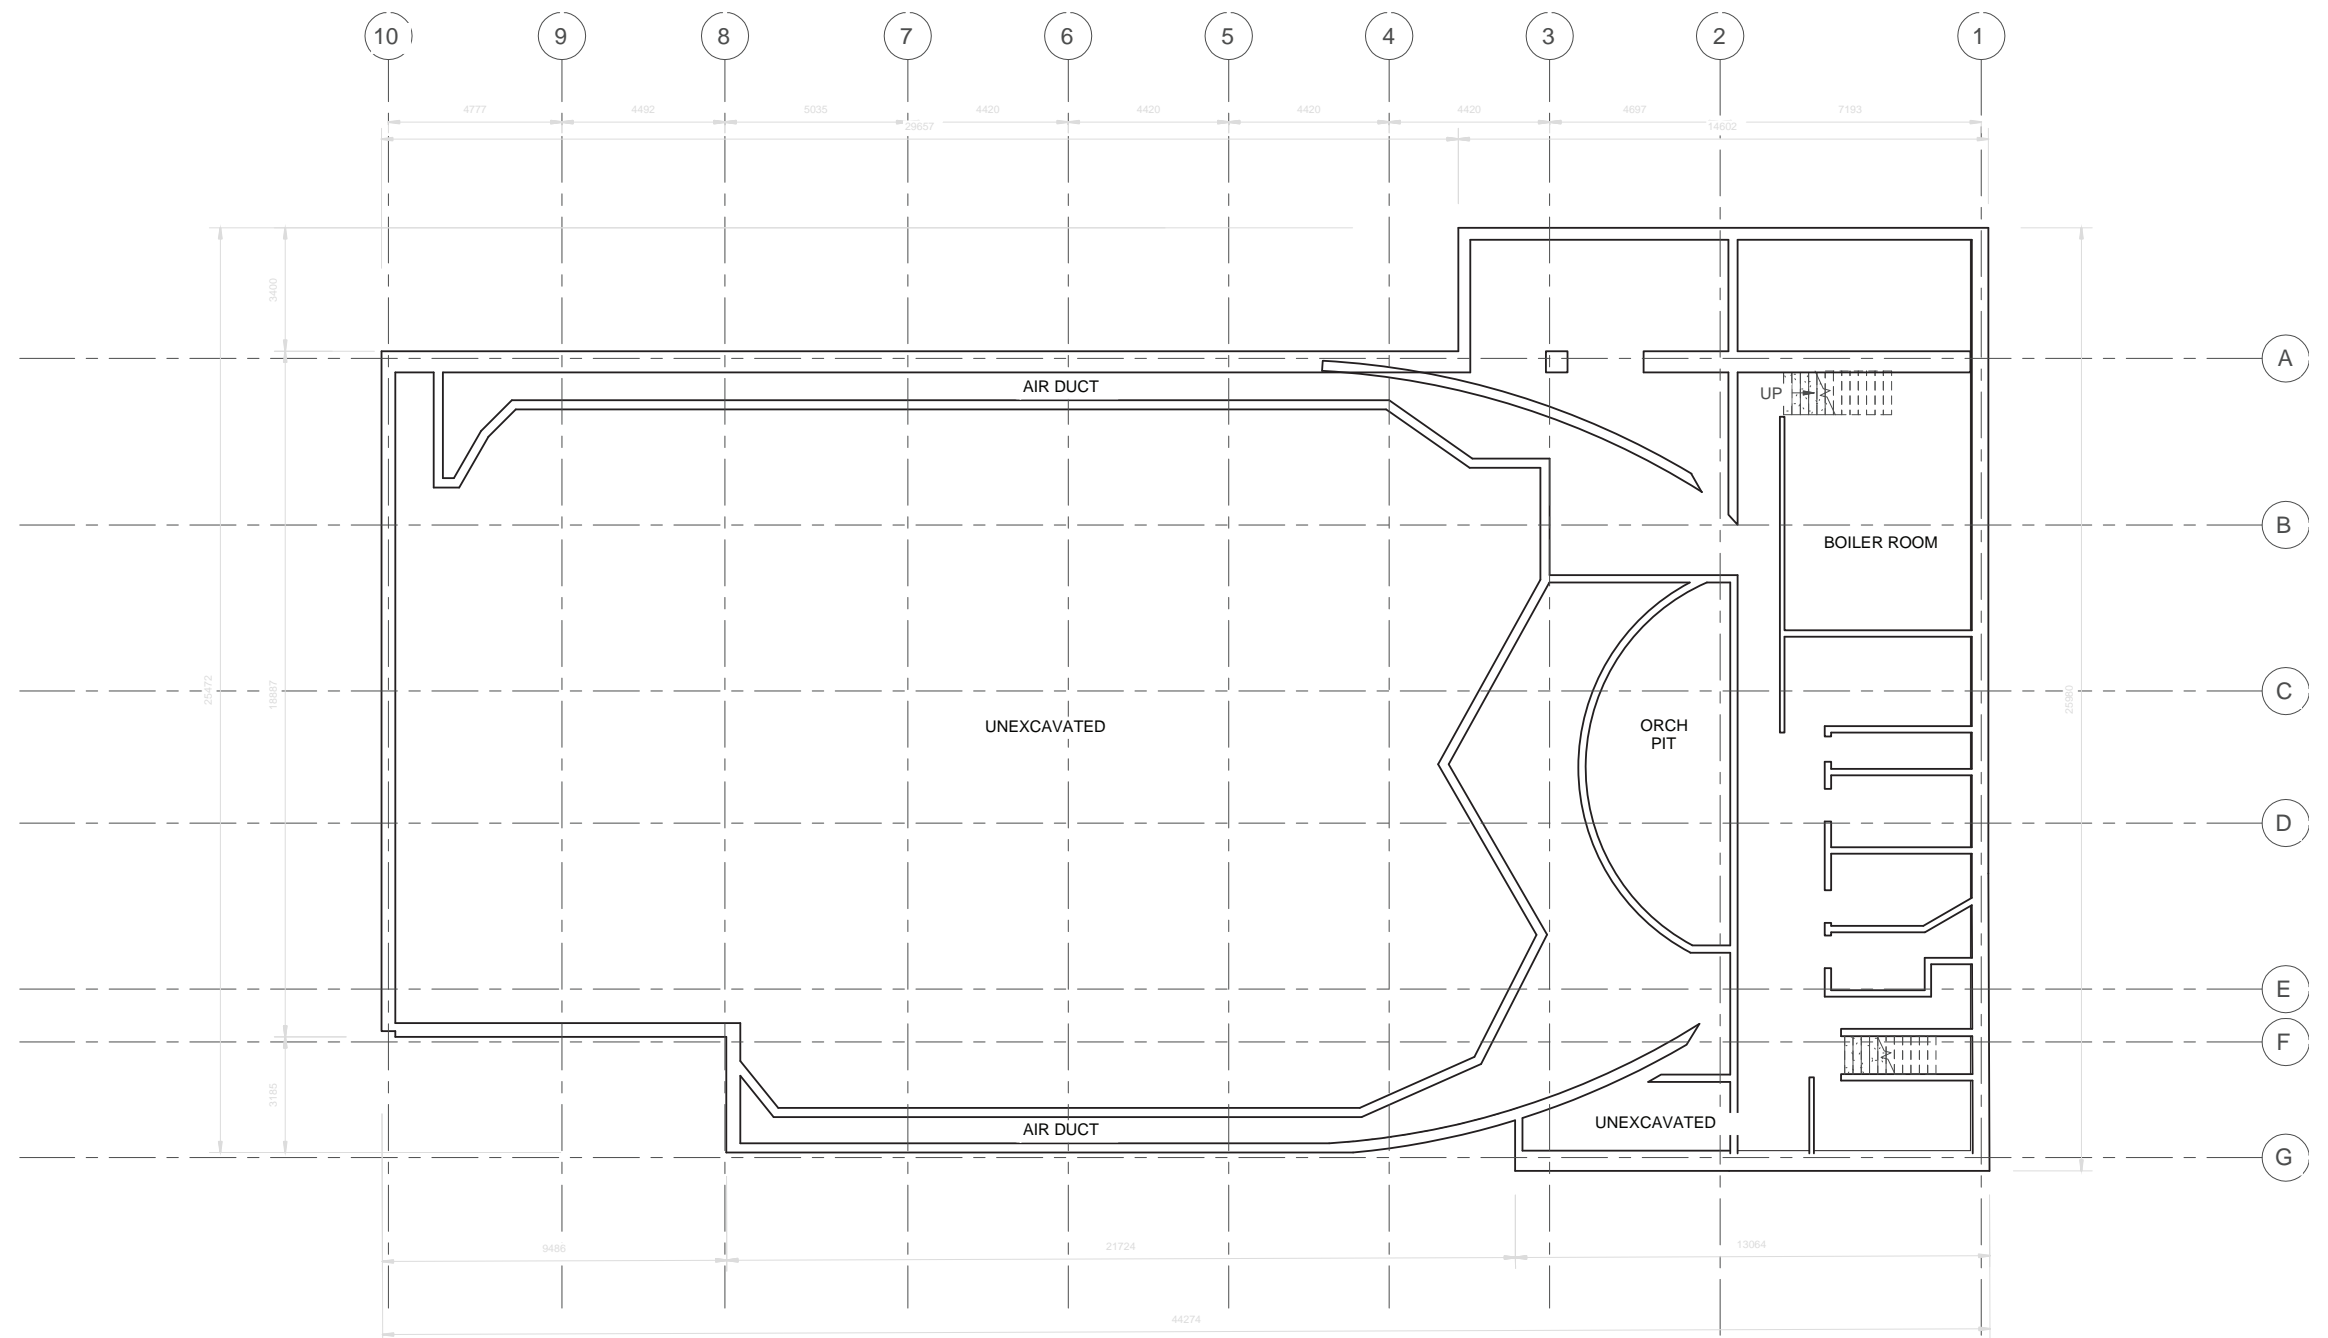
Tivoli Theatre - Basement floor plan [Source: Aventus Developments]

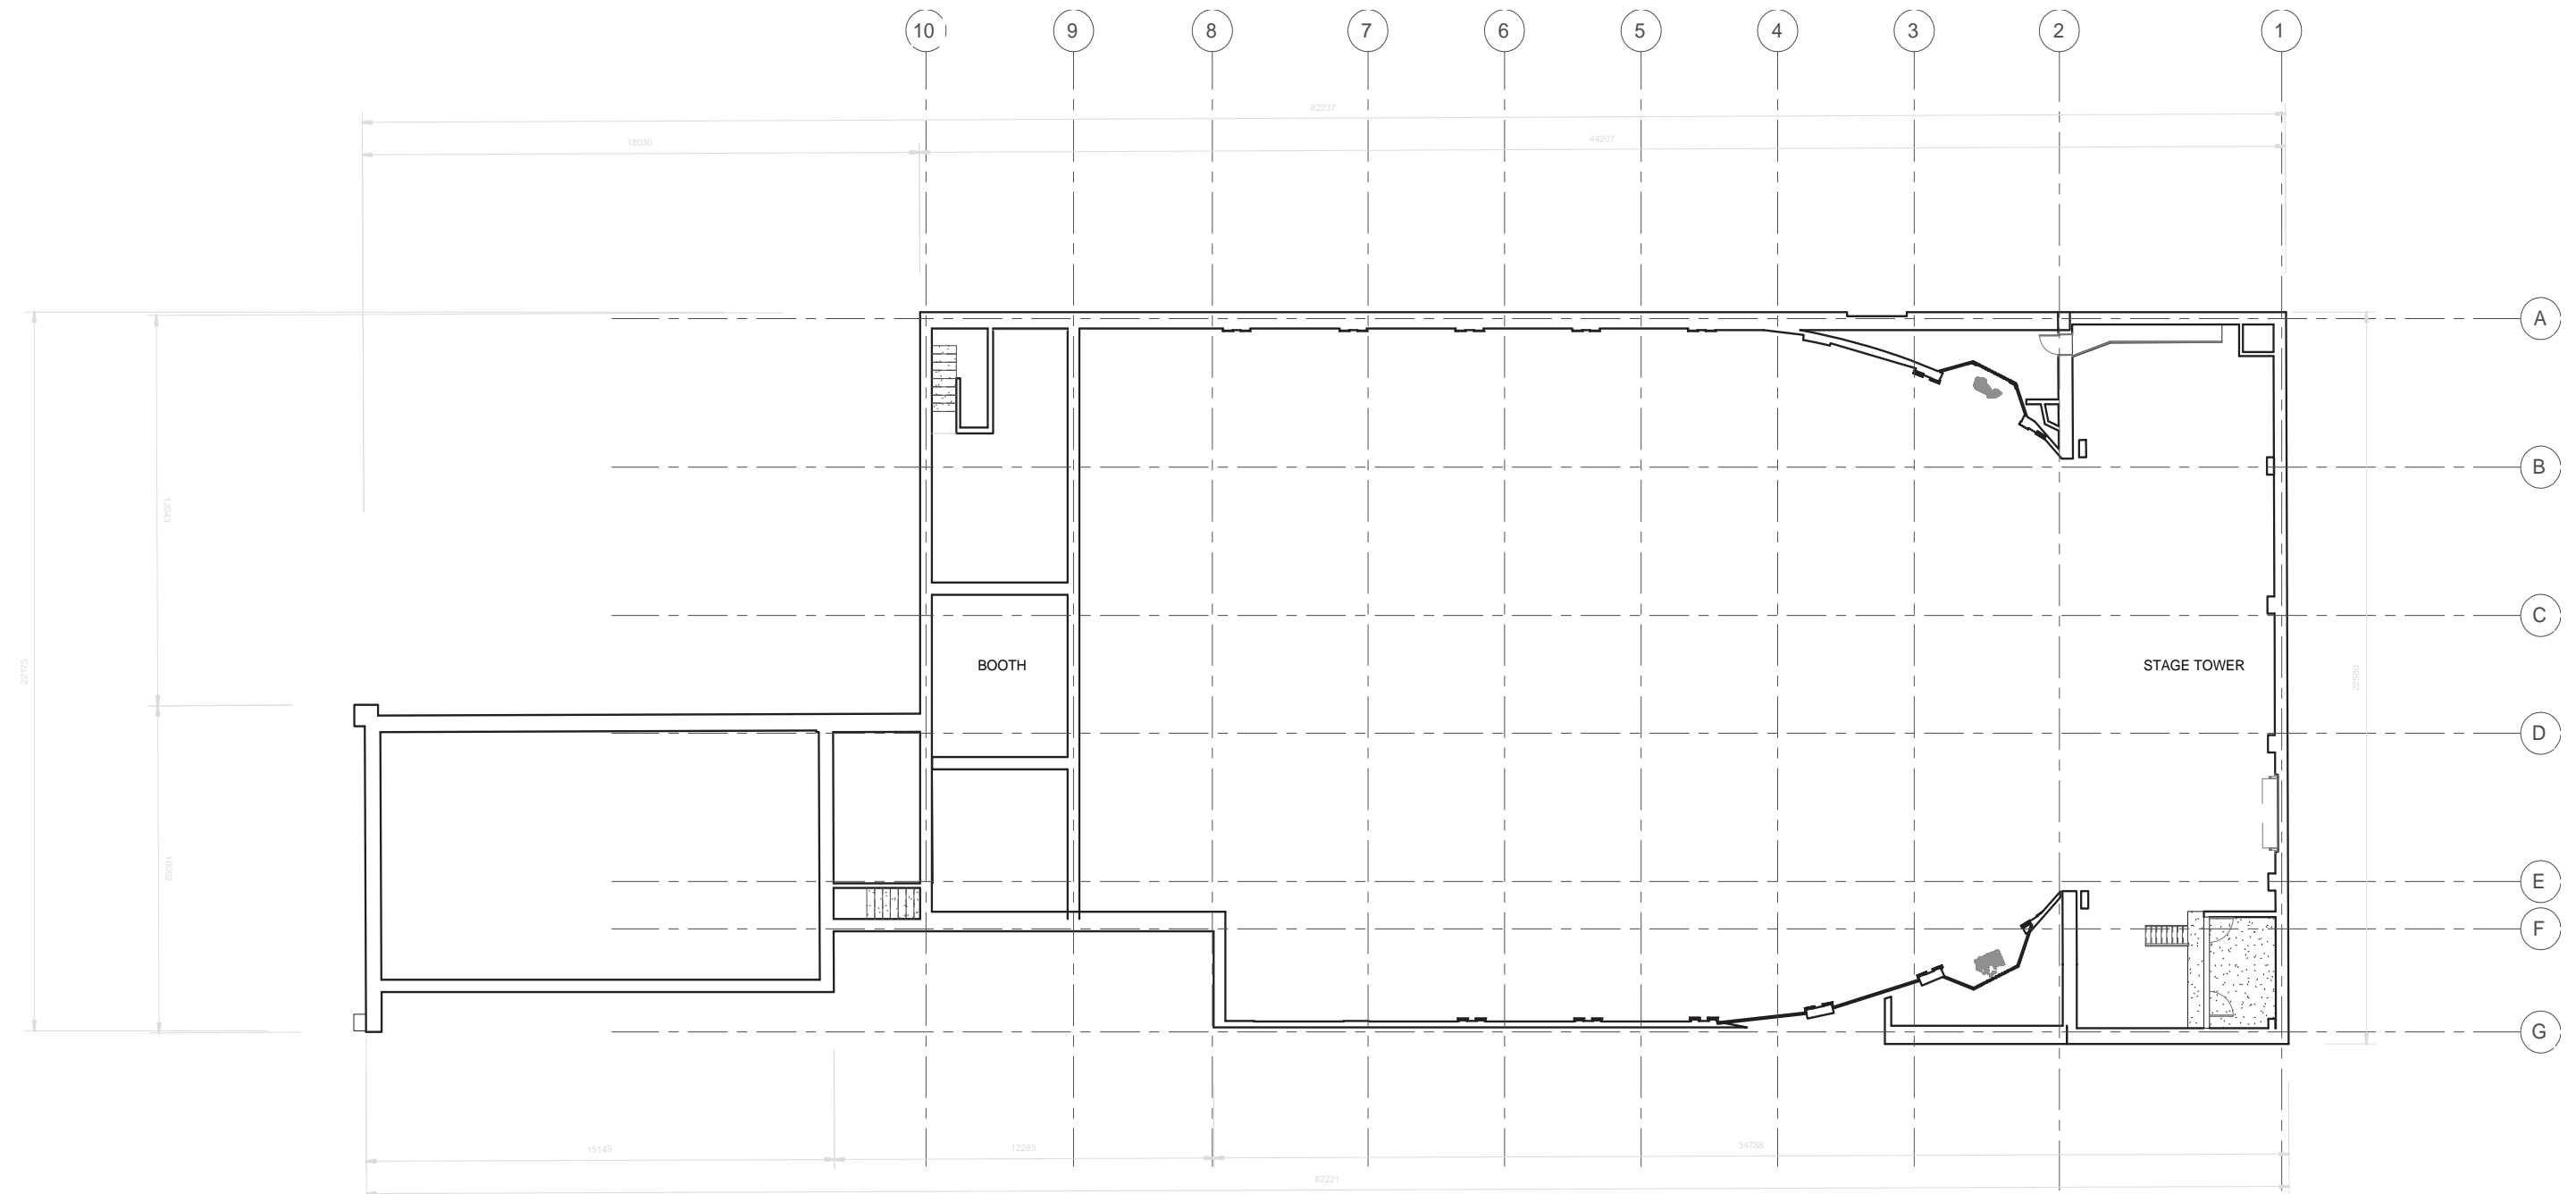
Tivoli Theatre - Basement floor plan [Source: Aventus Developments]

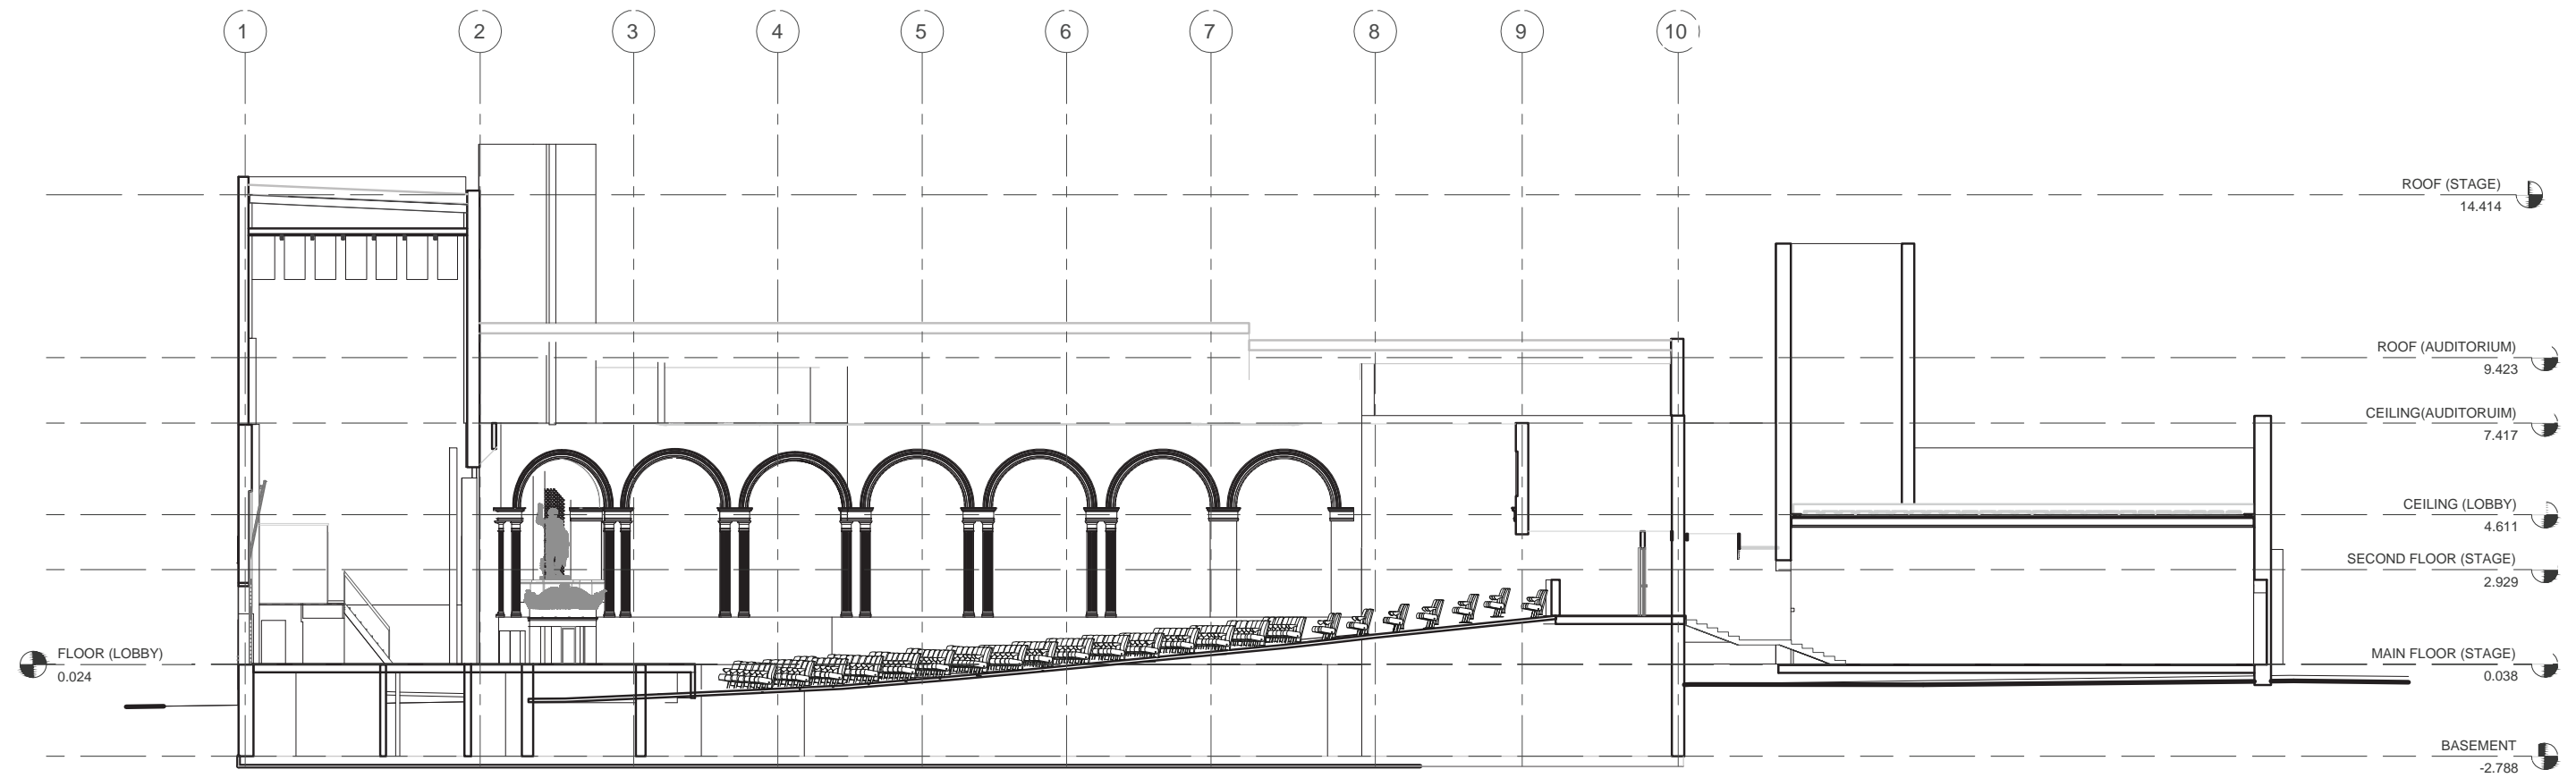
Tivoli Theatre - Section [Source: Aventus Developments]
