CONDITIONS & ALTERATIONS REPORT

191 Melville Street Dundas, Ontario

Issued: February 5, 2025

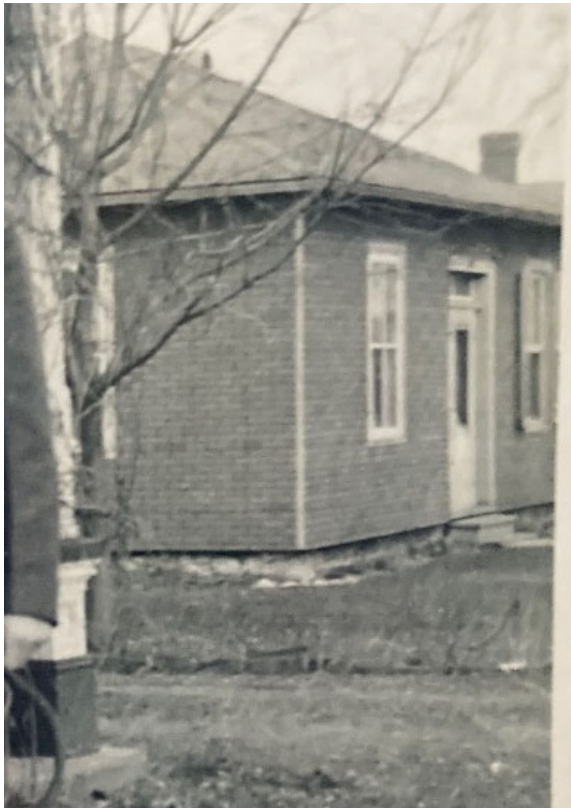
RIGHT North/East exterior front elevation circa 1943. Exterior was previously clad with *roughcast* a cementitious mortar mix with stone texture. At the date of this photo exterior was reclad with Insul-Bric siding on stacked fieldstone foundation. Note the extension of walls beyond existing stone foundation. Two distinctly spaced front facing windows with a central door complete with transom but no sidelights visible
RIGHT Photo credit: Woolley Family, 1943 (Ref.3)

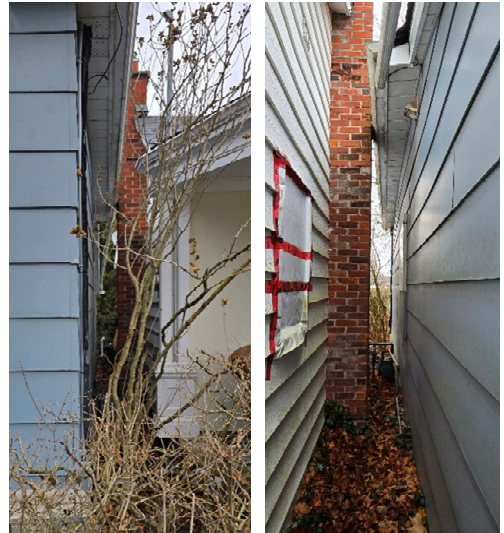
Side elevation photos
LEFT photo facing north between bldgs.
RIGHT photo facing south between bldgs.
Note that ex 191 Melville eaves trough is touching neighboring dwelling (Owner, 2024)

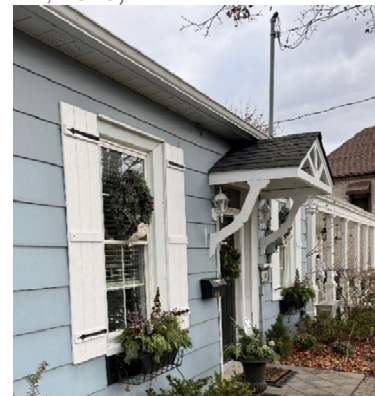
Front elevation covered roof at entry
(Park Eight, 2024)

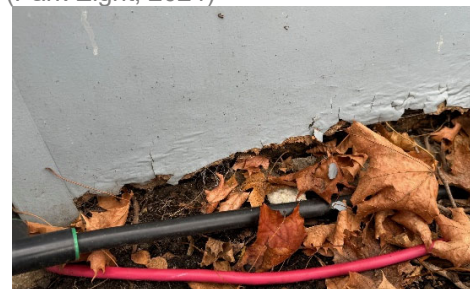
- The existing, non-original painted wood particle board siding is in fair shape overall. Defective conditions observed along bottoms near grade of perimeter see BOTTOM photo
- The existing, non-original pre-finished aluminum capping and trim are in good condition
- The existing, non-original painted wood shutters are in fair condition but not historically significant
- The existing, non-original asphalt shingles are in fair condition showing some granule loss
- The existing, non-original rooflines created by numerous additions over the years have created complex roof geometry that is challenging to maintain and prone to leaf & snow build-up. Additions extend along entire rear and side of house along the west side see TOP photo

Painted particle wood siding with matching painted corner caps being rotted at grade (Park Eight, 2024)

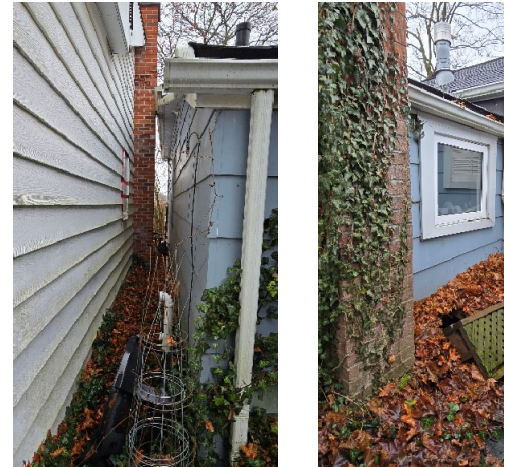
- Two brick chimneys very close to the property line along side elevation.

LEFT is a photo of the neighboring chimney located at 189 Melville touching the eaves trough of 191 Melville

RIGHT ivy-covered chimney at 191 Melville which has been repaired in the past. Note the different brick & mortar textures above roofline. Typically, chimneys would be centrally located to improve heat distribution. Note that this chimney is located on the north east corner

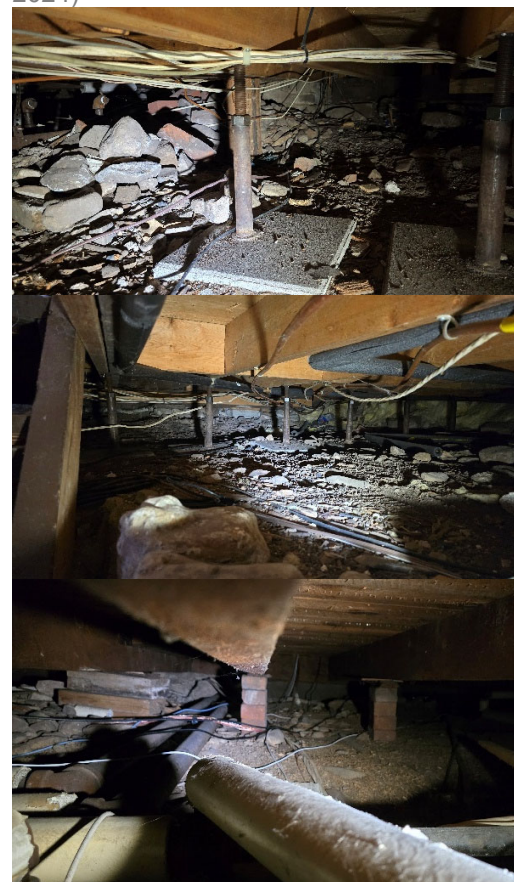
- The stacked fieldstone foundation partially dug out with dirt floor. Foundation is in poor condition showing deep mortar loss, material delamination and loose stone. Delamination is evident as early as the 1943 historical photo (Ref.3).
- Entirety of home is crawlspace with a small utility basement dug out of the middle comprised of limewash parged stone foundation walls which are experiencing delamination

- Several different styles of columns are present. This is a sign of unstable building especially how numerous
- The existing, non-original wood columns either show rot from contact with ground or comprised of more modern kiln-dried lumber stacked on the flat
- The stacked brick supports do not appear on footings of any sort
- The metal adjustable jack posts estimated 1950s are numerous and placed on concrete pavers which are not a suitable footing solution. See MIDDLE photo shows 6 columns in a line

Basement & crawl space (Owner, 2024)

- The existing, non-original floor framing comprise 2/3rd of the basement photos. Note the plywood subfloor pierced by conventional floor cleats which re-confirms additions were non-original and have undergone extensive replacement
- Only a portion of original rough-cut joists remain toward the front of building

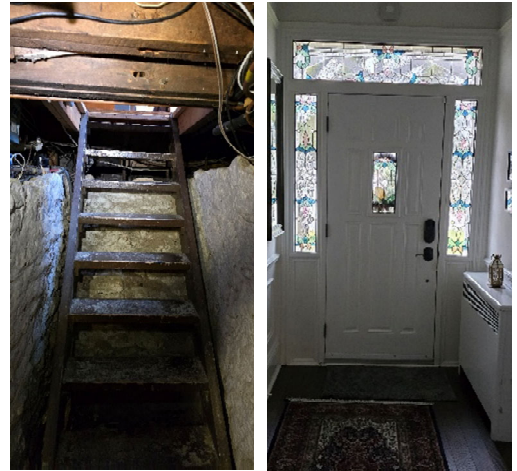
- The existing, non-original access stair leading down to partial utility basement is comprised of milled wood and not characteristic of the sharp edges & square nails found of rough sawn lumber
- Note the only rough sawn joists are visible at the header leading down stair roughly 1/3rd of visible framing. All floor members beyond are milled modern style remaining 2/3^{ds}

LEFT Basement stair (Owner, 2024)
RIGHT Door Interior (Owner, 2024)

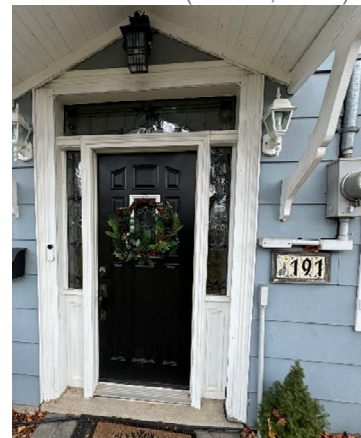
- Modern replacement of front door is apparent by the door material & inconsistent moldings at door surround visible from the exterior
Redundancy of 3 exterior lights & awkward placement of the electrical meter directly on the front of the home with heavy conduit. All features illuding to multiple renovations over time aimed for convenience rather than charm.
- Previous historical photos show a transom but no sidelights visible. Note the matching stained glass insert in the modern door is a perfect match to the remaining glass. The stained glass itself with wavy texture, shallow bevels and modern round frame style appears to be non-original. TOP RIGHT

Door exterior (Park Eight, 2024)
