## **BUILDING CONDITION ASSESSMENT**

### **96 JOHN ST. S, HAMILTON, ONTARIO**

**MARCH 2025**

**PROJECT NUMBER: 2025-JPS-013**

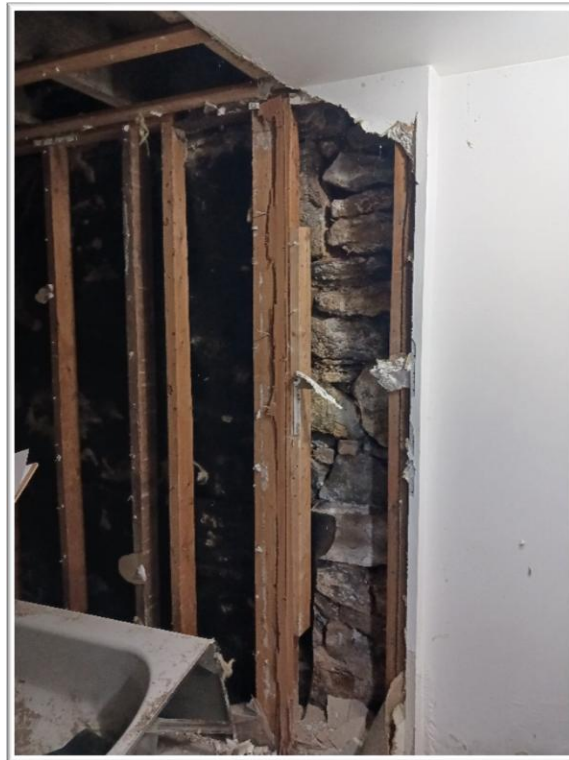
The existing rubble foundation wall is not waterproofed from the exterior, resulting in significant water infiltration. Over time, this has led to deterioration of the foundation material, weakening the structural integrity of the building. Addressing these issues would require exterior excavation, installation of a proper waterproofing membrane, a weeping tile system to manage water drainage, and repointing of the stone wall to restore its stability. Without these measures, continued water penetration will accelerate deterioration and further compromise the foundation's load-bearing capacity.

**Figure 3:** Damaged Foundation wall

The rubble foundation has experienced extensive deterioration due to prolonged water infiltration. The lack of waterproofing has allowed moisture to seep into the foundation walls, weakening their load-bearing capacity and accelerating material degradation.

To address this issue, the foundation must be excavated, cleaned, and waterproofed to prevent further moisture penetration. A waterproof membrane should be applied to the exterior foundation wall to create a sealed barrier against water infiltration. Additionally, a weeping tile system must be installed at the base of the foundation to effectively redirect groundwater away from the structure. Repointing of deteriorated mortar joints and stone replacements will be necessary to restore structural integrity. These measures will reduce water-induced deterioration and enhance the long-term stability of the foundation.

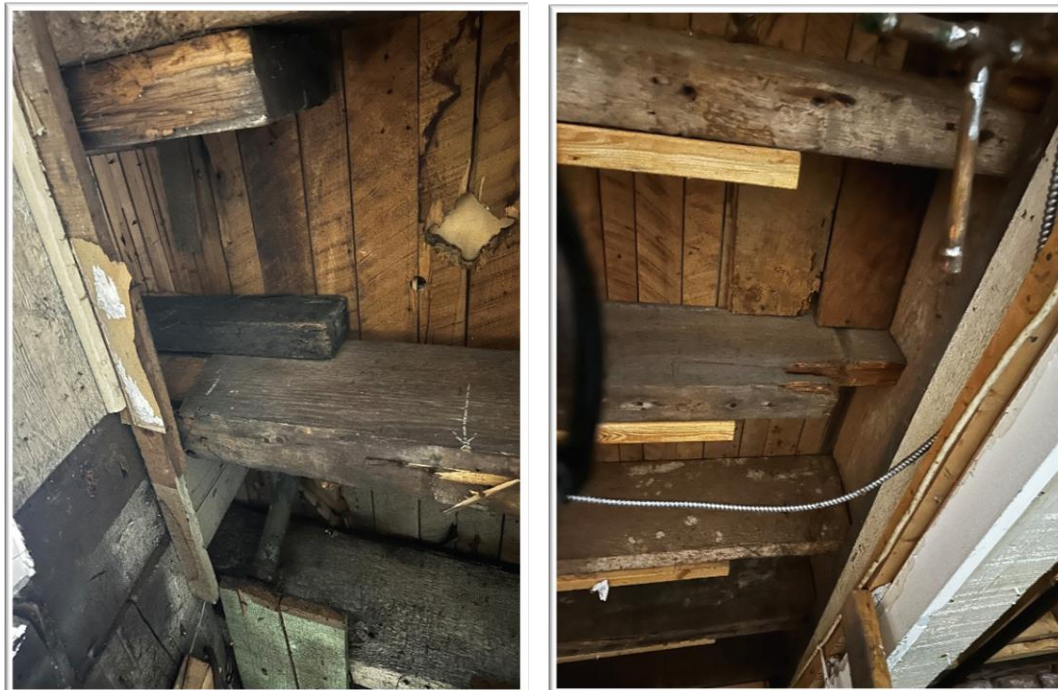
Significant structural deficiencies were observed on the ground floor joists, primarily due to water infiltration from the exterior grade level. The ground floor is at the same elevation as the exterior, allowing moisture to penetrate and cause extensive damage at the joist support points. A load-bearing wall was introduced at some point to provide additional support, but it has since deteriorated, further reducing the floor system's overall stability.

Additionally, the ground floor joists lack proper bearing on the supporting beams, which does not comply with standard building code requirements. Approximately 90% of the floor joists spanning from the south wall to the middle beam either have insufficient bearing or are not properly secured to the main beam. As per structural standards, joists must either have a minimum bearing length on beams or be secured using joist hangers to ensure adequate load transfer. However, in this case, the joists appear to be loosely

resting on the beams or wedged between adjacent elements without proper support. This condition significantly increases the risk of joist movement, deflection, or even dislodgment under load.

The combined effects of moisture-related deterioration and improper bearing conditions severely compromise the stability of the ground floor system. Without corrective measures, these deficiencies could lead to localized floor failures or progressive structural weakening. To address these issues, damaged joists must be replaced or reinforced, proper bearing must be ensured on beams, and structural joist hangers should be installed where necessary. Additionally, waterproofing measures should be implemented at the foundation level to prevent further water infiltration and protect the integrity of the ground floor structure.

**Figure 4: Inadequate Joist Bearing**

The ground floor joists have deteriorated significantly due to moisture infiltration and lack of proper bearing conditions on the beams. The absence of secure connections between the joists and beams increases the risk of movement, deflection, and localized failure.

To correct these deficiencies, all damaged ground floor joists must be replaced or reinforced. Joists that have lost material integrity at their support points should be removed and replaced with properly sized members. Additionally, secure bearing conditions must be established by ensuring that the joists meet the minimum bearing length on beams or by installing code-compliant joist hangers. Structural reinforcement of the supporting beams may also be required to improve overall load distribution and floor stability.

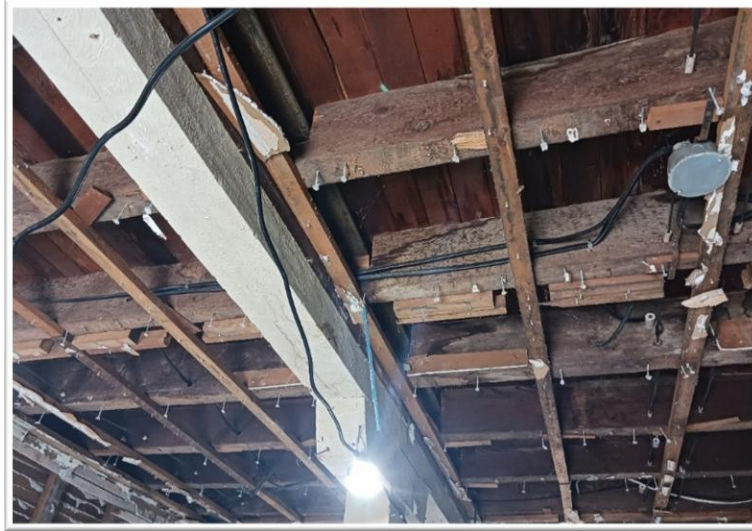
All existing second-floor joists have been cut at their support points on top of the middle beam by a plumber to accommodate piping. This alteration has significantly weakened the structural integrity of the floor, as the joists are no longer able to provide adequate support. The removal of critical portions of the joists reduces their load-carrying capacity and increases the risk of localized failures, further compromising the overall stability of the building.

**Figure 5:** Compromised Joists Due to Top Cuts for Plumbing Installation

To restore structural integrity, proper reinforcement of the cut joists is necessary, either by installing sister joists or other structural strengthening measures. Without intervention, the weakened second-floor joists increase the likelihood of progressive structural failure.

The second-floor joists have been severely compromised due to modifications where the tops of the joists were cut at their bearing points to accommodate plumbing installations. This alteration has significantly weakened their ability to carry loads, increasing the risk of localized failures.

To restore their load-bearing capacity, additional support joists must be installed alongside the compromised members to strengthen the existing structure. These new joists must be properly fastened and secured to ensure effective load distribution. If the extent of damage is severe, full replacement of the affected joists may be necessary. Additionally, any future mechanical or plumbing modifications must be carefully planned to avoid further weakening of structural components. Proper review and coordination should be conducted to ensure that essential load-bearing elements remain intact.

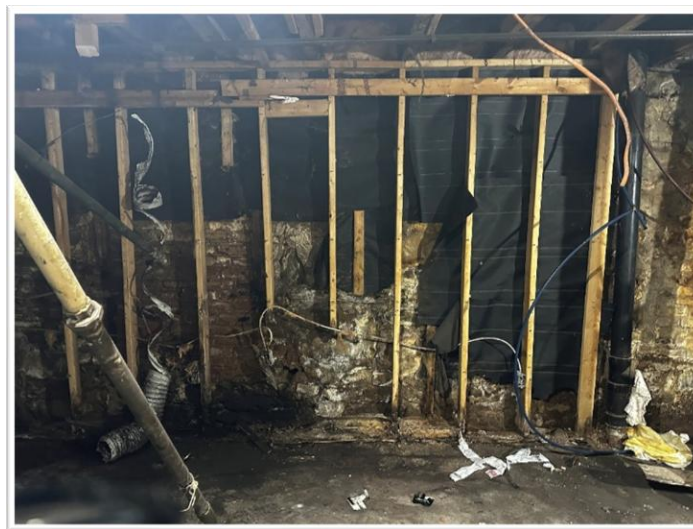
The north exterior wall was originally an interior wall but became an exterior wall after a portion of the building was demolished. However, it was never properly waterproofed, allowing water infiltration over time. The continuous exposure to moisture has led to material degradation, weakening the structural performance of the wall. Without proper waterproofing, the deterioration will persist, further jeopardizing the building's stability.

**Figure 6:** Improper Waterproofing

The north exterior wall was originally an interior partition and was not designed to withstand continuous moisture exposure. The absence of waterproofing has led to material deterioration, weakening the overall stability of the wall.

To prevent further degradation, the wall must be properly waterproofed using a moisture barrier and sealants. If sections of the masonry show severe material loss, localized repairs or reinforcement will be necessary to restore its structural integrity. Ensuring proper waterproofing and drainage will prevent recurring water damage and improve long-term durability.

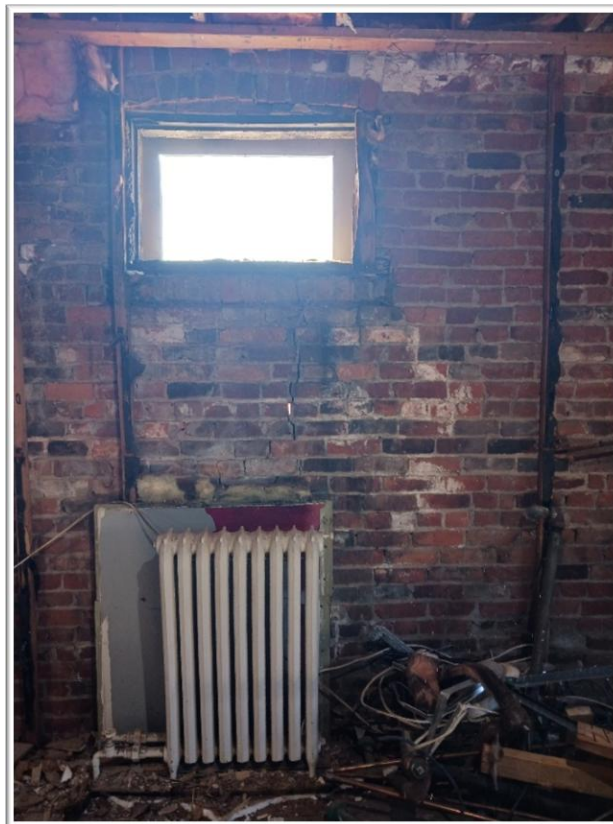
Significant cracking was observed in the exterior masonry wall, which serves as a load-bearing element supporting the floor joists. The cracks, particularly around the window opening, indicate structural distress

and potential weakening of the wall's load-carrying capacity. A prominent vertical crack extends downward from the window, suggesting differential settlement or structural movement.

Additionally, the lintel beam above the window exhibits visible cracks, which may be attributed to excessive loading, material degradation, or insufficient reinforcement. Since this wall plays a critical role in supporting the floor system, any compromise in its integrity can lead to further structural instability. Water infiltration through these cracks can accelerate deterioration, weakening the masonry and increasing the risk of localized failure. Given the extent of damage, addressing these issues would require a detailed structural intervention rather than localized repairs to ensure the stability of the load-bearing wall and its supported elements.

**Figure 7:** Crack on Exterior Load Bearing Wall and Lintel

The exterior load-bearing masonry wall exhibits significant structural distress, with visible cracks around a window opening. These cracks indicate differential settlement or material failure, reducing the wall's ability to carry floor loads. Additionally, the wood lintel above the window has cracked and deflected, suggesting material degradation or excessive loading.

Given the extent of damage, a localized repair approach is not sufficient. To ensure long-term structural stability, the damaged sections of the wall must be rebuilt, and the compromised lintel must be replaced with a properly reinforced structural member. The masonry at the bearing points of the lintel must also be reconstructed to restore adequate load distribution.

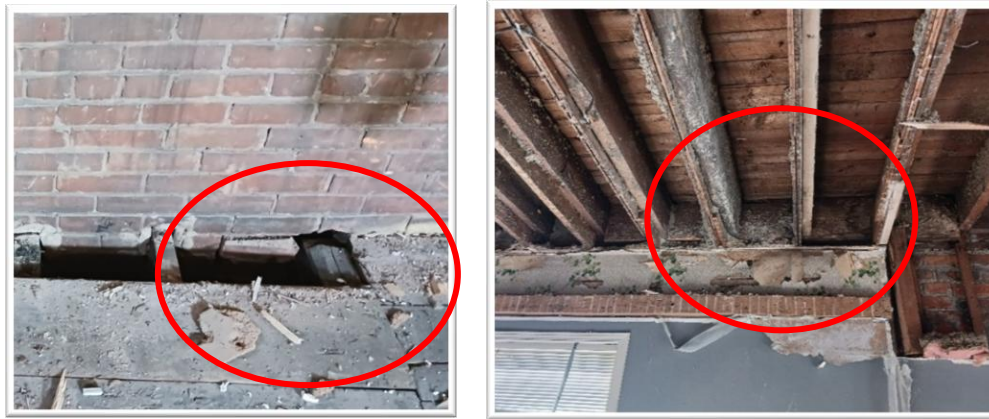
The floor joists exhibit inadequate bearing conditions on load-bearing walls, compromising structural stability. In one instance, a joist had been cut at the top near its support, reducing its effective bearing area and weakening its load transfer capacity. Additionally, a visible gap between the joist and the wall suggests either differential settlement or localized material loss at the bearing point, further reducing structural support.

As shown in the image, several joists lack proper bearing on the exterior load-bearing wall, appearing to rest partially on deteriorated material. The absence of sufficient bearing prevents effective load transfer, increasing the risk of localized failures and excessive deflection over time. The weakened condition of the bearing points further reduces the structural integrity of the floor system.

Figure 8: Inadequate Joist Bearing on Load-Bearing Wall

To restore stability, joist connections must be reinforced, and proper bearing conditions must be reestablished. Where joists do not fully seat on the exterior wall, corrective measures such as extending the joists, installing ledger boards, or using engineered joist hangers must be implemented. Addressing these deficiencies is essential to prevent further structural weakening and ensure the long-term integrity of the floor system.

A floor joist was found to have been cut at the top near its support on a load-bearing wall. Additionally, a visible gap between the joist and the wall suggests differential settlement or material loss at the bearing point.

To restore proper load transfer, the bearing area must be repaired, and the joist connection must be reinforced. If settlement is a contributing factor, additional structural stabilization measures may be required to prevent further displacement.

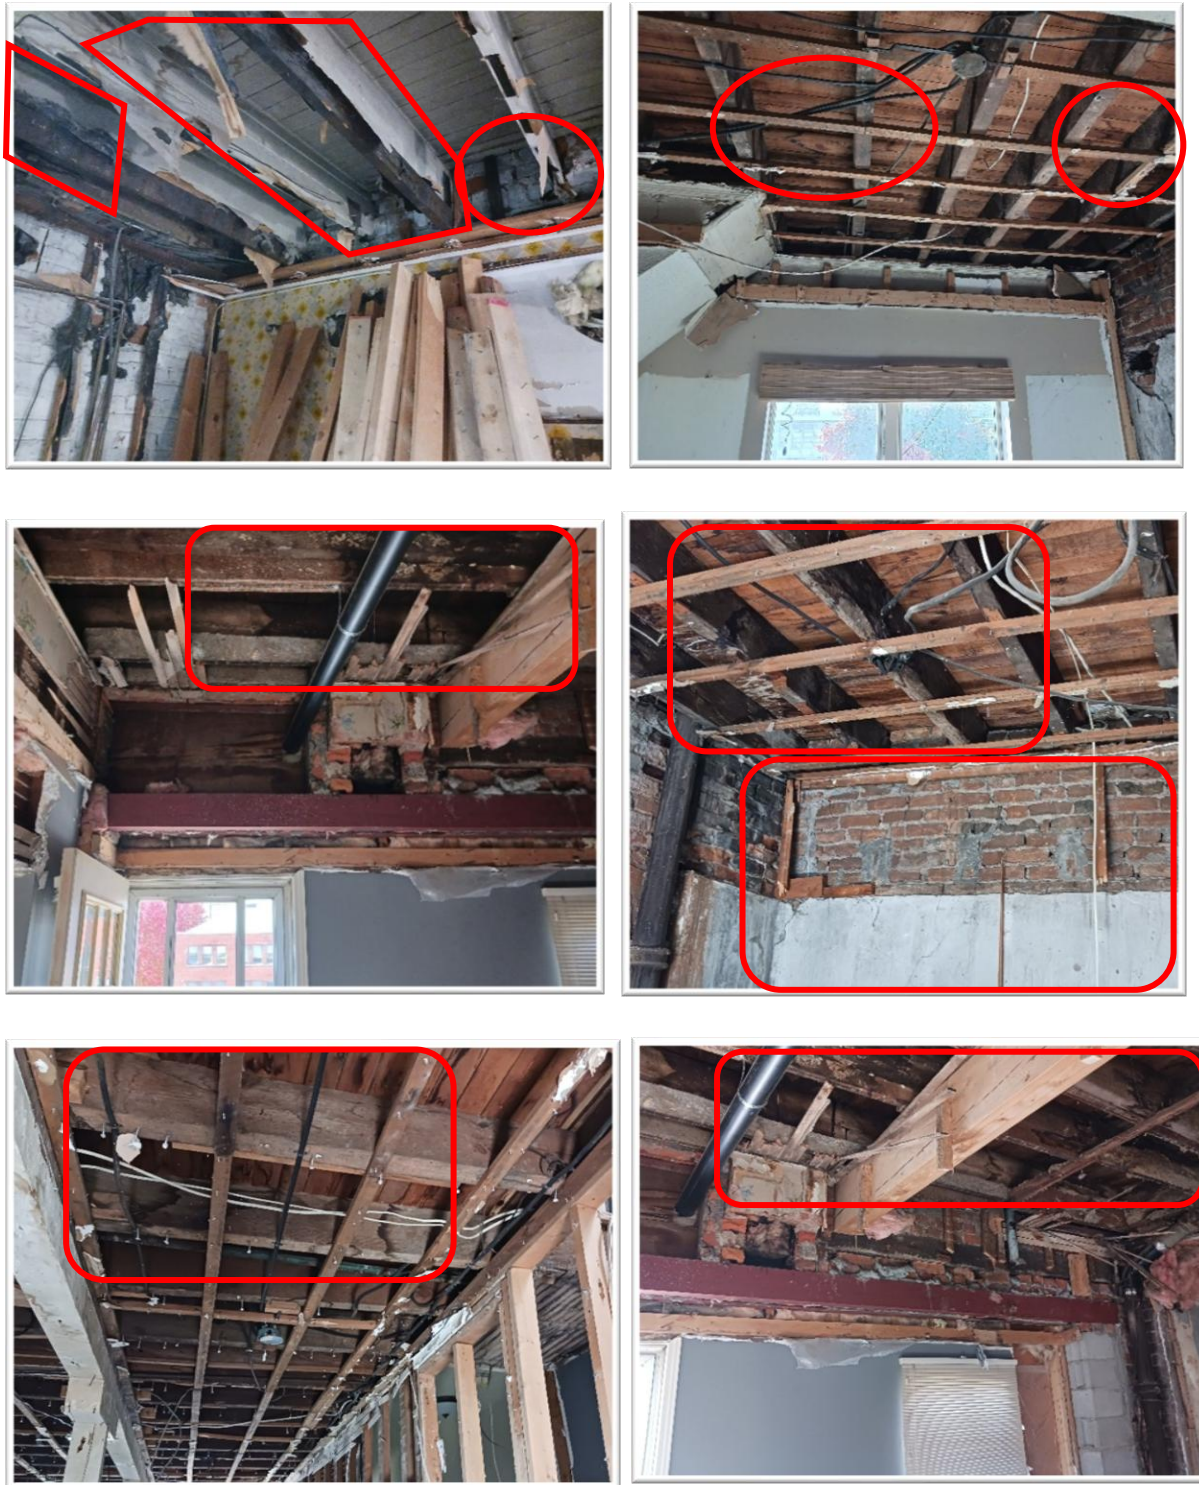
Severe deterioration of the floor joists is evident in multiple areas throughout the building, primarily due to prolonged water infiltration. These joists, which are critical structural components, rest on a load-bearing masonry wall and are responsible for transferring floor loads to the supporting structure. Visible signs of damage include wood decay, discoloration, and partial material loss, indicating long-term moisture exposure. In some locations, sections of the joists appear to have weakened significantly or rotted away, reducing their ability to provide proper support. Additionally, the floor panels above show water infiltration marks, confirming widespread moisture damage. The continuous exposure to water has severely compromised the structural integrity of both the floor system and its supporting elements.

The load-bearing masonry wall beneath the joists also exhibits significant distress, further compounding the structural issues. Signs of deterioration include missing mortar joints, crumbling bricks, and localized material loss at the upper section where the joists are supported. Moisture infiltration has weakened the masonry bond, reducing its ability to provide stable support. In several areas, gaps are visible between the joists and the wall, likely due to settlement, displacement, or material deterioration at the bearing points. The compromised condition of both the joists and the masonry wall affects the overall load transfer, increasing the risk of structural failure.

**Figure 9:**Joist deterioration due to water infiltration and load bearing wall cracks

To restore stability, the damaged sections of the load-bearing wall must be repaired by replacing deteriorated bricks and mortar, ensuring proper load distribution. Additionally, affected joists will require

reinforcement or replacement to restore their structural capacity. Addressing the root cause of water infiltration is also essential to prevent further deterioration and ensure the long-term stability of the structure.

The floor joists and load-bearing masonry wall have been severely affected by water infiltration, resulting in wood decay, material loss, and weakened structural performance. The masonry wall supporting these joists has also suffered significant deterioration, with crumbling mortar joints and missing sections.

To restore stability, the damaged floor joists must be reinforced or replaced. Any joists that show signs of advanced material loss must be replaced with structurally sound members. Additionally, the load-bearing masonry wall must be repaired by replacing deteriorated bricks and repointing mortar joints to restore its load-carrying capacity. Waterproofing the surrounding areas is critical to prevent future water-related deterioration.

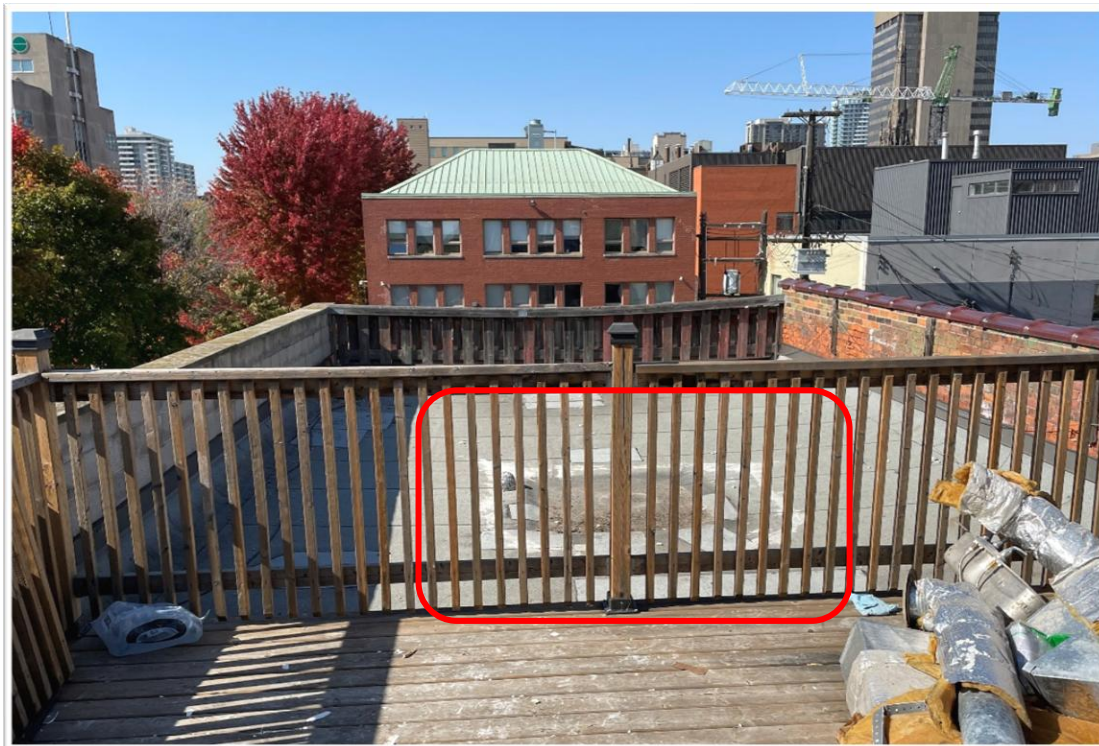
A noticeable dip is present on the roof, indicating failure of the underlying roof joists. This deflection suggests that the joists have bowed under excessive loading or weakened due to long-term deterioration. When joists fail, they lose their ability to maintain a level surface, resulting in a sagging roof structure.

Additionally, the roof drainage system is located to the left of the dip, meaning water will not naturally flow toward the drain. Instead, water is likely to accumulate in the depressed area, leading to water ponding issues during rainfall. Prolonged moisture exposure can further weaken the joists, accelerating structural deterioration and increasing the risk of further deflection or collapse.

**Figure 10:** Significant Dip on the Roof

To restore the structural integrity of the roof, the failed joists must be reinforced or replaced, and the roof slope should be corrected to ensure proper drainage. Additionally, the drainage system should be evaluated to determine whether repositioning or additional drains are required to prevent further structural issues.

The noticeable dip in the roof indicates that the underlying roof joists have failed. This deflection prevents proper drainage, increasing the risk of water ponding and accelerating deterioration.

To correct this issue, all failed roof joists must be replaced or reinforced. Additionally, the roof slope must be adjusted to ensure that water flows toward the drainage system rather than accumulating in depressed areas. The existing drainage system should be reevaluated, and if necessary, repositioned or supplemented with additional drains to prevent future water-related structural issues.

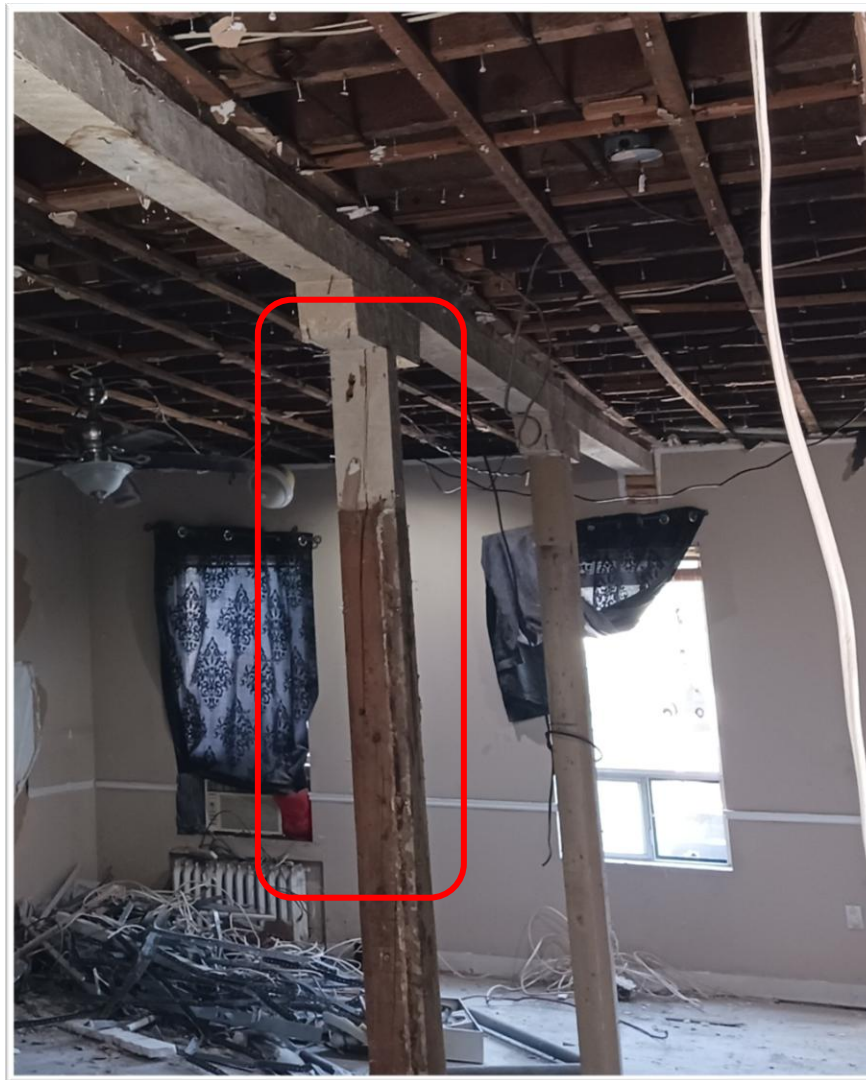
A significant vertical crack is visible on the structural wood column, extending from the top to approximately midway down its length. This column plays a critical role in supporting the beam above, which in turn carries floor and ceiling loads. While the crack may not pose an immediate structural concern, continued expansion of the crack over time could severely compromise the column's stability, ultimately leading to failure of the structure it supports.

Vertical cracks in a wood column typically develop due to excessive loading, drying shrinkage, or material defects. If the crack continues to widen, it will reduce the column's effective cross-section, weakening its capacity to transfer loads. Over time, if left unaddressed, this damage could lead to further splitting, increased deflection in the supported beam, and potential structural failure. This issue was also observed at another location in the building, reinforcing the need for preventative action before the cracks progress further.

**Figure 11:** Cracked Structural Column

To prevent future failure, reinforcement or replacement of the column should be considered. If reinforcement is pursued, methods such as steel plate wrapping or bolted splints could be used to improve the column's load-bearing capacity and prevent further cracking. However, if the crack continues to grow and significantly compromises the column's strength, complete replacement will be necessary to ensure the structural integrity of the building.

A significant vertical crack was observed in a primary structural wood column, reducing its ability to effectively transfer loads. While the crack may not pose an immediate failure risk, continued widening could lead to loss of column stability.

To prevent progressive failure, the cracked column should be reinforced using steel plate wrapping or bolted splints. If the crack continues to expand, full replacement will be required to ensure long-term structural stability.

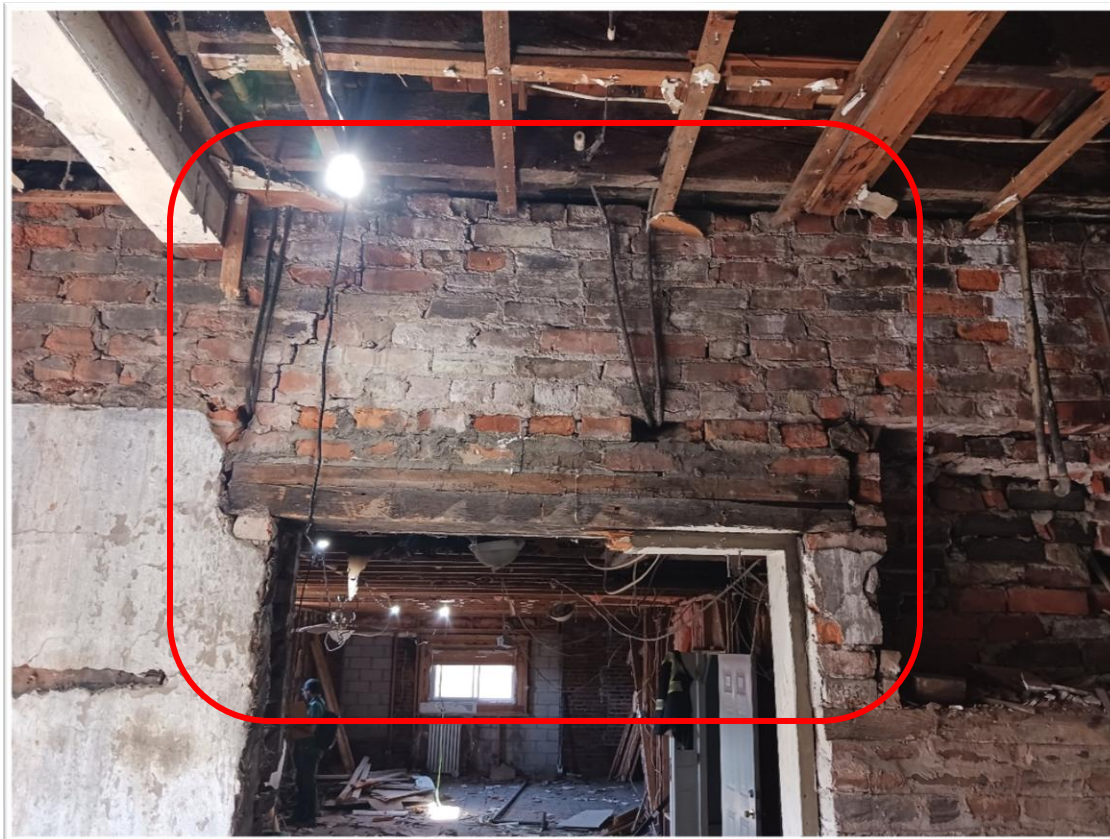
The masonry wall in the image exhibits severe structural distress, with visible cracking, material loss, and a compromised lintel. The wood lintel above the opening appears to be significantly deflected, indicating that it is no longer providing adequate support. This deformation suggests prolonged material deterioration, excessive loading, or moisture-induced weakening over time.

Additionally, the bearing conditions of the lintel on both sides are compromised. The masonry supporting the lintel has deteriorated, with visible cracks and displacement at the bearing points. The left side of the opening shows a clear separation between the concrete and masonry, indicating differential movement that further weakens the structure. On the right side, the masonry at the lintel support has also deteriorated, reducing its capacity to carry loads effectively.

Although this is a non-load-bearing wall, its current condition poses a significant risk of localized collapse. The extensive damage to both the lintel and its supports means that the entire section needs to be demolished and rebuilt to restore structural integrity. Proper reconstruction with a reinforced lintel and stable bearing conditions will ensure long-term durability and prevent further structural instability.

**Figure 12:** Deflected Lintel with Compromised Supports and Cracked Masonry Wall

The wood lintel above an opening has visibly deflected, while the supporting masonry has developed severe cracks. The masonry supporting the lintel has deteriorated on both sides, reducing its ability to provide adequate bearing.

Given the extent of the deterioration, the entire lintel and its supporting masonry must be rebuilt. A new reinforced lintel should be installed, and the surrounding wall sections must be reconstructed to restore load-bearing capacity. These measures will ensure long-term structural stability and prevent further localized failures.
