VanBoxmeer & Stranges Ltd.

October 12, 2023
VB&S Project: 23263

Summary of Building Inspection **535 Old Dundas Rd** **Ancaster, Ontario**

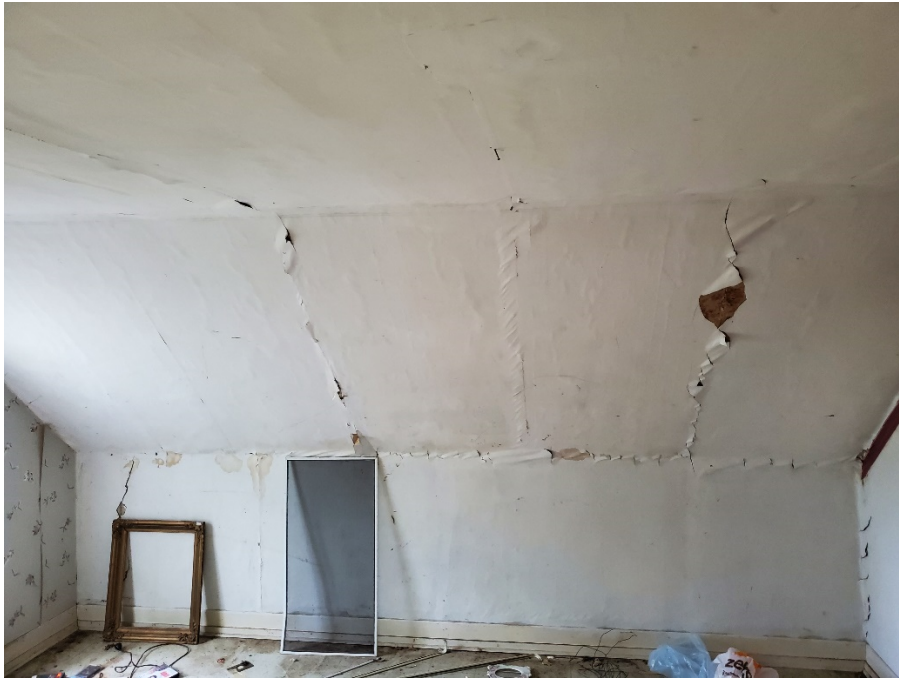
The building is constructed using wood framing. The roof is constructed as a conventional wood rafter with collar ties partway up the rafters. It could not be determined if the floor joists act as ties at the base of the rafter. The roof framing over the kitchen bears on knee walls. The knee walls were supported on what appeared to be wood beams from below. See **Photo No 01 & 02**.

Photo No 01: 2nd Floor North Wall above Kitchen

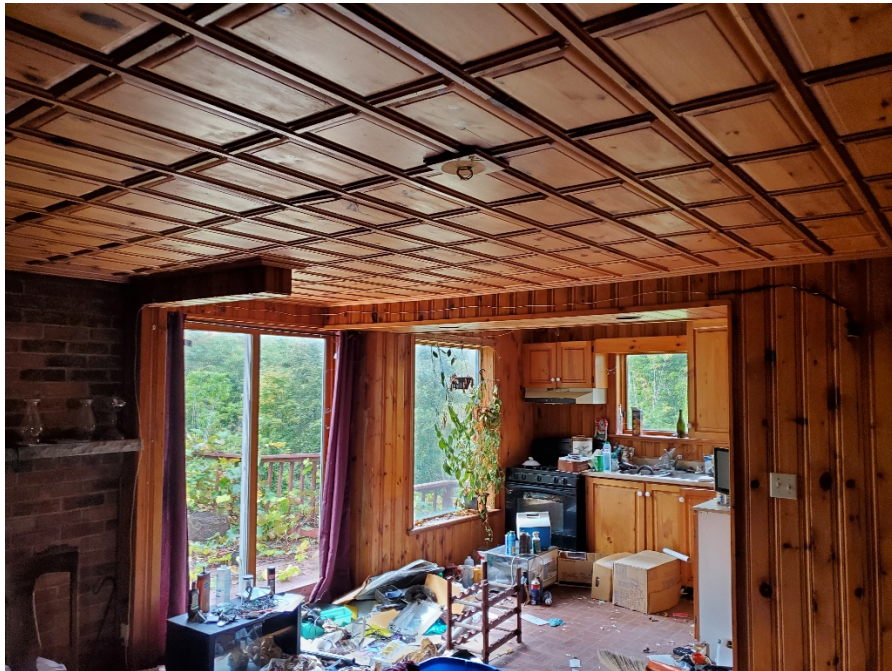
Photo No 02: North Kitchen Wall below Photo No:01

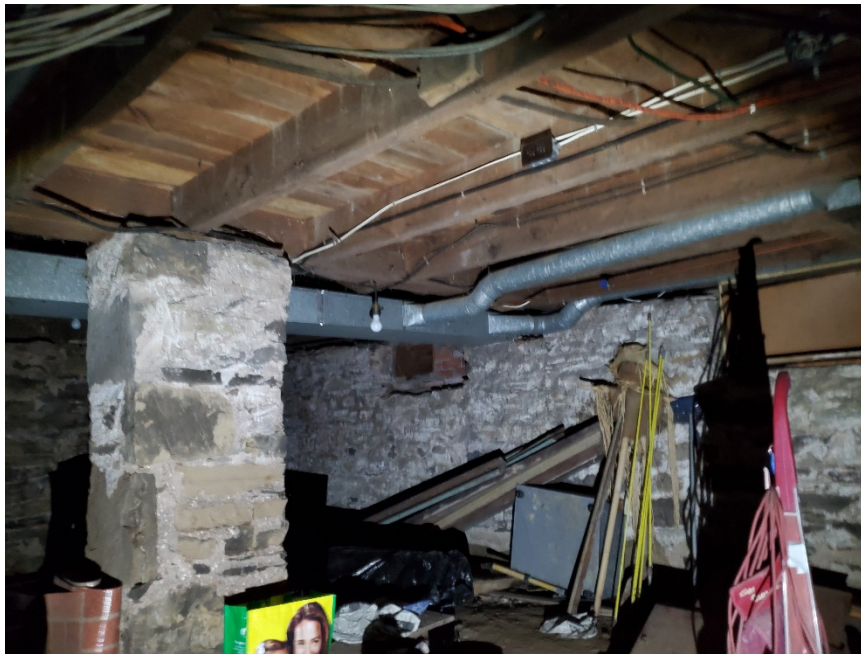
During the site review, the framing of the floor structure was recorded to get a better understanding of the building and tracking the loads to foundation. Where visible, the framing was recorded including the member sizes, spans and the bearing locations. The underside of the main floor was completely exposed. See **Photo No 03** for part main floor framing.

The west end of the east side main 8x8 timber floor beam, See **Photo No 03**, does have adequate support at the interior foundation wall.

Photo No 03: Main Floor Framing (Original House)

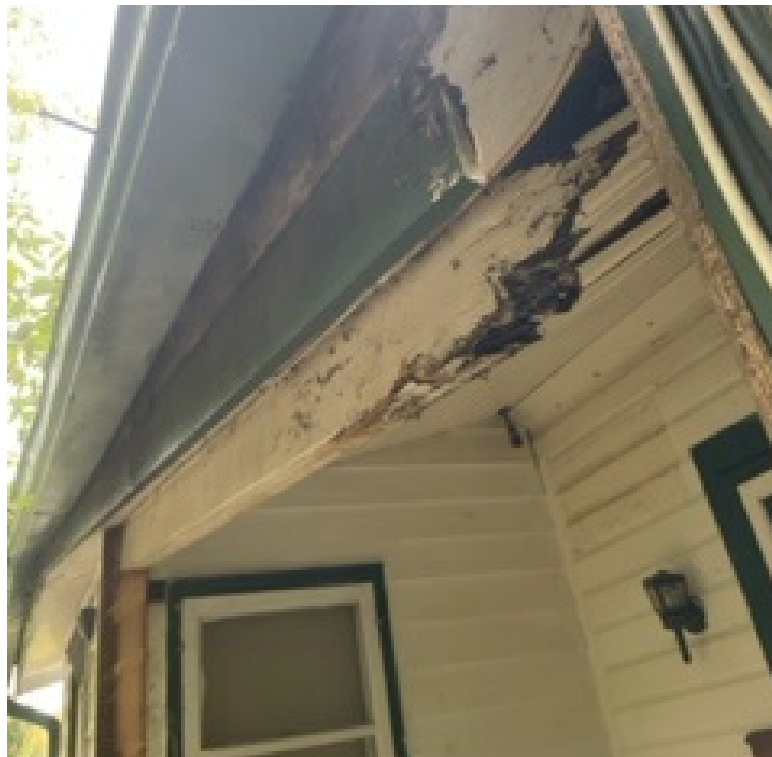
Review of the exterior was completed. The framing of the covered veranda at the south side of the house had collapsed. See **Photo No 04 & 05**. It was apparent that the end of the wood beam at the east side of the veranda had rotted and collapsed.

Photo No 04: Collapsed Roof

The exterior wood siding has many areas of decomposition. In one location the veranda roof has failed and collapsed. If this structure is to remain, we recommend removing the plaster and lath at the base of the main floor walls to determine if the studs and sill plates are decomposed.

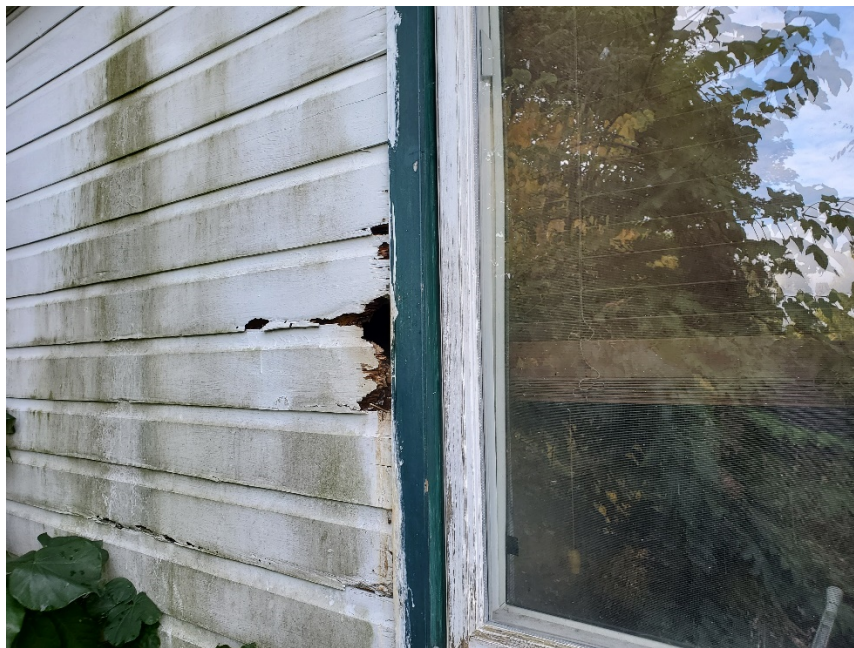
There were many areas around the perimeter of the exterior where the wood siding, and wood window sills were rotted as well. See **Photo No 06 & 07**. Photos 06 & 07 show a couple of locations of many where the exterior wood siding, sills or window jambs were decomposed.

Photo No 06: Rotted Siding

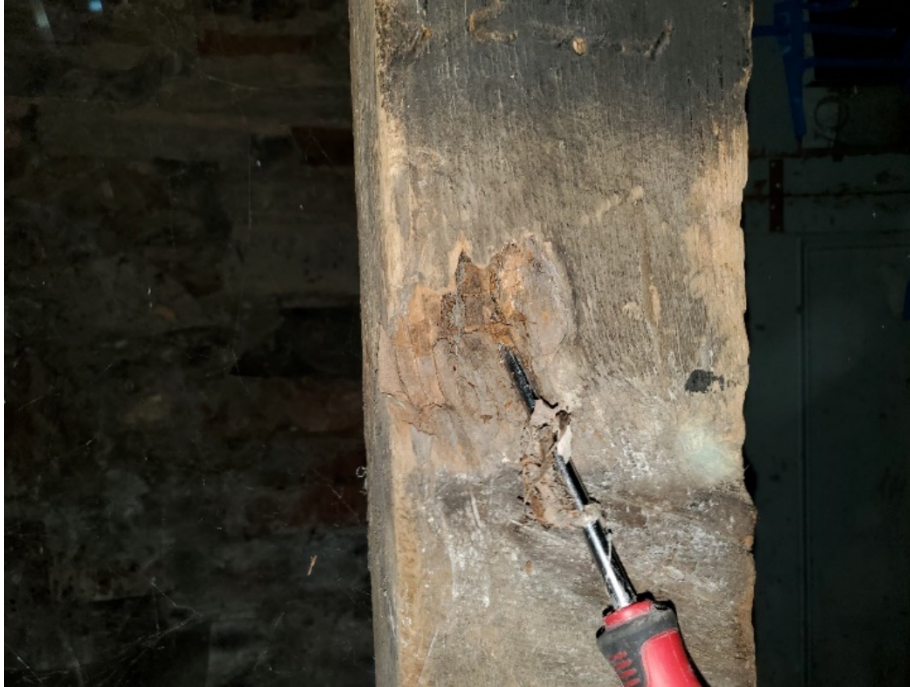
At the west side structure, an existing wood post at the west end of the beam was partially rotted at the base and a wood knot that was severely rotted. See **Photo No 08 & 09**.

Photo No 09: Rotten Wood Knott

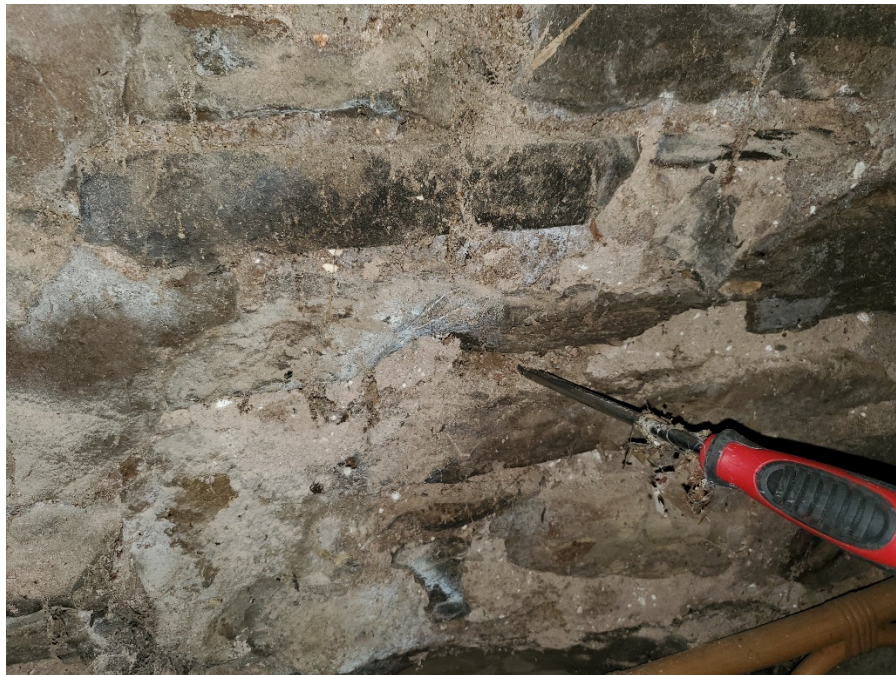
For two of the 3 areas of the basement, the foundations are constructed of stone and mortar. Upon closer inspection of the foundation, it was quite evident that the mortar is severely spalled. See **Photo No 10 & 11**. The photos show how easily the screwdriver penetrates the spalled mortar joints.

Photo No 10: Spalled Mortar Joint

The mortar joints in stone foundations are severely spalled. Repairing the foundation would also require a lot of financial resources. An option would be the temporary support of the house with a complete demolition and replacement of the stone foundation to cast-in-place or block foundation and footing.

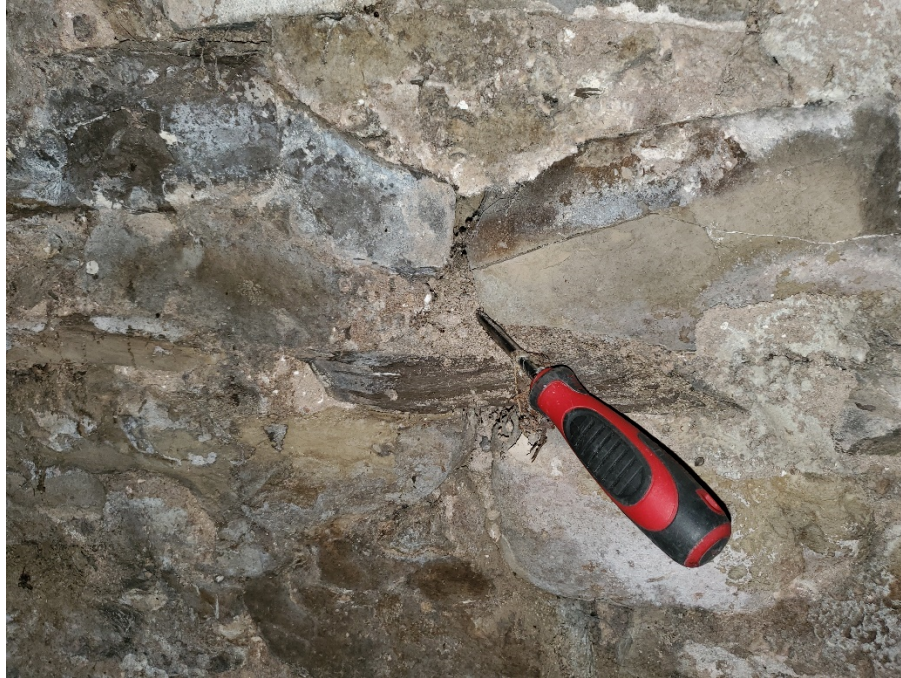
Photo No 11: Spalled Mortar Joint
