HERITAGE FEATURE ASSESSMENT

Project: Yeshiva of Hamilton

Address: 235 Bowman Street, Hamilton

Subject: **Assessment of Existing Historic Steel Sash Windows**

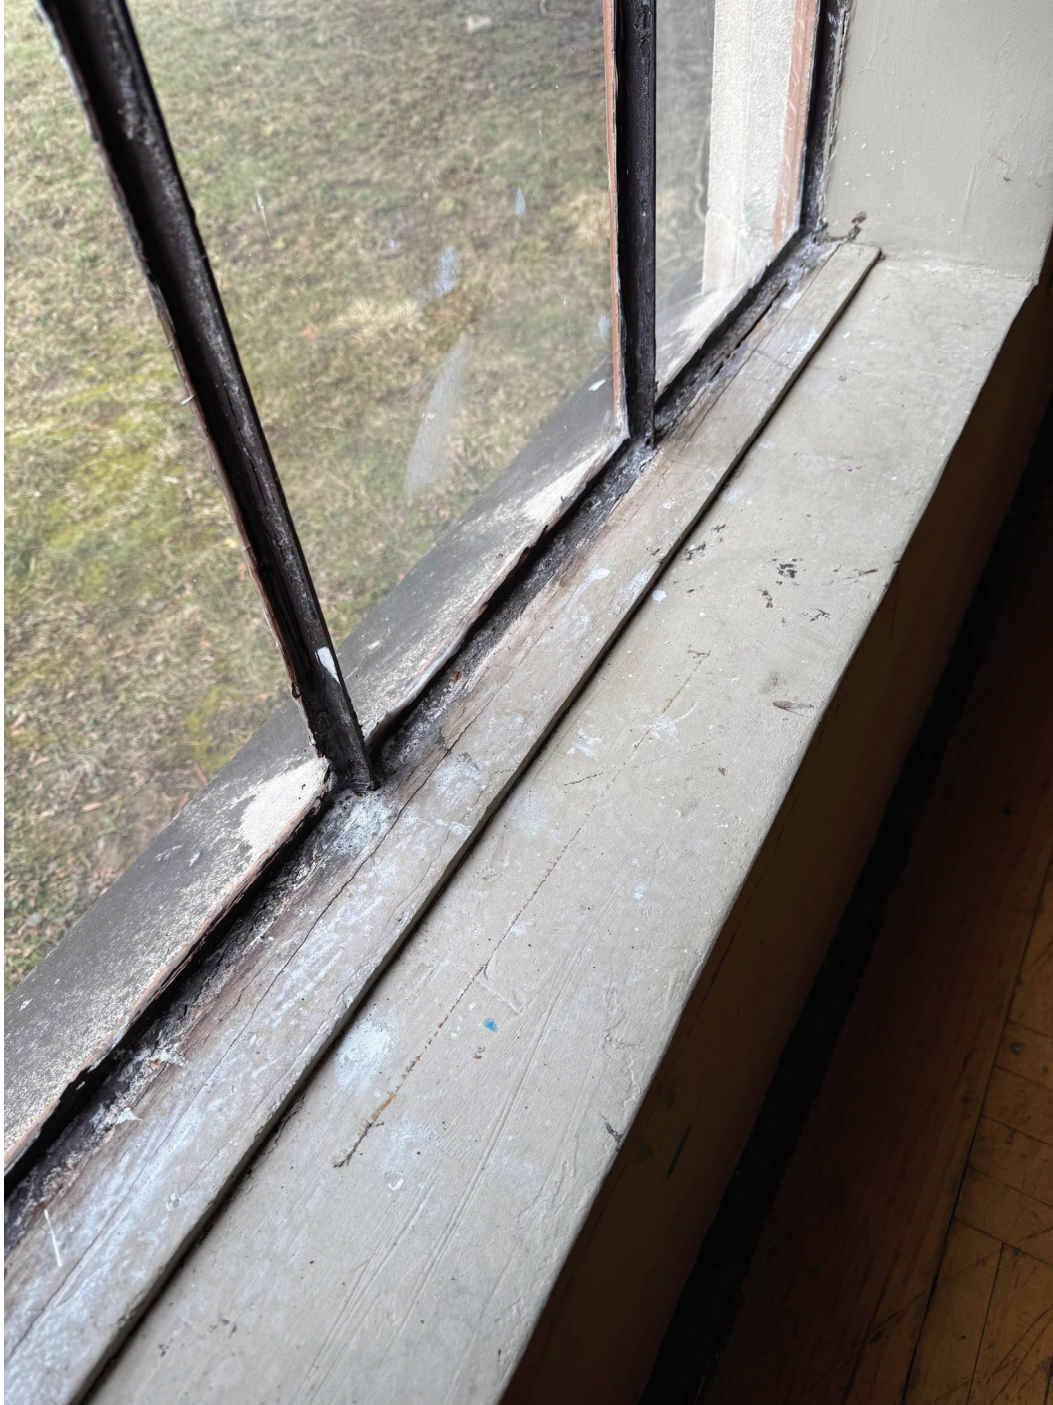
Figure 1 – Existing corroded steel window frame

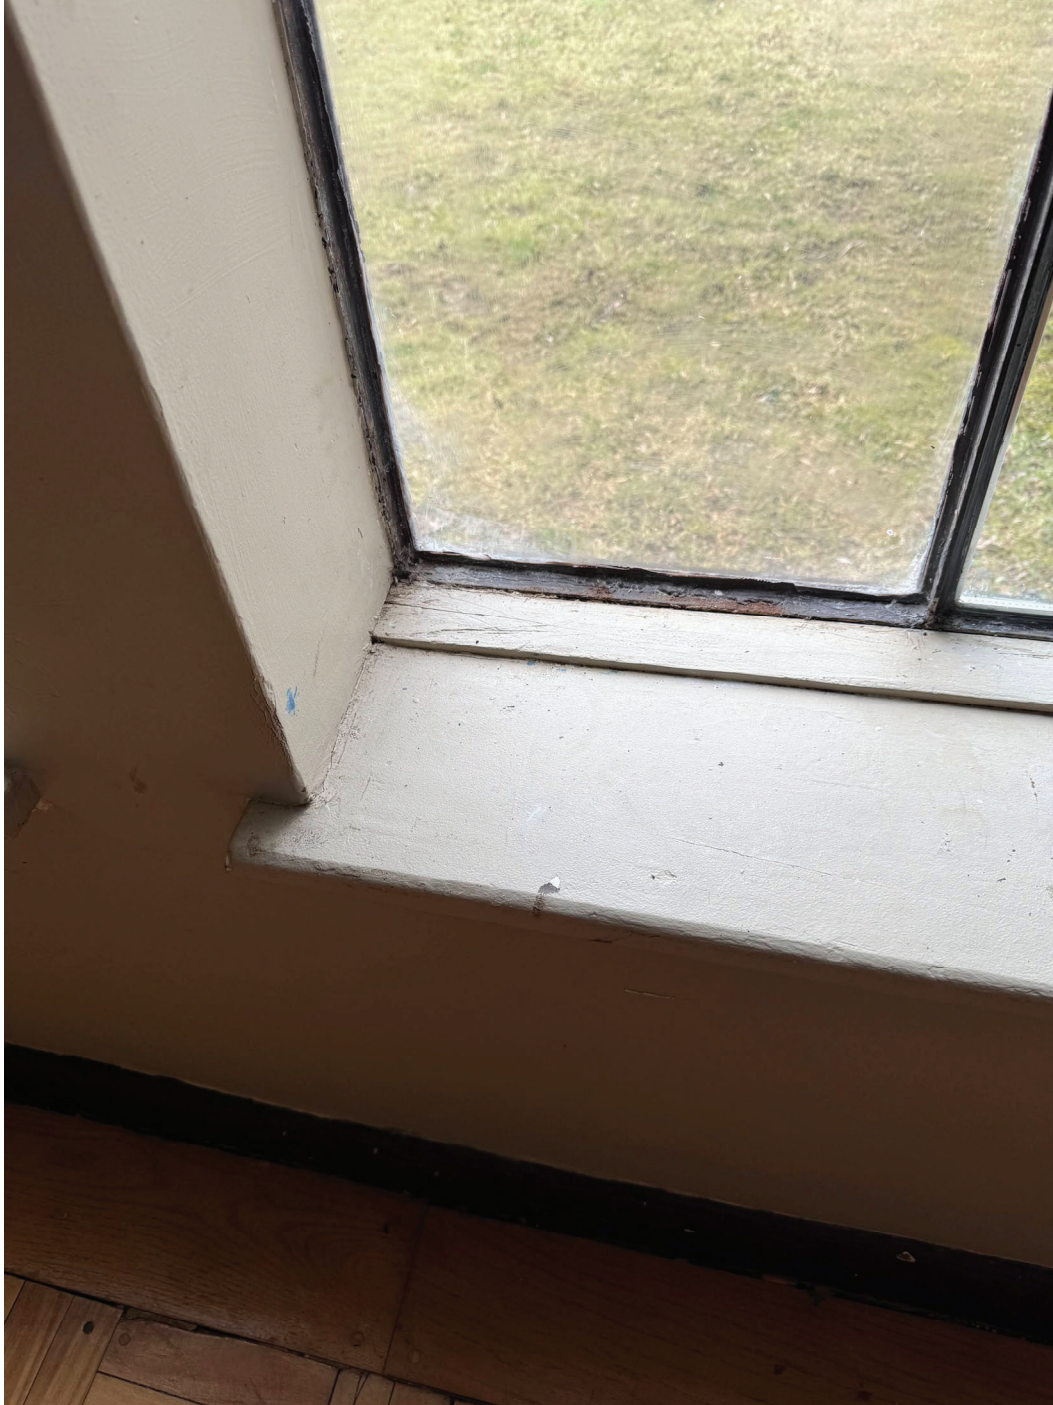
Figure 2 – *Existing rusted steel window frame*

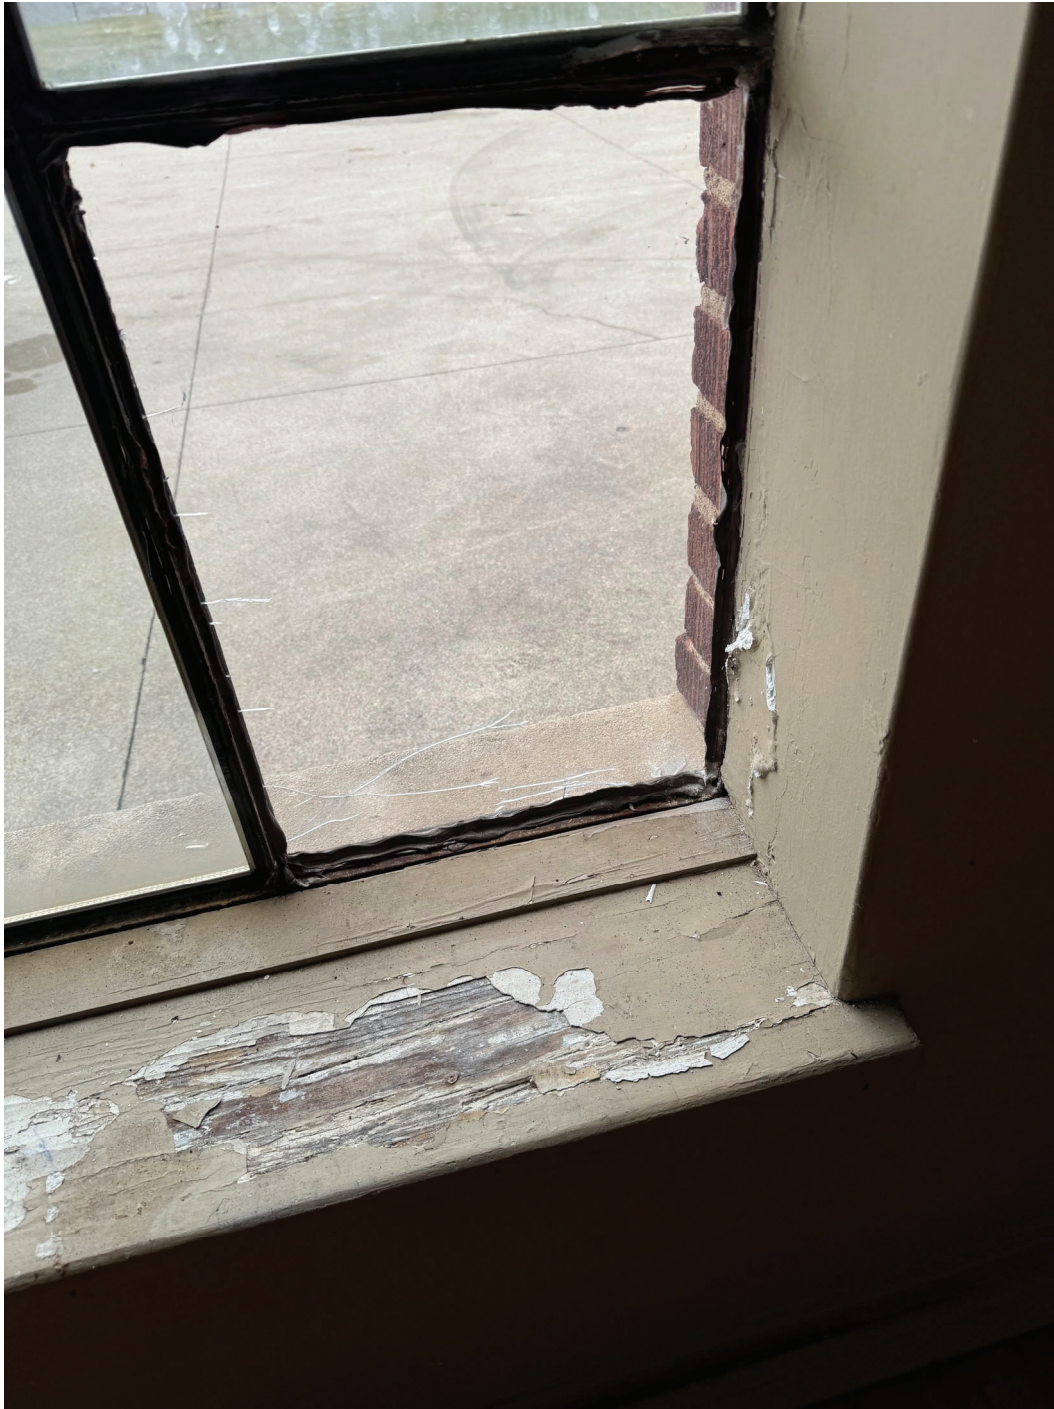
The steel windows at 235 Bowman Street, Hamilton, ON show signs of extensive corrosion. Wood sills are degrading due to condensation from the primarily single-glazed windows. Previous attempts to exclude moisture with silicone and other caulking have made matters worse by retaining moisture that otherwise may have drained away, thereby exacerbating corrosion of the steel frames.

Figure 3 – Existing corroded steel window frame patched with caulking, cracked glass, and water-damaged wood window sill.

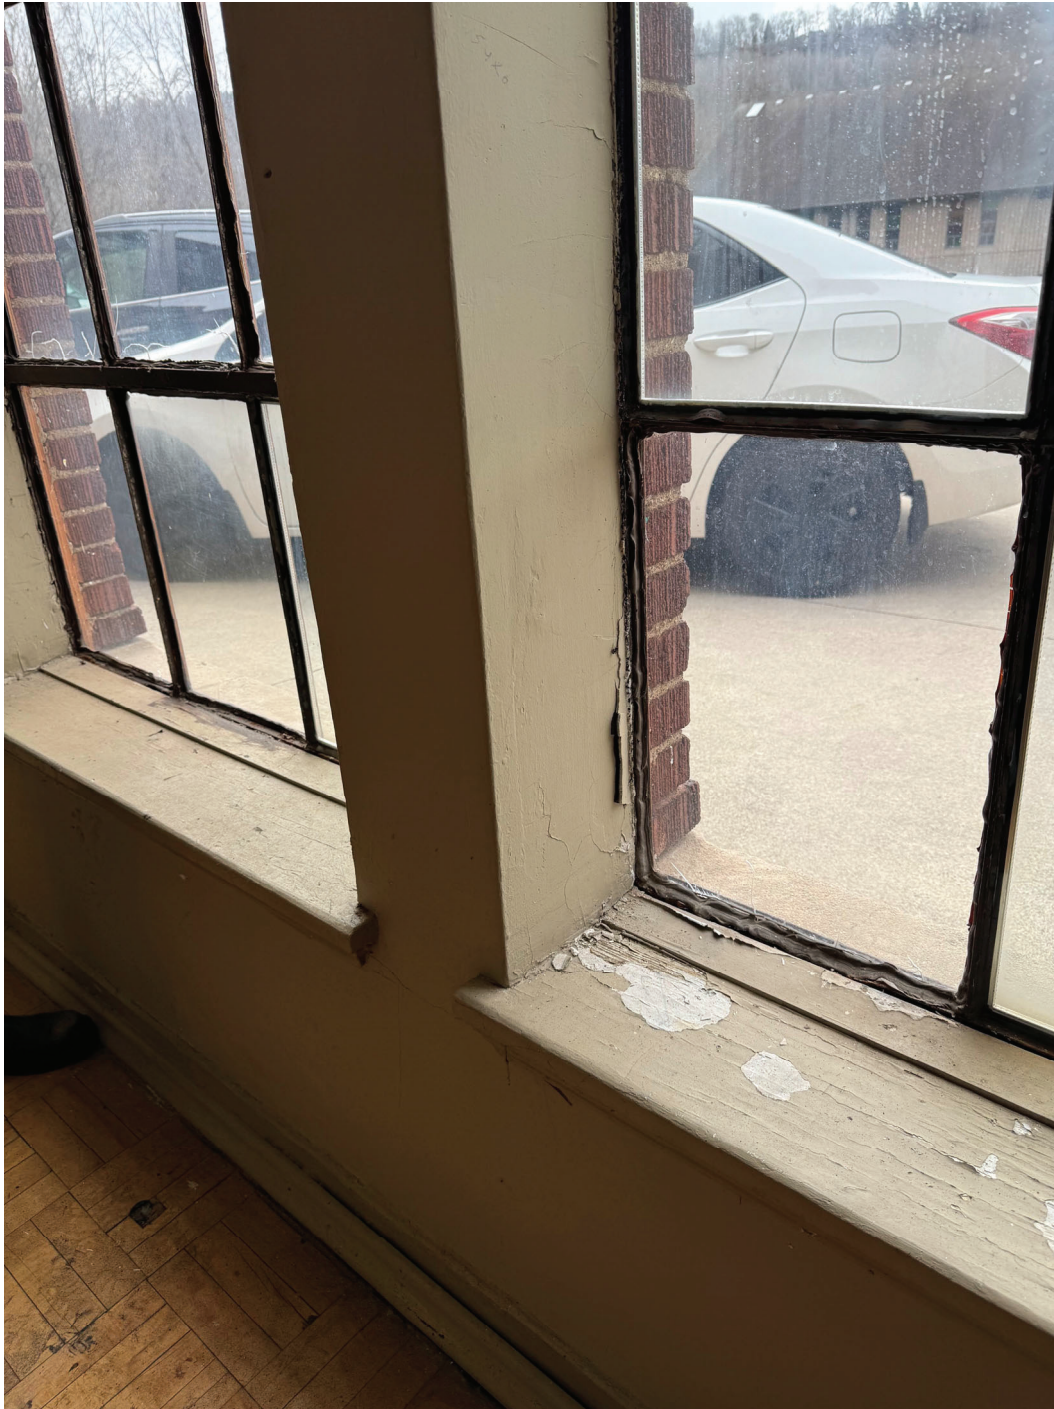
Figure 4 – Existing corroded steel window frame patched with caulking, and water damaged wood window sill.

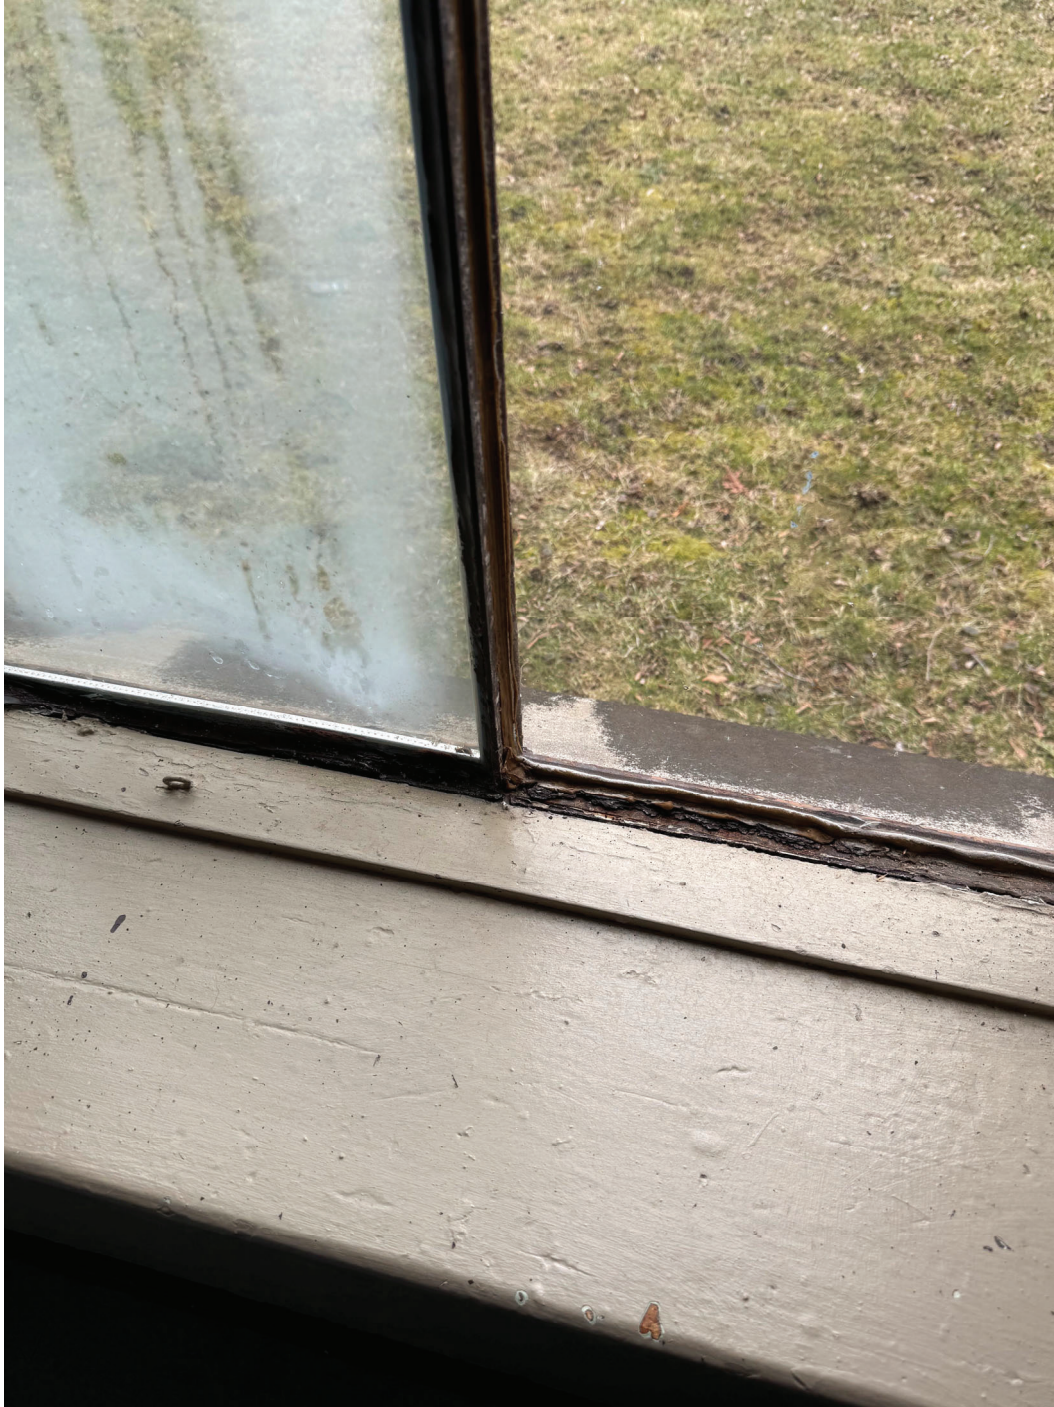
Figure 5 – Existing corroded steel window frame.

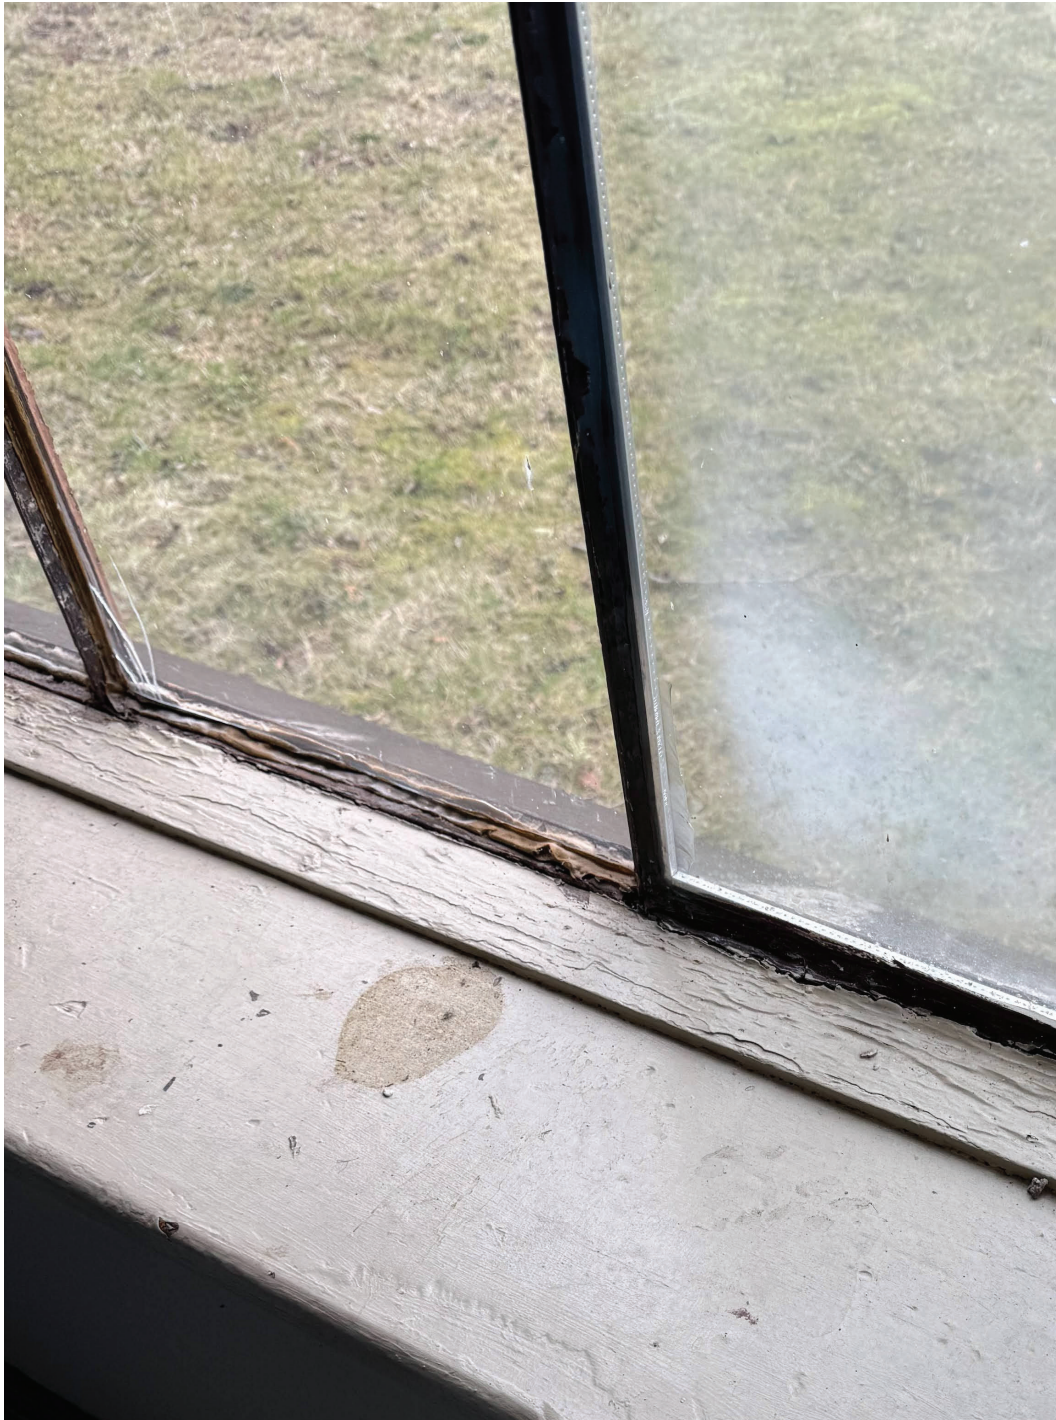
Figure 6 – Existing corroded steel window frame with cracked glass, and water damaged wood window sill.
