# HERITAGE PERMIT REVIEW SUB-COMMITTEE ADDENDUM

\*9.4 HP2025-026 - 1007 Beach Boulevard, Hamilton (Hamilton Beach Heritage Conservation District, Part V)

# HERITAGE IMPACT ASSESSMENT

1007 Beach Boulevard, Hamilton, ON

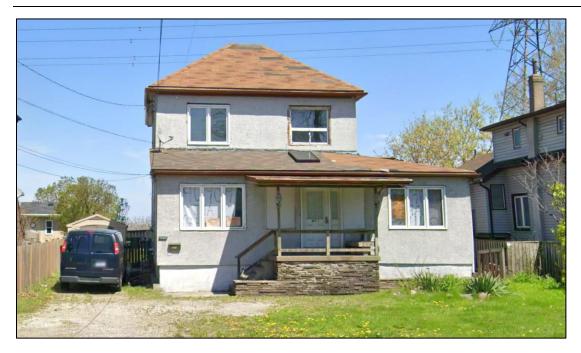
**Figure 1:** Front view of existing dwelling from Beach Boulevard from Google Streetview (May 2025)

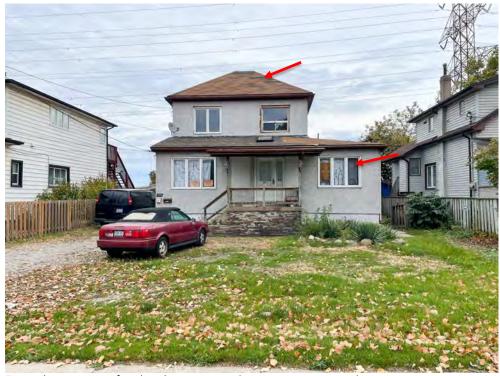
Front elevation – roof and replacement windows in very poor condition

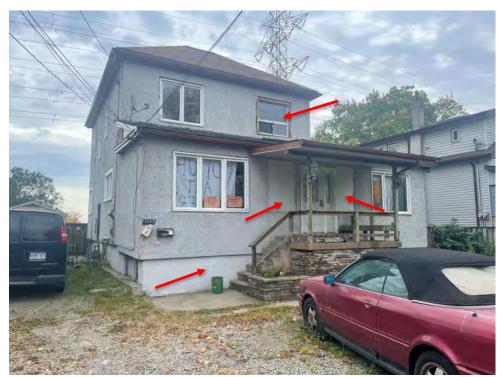
Front entrance – cracks visible in the parged foundation – original openings boarded up – mis-matched replacement windows

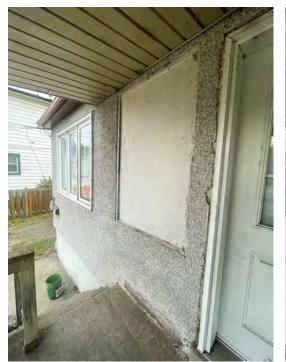
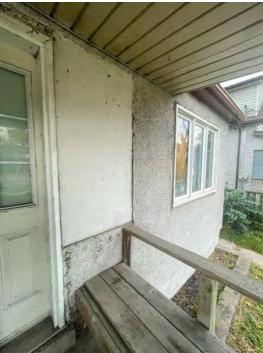
Boarded up openings – vinyl replacement doors and windows – locations and sizes of windows have been changed

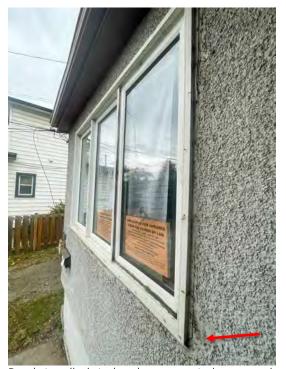
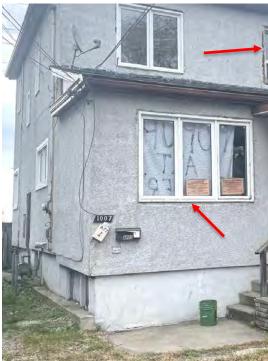
Poorly installed vinyl replacement windows – modern cement parging with patching and gaps around window openings

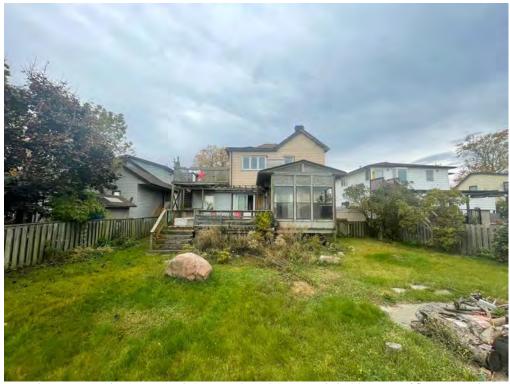
Rear elevation – replacement vinyl doors and windows – vinyl cladding on 2<sup>nd</sup> floor – poorly constructed enclosed porch and decks – poorly installed replacement vinyl windows

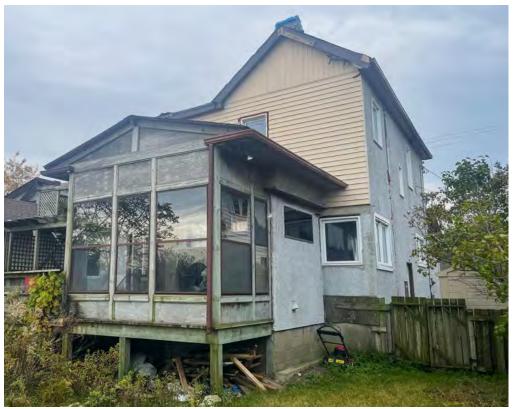
Rear and north side elevation – mish-mash of materials – poorly installed replacement vinyl windows

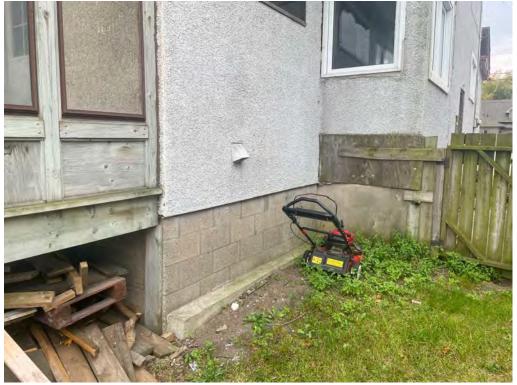
REAR ADDITION – concrete block foundation – cement parging above

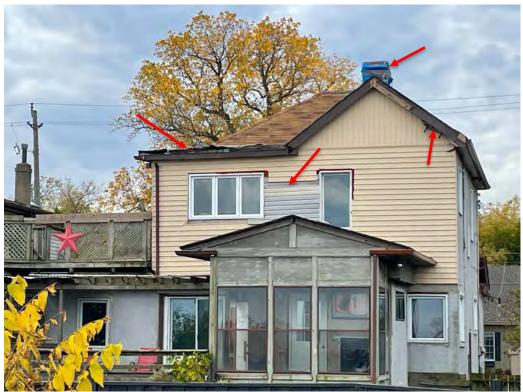
REAR ELEVATION – roof is in very poor condition – shingles lifting and tarp on chimney – rotted soffit & fascia boards – poorly fitted replacement windows – patched siding

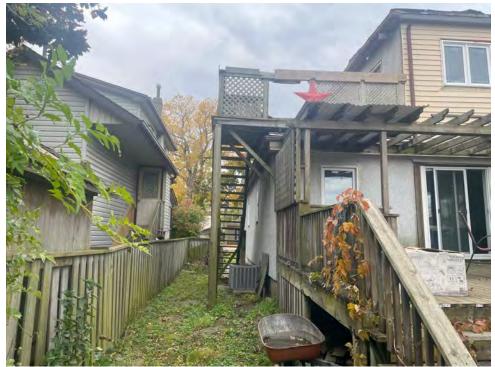
South side yard – poorly constructed deck and exit stair

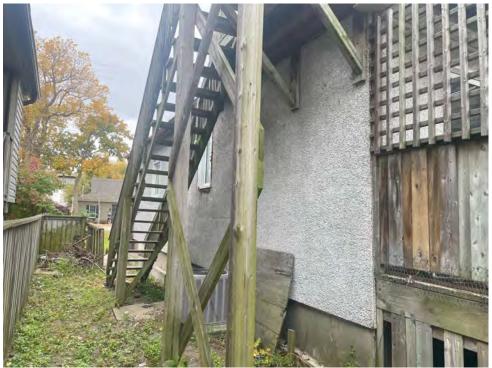
SIDE ELEVATION - parge foundation with cement stucco above - wood fire escape attached to stucco

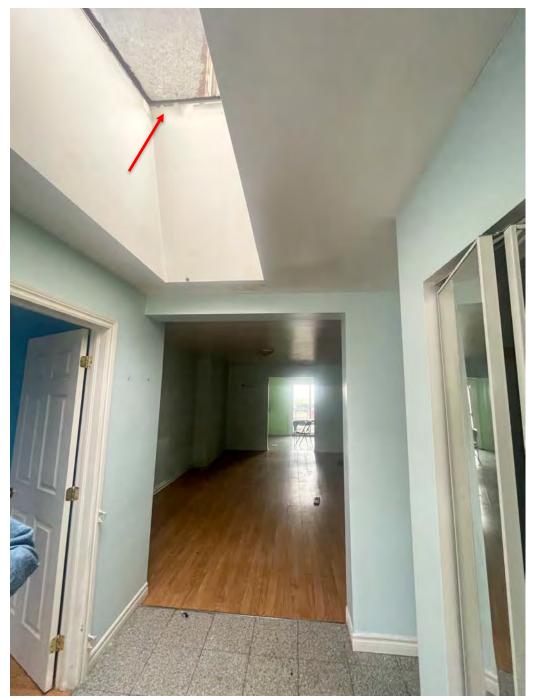
INTERIOR – modern skylight in entrance hall is leaking – modern finishes – no historic features or finishes

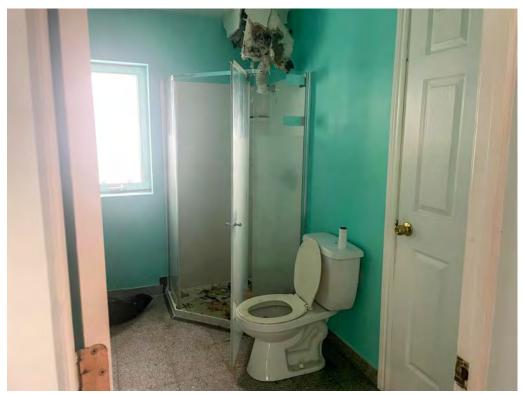
Interior – 1<sup>st</sup> floor bathroom – a portion of the ceiling has collapsed - modern finishes – no historic features or finishes

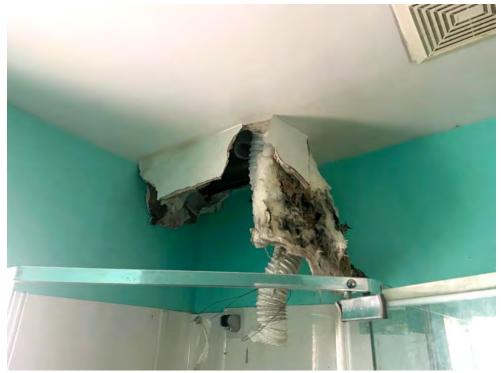
Interior – 1<sup>st</sup> floor bathroom – water damage

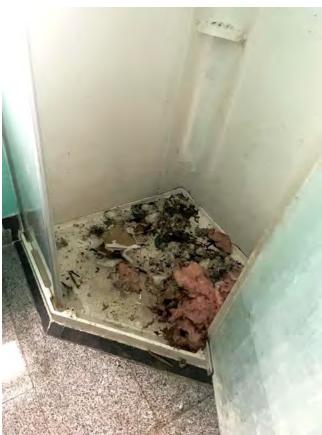
Interior – 1st floor bathroom – wet insulation and drywall debris where a portion of the ceiling has collapses

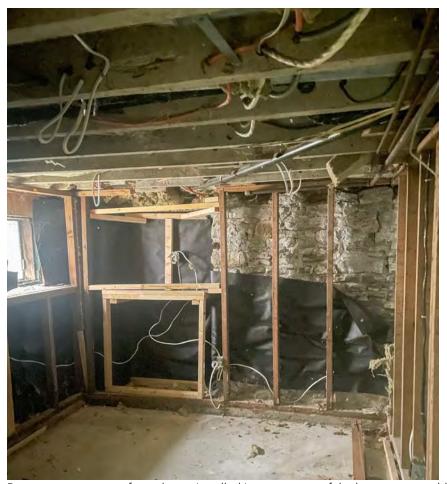
Basement – waterproof membrane installed in some areas of the basement to address damp issues

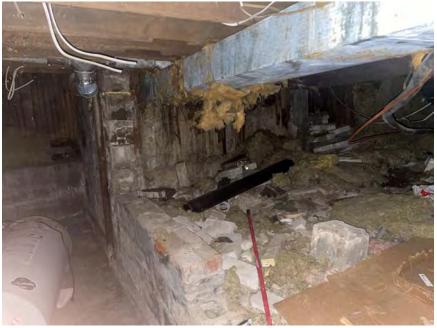
Basement – modern ducting installed through older foundation and wood joists – insulation debris and damp conditions

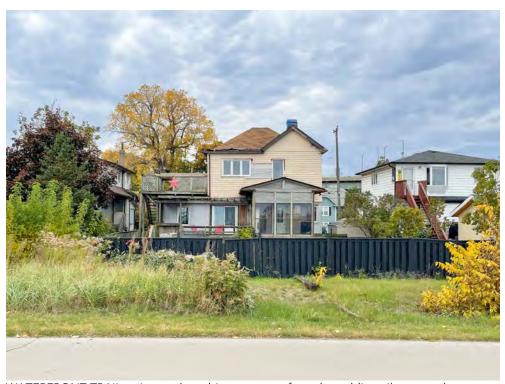
WATERFRONT TRAIL – view to the subject property from the public trail – currently an eyesore due to its poor condition and shoddy construction
