Notice of Intent to Cut Application Form – Woodland Conservation By-law

**NOTICE OF INTENT TO CUT, BURN, OR DESTROY TREES
BY OTHER MEANS, PURSUANT TO
THE REGION OF HAMILTON-WENTWORTH
WOODLAND CONSERVATION BY-LAW NO. R00-054**

Existing Conditions
 Forest Assessment
 Project: P1380
 Date: 25 October 2016
 Scale: 1:300

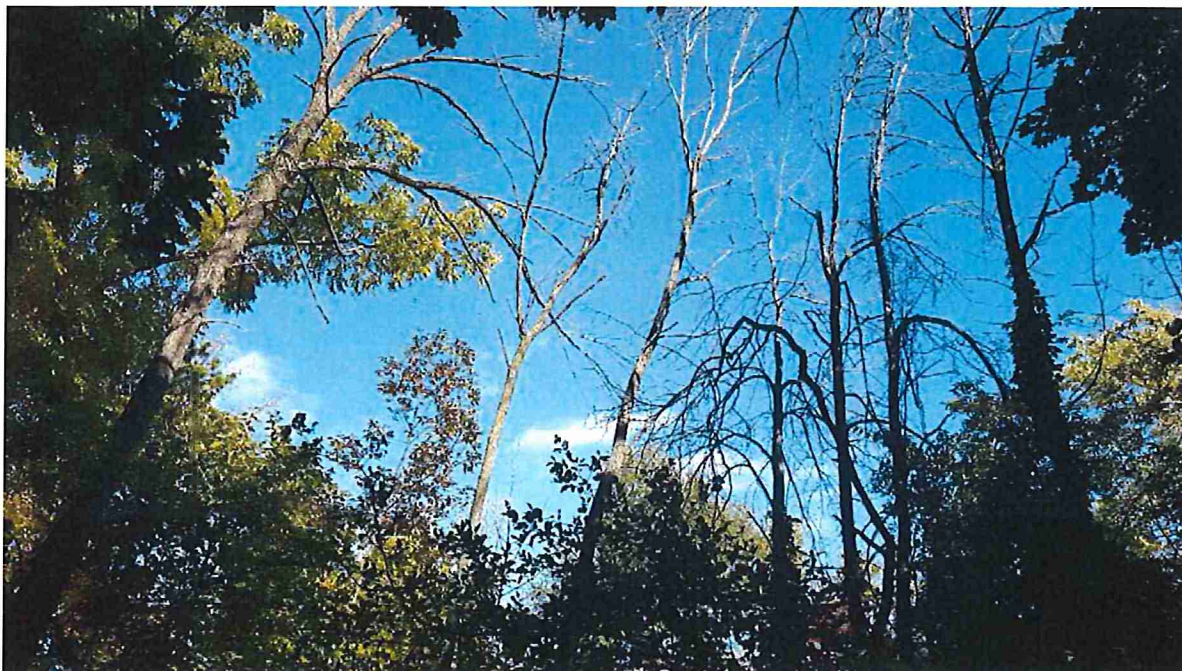
The subject area has poor ecological integrity with low native tree species diversity and a high population of non-native, invasive Common Buckthorn. The forest floor is disturbed with little to no native tree species regeneration. If left unmanaged, it is unlikely that this wooded feature would be able to self regenerate due to the lack of tree regeneration and dense Common Buckthorn cover. Based on these characteristics, the subject area represents a low constraint to development. It is recommended that the Shagbark Hickory and White Oak be protected at their dripline. Preservation of the Red Oak may be considered during the planning process via a Tree Inventory and Preservation Plan report.

Photo 1. Area of dead, standing Ash trees

Replacement of the conifer plantation through restoration of other lands on the subject property is recommended. The removal of trees within the conifer plantation may be compensated by planting trees along the escarpment brow, as recommended by GeoProcess Research Associates' Restoration Plan (12 January 2017) and shown in Figure 2 of this report. Currently, the area along the top of the escarpment brow is very narrow and consists of a few scattered trees. The intent of the replacement tree plantings is to expand the wooded area along the top of the escarpment brow through reforestation techniques. Plantings will be contiguous to the larger ecological feature, replacing Sanatorium Road with a forested area. All planted trees will be native and reflective of the local landscape (ecological land type). The area of conifer plantation proposed for removal is approximately 0.28 ha and the area of replacement plantings is approximately 1.03 ha. The recommended replacement plantings will serve to buffer and expand the larger ecological feature along the escarpment brow while increasing the ecological function and value of the area to be restored.

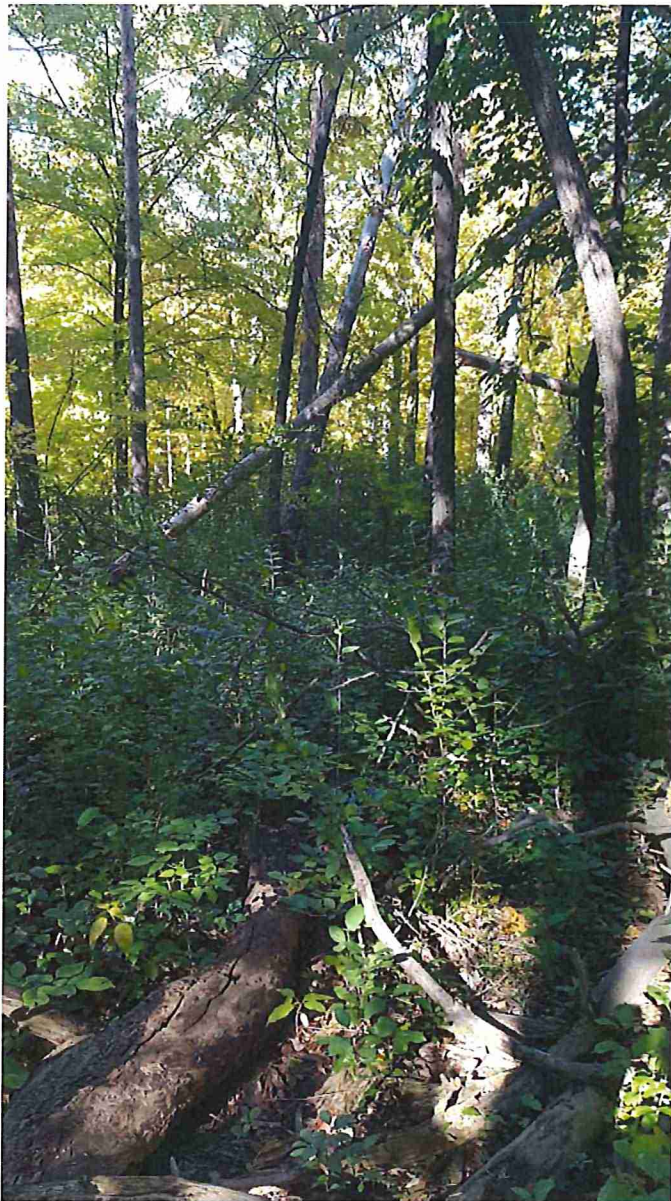
Photo 2. Failed trees and dense Common Buckthorn regeneration

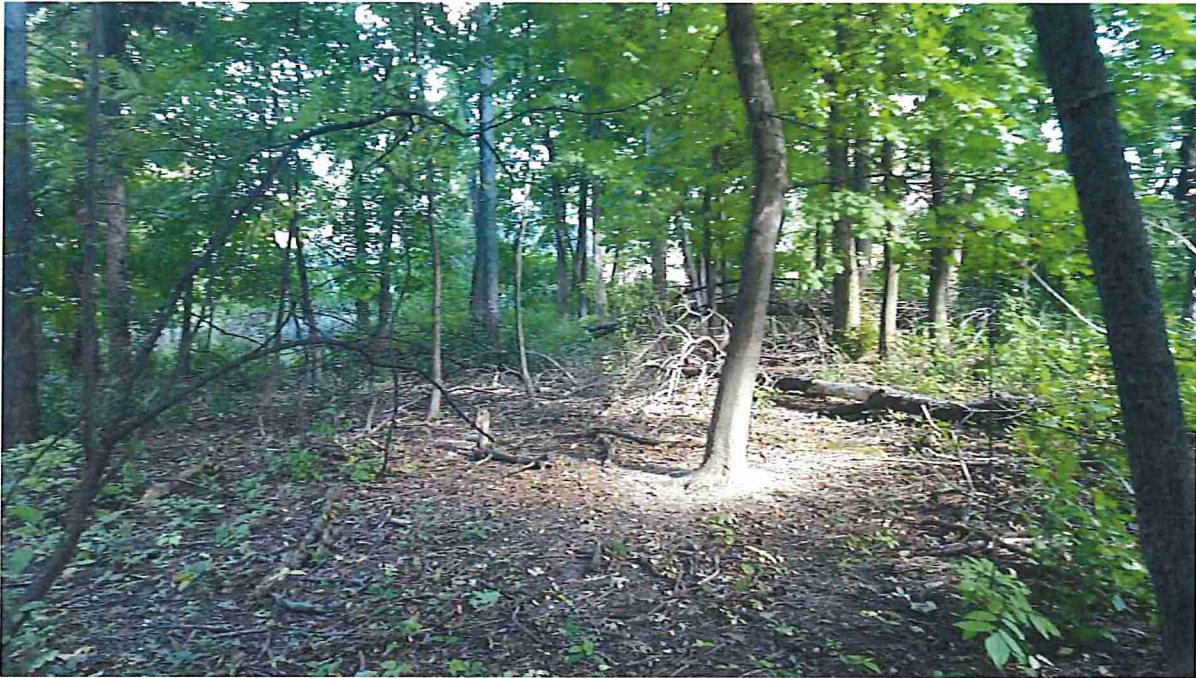
Photo 3. Open, understory with disturbed forest floor and limited to no tree regeneration

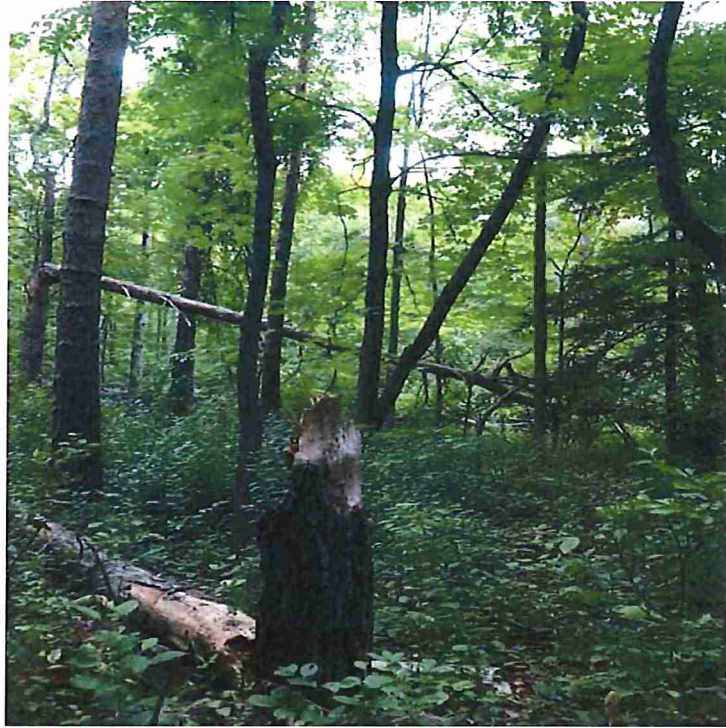
Photo # 3

Eastern Woodland –
heavy Common
Buckthorn
understory and
groundlayer

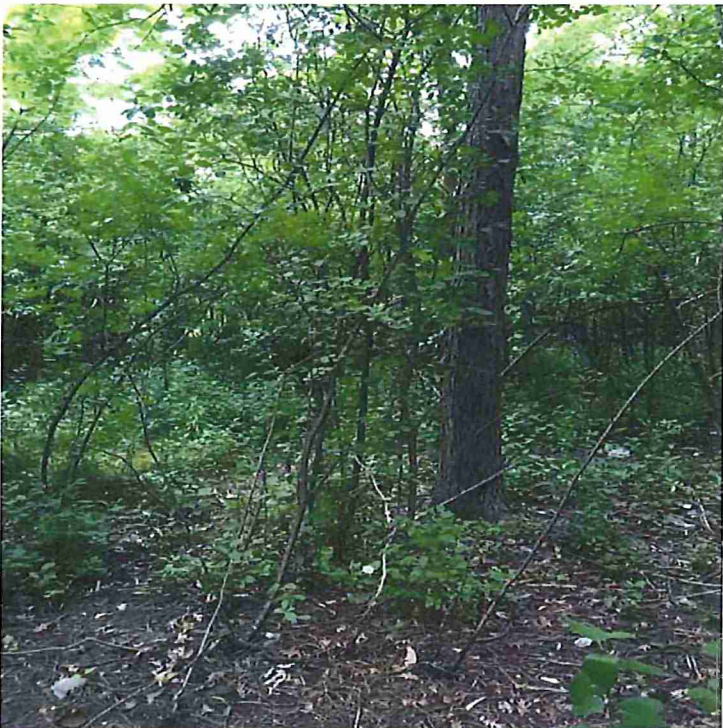
<p>Photo # 6</p> <p>Brow Lands</p> <p>July 27, 2016</p> <p>Eastern Woodland – poor forest structure due to high levels of non- native invasive species and historic and on-going recreational use</p>

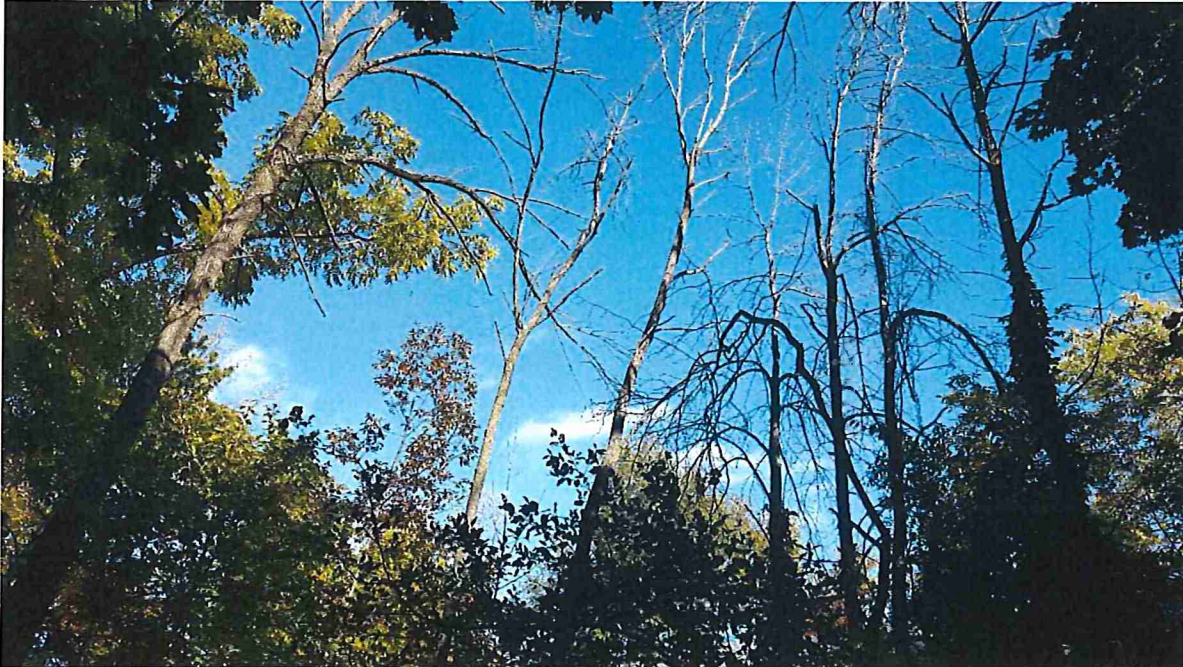
The subject area has poor ecological integrity with low native tree species diversity and a high population of non-native, invasive Common Buckthorn. The forest floor is disturbed with little to no native tree species regeneration. If left unmanaged, it is unlikely that this wooded feature would be able to self regenerate due to the lack of tree regeneration and dense Common Buckthorn cover. Based on these characteristics, the subject area represents a low constraint to development. It is recommended that the Shagbark Hickory and White Oak be protected at their dripline. Preservation of the Red Oak may be considered during the planning process via a Tree Inventory and Preservation Plan report.

Photo 1. Area of dead, standing Ash trees

Replacement of the conifer plantation through restoration of other lands on the subject property is recommended. The removal of trees within the conifer plantation may be compensated by planting trees along the escarpment brow, as recommended by GeoProcess Research Associates' Restoration Plan (12 January 2017) and shown in Figure 2 of this report. Currently, the area along the top of the escarpment brow is very narrow and consists of a few scattered trees. The intent of the replacement tree plantings is to expand the wooded area along the top of the escarpment brow through reforestation techniques. Plantings will be contiguous to the larger ecological feature, replacing Sanatorium Road with a forested area. All planted trees will be native and reflective of the local landscape. The area of conifer plantation proposed for removal is approximately 0.28 ha and the area of replacement plantings is approximately 1.03 ha. The recommended replacement plantings will serve to buffer and expand the larger ecological feature along the escarpment brow while increasing the ecological function and value of the area to be restored.

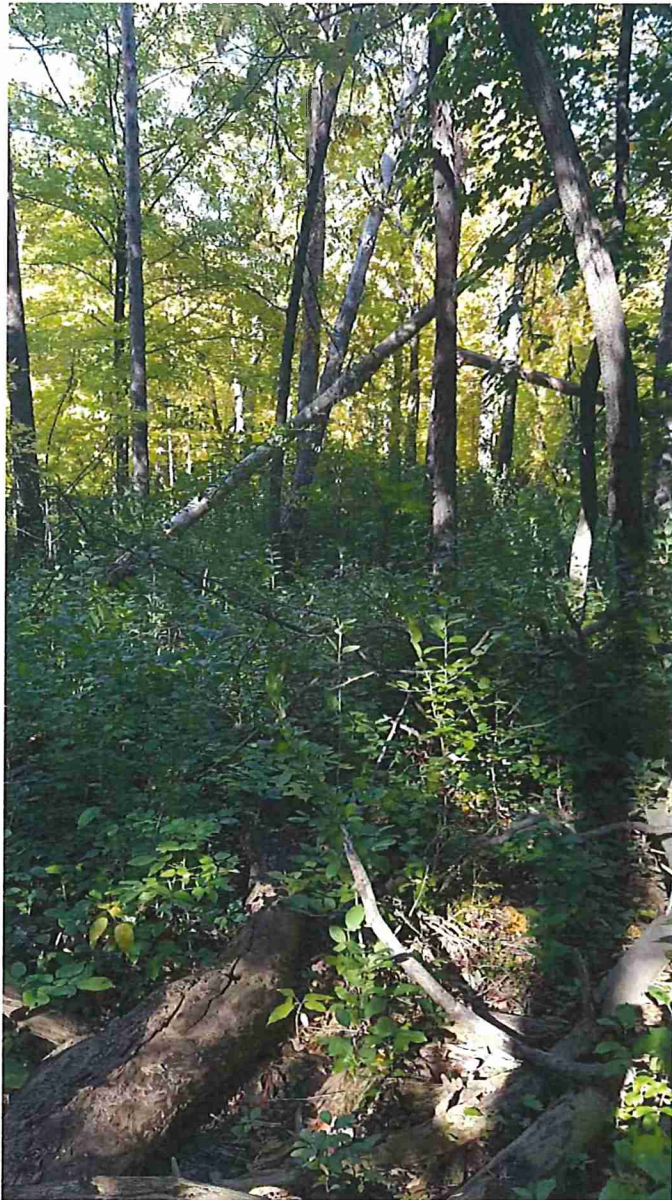
Photo 2. Failed trees and dense Common Buckthorn regeneration

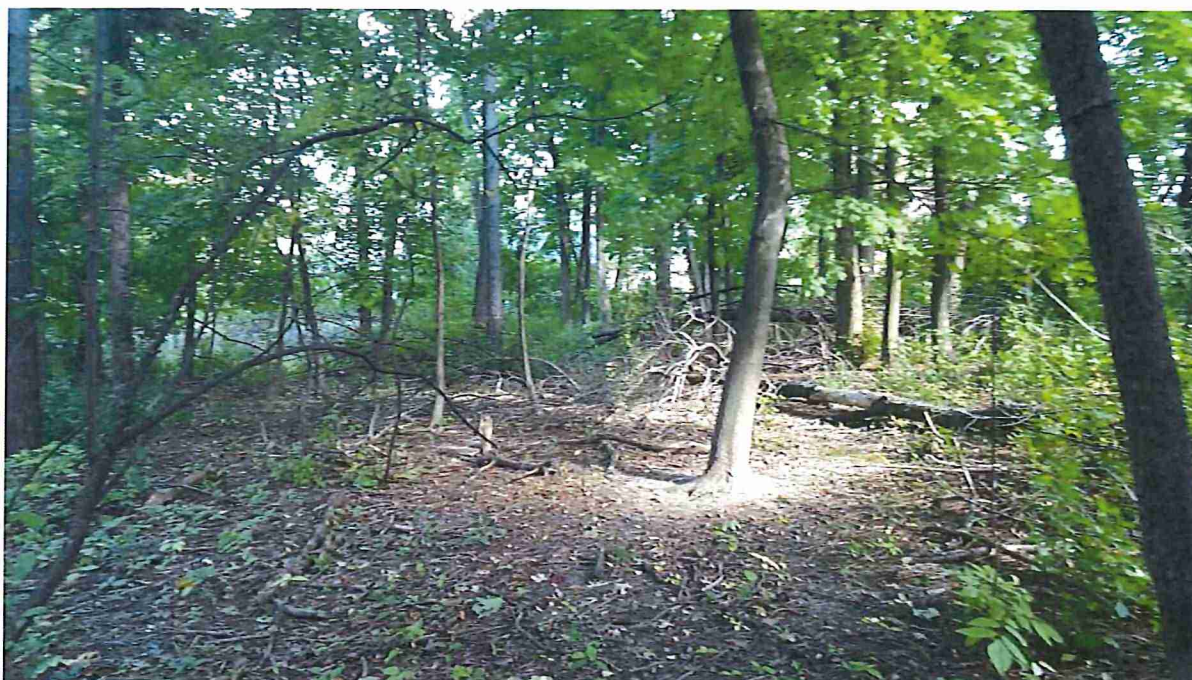
Photo 3. Open, understory with disturbed forest floor and limited to no tree regeneration
