TREE INVENTORY AND PROTECTION PLAN

616 Mill Street
City of Hamilton
September 2023

SUBJECT: Tree Inventory and Protection Plan, 616 Mill Street, City of Hamilton

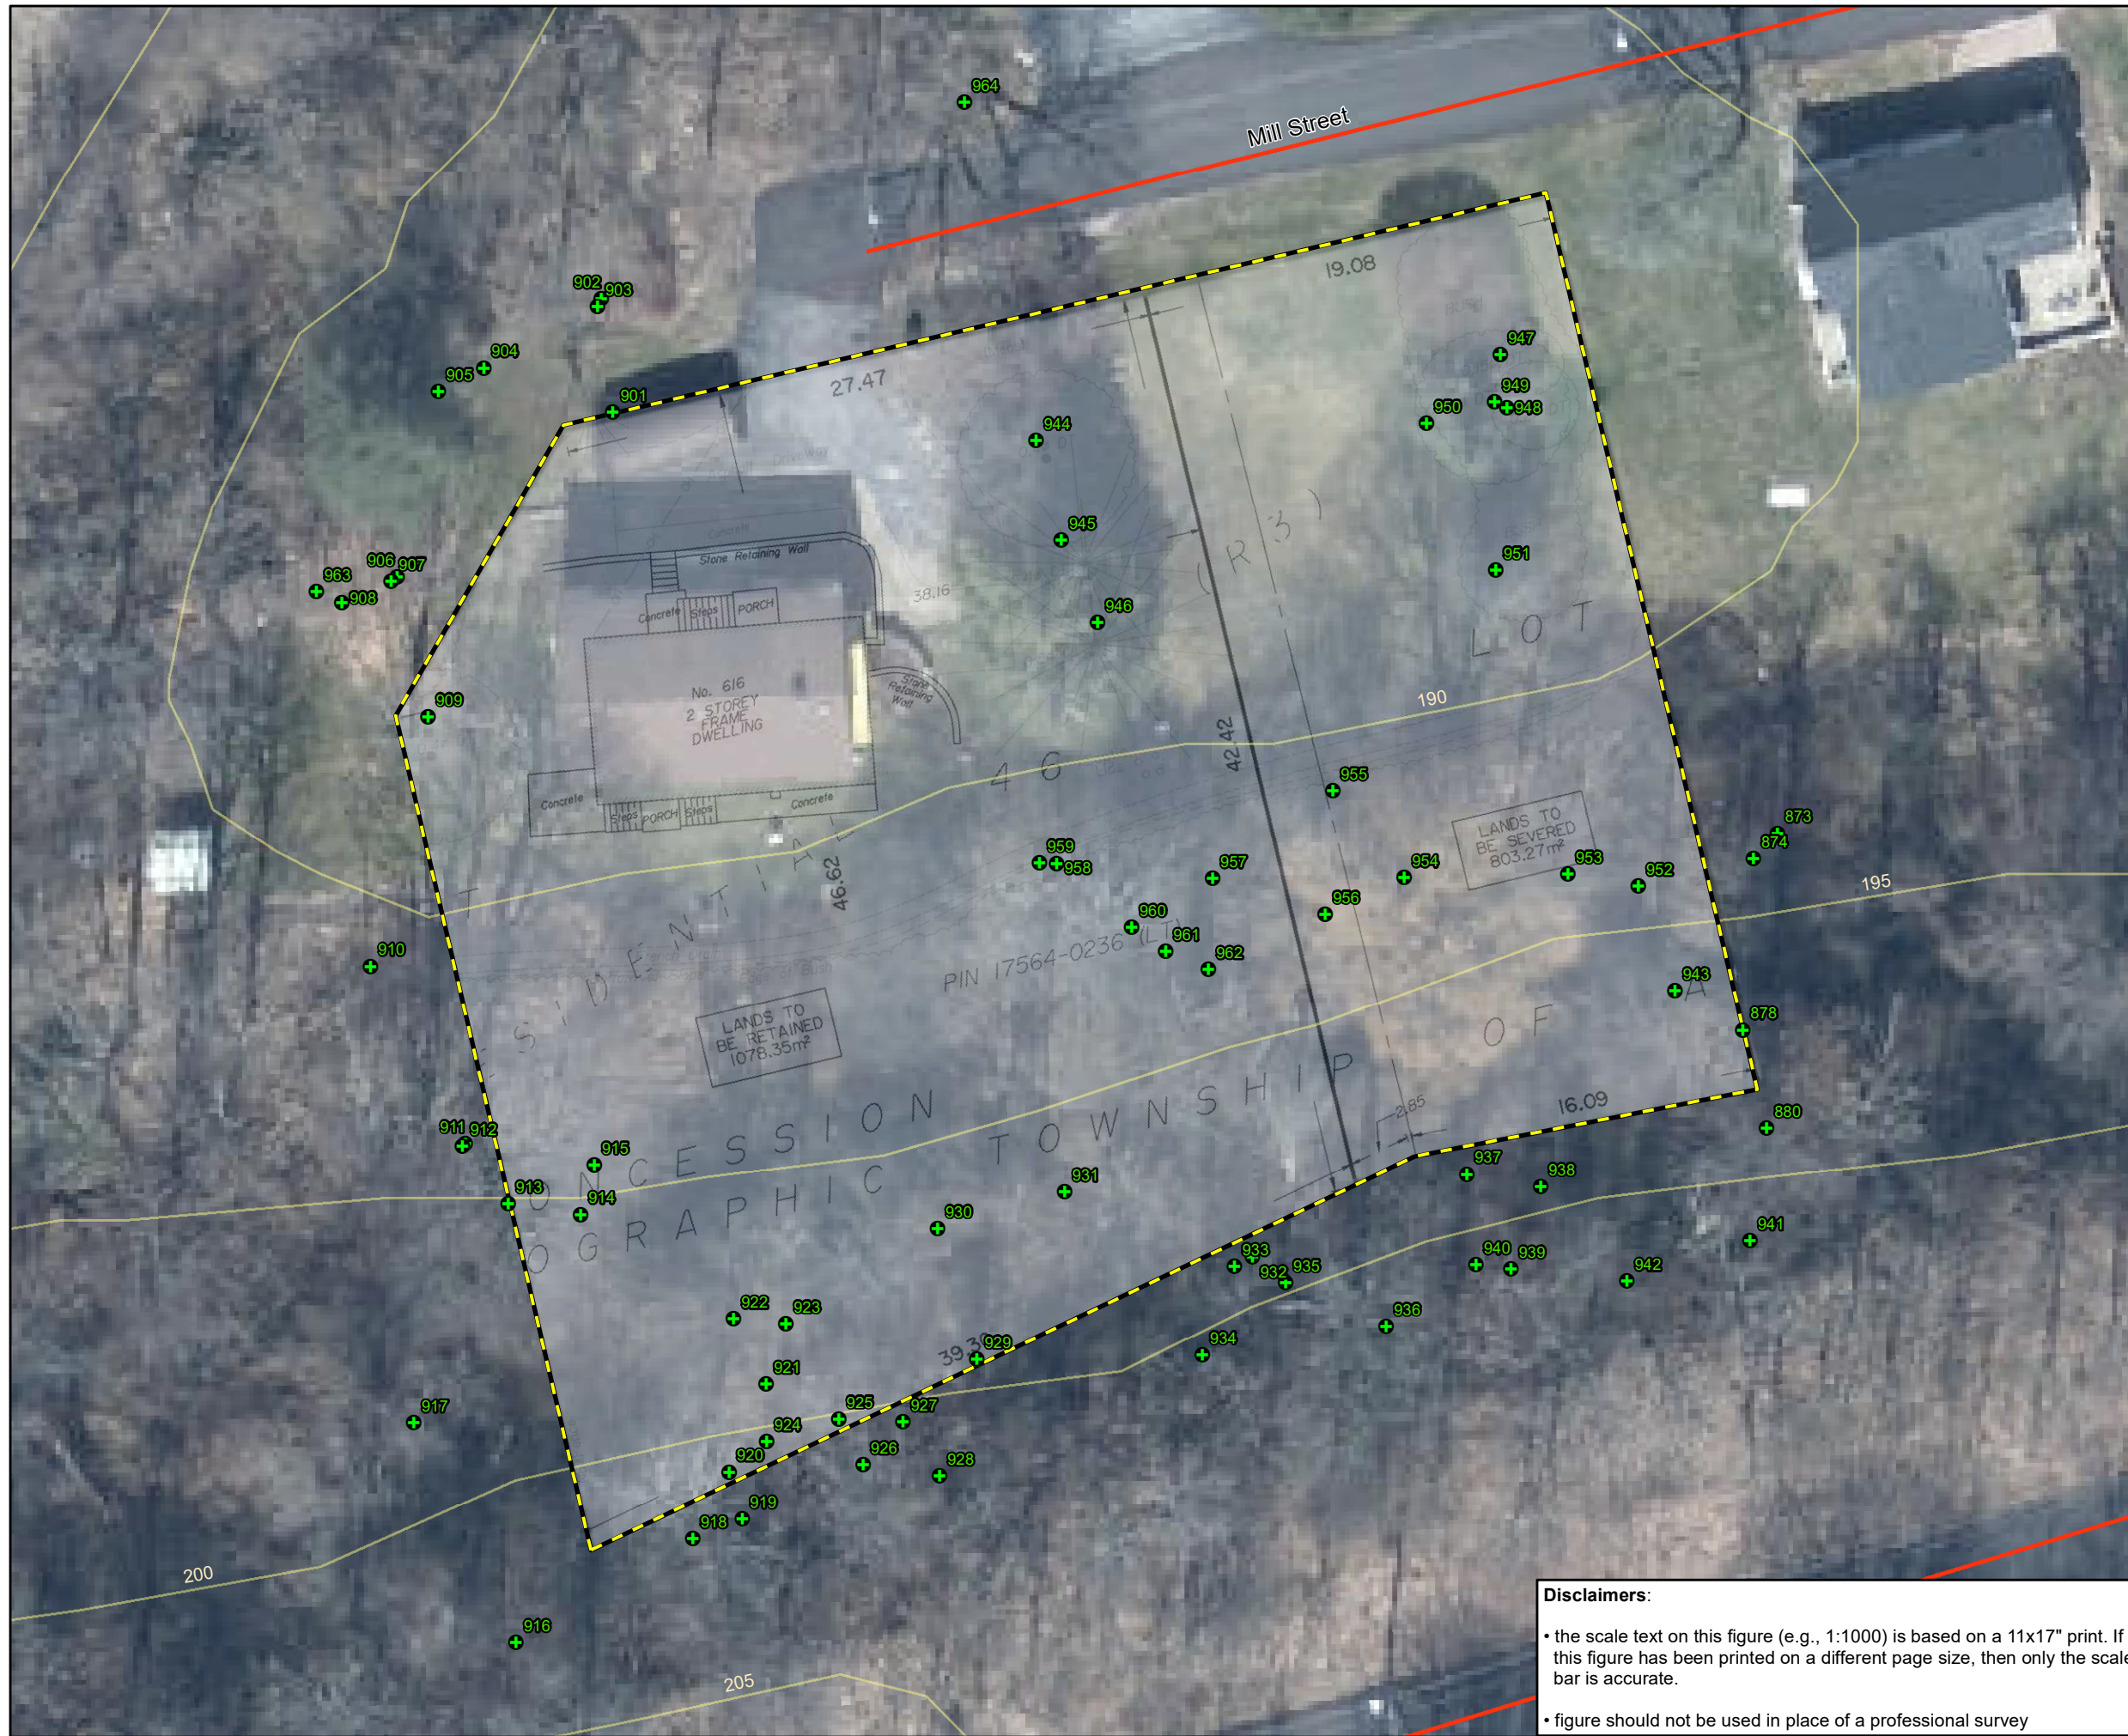
Figure 2. Tree Inventory
616 Mill St., City of Hamilton
Prepared for: Charlie Firth

At the time of our site visit on July 31, 2023 the subject property consisted of residential property that was primarily cleared with manicured yard, landscape trees, gardens, dwelling a associated structures. The treed portion of the property consisted scattered trees within the developed portion of the property and a forest community in the rear portion of the subject property. This report provides an inventory of trees located on the subject property and within 6.0 m of the property line (**Figure 2** and **Figure 3**).

A total of sixty eight (68) trees were assessed in this study with tree tags 901 – 964 and previously tagged trees 873, 874, 878 and 880. Trees inventoried consisted primarily of deciduous species with three (3) live conifer being inventoried with ages ranged from young to mature. Tree size ranged from 11.0 to 109 cm in DBH within the subject property and lands directly adjacent. Fifteen (15) different species were documented within the proposed development areas with American Basswood (*Tilia americana*), Black Cherry (*Prunus serotina*), Black Walnut (*Juglans nigra*), Blue Spruce, Butternut, Eastern Redbud, Green Ash (*Fraxinus pennsylvanica*), Horse Chestnut (*Aesculus hippocastanum*), Manitoba Maple (*Acer negundo*), Norway Maple (*Acer platanoides*), Scots Pine, Silver Maple, and White Spruce (*Picea glauca*). Three (3) additional trees were identified to species genus (Ginko Species, Spruce Species – *Picea* sp., Willow Species – *Salix* sp.) and four (4) dead trees of unknown species. The complete inventory and health assessment of trees can be found in **Appendix 1**.

Emerald Ash Borer (*Agilus planipennis*; EAB) has affected Green Ash within the assessed area with many Green Ash being dead and only five (5) trees being alive. Of the Green Ash that are alive, all

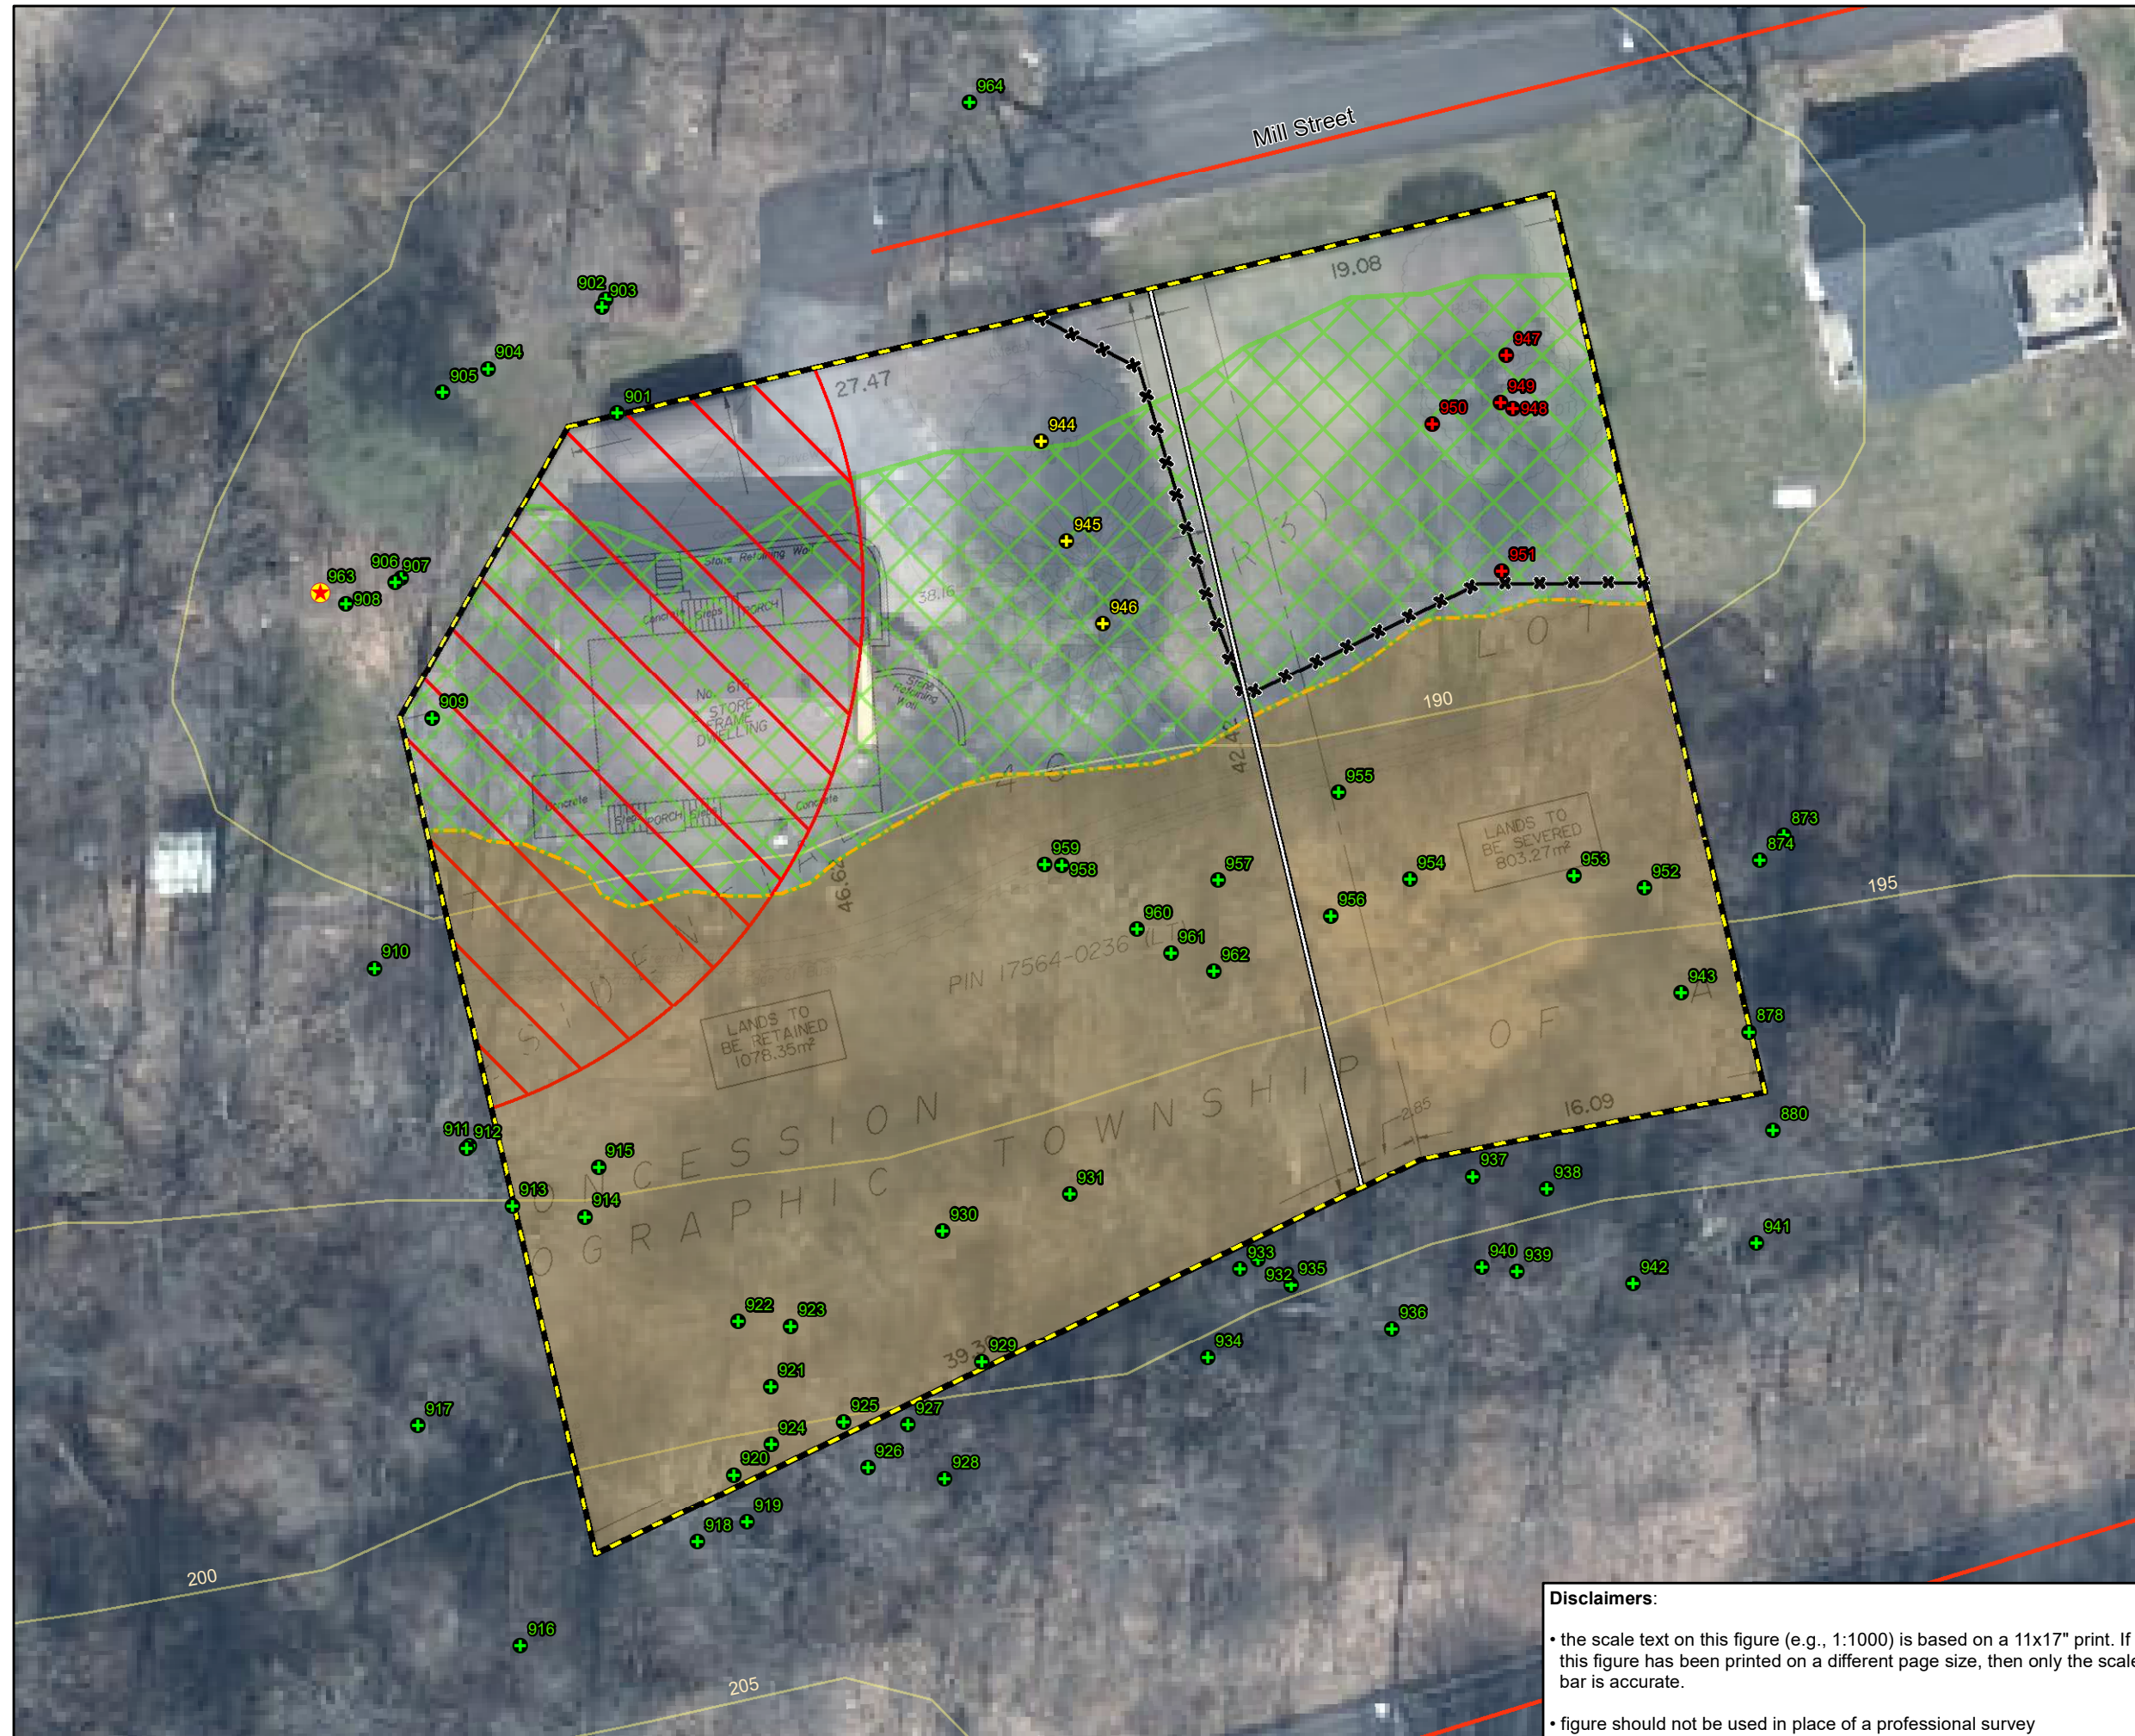
Figure 3. Tree Inventory Outcome
 616 Mill St., City of Hamilton
 Prepared for: Charlie Firth

Figure 3 provides an overlay of the proposed severance with RiverStone's anticipated tree preservation / removal direction.

- Severed Lot 1 – Trees 947, 948, 949, 950 and 951 are assumed to require removal for development. All of these trees are in fair to good condition and located within a landscape feature where limbs have been pruned and undergrowth suppressed.
- While trees 944, 945 and 946 are located solely on the retained lot, these trees should be considered boundary trees due to their location to the property boundary. Any maintenance (e.g., pruning), removal or work within the dripline of these trees requires permission from the adjacent property owner.
- Tree protection fencing is recommended along the edge of the significant woodland and to the severance side of tree 944, 945 and 946 as indicated on Figure 3.

- **Detailed redevelopment and grading plans for subject property must consider all trees on adjacent properties as mapped on Figure 3 as design constraints.**
