City of Hamilton - Heritage Permit Application Note Sheet

Address: 252 James Street North, Hamilton (Christ's Church Cathedral, Part IV)
Permit Number: HP2024-038

Description of proposed alterations:

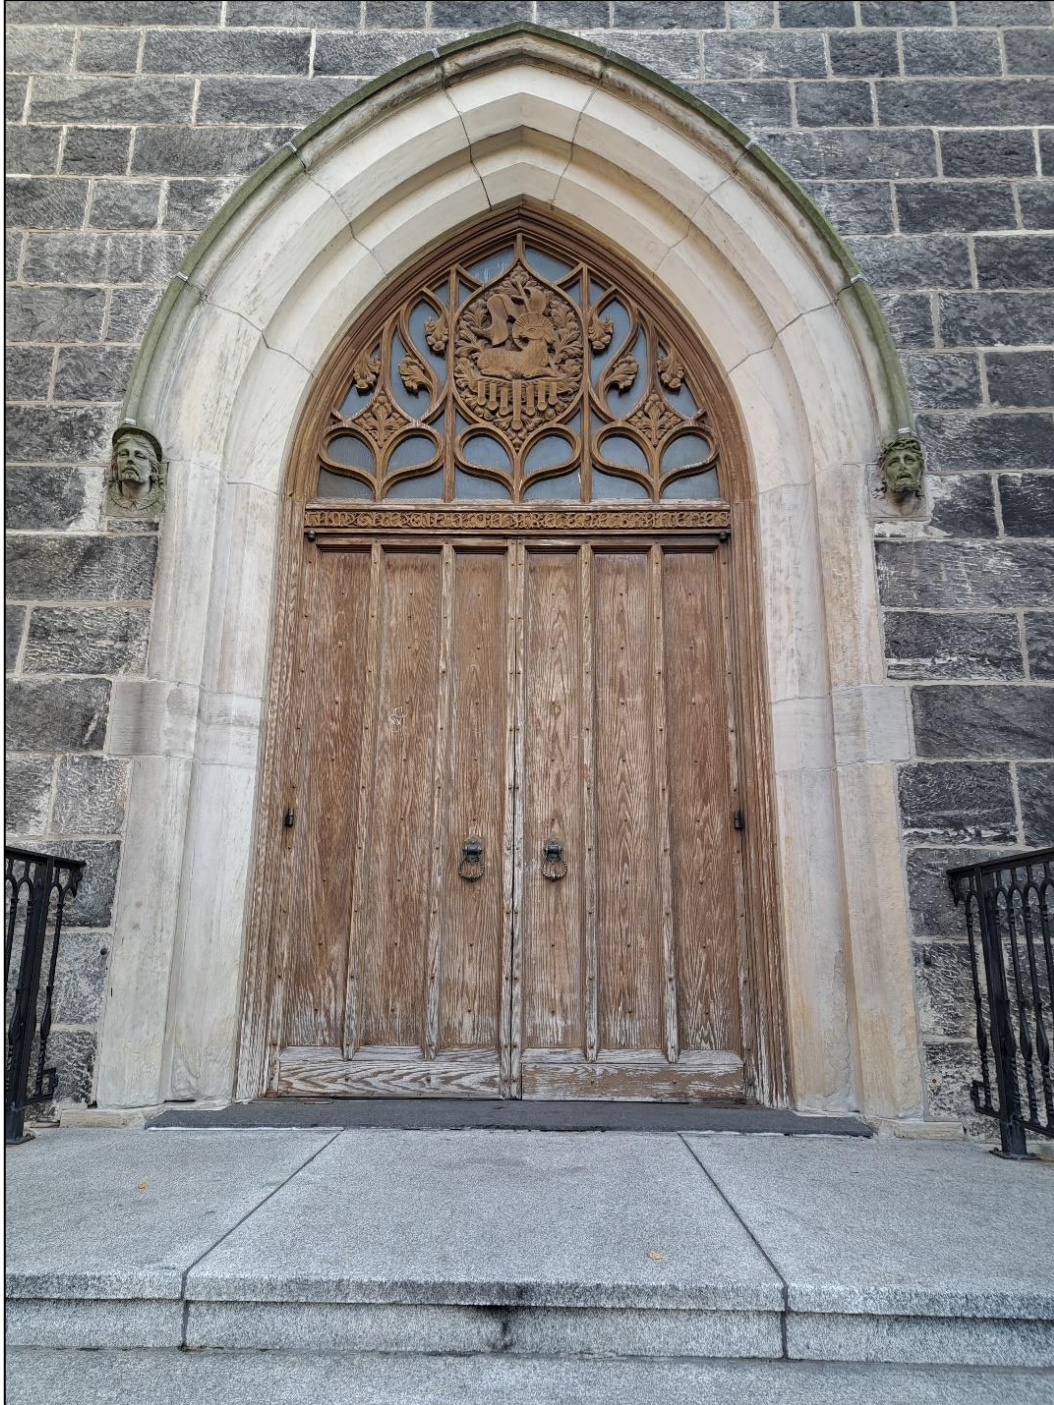
Figure 1: Door to be restored (middle door of the 3 at the front of the building)

- Restoration of the main set of central front oak doors, including:
 - Temporarily removing the doors for restoration off-site;
 - Restoring, staining, and varnishing the doors, transom and door frame;
 - Installing weather seals to the jambs, header and threshold;
 - Refurbishing the existing hardware;
 - Installing a new set of panic set bars to both doors for fire safety; and,
 - Installing new brass kick plates to the interior.
 - Interim repairs to the southern set of doors to allow for access and fire safety during restoration of the central doors
-

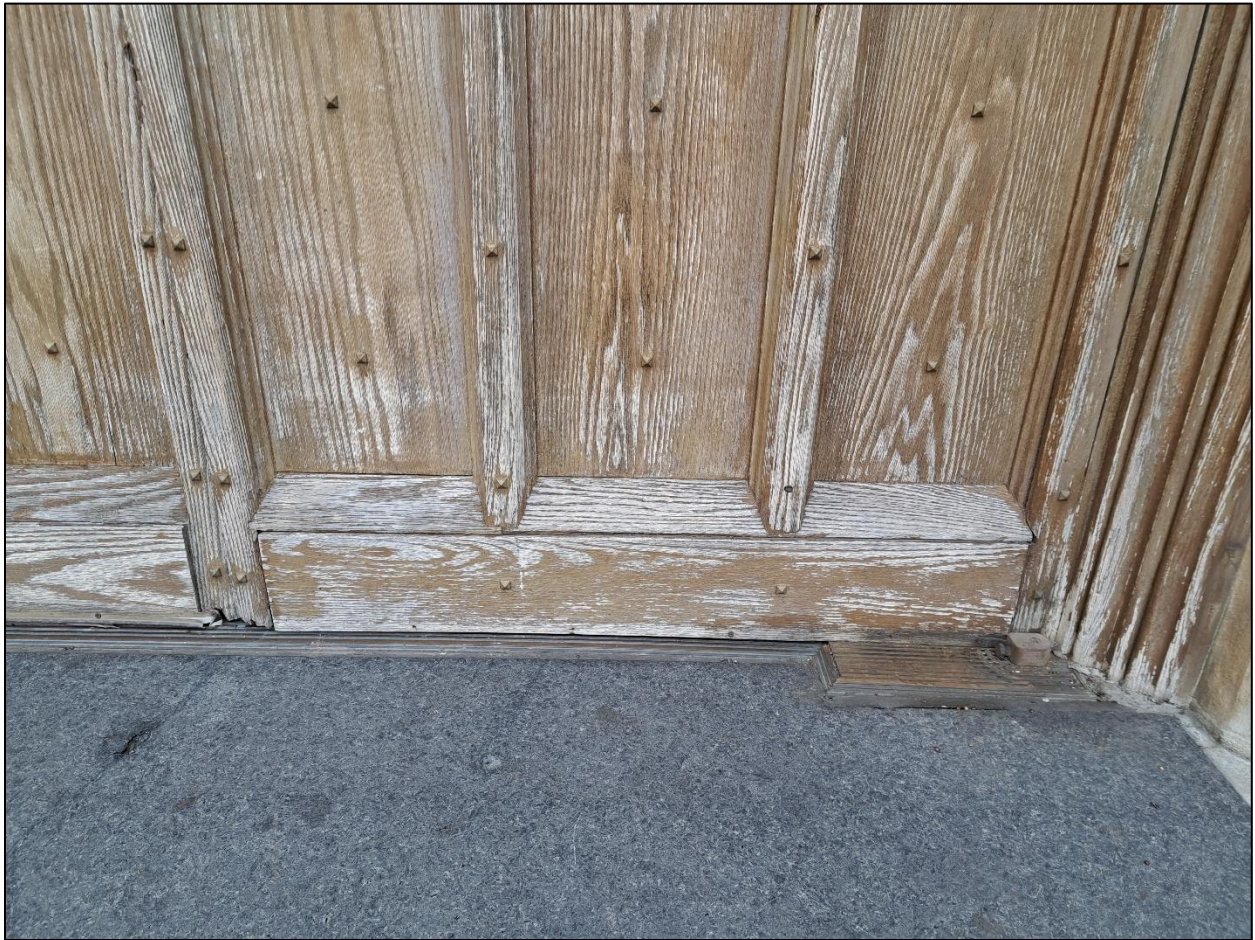
Figure 2: Heaving door jam and stile to be repaired

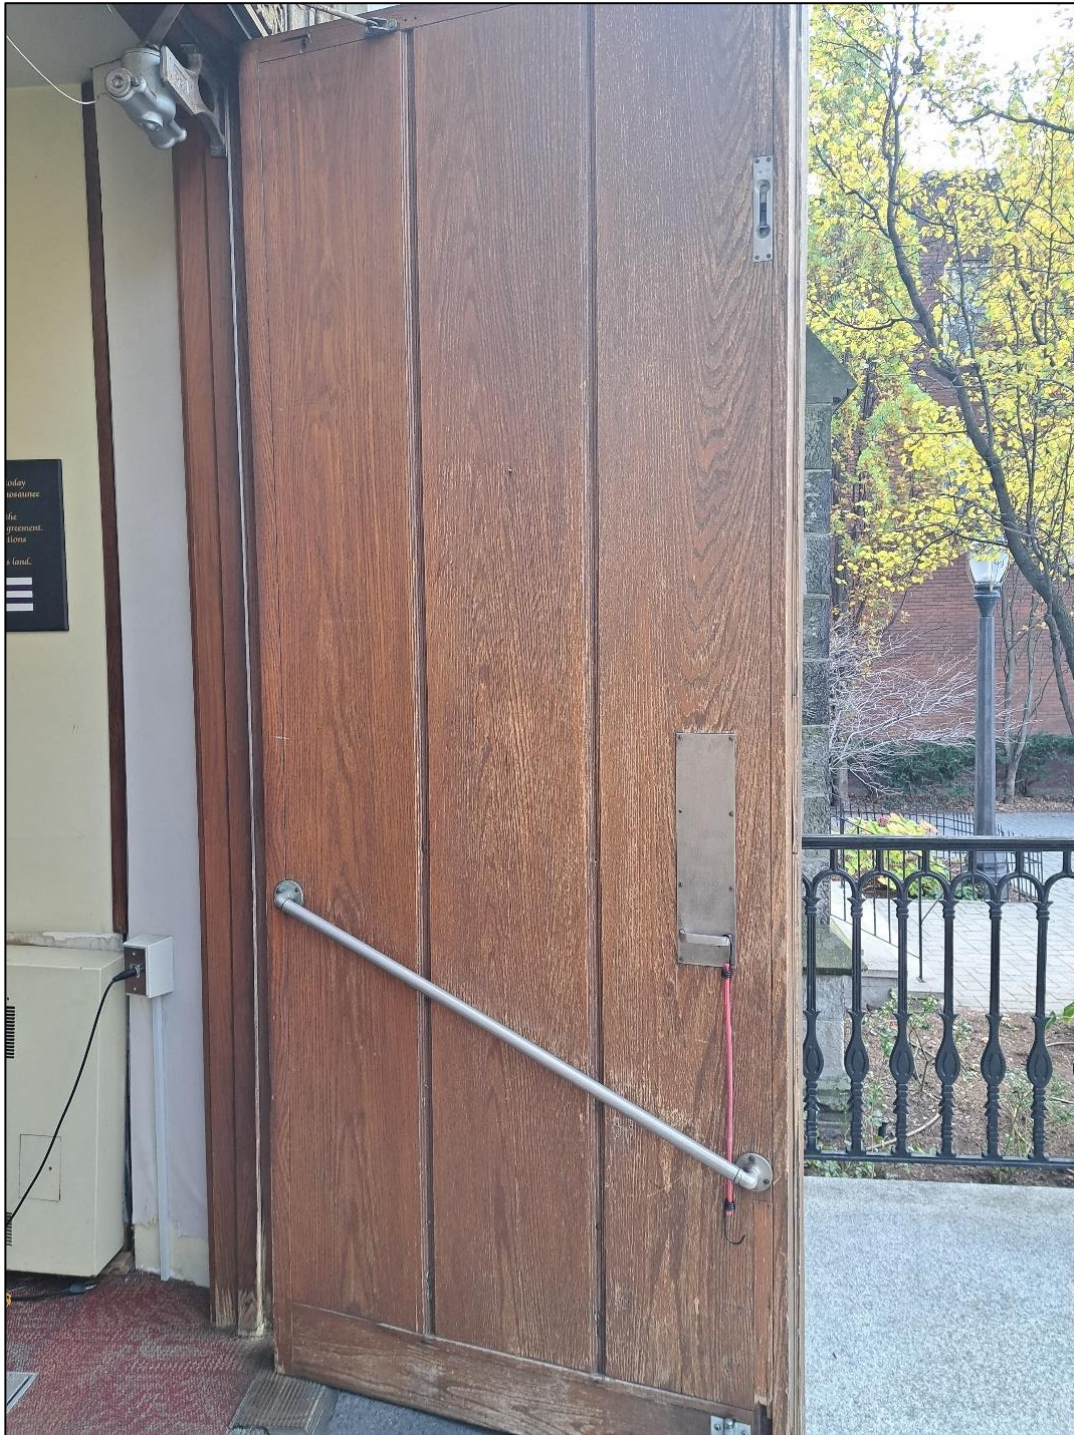
Figure 3: Inside of the main door

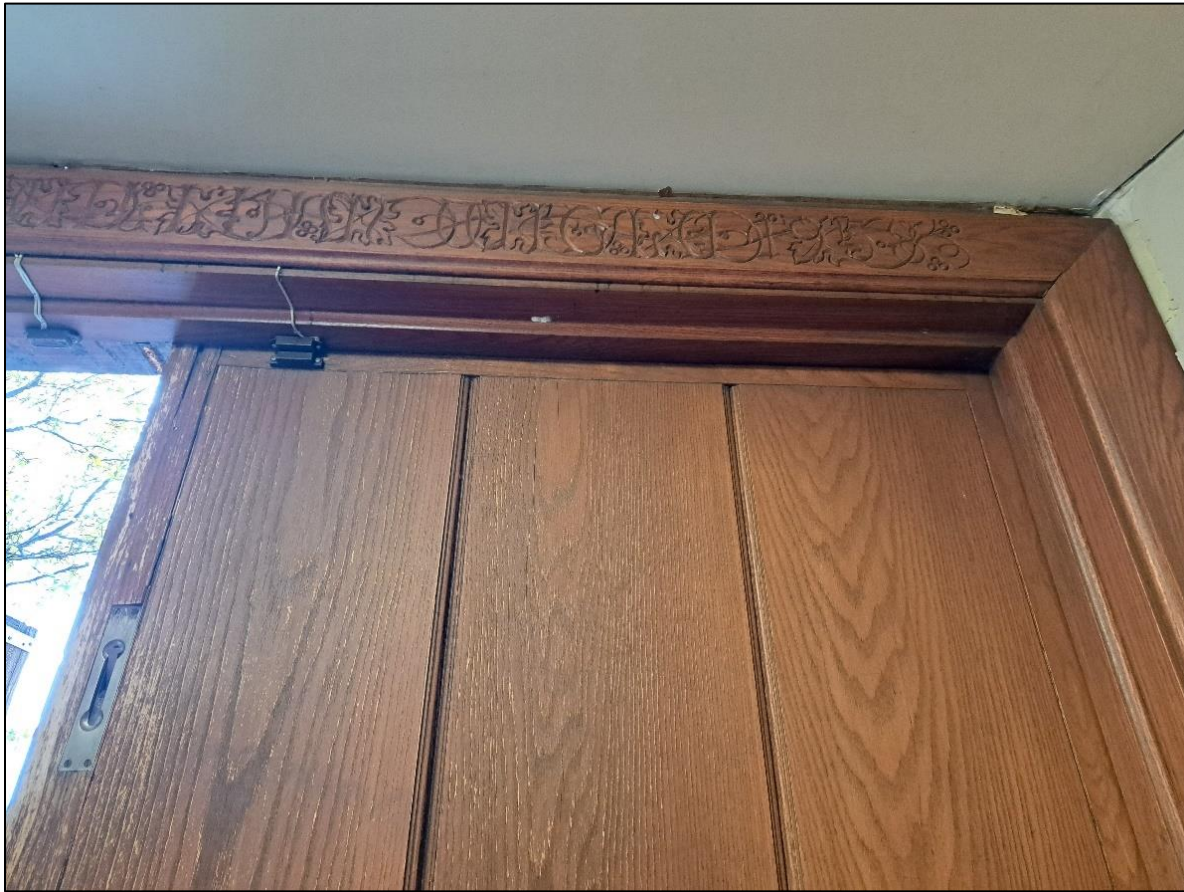
Figure 4: Inside of main door

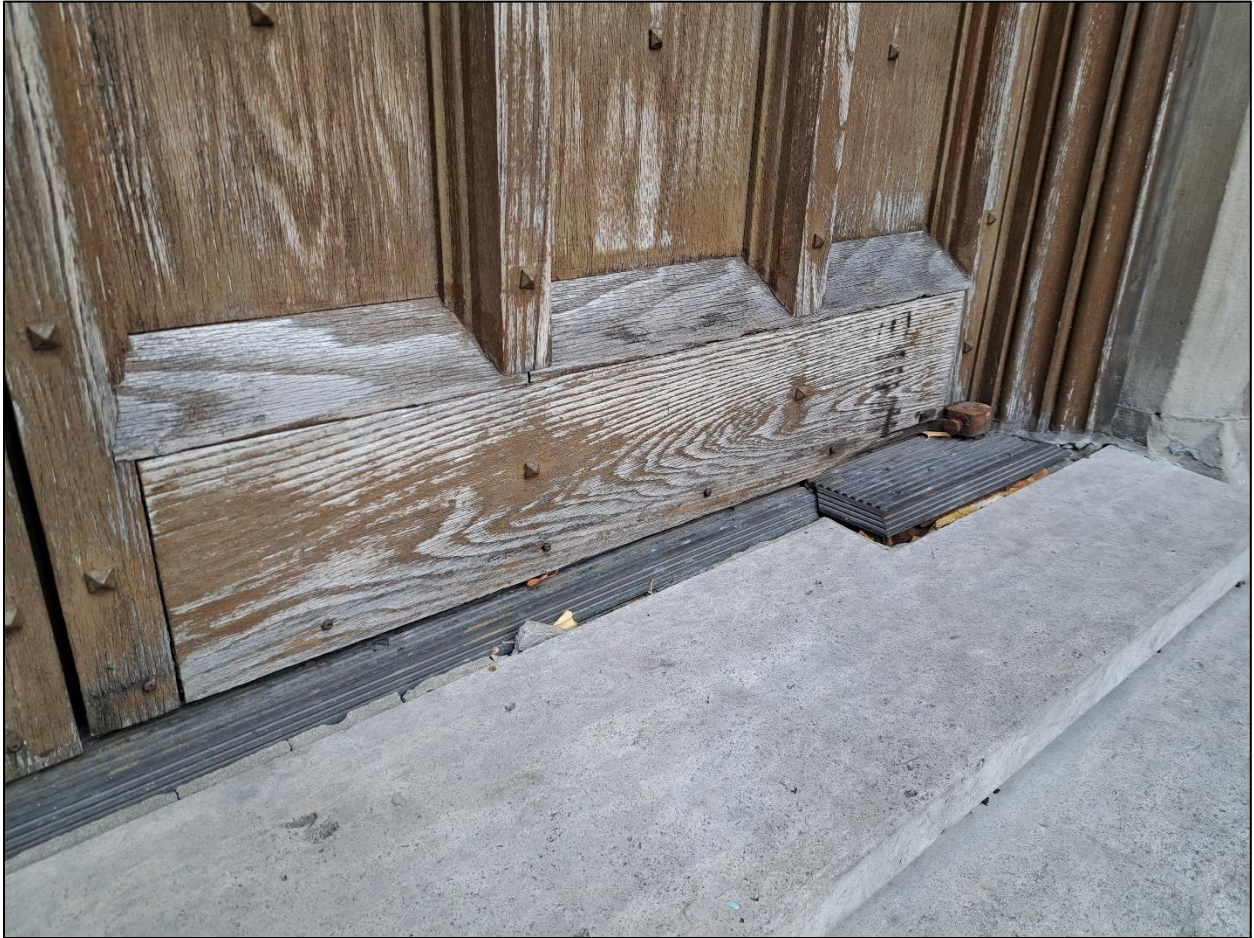
Figure 5: South door damage to be repaired and used as interim entrance door during restoration
