# City of Hamilton Heritage Committee

Meeting December 13, 2024

108 James Street North,  
111-115 Hughson

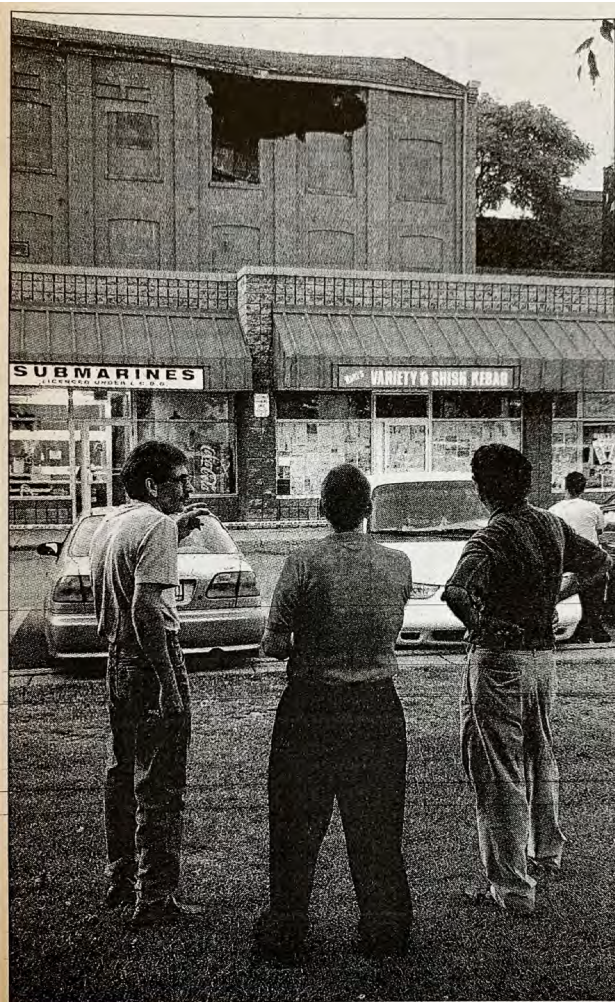
Passersby study the gaping hole in the Tivoli wall. The building was erected in three sections, with the earliest dating to 1875.

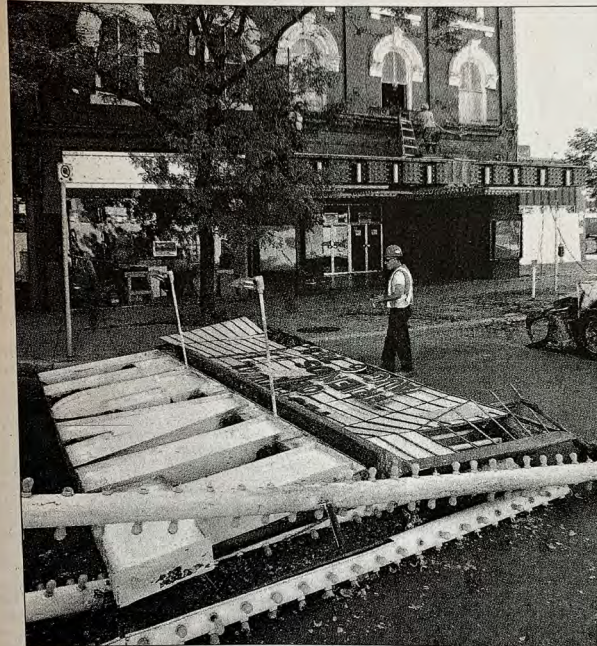
City crews removed the marquee of the Tivoli Theatre on James Street North on Saturday. A wall collapsed last week, and a civil engineer determined the sign was pulling away from the front of the theatre, creating a hazard for pedestrians and drivers. Dismantling of parts of the building continued yesterday.

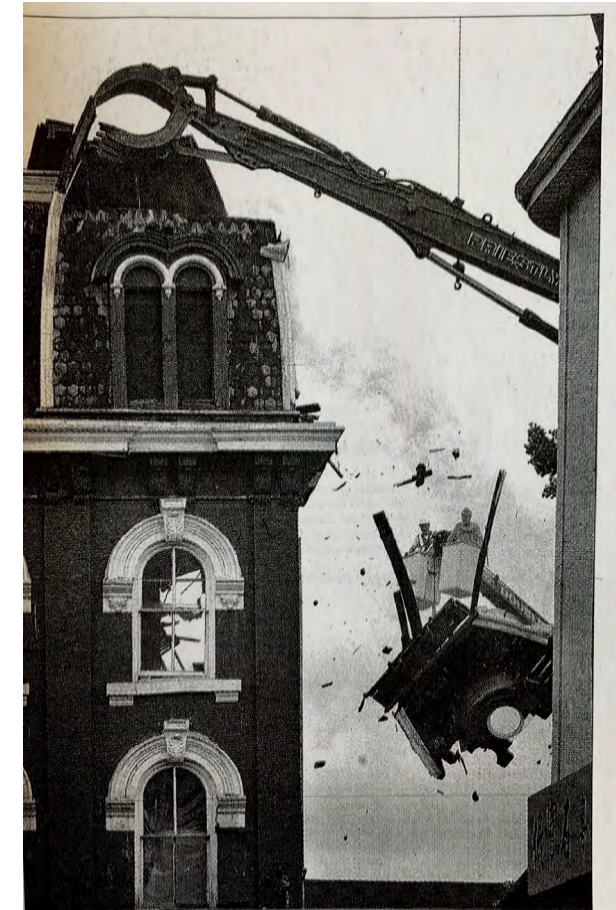
Debris flies as workers remove a section of the Tivoli's third-floor yesterday, which was in danger of falling.

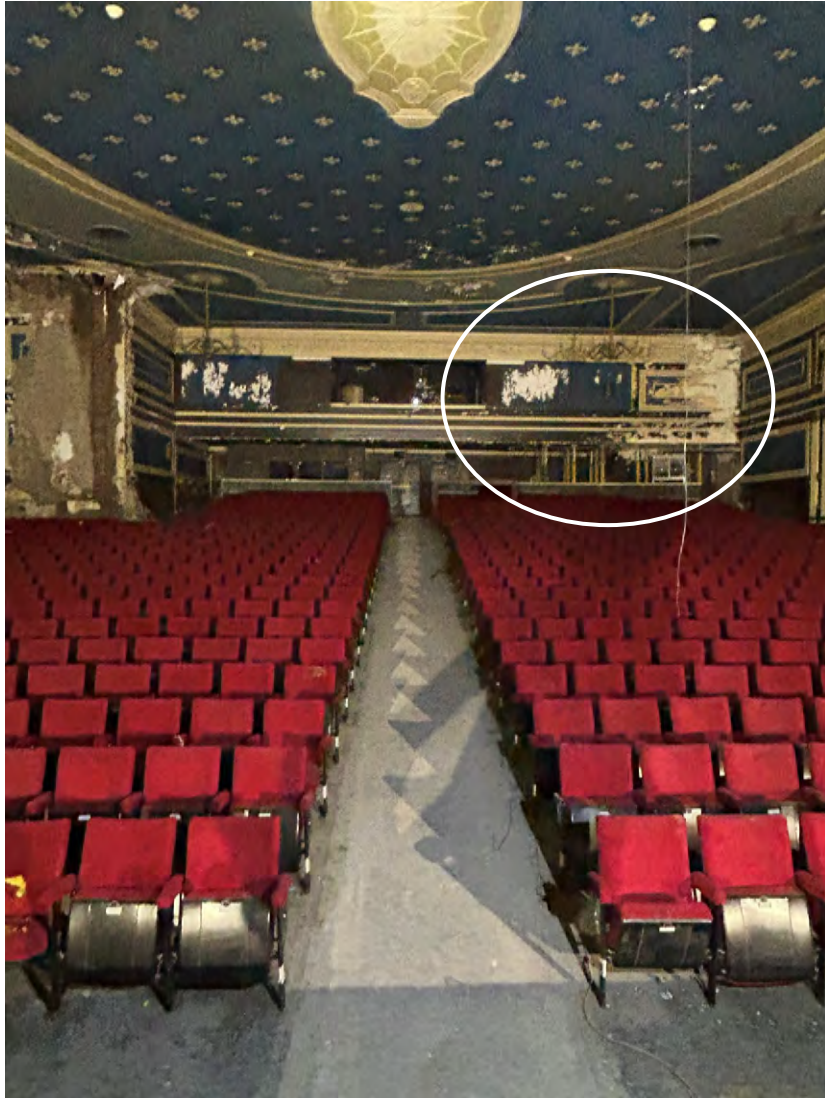
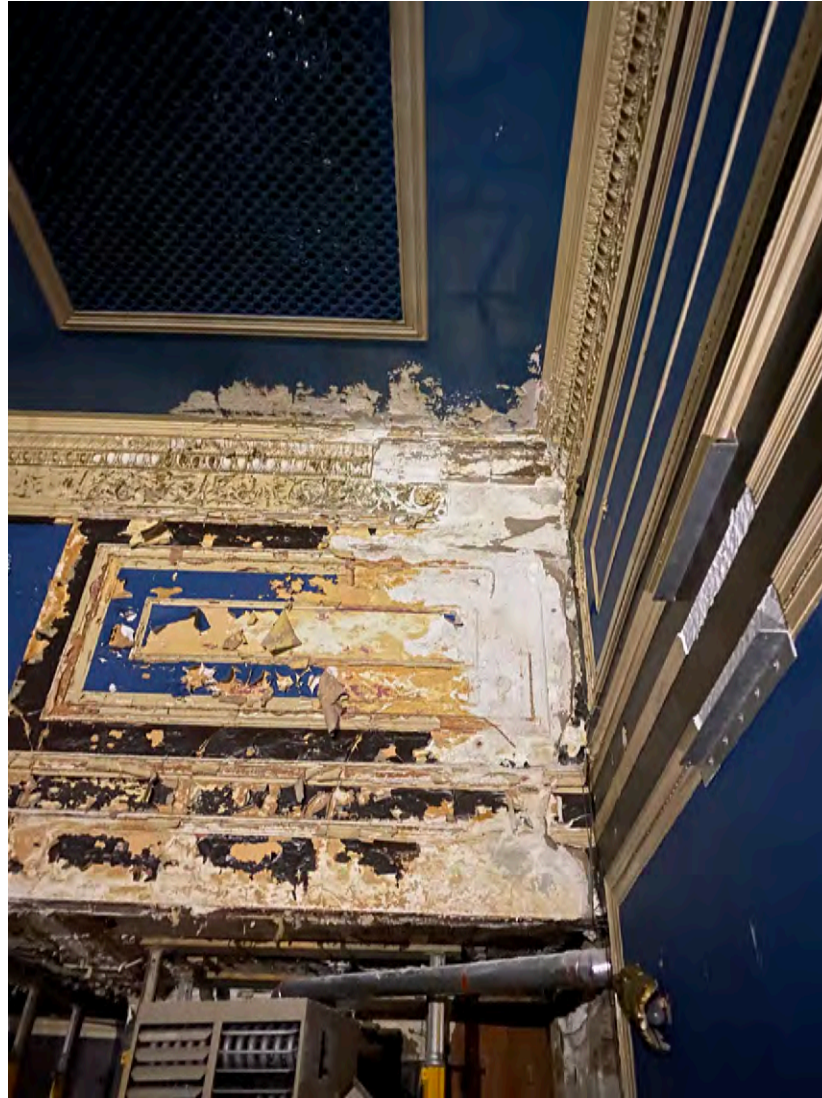
Projection room finishes are damaged due to structural deterioration of the floor and roof systems.

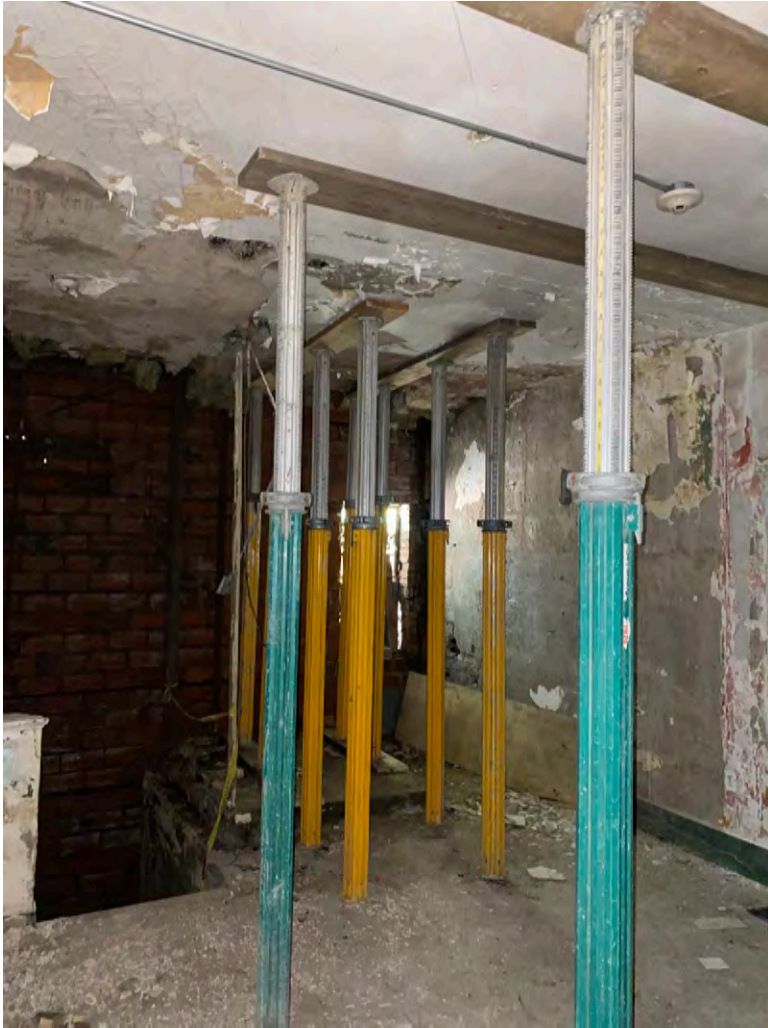
Observation: Shoring up to ceiling of roof structure. Ceiling has significant moisture damage and is on the verge of collapse. Shoring is installed but may not prevent collapse of moisture ridden gypsum panels.

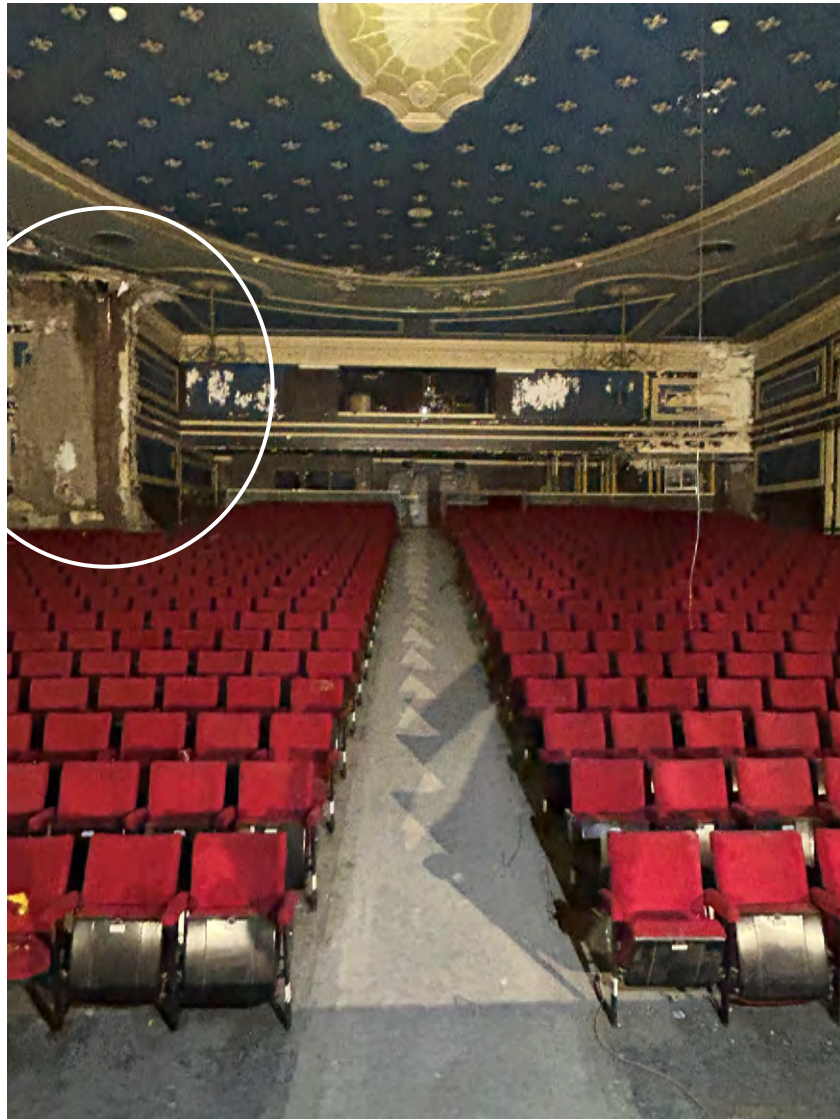
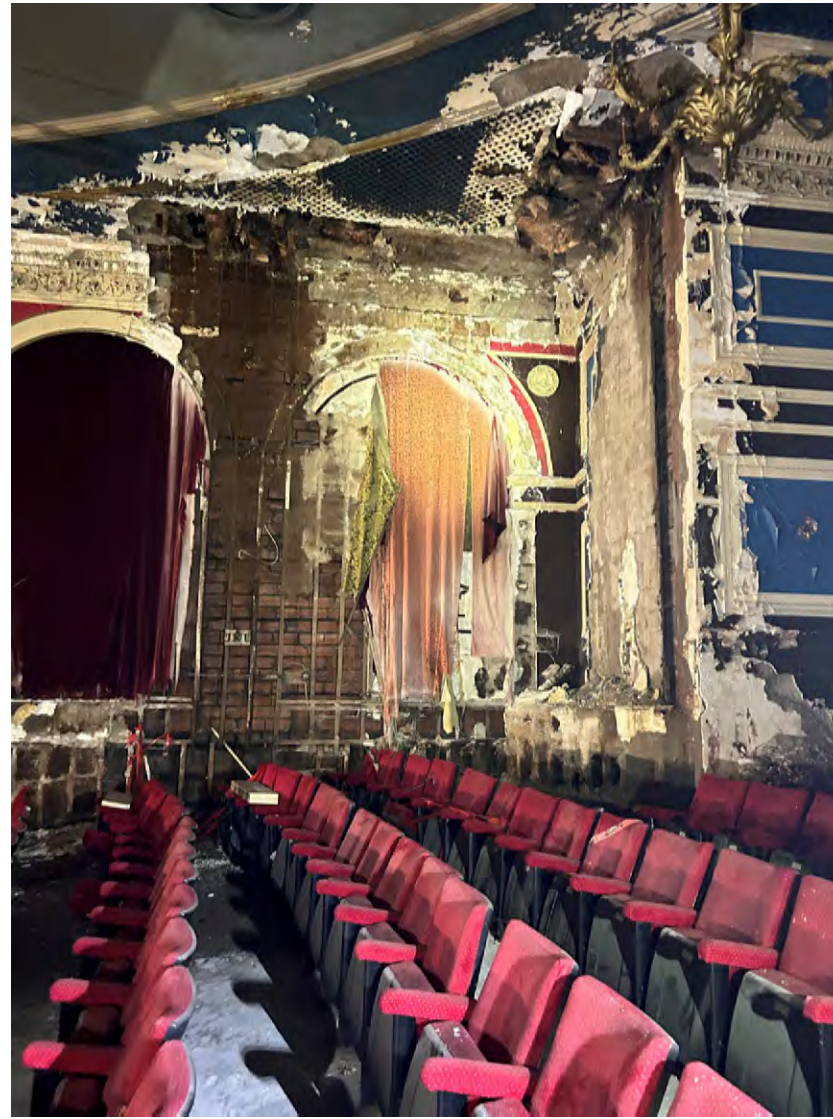
Observation: Brick and clay tile interior walls covered with plaster finish in most areas. Plaster is in poor condition; where visible, clay tiles and bricks are in poor condition.

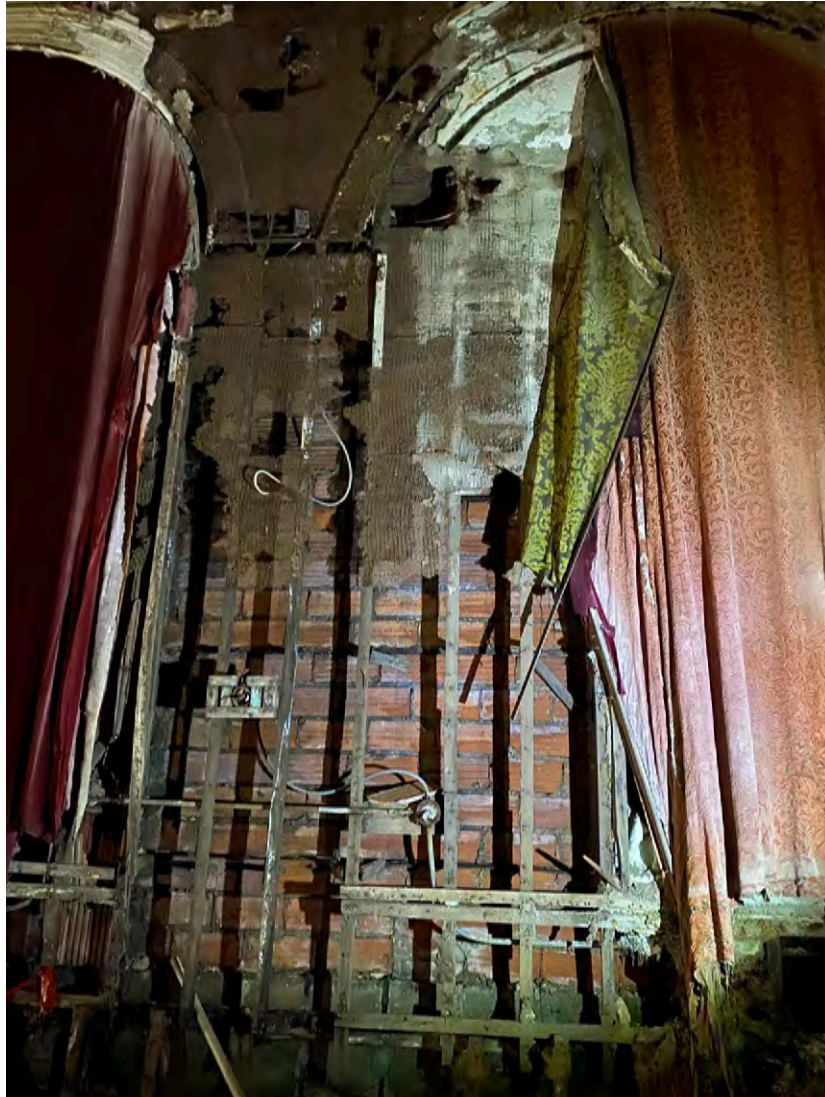
Observation: Brick and clay tile interior walls covered with plaster finish in most areas. Plaster is in poor condition; where visible, clay tiles and bricks are in poor condition.

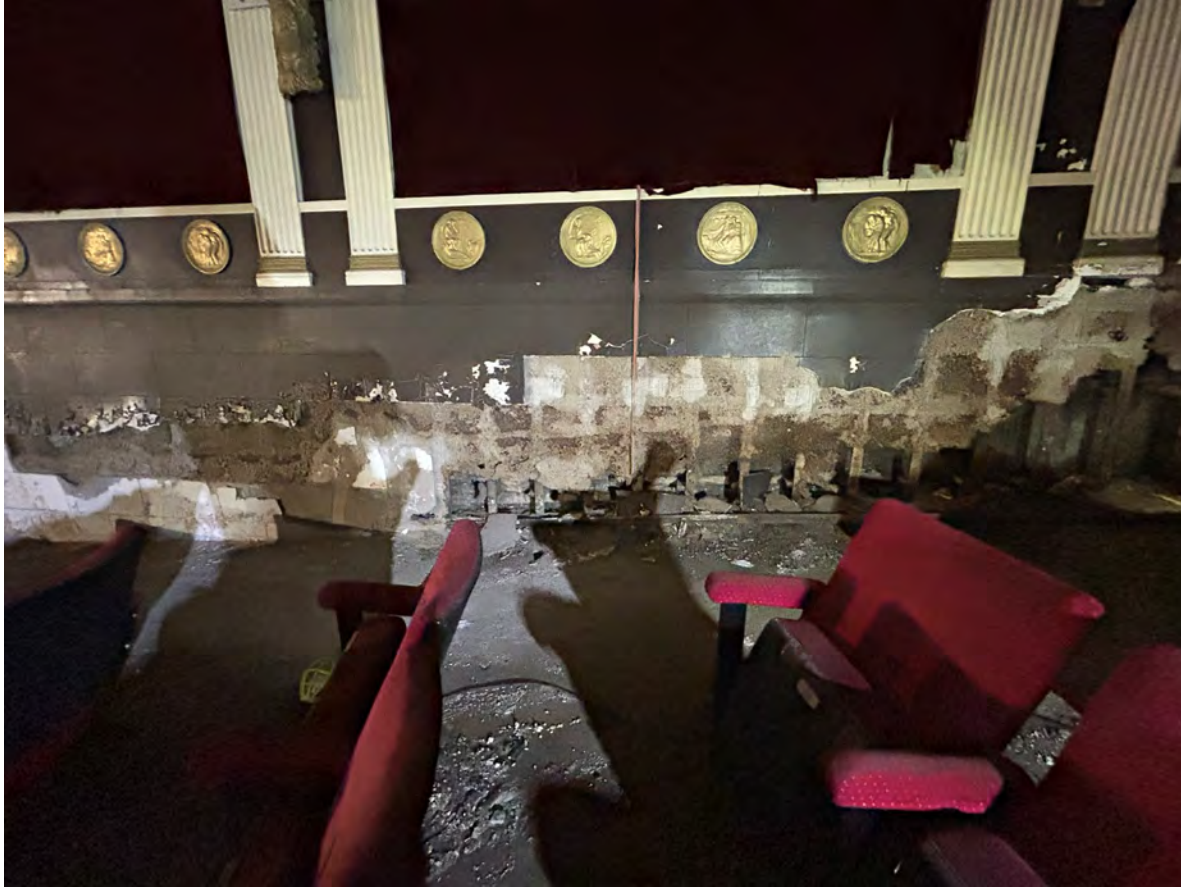
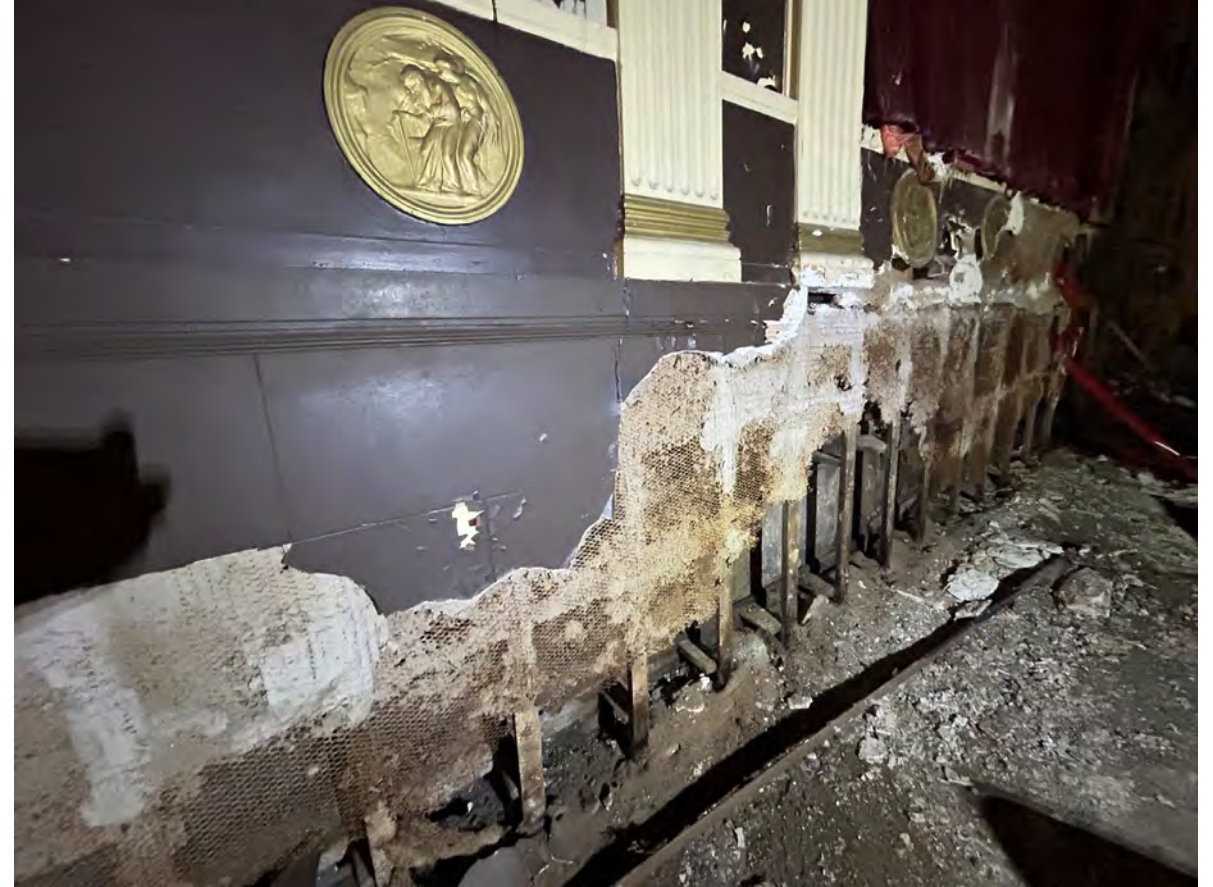
Auditorium Walls

Observation: Plaster is attached to metal lath which is corroding.

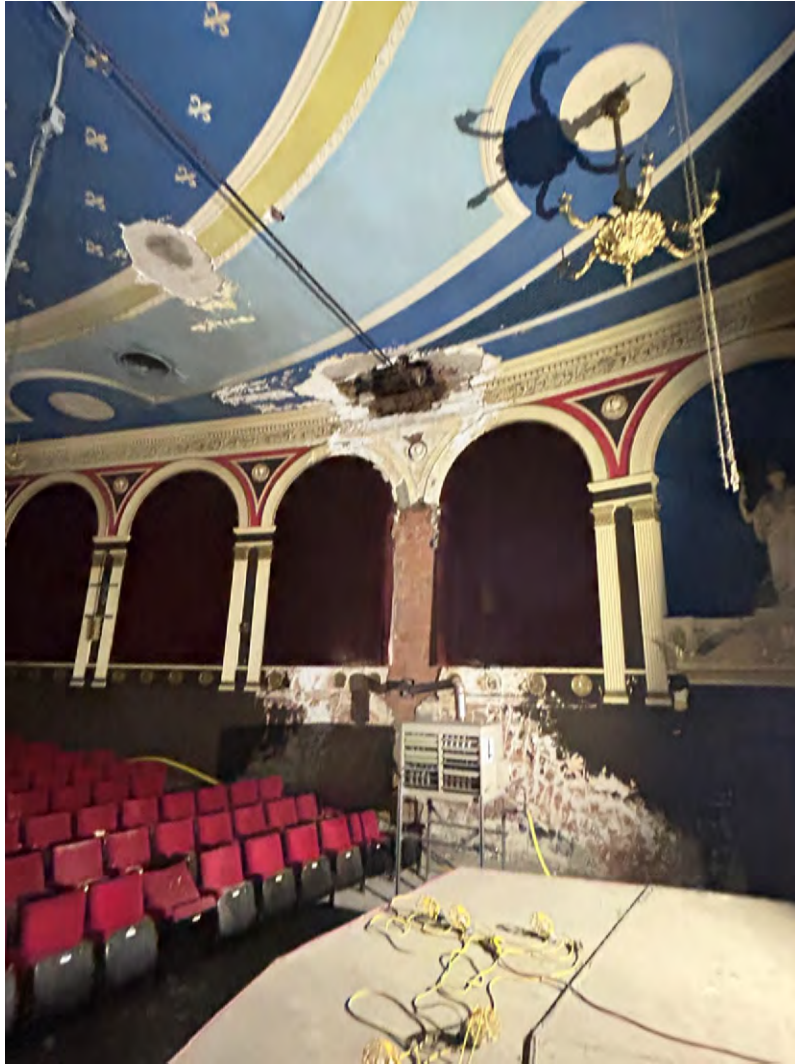
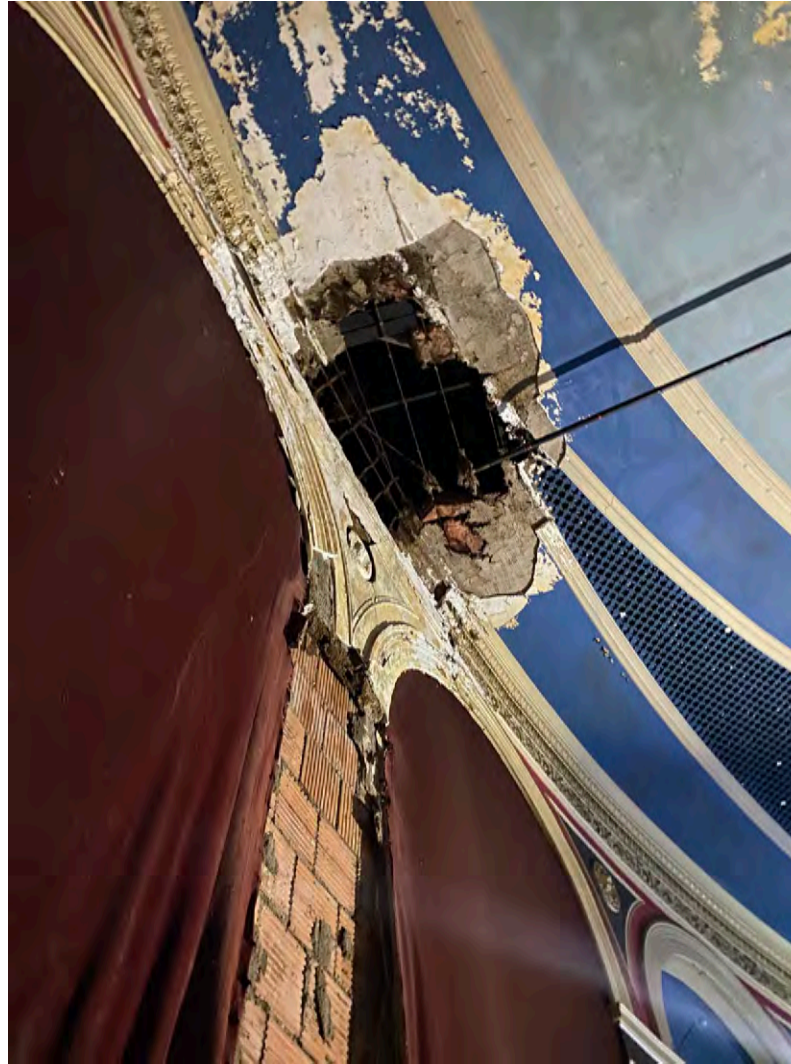
Auditorium Ceiling Structure

Observation:  
Deterioration of plaster finishes in friable condition and clay tile column support. Structural steel column baseplates are corroded making investigation of the superstructure requires removal of all of the clay tile.

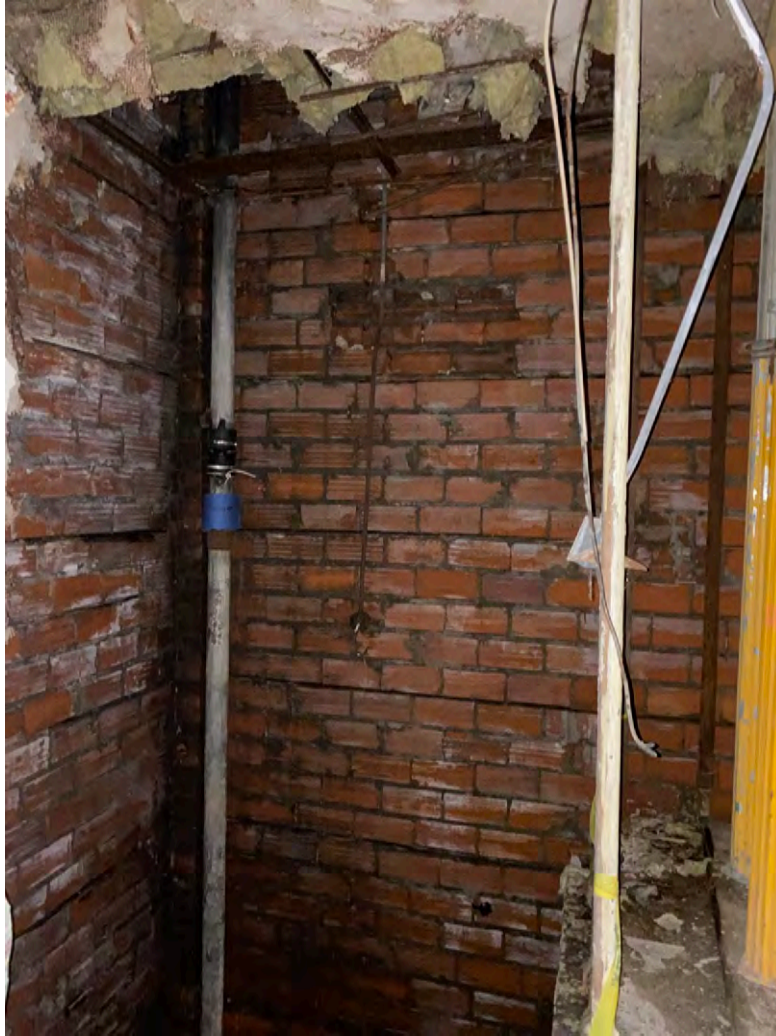
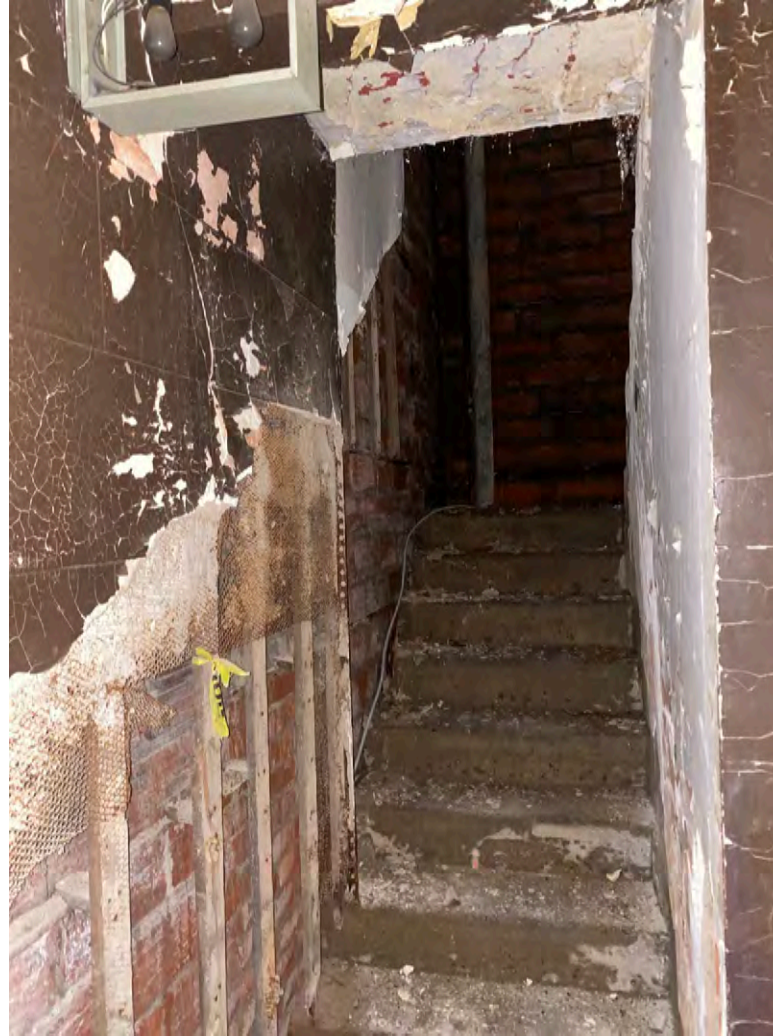
Wall Structure

Observation:  
Deterioration to clay tile and brick at inside of walls. Walls are in poor condition where viewed. Considerable cracking of brick walls was observed.

Airborne contamination observed.

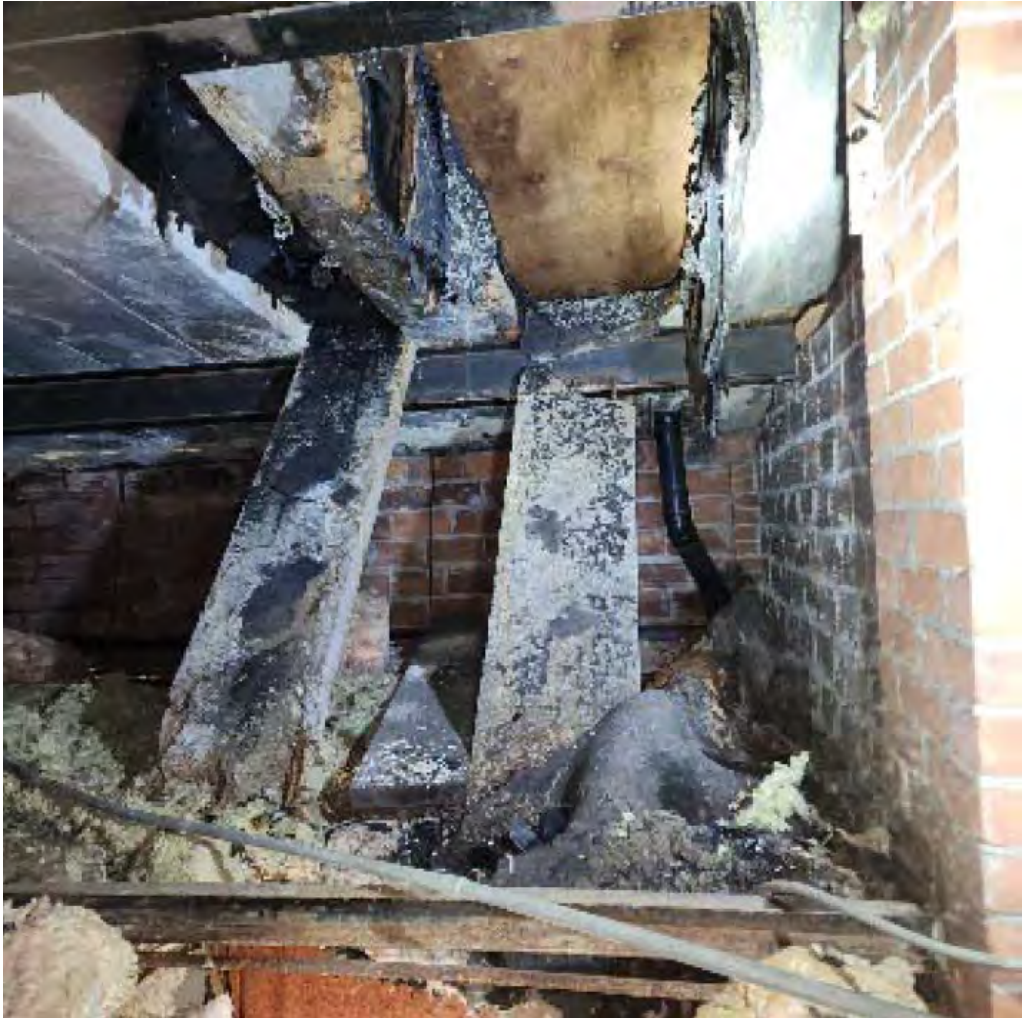
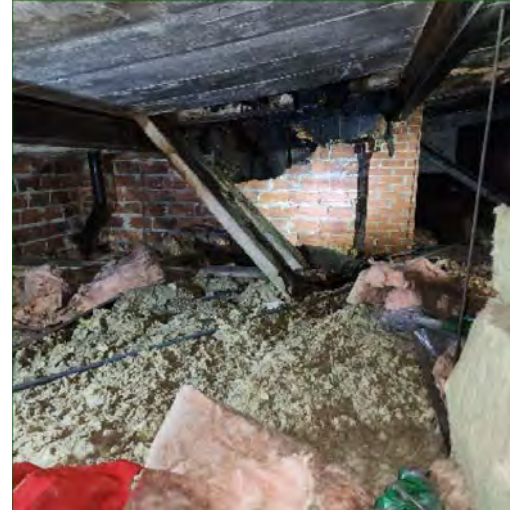
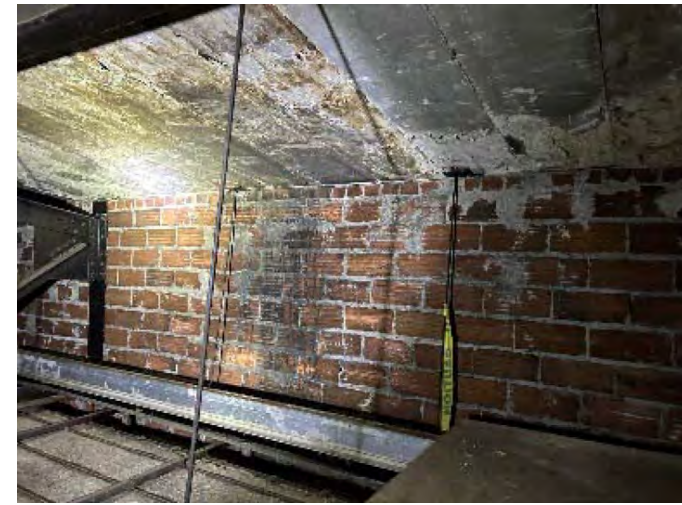
Conditions – Roof Structure

Observation: Gypsum panel roof structure with damage at penetrations, several areas are stained with moisture damage. Panel roof structure loses significant structural integrity when wet.

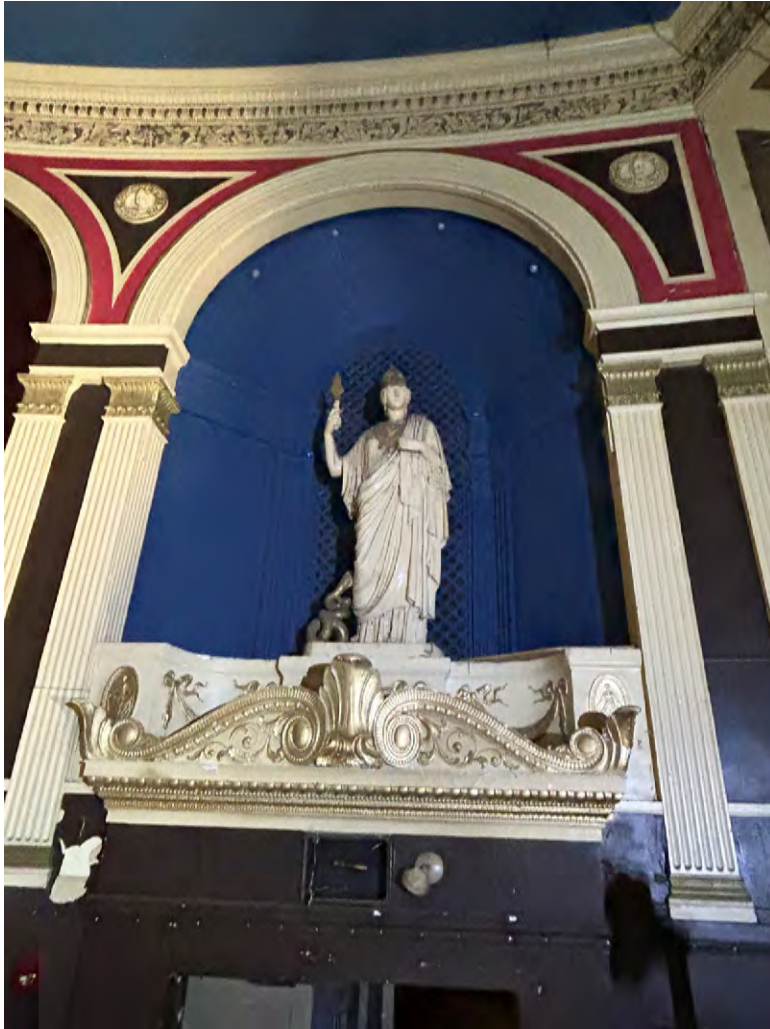
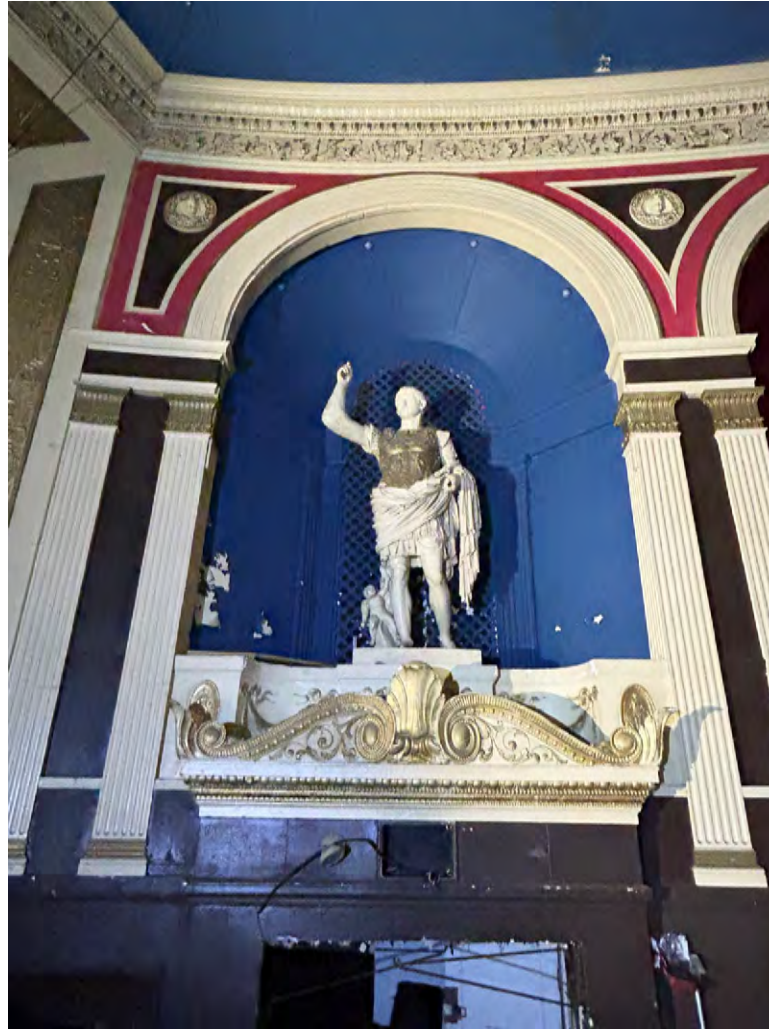
Both statues are plaster, not bronze as per the designations. They are finished in a porcelain paint to mimic original sculptures which were marble.

Overall shape of these pieces are fair, and structurally sound, and can be restored and finished for future use.

Statuary – surface contamination of asbestos-fibers as per Environmental Report.

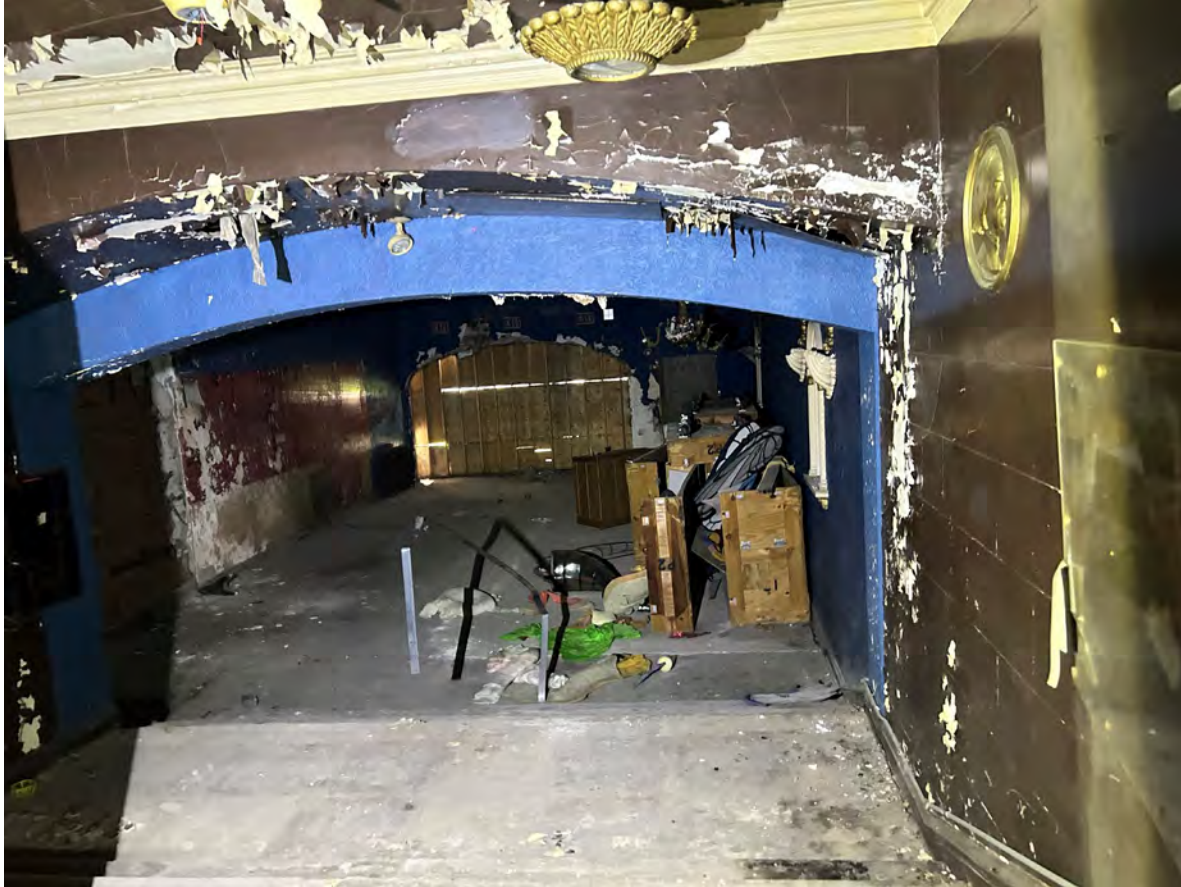
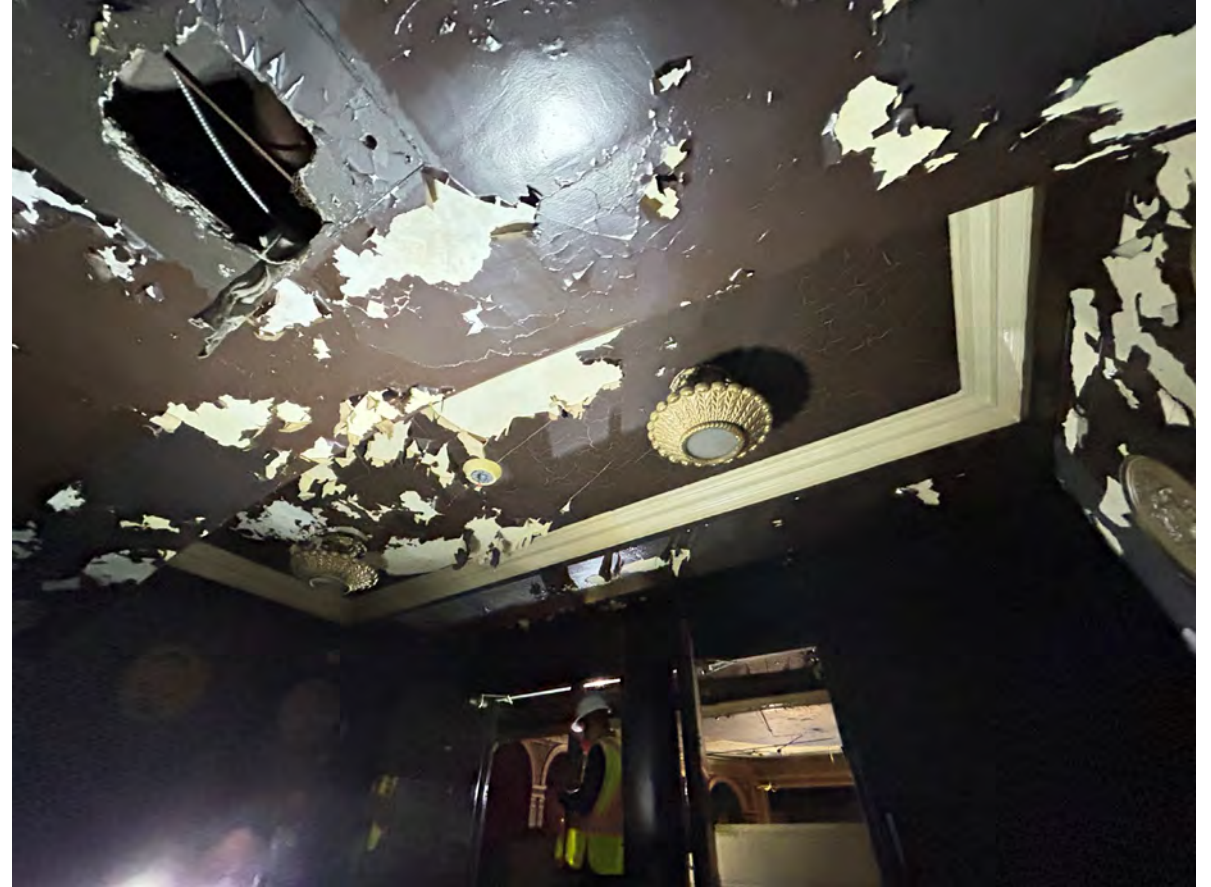
Lobby Area – peeling lead paint indicates moisture intrusion.

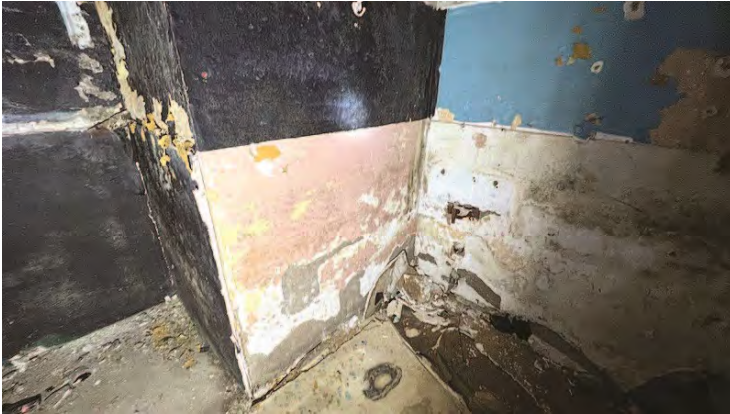
Example of moisture damage on lower walls throughout rooms below stage area.

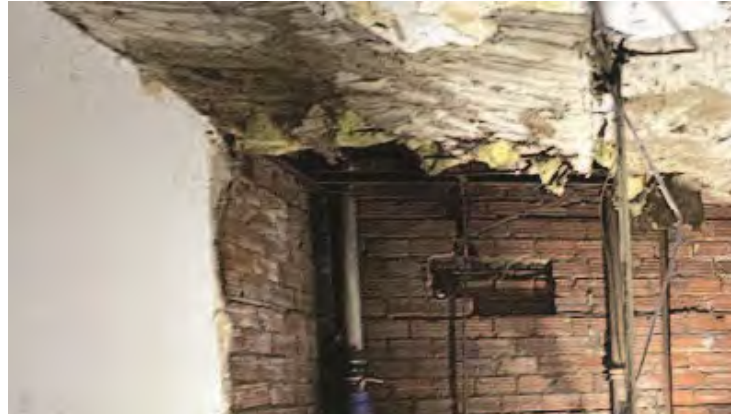
Water damage and mould growth in west corner of south elevation, seen from the second floor.

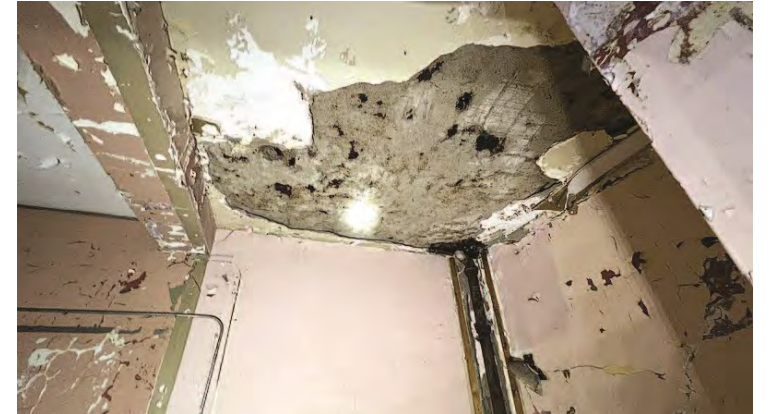
Water-damaged ceiling and mould growth on second floor.

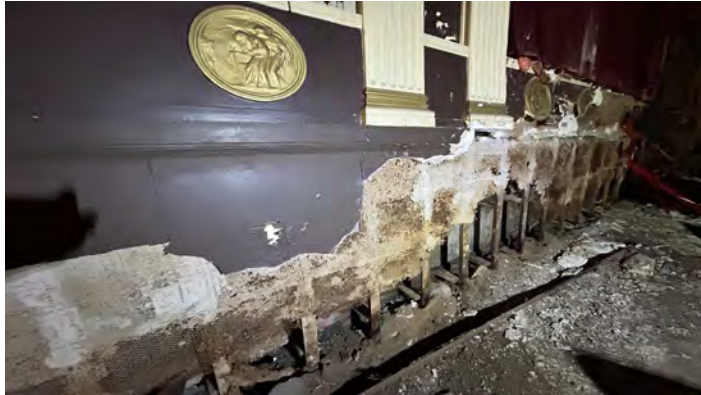
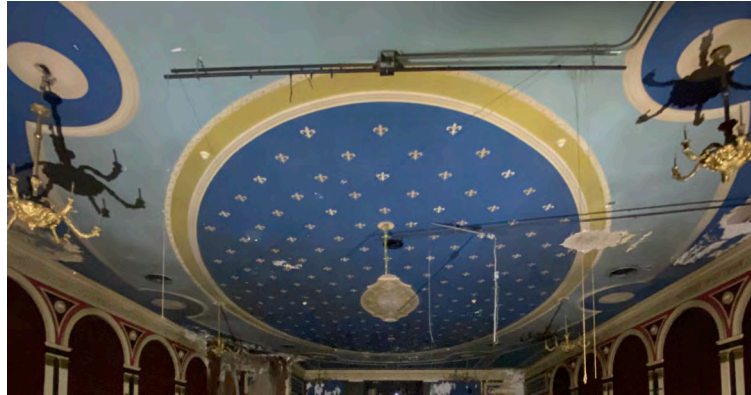
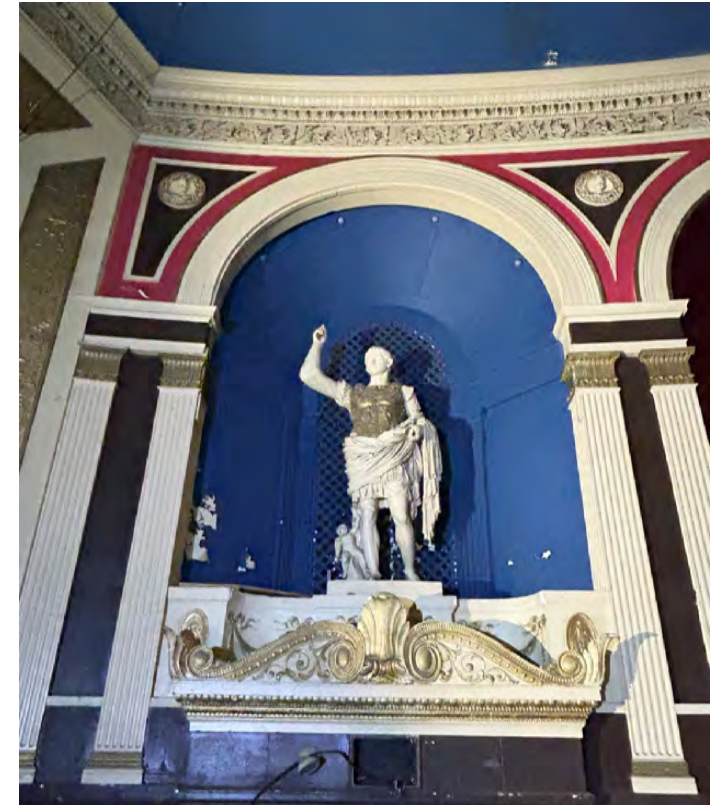
The condition of the asbestos-containing plaster throughout the building is extremely poor, evidenced by widespread damage to plaster walls and ceilings. Debris from this asbestos plaster can be found throughout the premises. Consequently, it is recommended to treat all building surfaces as contaminated with asbestos fibers due to the extent of plaster damage and debris present. -- *Access Environmental Solutions, April 9, 2024*

Hazardous Materials Report – Asbestos throughout the building.
